# SQUALICUM CREEK WATERSHED CHANNEL MIGRATION ZONE MAPPING TECHNICAL REPORT

Prepared for the City of Bellingham Department of Public Works  
September 13, 2016

**RE: Squalicum Creek and Associated Tributary Channel Migration Zone Mapping**  
Whatcom County, Washington

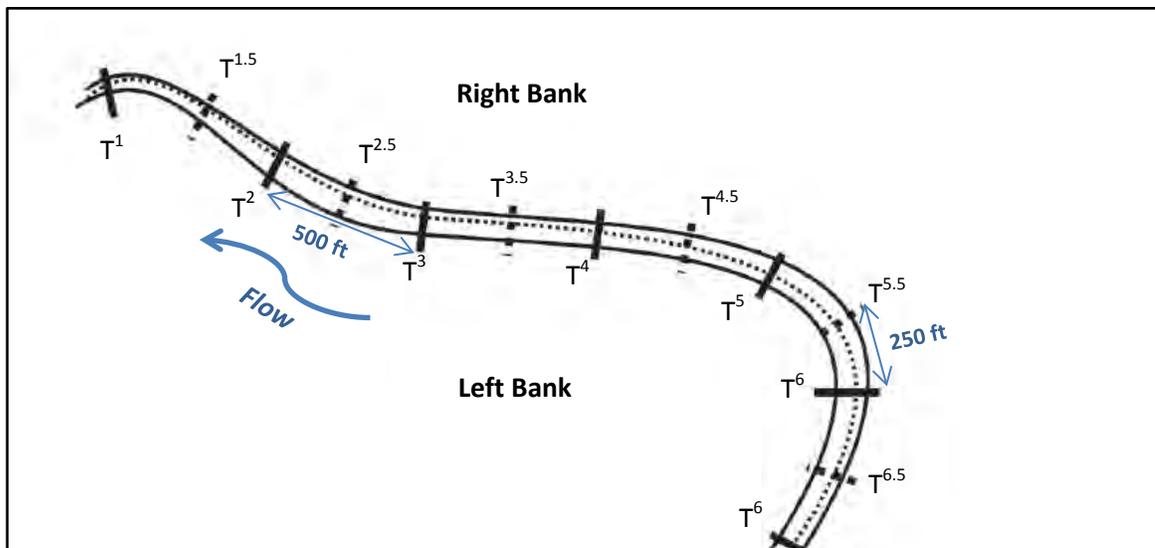
**Figure 2. Reach layout geometry for field data collection of bankfull measurements, bank composition and vegetative cover.** Reach Transects (500-ft apart) are denoted by “T” with whole number superscript, while “half transects” (between transects at 250-ft) are denoted by the previous transect number plus 0.5 superscript. Vegetative cover plots (qualitative % cover per vegetative layer) consist of a rectangular area, 250-ft in length and a width equal to the bankfull width ( $B_{f_w}$ ) plus 50-ft landward of  $B_{f_w}$  from the left and right banks respectively.

Squalicum Creek and its tributaries were divided into stream sections of various lengths, typically ~3,500 feet on average, (Figure 2) which were then transposed onto 8.5x11-in sheets at a 1:4,860 scale. Each reach was then labeled with a coded identifier (A-1, A-2, A-3, etc.; B-1, B-2, B-3, etc.) based on the tributary (i.e. Baker Creek, Spring Creek, or the Squalicum Creek mainstem) and the order in which it was to be surveyed. Using LiDAR and aerial imagery of each stream reach as a guide, surveyors collected geomorphic data *in situ* using corresponding 8.5x11-in mylar sheets while traveling upstream. Areas exhibiting qualifying characteristics of HMZs, EHAs, and AHZs were noted and marked with a Garmin GPS (60CSx), while a qualitative assessment of stream bank erosion susceptibility (low, moderate, severe, or armored) was performed by shading bank segments on the mylar sheets to indicate the appropriate classification (Appendix IV).

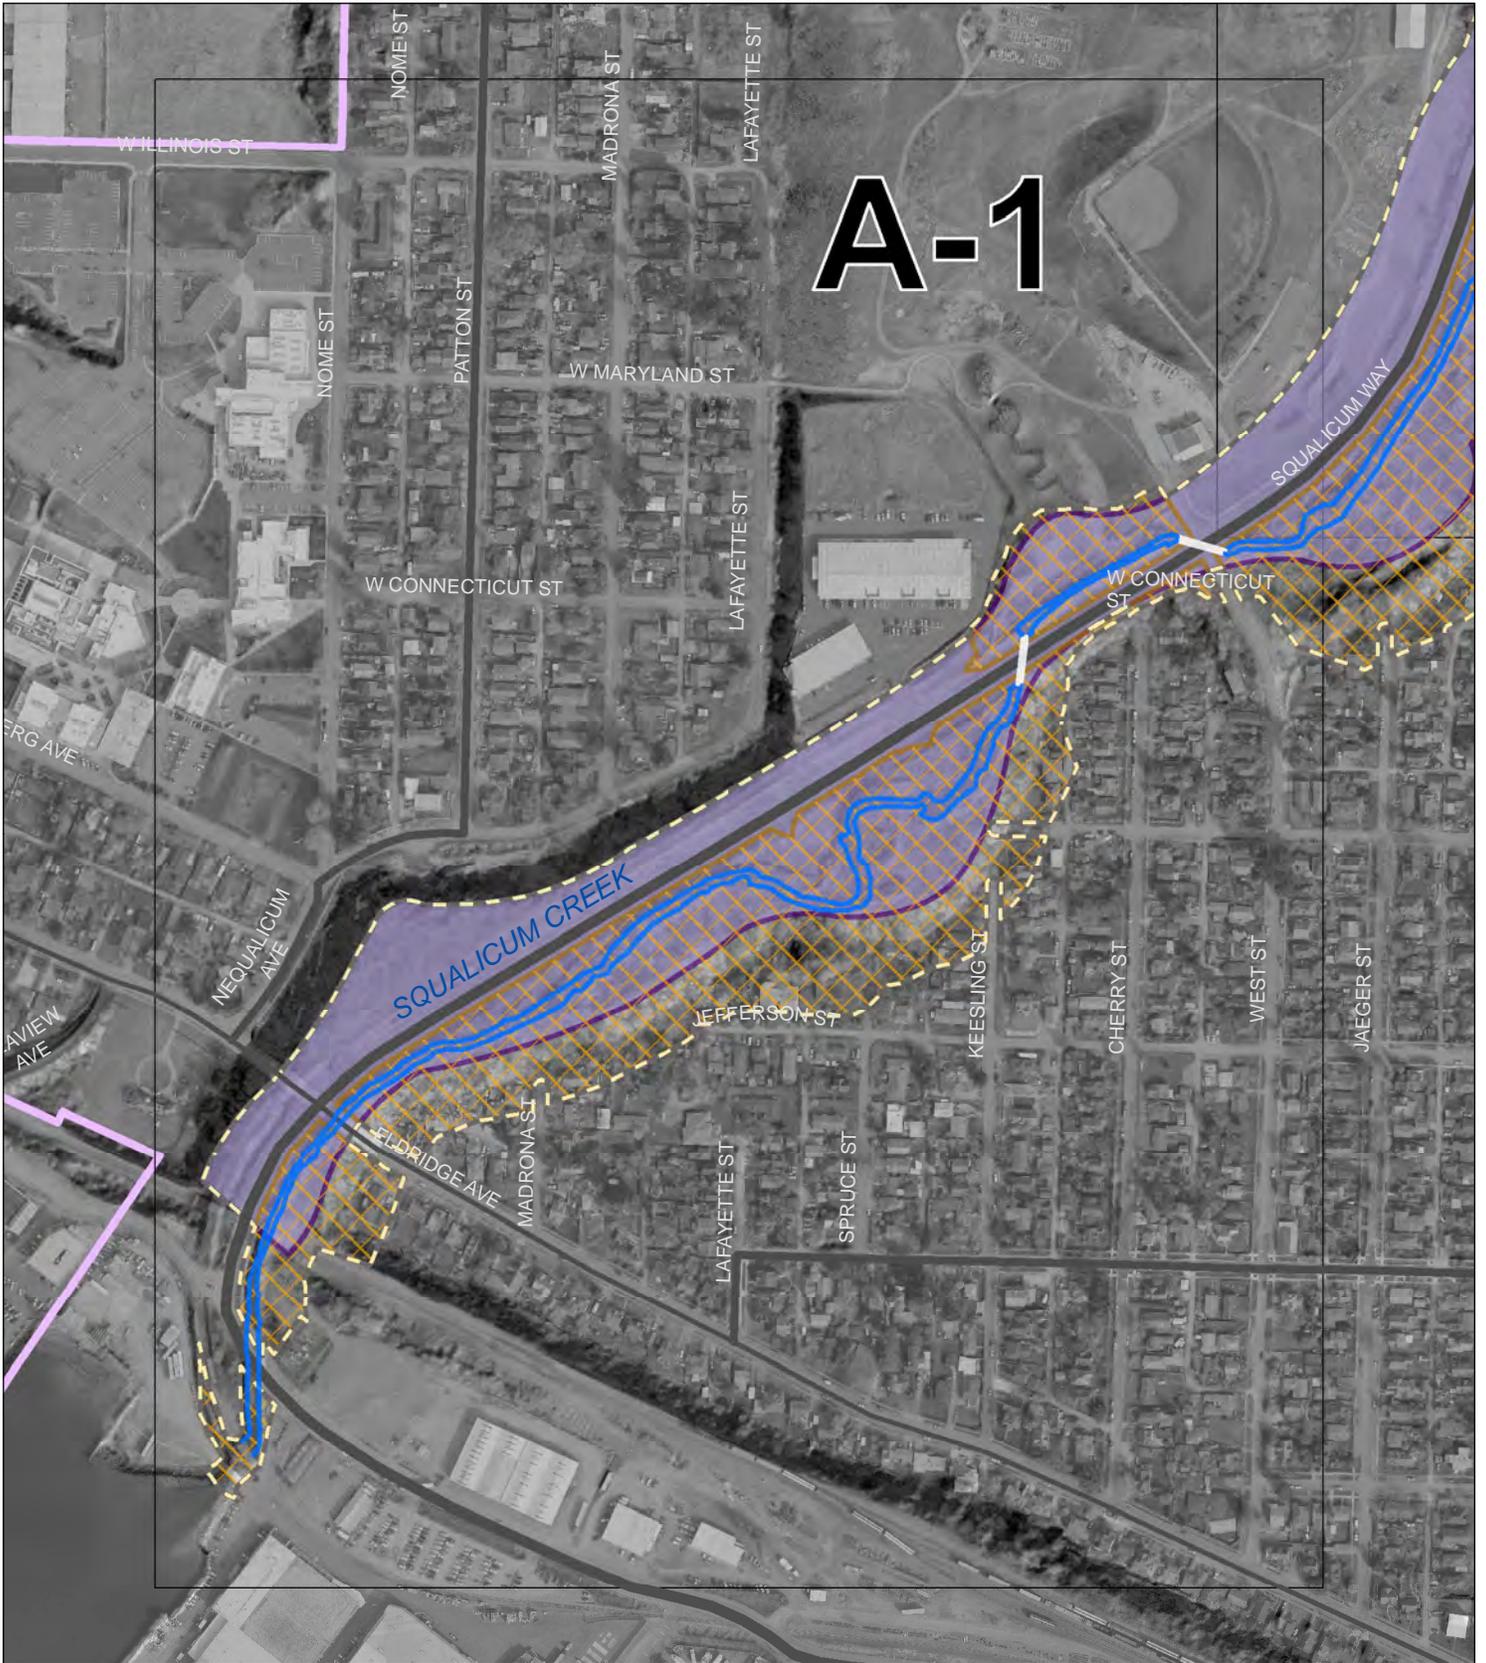
# A-1

- Streams
- Culvert
- Lakes
- Channel Migration Zone (CMZ)
- Erosion Hazard Area (EHA)
- Historic Migration Zone (HMZ)
- City Boundary
- Urban Growth Area

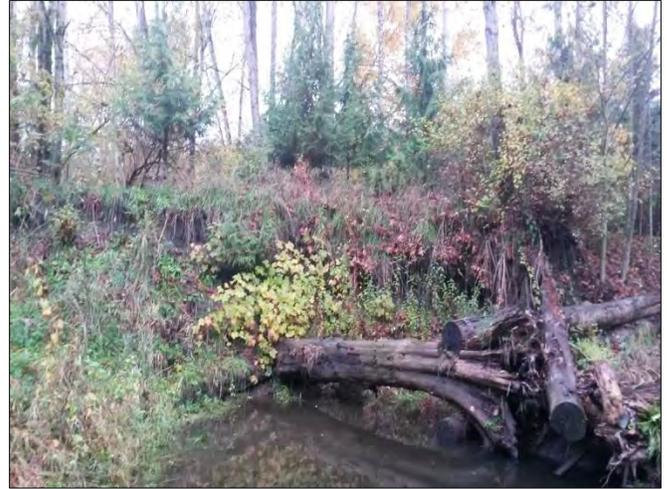
**Photo 2:** Installed LWD near mouth.

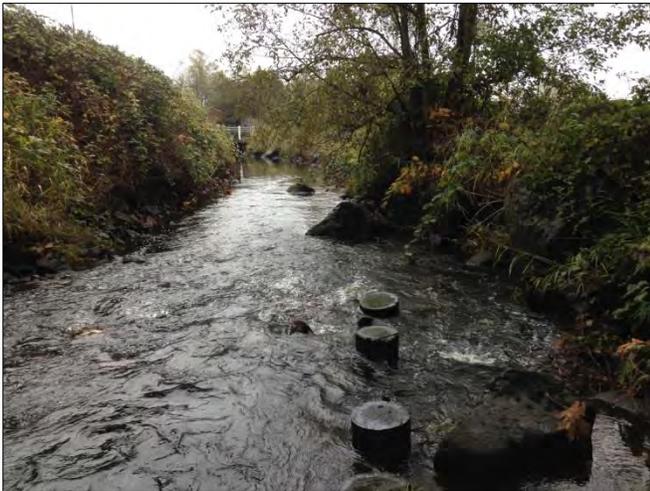
**Photo 3:** Armored banks with blackberry.

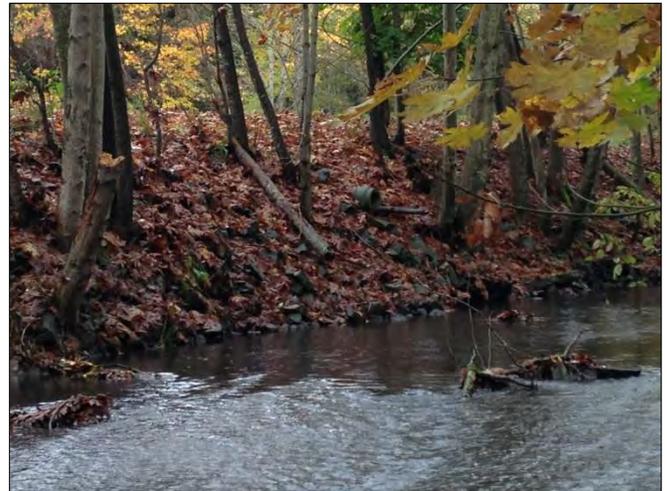
**Photo 4:** Relict bank armoring.

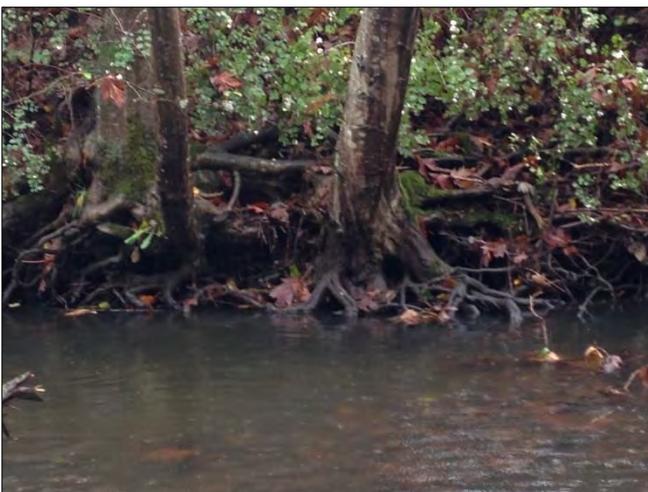
**Photo 5:** Undercut banks below maturing alders.

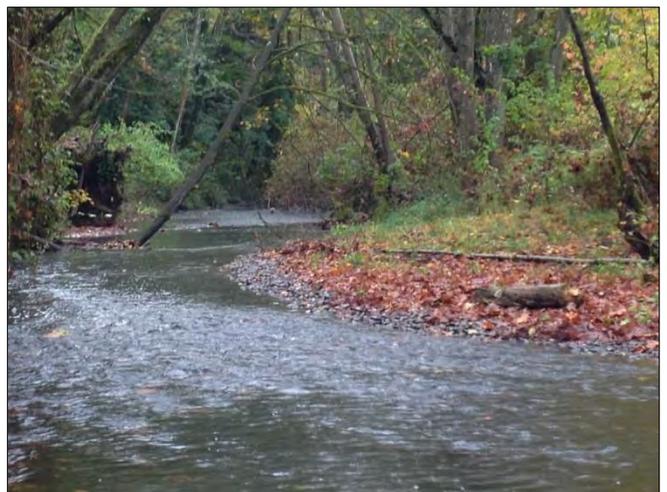
**Photo 6:** Wide banks of Lower Squalicum with gravel.

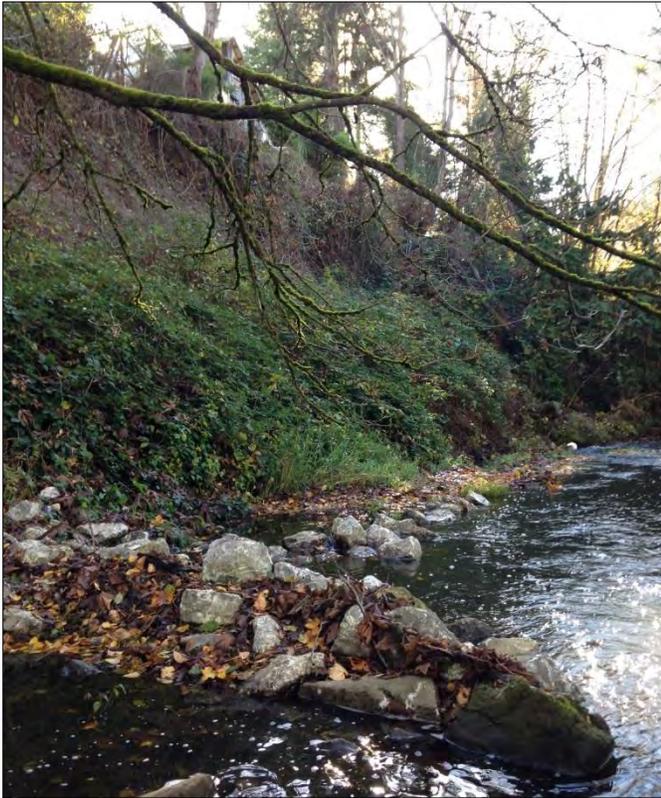
**Photo 7:** "Wing dam" with severe erosion in background.

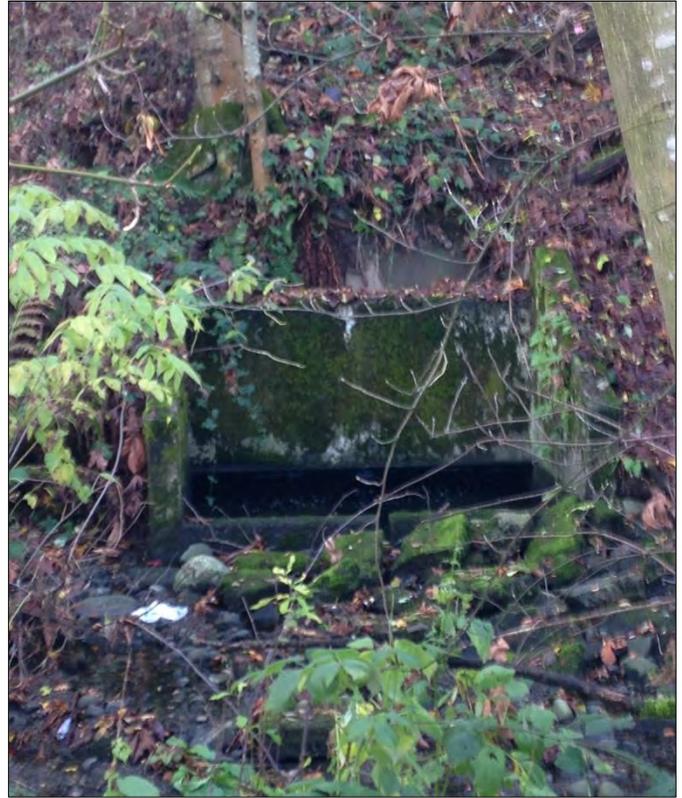
**Photo 8:** Relict stormwater feature.

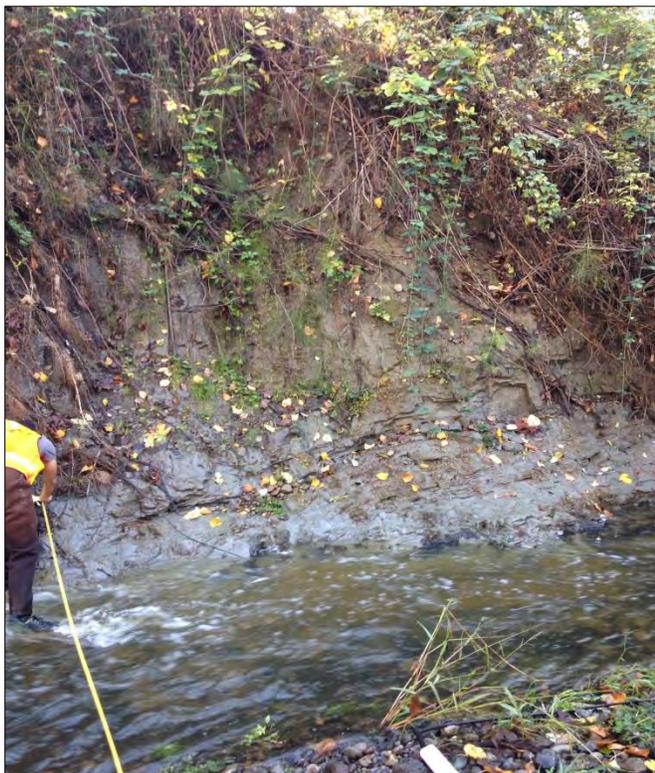
**Photo 9:** Glaciomarine drift "clayey" banks.

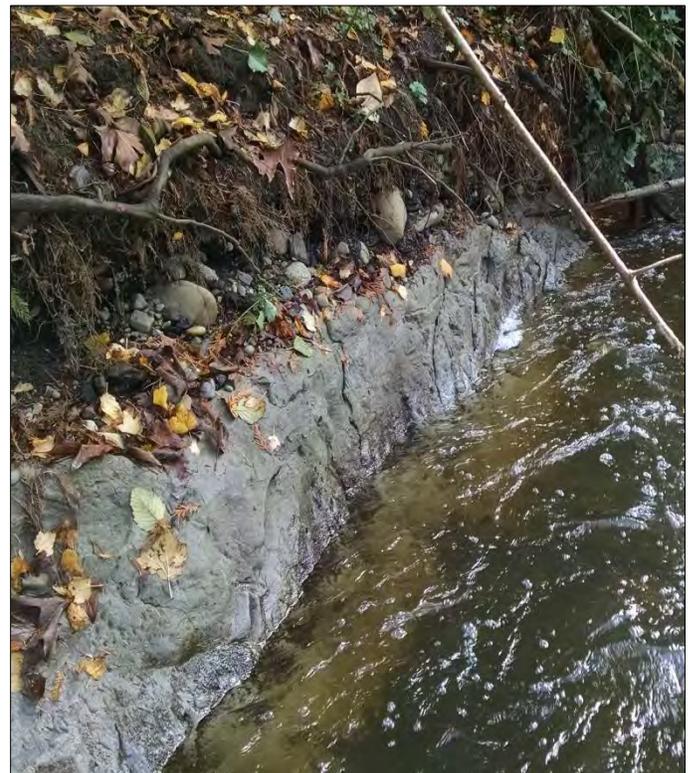
**Photo 10:** Glaciomarine drift bank demonstrating "resistance" to erosion.

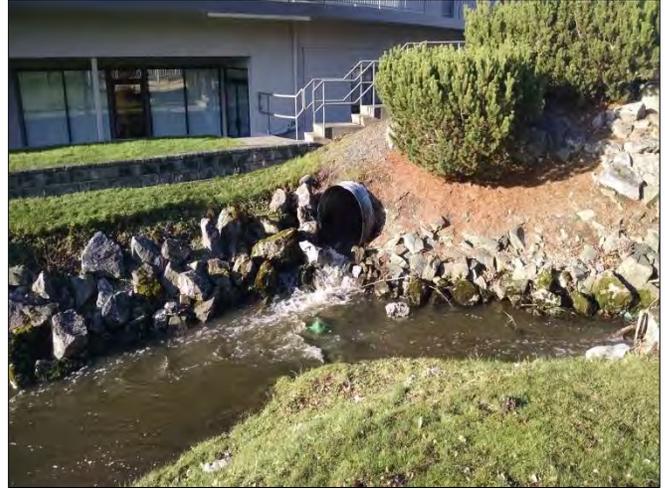
**Photo 12:** Culvert "mouth" of tributaries.

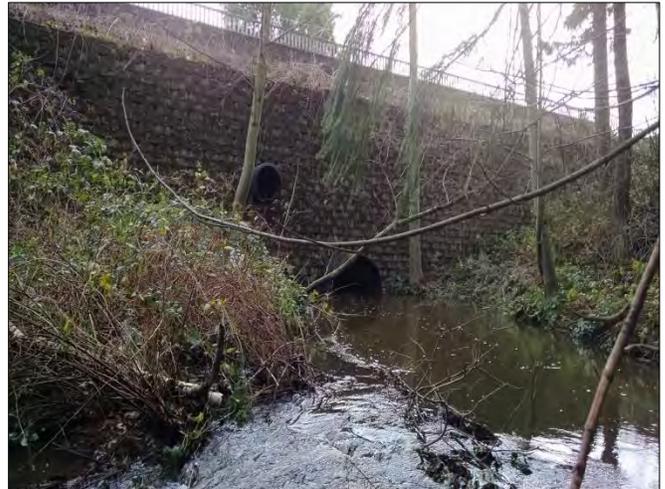
**Photo 14:** Culvert wetland near Bakerview Rd.

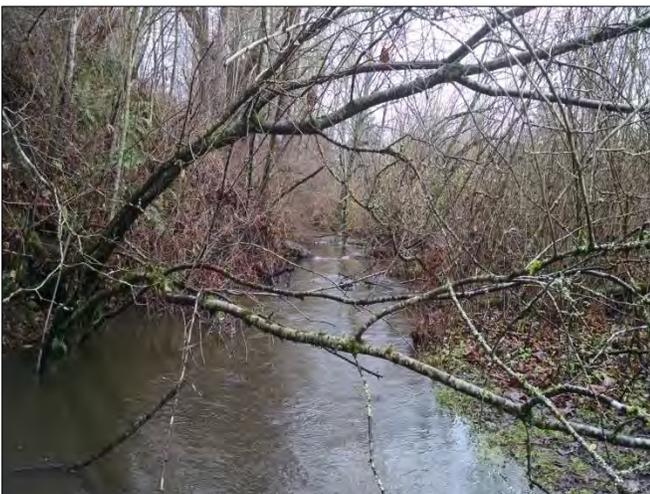
**Photo 15:** Upper stream segment of B-5.

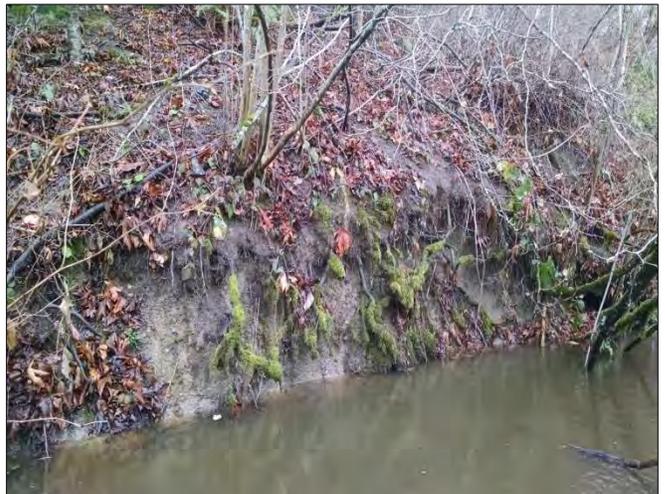
**Photo 16:** Bank erosion in reach B-5.

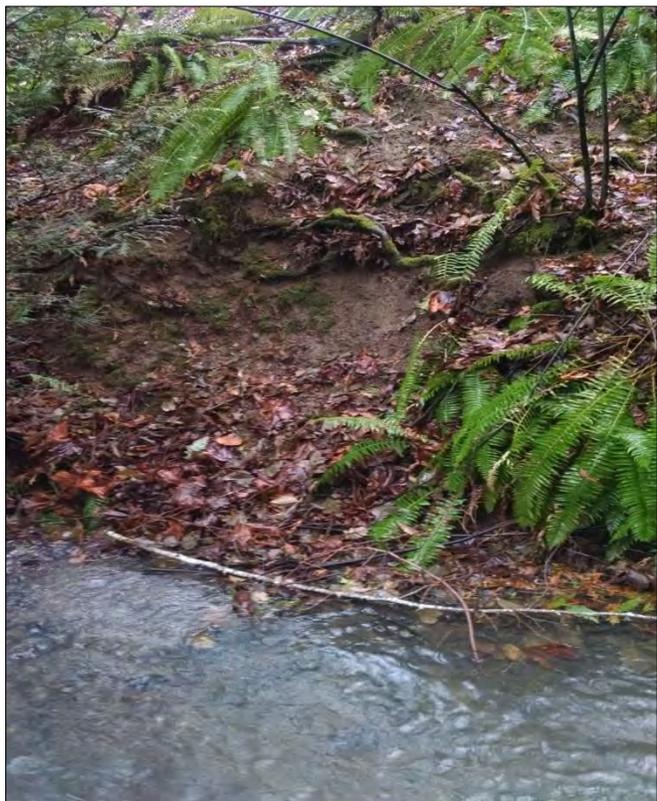
**Photo 17:** Evidence of later erosion.

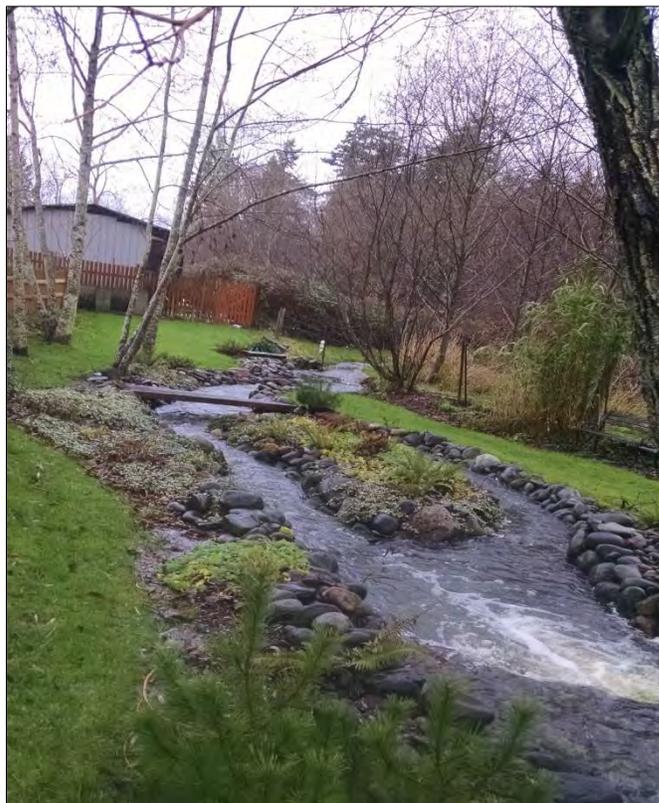
**Photo 18:** Channel modification on private property.

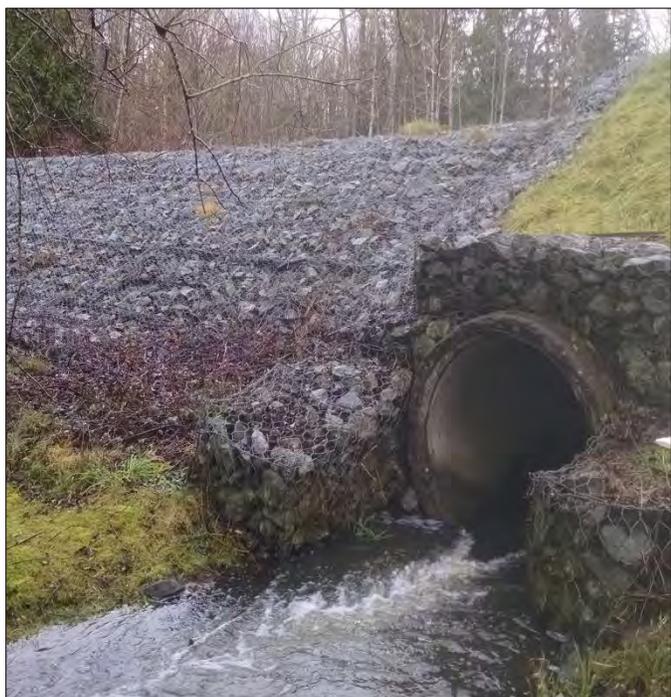
**Photo 19:** Stormwater control structure.

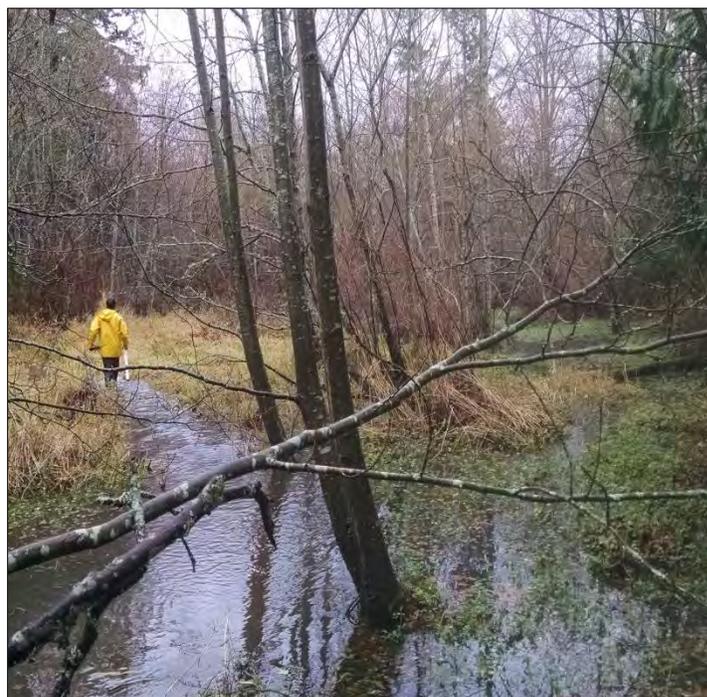
**Photo 20:** Wetland upstream of stormwater structure.

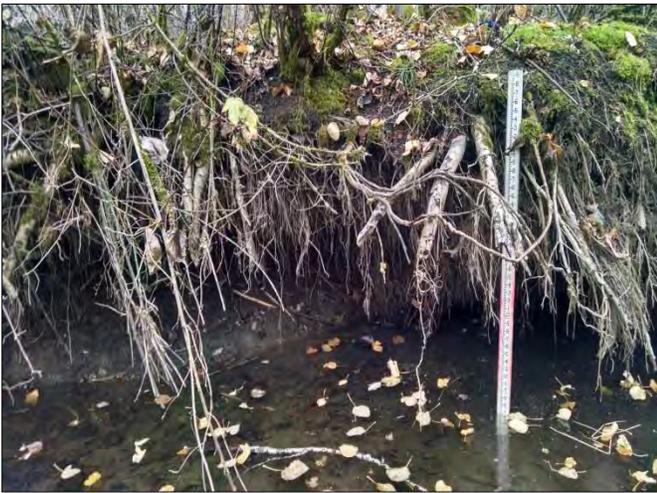
**Photo 23:** Severe undercut bank behind Hospital.

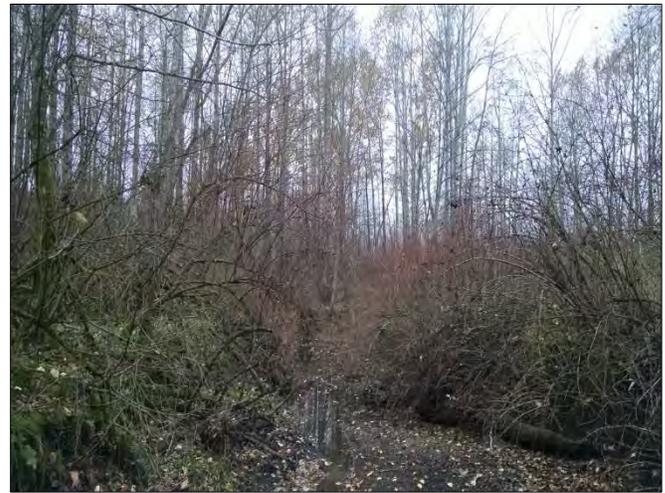
**Photo 24:** Thick underbrush, bank erosion.

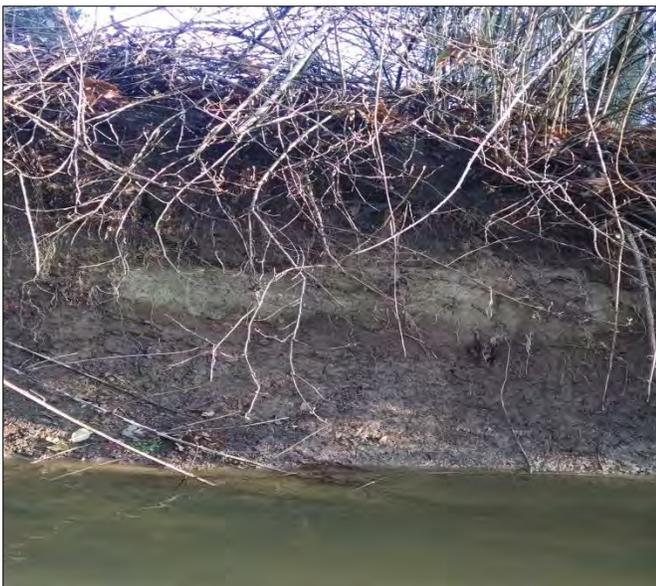
**Photo 25:** Active erosion in D-6.

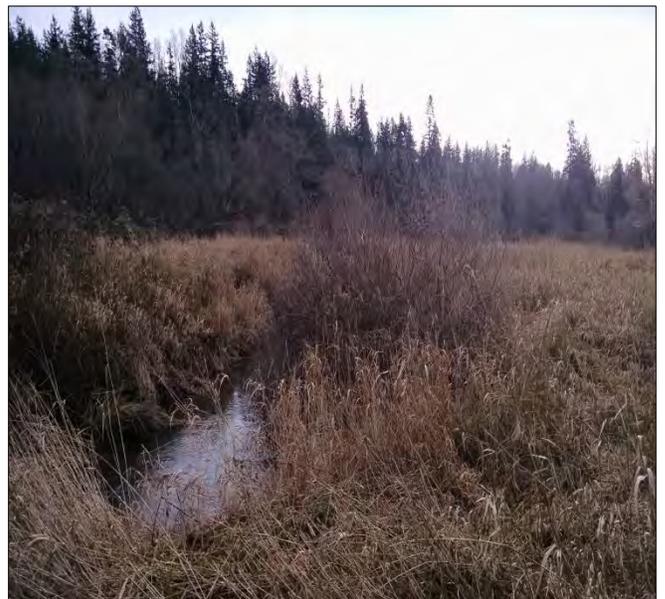
**Photo 26:** Canarygrass field wetland in D-5.
