# Anderson Creek Characterization and Alternatives Analysis

Bellingham, Washington

City of Bellingham  
Public Works Department  
Natural Resources Division

August 2019

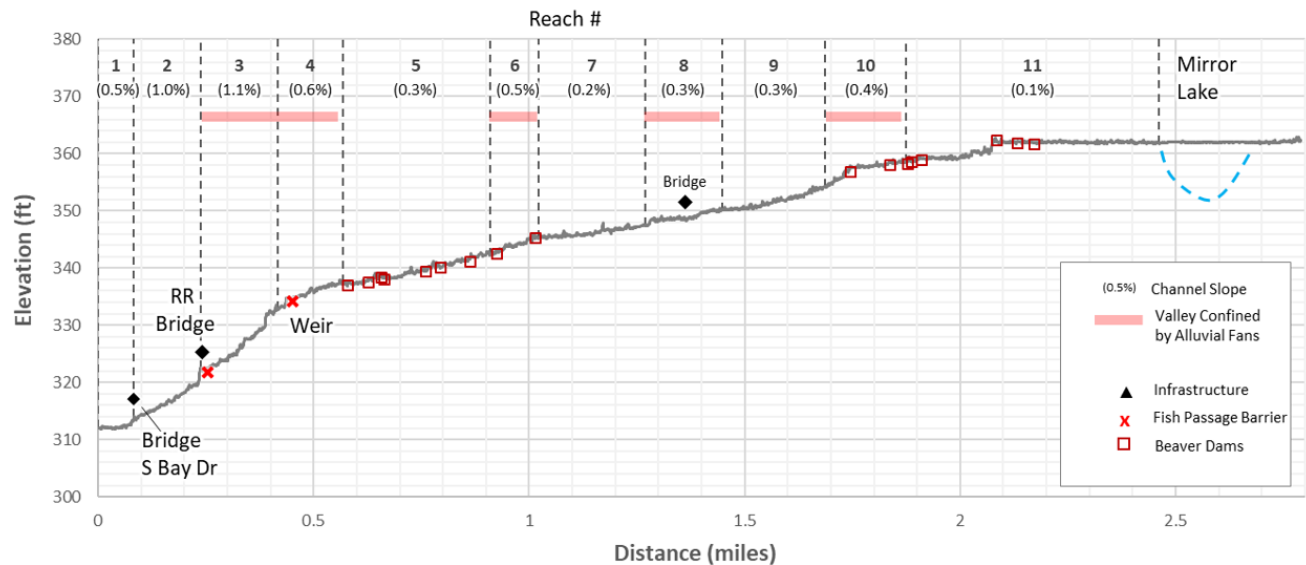
Figure 7. Anderson Creek Longitudinal profile from 2013 LiDAR showing the 11 geomorphic reaches.

As noted in Figure 7, beavers are active throughout the watershed, and have an enduring influence in Reaches 5, 10, and 11. The most active beaver colonies are in Reach 11 below Mirror Lake. Many of the lower dams are not active as of 2018.

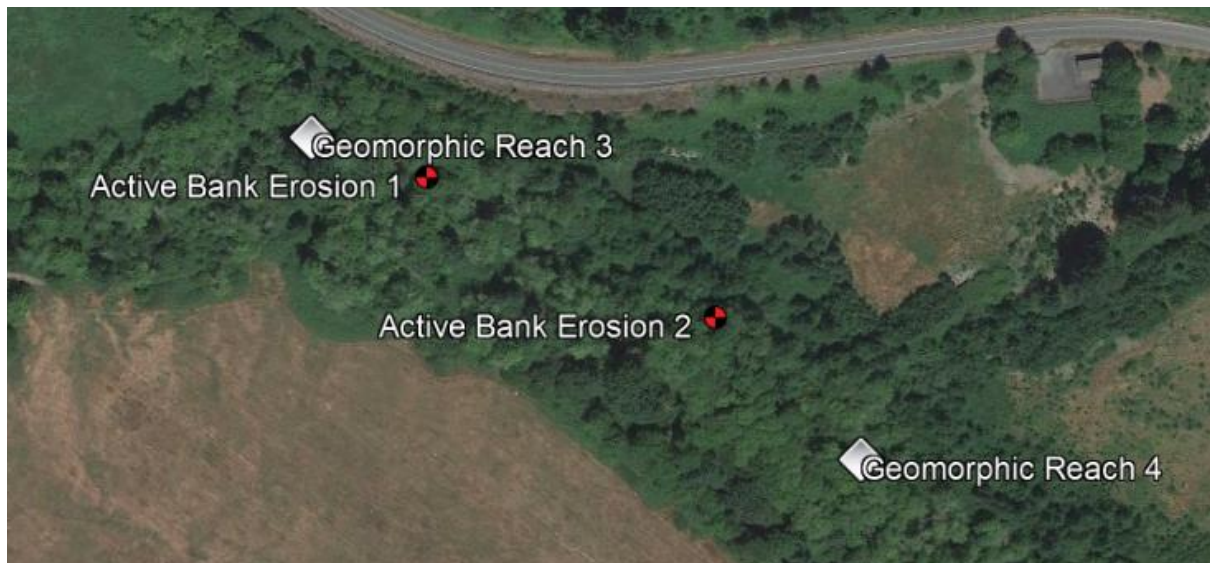
Figure 8 Active bank erosion locations in Anderson Creek geomorphic reach 3.

Only two significant areas of bank erosion were observed during the 2018 surveys, both in geomorphic reach 3 (Figure 8 and Figure 9). In these locations, bank erosion was 3 meters (9 feet) and 7 meters (21 feet) long, respectively. Reach 3 is where the channel is most influenced by the railroad grade, so the channel is likely responding to a combination of past confinement and incision.

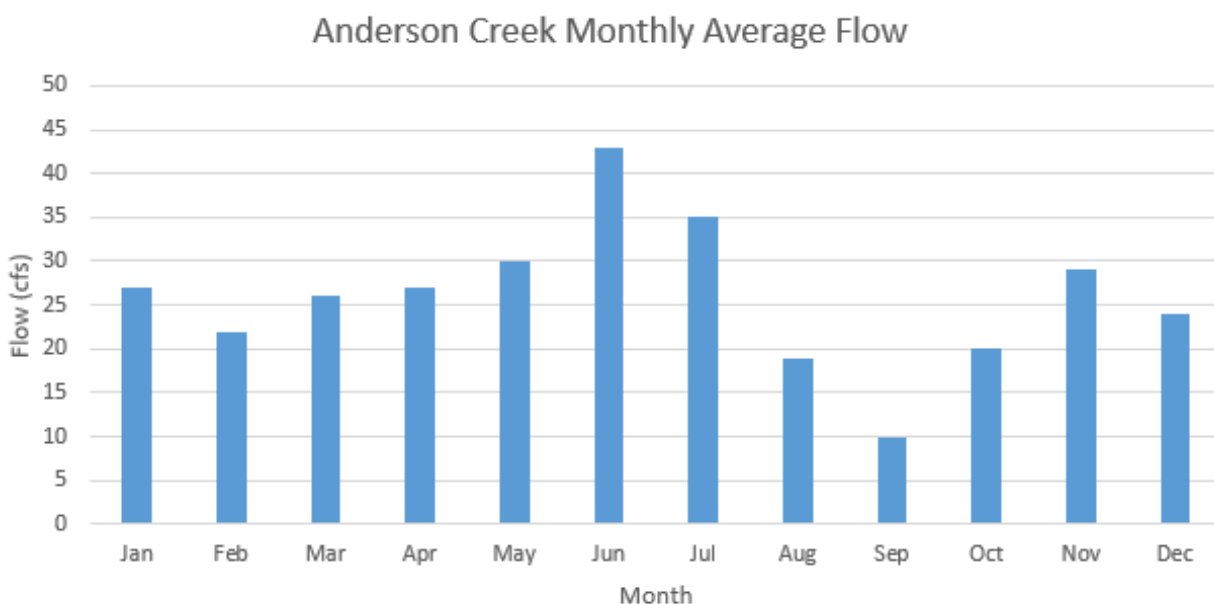
Flow in Anderson Creek is influenced by both direct rainfall and snowmelt from higher elevations. Rain events drive high flows from November to January, and snowmelt peaks drive high flows in June and July as captured in monthly average flows (Figure 11). Flows in Anderson Creek have been gauged by the USGS. The gauge at the South Bay Road crossing has operated by the USGS from 1969 to 1977 and then from 2007 to present. For 1992 to 2007, Western Washington University's Institute for Watershed Studies operated the gauge.

**Figure 11 Anderson Creek hydrology shown as average monthly creek flow in cubic feet per second (cfs). Please note that these long-term statistics include diversion flows**

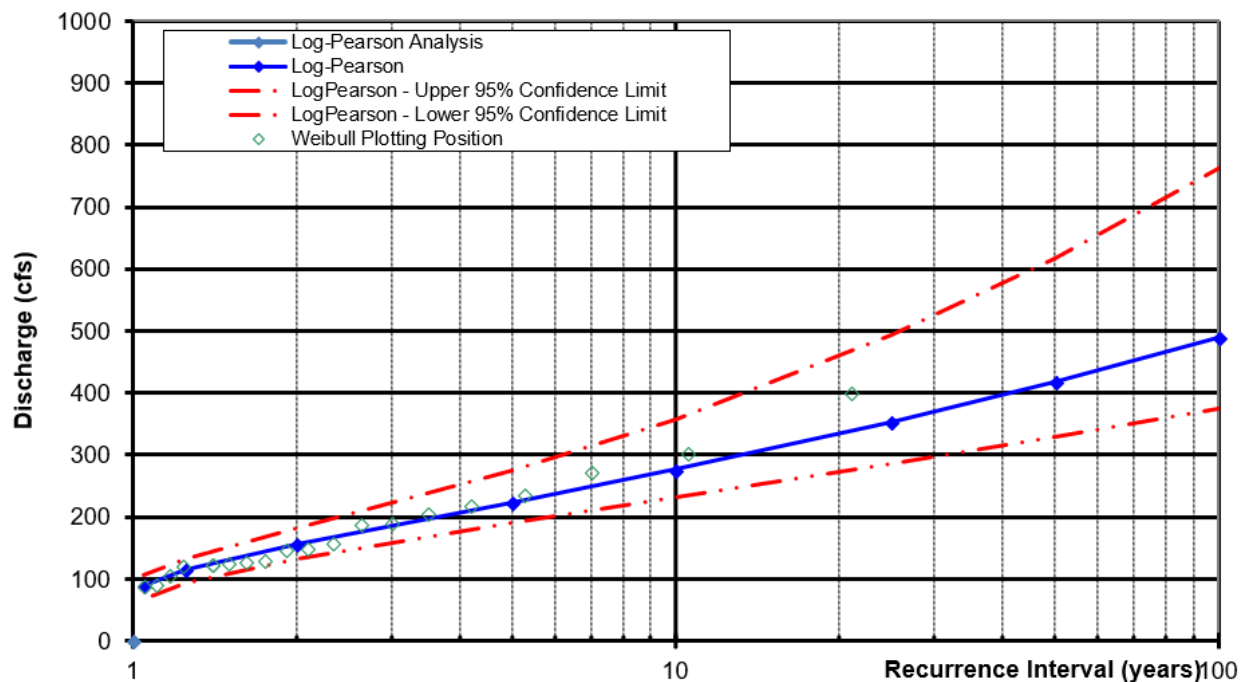
Figure 12 Log-Pearson analysis of flood recurrence intervals for Anderson Creek.

- Annual flood = 100 cfs
- 2-year flood = approx. 150 cfs
- 10-year flood = approx. 275 cfs
- 100-year flood = approx. 500 cfs.

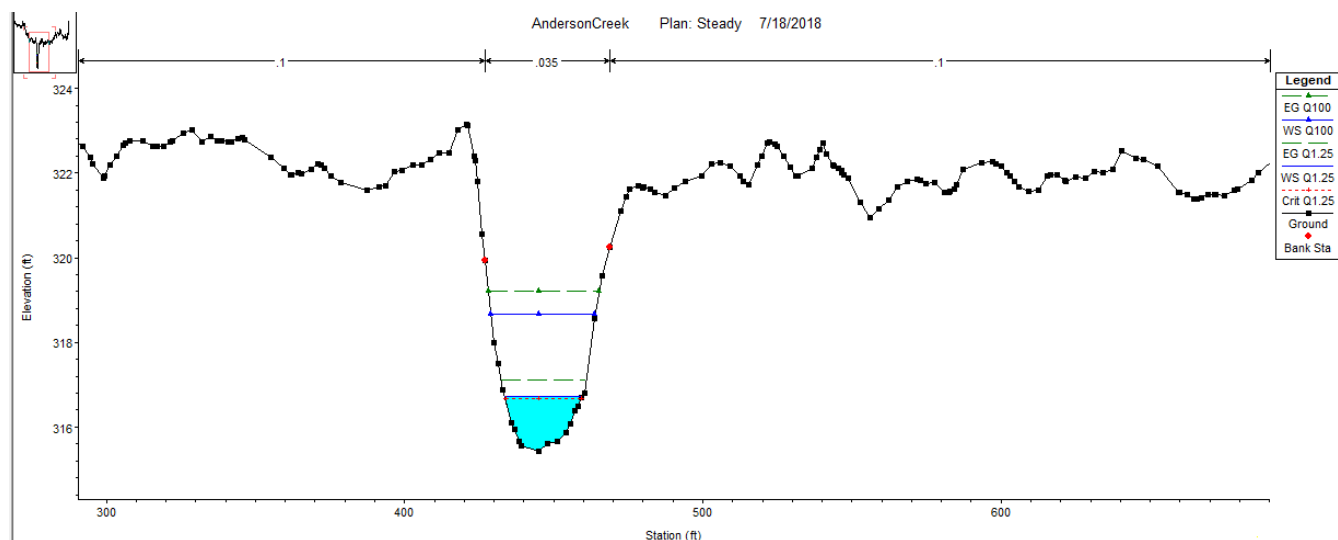
Existing FEMA maps do not depict any regulated floodplain around Anderson Creek. However, they do identify a limited “A” Zone, or 100-year floodplain zone, around Mirror Lake. To further understand the hydraulics of Anderson Creek, we developed a 1D HEC RAS model based on 2013 LiDAR and limited survey data collection. The hydraulic model results suggest that the channel is confined within the banks of the creek, with just a few areas of broad inundation at the 100-year flow. The figures below (Figure 14 and Figure 15) illustrate the variance between confined reaches and reaches with broader inundation at high flows.

Figure 14. HEC-RAS results in Reach 2 showing the 1.25 year recurrence interval flow (Q1.25) in blue shading and the 100 year recurrence interval flow (Q100) stage in dark blue with triangles. Note that EG = Energy Grade, Crit = Depth at critical flow.

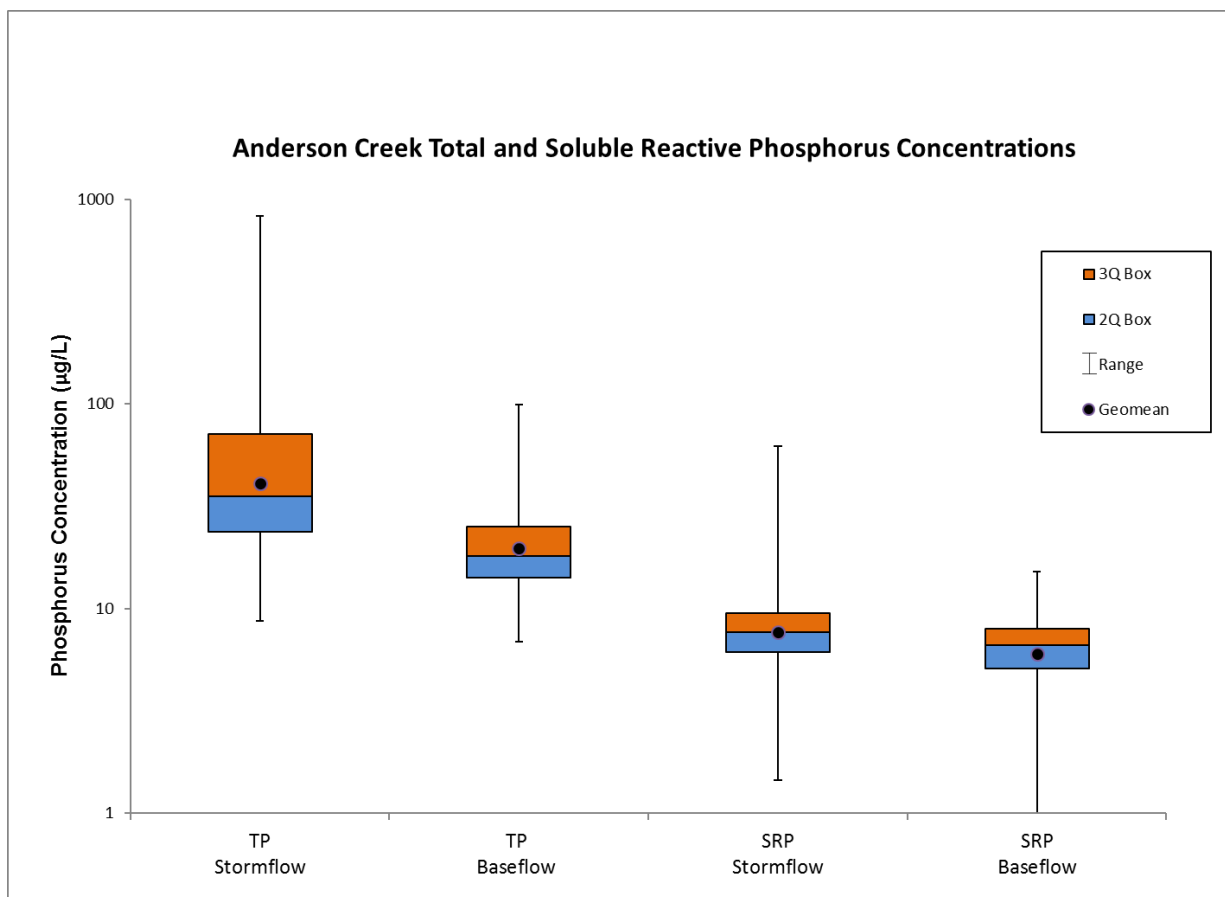
Figure 16. Phosphorus Concentrations in Anderson Creek (*note log scale*)

Figure 17 shows the total phosphorus (TP) and soluble reactive phosphorus (SRP) concentrations in stormwater and baseflow samples collected from Anderson Creek by the City, Whatcom County, and WWU collected stormwater and baseflow samples between June 2007 and May 2018. As shown in the figure, total phosphorus concentrations were much higher than soluble reactive phosphorus concentrations, indicating that most of the phosphorus is in particulate form. This is consistent with other recent studies that found most of the phosphorus load to Lake Whatcom enters the lake adsorbed to suspended sediments from creeks (e.g., Beeler and Mitchell 2017).

Figure 17 also shows that total phosphorus concentrations were considerably higher in stormflow as compared to baseflow samples, while soluble reactive phosphorus concentrations in stormflow samples were similar to baseflow concentrations. This pattern indicates that the increase in total phosphorus during storm events is attributable to particulate rather than dissolved phosphorus.

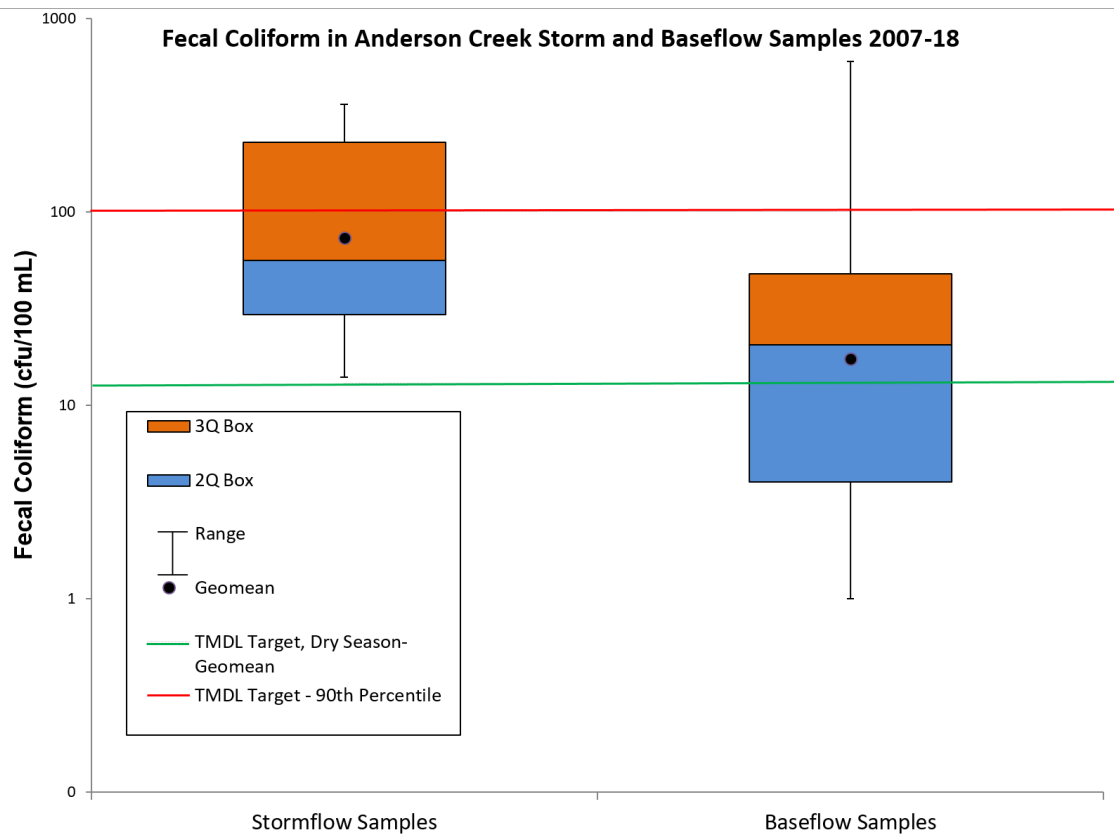
Figure 17. Fecal Coliform Bacteria in Anderson Creek Storm Event and Baseflow samples (2007–2018)

Figure 18 shows the fecal coliform concentrations in storm event and baseflow samples collected from Anderson Creek by the City, Whatcom County, and WWU during 2007–2018. Table 1 below compares the results to the TMDL targets. As shown in the table, fecal coliform concentrations exceeded the TMDL targets.

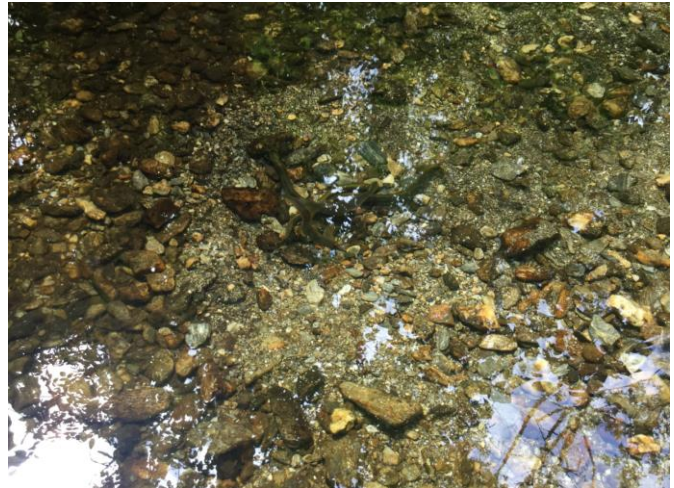
Spawning lamprey observed during field reconnaissance

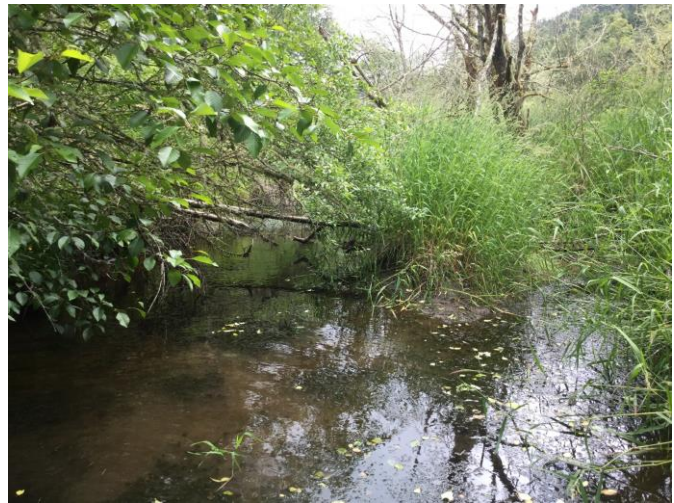
Example of Anderson Creek pool currently in poor to fair condition, from reach 5.

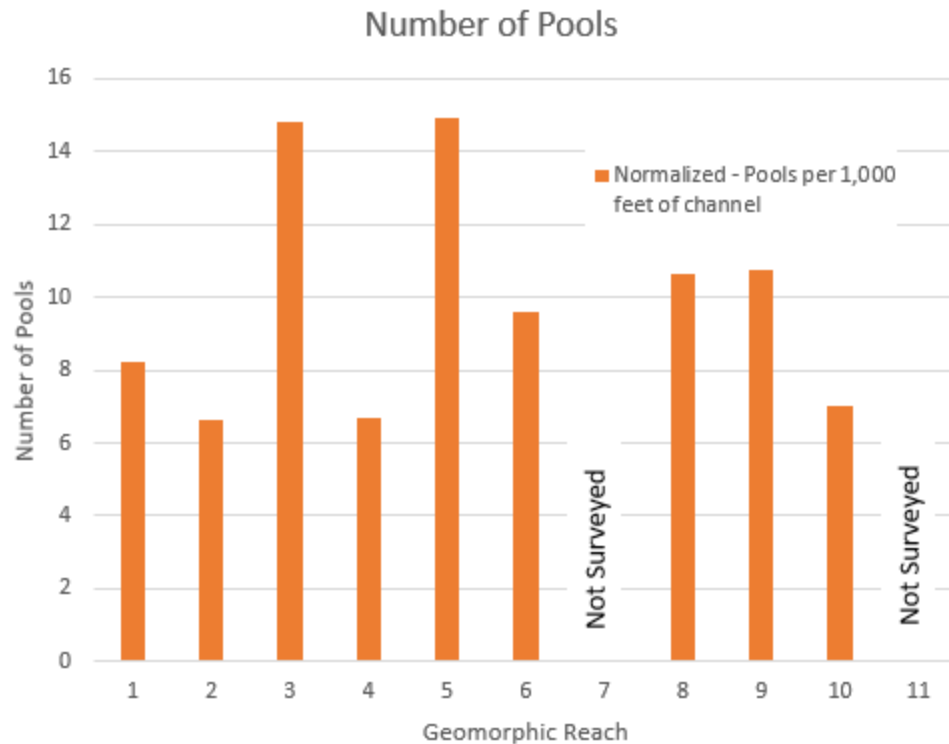
Figure 18. Normalized number of pools/1,000 feet of channel in Anderson Creek

- ▶ There are approximately 90 pools in Anderson Creek. Approximately a third of the pools are in good condition based on having clean spawning gravels over 50 percent of the tailout.
- ▶ Pools forced by beaver dams are the most common form.
- ▶ Pools are most common in Geomorphic Reaches 3 and 5, notably upstream of the railroad bridge. In Reach 3, pool formation is related to higher channel slope and in Reach 5, pools are typically forced by beaver dams.
- ▶ Pool tail outs include appropriate spawning gravel, particularly in the higher gradient reaches.

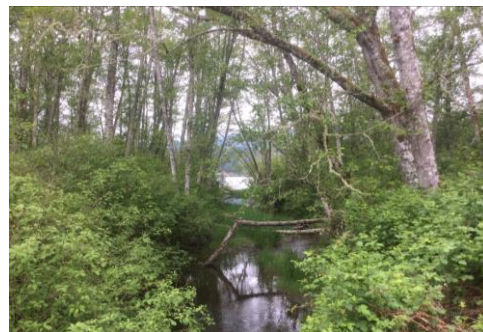
Red Alder / Salmonberry Forest at Anderson Creek (2018)

Despite the current high level of functioning of the riparian corridor, the deciduous forest is aging and generally does not include establishing conifers. Much of the canopy is currently comprised of red alder trees, which are senescing and reaching the end of their lifespan. The source of coniferous seed has largely been extirpated from the valley bottom, due to logging. Aside from a 2-acre red alder / bigleaf maple/conifer reference site, the riparian forest will require active management to avoid loss of mature coniferous trees over time and the

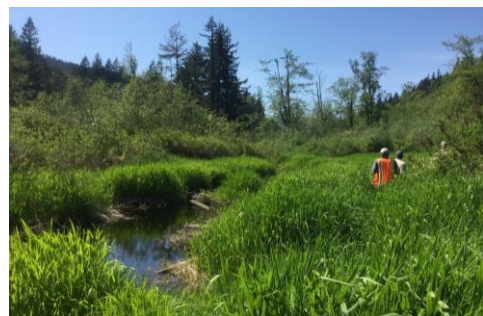
Red Alder / Willow / Spirea Wet Shrubland

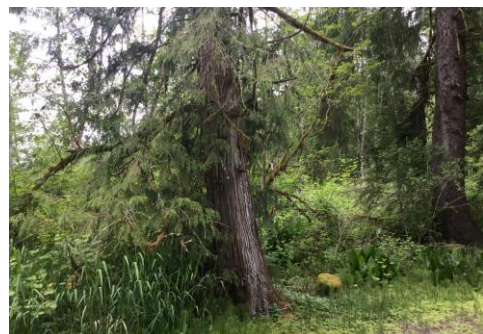
Western red cedar along Anderson Creek (2018)

beneficial canopy cover and source of large wood/key pieces they provide. Conifers will need to be manually re-established through plantings, in order to facilitate natural forest succession and to provide a future source of in-channel wood (see Section 2.6). In much of the riparian corridor there are also dense shrubs, typically salmonberry, in the understory which can outcompete tree species. Therefore, due to a lack of diverse tree-seed sources, and natural competition with shrub-species, there is a risk of losing the valuable forest and shade in the stream corridor over time.

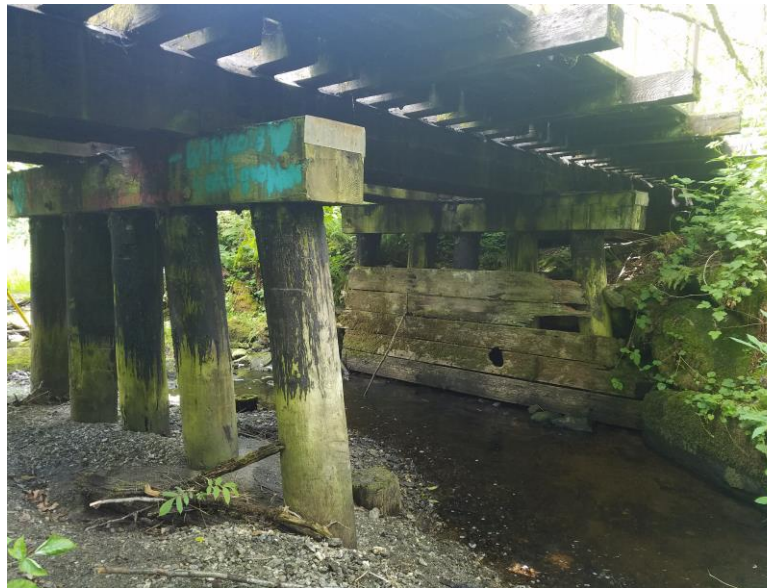
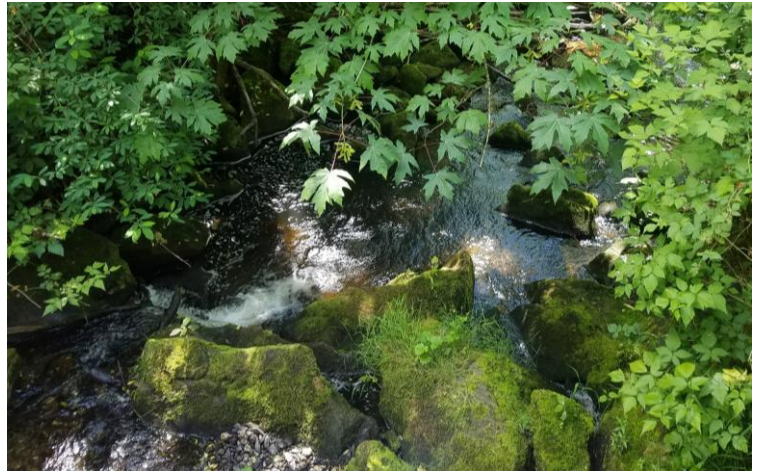
## Remove Railroad Bridge

- 15 vertical 14" diameter piers
- 55' x 17' bridge deck (approximate dimensions), and
- a wooden retaining wall
- lumber appears to be treated with creosote
- Riprap was placed along the stream banks both upstream and downstream of the railroad bridge to prevent channel erosion from impacting bridge stability, however this has resulted in a fish passage barrier and a reduction in instream habitat (see photo).
- The riprap exists along the right bank of the channel from 30 ft upstream of the bridge to 50 ft downstream of the bridge and along the left bank for 115 feet downstream of the bridge.
- Approximately 10 ft downstream of the bridge, riprap within the channel has created a 2 ft drop over large riprap (see top image).

Railroad bridge and riprap

Riprap fish passage barrier downstream of bridge

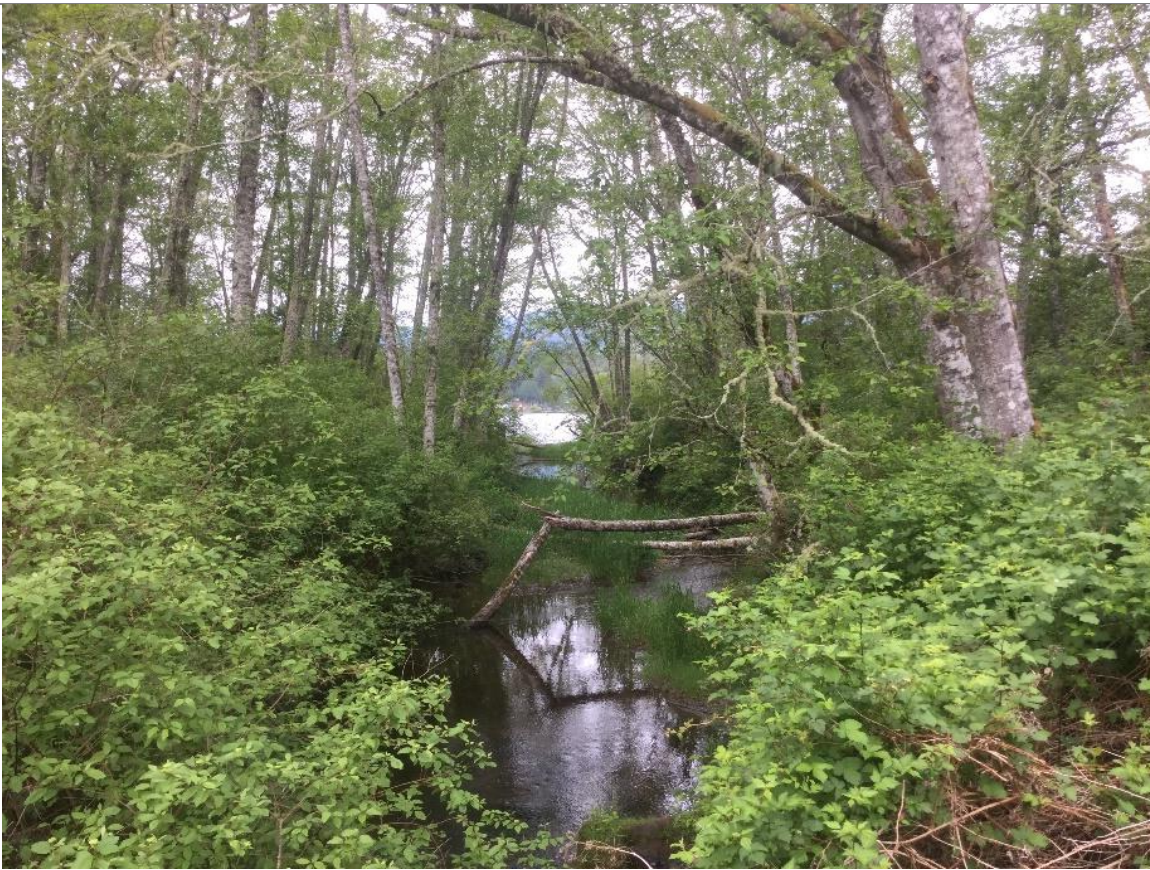
Approximately 55 acres of red alder / salmonberry riparian forest was delineated in the Anderson Creek Corridor. These areas are characterized by a mature canopy of red alder growing over a dense salmonberry-dominated understory. Other species in the canopy include a few relict black cottonwood and big leaf maple. Understory plants also include red elderberry, red osier dogwood, thimbleberry, Nootka rose, twinberry, stink currant, and Indian plum. Red alder trees in these areas ranged from 20-60 cm dbh. As the red alders continue to mature and senesce over the next 30 years, it is likely the forest will transition to a salmonberry shrub thicket.

Figure 21. Photo of existing Red Alder / Salmonberry Forest at Anderson Creek (2018)

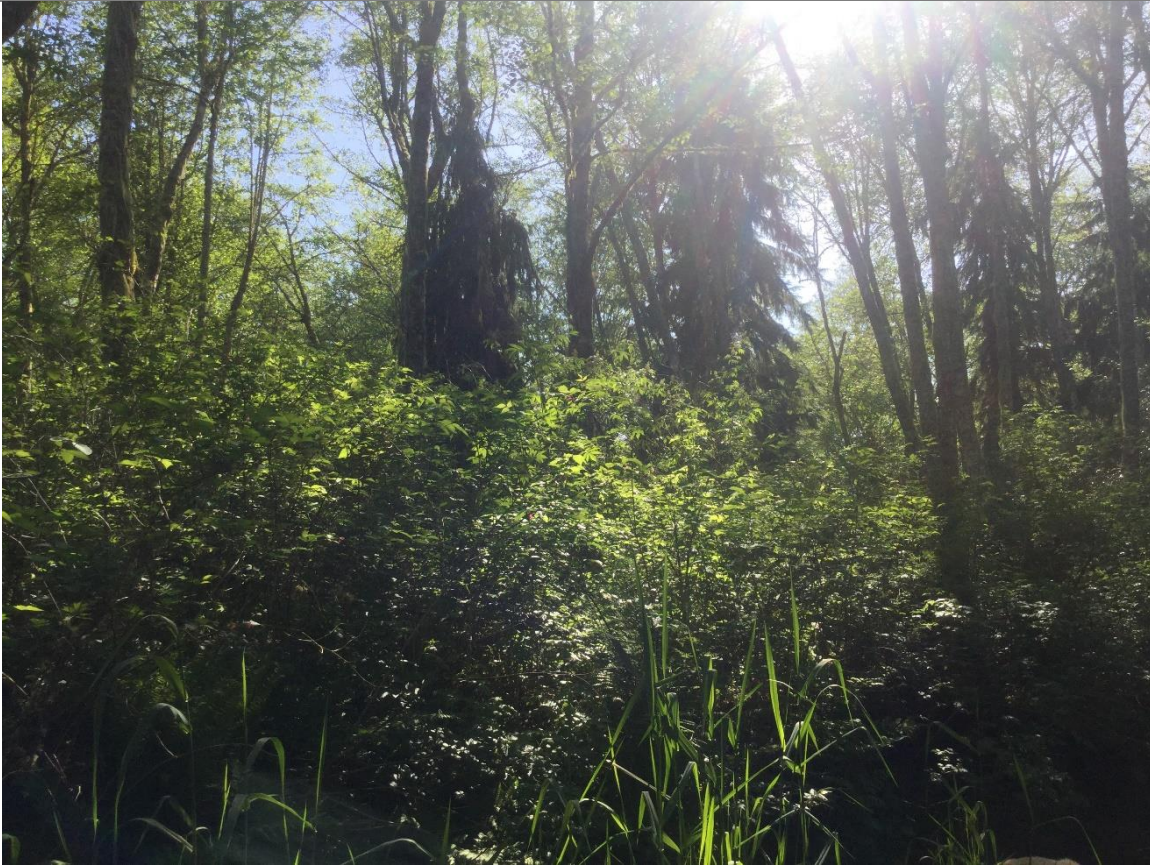
Approximately 42 acres of red alder / big leaf maple forest were delineated in the Anderson Creek corridor. The canopy in these areas is dominated by mature broadleaf trees. Red alder is largely dominant, although big leaf maple is co dominant in small areas. Both mature and emergent conifers exist in these areas, although they account for an estimated 10-20 percent or less of the forest canopy. Conifer species are primarily western red cedar and Sitka spruce. The understory is dominated by salmonberry, but also contains Nootka rose, thimble berry, twinberry, red elderberry and red osier dogwood. In areas where red alder is the dominant canopy species, there is potential for the forest to transition into a salmonberry shrub thicket.

Figure 22. Photo of existing Red Alder / Bigleaf Maple Forest at Anderson Creek (2018)

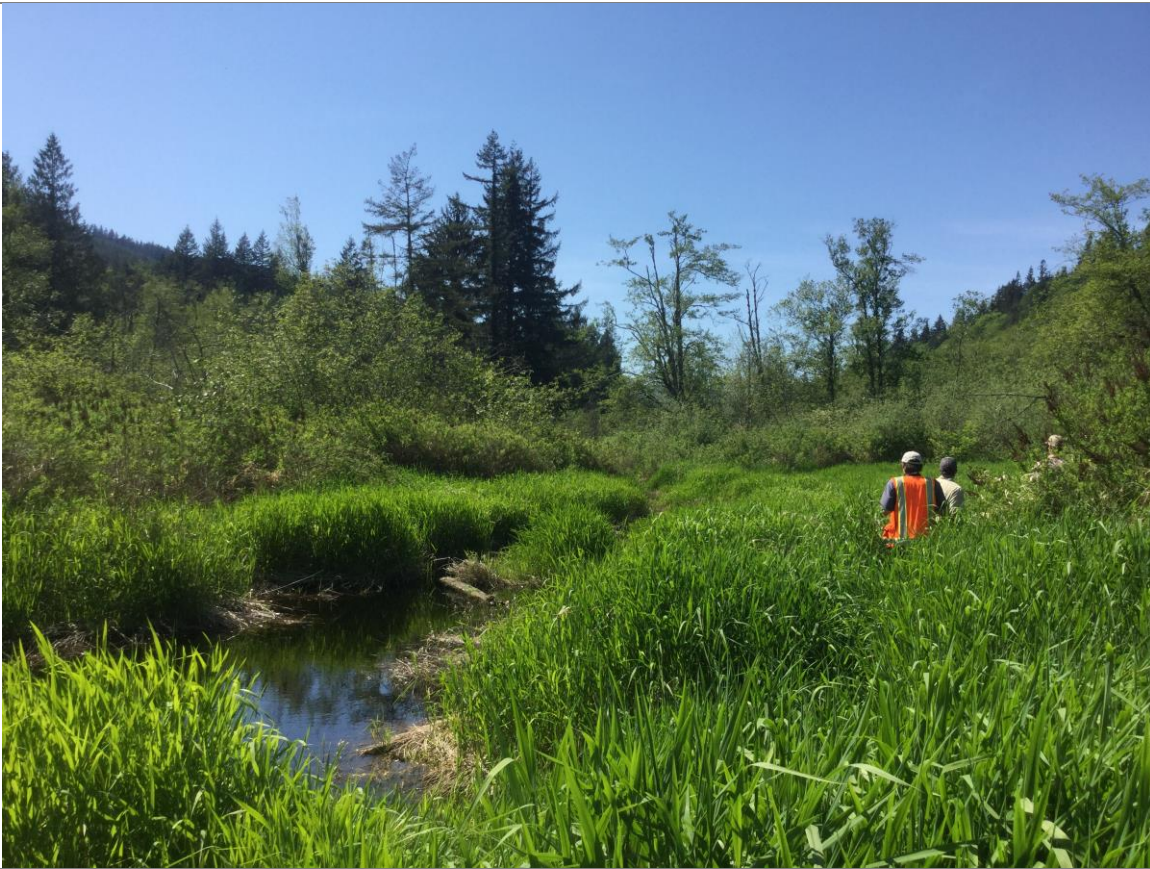
Approximately 28 acres of red alder / willow / spiraea wet shrubland were delineated in the Anderson Creek corridor. Vegetation in these areas is dominated by a dense spiraea, willow, and reed canary grass understory. In many areas directly adjacent to the stream bed, reed canary grass is outcompeting native vegetation. Twin berry and cascara are present as well, but are never dominant or codominant in the understory. These areas often include sparse mature to senescent red alders.

Figure 23 Photo of existing Red Alder / Willow / Spirea Wet Shrubland at Anderson Creek (2018)

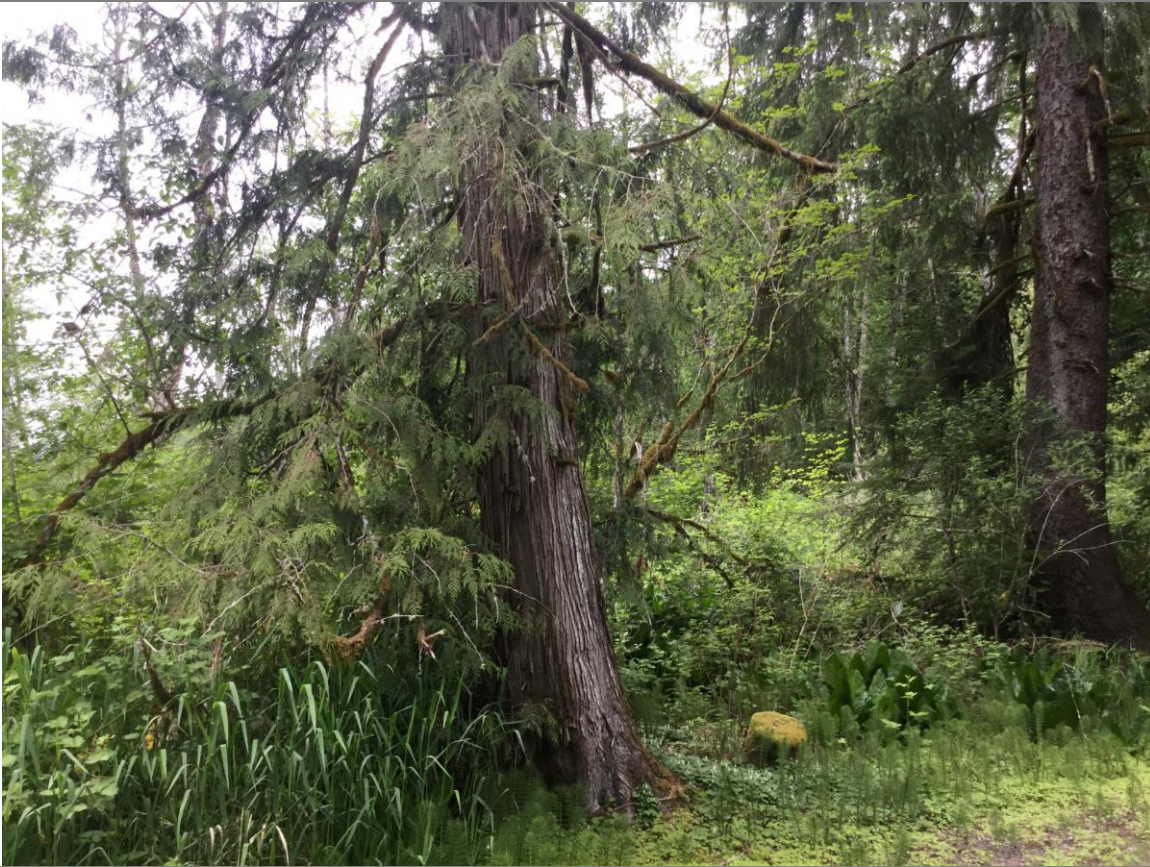
Approximately 5 acres of red alder / bigleaf maple / conifer forest was mapped in the Anderson creek corridor. Vegetation in these areas is characterized by mixed broadleaf and conifer tree communities. Red alder tends to be the dominant broadleaf species, although bigleaf maple is codominant in some areas. Western red cedar and Sitka spruce are the main conifers comprising the canopy layer. Understory shrubs are reduced in comparison to the two broadleaf dominated forest types described previously, with a more prevalent herb layer. Understory species include salmonberry, thimble berry, red elderberry, Indian plum and red osier dogwood.

Figure 24. Photo of existing Red Alder / Bigleaf Maple / Conifer Forest at Anderson Creek (2018)

Approximately 5.4 acres of red alder / bigleaf maple / conifer forest was mapped in the Anderson creek corridor. These areas likely represent reference conditions for the mixed coniferous and deciduous forests that the current red alder riparian forests have replaced. Red alder tends to be the dominant broadleaf species, although bigleaf maple is codominant in some areas. Western red cedar and Sitka spruce are the main conifers comprising the canopy layer. Understory shrub density is reduced in comparison to the two broadleaf dominated forest types, with a more prevalent herb layer. Understory shrub species include salmonberry, thimbleberry, red elderberry, Indian plum and red osier dogwood.
