# Anderson Creek Characterization and Alternatives Analysis

Bellingham, Washington

City of Bellingham  
Public Works Department  
Natural Resources Division

August 2019

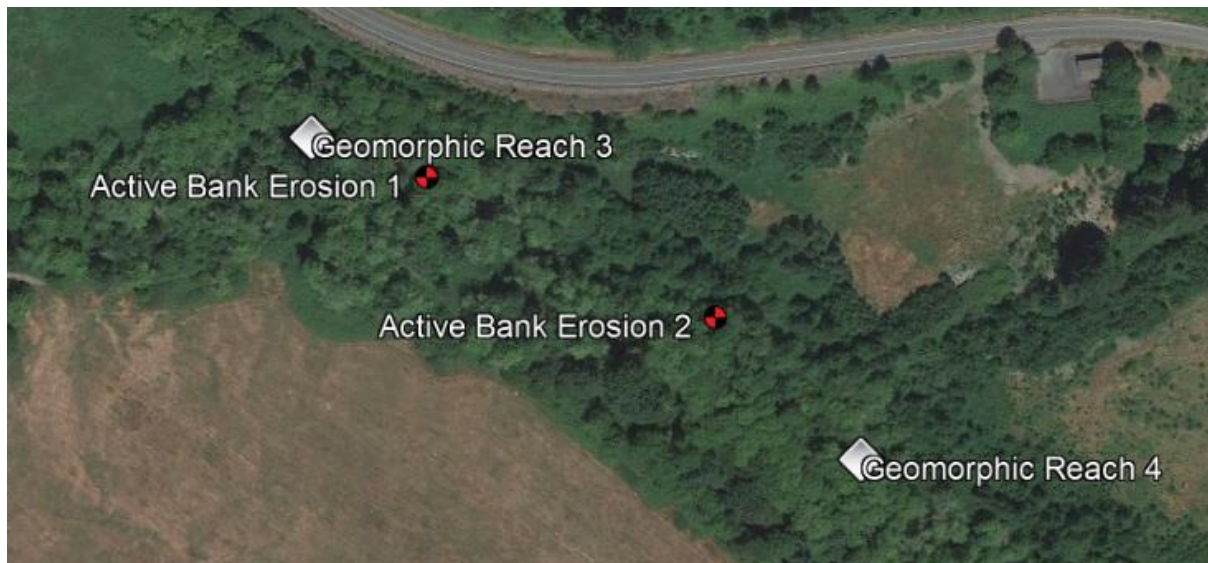
Figure 8 Active bank erosion locations in Anderson Creek geomorphic reach 3.

Only two significant areas of bank erosion were observed during the 2018 surveys, both in geomorphic reach 3 (Figure 8 and Figure 9). In these locations, bank erosion was 3 meters (9 feet) and 7 meters (21 feet) long, respectively. Reach 3 is where the channel is most influenced by the railroad grade, so the channel is likely responding to a combination of past confinement and incision.

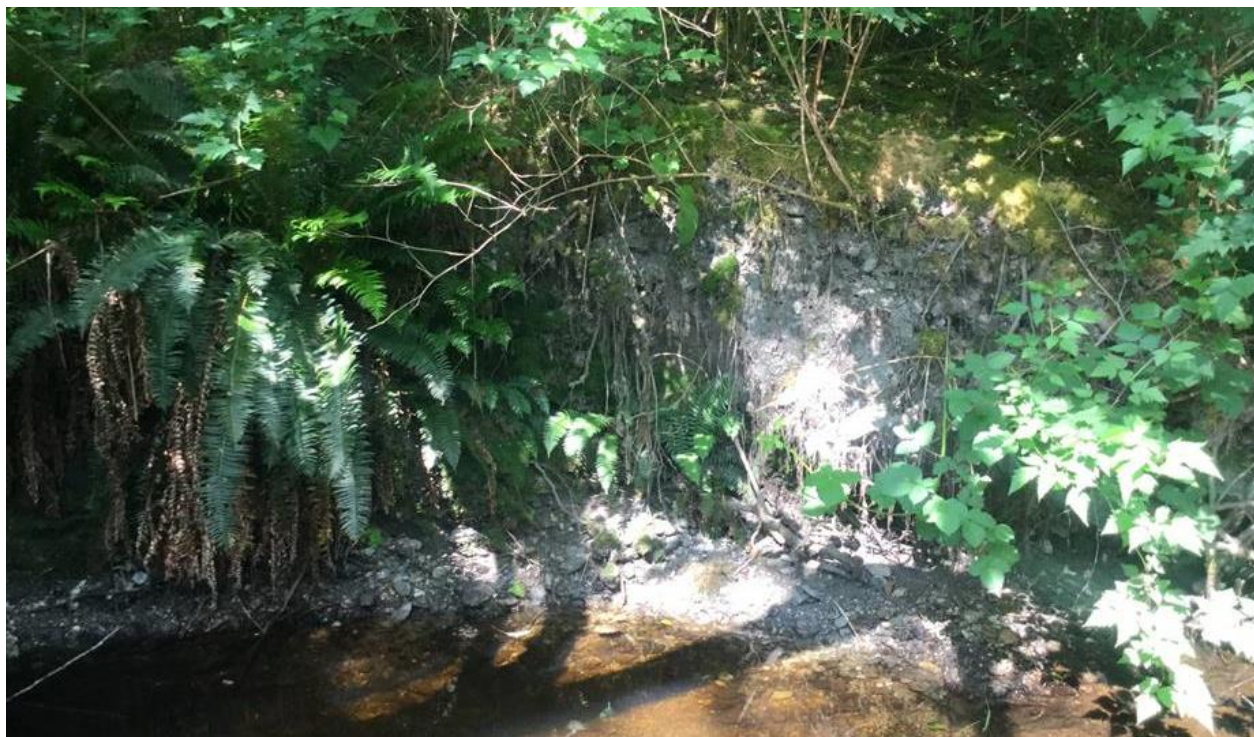
Figure 9 Photo of one of the active bank erosion locations in Anderson Creek reach 3.

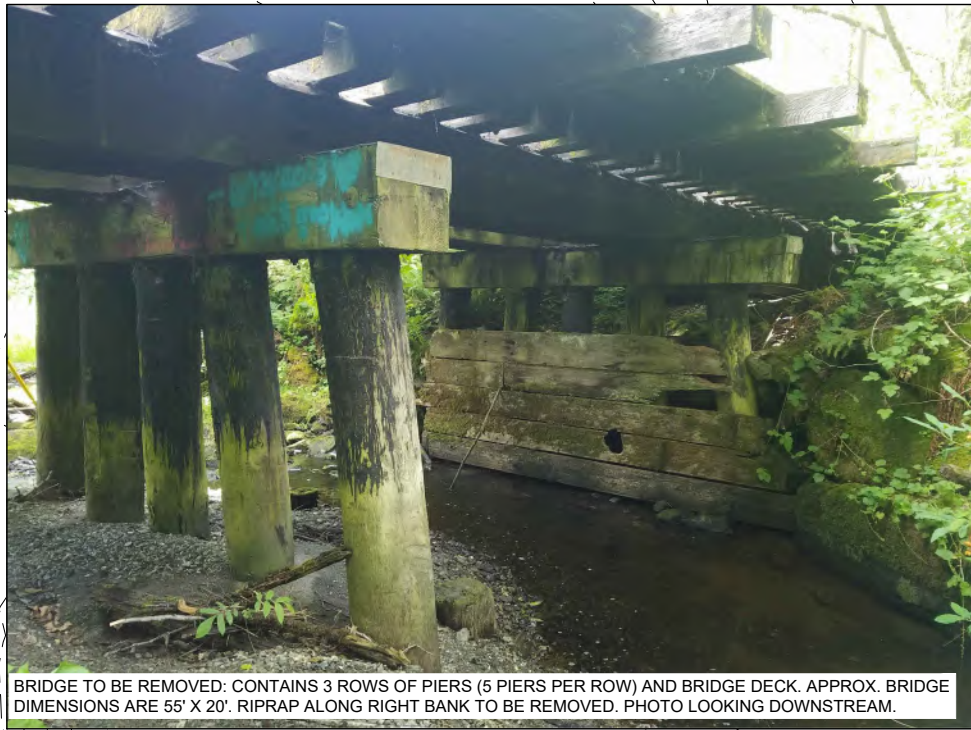
BRIDGE TO BE REMOVED: CONTAINS 3 ROWS OF PIERS (5 PIERS PER ROW) AND BRIDGE DECK. APPROX. BRIDGE DIMENSIONS ARE 55' X 20'. RIPRAP ALONG RIGHT BANK TO BE REMOVED. PHOTO LOOKING DOWNSTREAM.
