WASHINGTON STATE Joint Aquatic Resources Permit Application (JARPA) Form [\[help\]](#)

1. Project Name (A unique name for your project that you create. Examples: Smith's Dock or Seabrook Lane Development) [help]
Boulevard/Cornwall Overwater Pedestrian Walkway Project

BOULEVARD/CORNWALL OVERWATER PEDESTERIAN WALKWAY MITIGATION REPORT

BIOLOGICAL ASSESSMENT BOULEVARD/CORNWALL OVERWATER PEDESTRIAN WALKWAY

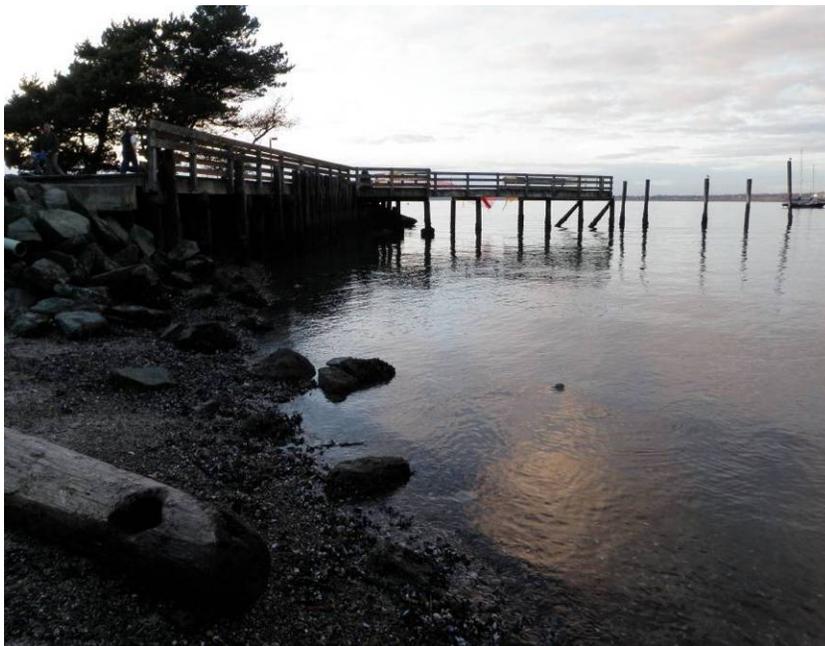
Photo 1 – Profile view of the existing pier at Boulevard Park from the adjacent pocket beach located at the northeast corner of Boulevard Park (facing west)

The southern terminus of the proposed overwater walkway will be located within Boulevard Park, a major public waterfront park facility in Bellingham that is owned, managed, and maintained by Parks. The park is located adjacent to Bellingham Bay between the Fairhaven District (south) and the Bellingham Waterfront District (north), and includes maintained lawn and landscaping, a small performance stage, public restrooms, picnic facilities, parking, trails, and ‘The Woods’ coffee shop. The park and its trails are used extensively for recreation by locals and visitors due to their scenic value and central location on Bellingham Bay. There is no shoreline access except for a small pocket beach at the northeast corner of the park (Photo 1). The remainder of the shoreline is heavily armored with rock and concrete riprap.

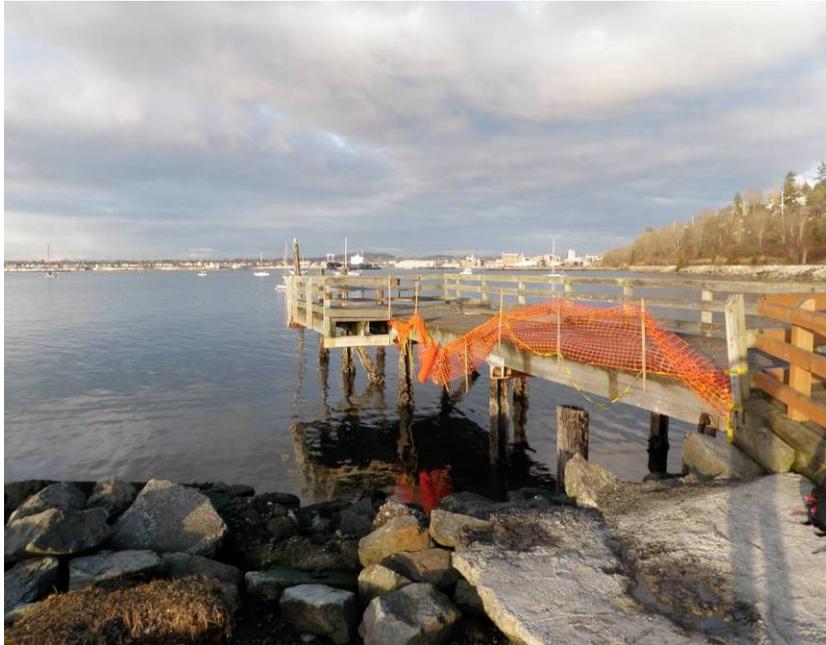
Photo 2 – View from Boulevard Park of the existing pier where the southern end of the overwater walkway will land (facing north)

An existing wharf and pier are located at the north end of Boulevard Park in the location of the southern terminus of the proposed overwater walkway (Photo 2). The pier is in structurally unsafe condition and is closed to the public. The overwater portion of the pier is supported by pier bents supported by 1-foot by 1-foot timber caps and eight corroded steel

H-piles. The overwater portion of the wharf is supported by approximately 87 creosote-treated timber piles. A low concrete wall supports the wharf on the landward side.

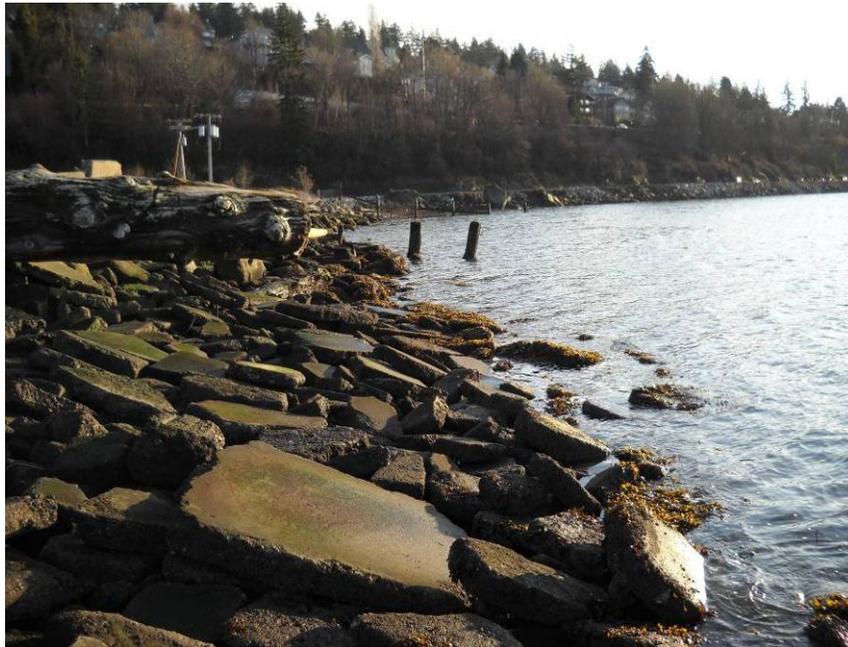
Photo 3 – View of the former Cornwall Avenue Landfill site where the north abutment of the proposed overwater walkway will land (facing southeast)

The former Cornwall Avenue Landfill site is located at the north end of the proposed walkway within the City’s Waterfront District redevelopment area. The upland portion is currently undeveloped and public access is restricted. Vegetation on the site is unmaintained. Non-native and invasive herbaceous plant species dominate the area near the proposed landing site. The shoreline is heavily armored with riprap and concrete rubble. Five derelict creosote-treated piles are located immediately offshore of the southwest corner of the property in the vicinity of the proposed walkway (Photo 3).

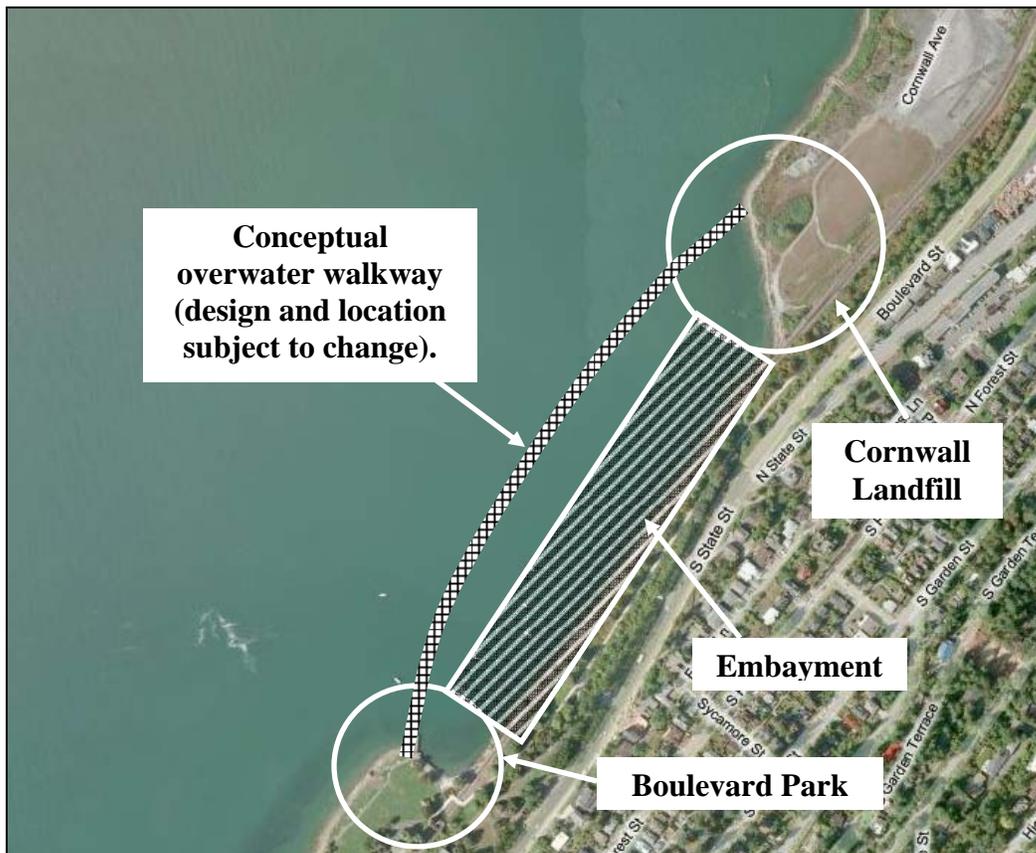
Figure 2. Eelgrass delineation site map

Native eelgrass (*Zostera marina*) beds are located in the embayment from approximately -2 feet MLLW to a depth of approximately -8 feet MLLW. See Sheet 2 for location and extent of the eelgrass beds. In addition, macroalgae was found mostly landward of the eelgrass (Grette Associates 2009).

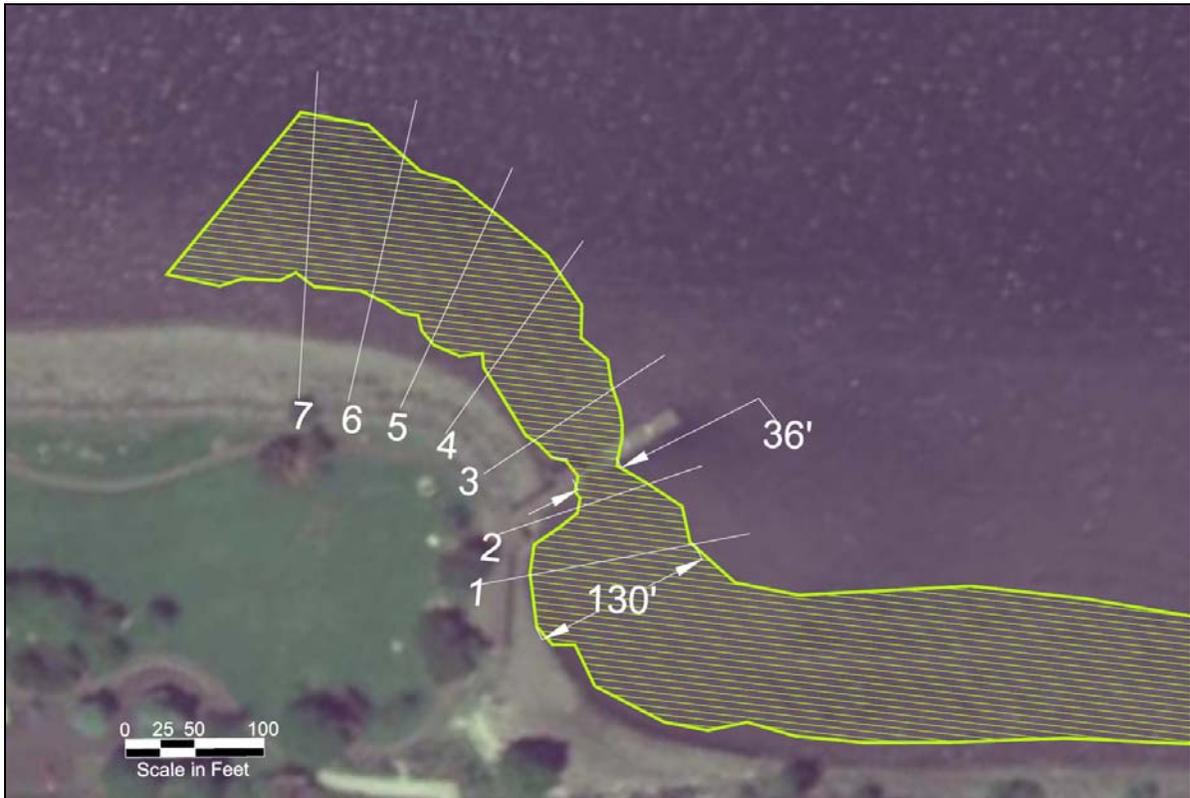
Figure 3. Boulevard Park transects, eelgrass bed

The average density of the Boulevard Park transects was 63.8 turions per square meter; the average density at the Cornwall Landfill site (on transects containing eelgrass) was 63.2 turions per square meter. It should be noted that, at Boulevard Park, lowest eelgrass densities were recorded in Transects 2 and 3, which are nearest the existing pier. The eelgrass band is also narrowest at the existing pier (Figure 3). Thus, potential impacts to eelgrass of the proposed walkway landing would be minimized by locating the walkway landing at the existing pier location. At the Cornwall Landfill site, as mentioned above, eelgrass ends at Transect 14 (Figure 4). Thus, eelgrass impacts would be avoided completely by locating the walkway landing north of Transect 14, or at the point of the Cornwall Landfill site. Additionally, concrete slabs located at approximately -2 to -3 ft MLLW north of Transect 14 limit eelgrass presence. It is possible that, were these slabs removed, eelgrass would establish in these locations.

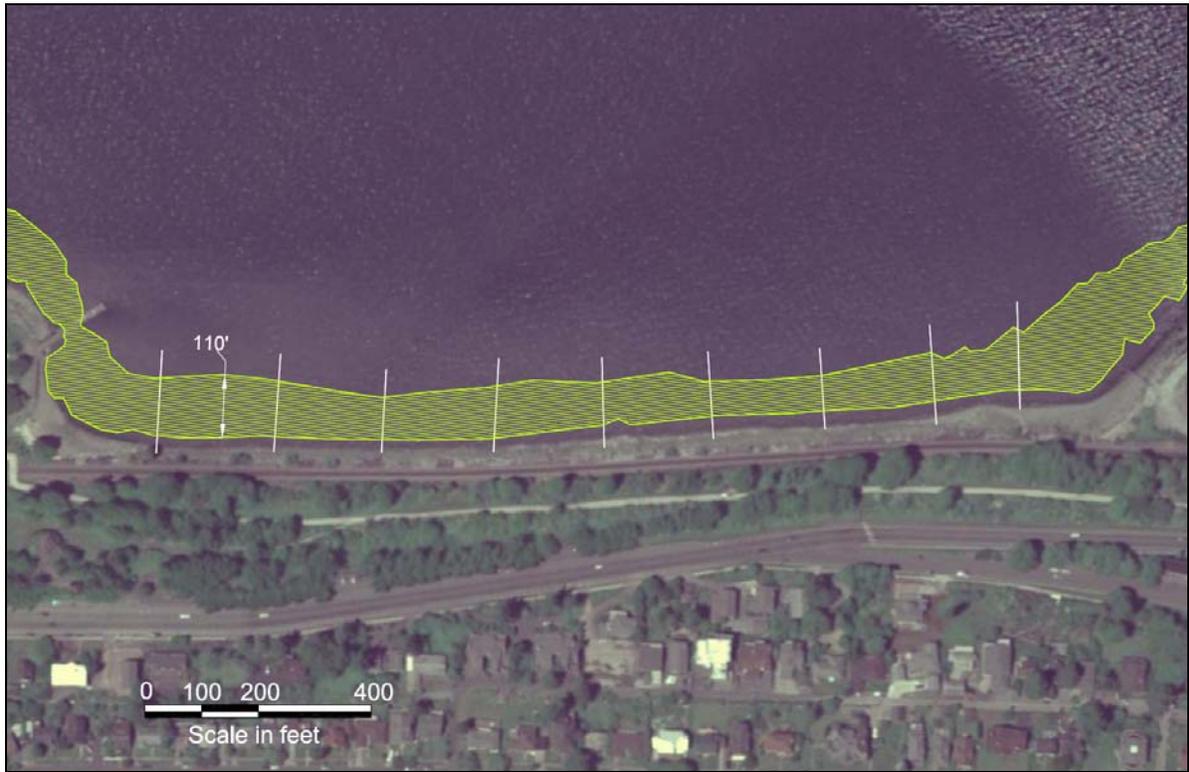
Figure 5: Embayment transects, eelgrass landward and waterward location

Sparse stands of macroalgae were present on several of the transects. Macroalgae was consistently found landward of eelgrass. Fucus and Ulva were present on most transects, and sparse Laminaria was observed further waterward on some transects.

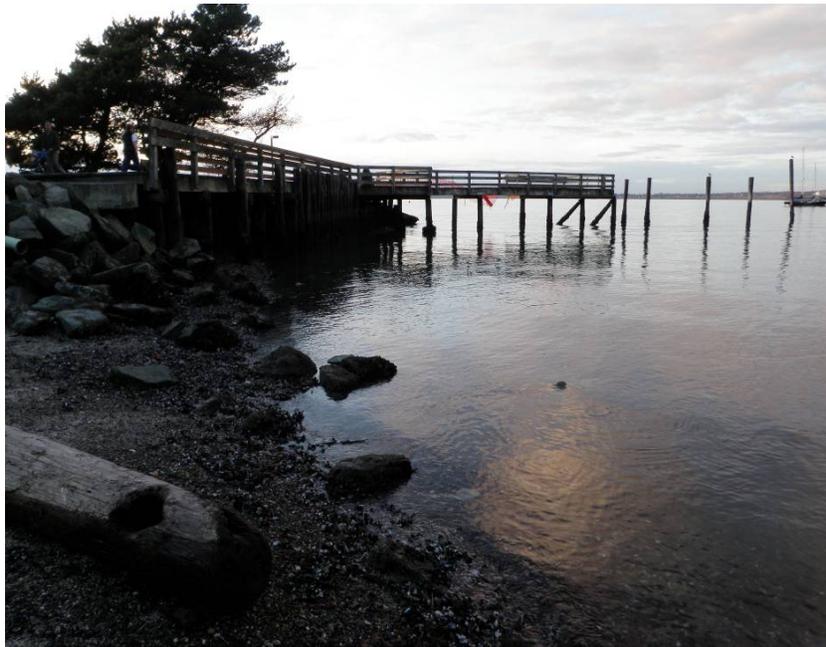
Photo 1 – Profile view of the existing pier at Boulevard Park from the adjacent pocket beach located at the northeast corner of Boulevard Park (facing west)

The southern terminus of the proposed overwater walkway will be located within Boulevard Park, a major public waterfront park facility in Bellingham that is owned, managed, and maintained by Parks. The park is located adjacent to Bellingham Bay between the Fairhaven District (south) and the Bellingham Waterfront District (north), and includes maintained lawn and landscaping, a small performance stage, public restrooms, picnic facilities, parking, trails, and 'The Woods' coffee shop. The park and its trails are used extensively for recreation by locals and visitors due to their scenic value and central location on Bellingham Bay. Subsurface conditions of the park are characterized by relatively soft soils and soft fill, with borings near the proposed overwater walkway encountering approximately 5 feet of earthen fill, 19 feet of wood waste fill, and 1 foot of sandy beach deposits over bedrock (Landau 2009). There is no shoreline access except for a small pocket beach at the northeast corner of the park (Photo 1). The remainder of the shoreline is heavily armored with rock and concrete riprap.

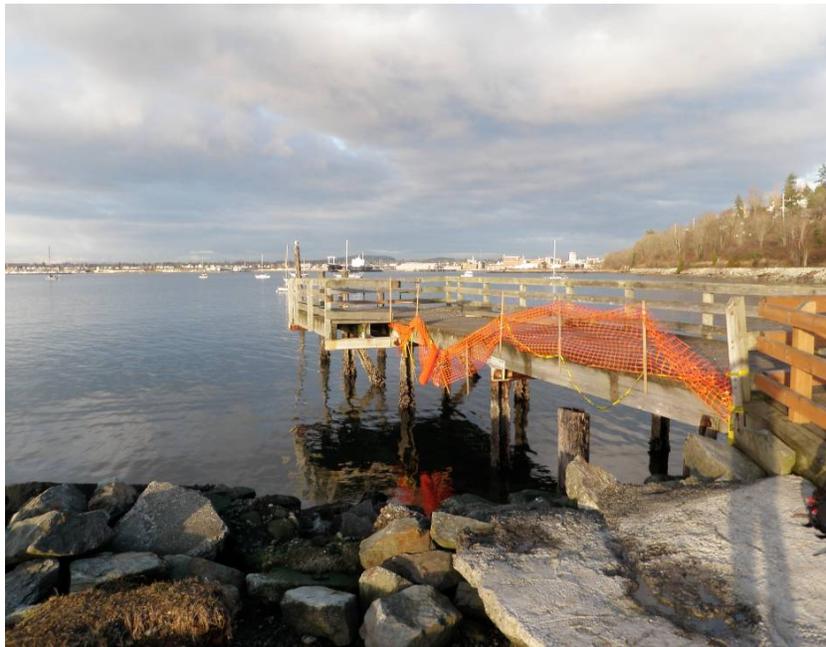
Photo 2 – View from Boulevard Park of the existing pier where the southern end of the overwater walkway will land (facing north)

An existing wharf and pier are located at the north end of Boulevard Park in the approximate location of the southern terminus of the proposed overwater walkway (Photo 2). The pier is in structurally unsafe condition and is, therefore, closed to the public. The overwater portion of the pier is supported by pier bents supported by 1-foot by 1-foot timber caps and eight corroded steel H-piles. The overwater portion of the wharf is supported by approximately 87 creosote-treated timber piles. A low concrete wall topped with riprap supports the wharf on the landward side. The wharf, pier, and associated piles will be removed as part of the compensatory mitigation described in Section 5.

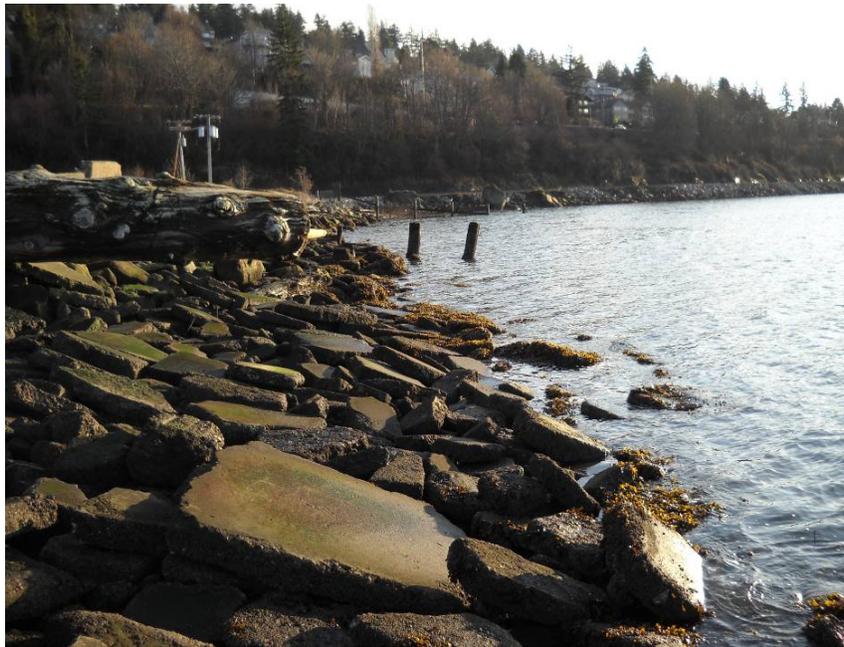
Photo 3 – View of the former Cornwall Avenue Landfill site where the north abutment of the proposed overwater walkway will land (facing southeast)

Five derelict creosote-treated piles are located immediately offshore of the southwest corner of the property in the vicinity of the proposed walkway (Photo 3). These piles will be removed as part of the compensatory mitigation described in Section 5.

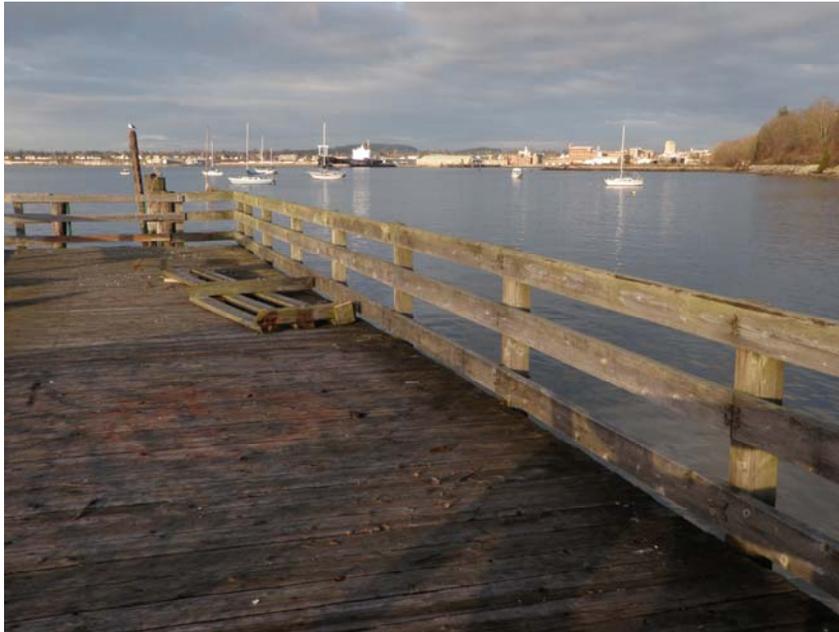
Photo 4 – View of proposed overwater walkway location from the existing pier at Boulevard Park where the southern end of the walkway will land (facing northeast)

The outermost portion of the embayment (a part of Bellingham Bay) between Boulevard Park and the former Cornwall Avenue Landfill site (Photo 4), is presently used for transient vessel moorage; however, these transient vessels do not have WDNR authorization to moor in this area. The bathymetry of the embayment between Boulevard Park and the former Cornwall Avenue Landfill site indicates that the shoreline is gently sloping from the upland toward the Whatcom Waterway navigation channel. The substrate along the shoreline of the Project area waterward of the riprap at each landing site primarily consists of gravel, cobble, sand, and shell fragments. A geotechnical study was conducted for the Project in October 2009, and borings indicated the material below elevation -20 feet MLLW is primarily composed of sand, soft clay, and silt. Four isolated creosote-treated piles are located within this portion of the embayment; these piles will be removed as part of the compensatory mitigation described in Section 5.

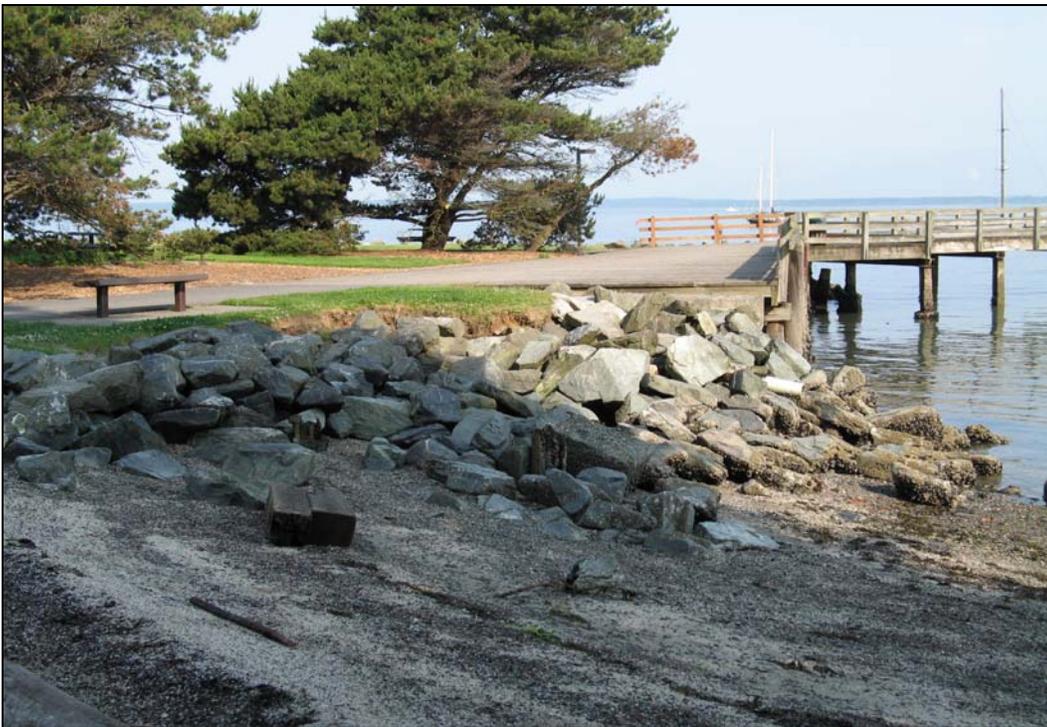
Figure 4 The vicinity of the southern abutment location in the Boulevard/Cornwall Overwater Pedestrian Walkway Project Area. The abutment will be located where the pier meets the wharf in the middle distance. View is to the northwest.

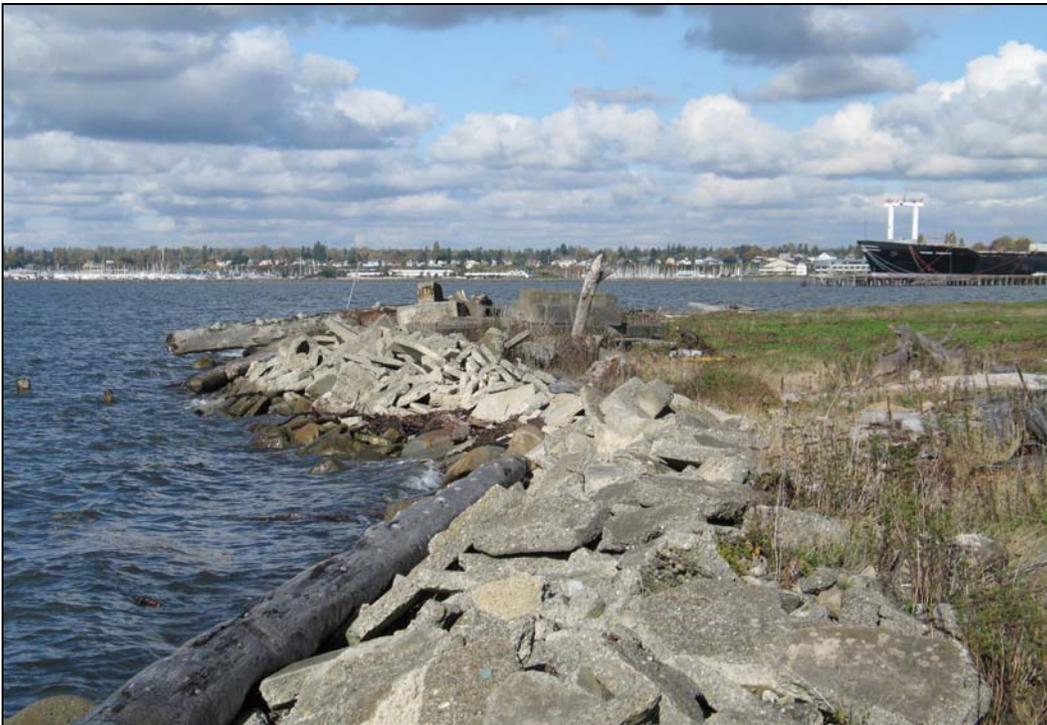
Figure 6 The vicinity of the southern abutment location in the Boulevard/Cornwall Overwater Pedestrian Walkway Project Area. The abutment will be located at the 'point' in the middle distance. View is to the northwest.

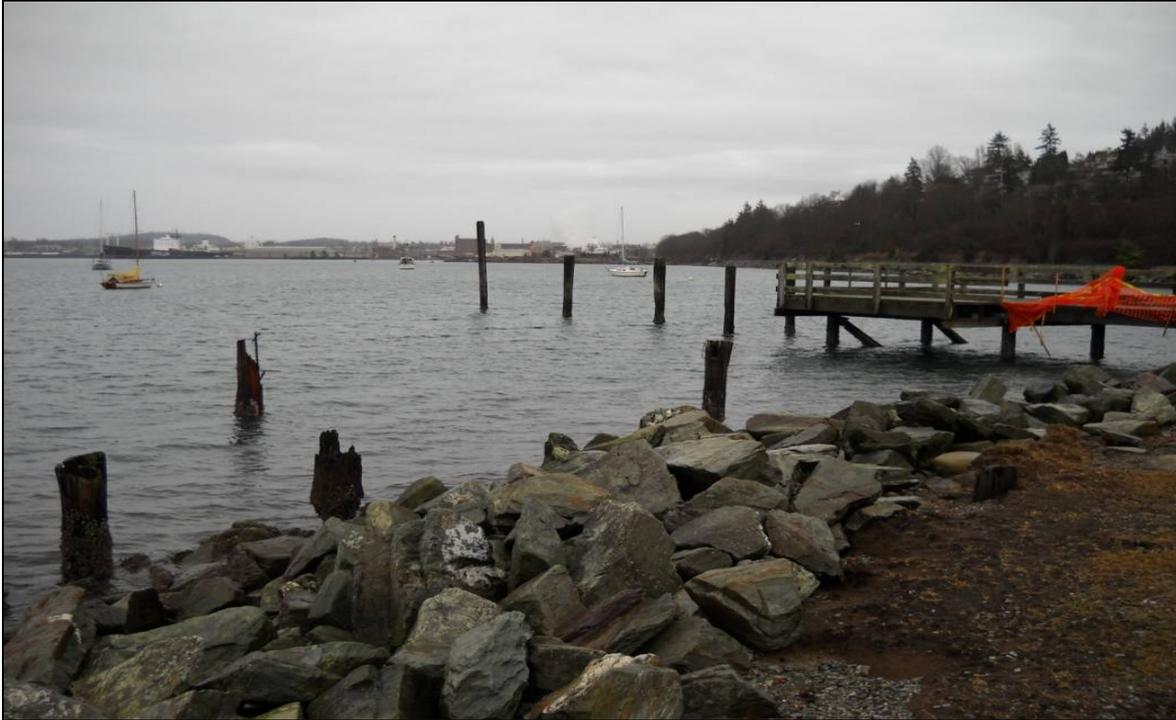
Old pilings near the existing dock at the northern end of Boulevard Park, Bellingham, Washington. View is to the northeast.

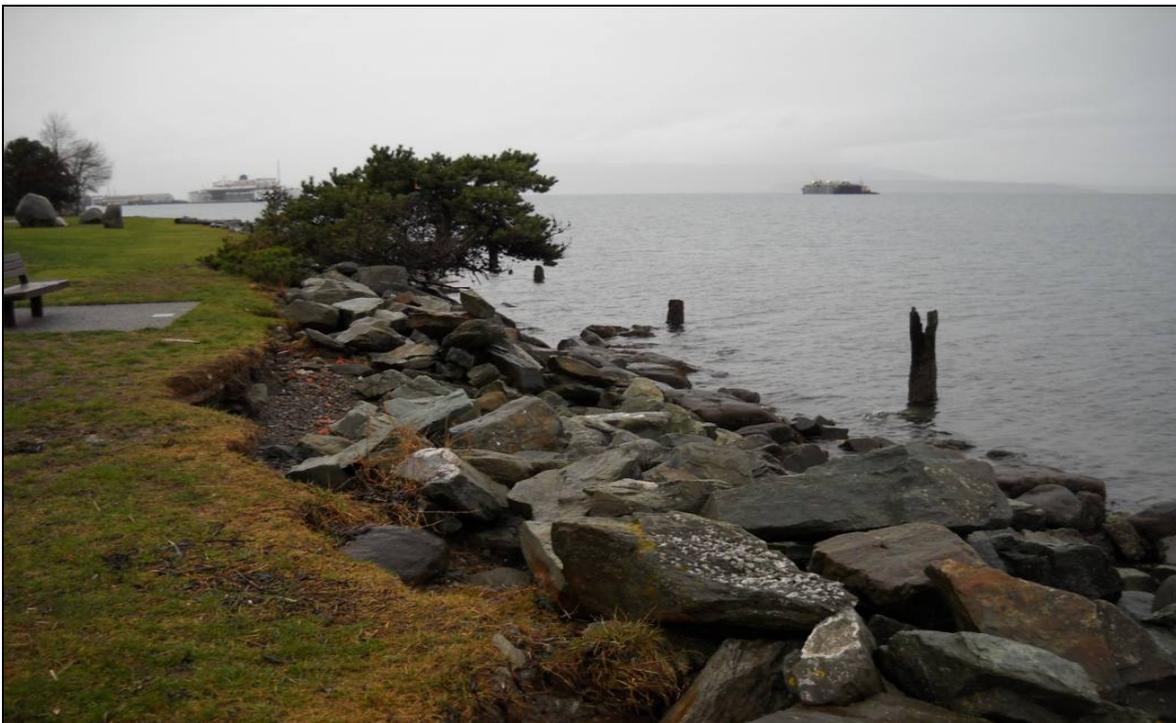
Old pilings southwest of the existing dock at the northern end of Boulevard Park, Bellingham, Washington. View is to the southwest.

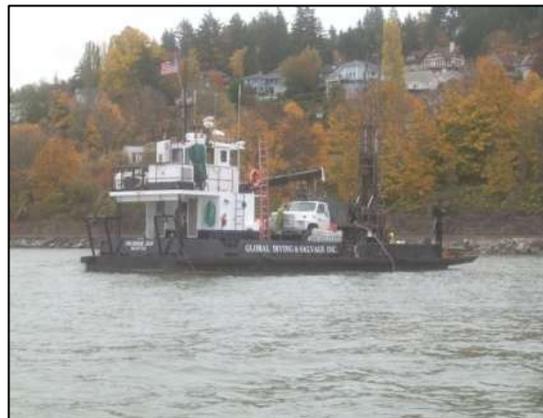
Six geotechnical borings were completed from an anchored barge using a subcontracted truck-mounted drill rig.

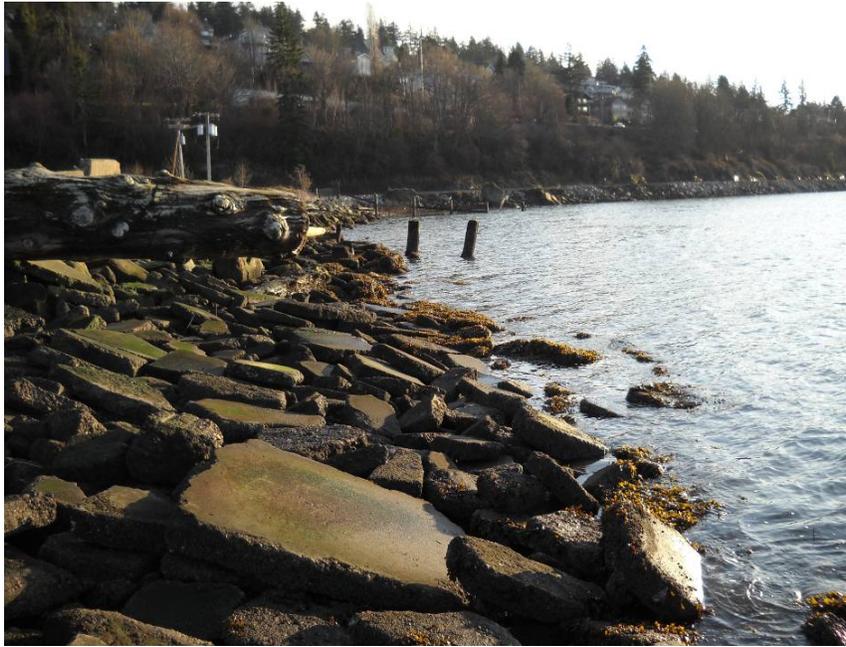
Photo 3 – View of the former Cornwall Avenue Landfill site where the north abutment of the proposed overwater walkway will land (facing southeast)

The former Cornwall Avenue Landfill site is located at the north end of the proposed walkway within the City’s Waterfront District redevelopment area. The upland portion is currently undeveloped and public access is restricted. Vegetation on the site is unmaintained. Non-native and invasive herbaceous plant species dominate the area near the proposed landing site. The shoreline is heavily armored with riprap and concrete rubble. Five derelict creosote-treated piles are located immediately offshore of the southwest corner of the property in the vicinity of the proposed walkway (Photo 3).

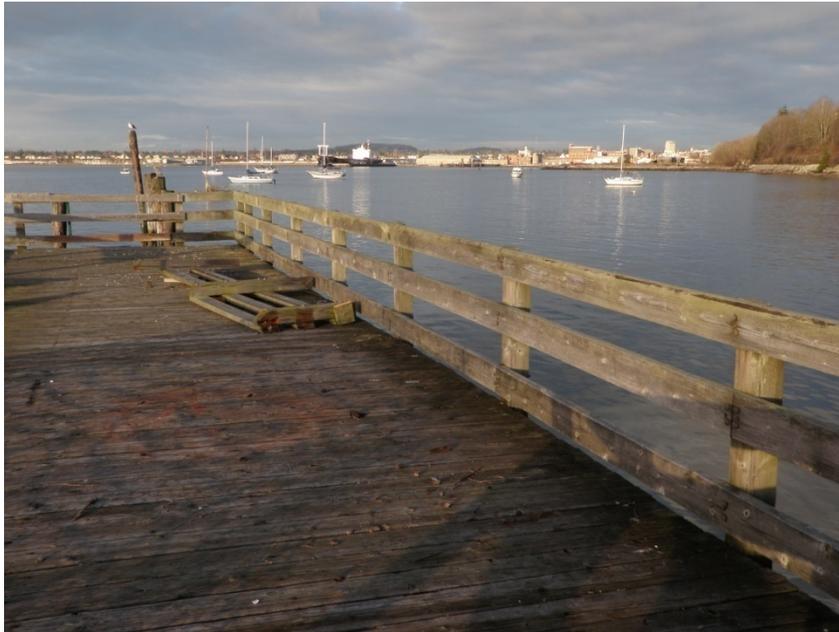
Photo 4 – View of proposed overwater walkway location from the existing pier at Boulevard Park where the southern end of the walkway will land (facing northeast)

The outermost portion of the embayment (a part of Bellingham Bay) between Boulevard Park and the former Cornwall Avenue Landfill site (Photo 4), is presently used for transient and derelict vessel moorage; however, these transient vessels do not have WDNR authorization to moor in this area. The bathymetry of the embayment between Boulevard Park and the former Cornwall Avenue Landfill site indicates that the shoreline is gently sloping from the upland toward the Whatcom Waterway navigation channel. The substrate along the shoreline of the Action Area waterward of the riprap at each landing site primarily consists of gravel, mud, cobble, sand, and shell fragments. A geotechnical study was conducted for the Project in October 2009, and borings indicated the material below elevation -20 feet mean lower low water (MLLW) is primarily composed of sand, soft clay, and silt.

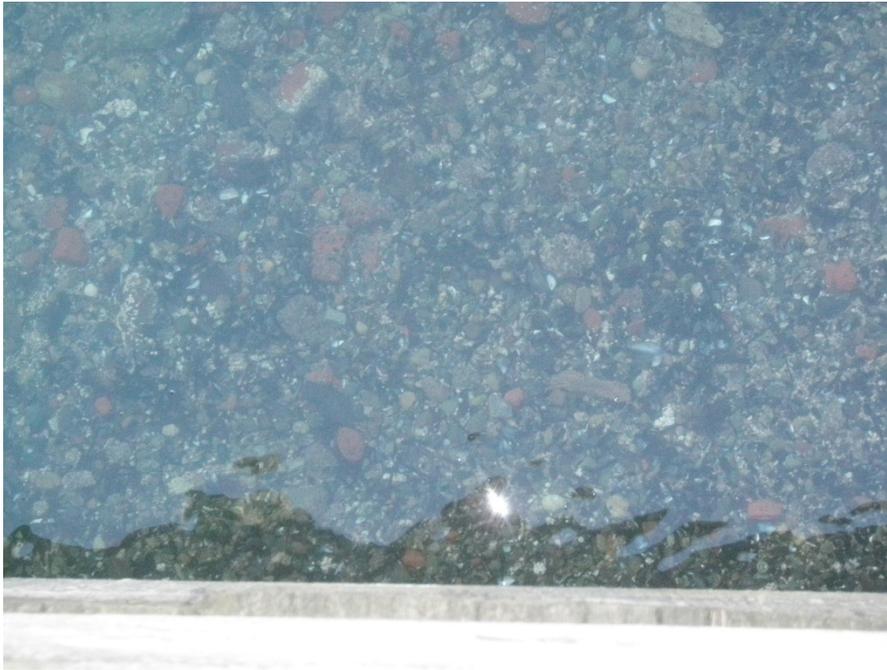
Photo 5

Typical substrate along the shoreline of the Action Area. Photo taken from the north end of Boulevard Park.

The substrate and slope within the Project Action Area have been extensively modified due to dredging, shoreline armament, and fill activities to support historic log storage and various industrial activities. The substrate slopes gently toward Bellingham Bay from the embayment between Boulevard Park and the former Cornwall Avenue Landfill site to the Whatcom Waterway navigation channel. A geotechnical study was conducted in October 2009 for the Project and results depict substrate below -20 MLLW as primarily composed of sand, soft clay, and silt. Substrate along the shoreline of the Action Area waterward of the riprap at each landing site primarily consists of gravel, cobble, sand, and shell fragments (Photo 5).

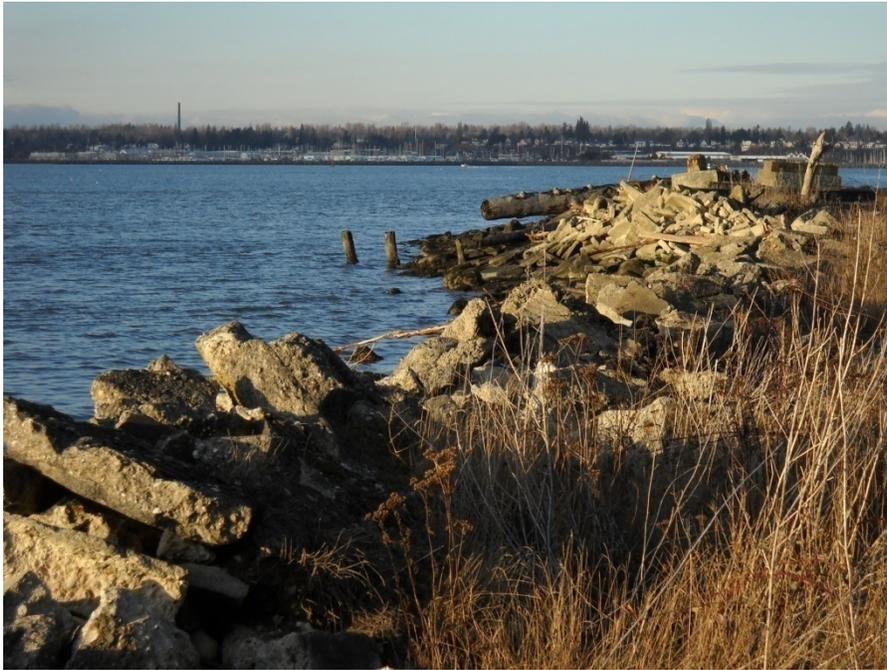
Photo 7

View of the former Cornwall Avenue Landfill site shoreline, facing northwest

(Photo 6), whereas the former Cornwall Avenue Landfill site includes mostly non-native and invasive species of grasses and shrubs (Photo 7).
