WETLAND CHARACTERIZATION: CHUCKANUT VILLAGE MARSH

JUNE 2008

Prepared For:
WHATCOM COUNTY PUBLIC WORKS
2011 Young Street, Suite 201
Bellingham, WA 98225

Prepared By:
NORTHWEST ECOLOGICAL SERVICES, LLC
1229 Cornwall Avenue, Suite 313
Bellingham, WA 98225
360.734.9484

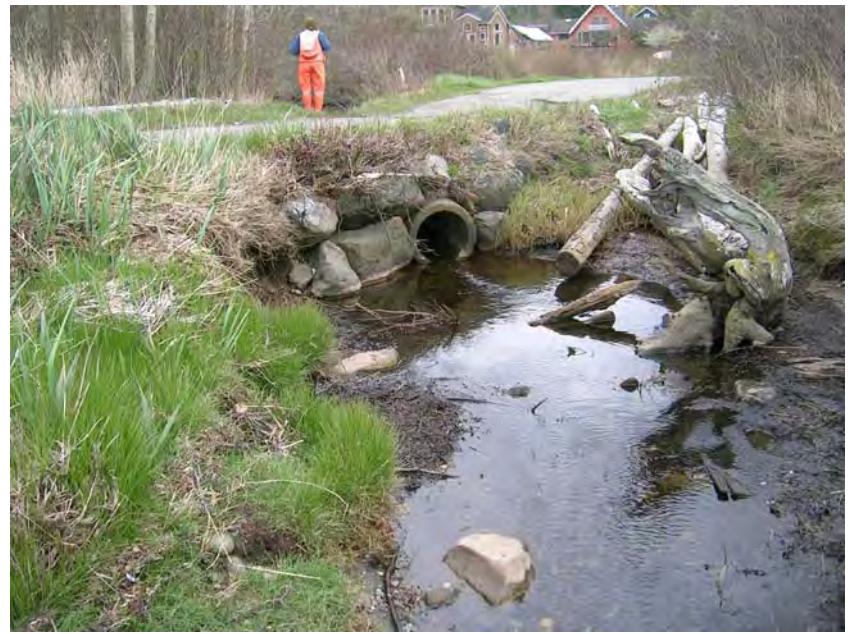
Photo 1. Downstream end of Fairhaven Avenue culvert. Low tide.

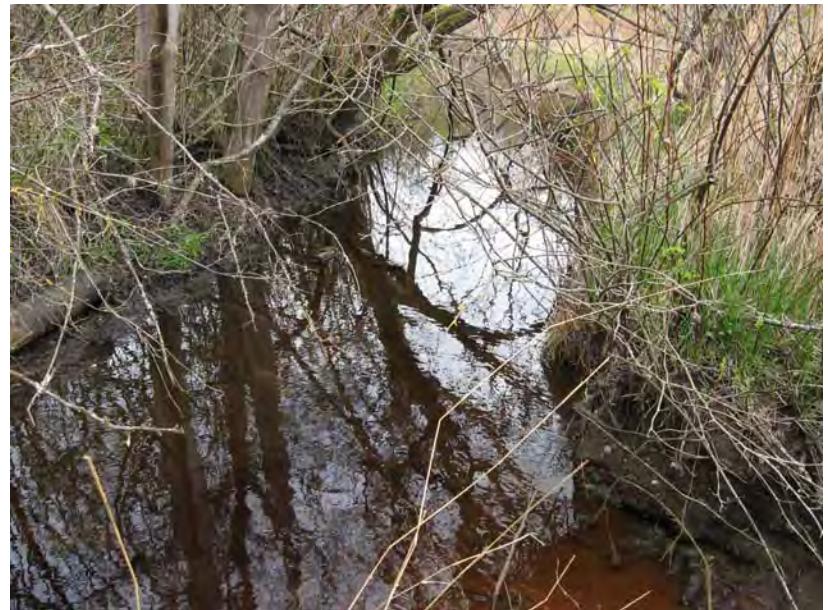
Photo 2. Marsh ditch at intersection between two primary ditches. Low tide.

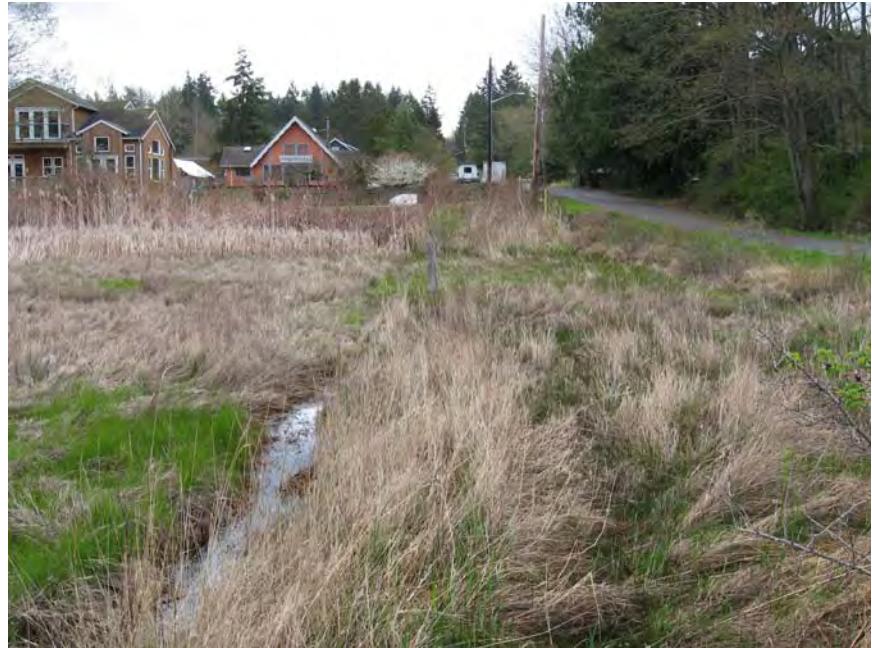
Photo 3. View east from Ditch intersection. Viewing southern ditch. Juncus Unit on right of ditch; PEM Distichlis Unit left of ditch; PEM Typhus unit ahead and left of ditch. Low tide.

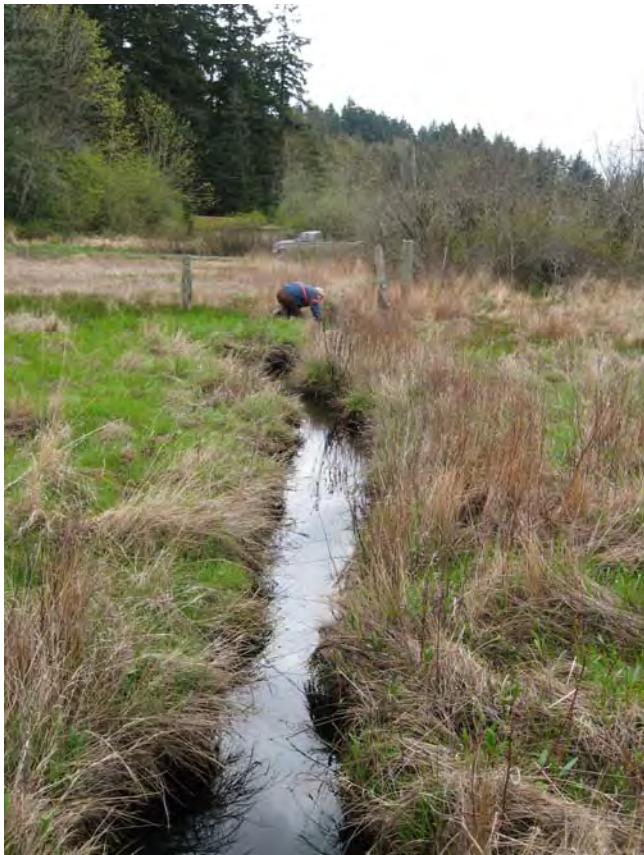
Photo 3. View south from middle of north/south ditch. From from PEM Juncus unit into PEM Distichlis Unit. Low tide.

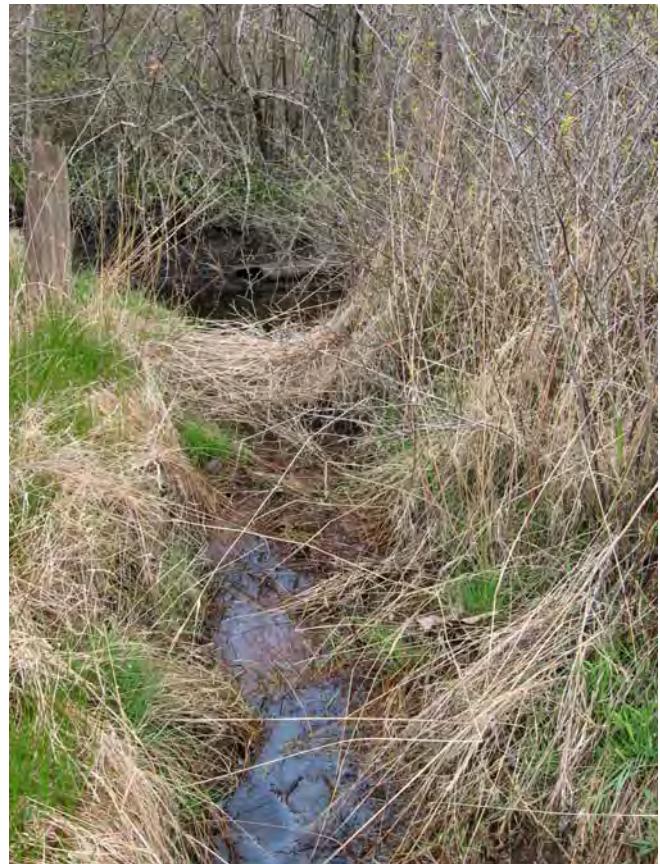
Photo 4. View south. Detail north/south ditch about 30 feet upstream of ditch intersection. Low tide.

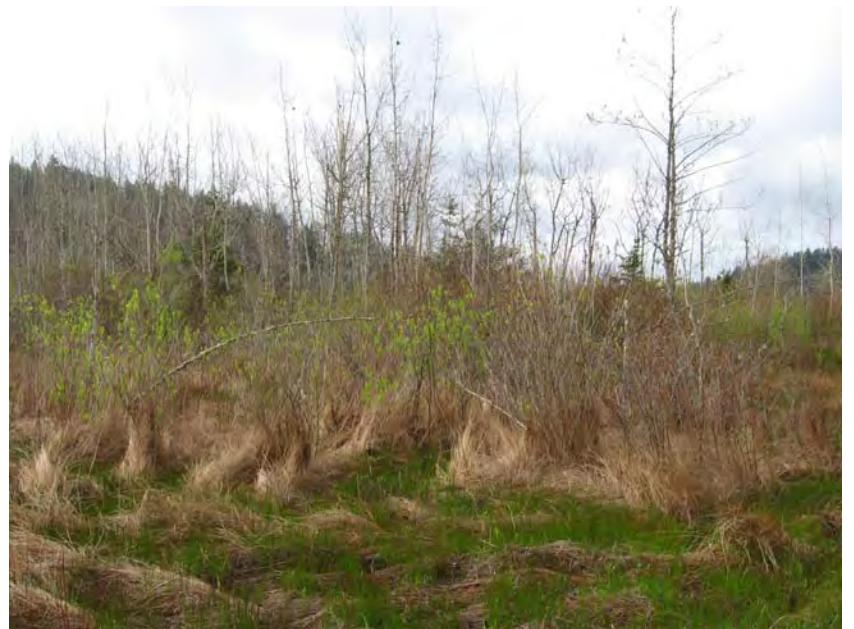
Photo 5. View west from PEM *Juncus* Unit view PSS Deciduous Shrub Unit. Low tide.

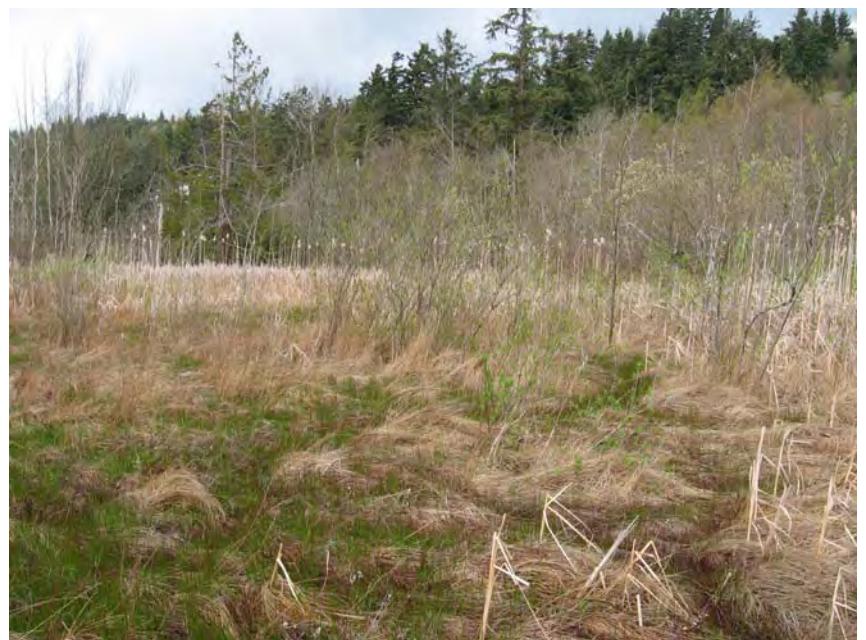
Photo 6. View northwest into PEM *Typha* Unit. Low tide.

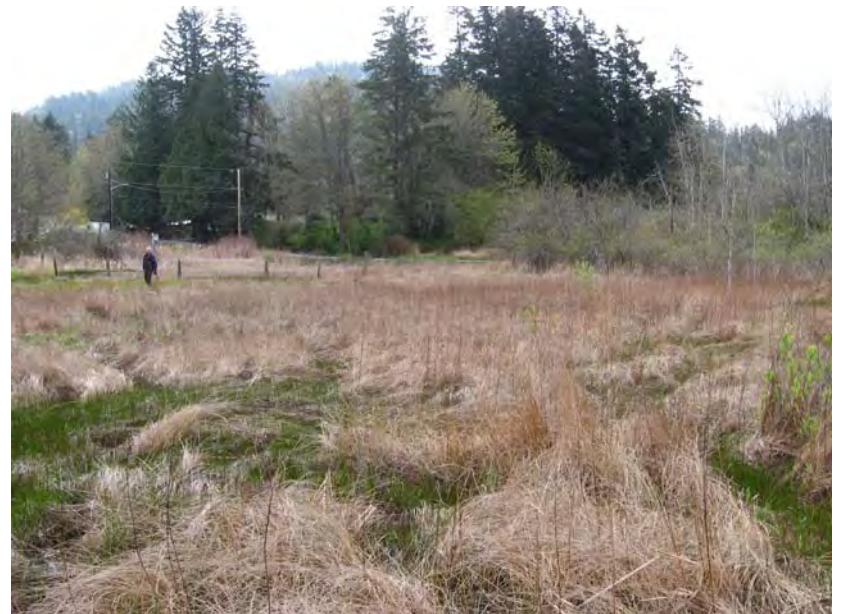
Photo 7. View south into PEM *Juncus* Unit. Low tide.

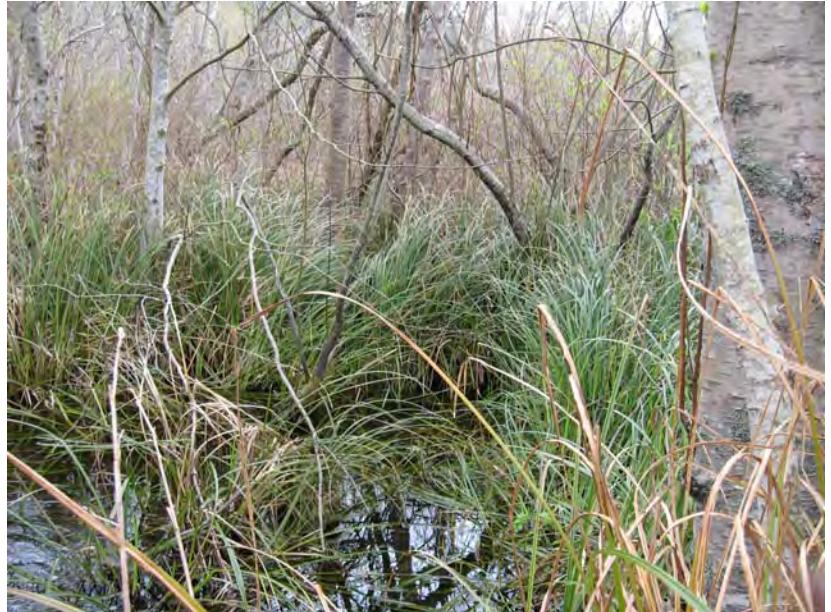
Photo 8. Detail in Palustrine Forested Community. Low tide.

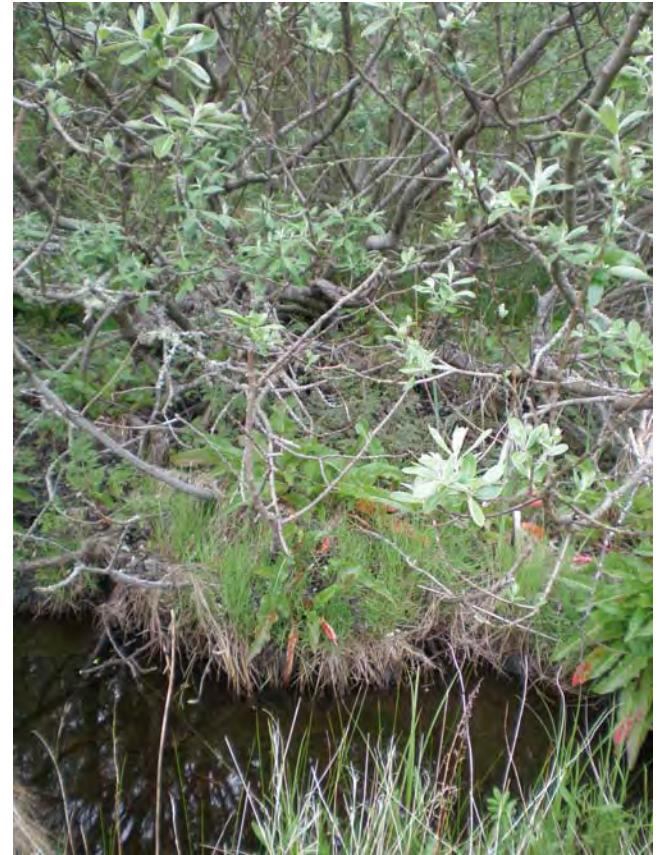
Photo 9. Detail in Palustrine Scrub-Shrub community in the Salix Unit. Note surface water channel. Low tide.

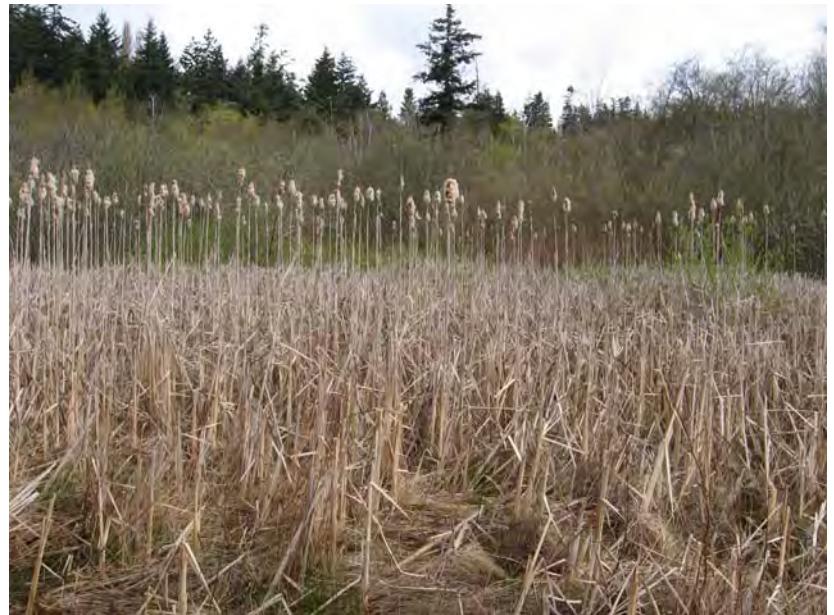
Photo 10. View north into Palustrine Emergent community, *Typha* Unit. Low tide.

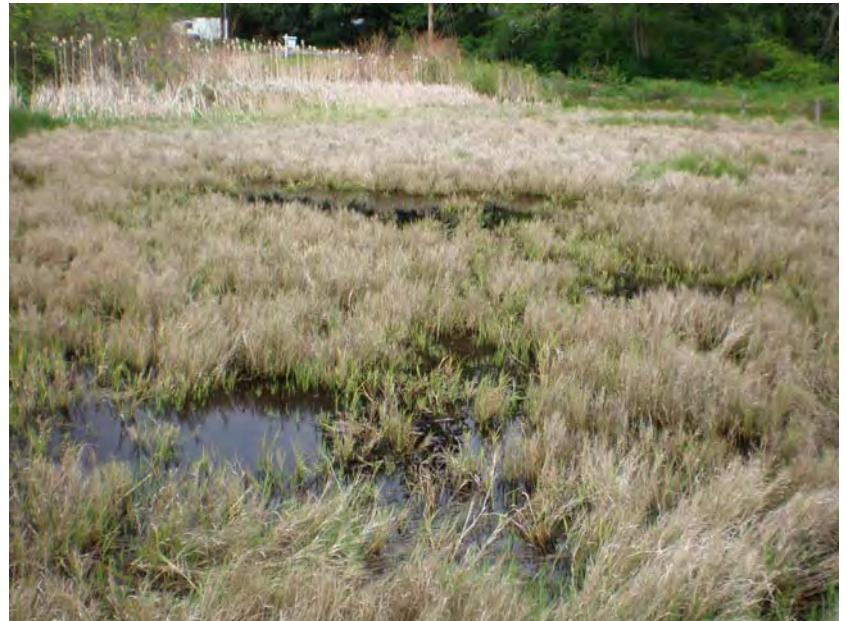
Photo 11. Detail of Palustrine Emergent community, *Distichlis* Unit. Photo taken after day of heavy rains. Pools had tannic water with mosquito larvae. Low tide.

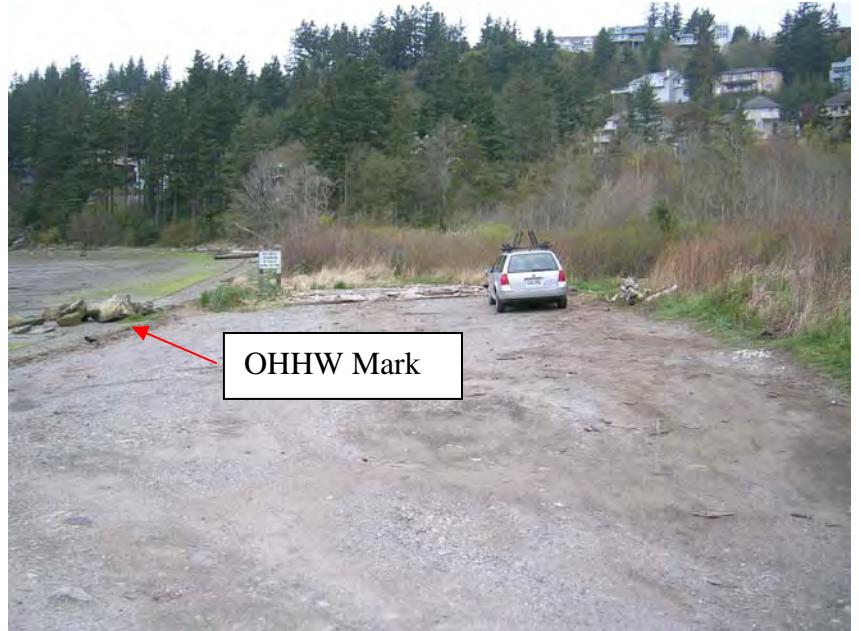
Photo 12. Detail of existing parking area and Upland Shrub community. Low tide.

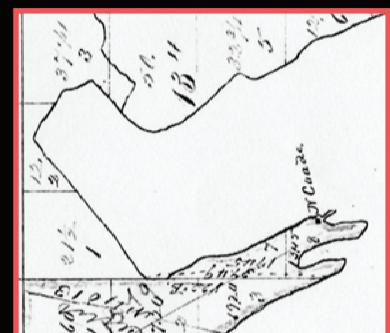
1859 US GLO

Deputy Surveyors of US Land Office traversed the US Meander Line & noted sand & gravel beaches in today's "Mud Bay".
