Preliminary Stormwater Management Report

THE WOODS AT VIEWCREST

June 16th, 2023

Pacific Surveying and Engineering Services, Inc.

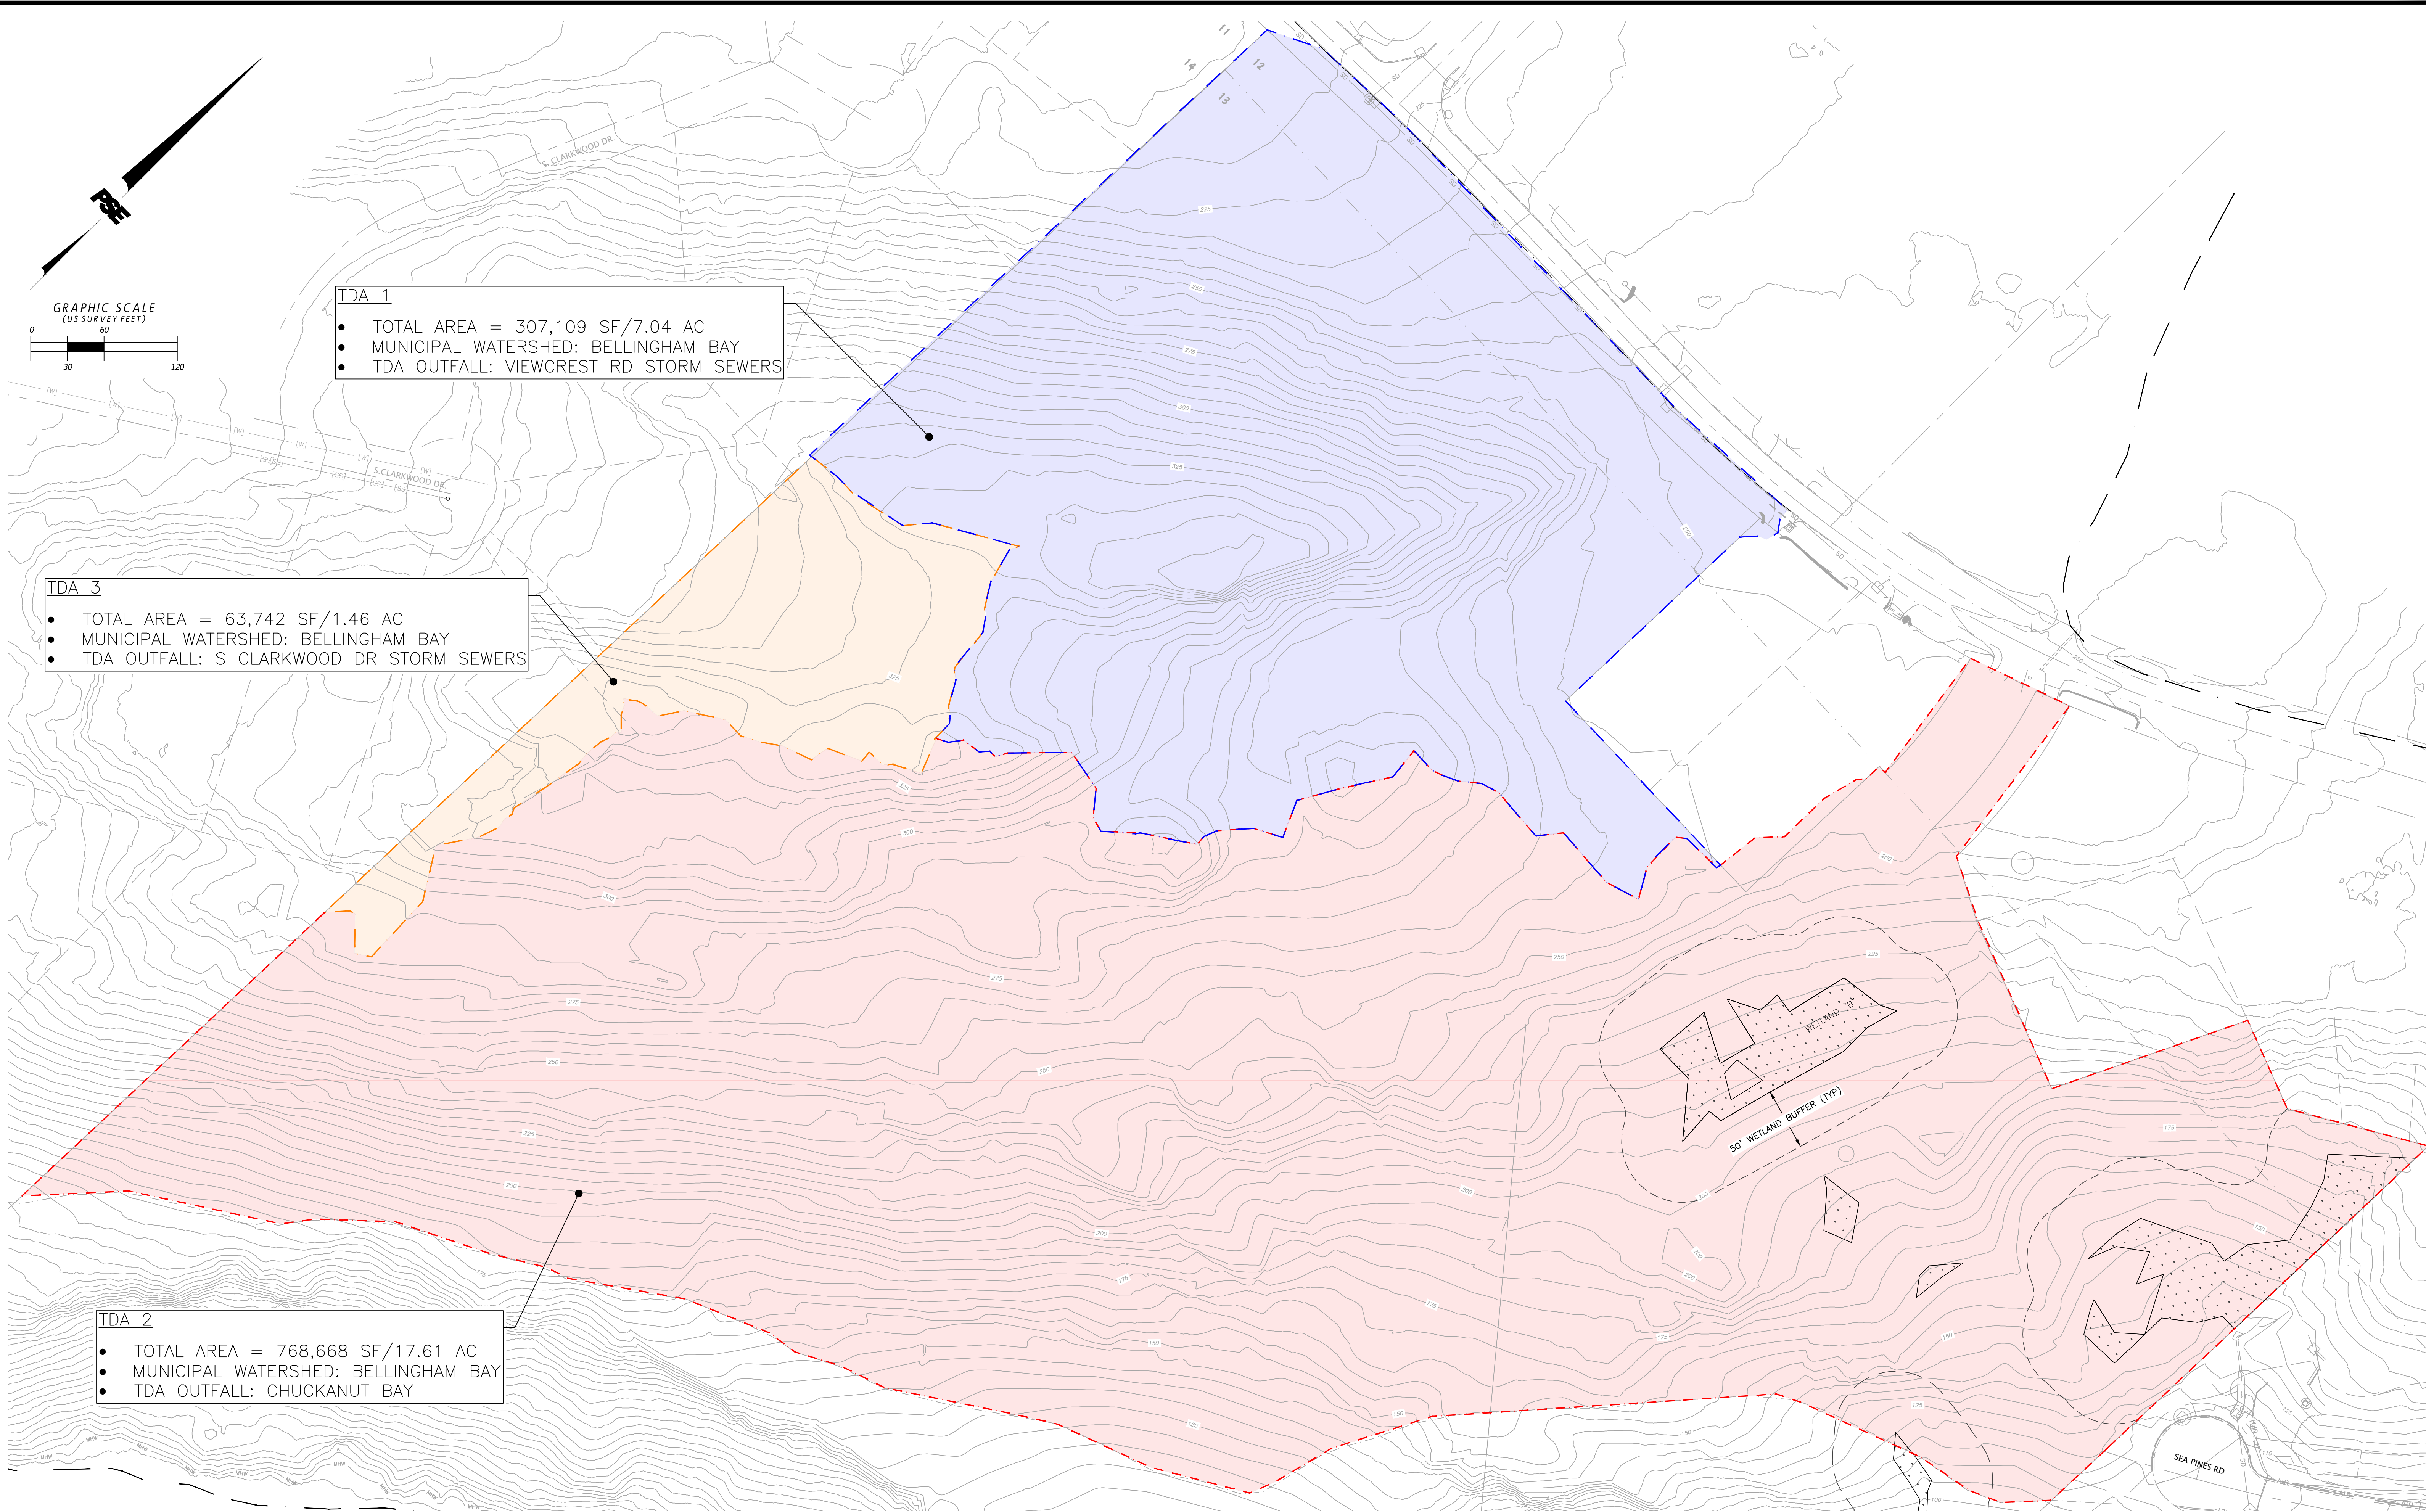
8.4 BASIN MAP

TDA 1

- TOTAL AREA = 307,109 SF/7.04 AC
- MUNICIPAL WATERSHED: BELLINGHAM BAY
- TDA OUTFALL: VIEWCREST RD STORM SEWERS
