# Preliminary Stormwater Management Report

THE WOODS AT VIEWCREST

June 16<sup>th</sup>, 2023

Pacific Surveying and Engineering Services, Inc.  
909 Squalicum Way, Suite 11  
Bellingham, Washington 98225  
(360) 671-7387  
[www.psesurvey.com](http://www.psesurvey.com)

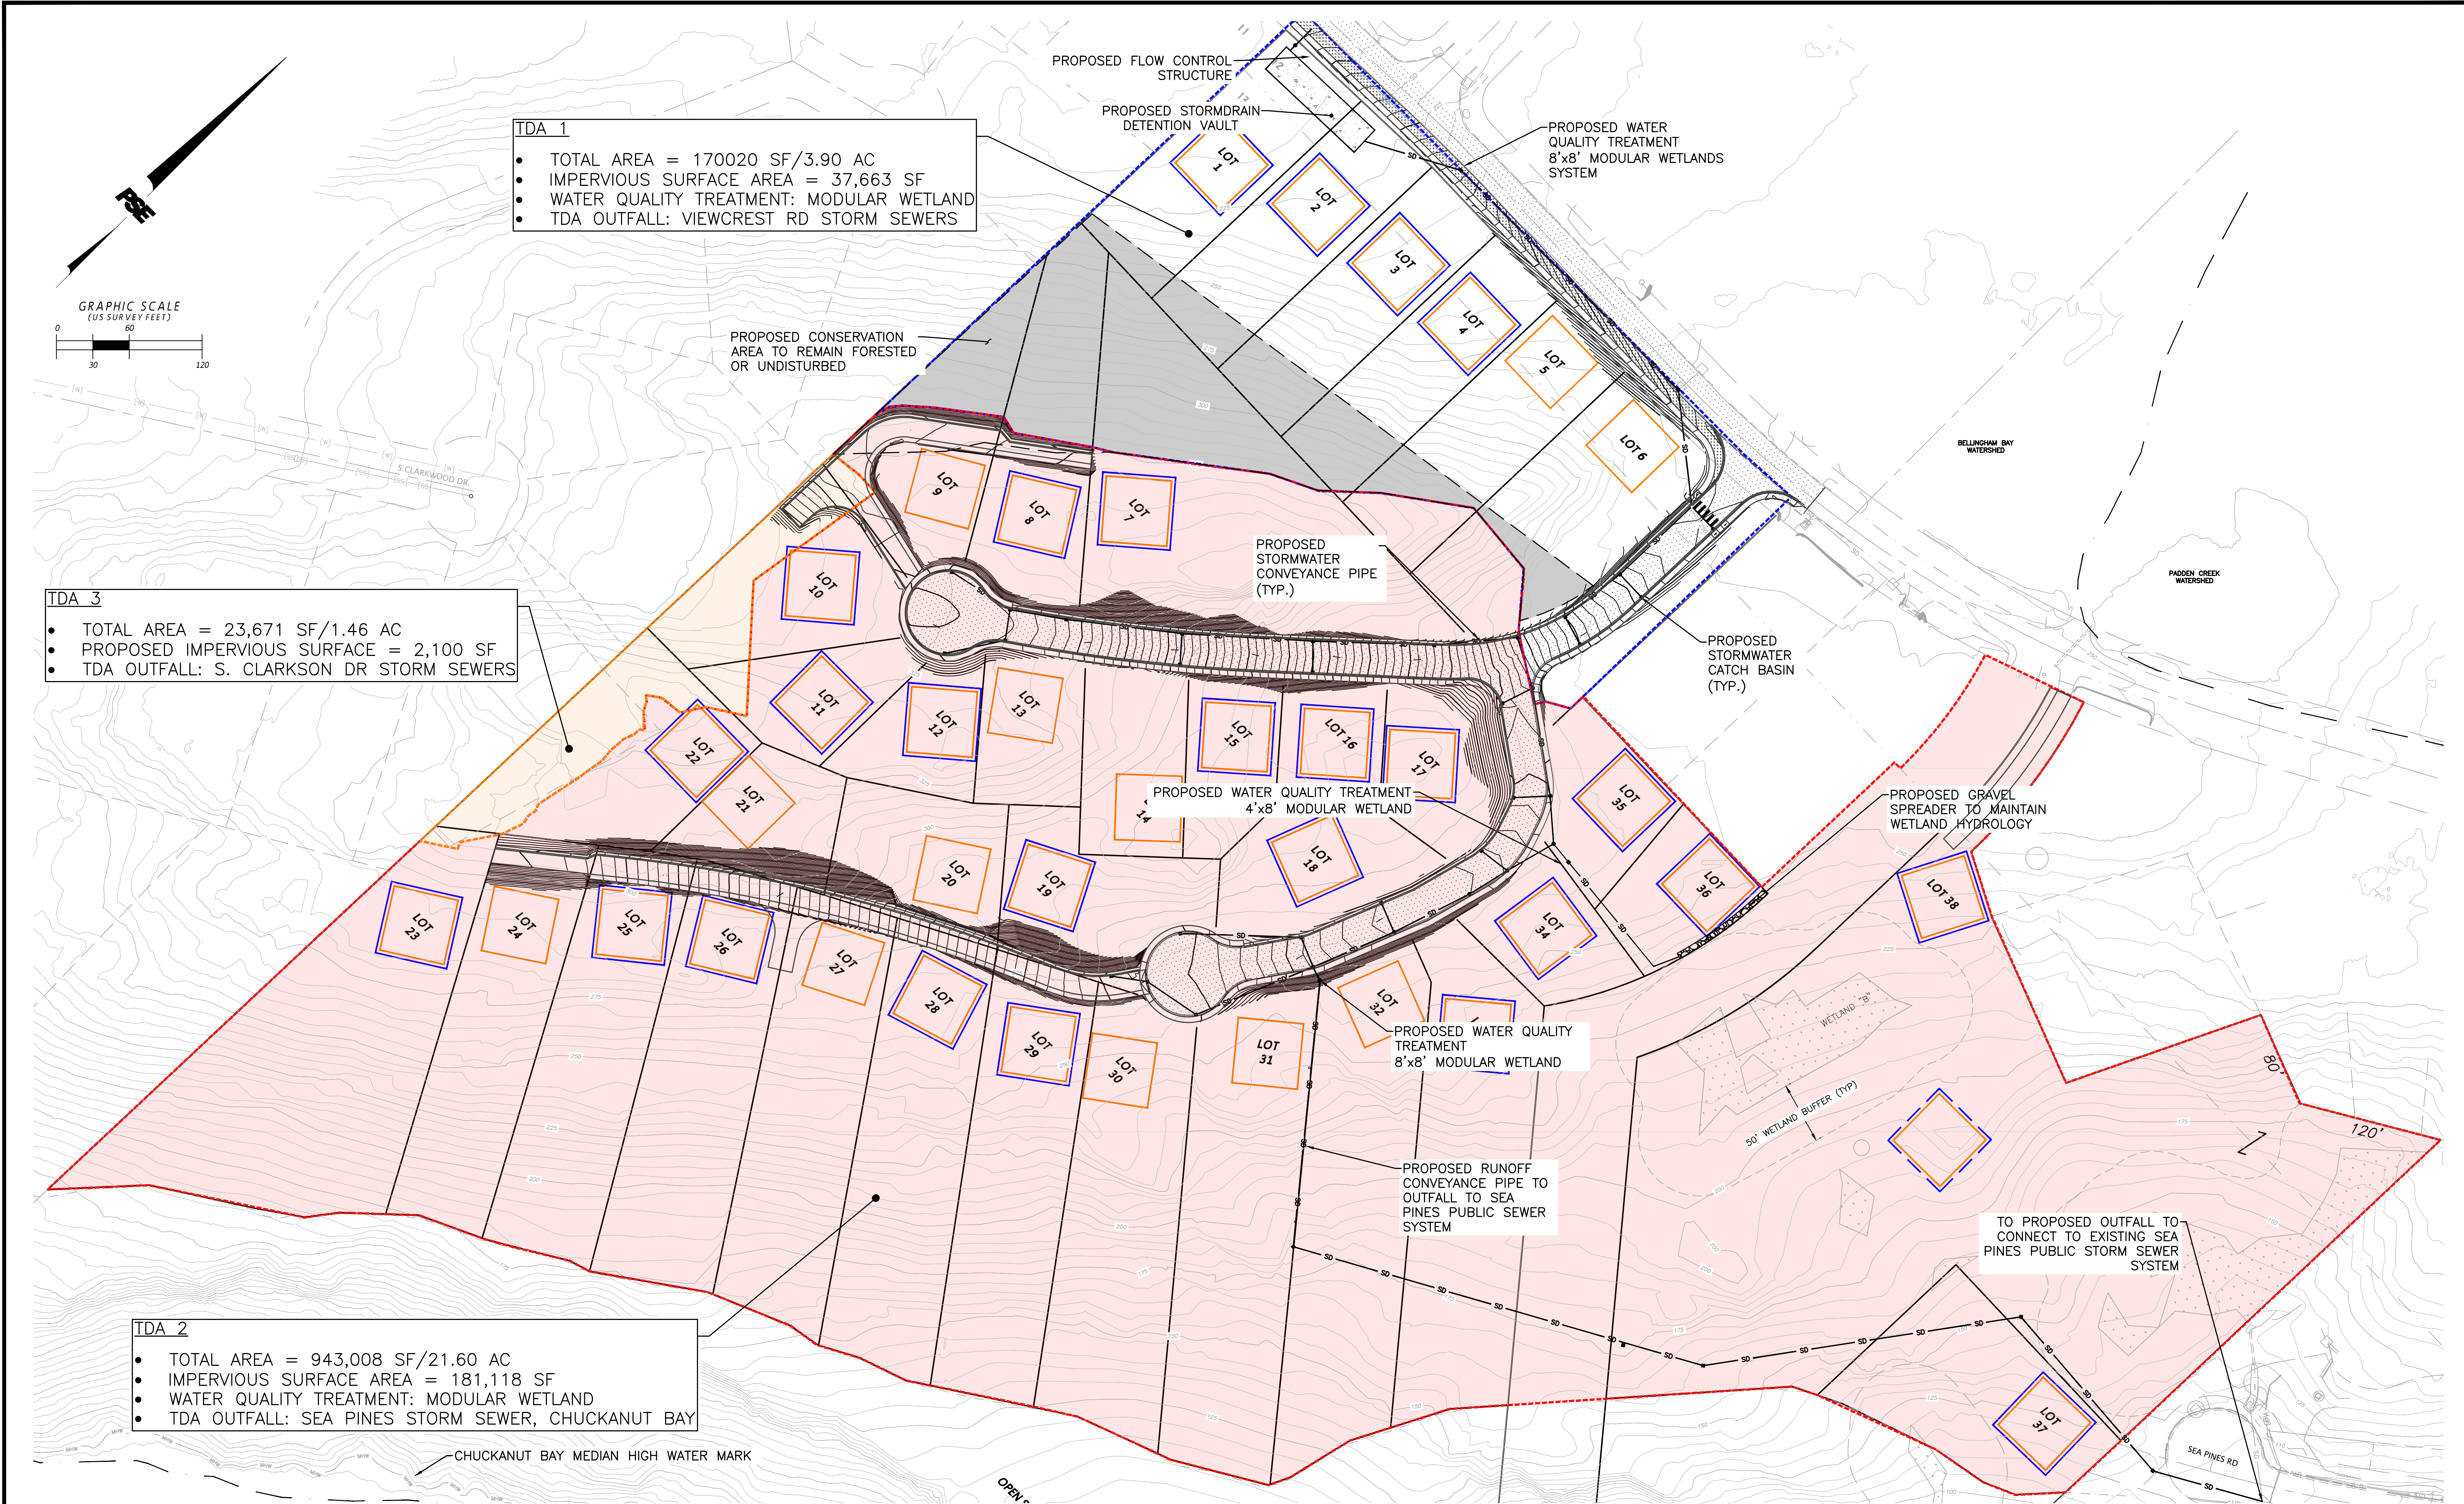
**TDA 1**

- TOTAL AREA = 170020 SF/3.90 AC
- IMPERVIOUS SURFACE AREA = 37,663 SF
- WATER QUALITY TREATMENT: MODULAR WETLAND
- TDA OUTFALL: VIEWCREST RD STORM SEWERS

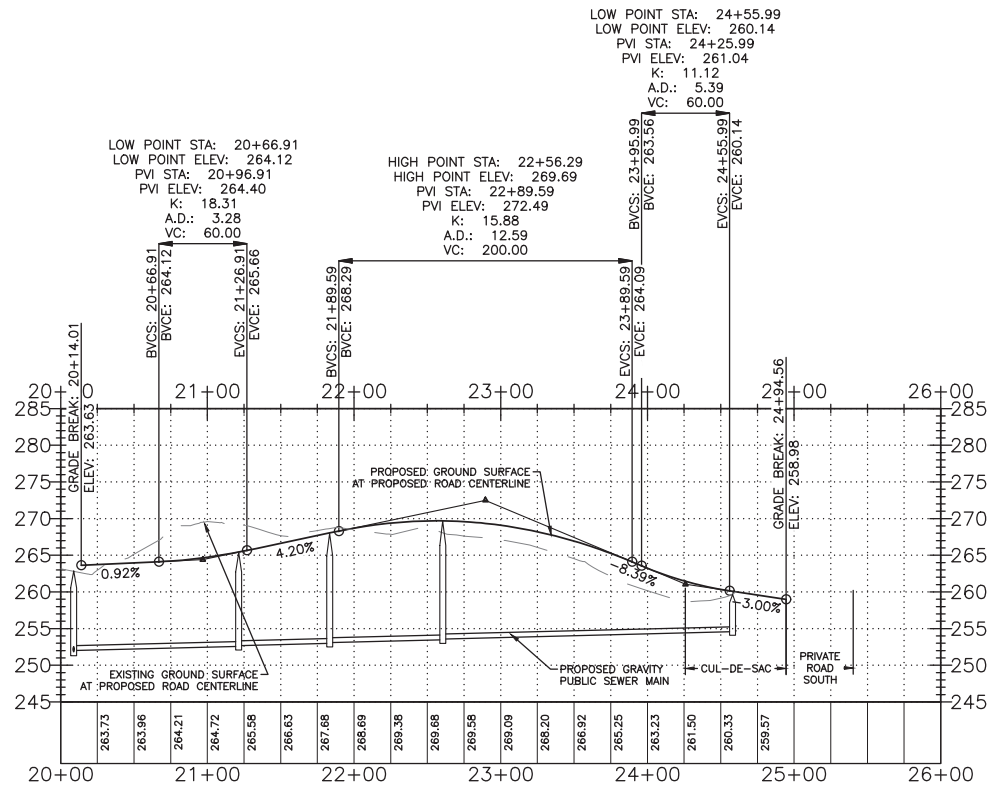
PUBLIC ROAD EAST PROFILE

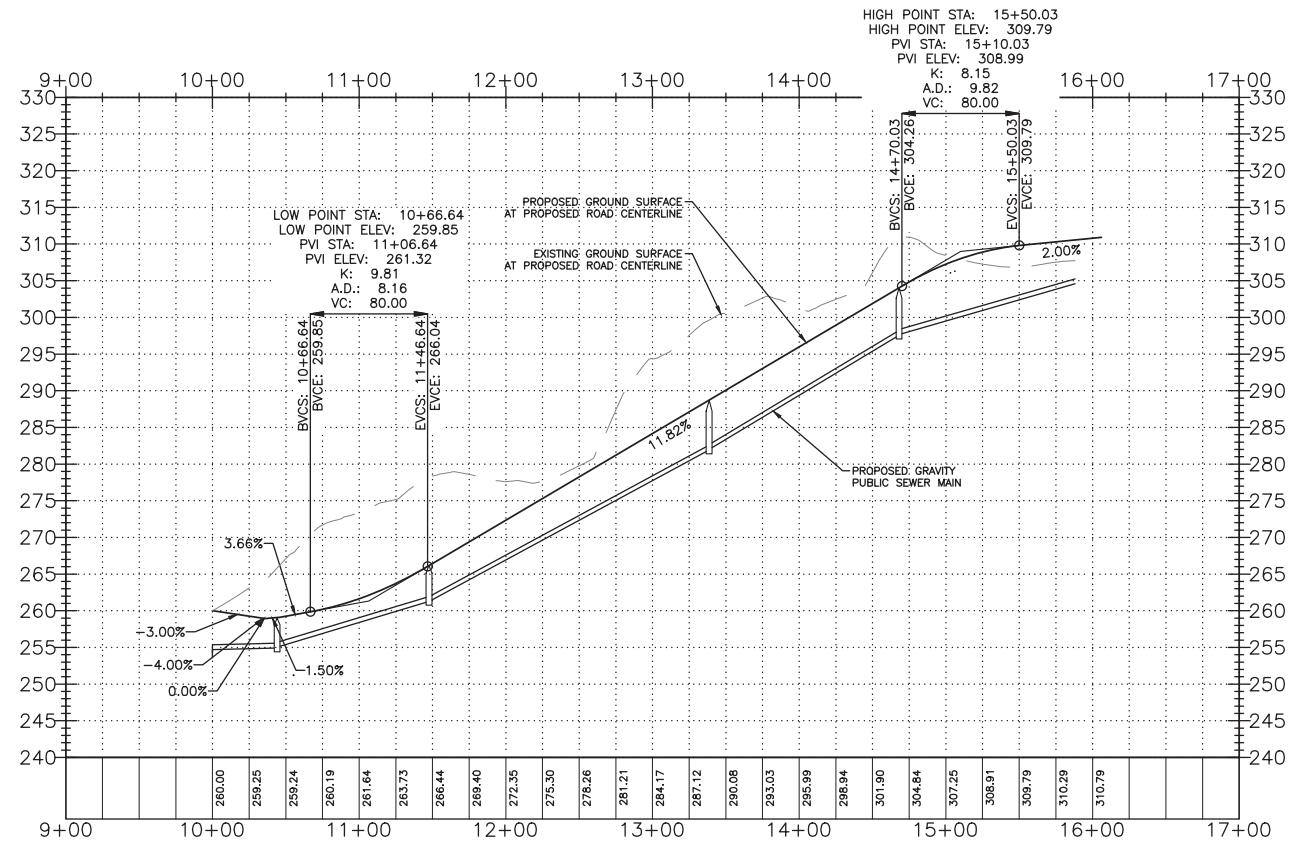
PRIVATE ROAD SOUTH PROFILE

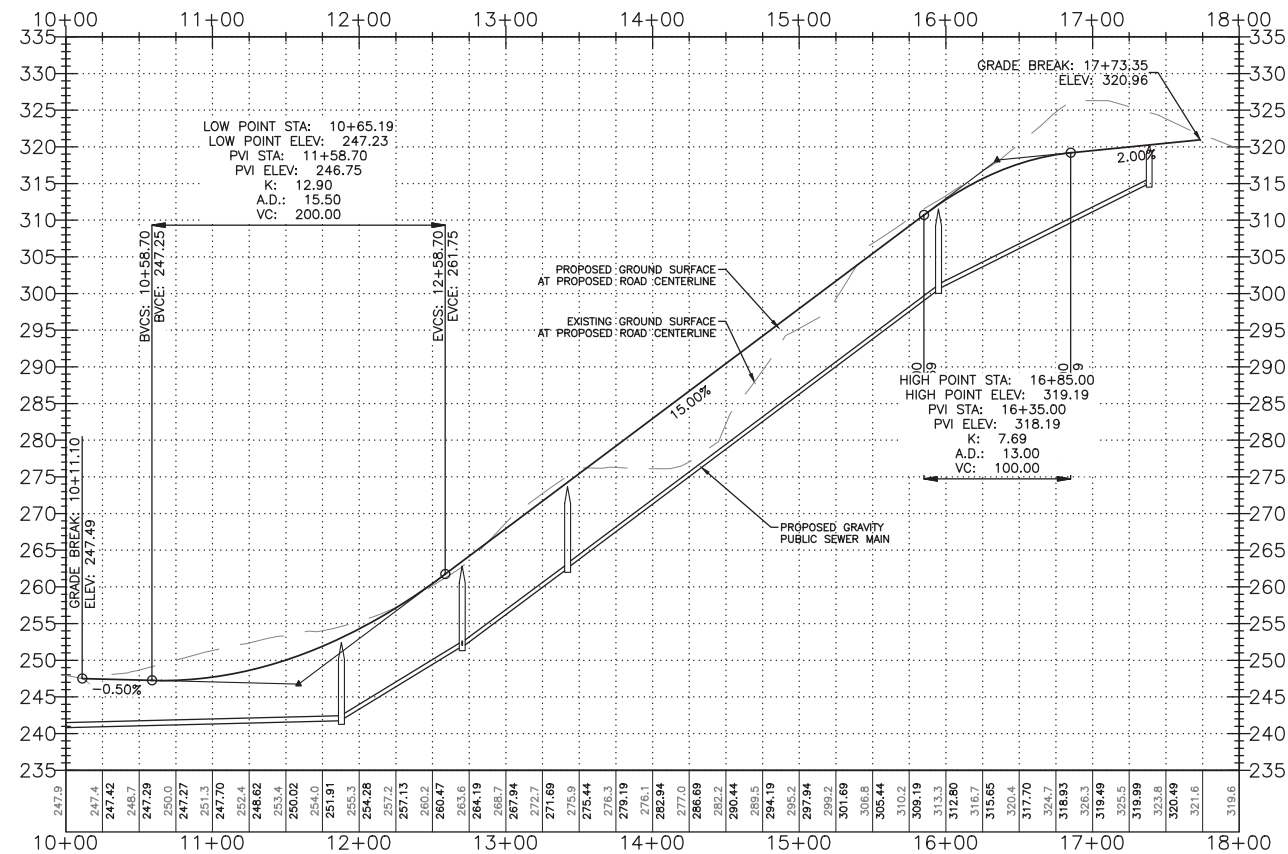
PUBLIC-WEST PROFILE

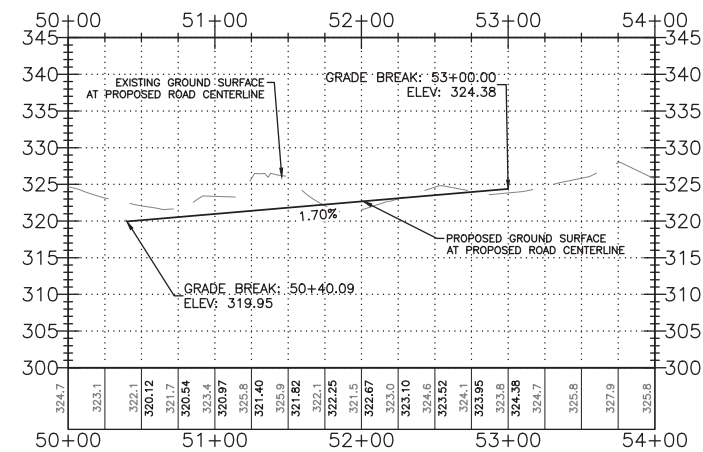
PRIVATE\_ROAD\_NORTH PROFILE

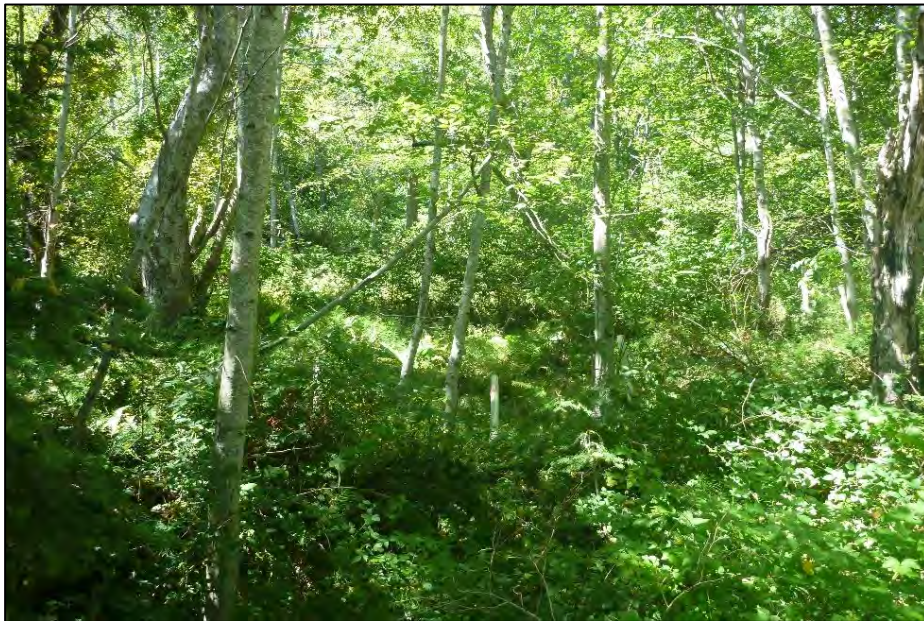
Overview of Wetland A, looking west

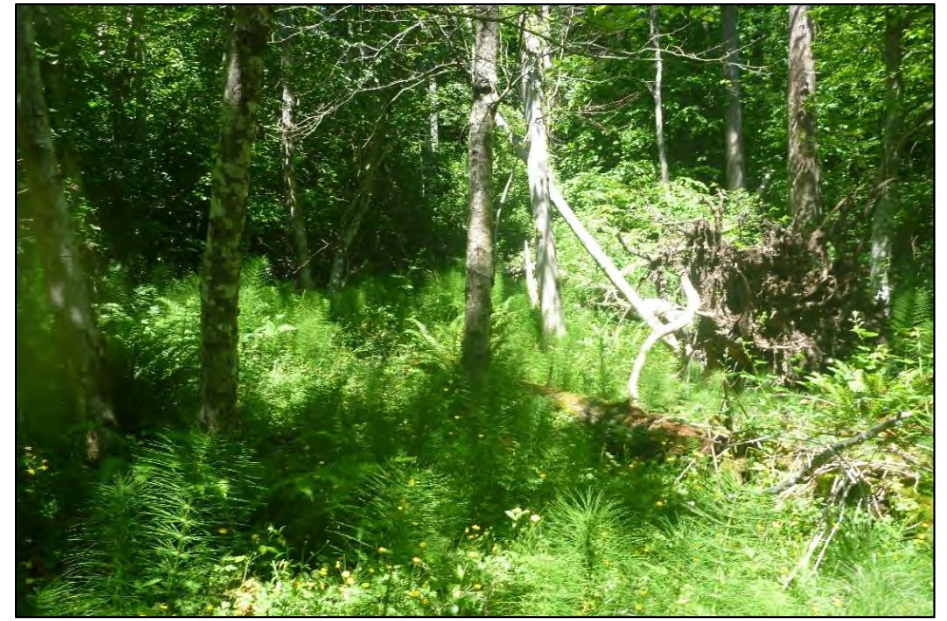
Overview of Wetland A, looking northwest

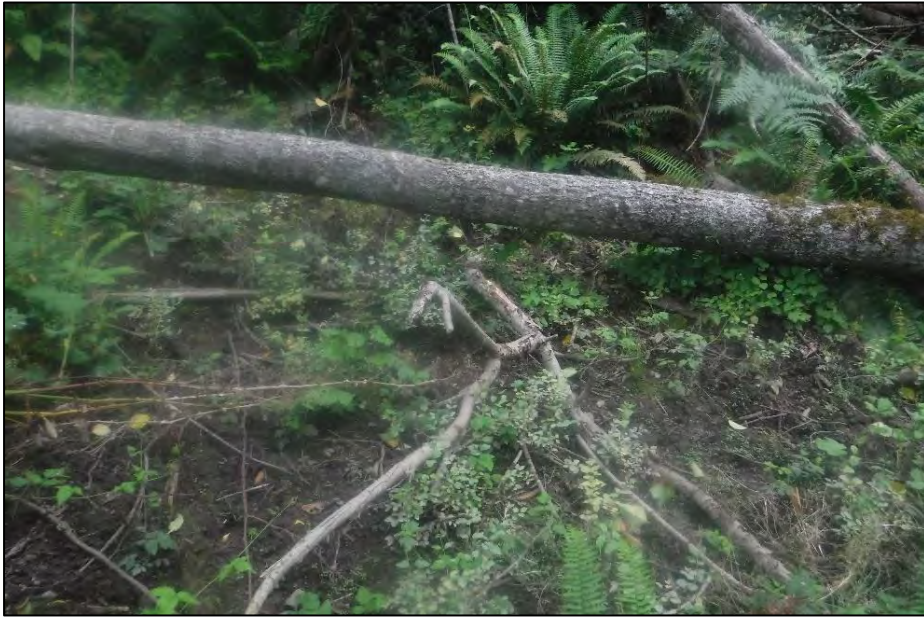
Detail of Wetland B

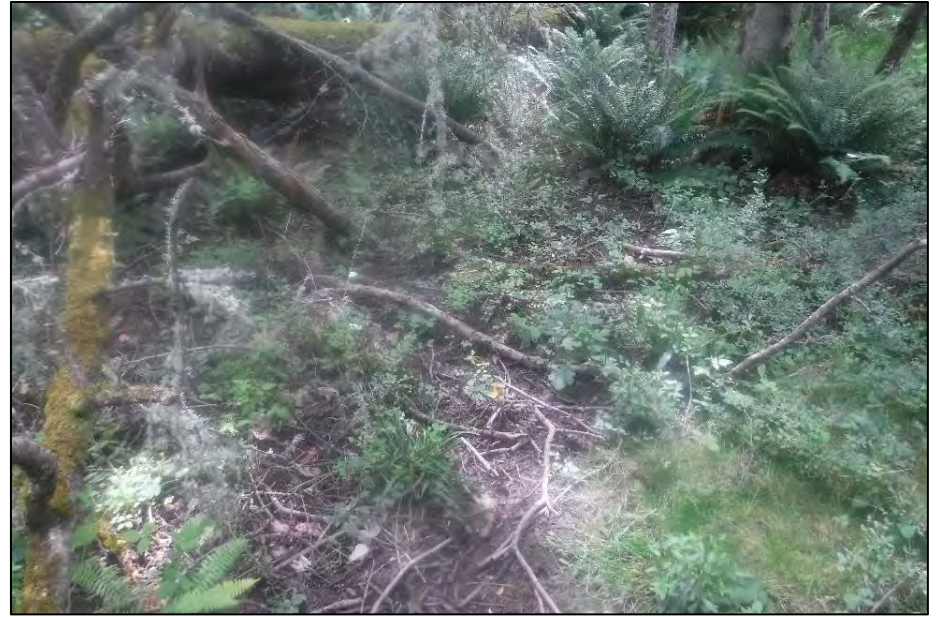
Detail of Wetland B

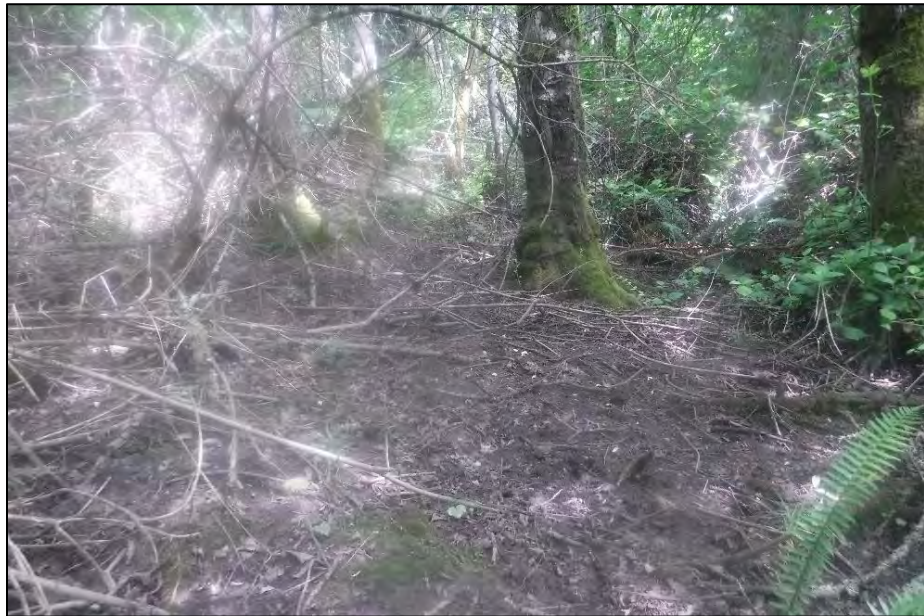
Overview of Wetland C

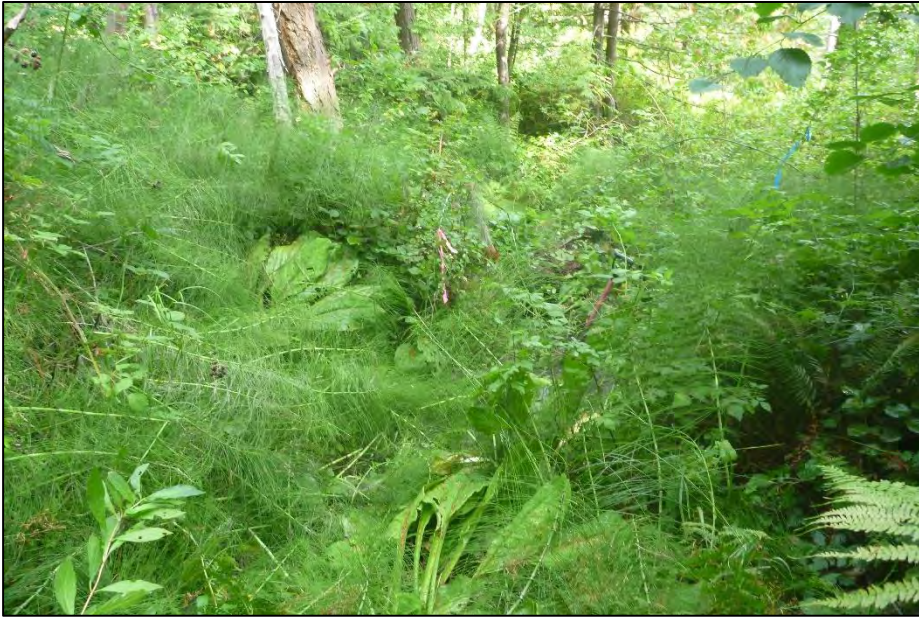
Overview of Wetland D

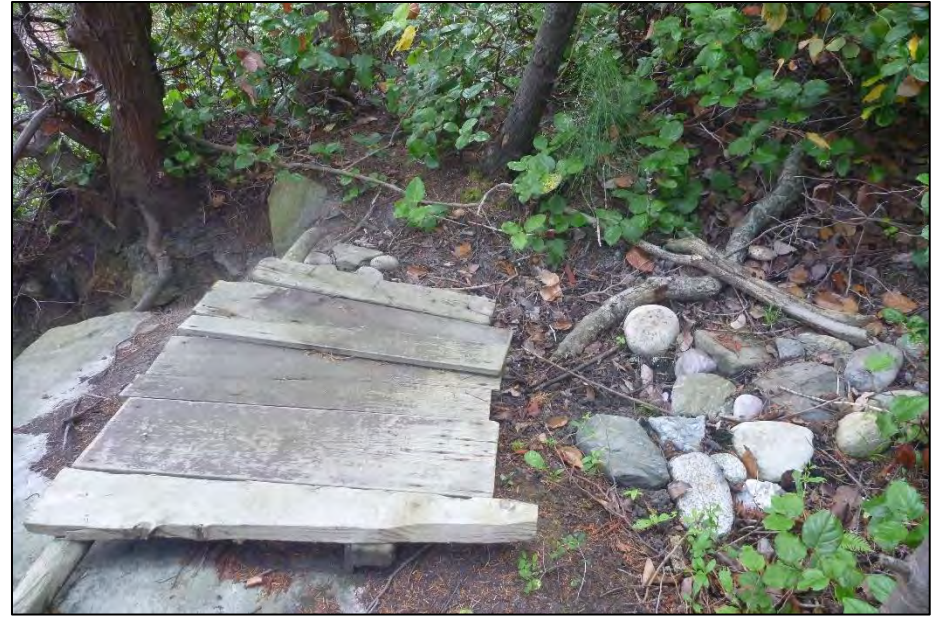
Detail of Wetland D outlet

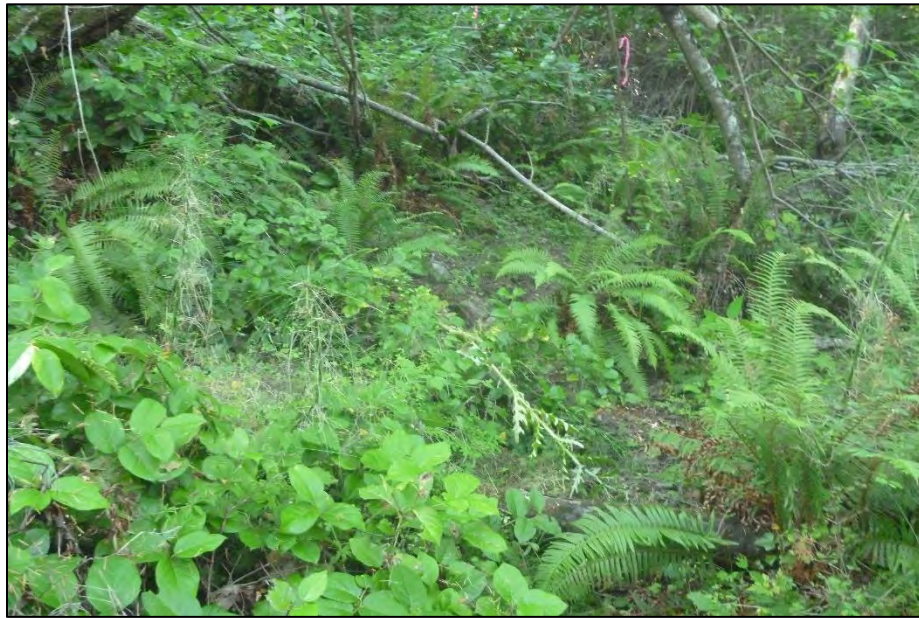
Overview of seep

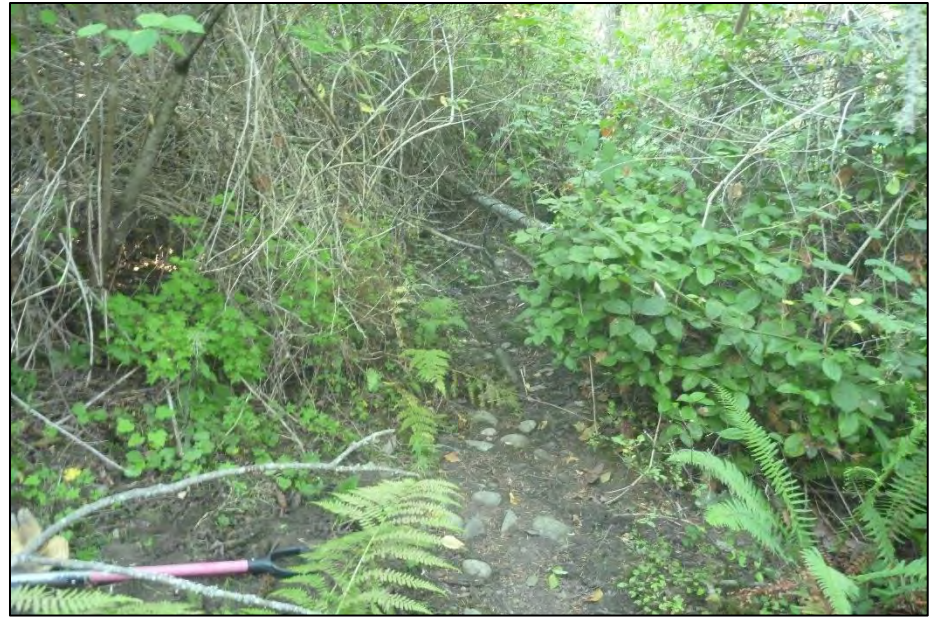
Seep from downslope

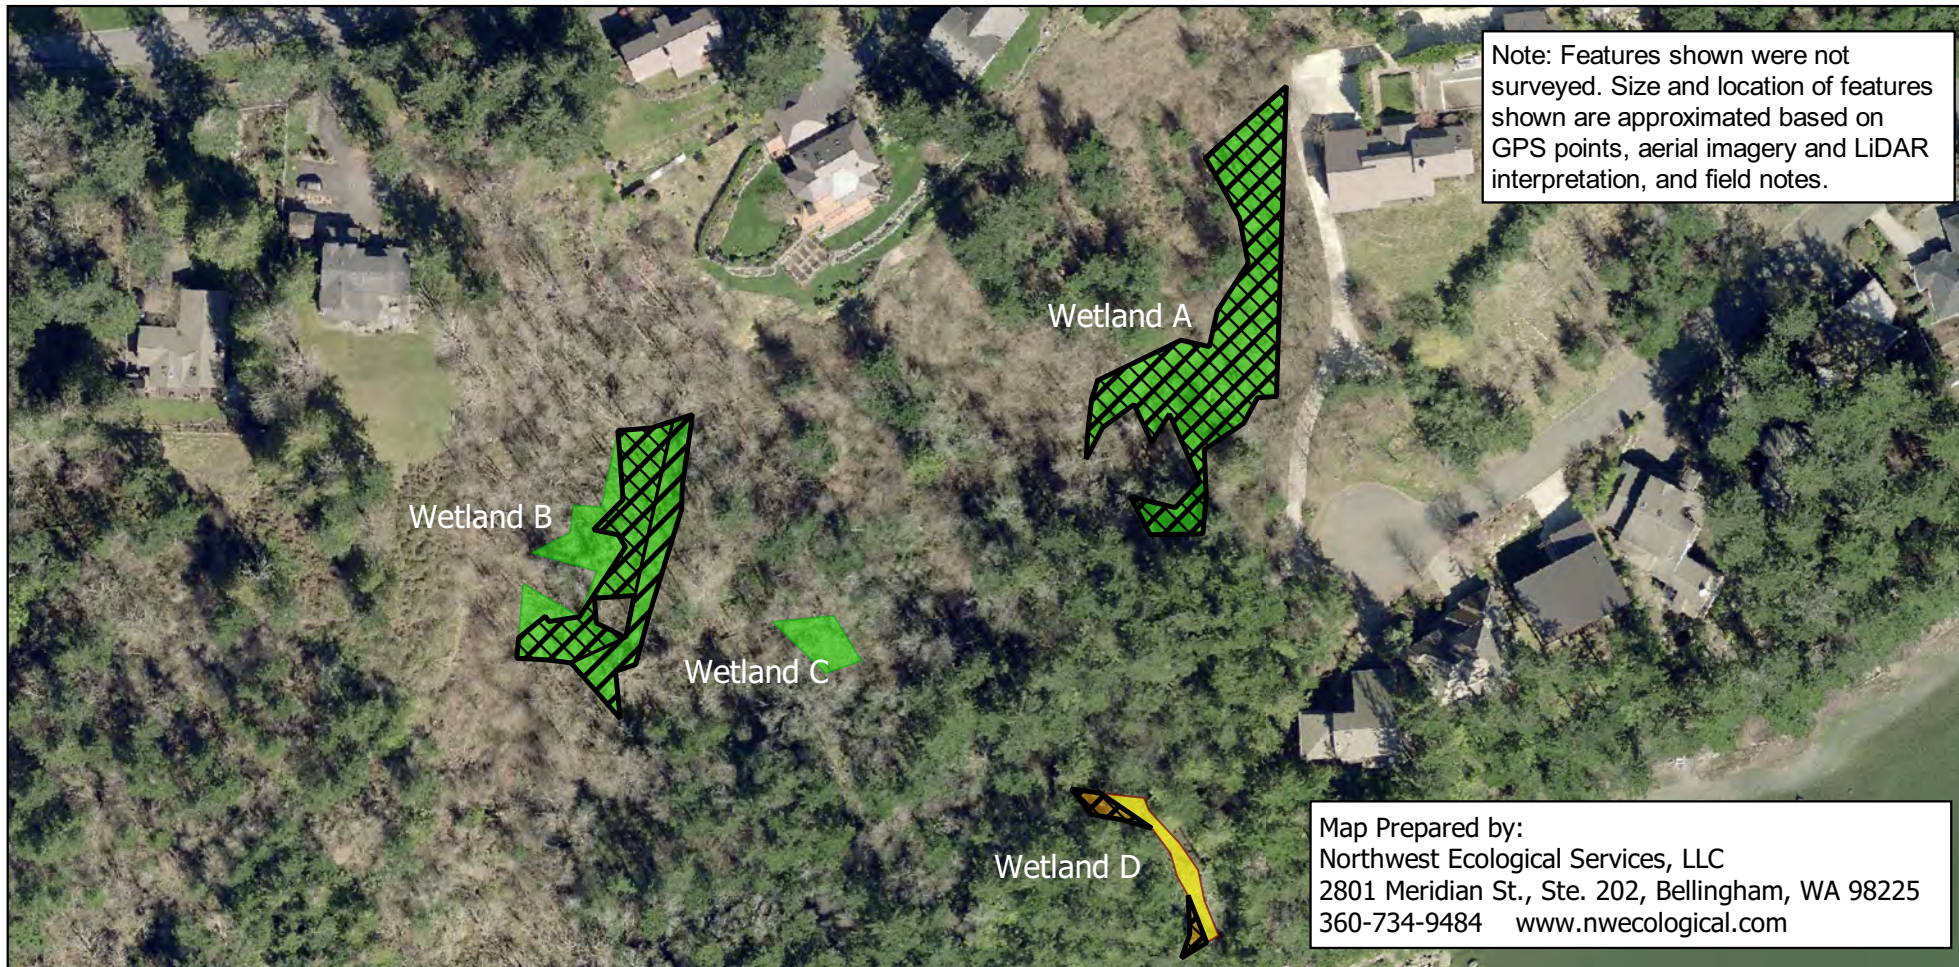
| <p><b>NORTHWEST</b><br/><b>ECOLOGICAL</b></p> | <p><b>Wetland Rating Figure:<br/>Vegetation Map</b></p> <p><b>Viewcrest<br/>Wetland Delineation Update</b></p> | <p><b>Attachment A</b></p> <p><b>OCT 2021</b></p> |

Forested
  Scrub Shrub
  Dense Veg

Emergent
  Rigid Veg
