Preliminary Stormwater Management Report

THE WOODS AT VIEWCREST

October 19, 2022

Pacific Surveying and Engineering Services, Inc.
909 Squalicum Way, Suite 11
Bellingham, Washington 98225
(360) 671-7387
www.psesurvey.com

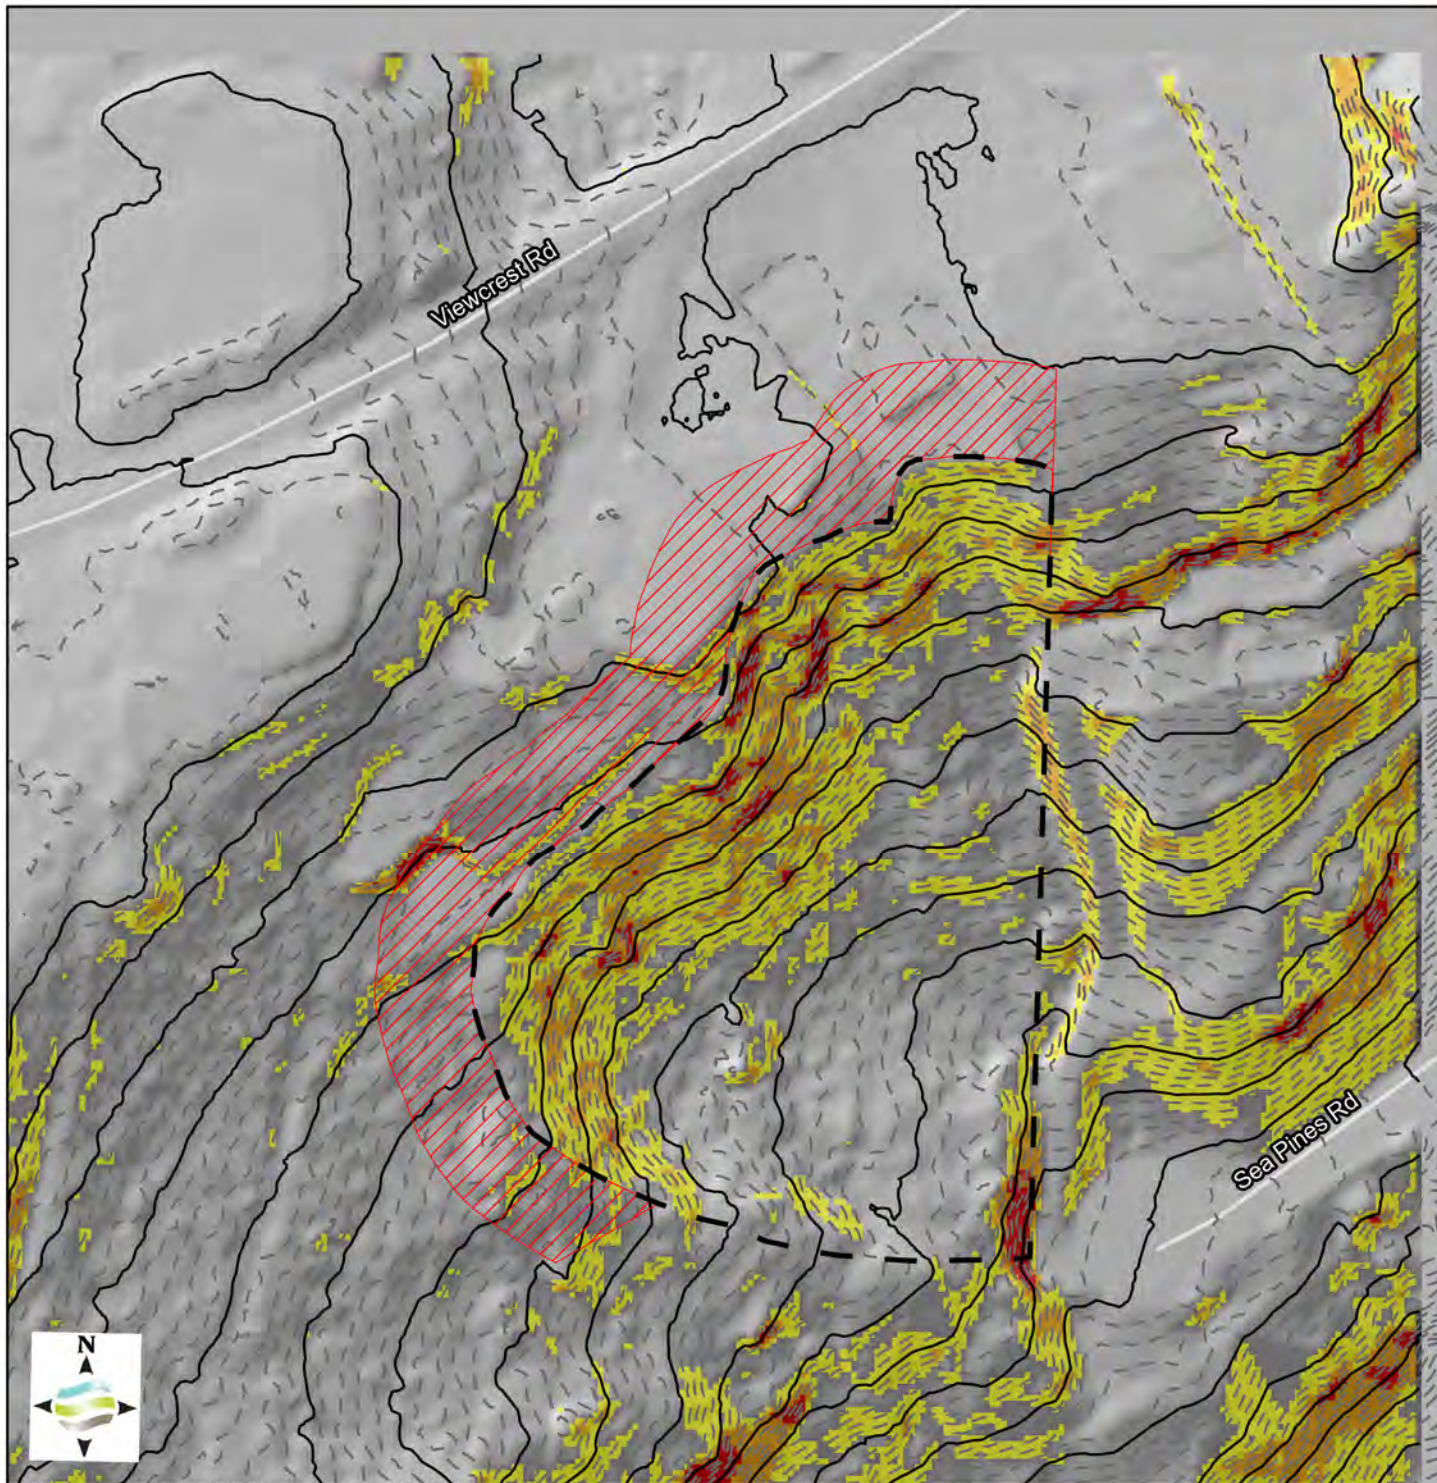
- Landslide Hazard Area (LHA)
- 50ft LHA Buffer
- contours_10
- 2ft Contours
- Roads

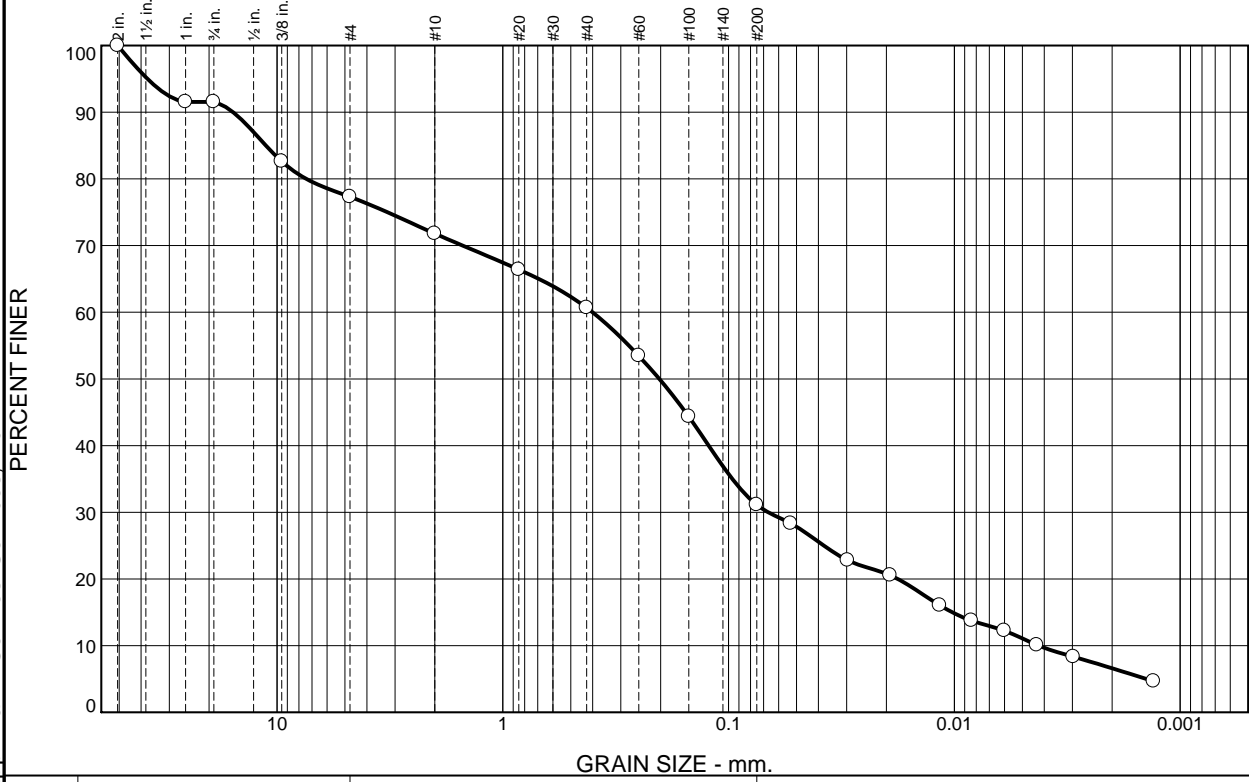
% +3"	% Gravel		% Sand			% Fines	
	Coarse	Fine	Coarse	Medium	Fine	Silt	Clay
0	8	15	5	11	30	20	11

SIEVE SIZE	PERCENT FINER	SPEC.* PERCENT	PASS? (X=NO)
2"	100		
1"	92		
3/4"	92		
3/8"	83		
#4	77		
#10	72		
#20	66		
#40	61		
#60	53		
#100	44		
#200	31		
#270	28		
0.0297 mm.	23		
0.0192 mm.	21		
0.0116 mm.	16		
0.0084 mm.	14		
0.0060 mm.	12		
0.0043 mm.	10		
0.0030 mm.	8.3		
0.0013 mm.	4.7

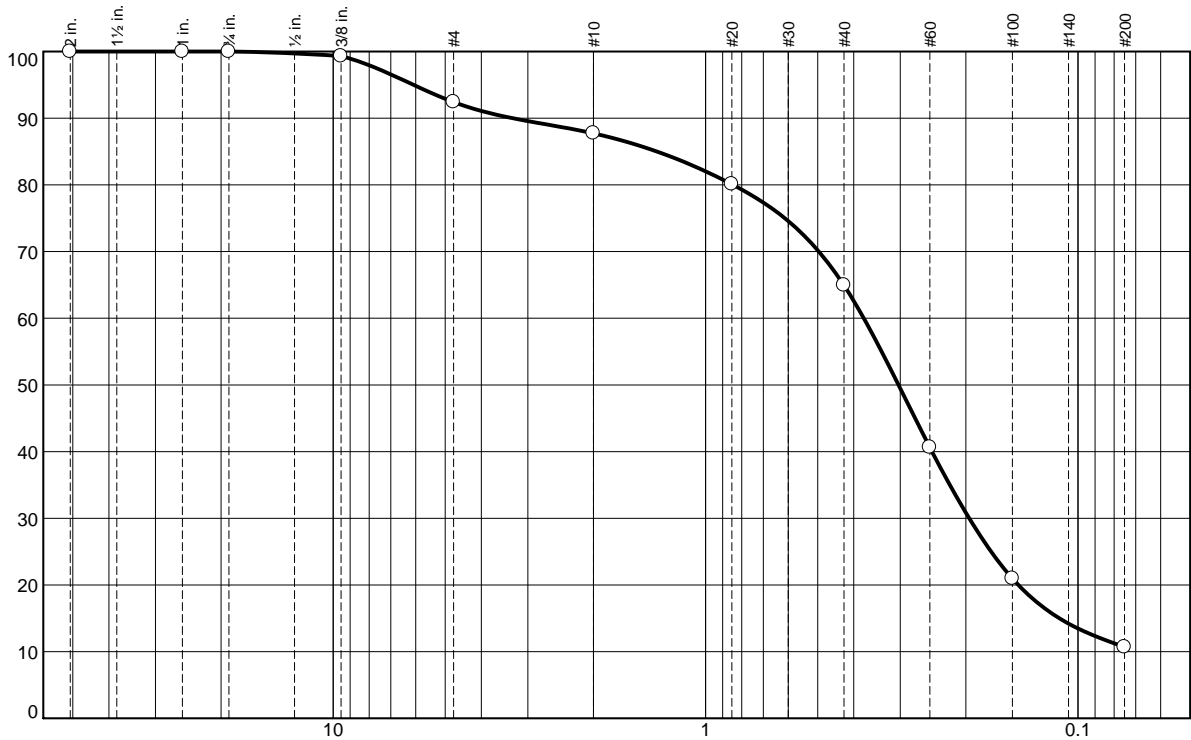
% +3"	% Gravel		% Sand			% Fines Silt
	Coarse	Fine	Coarse	Medium	Fine	
0	0	8	4	23	54	11

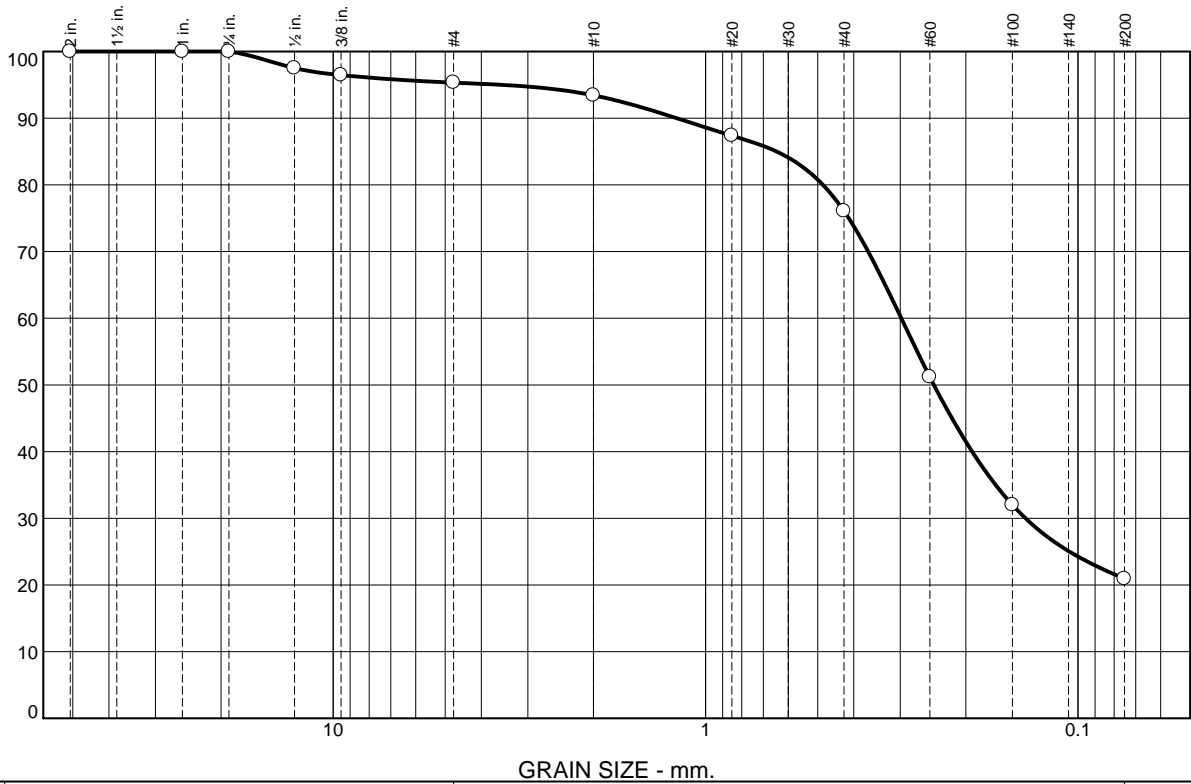
% +3"	% Gravel		% Sand			% Fines
	Coarse	Fine	Coarse	Medium	Fine	Silt
0	0	5	2	17	55	21

SIEVE SIZE	PERCENT FINER	SPEC.* PERCENT	PASS? (X=NO)
2"	100		
1"	100		
3/4"	100		
1/2"	98		
3/8"	96		
#4	95		
#10	93		
#20	87		
#40	76		
#60	51		
#100	32		
#200	21

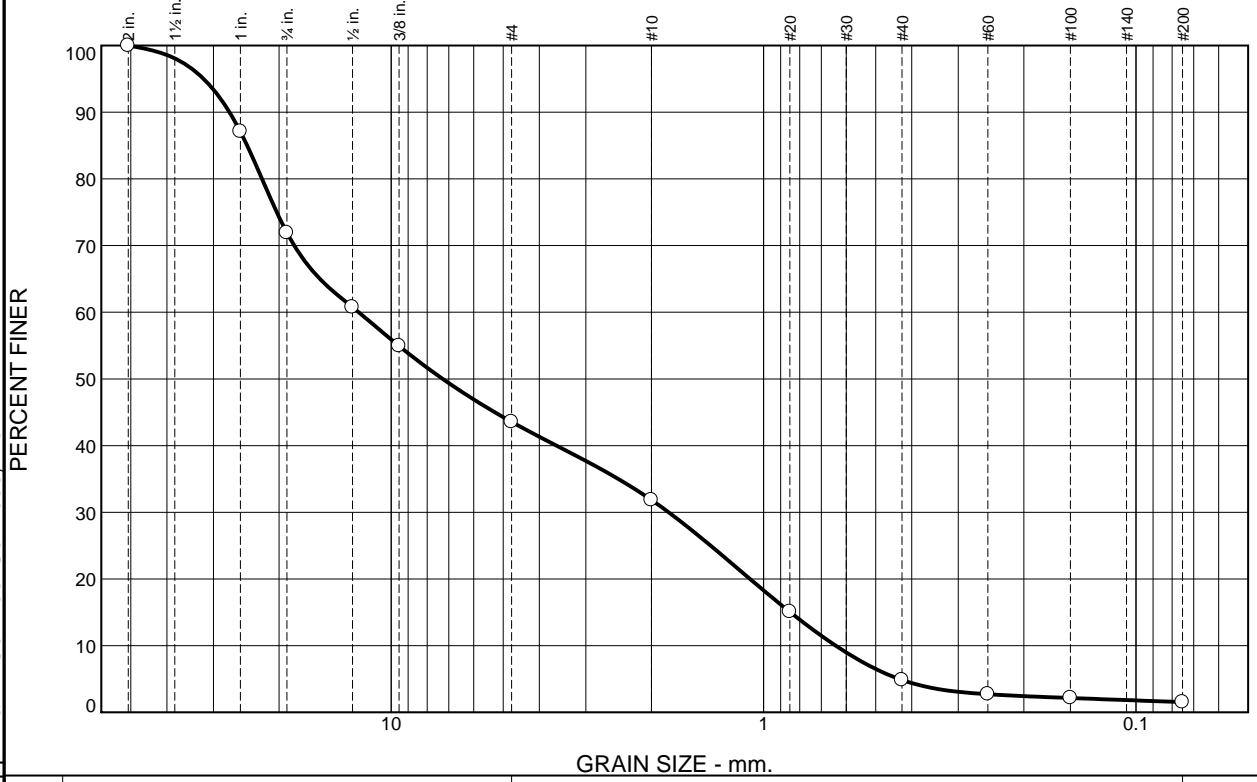
% +3"	% Gravel		% Sand			% Fines Silt
	Coarse	Fine	Coarse	Medium	Fine	
0	28	28	12	27	3	2

SIEVE SIZE	PERCENT FINER	SPEC.* PERCENT	PASS? (X=NO)
2"	100		
1"	87		
3/4"	72		
1/2"	61		
3/8"	55		
#4	44		
#10	32		
#20	15		
#40	5		
#60	3		
#100	2		
#200	1.5

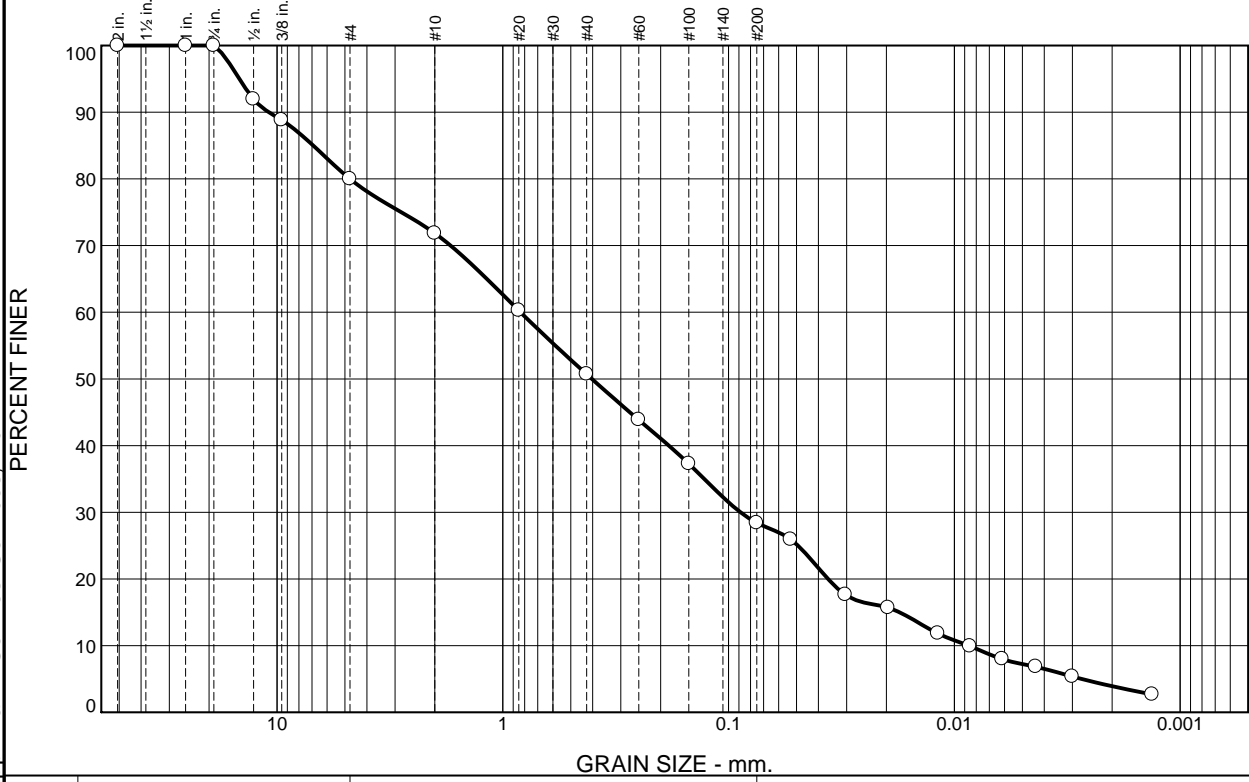
% +3"	% Gravel		% Sand			% Fines	
	Coarse	Fine	Coarse	Medium	Fine	Silt	Clay
0	0	20	8	21	23	21	7

SIEVE SIZE	PERCENT FINER	SPEC.* PERCENT	PASS? (X=NO)
2"	100		
1"	100		
3/4"	100		
1/2"	92		
3/8"	89		
#4	80		
#10	72		
#20	60		
#40	51		
#60	44		
#100	37		
#200	28		
#270	26		
0.0304 mm.	18		
0.0196 mm.	16		
0.0118 mm.	12		
0.0085 mm.	9.9		
0.0061 mm.	8.0		
0.0044 mm.	6.8		
0.0030 mm.	5.4		
0.0013 mm.	2.7

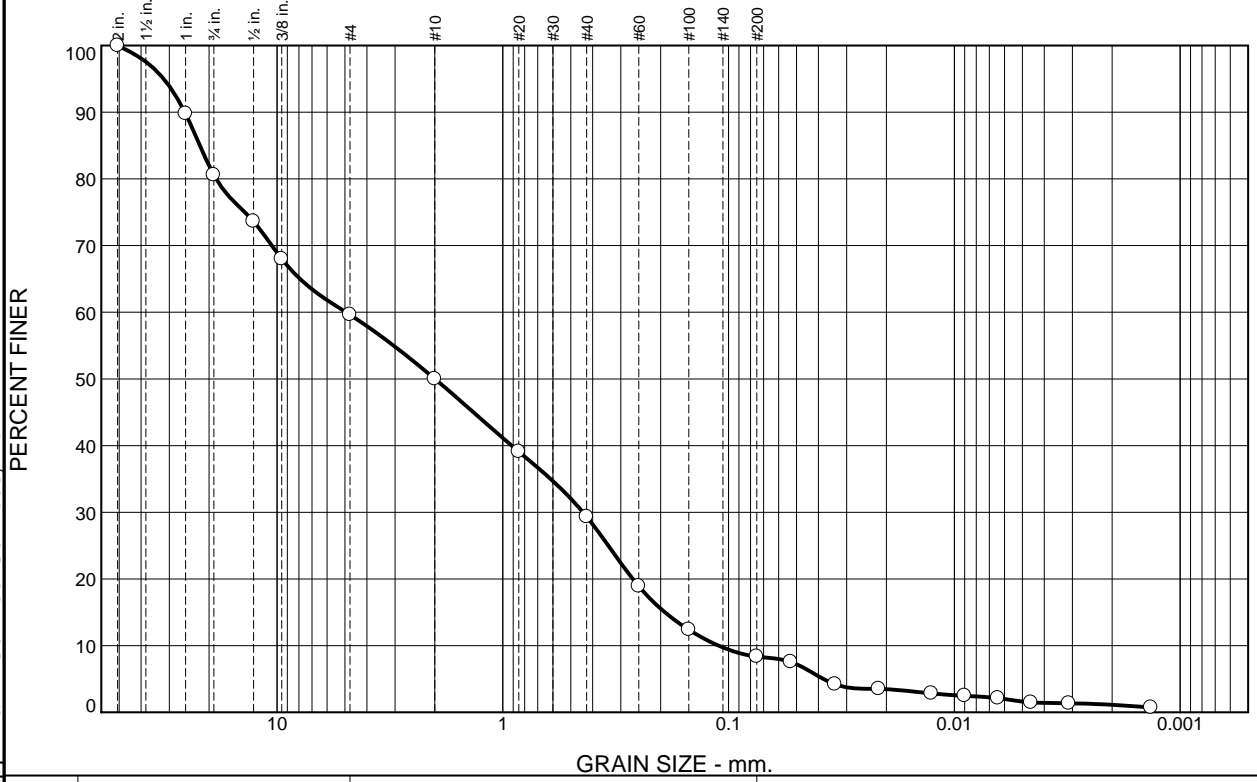
% +3"	% Gravel		% Sand			% Fines	
	Coarse	Fine	Coarse	Medium	Fine	Silt	Clay
0	19	21	10	21	21	6	2

SIEVE SIZE	PERCENT FINER	SPEC.* PERCENT	PASS? (X=NO)
2"	100		
1"	90		
3/4"	81		
1/2"	74		
3/8"	68		
#4	60		
#10	50		
#20	39		
#40	29		
#60	19		
#100	12		
#200	8.3		
#270	7.6		
0.0338 mm.	4.2		
0.0216 mm.	3.5		
0.0126 mm.	2.8		
0.0090 mm.	2.5		
0.0064 mm.	2.1		
0.0046 mm.	1.5		
0.0031 mm.	1.3		
0.0013 mm.	0.7

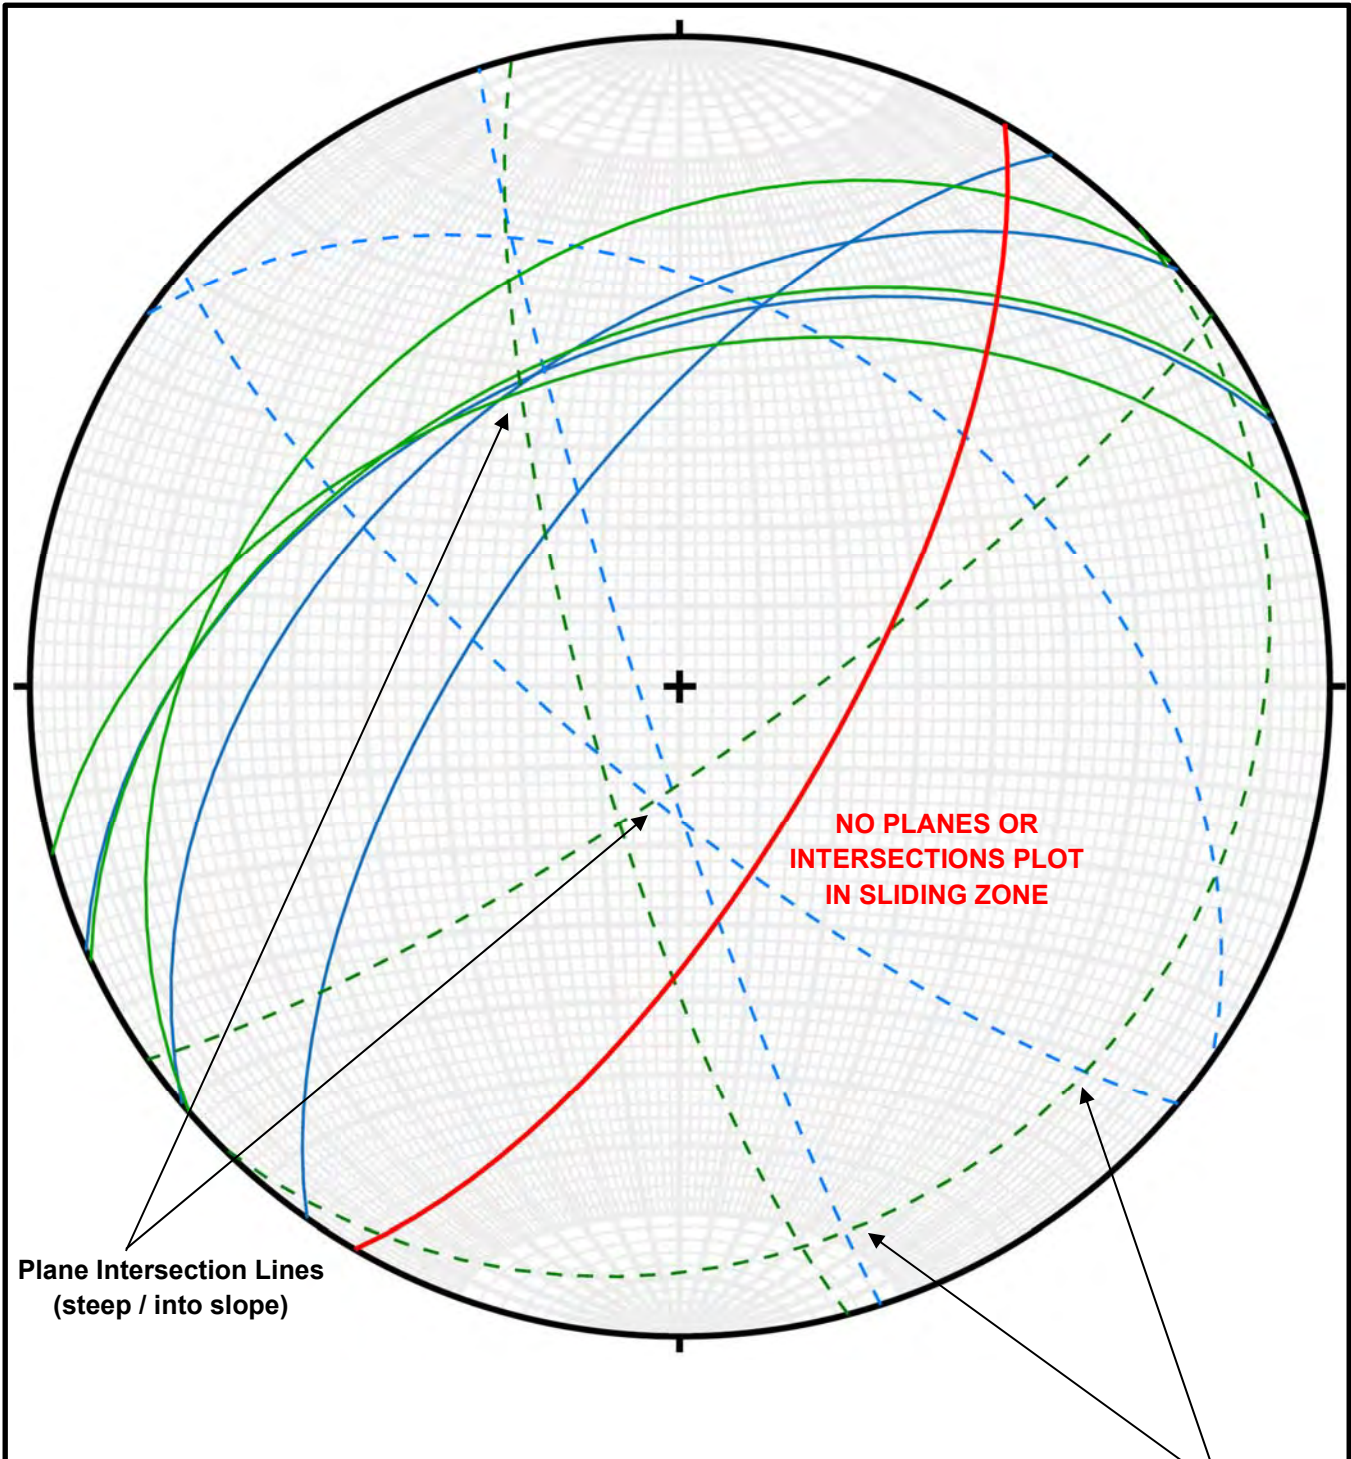
Plane Intersection Lines
(steep / into slope)

**NO PLANES OR
INTERSECTIONS PLOT
IN SLIDING ZONE**

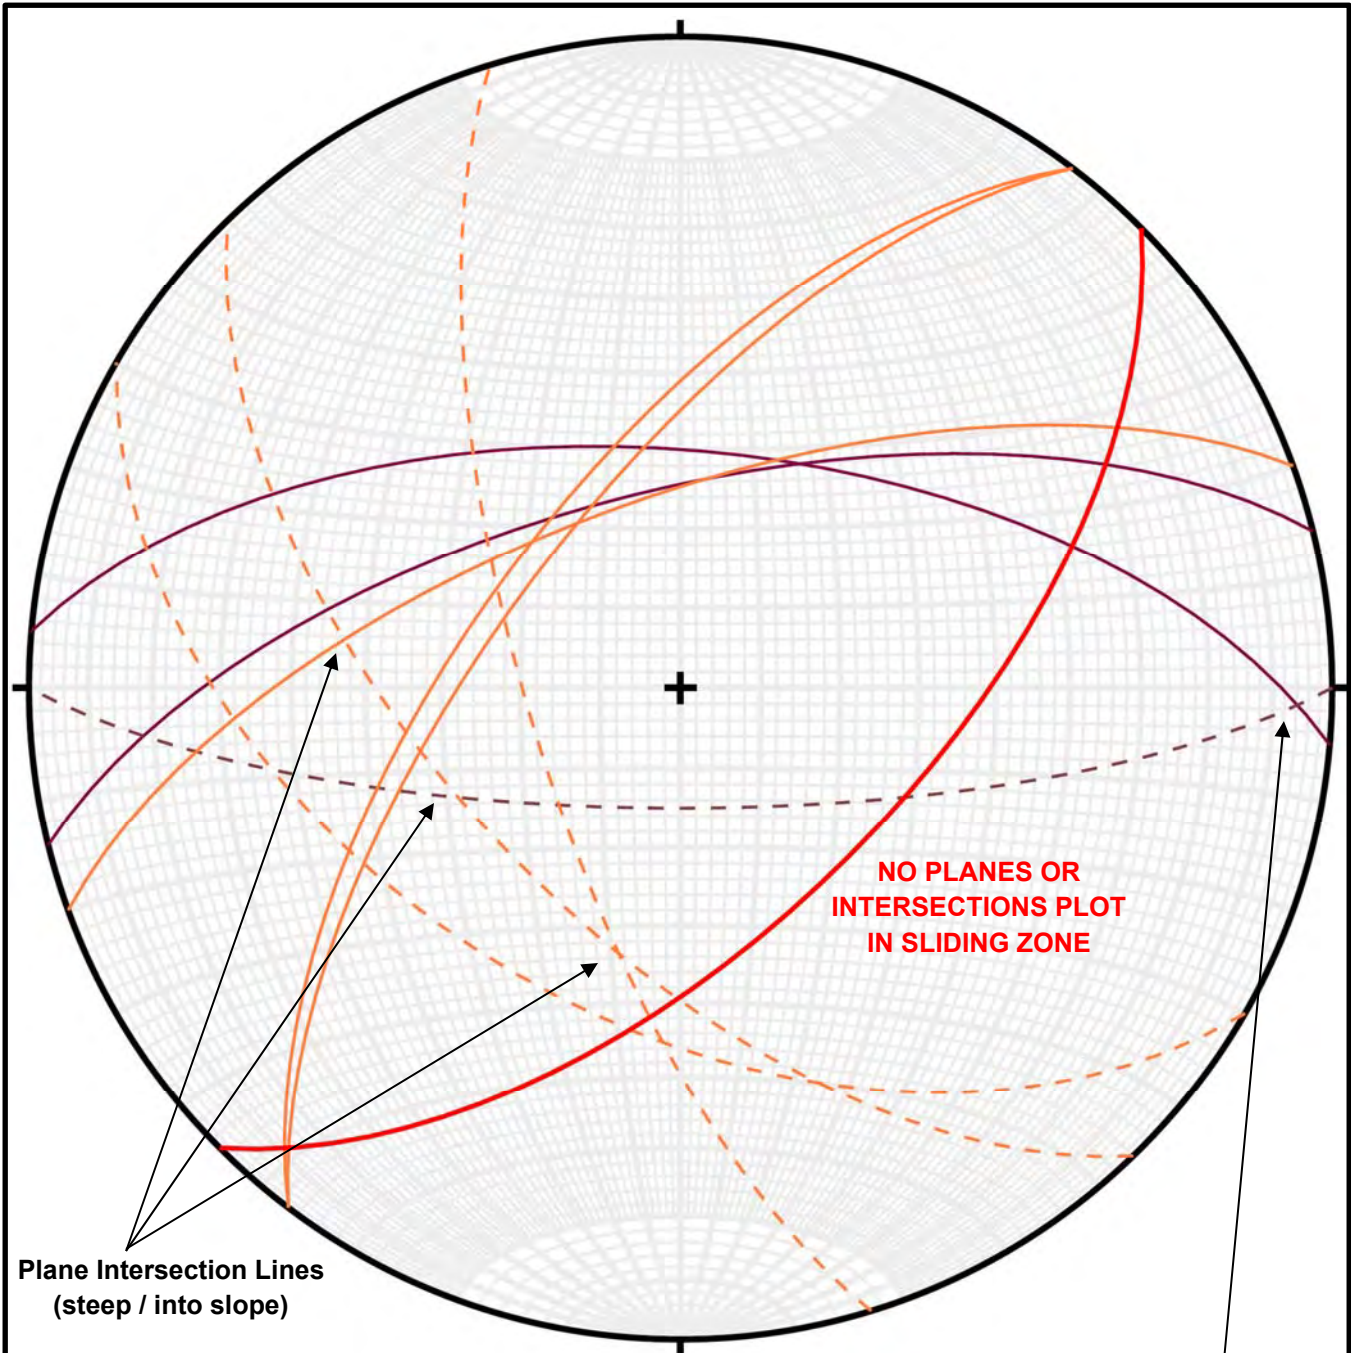
Figure
10a

Plane Intersection Lines
(steep / into slope)

**NO PLANES OR
INTERSECTIONS PLOT
IN SLIDING ZONE**

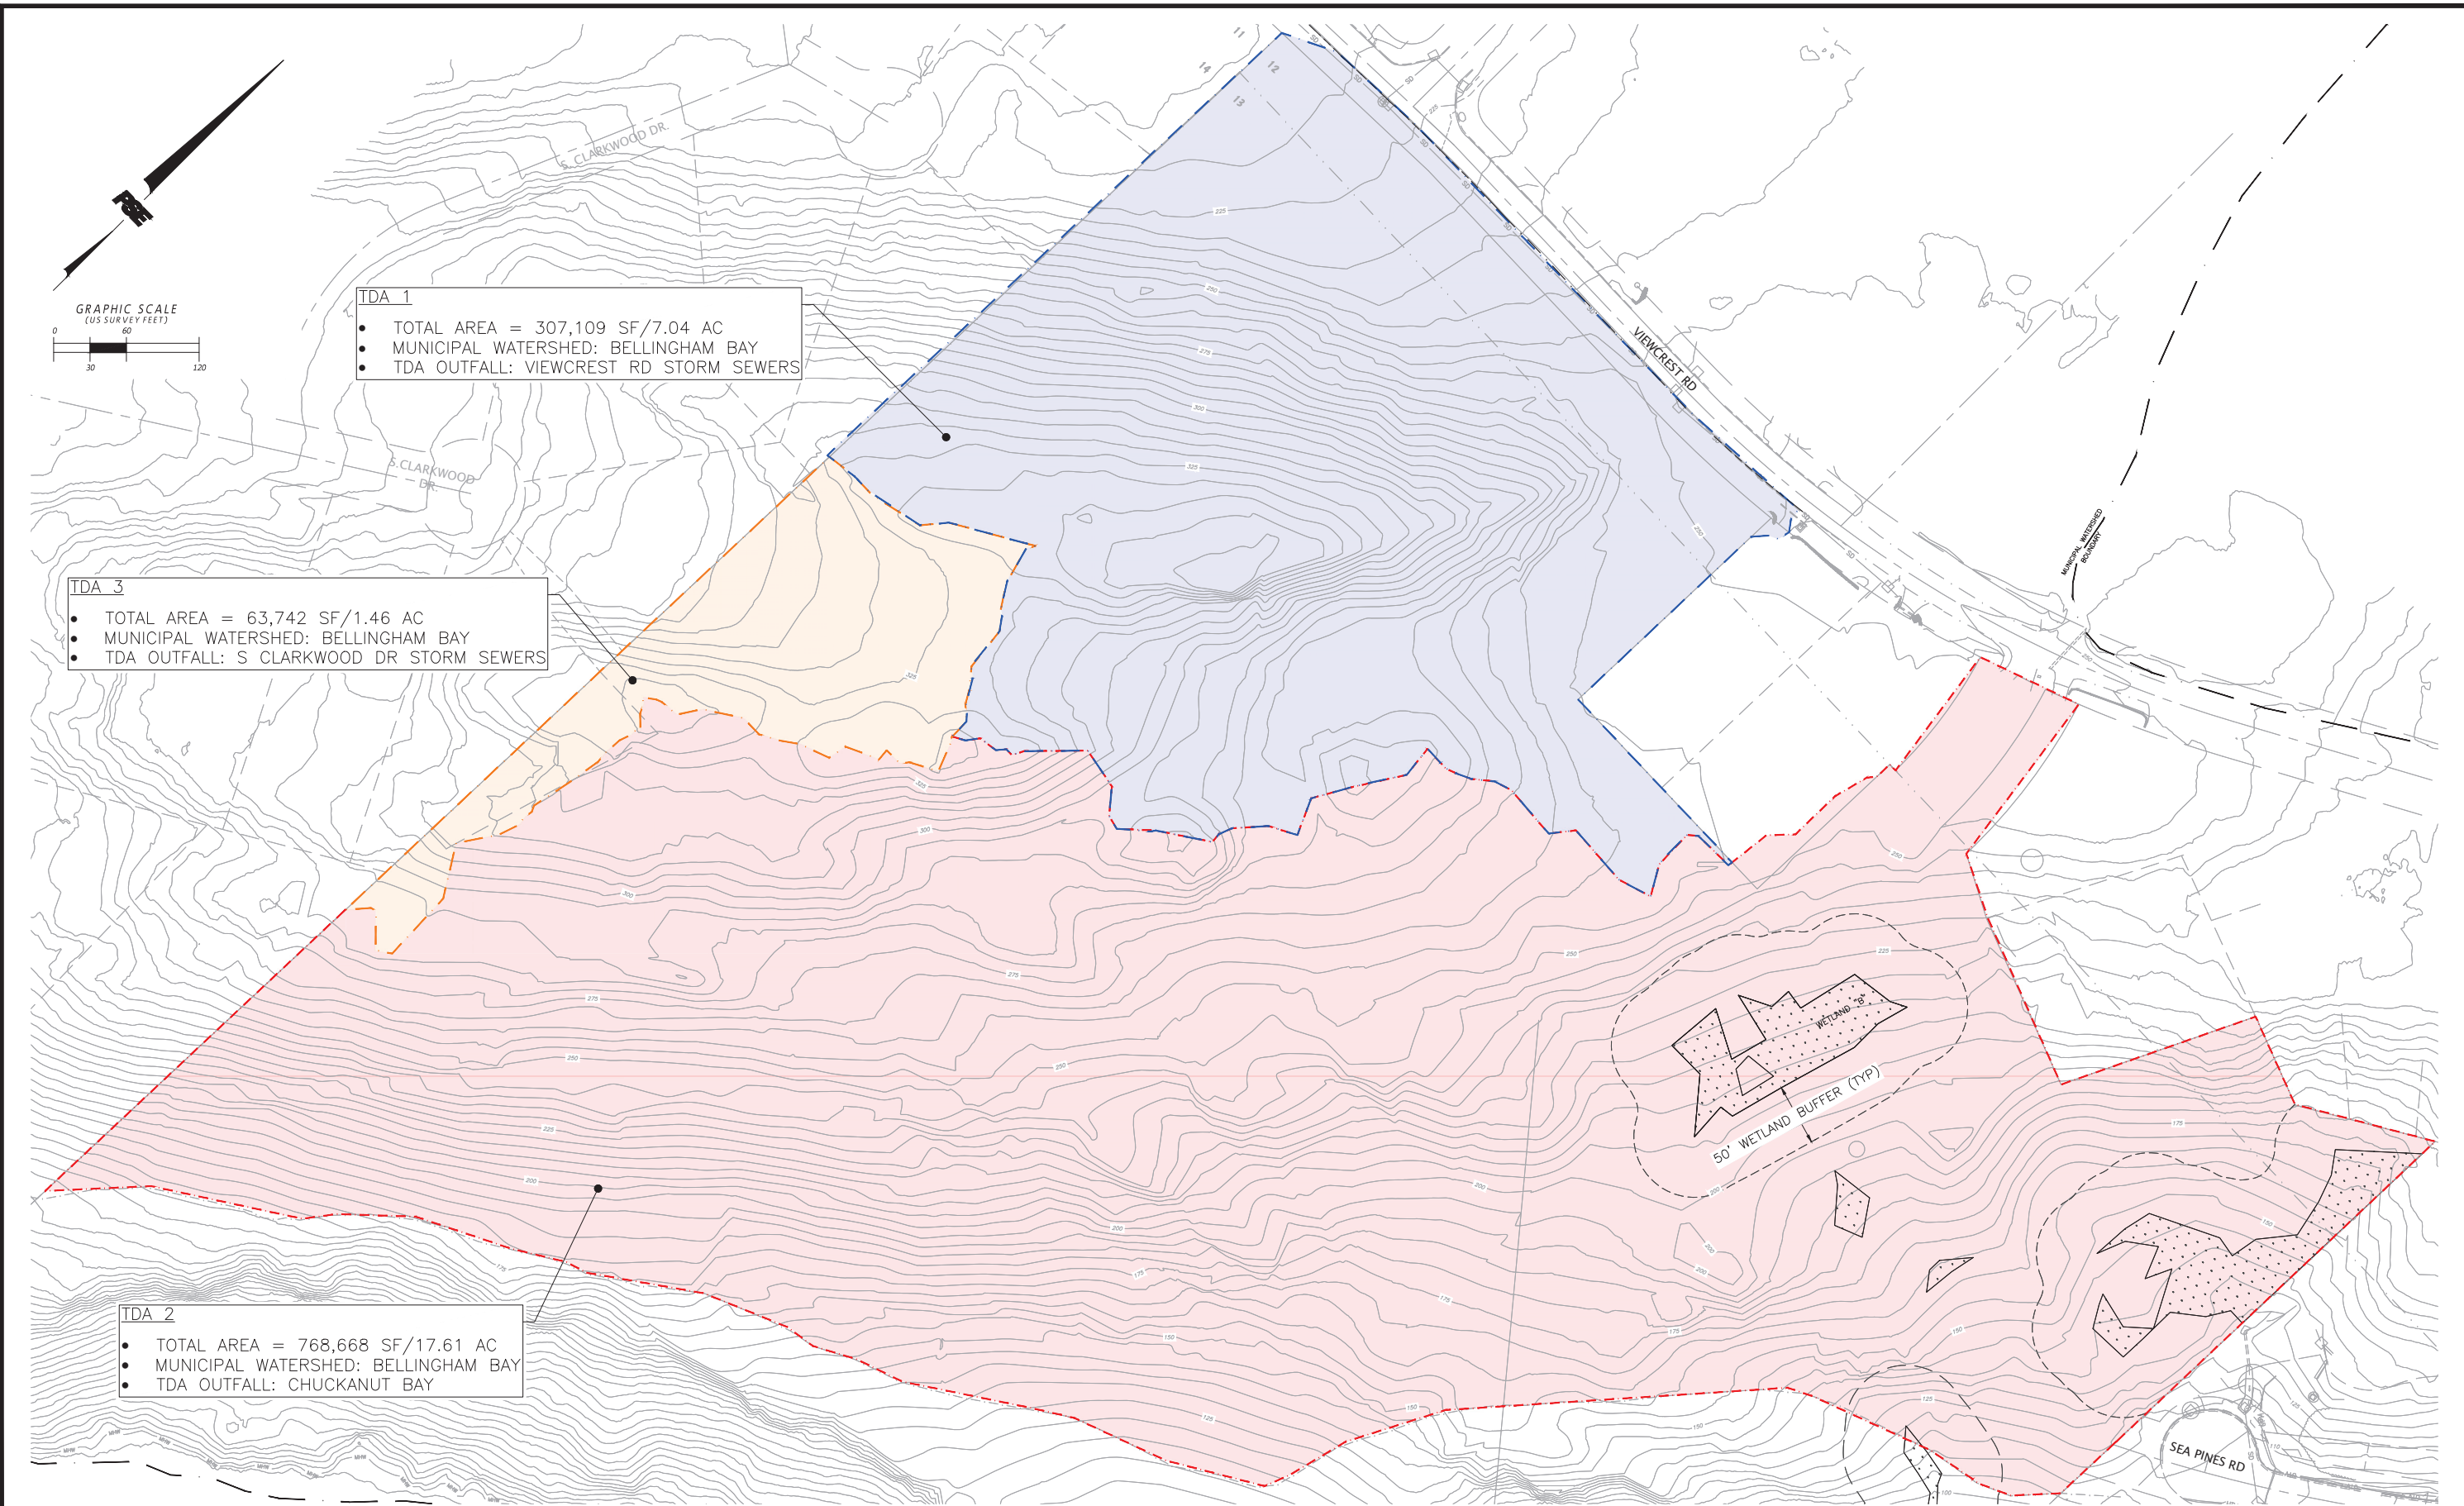
8.4 BASIN MAP

- TOTAL AREA = 938,277 SF/21.50 AC
- IMPERVIOUS SURFACE AREA = 175,288 SF
- WATER QUALITY TREATMENT: MODULAR WETLAND
- TDA OUTFALL: DISPERSION FIELD FOR WETLAND RECHARGE, CHUCKANUT BAY
