# Preliminary Stormwater Management Report

THE WOODS AT VIEWCREST

October 19, 2022

Pacific Surveying and Engineering Services, Inc.  
909 Squalicum Way, Suite 11  
Bellingham, Washington 98225  
(360) 671-7387  
[www.psesurvey.com](http://www.psesurvey.com)

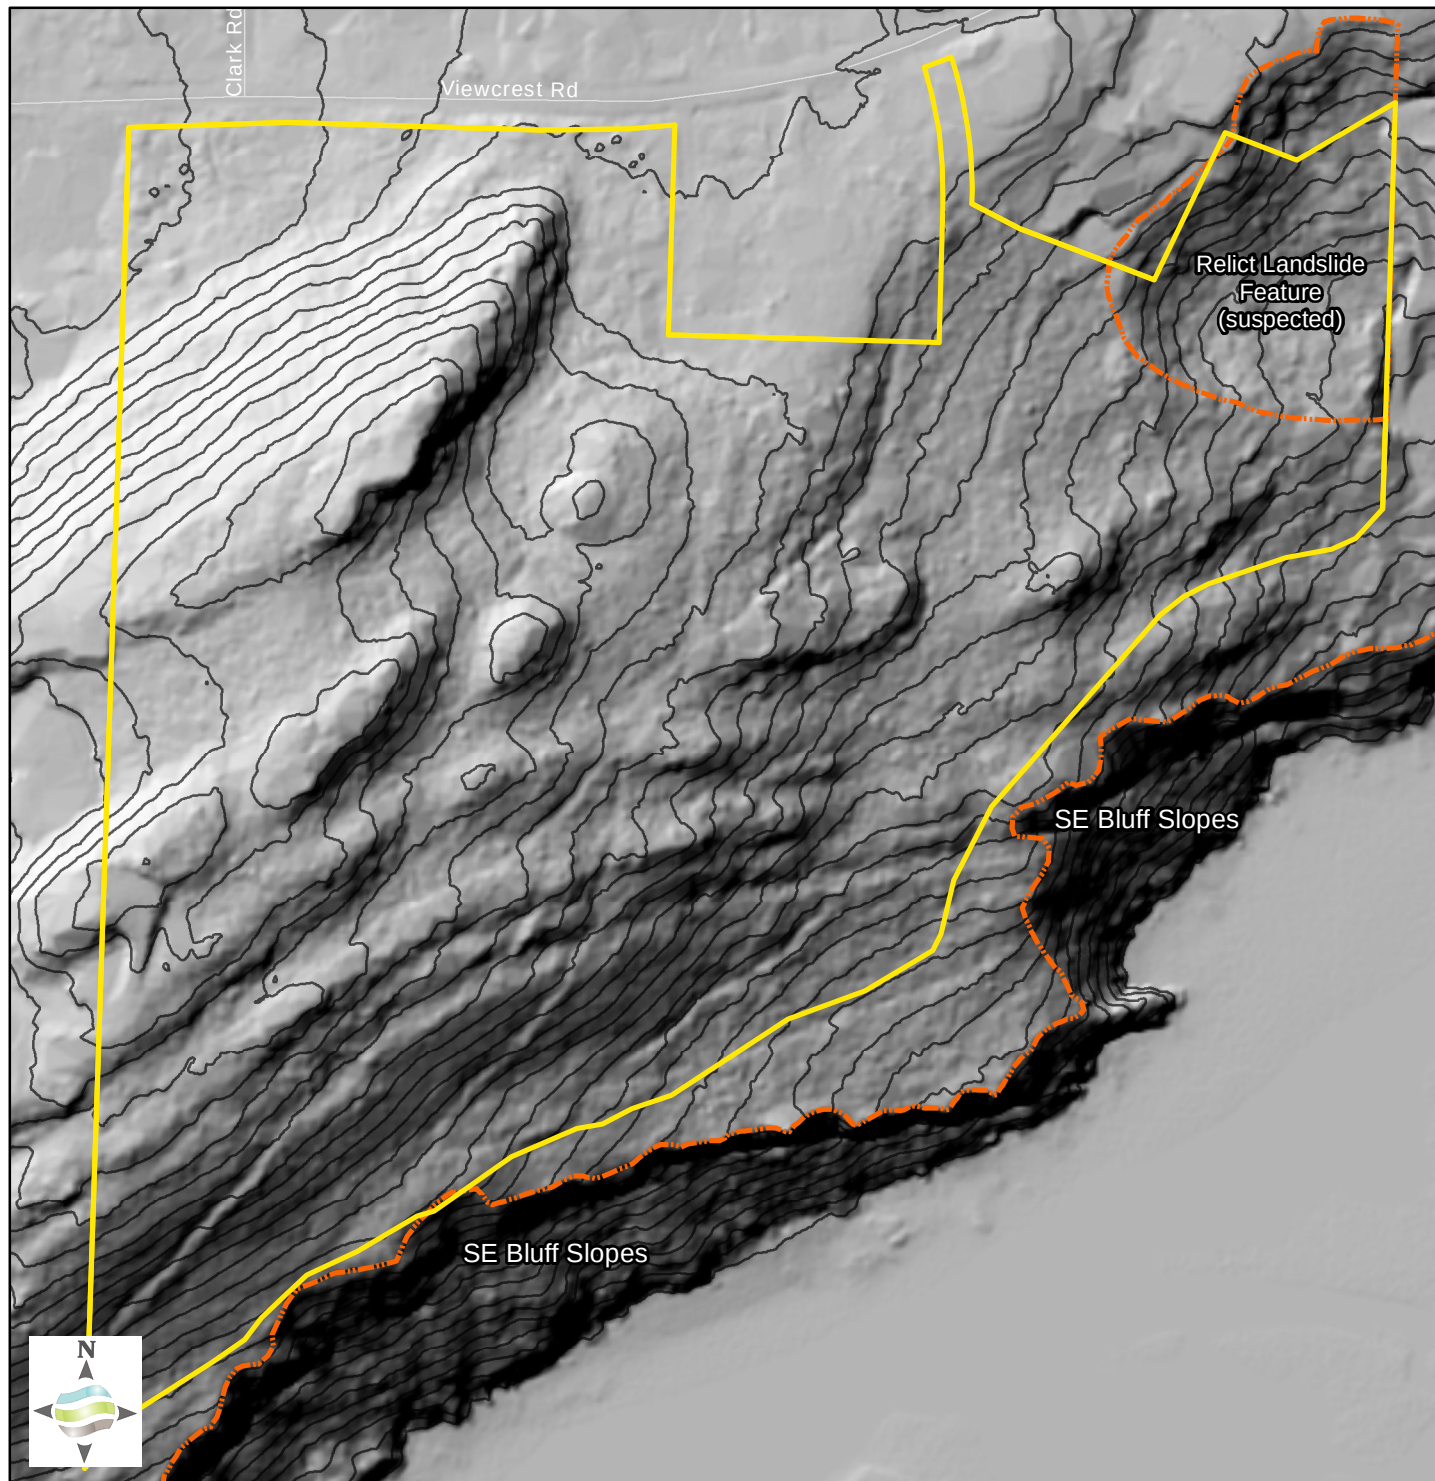
Jones - Edgemoor Estate  
 LiDAR Overview w/ Feature Annotation

- Study Area
- - - Landslide Hazard Area (LHA)
- 10ft-Contours
- Roads
