# Preliminary Stormwater Management Report

THE WOODS AT VIEWCREST

October 19, 2022

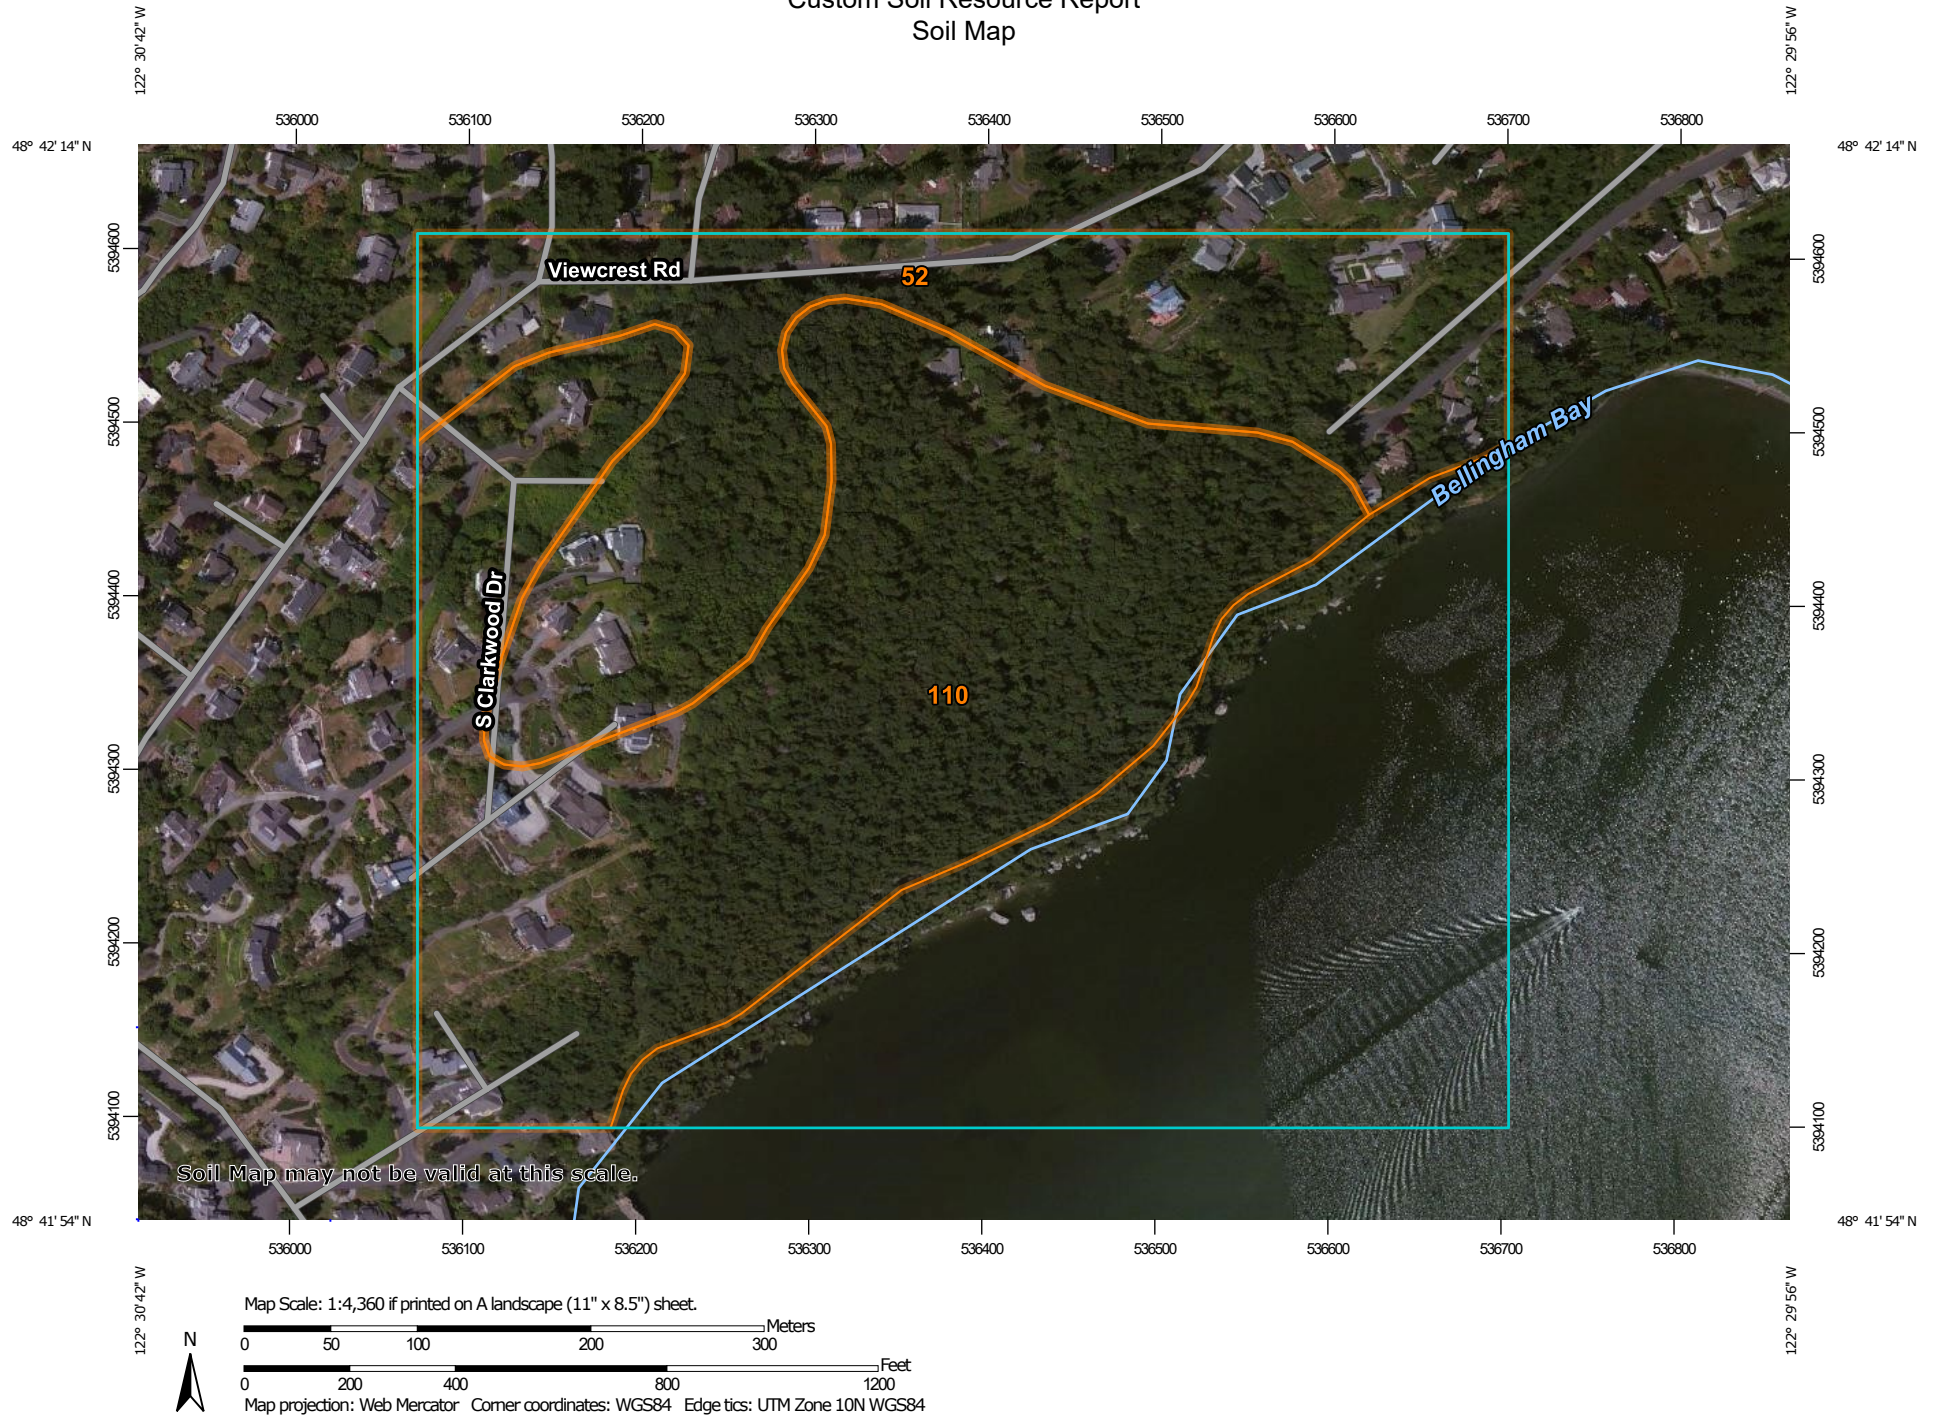
# Custom Soil Resource Report Soil Map

The soil map section includes the soil map for the defined area of interest, a list of soil map units on the map and extent of each map unit, and cartographic symbols displayed on the map. Also presented are various metadata about data used to produce the map, and a description of each soil map unit.

In the vicinity of the proposed site improvements soils consist of mainly of Everett-Urban loam (unit 52) with a hydrologic soil group rating B per the NRCS Web Soil Survey. Minor areas of the project site are composed of Nati loam (Unit 110) with a hydrologic soil group rating C per NRCS Web Soil Survey. The complete NRCS soil survey can be found in Appendix 8.2

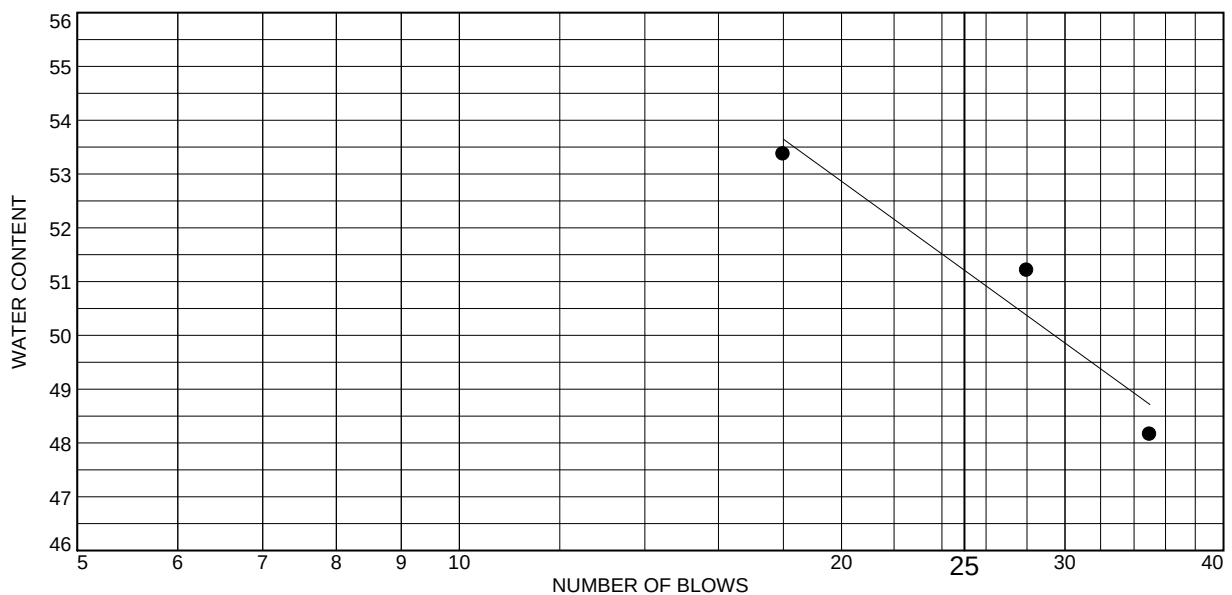
## LIQUID AND PLASTIC LIMITS TEST REPORT

| MATERIAL DESCRIPTION | LL | PL | PI | %<#40 | %<#200 | USCS |
|---|---|---|---|---|---|---|
| Native Material<br>poorly graded sand with silt | 51 | 25 | 26 | | 20 | |
