*Revision 2*– December 6, 2022  
Project No. 20-0424

**Regarding: Stormwater Infiltration Feasibility Letter – *Revision 2 (12.6.22)***

2500 Block E McLeod Rd  
(TPN: 3803165042430000)  
Bellingham, WA 98226

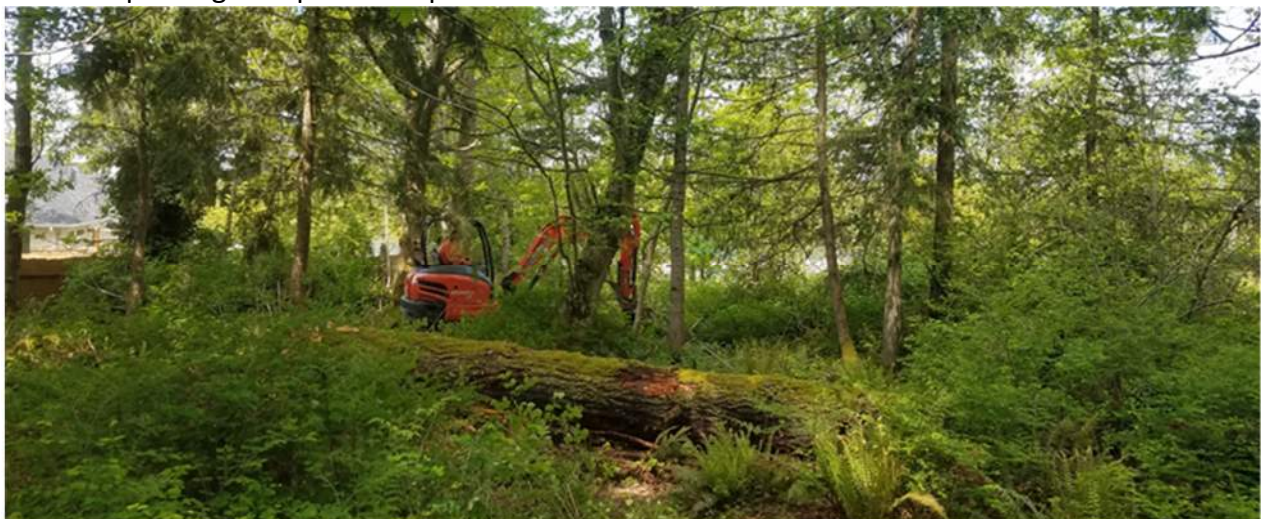
**Image 1** – Typical surface conditions of site interior. View facing north with test pit TP-9 in progress.

The vacant subject property is among a residential neighborhood, located to the northwest of the Barkley area in Bellingham, WA. The property is bound to the north by East McLeod Road with Squalicum High School property farther north. The south and western boundaries of the property are adjacent to residential subdivision developments with increased population density toward the southwest. The east side of the property is bordered by a public trail that provides access to a park to the south with moderate density residential development farther to the east. Within the property, land is completely undeveloped and forested with few indications of historic logging including stumps and downed trees. Mature trees include fir, cedar, alder and maple with numerous vine maples and other juvenile tree growth. The understory of the site includes dense native growth of ferns, oceanspray, and blackberry brambles. The site is crossed in multiple locations by footpaths from animals and human activity. Topography on the property generally descends from the southeastern corner of the site to the northwestern corner at the low point. Several small undulations were observed among the site but in general gradient was consistent and was approximately 30% or less on average. Surface conditions were generally moist and no surface water ponding was observed throughout the property during our site visit in early May 2020.
