# Lake Whatcom Stormwater

City of  
**Bellingham**

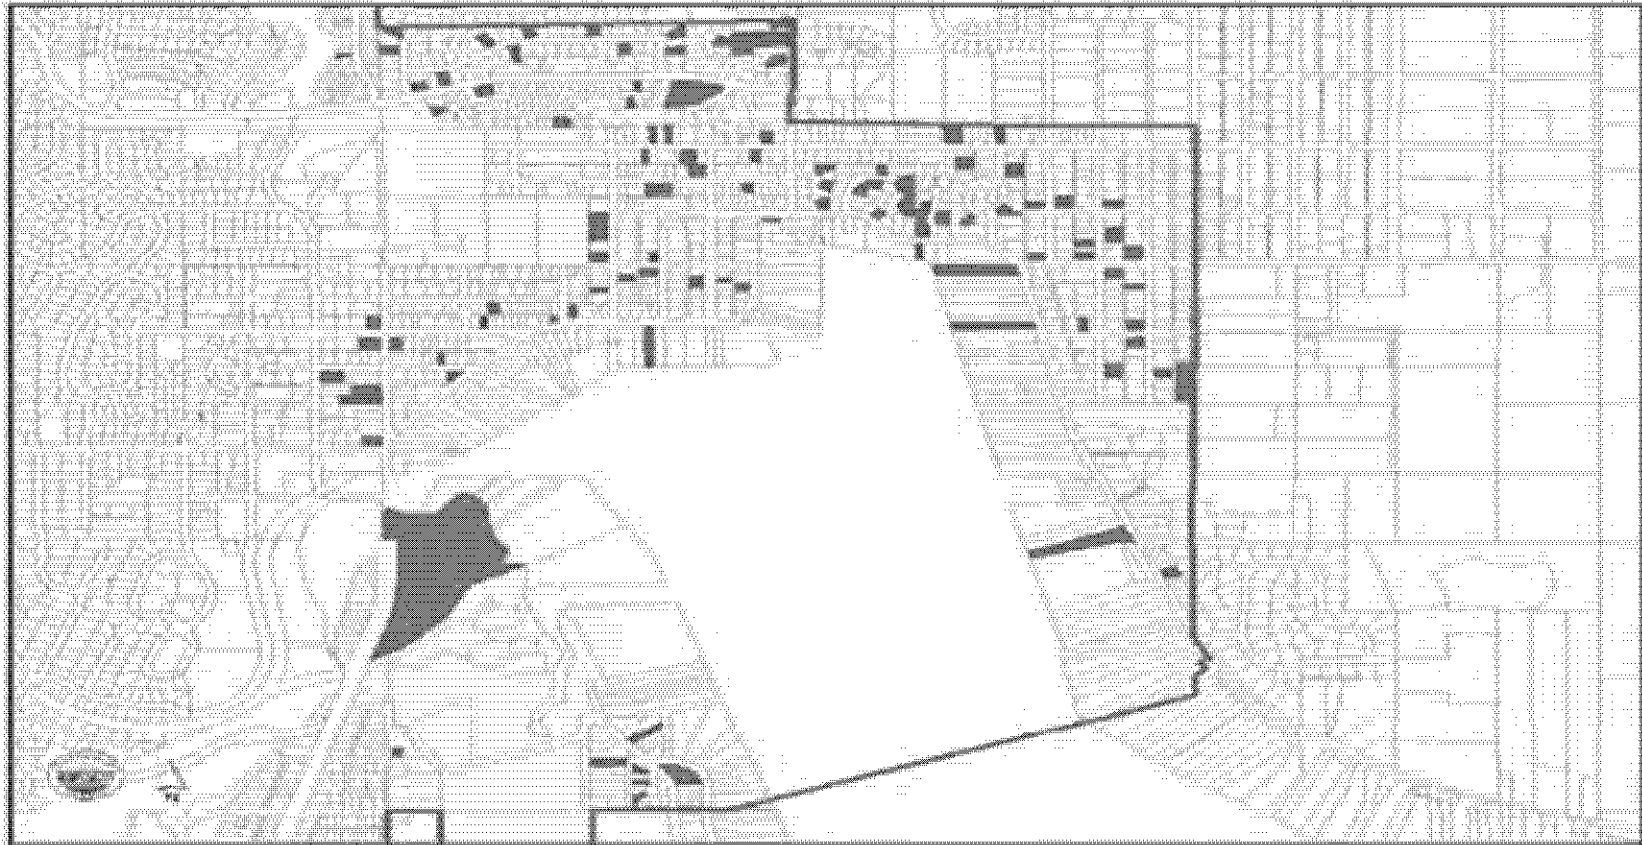
## Properties Retrofitted (10/2008 – Present) 115 Single Family Homes

The red areas indicate 115 homes that have been retrofitted to date primarily through the rain barrel retrofit program, which reduces runoff by dispersion.

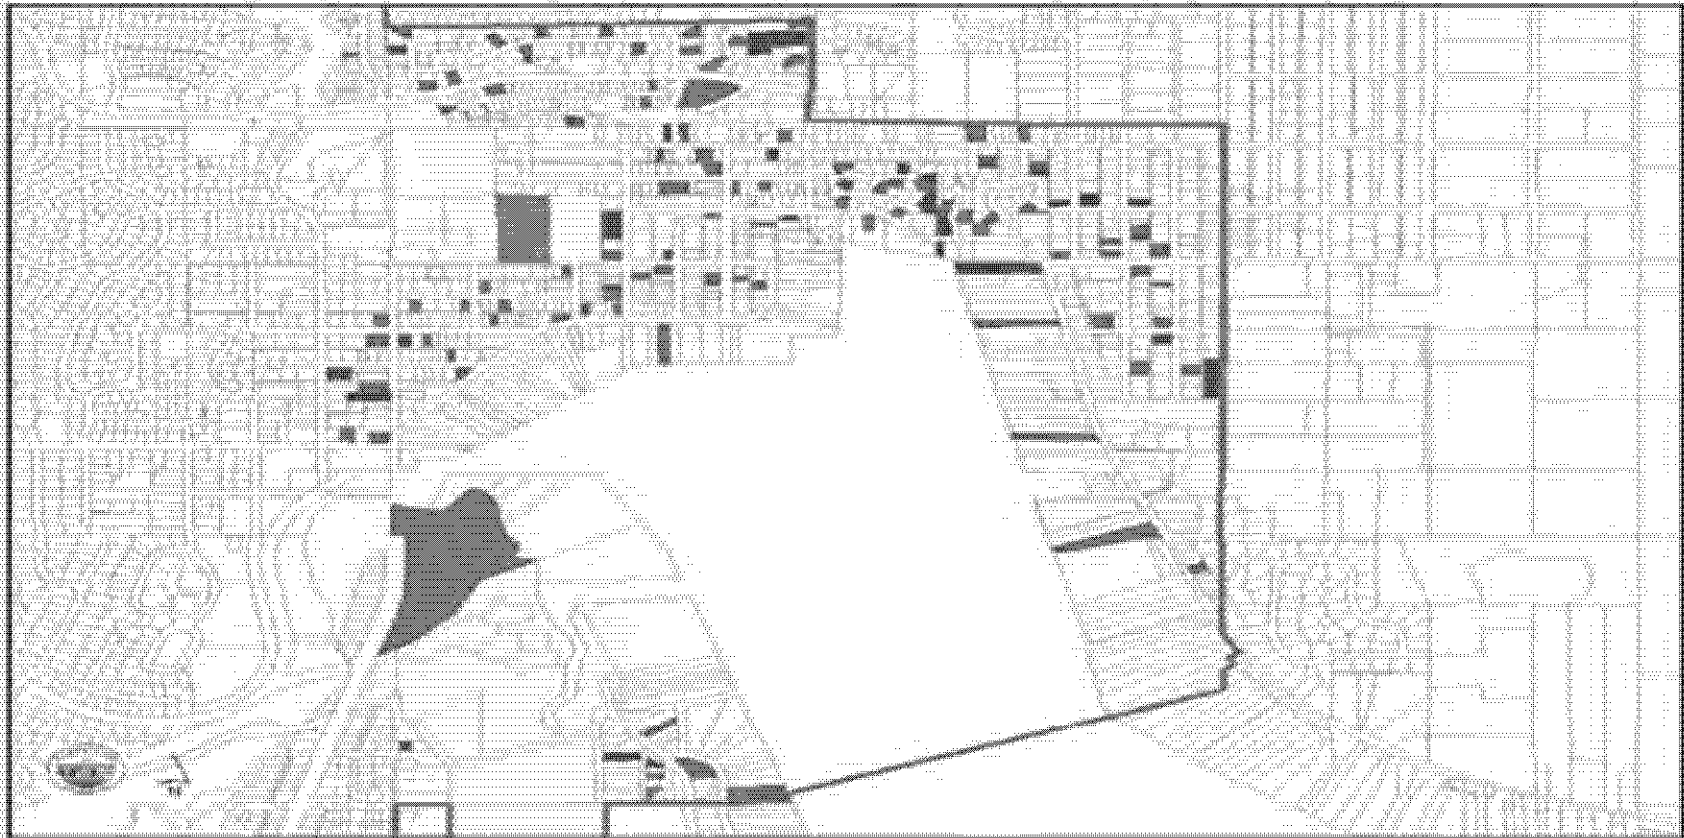
# Properties Receiving On-Site Consultations

The additional properties in yellow indicate property owners that have received on-site consultation but, at this point, have not chosen to participate.
