LITTLE SQUALICUM CREEK WETLANDS MITIGATION PLAN

**LITTLE SQUALICUM CREEK
OFF-SITE WETLANDS MITIGATION PLAN**

January 24, 1992

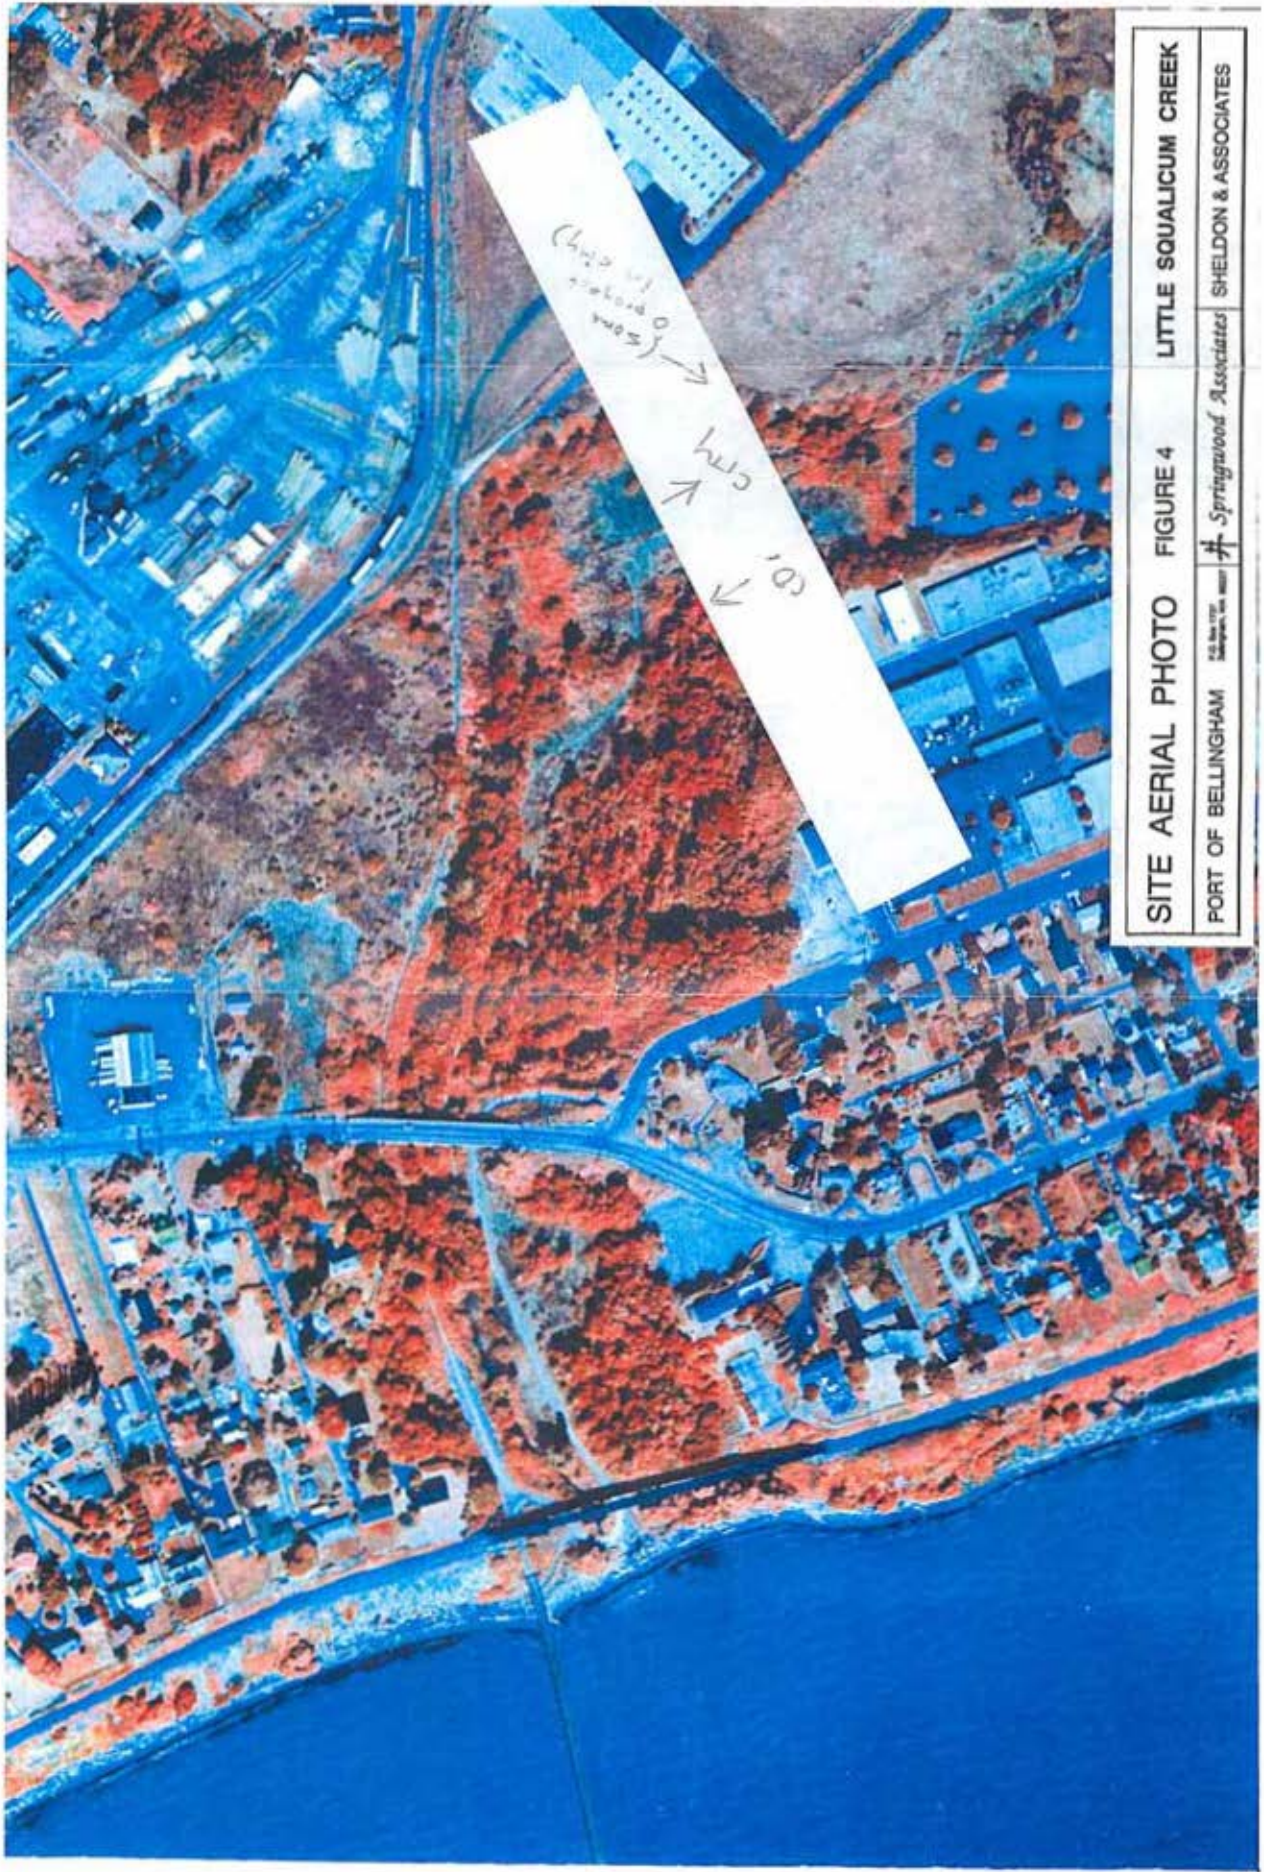
SITE AERIAL PHOTO FIGURE 4 LITTLE SOUALICUM CREEK

The site is approximately 12.5 acres and occupies a small ravine with a relatively level bottom and steep sides. Little Squalicum Creek is a small stream with a well developed riparian edge that is located on the extreme northern boundary of the property. The steep side slopes are vegetated with blackberry and alder and are relatively undisturbed. The vegetation in the bottom is predominantly young deciduous forest and open meadow, and generally reflects the history of disturbance the site has experienced.

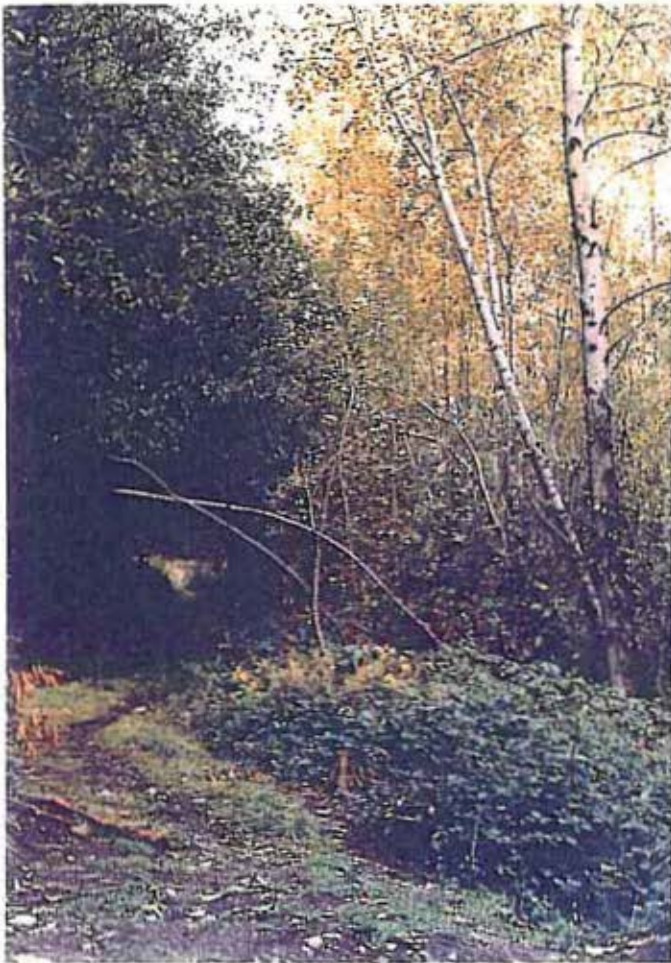
Young deciduous forest with blackberry understory
(future conversion to forested wetland)

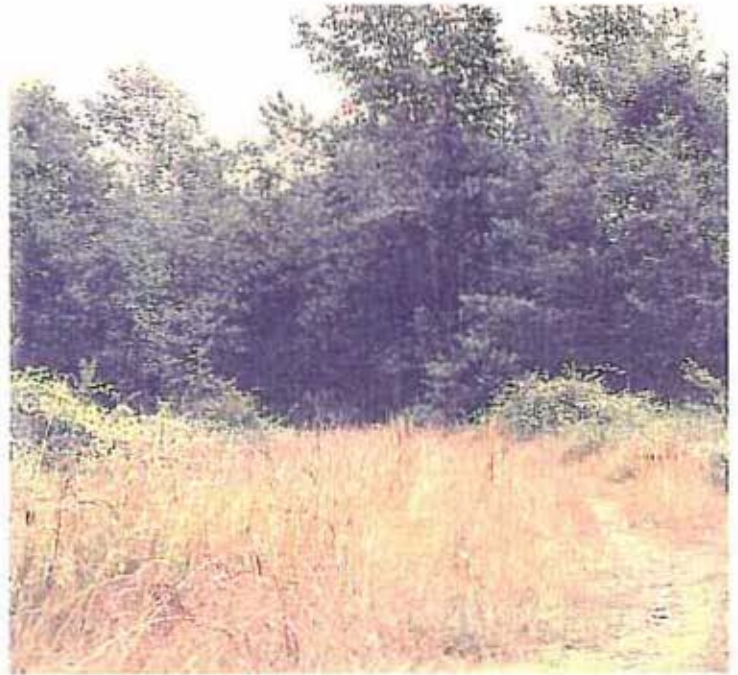
Meadow with shrubs (future Wetland Cell 6)

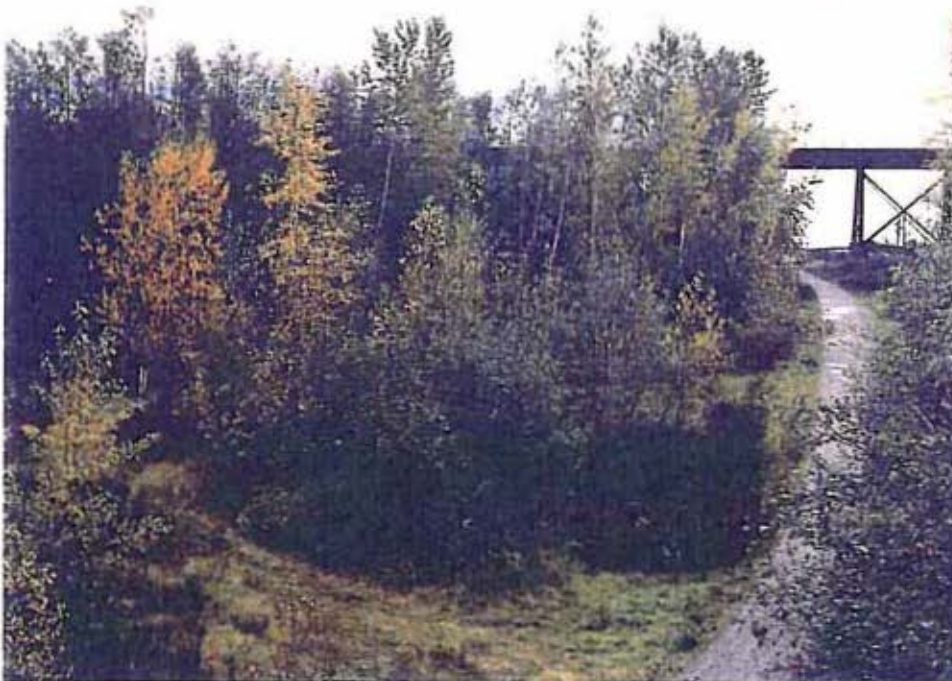
Area west of Marine Drive
overpass (future stream
channel)

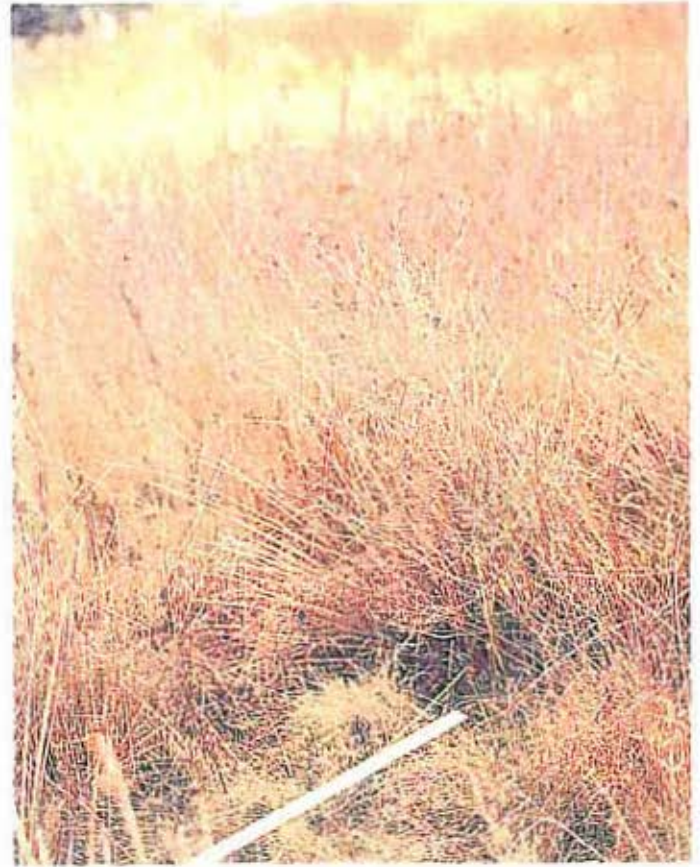
B. Wet meadow with rose

Reference plant communities were selected from 8 sites around Whatcom County to provide information about local plant associations and wetland conditions that will be useful in designing new wetlands systems. The three plant communities types proposed in this mitigation (wet meadow, emergent, scrub-shrub) will be based on these local reference communities. See Figure 9: Reference Community Photos.

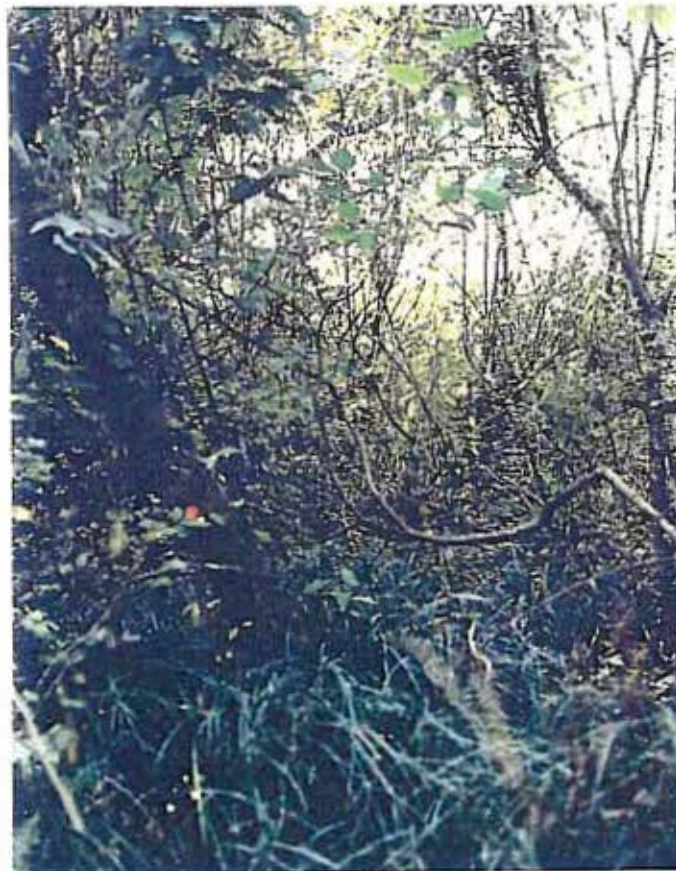
C. Forested wetland with scrub-shrub/emergent

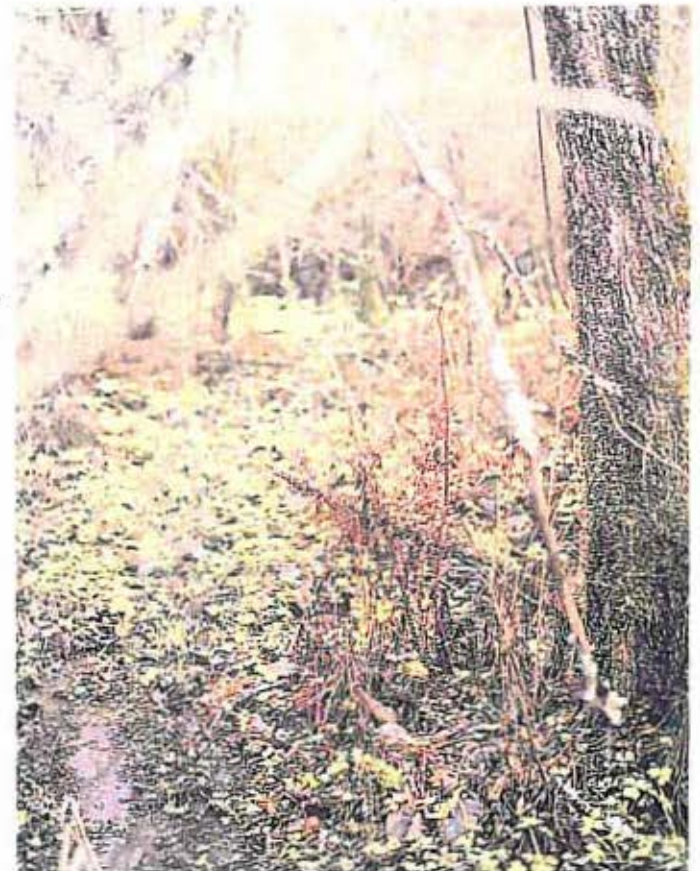
D. Scrub-shrub wetland with emergent understory
