# **Long-Term Temperature and Shade Monitoring of Whatcom Creek**

*Report Prepared for:*

**The City of Bellingham  
Public Works Department  
210 Lottie Street  
Bellingham, WA 98225**

**April 2013**

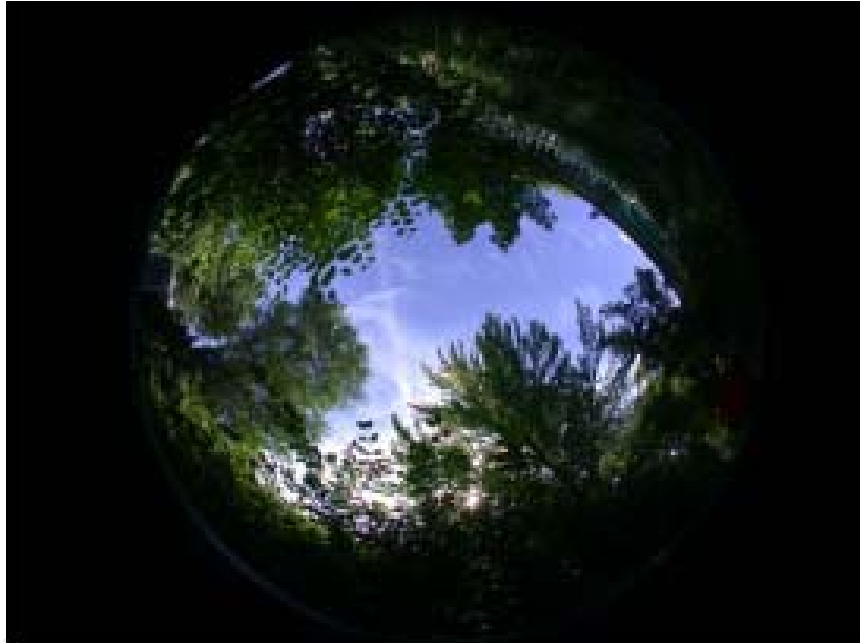
Figure 4. Example of hemispherical photograph.  
**Source:** Stohr and Bilhimer (2008)

Station ID photos were also taken at each photo point prior to each canopy photo; one facing the right bank and one facing the left bank. Where possible the ID photos included landscape
