Long-Term Temperature and Shade Monitoring of Whatcom Creek

**The City of Bellingham
Public Works Department
210 Lottie Street
Bellingham, WA 98225**

**R2 Resource Consultants, Inc.
15250 NE 95th Street
Redmond, WA 98052**

April 2013

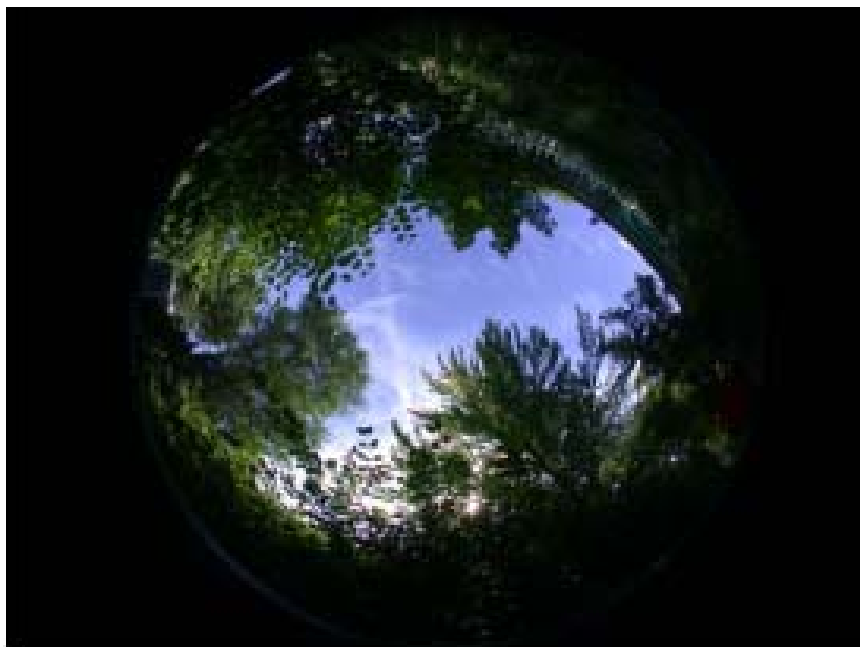
Figure 4. Example of hemispherical photograph.
Source: Stohr and Bilhimer (2008)

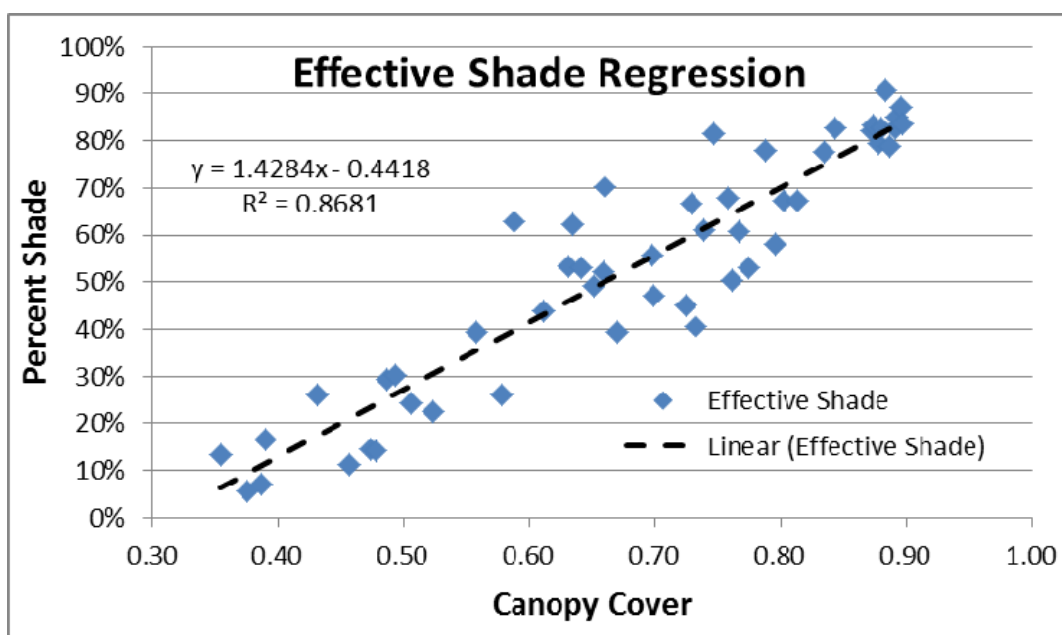
y	=	Effective Shade percent.
x	=	Canopy Closure levels.
R^2	=	the proportion of the variation of y explained by x.

Figure 9. Linear relationship between effective shade and canopy cover in Whatcom Creek riparian zones during 2011 monitoring.

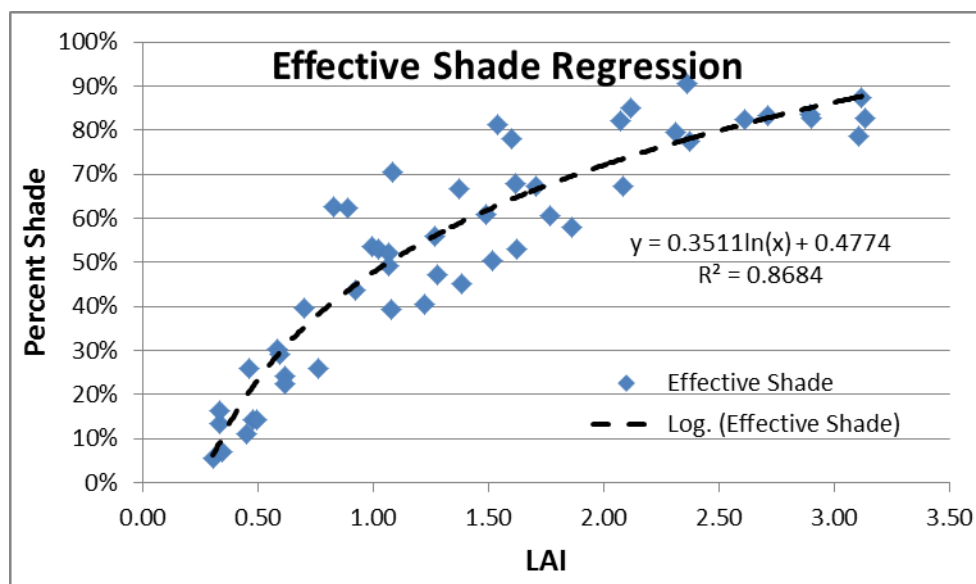
y	=	Effective Shade percent.
x	=	Leaf Area Index (LAI)
ln	=	natural log
R^2	=	the proportion of the variation of y explained by x

Figure 10. Logarithmic relationship between effective shade and leaf area index (LAI) in Whatcom Creek riparian zones during 2011 monitoring.

Conversely, a logarithmic expression fits the data best in explaining relationship between effective shade and LAI as follows:
