Stormwater Site Plan Plat of Squalicum Heights Bellingham, Washington TPN. 380316 504243

Freeland & Associates, Inc. 220 W. Champion Street; Suite 200 Bellingham, WA 98225 (360) 650-1408

June 2023

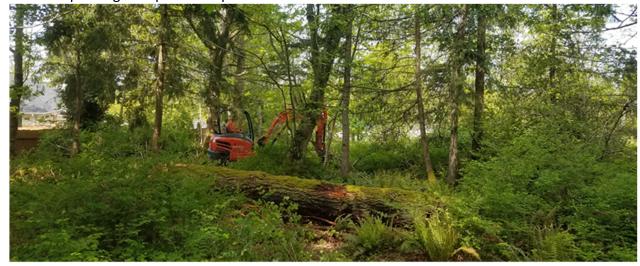
Image 1 – Typical surface conditions of site interior. View facing north with test pit TP-9 in progress.
