WEST CEMETERY CREEK SEDIMENT MANAGEMENT ALTERNATIVES FEASIBILITY STUDY

**Prepared for City of Bellingham Public Works Department
December 10, 2013**

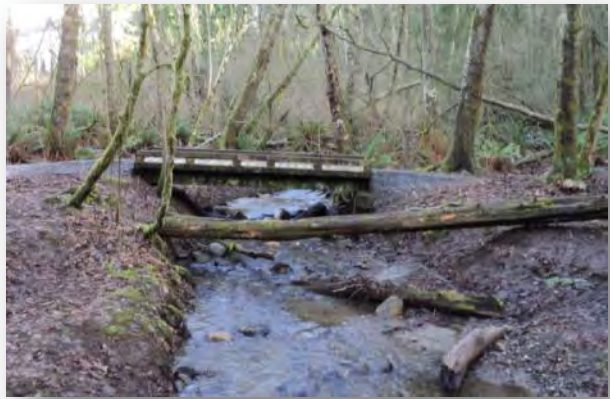
Photo 2: Alluvial plan development in the transition between middle and lower watershed.

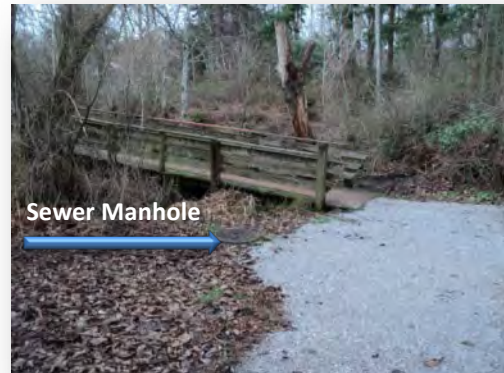
Photo 3. East end of bridge and sewer man hole within frequent flooding area.

It is recommended that the sewer manhole riser adjacent to the floodplain be elevated at some point in the future to avoid flooding impacts to the sewer system or a release of sewage into the watershed. A few inches of freeboard currently exist from current flooding levels and this freeboard will diminish over time as the channel bed aggrades. The costs to implement this project are low, but the potential damages could be significant.

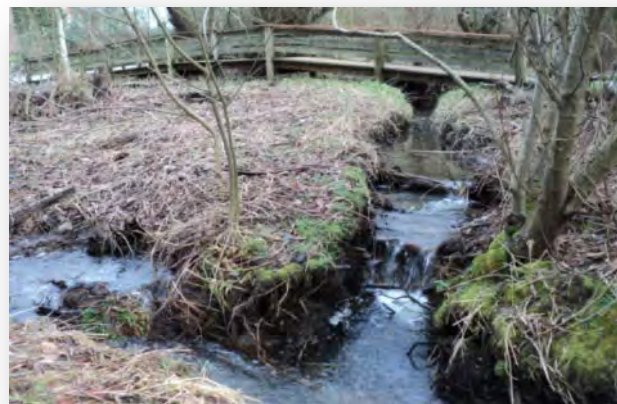
Photo 4. Toledo-Wildflower Bridge confluence of west and east channels downstream of bridge

There are currently two primary channels flowing under the bridge. The western channel is incised approximately 1.5 feet into the alluvial deposits and appears to carry the dominant flows. Currently the channel runs close to the western extent of the bridge and along the armored levee (Photos 4 and 5). The western channel appears to be incised into either fill or the native glacial till that is the underlying geology. The eastern channel appears to be aggrading and

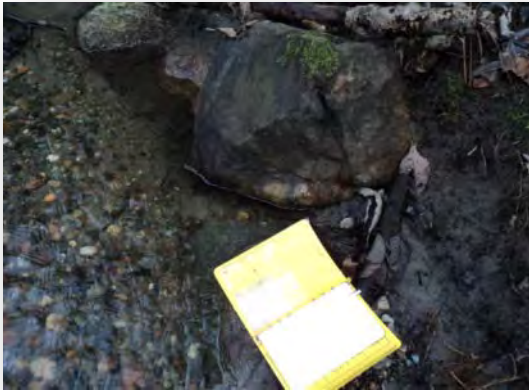
Photo 5. West channel armored levee and gravel bedload.

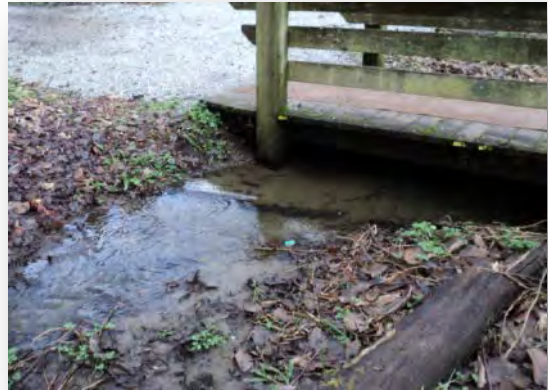
Photo 6. Eastern channel fine-grained bedload.

has a finer-grained substrate than the western channel (Photo 6).

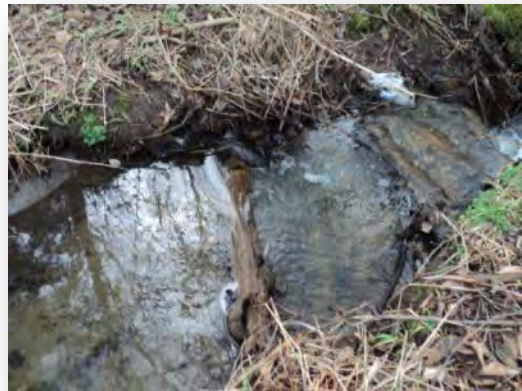
Photo 7. Constructed weirs

It is anticipated that the stream in the bridge sub-reach was relocated and modified during the construction of the Pinewood Hills and Toledo Court housing development in 1994 and 1995. In 1996 the Magnolia Hills housing development was constructed east of the bridge and included the installation of Wildflower Way, residences, and utilities. Additional changes to the reach during the construction of the housing development likely included installation of stream weirs (Photo 7) and a 3 foot high armored levees on the western bank.

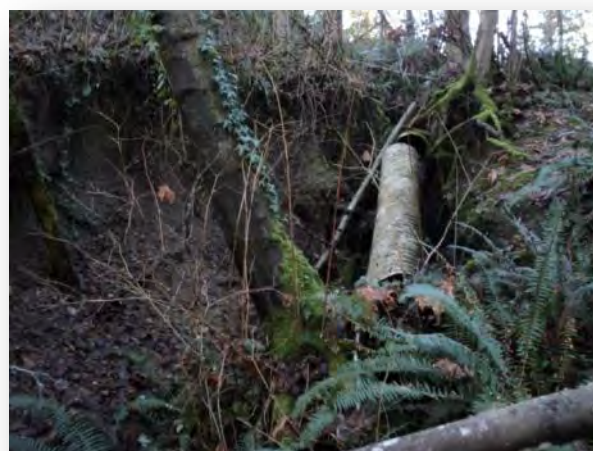
Photo 8. Failing outfall, mass wasting, erosion and incision into road fill north of Lakeway Drive.

Two failing stormwater outfall culverts were identified as the largest single point-source contributors of sediment within the upper and middle watershed reaches (Figure 2-10). These culvert outfalls are perched creating drops of 3 to 8 feet, and the culvert segments have detached in one instance. During large storm events, the unconsolidated road fill that is supporting the culverts and the adjacent roads is rapidly eroded and sediment is entering the stream. The larger of the two failing outfalls is below Lakeway Drive (Photo 8 – preceding page) and the second one is below Old Lakeway Drive (Photo 9).

The failing culvert that was found to have contributed the largest amount of sediment to the stream recently is located north of Lakeway Drive and the junction with West Cemetery Creek on the western bank. This culvert drains stormwater runoff from Lakeway Drive. It appears that bypass runoff has undermined the culvert, caused culvert segments to come apart and road-fill to erode, creating a significant waterfall, scour and mass wasting. During large storm events the runoff is rapidly eroding the loose road fill and causing siltation and mobilized sediment to reach the stream. If left unchecked, this problem may undermine the structural integrity of Lakeway Drive.

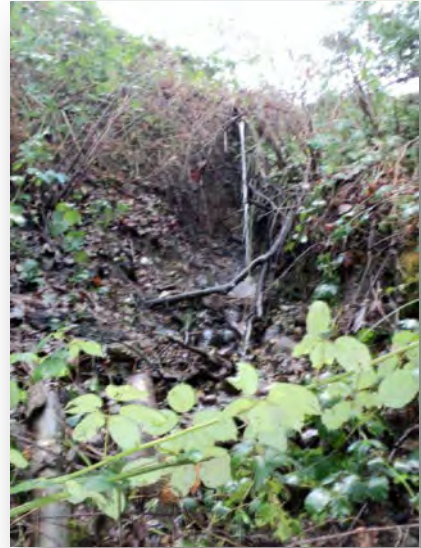
Photo 9. Failing outfall below (north) Old Lakeway Drive.

The second failing culvert that contributes significant sediment to the stream is located north of Old Lakeway Drive on the western bank of West Cemetery Creek. This stormwater outfall drains the residences around Woburn Street and Newton Street. This outfall is smaller than the one on Lakeway Drive, but it still releases stormwater into the ravine through a 3 to 5 foot drop, which

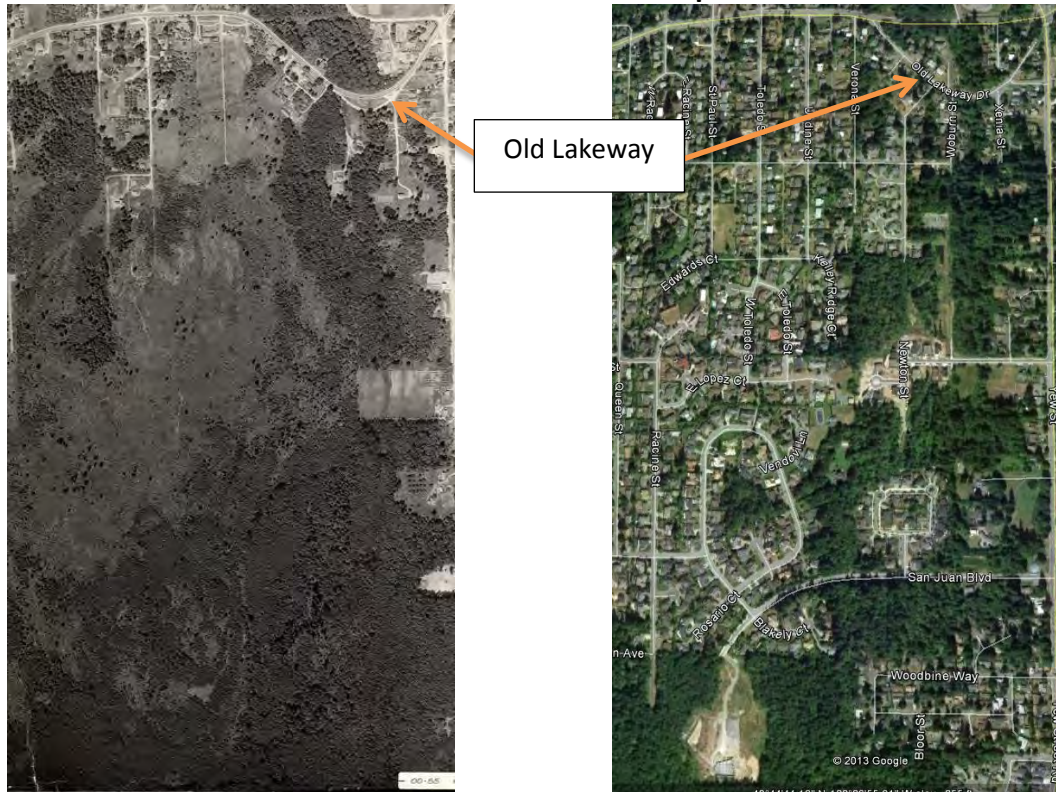
Figure 2-2: Watershed Land Use

1950 to 2011 Watershed Urbanization Relative Comparisons – Lower Watershed

1950 to 2011 Watershed Urbanization Relative Comparisons – Middle Watershed
