# **WEST CEMETERY CREEK SEDIMENT MANAGEMENT ALTERNATIVES FEASIBILITY STUDY**

**Prepared for City of Bellingham Public Works Department  
December 10, 2013**

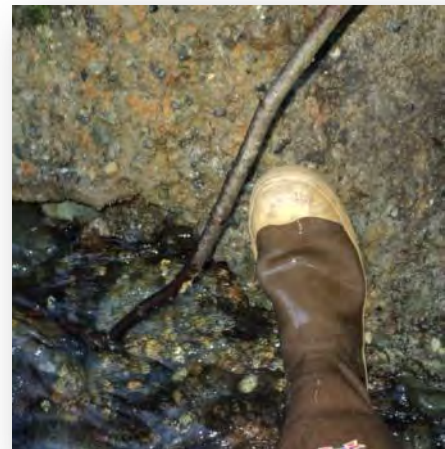
Photo 1: Eroding glacial sediment (till) in base of channel.

The Middle Watershed Reach is predominately an erosional and transport reach with very little sediment storage available. The Chuckanut Formation is exposed in a few places within the streambed at the base of the gorge and occasionally on the channel banks. The stream has incised into the mantle of glacial deposits ranging between approximately 1 to 40 feet thick overlays the bedrock and this mantle is the primary component of the gorge side walls and locally provides channel bedform and grade control. The glacial soils contribute to a wide range of sediment sizes that are recruited by the stream, but the predominant sediment size fraction is fine grained silt and sand.

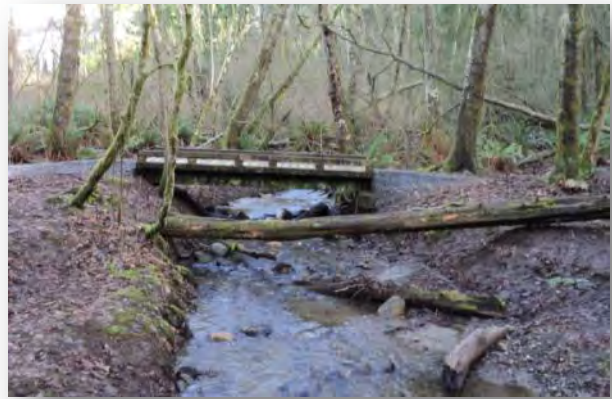
Photo 2: Alluvial plan development in the transition between middle and lower watershed.

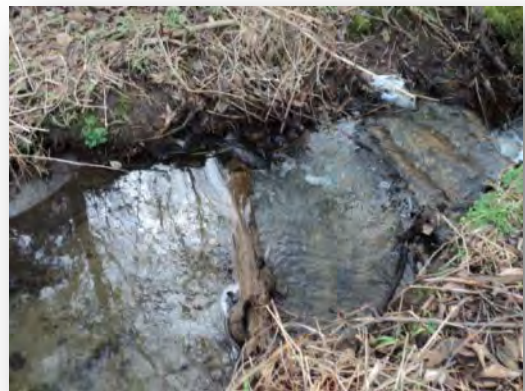
Photo 7. Constructed weirs

It is anticipated that the stream in the bridge sub-reach was relocated and modified during the construction of the Pinewood Hills and Toledo Court housing development in 1994 and 1995. In 1996 the Magnolia Hills housing development was constructed east of the bridge and included the installation of Wildflower Way, residences, and utilities. Additional changes to the reach during the construction of the housing development likely included installation of stream weirs (Photo 7) and a 3 foot high armored levees on the western bank.

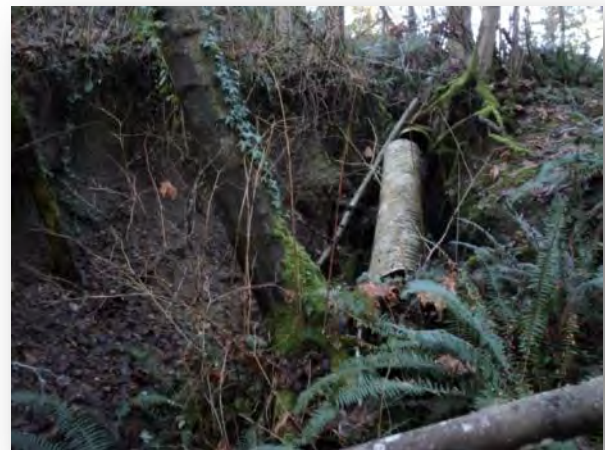
**Photo 8.** Failing outfall, mass wasting, erosion and incision into road fill north of Lakeway Drive.

Two failing stormwater outfall culverts were identified as the largest single point-source contributors of sediment within the upper and middle watershed reaches (Figure 2-10). These culvert outfalls are perched creating drops of 3 to 8 feet, and the culvert segments have detached in one instance. During large storm events, the unconsolidated road fill that is supporting the culverts and the adjacent roads is rapidly eroded and sediment is entering the stream. The larger of the two failing outfalls is below Lakeway Drive (Photo 8 – preceding page) and the second one is below Old Lakeway Drive (Photo 9).

The failing culvert that was found to have contributed the largest amount of sediment to the stream recently is located north of Lakeway Drive and the junction with West Cemetery Creek on the western bank. This culvert drains stormwater runoff from Lakeway Drive. It appears that bypass runoff has undermined the culvert, caused culvert segments to come apart and road-fill to erode, creating a significant waterfall, scour and mass wasting. During large storm events the runoff is rapidly eroding the loose road fill and causing siltation and mobilized sediment to reach the stream. If left unchecked, this problem may undermine the structural integrity of Lakeway Drive.

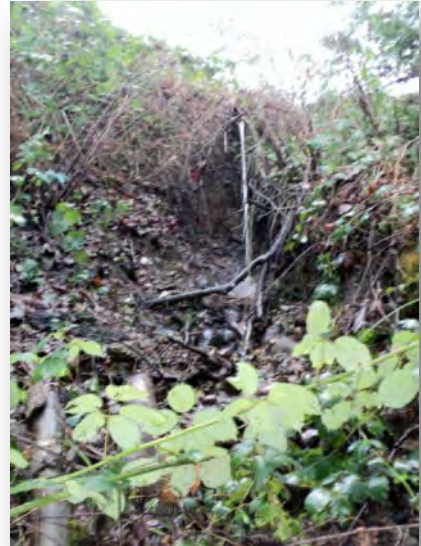
Photo 9. Failing outfall below (north) Old Lakeway Drive.

The second failing culvert that contributes significant sediment to the stream is located north of Old Lakeway Drive on the western bank of West Cemetery Creek. This stormwater outfall drains the residences around Woburn Street and Newton Street. This outfall is smaller than the one on Lakeway Drive, but it still releases stormwater into the ravine through a 3 to 5 foot drop, which

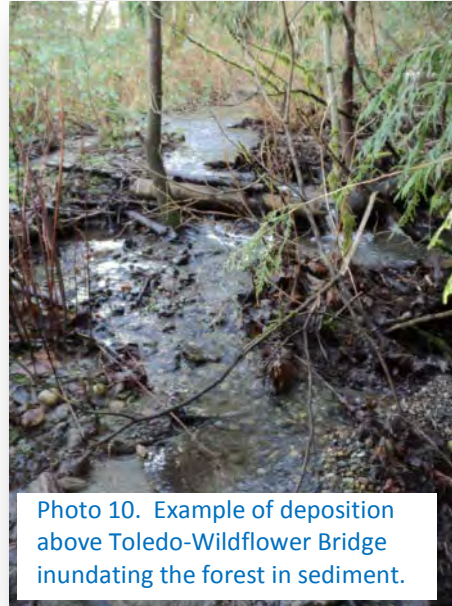
Photo 10. Example of deposition above Toledo-Wildflower Bridge inundating the forest in sediment.

The lower watershed is predominantly transport-limited, and therefore depositional landforms (alluvial fans, floodplains, and floodplain terraces) develop (Photo 10 – following page). As a result of the net deposition, portions of the stream have developed a limited braided channel form with multiple channels, gravel bars, and inundated floodplain areas. While the net sediment process in the lower reach is transport-limited, periods of supply-limited conditions may occur creating short-term erosion and incision in portions of the impact area sub-reach.

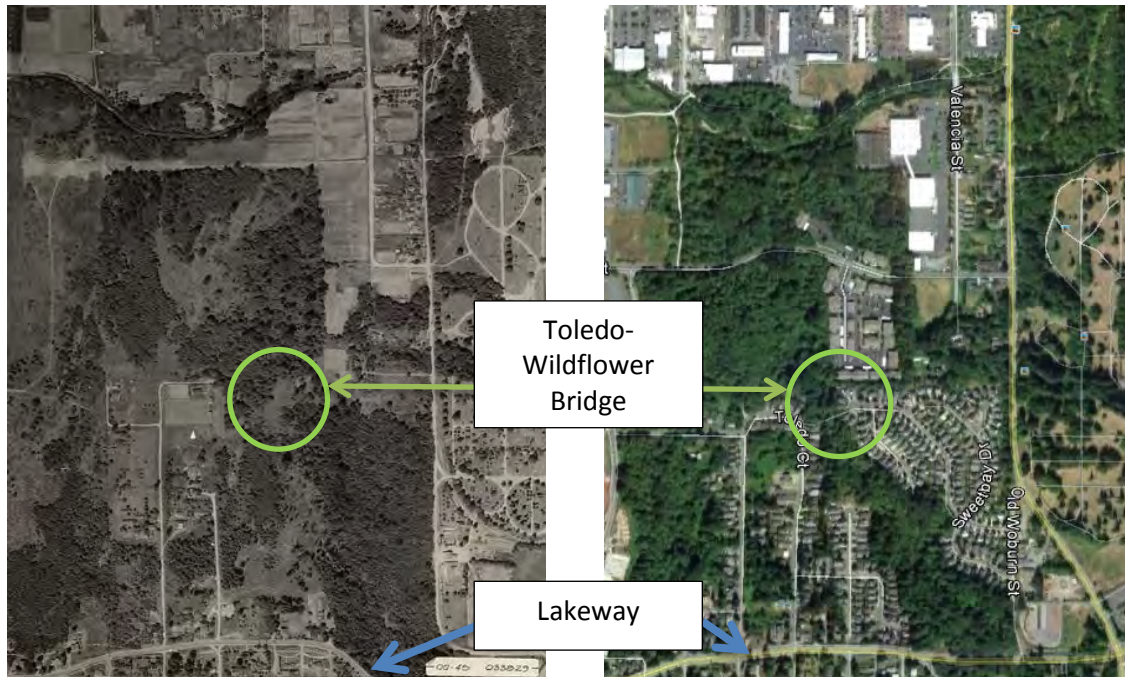
## Figure 2-2: Watershed Land Use

### 1950 to 2011 Watershed Urbanization Relative Comparisons – Lower Watershed

### 1950 to 2011 Watershed Urbanization Relative Comparisons – Middle Watershed

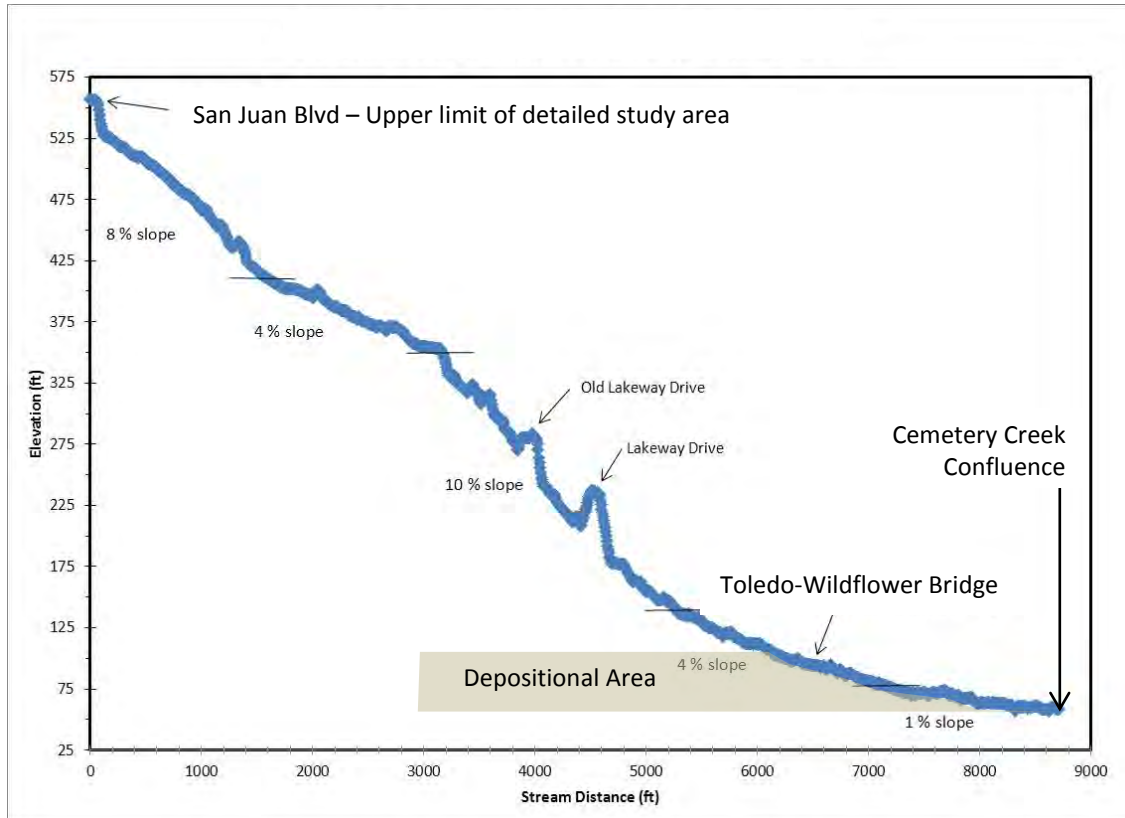
**Figure 2-7: Stream Profile**

**West Cemetery Creek Channel Gradient (in percent) – San Juan Boulevard to Cemetery Creek Confluence**
