Whatcom Creek:

Ten-Years After Summary Report

City of Bellingham
Department of Public Works
Environmental Resources

R2 Resource Consultants, Inc.
15250 NE 95th Street
Redmond, Washington 98052

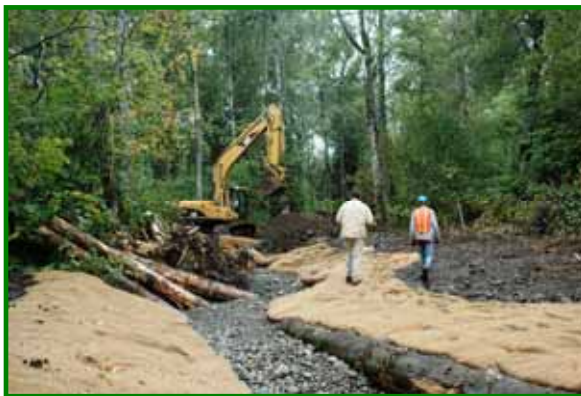
Source: City of Bellingham
Cemetery Creek Channel Reconstruction

ponds, and reconfiguration of the Cemetery Creek channel to include large woody debris, meanders, pools, backwaters and complex habitats in the formerly channelized stream. Ponds and backwaters provide refuge for salmon during high flows and wetland habitat for amphibians and other wildlife throughout the summer months. These projects enhanced habitat conditions throughout the area, while minimizing impacts to surrounding vegetation and ground surfaces. In addition, portions of an anthropogenic gravel berm were removed from the Salmon Park area, restoring geomorphic function by allowing Whatcom Creek to access and migrate within its associated floodplain.

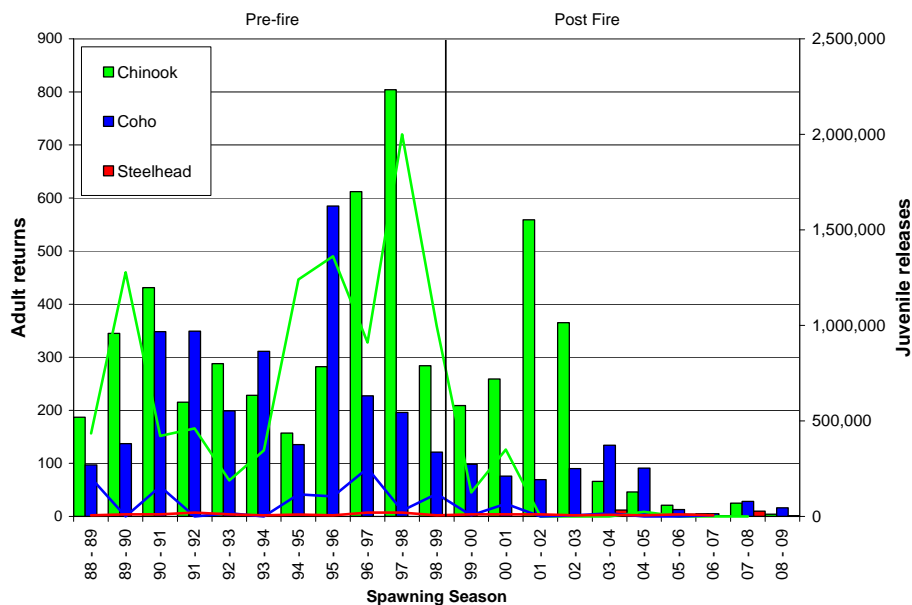
Anadromous fish returns and juvenile releases to the Whatcom Creek hatchery since 1989. Bars represent adult fish returns and lines represent juvenile fish releases (from R2 2009).

Since the fire, physical conditions in Whatcom Creek have been improving. Flows in Whatcom Creek have increased during the spawning season of Chinook, chum, and coho as compared to before the burn. The increase is due to changes in flow management as well as an increase in the amount of water available when delivery of 51 cfs to the Georgia Pacific Paper Mill ceased in 2001. Increased flows provide better fish access and more habitat at some times of the year. In addition, habitat surveys show that habitat and water quality have been maintained or improved by the emergency response and long-term restoration actions. As a result, while the fire may have contributed to reduced adult returns of salmon, it seems unlikely that it is the major factor responsible for the observed decline.

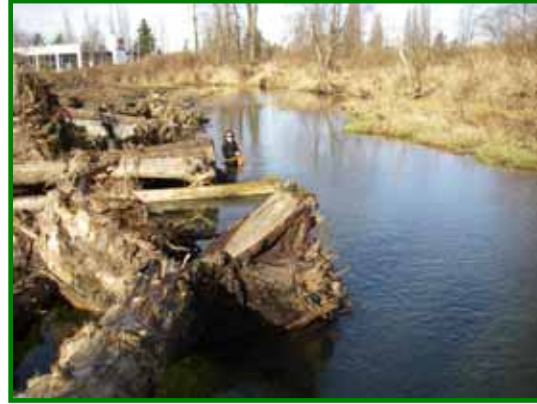
Source: City of Bellingham
Conducting Survey of Large Woody Debris

emergency response resulted in short-term improvements of habitat. Subsequent instream habitat restoration projects have maintained improved habitat conditions, particularly downstream of Woburn Street. Throughout the stream, the amount of wood and the number of pools is similar to, or better than in 1999. Off-channel habitats and the meandering channel configuration established by restoration projects at Salmon Park, Cemetery Creek, and Red Tail Reach have improved habitat complexity, and substantially increased backwater habitat that serves as refuge for juvenile salmon during floods.

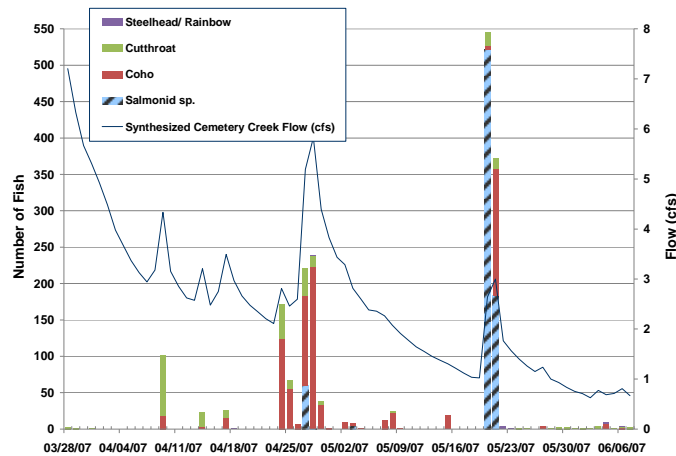
Cemetery Creek Smolt Trap Results from 2007 (from Forester 2009).

The smolt trap is constructed on Cemetery Creek just downstream of the West Pond. Juvenile fish moving downstream in Cemetery Creek are intercepted in a screened box; the box is checked at least twice a day, and more often during high flows. Fish are identified to species and recorded by size class. Trapping occurred in 2007, and is underway in the spring of 2009. In 2007, a total of 1,984 fish were collected from the trap between March 28 and June 7. Coho salmon and cutthroat trout dominated out-migration. Non-native species such as smallmouth bass, and goldfish were also occasionally encountered. As of May 15, 2009, almost 1000 salmonids had been counted at the trap, predominantly coho salmon and cutthroat trout.

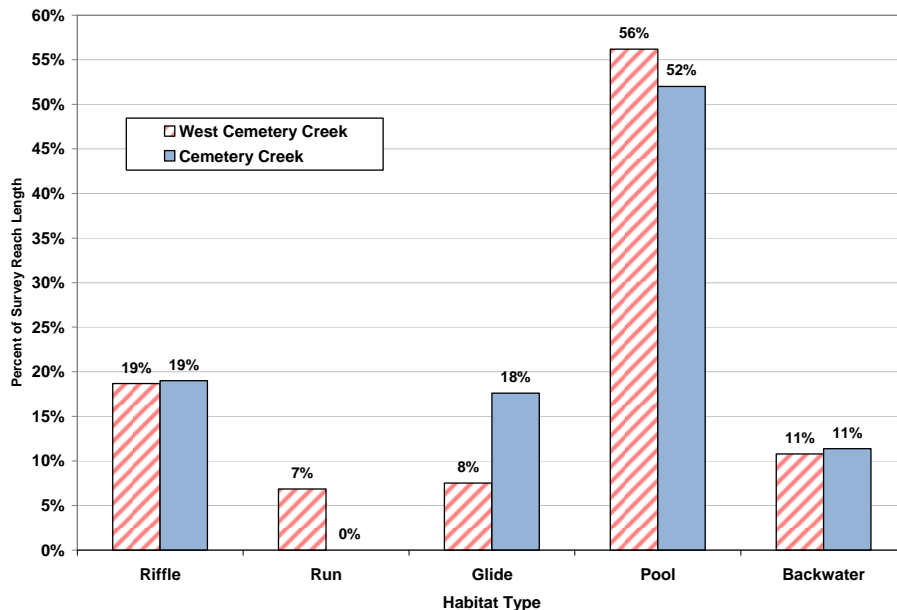
Habitat Unit Subtypes in Mainstem and West Cemetery Creek in 2008 (from Forester 2009).

Prior to restoration, Cemetery Creek consisted of a narrow, channelized stream with little habitat complexity. The restoration project increased pool and pond habitat; in 2007, more than 50 percent of the project reach consisted of those low velocity habitat types. Deep, low velocity areas provide refuges that allow small fish to avoid swift flows during floods. Riffle habitats were the second most common, representing about 20 percent of the habitat. Riffles provide substrate for macroinvertebrates, and the clean gravels needed for successful salmon spawning.

Habitat conditions currently are rated good in West Cemetery Creek, and fair to good in Mainstem Cemetery Creek according to NMFS standards for properly functioning conditions (NMFS 1996).
