# Whatcom Creek:

## Ten-Years After Summary Report

**City of Bellingham**  
Department of Public Works  
Environmental Resources

**R2 Resource Consultants, Inc.**  
15250 NE 95th Street  
Redmond, Washington 98052

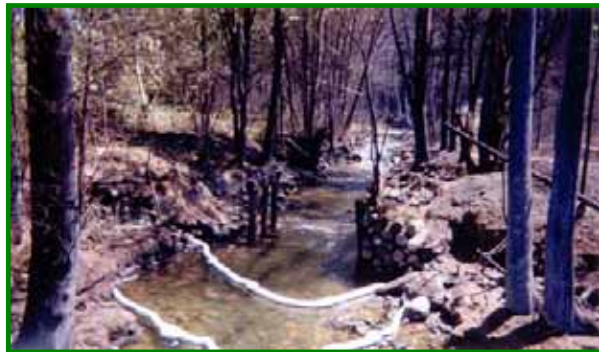
Source: U.S. Environmental Protection Agency  
Absorbent Boom in Whatcom Creek

Hannah and Whatcom creeks were heavily impacted by the incident. After skimming as much gasoline as possible from the water, the stream channel was cleaned by excavating and removing contaminated soil and logs, and taking the material to a hazardous waste depository. Where excavation was impossible, stream bed gravel was manually washed and flushed.

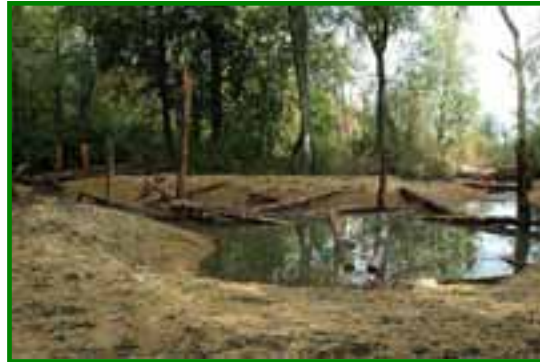
Pond Created at Cemetery Creek

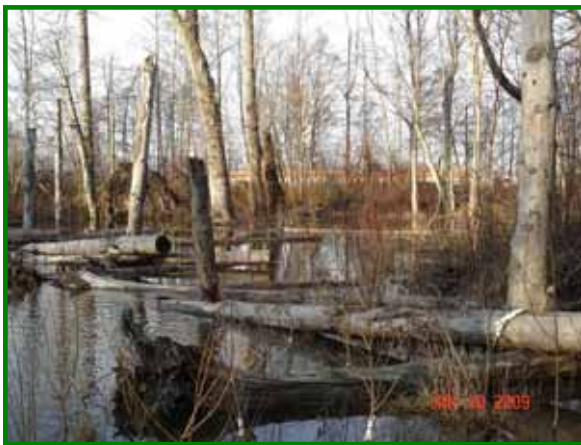
Salmon Park Wetland and Backwater Habitat

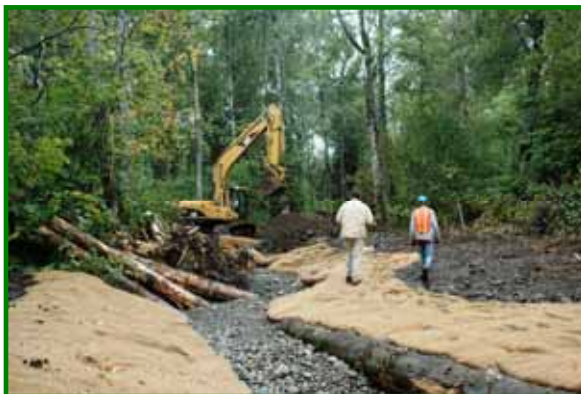
Cemetery Creek Channel Reconstruction

ponds, and reconfiguration of the Cemetery Creek channel to include large woody debris, meanders, pools, backwaters and complex habitats in the formerly channelized stream. Ponds and backwaters provide refuge for salmon during high flows and wetland habitat for amphibians and other wildlife throughout the summer months. These projects enhanced habitat conditions throughout the area, while minimizing impacts to surrounding vegetation and ground surfaces. In addition, portions of an anthropogenic gravel berm were removed from the Salmon Park area, restoring geomorphic function by allowing Whatcom Creek to access and migrate within its associated floodplain.

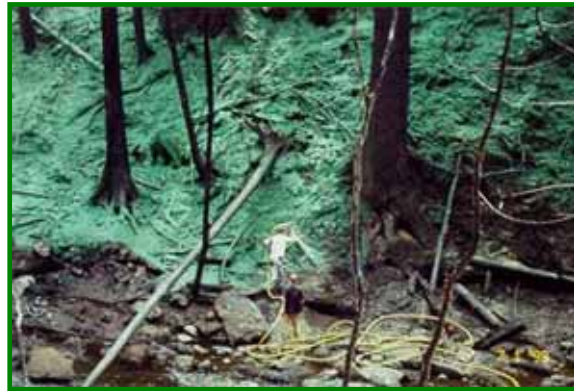
Source: Polaris Applied Sciences  
Hydroseeding Exposed Slopes Following the Fire

One of the greatest fears immediately following the fire was that slopes would undergo severe erosion during heavy fall rains following the fire. Immediate treatment and riparian plantings, in combination with recovery of plants whose roots survived underground prevented this from happening. No major areas of erosion that could be directly related to the 1999 fire were observed in 2009. In general, slopes in these areas are well vegetated and appear stable.

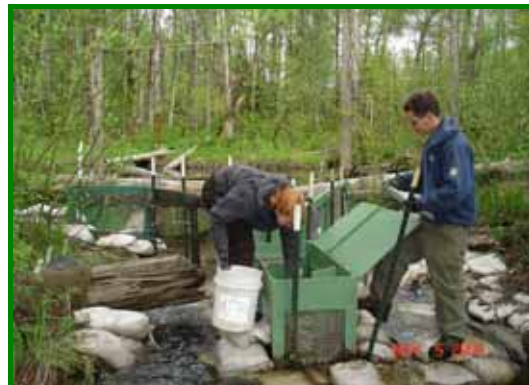
Source: City of Bellingham  
Checking Smolt Trap in Cemetery Creek

The smolt trap is constructed on Cemetery Creek just downstream of the West Pond. Juvenile fish moving downstream in Cemetery Creek are intercepted in a screened box; the box is checked at least twice a day, and more often during high flows. Fish are identified to species and recorded by size class. Trapping occurred in 2007, and is underway in the spring of 2009. In 2007, a total of 1,984 fish were collected from the trap between March 28 and June 7. Coho salmon and cutthroat trout dominated out-migration. Non-native species such as smallmouth bass, and goldfish were also occasionally encountered. As of May 15, 2009, almost 1000 salmonids had been counted at the trap, predominantly coho salmon and cutthroat trout.

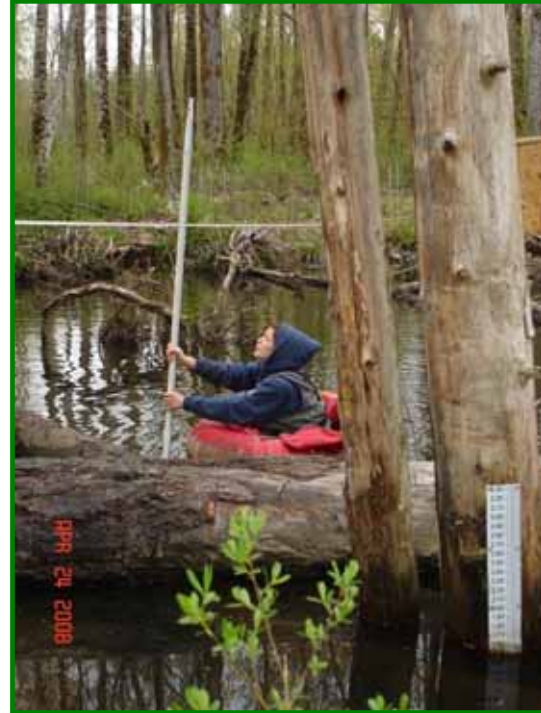
Pond Bathymetry Survey

Ponds and streams are monitored to ensure the project continues to provide high quality habitat for fish. Pond depths are measured to track the rate at which sediment accumulates in the ponds. Channel cross-sections are surveyed to confirm that bank erosion is minimal and that the reconfigured channel does not fill with sediment or downcut. Stream surveys are conducted to track the quality of salmon habitat within the Cemetery Creek restoration site.

The depth and volume increased for all ponds from 2007 to 2008. This result is somewhat surprising as the most likely response of the ponds over time was hypothesized to be filling. Changes in depth may be related to surveyor techniques (i.e., the amount of force used to set the rod on the pond bottom).

Future surveys will be conducted using a depth sounder with a standard weight to avoid surveyor bias.
