# **WHATCOM CREEK RESTORATION PROJECT REPORT: 2007-2008**

**Associated with the  
Whatcom Creek Restoration Plan  
Developed for the June 10, 1999  
Olympic Pipe Line Gasoline Spill**

March 2009

Brenna Forester  
City of Bellingham  
Department of Environmental Resources  
Bellingham, WA

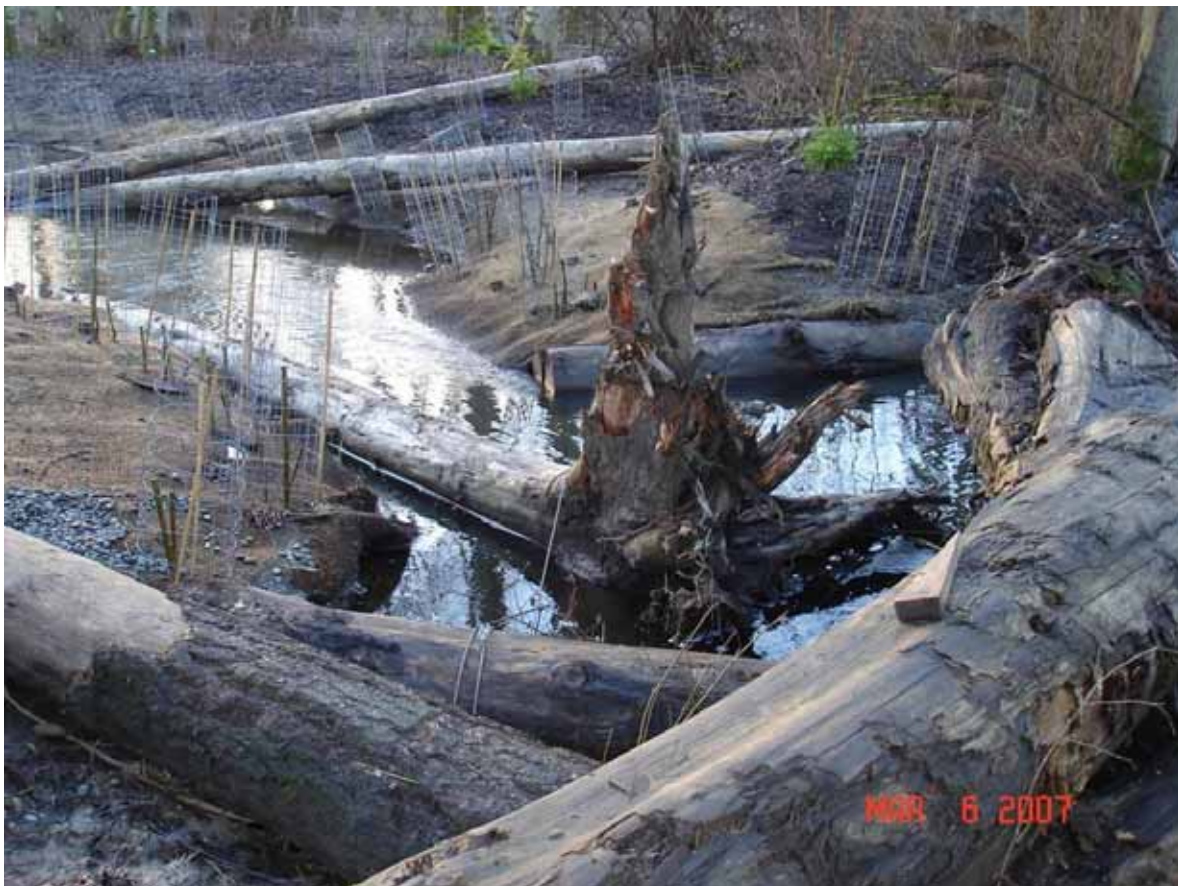
**Figure 2-1. Photo showing recently constructed stream channel in Cemetery Creek, with newly planted conifers, willow stakes and deciduous shrubs; March 6, 2007.**

Infill planting and the installation of additional willow cuttings occurred the following winter (2007). Supplementary infill planting, including additional sedges in swales and around pond margins occurred in April 2008.

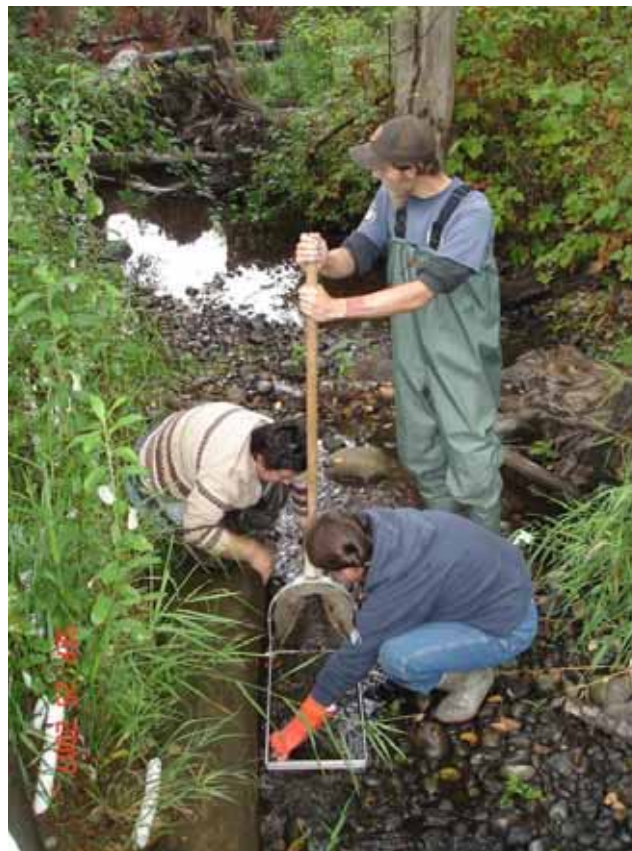
**Figure 2-13. WCC staff collecting a macroinvertebrate sample using the D-frame kick net.**

Macroinvertebrate sampling follows the methodology found in “Benthic Macroinvertebrate Biological Monitoring Protocols for Rivers and Streams” (Plotnikoff and Wiseman, 2001), with some modifications. Four substrate samples are taken from riffles within each of the three sites. Samples are collected using a D-frame kick net with a 2.0 ft<sup>2</sup> delineation square (Figure 2-13). Rocks within the frame are brushed for collection and sediment is disturbed to release a larger number of macroinvertebrates. Samples are contained separately in half and one-liter polycarbonate containers and are preserved in 85 percent ethanol. Each sample includes a waterproof label with watershed and stream name, site number and riffle number, the date and collector’s name.

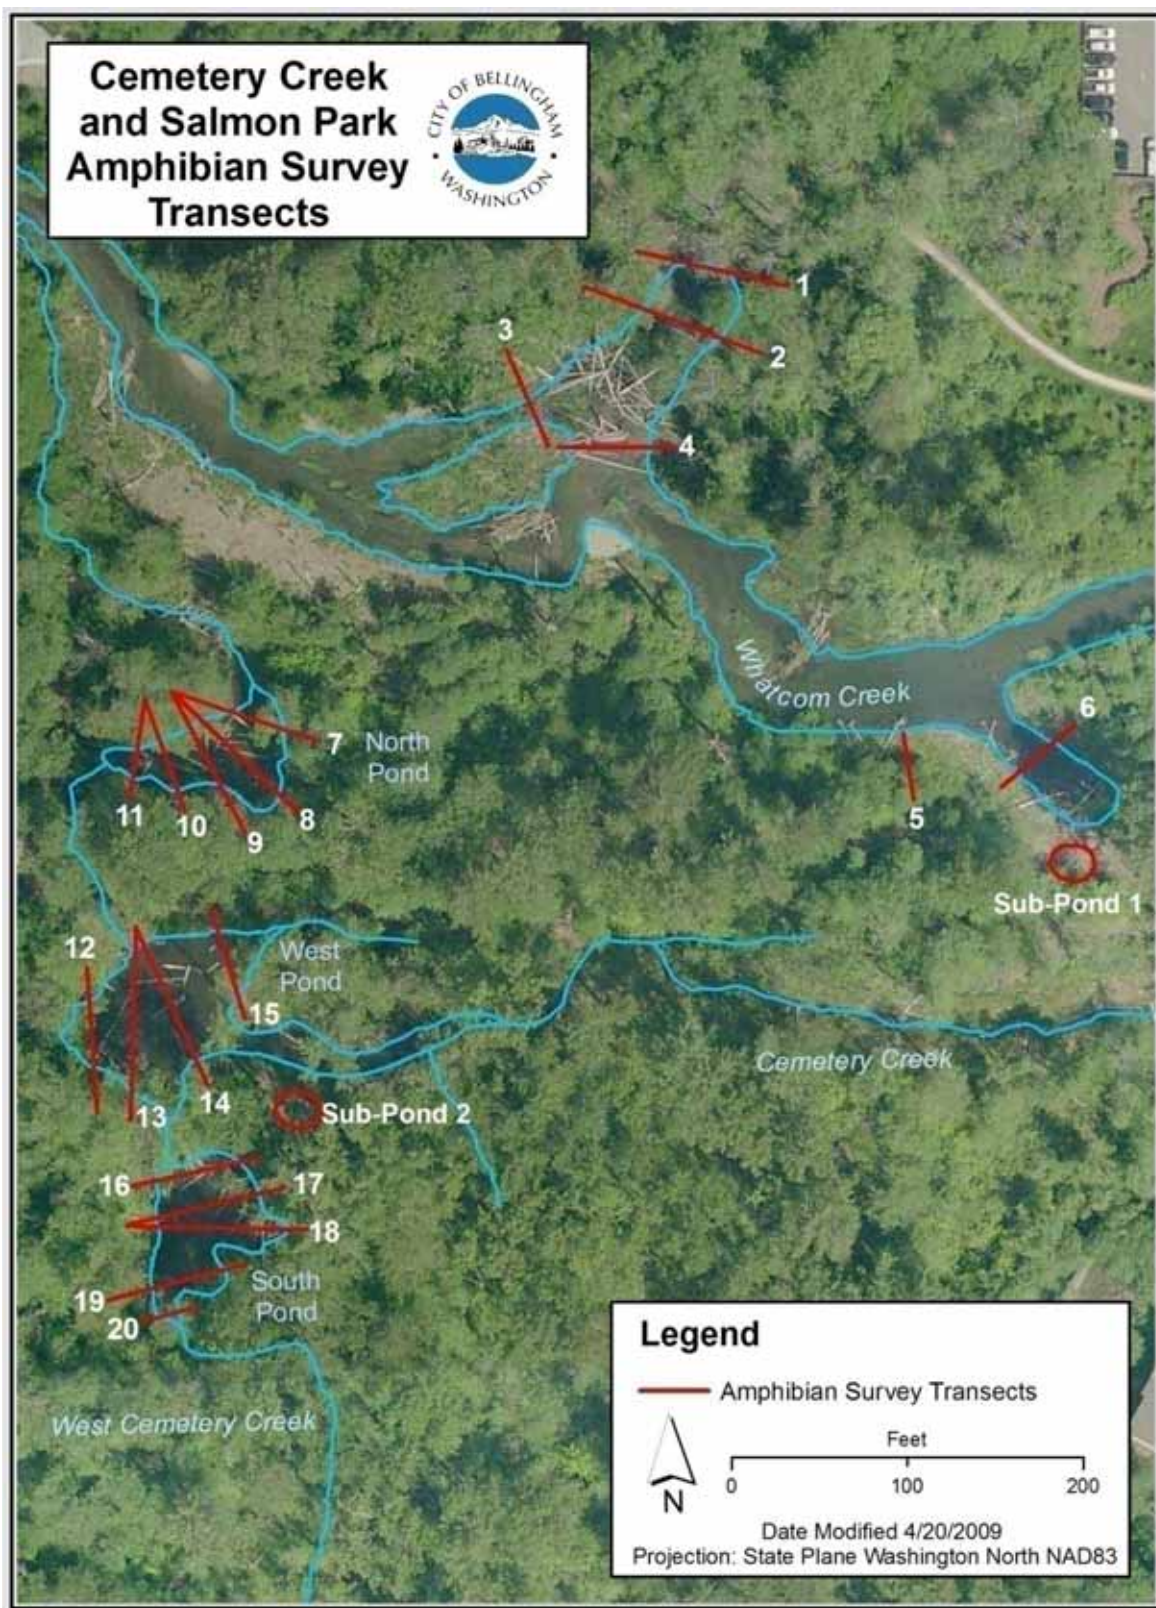
Figure 2-14. Map of amphibian survey transects. Surveyors randomly selected the right or left bank of each transect for sampling.
