# **WHATCOM CREEK RESTORATION PROJECT REPORT: 2007-2008**

**Associated with the  
Whatcom Creek Restoration Plan  
Developed for the June 10, 1999  
Olympic Pipe Line Gasoline Spill**

March 2009

Brenna Forester  
City of Bellingham  
Department of Environmental Resources  
Bellingham, WA

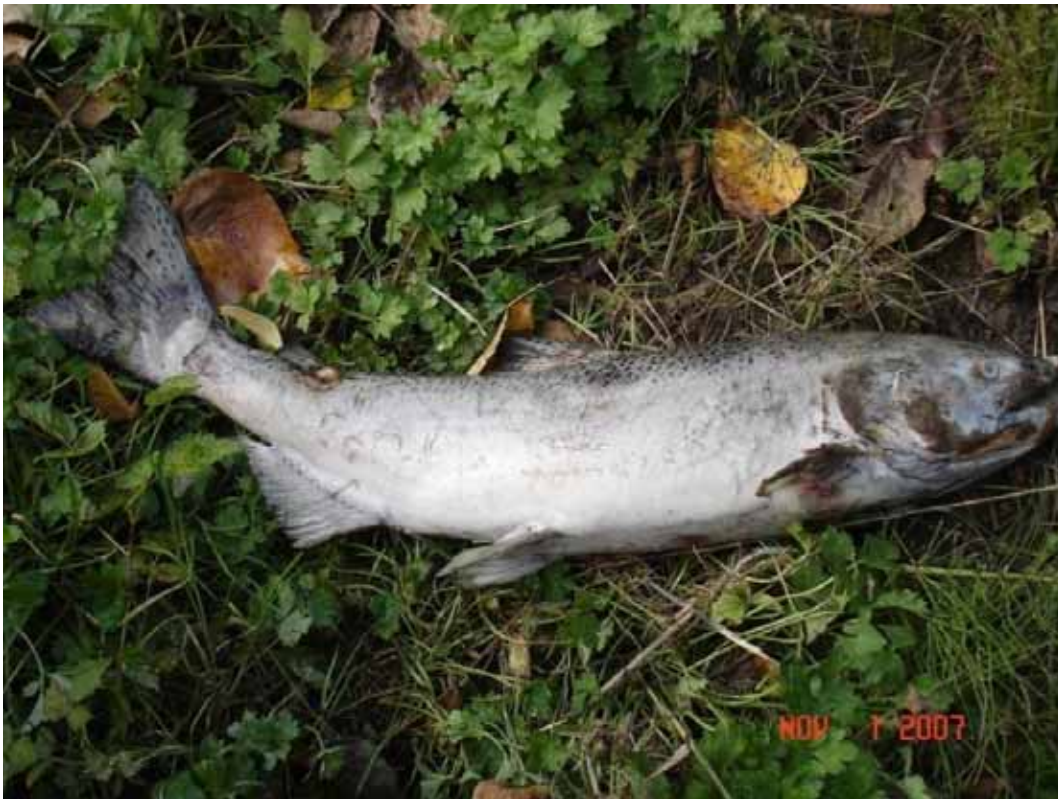
One live fish was identified during surveys in 2007-2008, a coho which was seen digging a redd in the Cemetery Creek channel. Five dead fish were found, two of which were positively identified: one male Chinook (Figure 2-6) and one coho. The male Chinook had not spawned; the coho was scavenged, preventing a determination of spawning status. Two redds were identified: the redd created by the coho and one additional redd also located in Cemetery Creek channel.

**Figure 2-6. Male, unspawned Chinook, found at upper end of the restoration site in Cemetery Creek on November 1, 2007.**

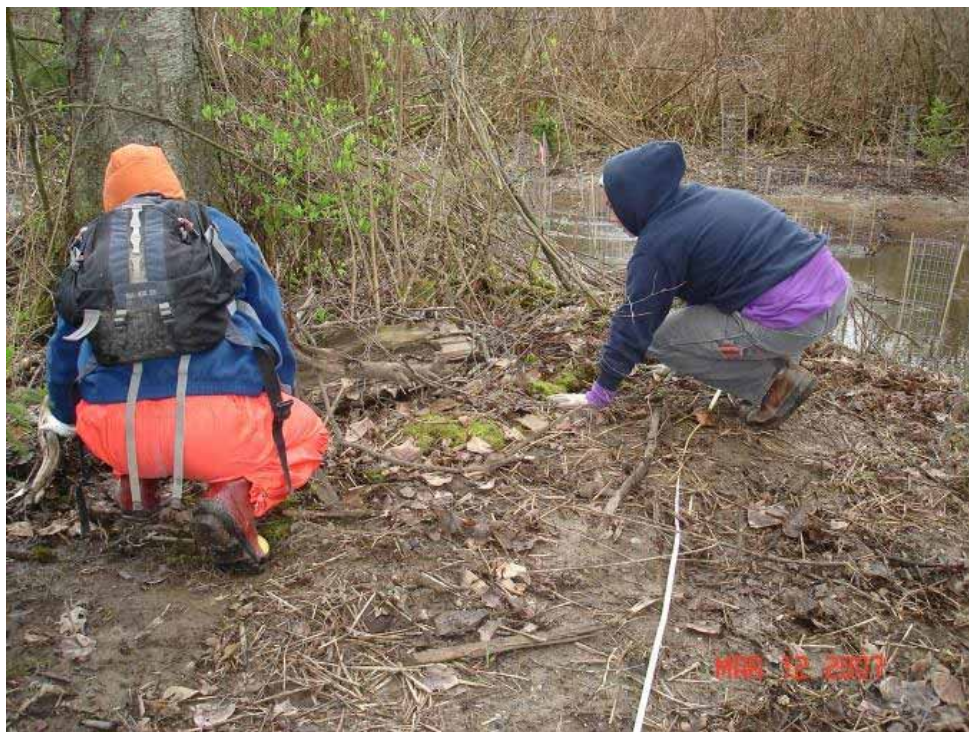
**Figure 2-15. Surveyors lifting logs and debris while completing amphibian surveys in 2007. Note lack of vegetative cover.**
