# Part 2: Table of Contents

## Part 2: Conditions Assessment

# Conditions Assessment Results

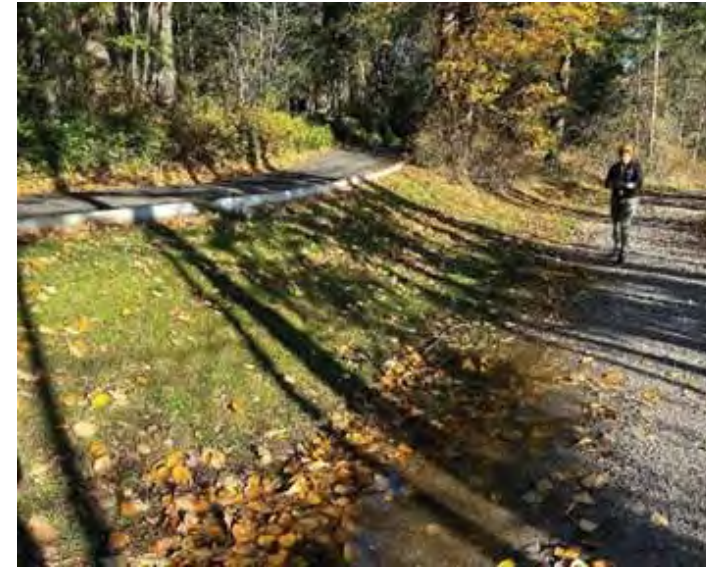
Figure 27. Main loop trail segment with drainage issues in Zone 4.

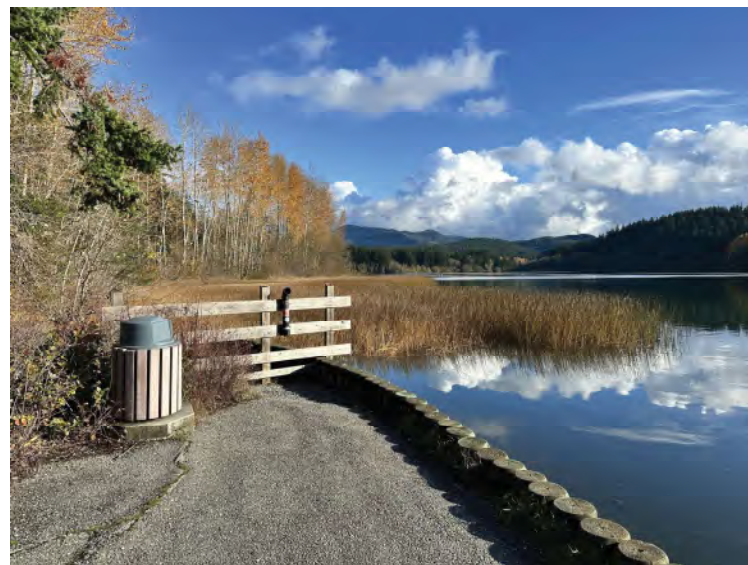
A treated wood piling bulkhead is located adjacent to the fishing area and parking lot in Zone 4 (northwest end of the lake). These pilings help retain an asphalt fishing and picnic area. Treated pilings leach toxic compounds into the water, which can pose health risks to humans, fish, and invertebrates (EPA 2024).

Fishing area bulkhead- looking south.

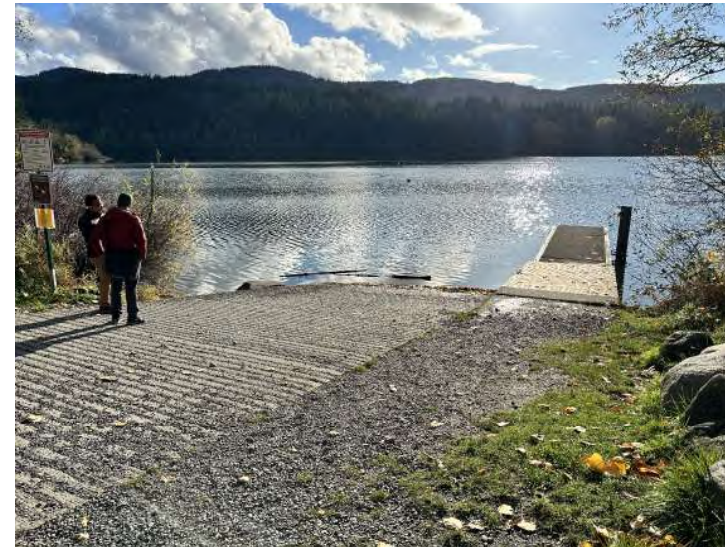
Boat launch ramp and dock- condition rating 3.

Boat launch ramp and dock.

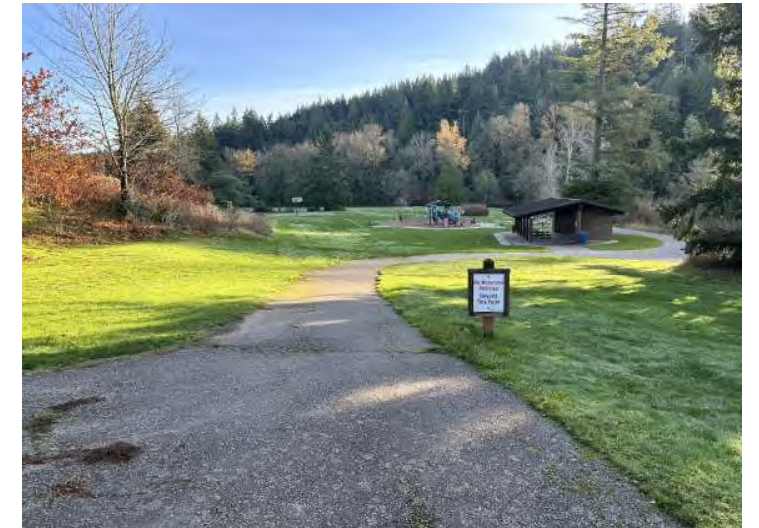
Access path to activity area often used by patron vehicles for access- barrier to unauthorized access should be installed.

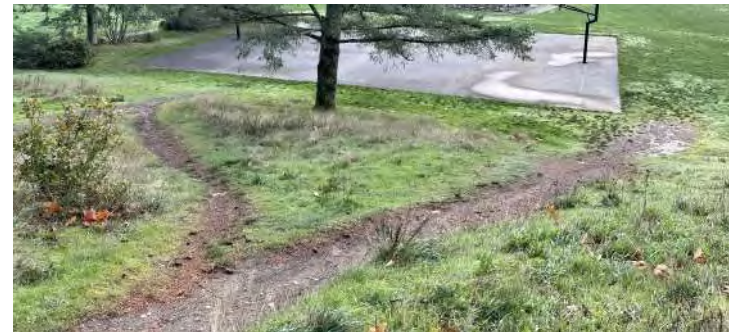
Footpaths contribute to slope erosion above basketball courts.
