# MF Nooksack Channel Monitoring & Adaptive Management As Built Monitoring

Final Report, Rev. 1

NHC Reference 2005776

**City of Bellingham Public Works**

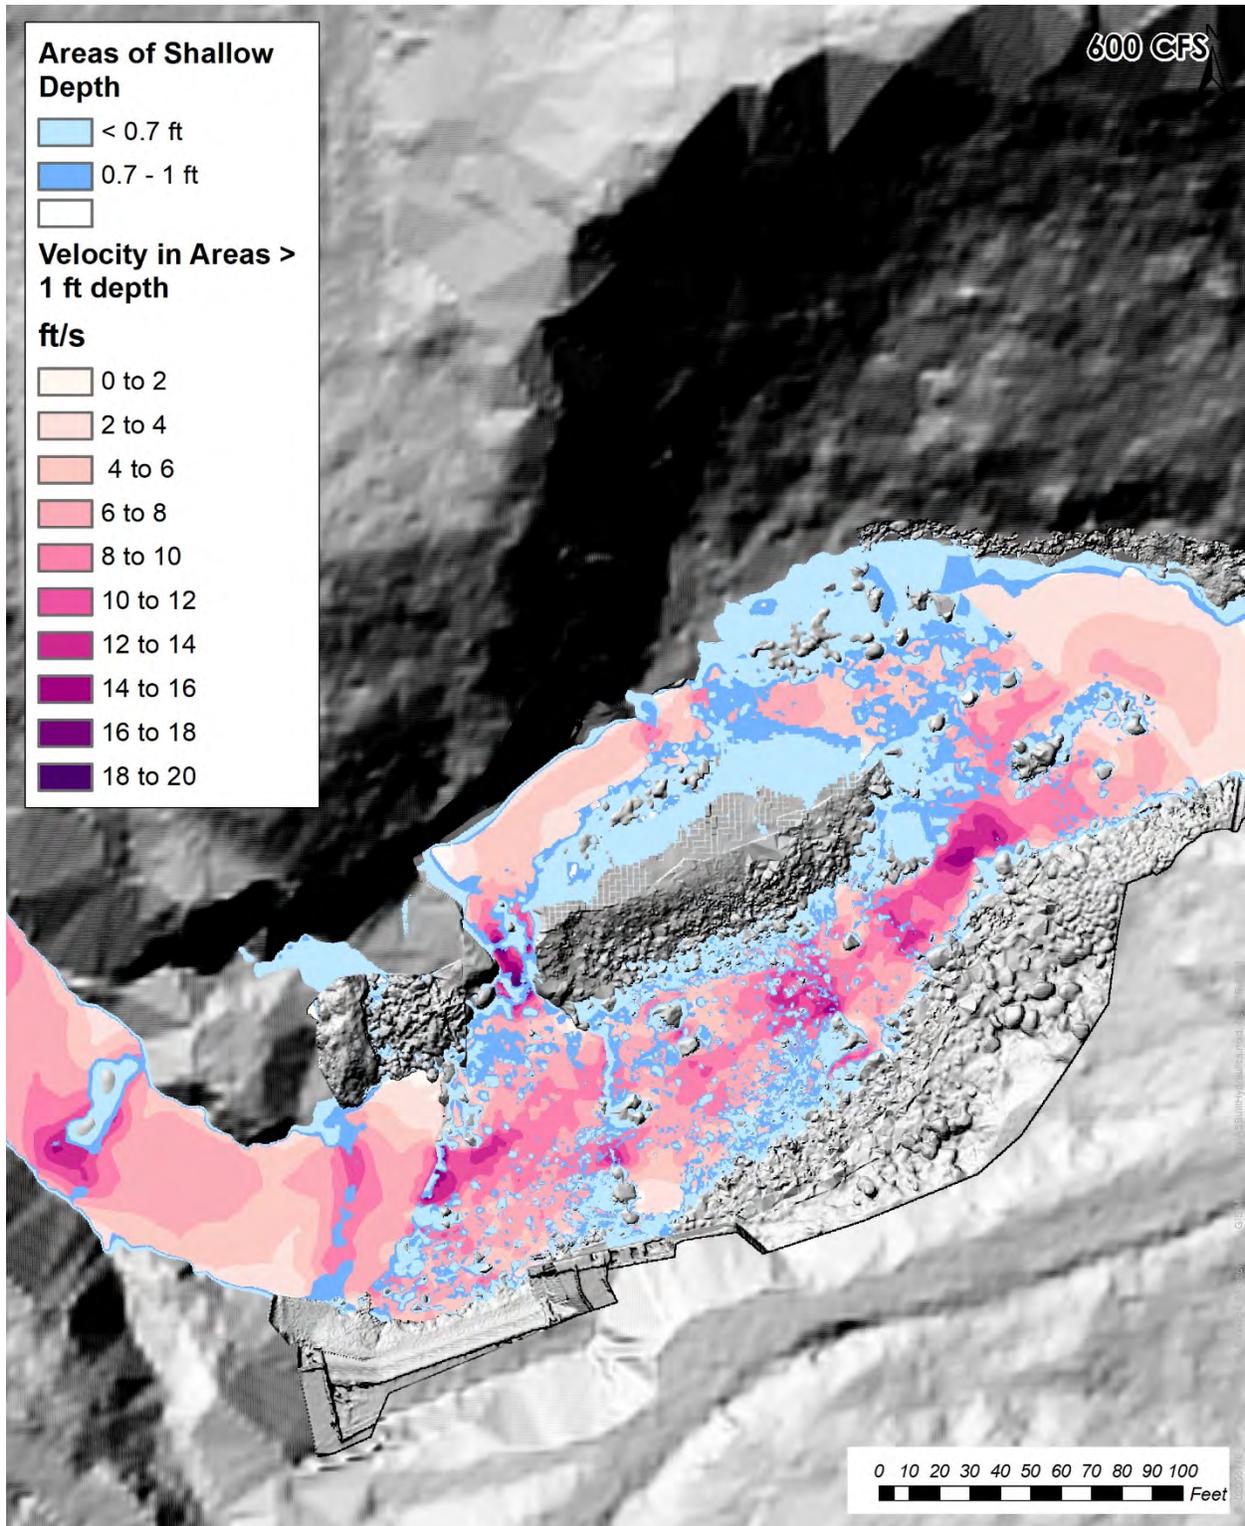
Figure 4.3 As-built hydraulic model results showing areas of shallow inundation and velocity in areas of deeper inundation for a discharge of 600 cfs.

Figure 4.2 through Figure 4.5 depict depth and velocity distributions predicted by the model for the approximate as-built terrain in the river regrade reach, over a similar range of flows assessed during design (DeVries, 2018). The velocities are depth averaged and are generally representative of velocities encountered by the target species adults in shallower water and may be higher than encountered by fish swimming along the bottom in deeper water.

Overall, there appears to be hydraulic longitudinal connectivity along both sides of the design channel with periodic refugia of lower velocity along the viable length at all flows modeled (Figure 4.2 through Figure 4.5). Based on depth, passage opportunities presently appear to be available over a wider section of flow for Steelhead than Chinook, and Chinook Salmon upstream passage may be more limited by depth over the 300-600 cfs flow range than at higher flows. There are two steeper locations that presently represent constrained, but passable sections along the Main Channel, and along the actively regrading secondary right bank flow pathways to the North. Both locations will continue to be monitored through the Spring and evaluated in greater detail after their adjustments appear to have completed for the season.
