# MF Nooksack Channel Monitoring & Adaptive Management As Built Monitoring

May 7, 2021  
Final Report, Rev. 1

NHC Reference 2005776

**City of Bellingham Public Works**  
104 W. Magnolia Street, Suite 109  
Bellingham, WA 98225

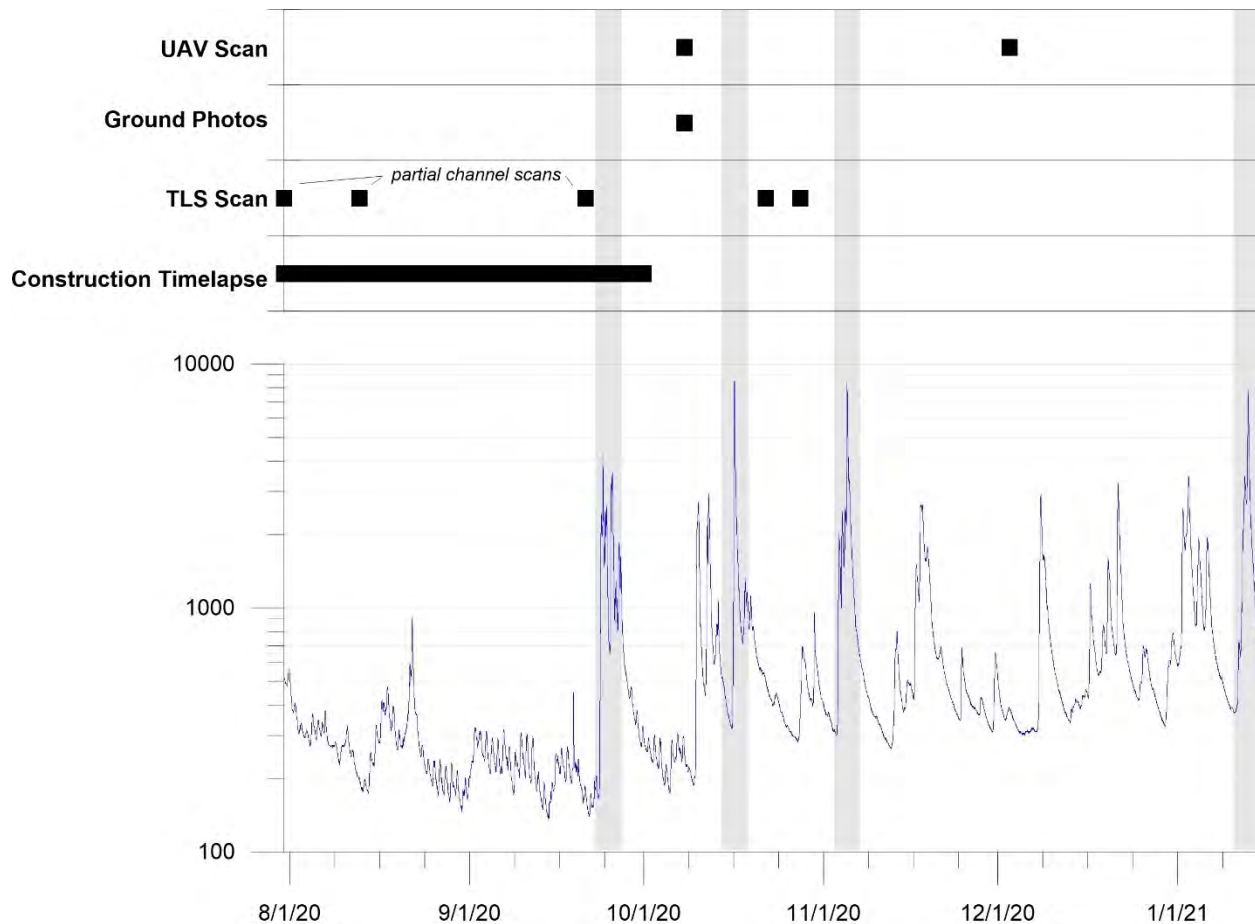
**Figure 1.1** Timeline of observation efforts. TLS scans of portions of the restored channel were also completed on 31 July and 13 August as individual segments of that channel were re-watered.

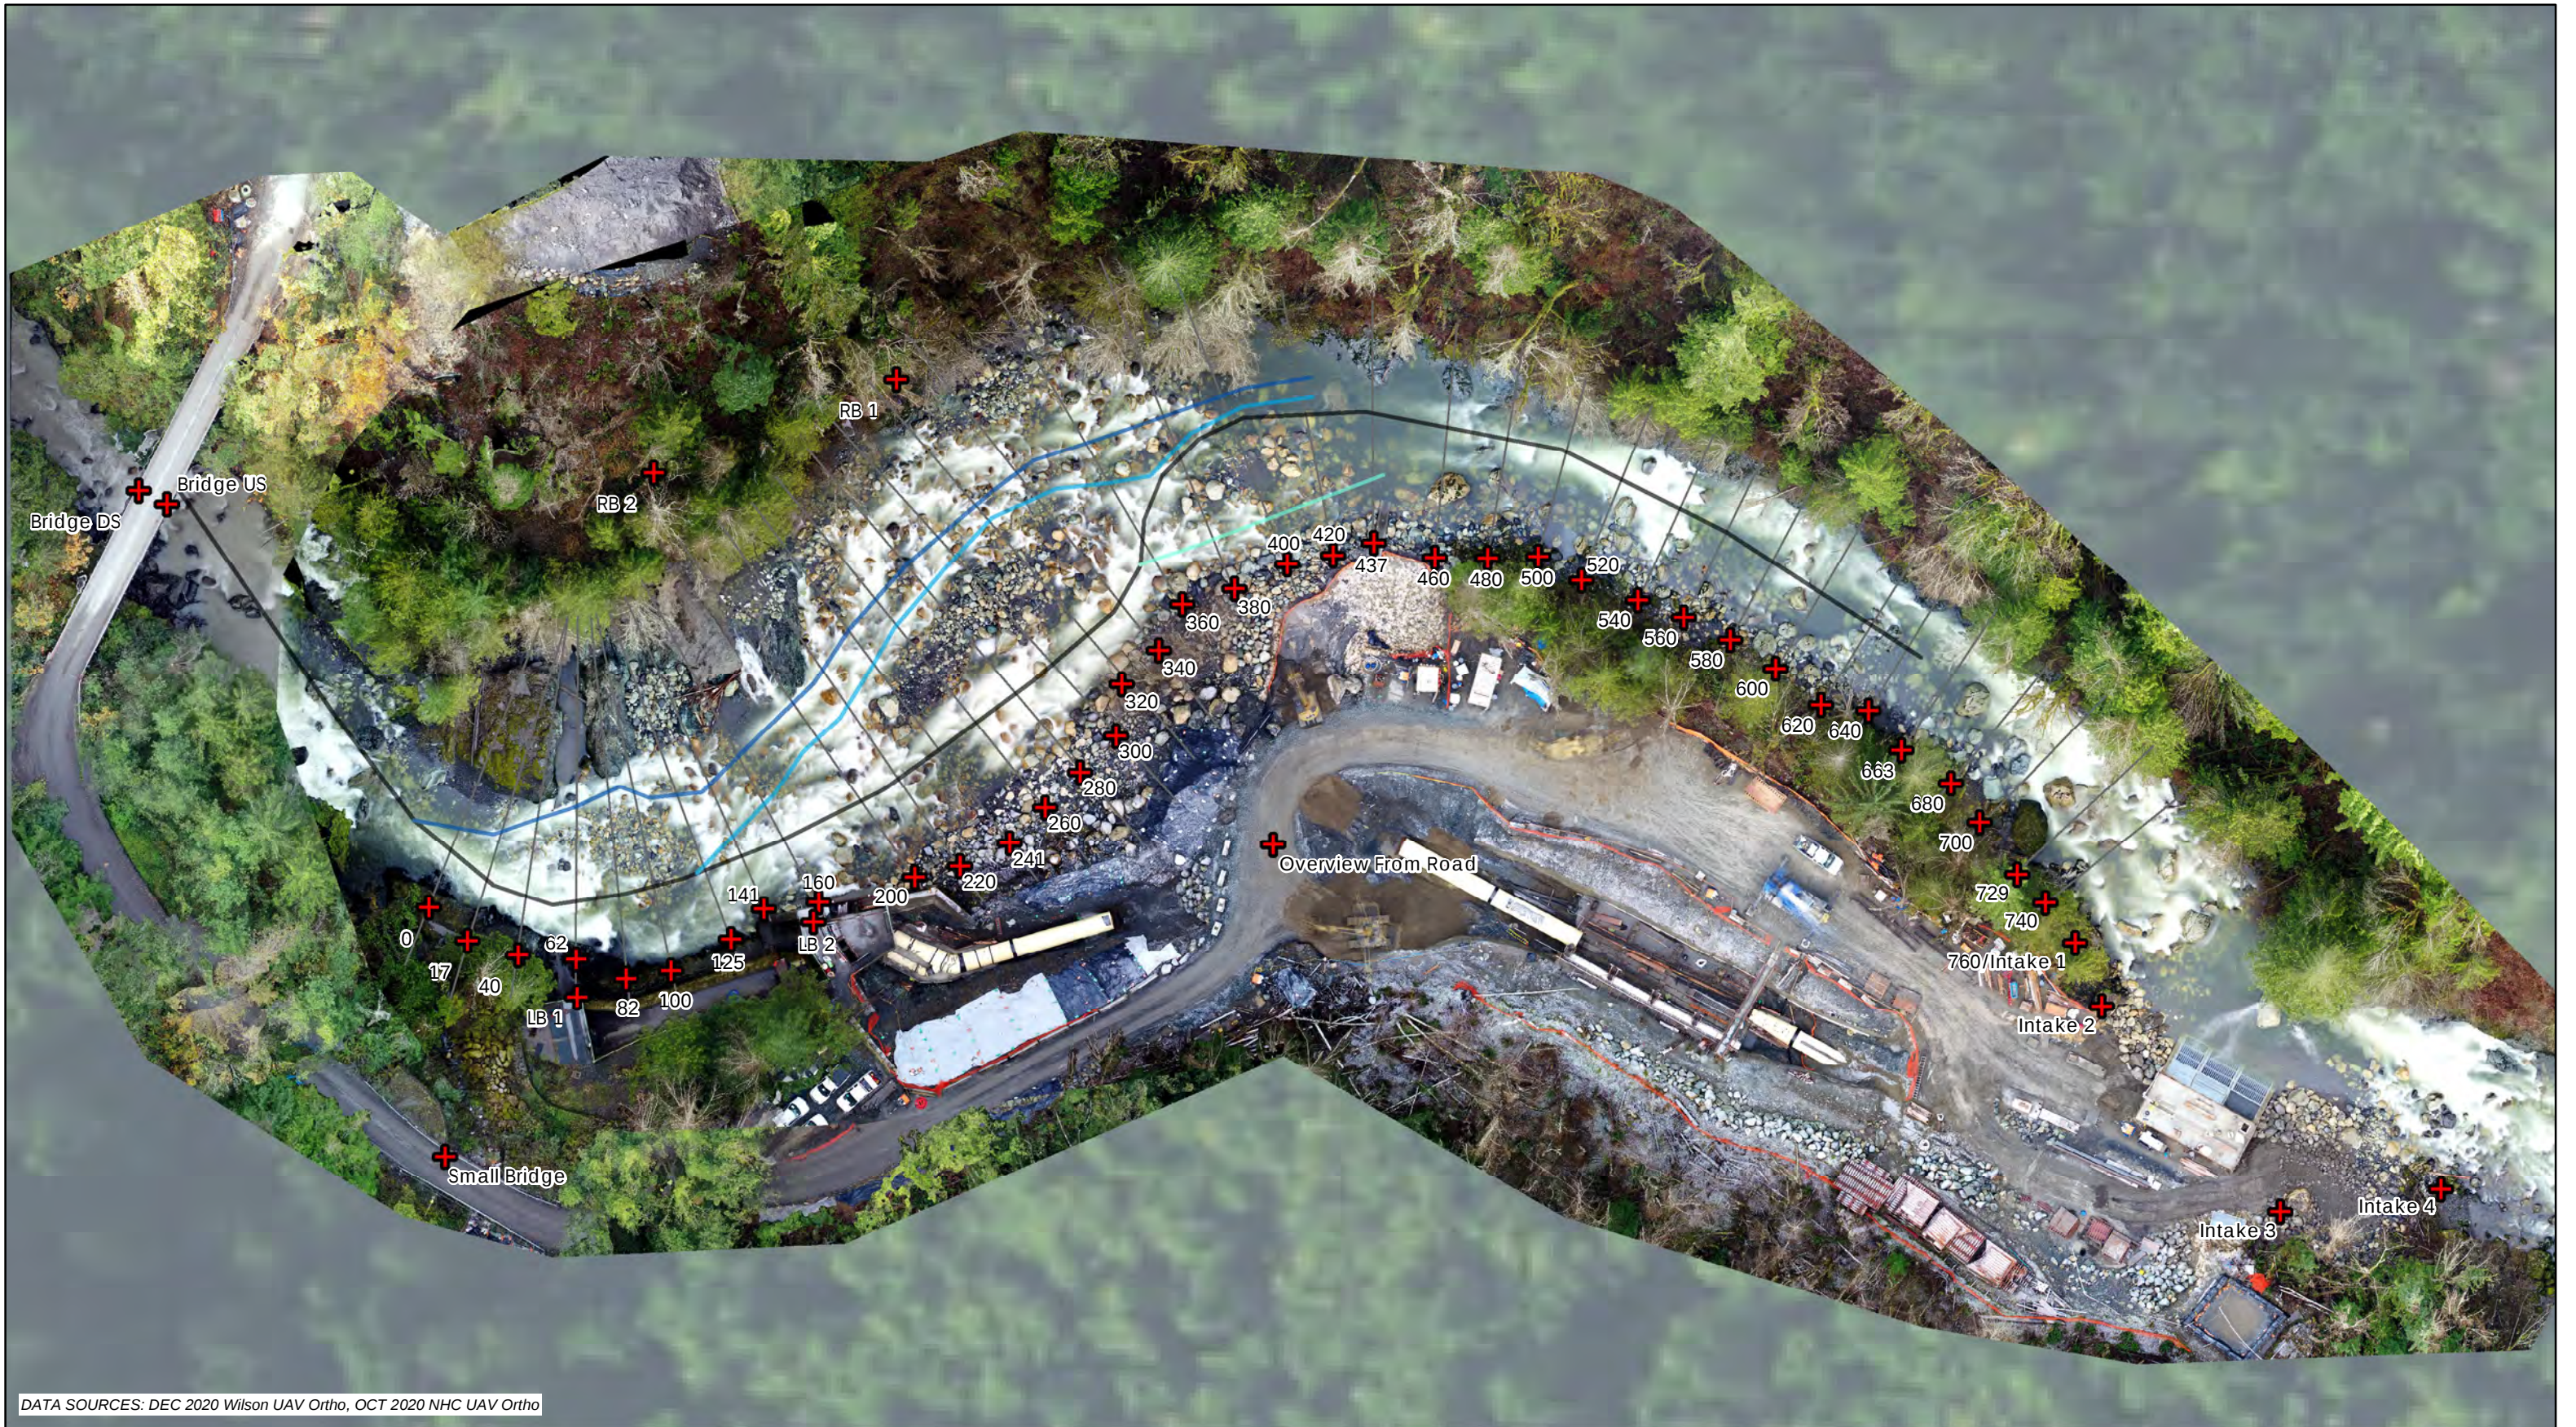
Topographic and profile extraction lines were also laid out on the site to define locations for measuring changes in water surface elevation and profile slope, as also illustrated in Figure 2.1. Topographic cross section extraction lines were laid out crossing the channel at each photo monitoring station.

Topographic profile extraction lines were laid out along dominant flow paths that may act as distinct fish passage routes. The measured distances along the bank provide a standardized “stationing” for the whole monitoring area. Because each profile extraction flow path has slightly different lengths than the Bankline, locations along the flow paths are defined by both along-path stations and by standard stationing.
