# MF Nooksack Channel Monitoring & Adaptive Management As Built Monitoring

May 7, 2021  
Final Report, Rev. 1

NHC Reference 2005776

**City of Bellingham Public Works**  
104 W. Magnolia Street, Suite 109  
Bellingham, WA 98225

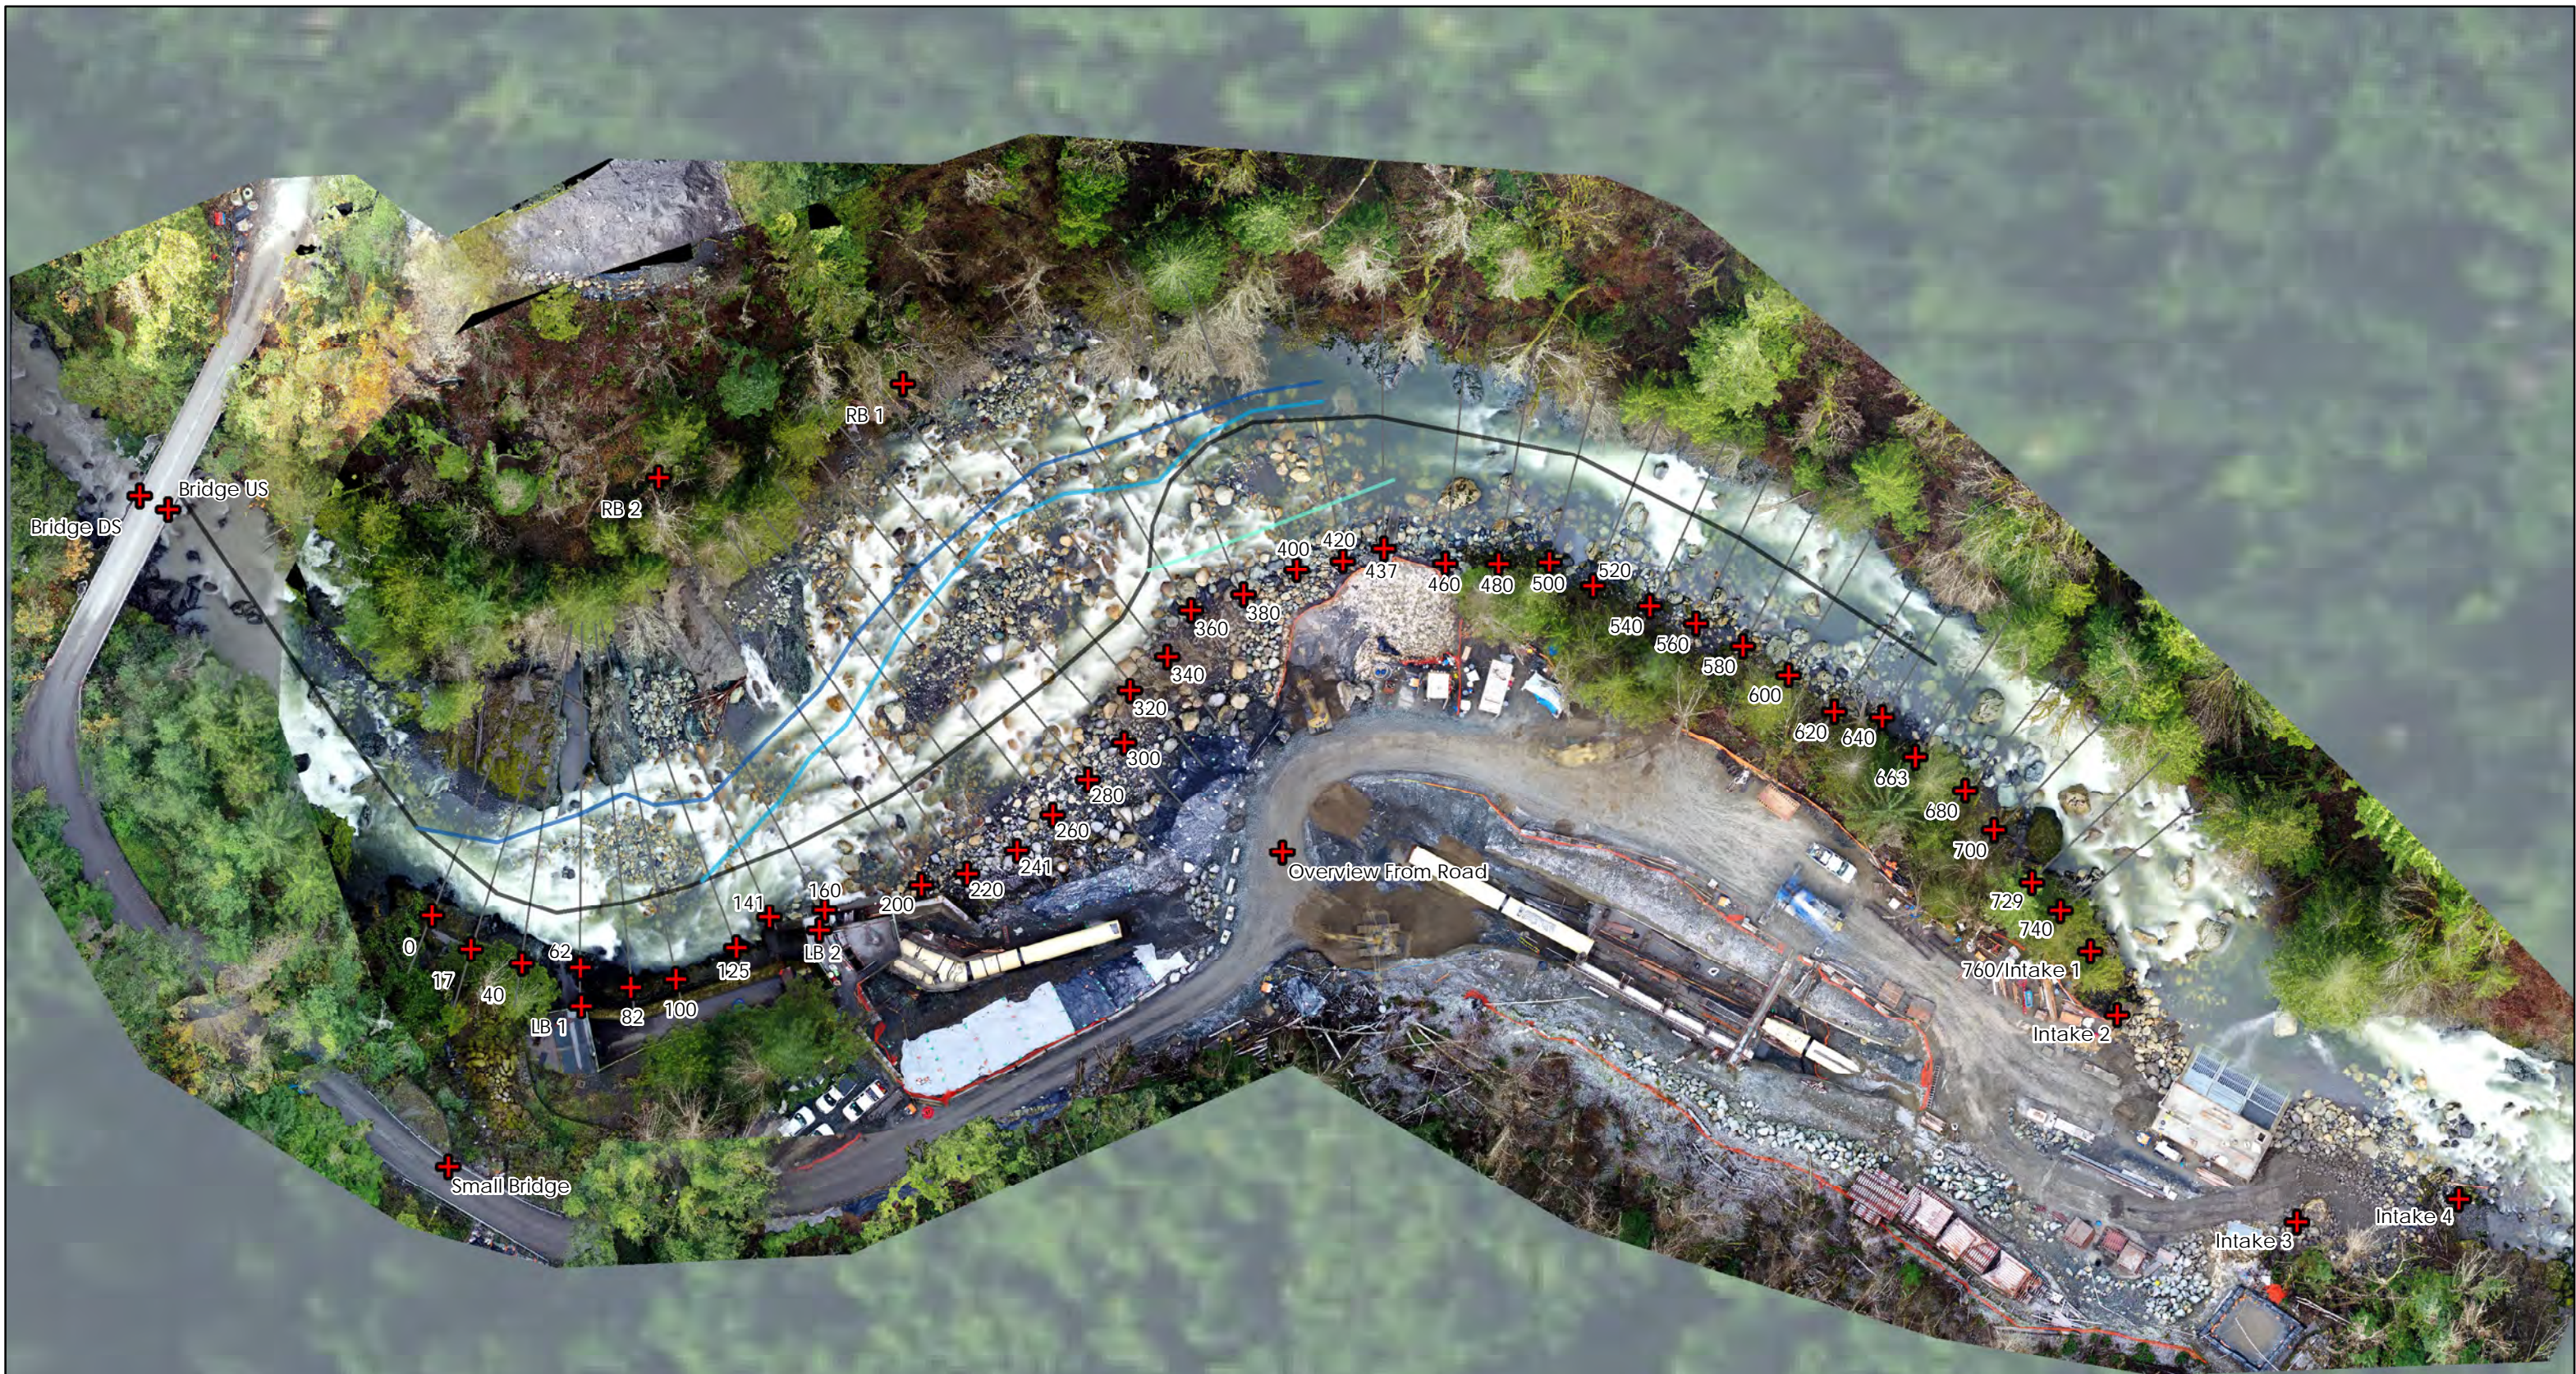
Topographic and profile extraction lines were also laid out on the site to define locations for measuring changes in water surface elevation and profile slope, as also illustrated in Figure 2.1. Topographic cross section extraction lines were laid out crossing the channel at each photo monitoring station.

Topographic profile extraction lines were laid out along dominant flow paths that may act as distinct fish passage routes. The measured distances along the bank provide a standardized “stationing” for the whole monitoring area. Because each profile extraction flow path has slightly different lengths than the Bankline, locations along the flow paths are defined by both along-path stations and by standard stationing.

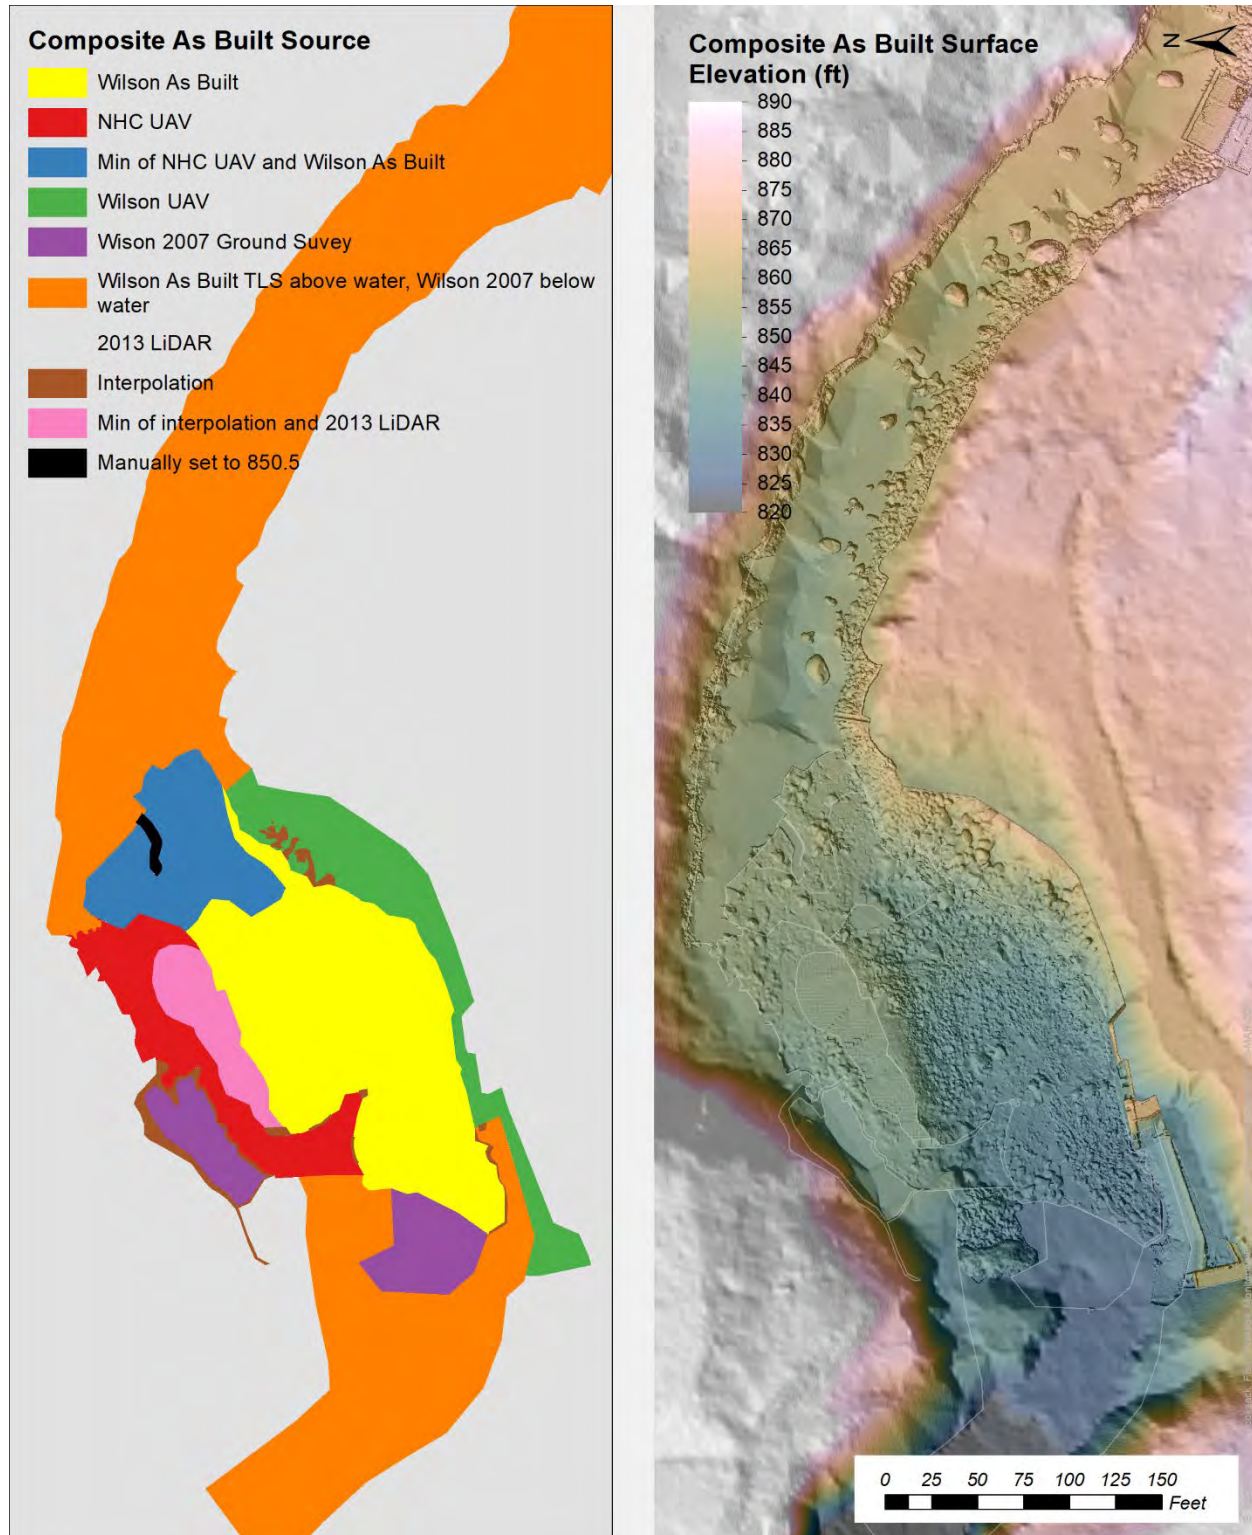
**Figure 2.2 Overview of as-built topographic surface and data sources combined to produce the surface.**

The domain where each of these data sources was used is shown in Figure 2.2. The north portion of the mid-channel bar, between station 240 and 340, was outside of the extent of the dewatered as-built TLS scans, but changed appreciably in the first flow pulse before the Oct 8<sup>th</sup> UAV overflight. Therefore, no data were available to represent the topography of this area. This hole was filled with simple interpolation unless this interpolation indicated an elevation above the 2013 LiDAR, in which case the lower LiDAR elevation was used. This qualitatively matches topography visible in the reference photo (Photo 2.1) for conditions just before the first high flow pulse, which adjusted the channel morphology (Photo 2.2).
