Technical Memorandum

Subject Lake Whatcom Tunnel Condition Assessment Report (Task 5.2) (Final)

Project Name Raw Water Intake Condition Assessment and Intertie Pipeline Design

Date June 14, 2024

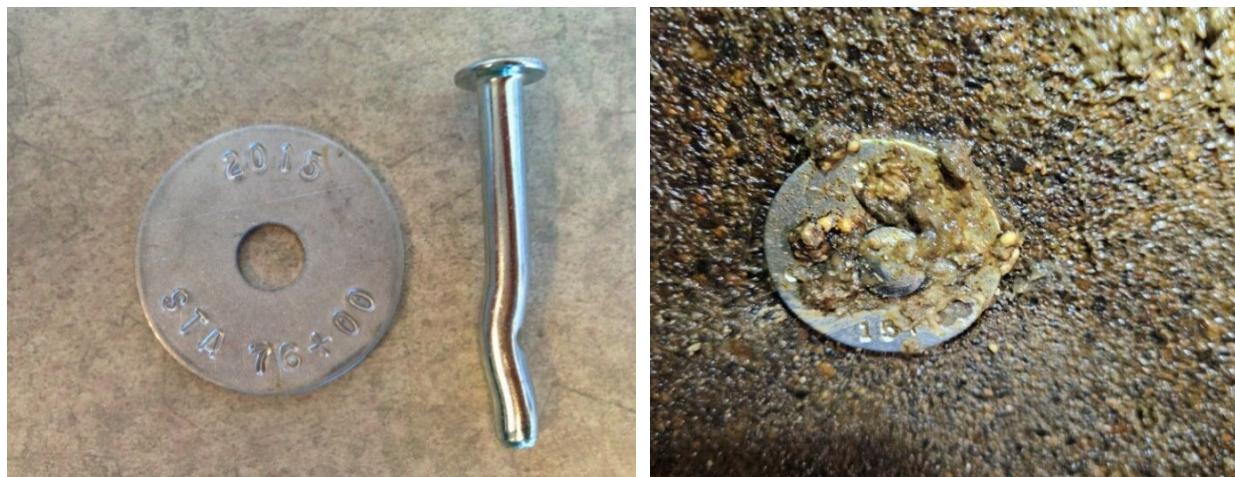
EXHIBIT 3

During the previous inspection (2015) permanent markers were placed every 100 feet on the south side of the tunnel to aid location of inspection documentation and to aid future inspections. The permanent markers consist of an aluminum washer stamped with the year "2015" and the corresponding station number, as shown in Exhibit 3. Washers were affixed to stainless steel friction anchors that were pounded into holes drilled with a rotary hammer drill. All markers were intact and, while experiencing some corrosion, were generally legible when observed through the course of completing the 2024 inspection.

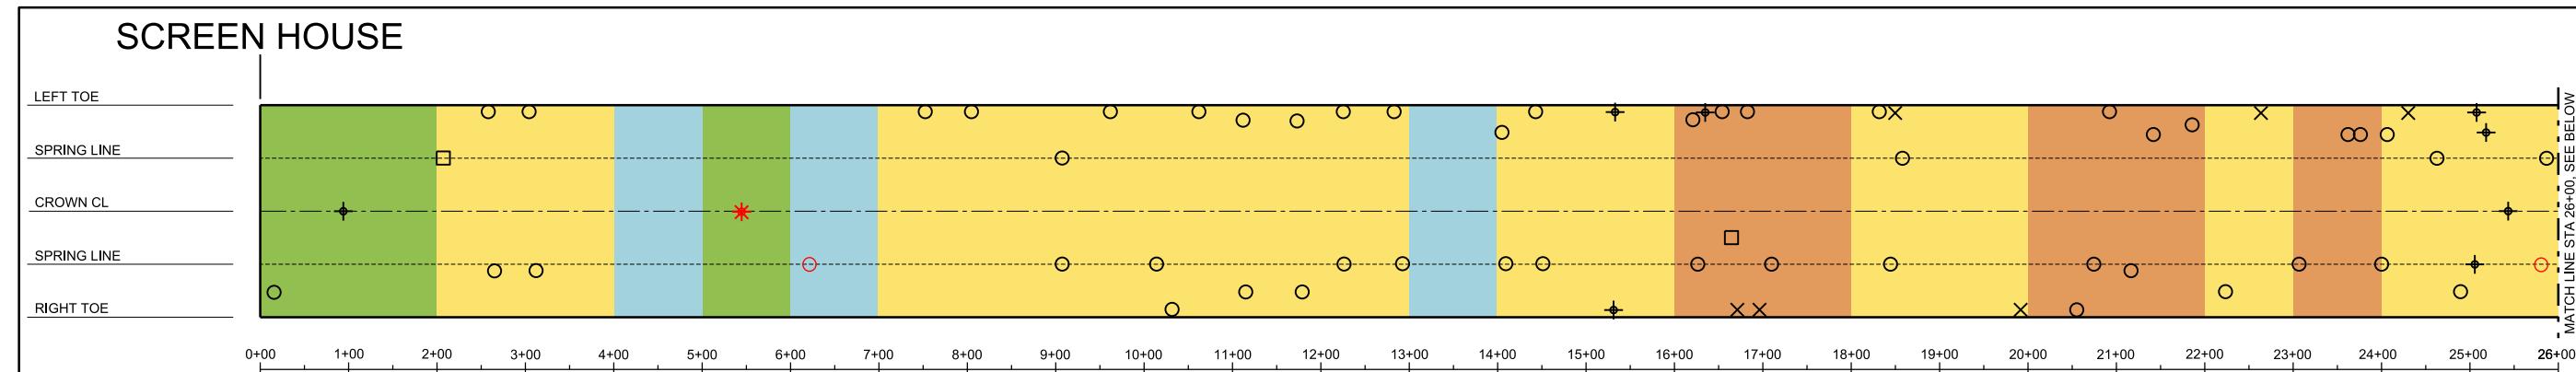
PLAN - STA 0+00 TO STA 26+00

highlighted. A graphical representation of the rehabilitation priority changes is presented in Attachment D. In addition to presenting distribution of rehabilitation priority along the tunnel, the figure in Attachment D presents the location of tunnel defects with a score or weighting of 4, the highest severity observed (no tunnel defects with a score of 5 were observed). New defects identified as part of the March 2024 inspection are presented in RED.
