# **GEOTECHNICAL INVESTIGATION & GEOHAZARD REPORT JONES EDMOOR ESTATE PROPOSED 38-LOT PLAT DEVELOPMENT VIEWCREST ROAD, BELLINGHAM, WA**

Subject: **Geotechnical Investigation & Geohazard Assessment**  
**Proposed 38-Lot Plat - Jones Edgemoor Estate**  
Viewcrest Road, Bellingham, WA

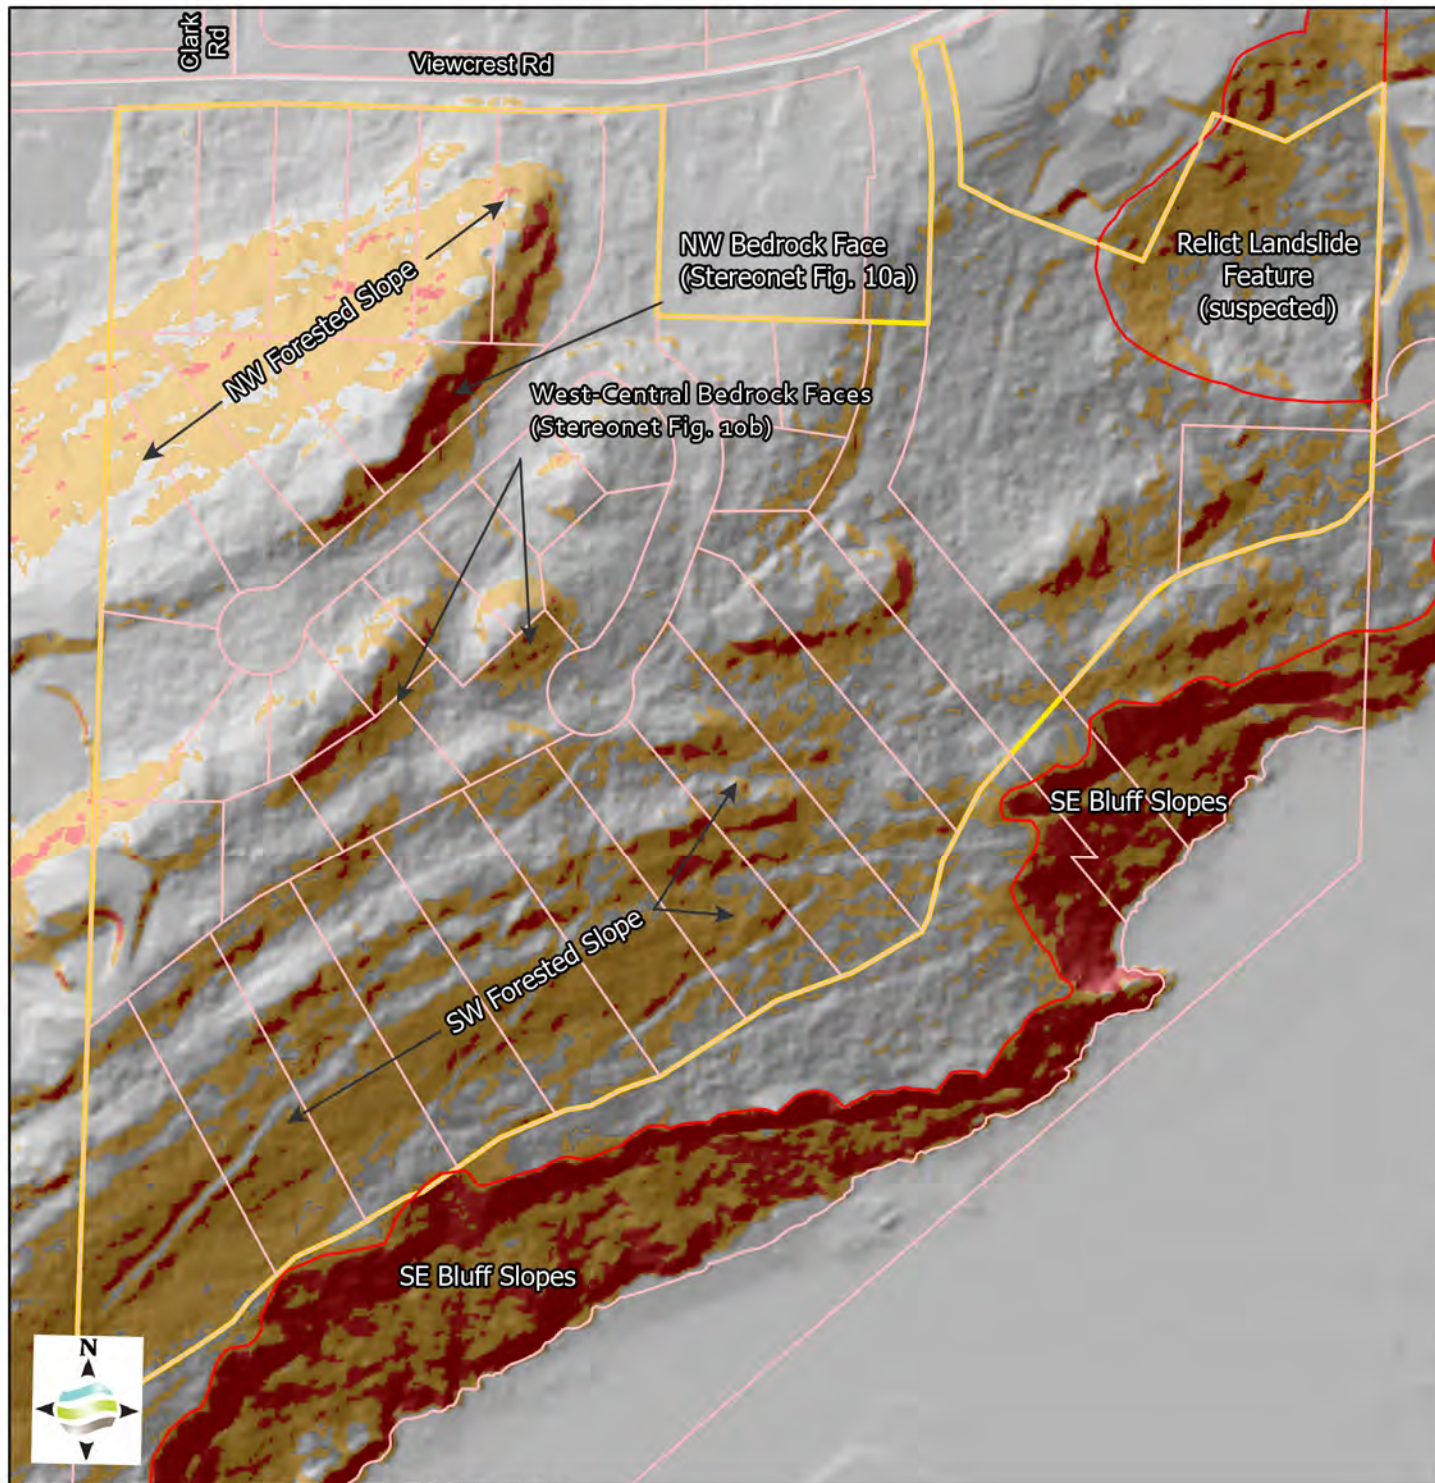
## Figure 9

Upon reviewing slope gradient and LiDAR maps, we identified several features for particular focus during reconnaissance. The features occur *within and bordering the proposed development area*, are indicated on the annotated site map (Figure 9, Appendix III), and include:

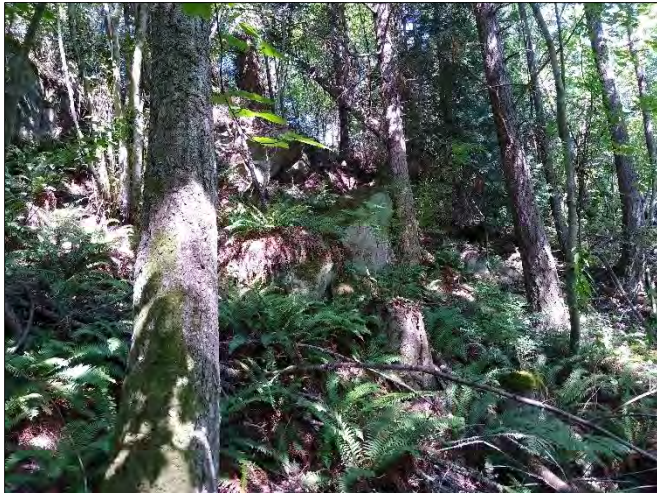
**Photo 9:** West-Central Bedrock Faces; West Outcrop, Northern Slope Area

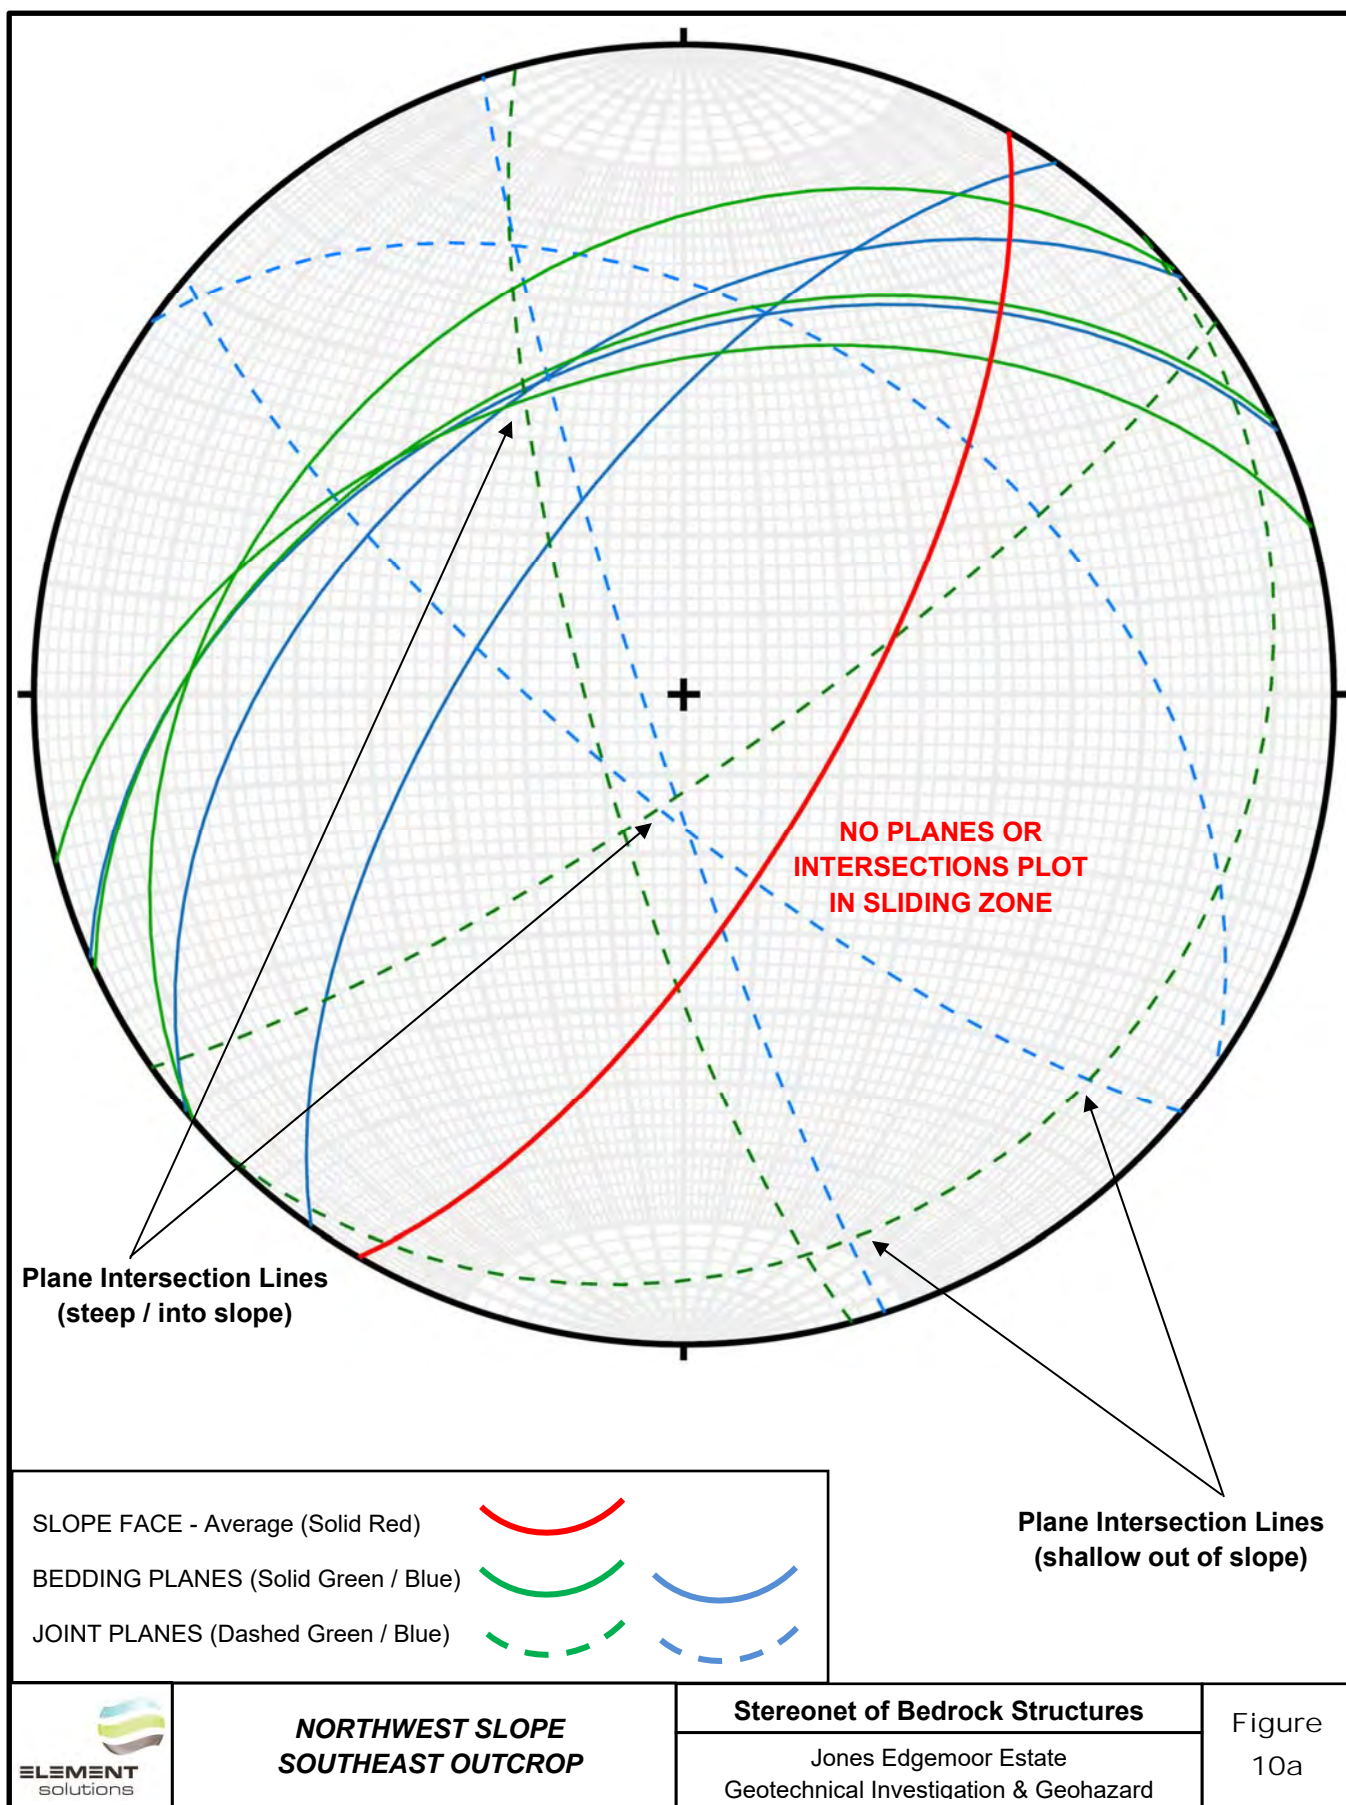
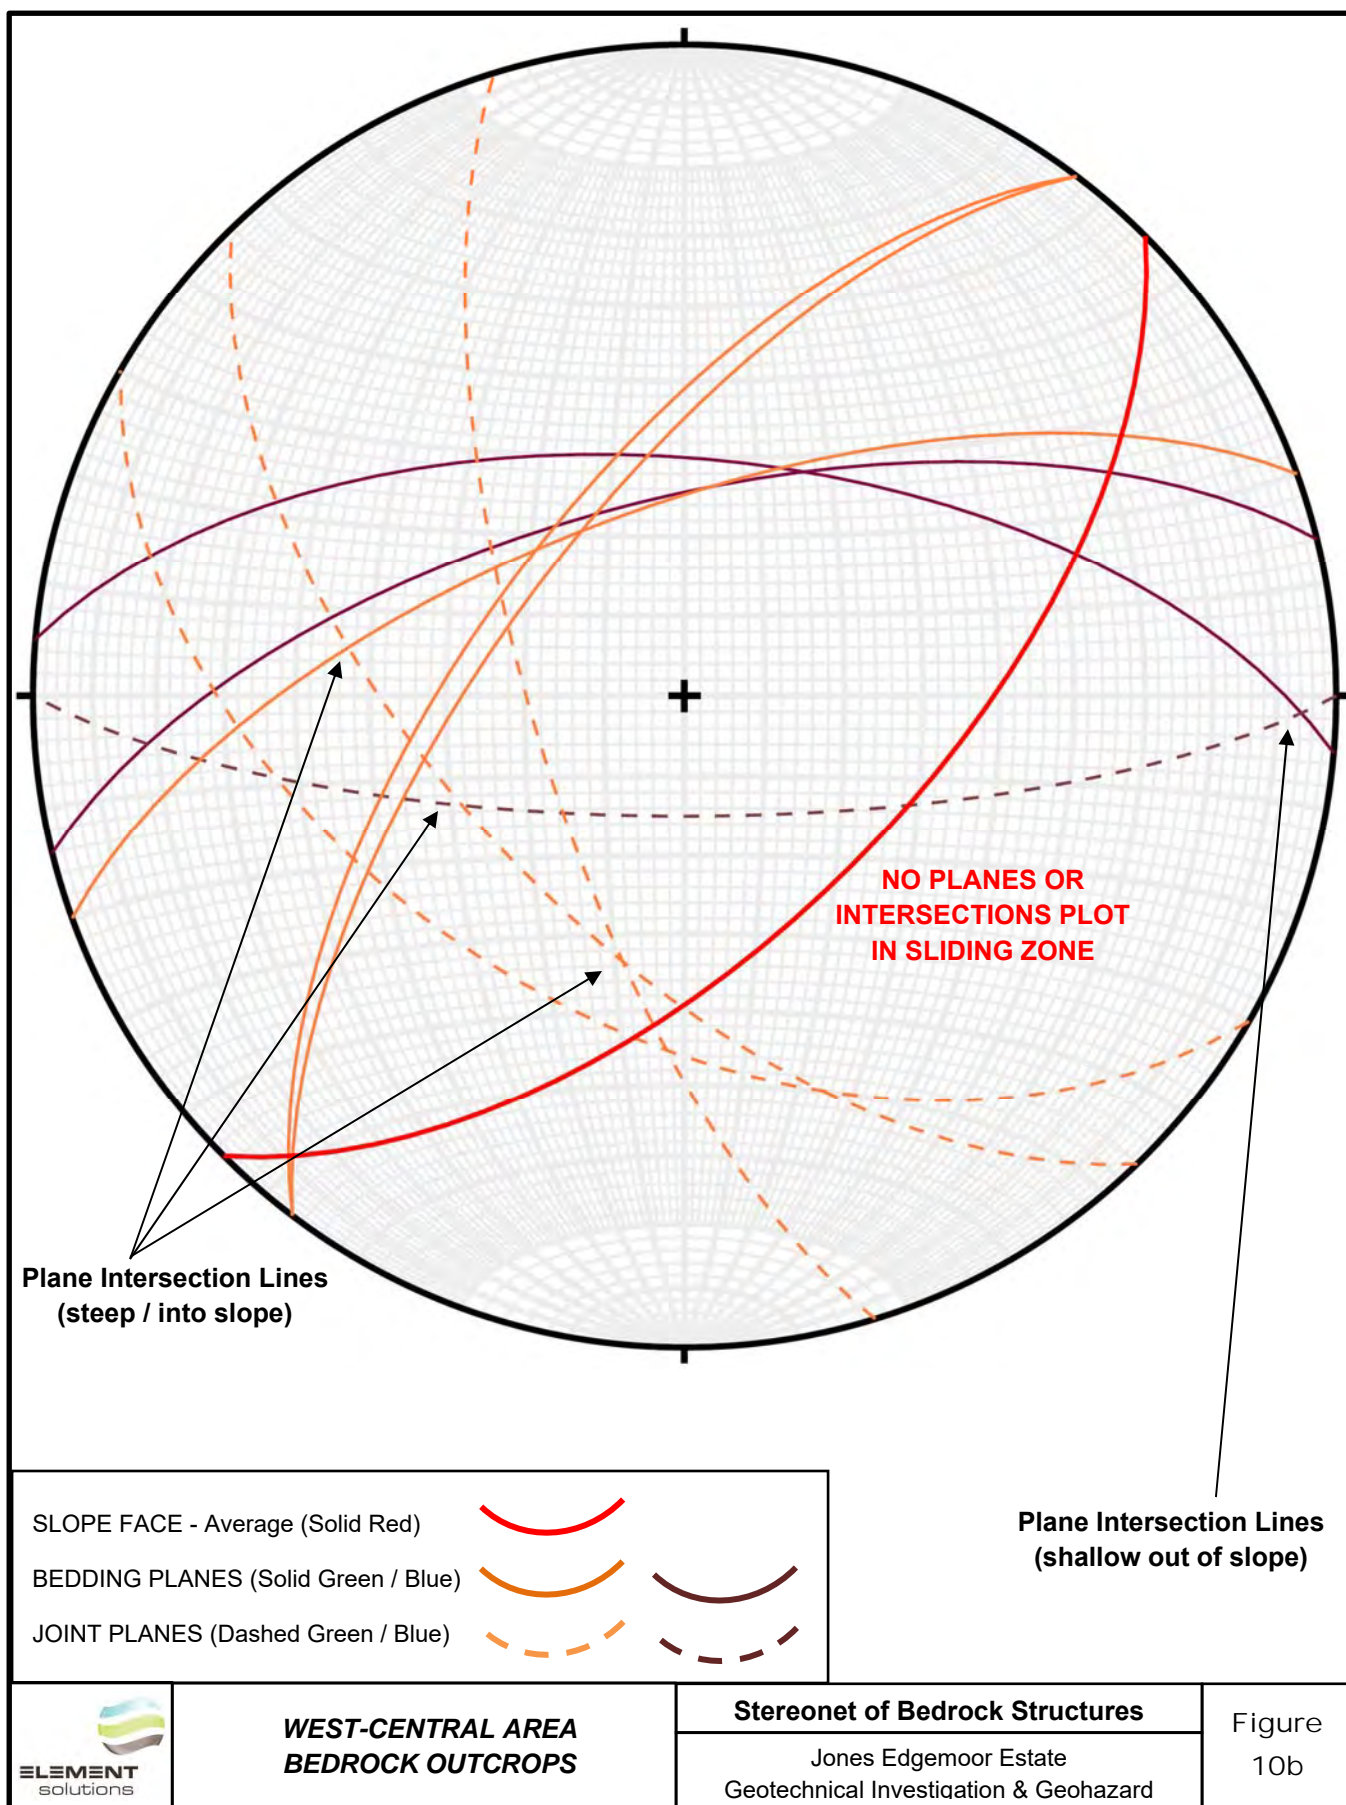
In the outcrops, the ***main joint pattern was observed to be steeply to moderately dipping west or southwest and striking NNW-SSE or NW-SE. The dominant orientation is normal or oblique to the exposure faces, and is close to orthogonal to average bedding.*** At the northwest cliff face (Stereonet Figure 10a), the main joints were near-vertical and one companion joint was measured (same strike, dipping opposite direction to NE). At the central outcrops, the main joint planes were typically steeply to moderately dipping to the SW (Stereonet Figure 10b). Joint structures are shown as dotted planes with bedding as solid lines in the attached Stereonet diagrams.

We examined potential wedge failure modes resulting from joint-to-bedding and joint-to-joint interactions at the site. The ***main intersection of bedding and joints plots in the northwest quadrant of the Stereonets, and plunges moderately to steeply northwest*** (Figures 10a & 10b), thus into the steep outcrops. Other intersections with bedding and shallow joint planes are all at low angles which do not pose a risk of sliding. While this avoids direct wedge failure, we note that the steep intersections could contribute to small-scale rock fall in the opposite direction when paired with other factors including cliff exposure.
