# **GEOTECHNICAL INVESTIGATION & GEOHAZARD REPORT JONES EDMOOR ESTATE PROPOSED 38-LOT PLAT DEVELOPMENT VIEWCREST ROAD, BELLINGHAM, WA**

Subject: **Geotechnical Investigation & Geohazard Assessment**  
**Proposed 38-Lot Plat - Jones Edgemoor Estate**  
Viewcrest Road, Bellingham, WA

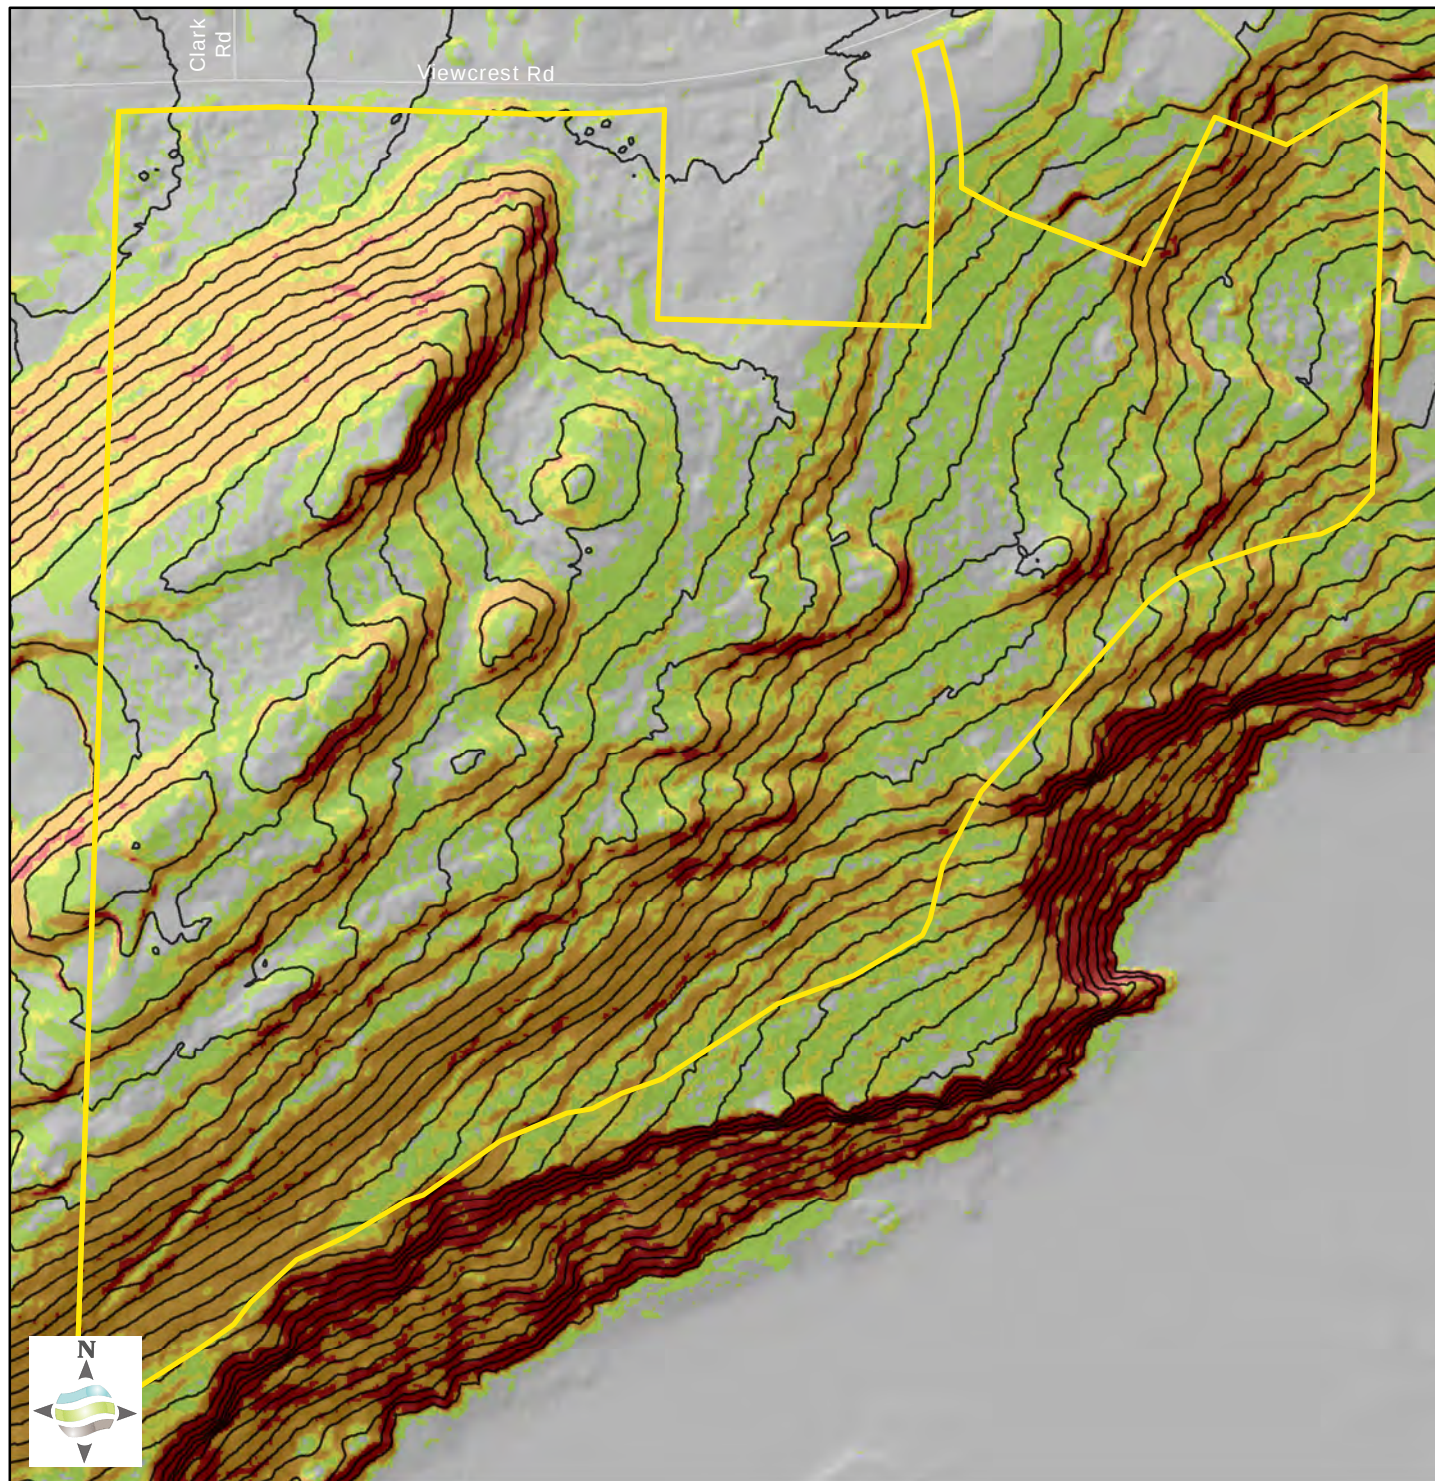
Jones - Edgemoor Estate  
 Percent Slope Map

The results of our detailed GIS-based topographic analysis are shown in Figures 3a and 3b. This detailed approach demonstrates that a majority of the site interior has grades of under 15% or between 15% and 30% (not regulated by critical area code), shown in light green and yellow shading, respectively. Small scattered areas within otherwise gentle topography are shown as exceeding 30% grade; however, the isolated occurrences are likely to reflect small surface variations on the scale of a few feet that are not indicative or relevant to development regulation. We conclude that the site generally does not contain EHAs that are not associated with and more appropriately classified as LHA areas (either *potential* or *identified*).

Areas over 40% grade are shown on Figures 3a and 3b as orange, and grades over 80% in red. ***The site contains various slope features within the plat development area that are correctly classified as potential LHAs.*** The steepest grades within the project area occur on the southeast faces of hillsides, and generally correspond to areas of bedrock exposure. Some isolated and small but steep features appear to be related to historical primitive road cuts. In Section 4, we present the findings of visual field review of steep slopes and steep rock exposures; and we provide interpretations of site stability based on a combination of reconnaissance findings and field data.

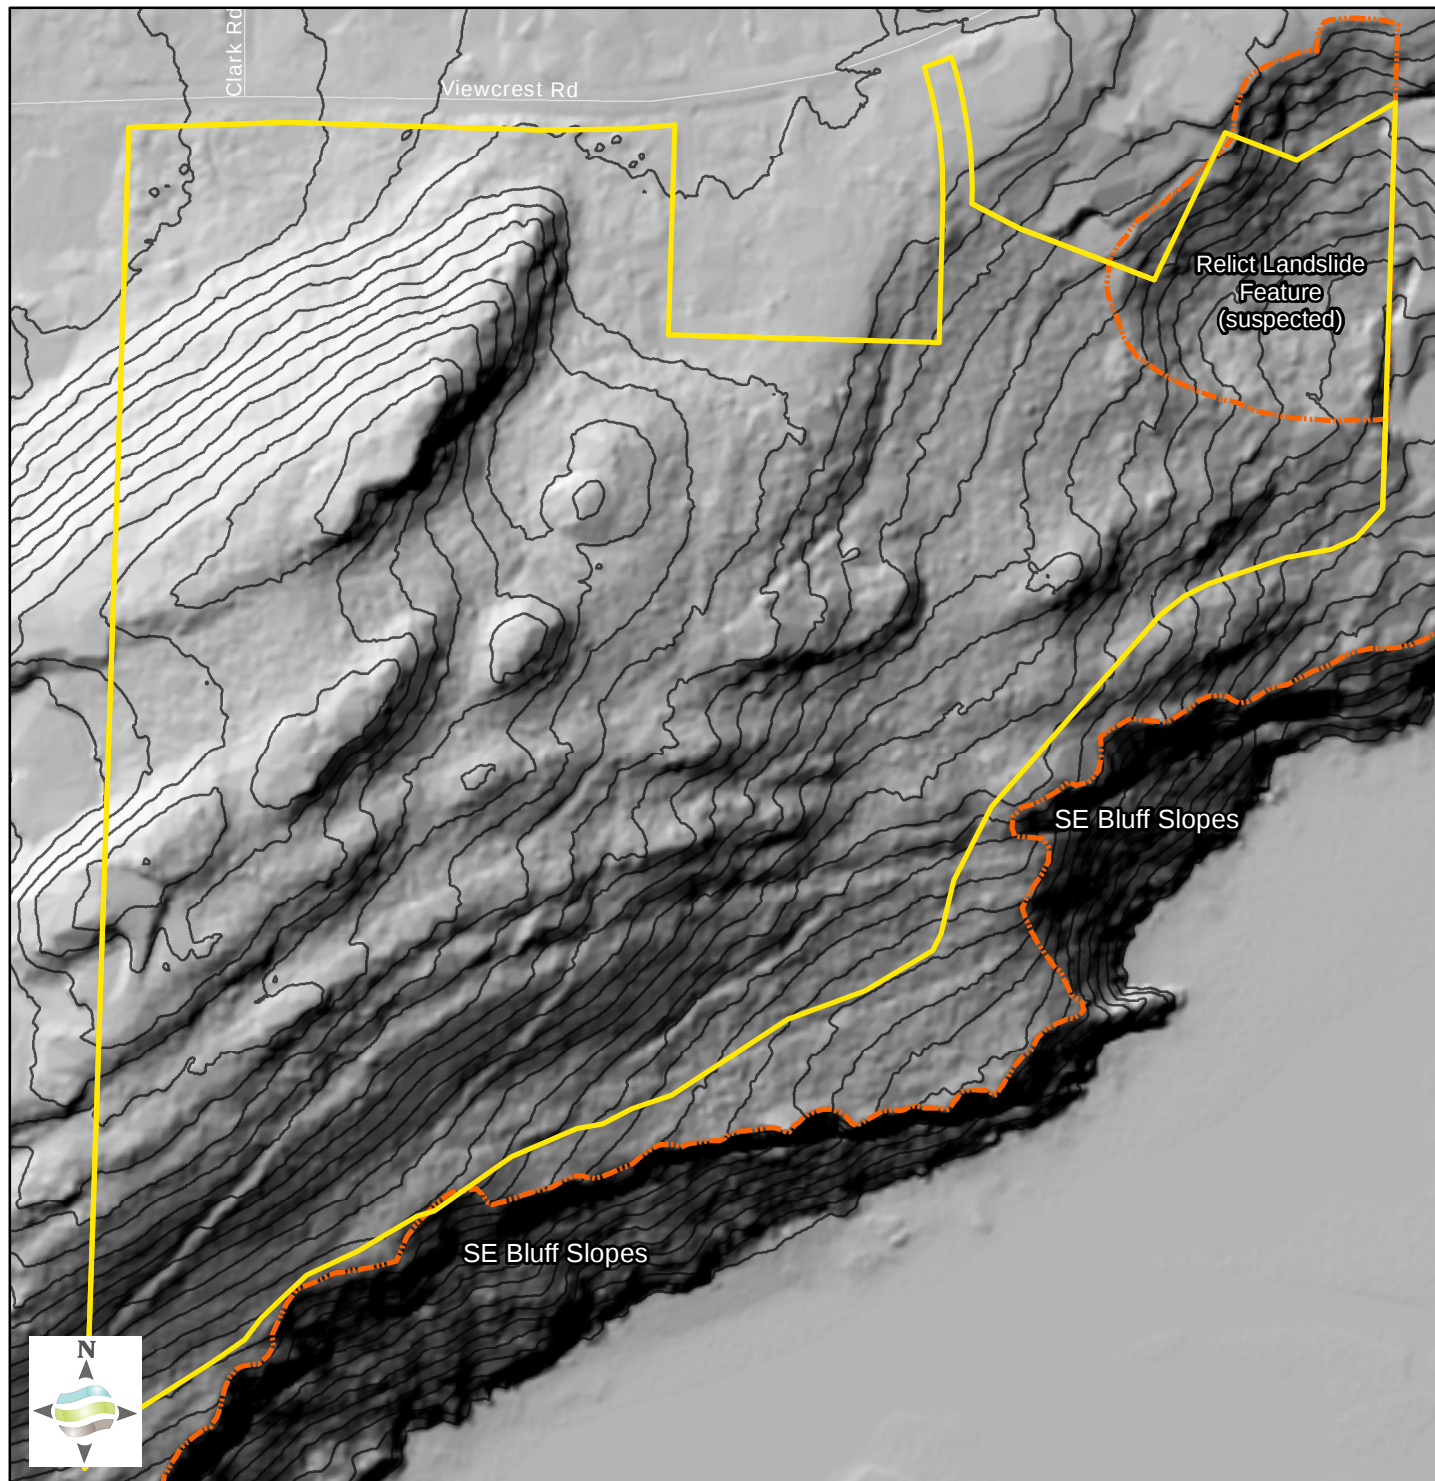
Jones - Edgemoor Estate  
 LiDAR Overview w/ Feature Annotation

Two features of special significance were evident in initial image review. These include: 1) the main southeast shoreline bluff slope, and 2) an area of bowl-shaped topography at the northeast corner of the property. Figure 4 presents site-wide LiDAR imagery including delineation and annotation of the areas noted below.

- 2) The northeast corner of the project area, to the west and northwest of the Sea Pines Road terminus, exhibits geomorphic features indicative of a historical landslide feature (Figures 4 & 5). However, the actual history of the feature is not known. Signs of potential historical mass wasting activity include a concave and convergent topography, arcuate slope crest, and steeper upper scarp with lower-angle interior slope. The presence of wetlands within the interior basin is also consistent with this interpretation. With exception of its northernmost areas downhill from other off-site residences (lots not in project area), the crest is somewhat diffuse below and adjacent to the project development area, indicating some time since formation of the landform. We infer that this is likely a historical mass wasting feature with local crest reactivation or episodic retreat occurrences at its north end. The likely cause(s) of the feature at its location are not clear. It is plausible that the area originally held thicker soil deposits than elsewhere, and may have been influenced by concentrated runoff, or subsurface groundwater concentration (given the wetland presence). It is also possible that the feature originally dates back to the time of late-stage glacial recession, when surface conditions were more volatile. We have delineated the approximate boundaries of the feature (Figures 4 & 5), and the preliminary plat layout has been adjusted to allow for avoidance of its extent plus an assumed standard 50-foot landslide hazard buffer. Based on the presumed avoidance, no further review is necessary at this time. The feature can be reviewed and investigated in detail in the future if necessary to reexamine the standard buffer assumed and applied for the plat application.

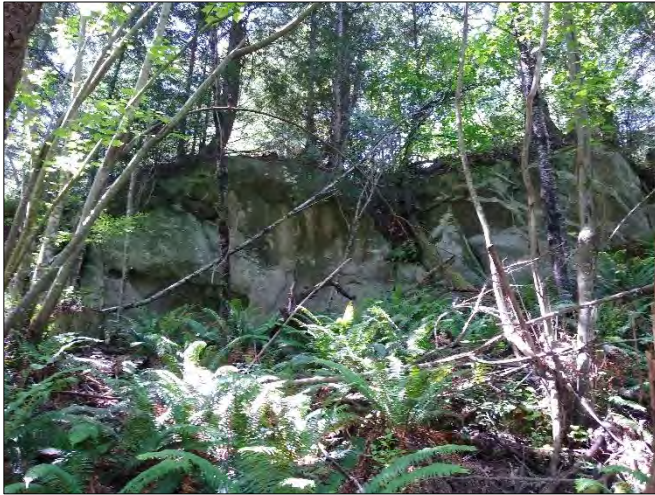
**Photo 7:** West-Central Bedrock Faces; West Outcrop

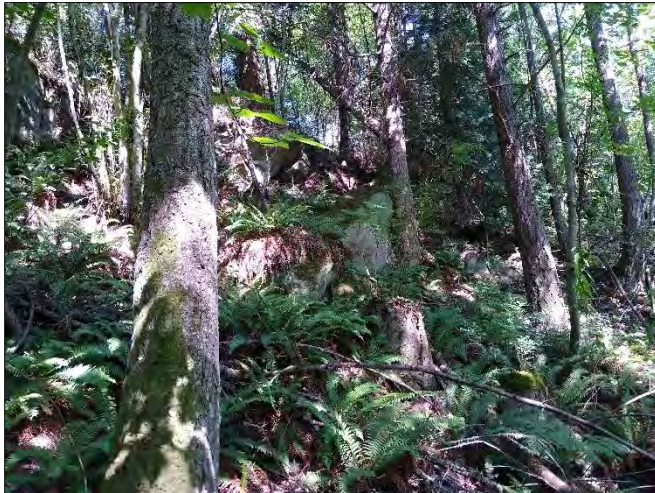
**Photo 9:** West-Central Bedrock Faces; West Outcrop, Northern Slope Area

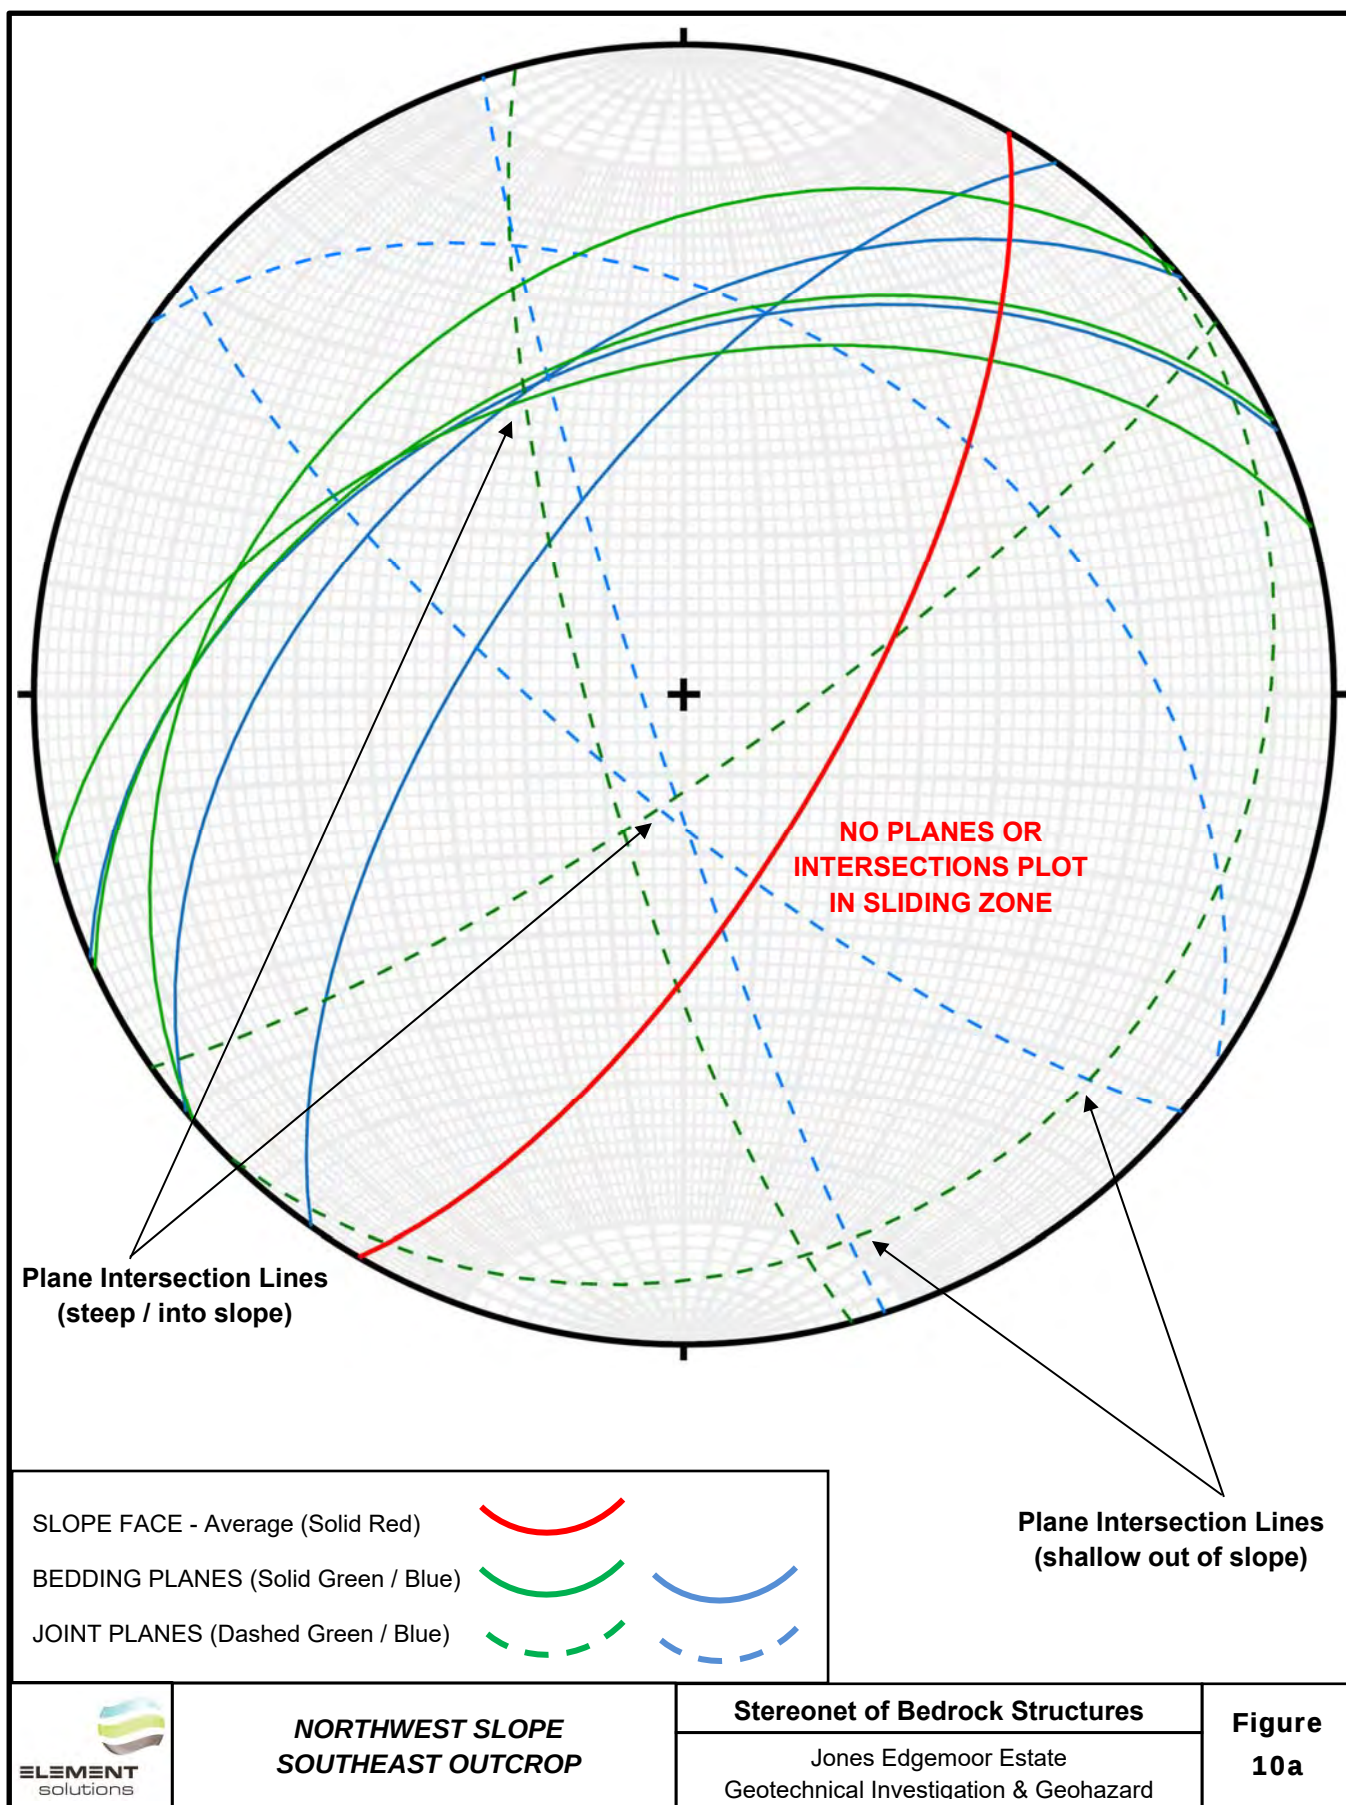
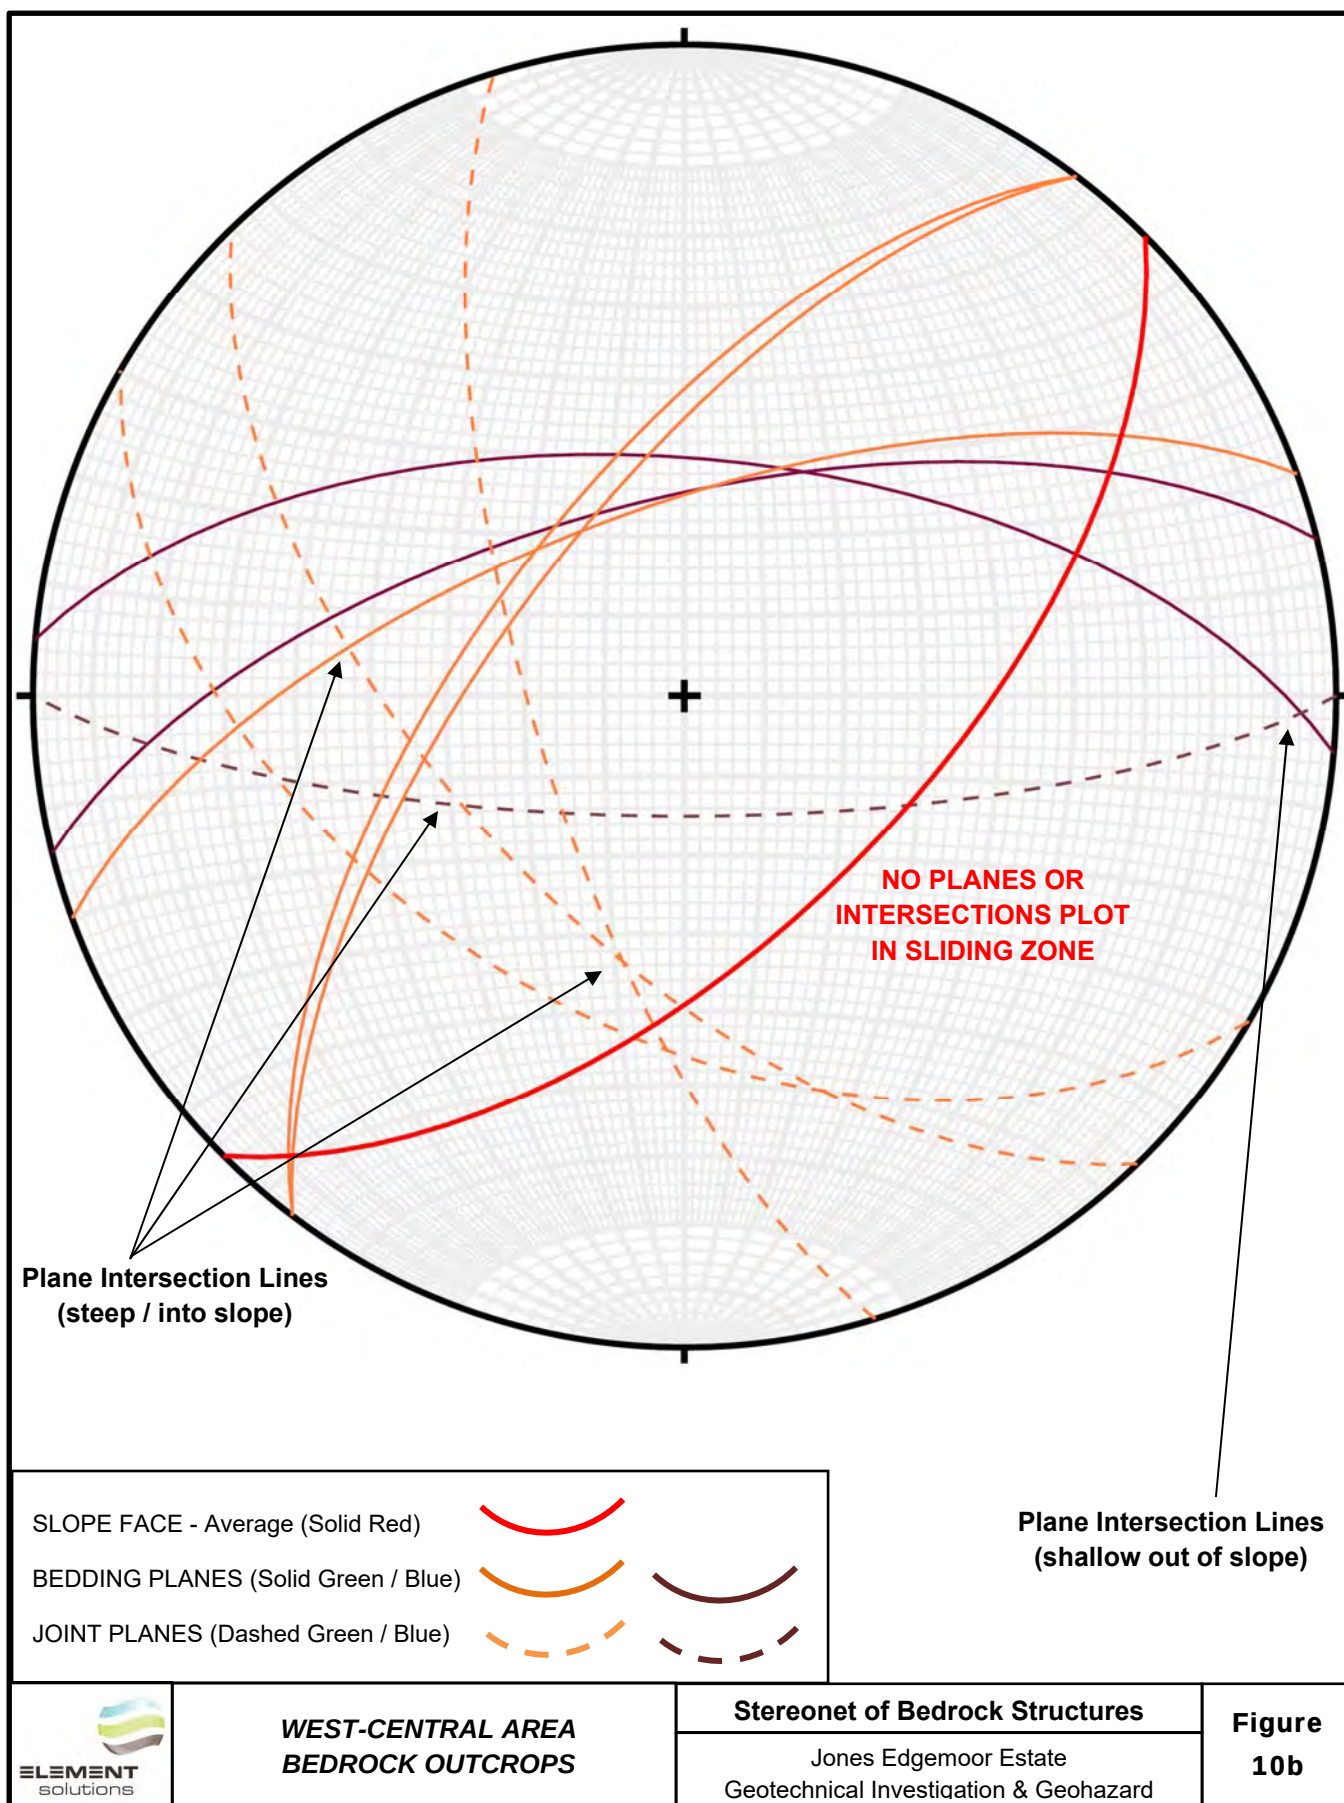
Strength of a rock mass is controlled and limited by internal structures that are planes of inherent weakness (bedding/foliation) or fractures (joints, veins, faults), rather than rock strength itself. Inherent planes are penetrative, while fractures tend to be discontinuous but regular in occurrence. Orientation of structures with respect to the slope face influences the potential for various styles of rock slope failures. Major failure types include planar sliding (along a continuous bedding or fracture plane), wedge failure (intersection of two planes forms sliding angle with respect to outcrop), and raveling or toppling (intermittent mass wasting parallel to face, style depends on rock type). Each type of failure is discussed below in terms of its interpreted potential at outcrops on site. Interpretations are adopted from Wyllie & Mah (Rock Slope Engineering, 4<sup>th</sup> Edition, 2005), based on prior work of Hoek and Bray (1981) for rock slope stability. Stereonet plots (Figures 10a & 10b) were used for graphical analysis and interpretation of failure modes.

We examined potential wedge failure modes resulting from joint-to-bedding and joint-to-joint interactions at the site. The ***main intersection of bedding and joints plots in the northwest quadrant of the Stereonets, and plunges moderately to steeply northwest*** (Figures 10a & 10b), thus into the steep outcrops. Other intersections with bedding and shallow joint planes are all at low angles which do not pose a risk of sliding. While this avoids direct wedge failure, we note that the steep intersections could contribute to small-scale rock fall in the opposite direction when paired with other factors including cliff exposure.
