**GEOTECHNICAL INVESTIGATION  
& GEOHAZARD REPORT  
JONES EDMOOR ESTATE  
PROPOSED 38-LOT PLAT DEVELOPMENT  
VIEWCREST ROAD, BELLINGHAM, WA**

Subject: **Geotechnical Investigation & Geohazard Assessment**  
**Proposed 38-Lot Plat - Jones Edgemoor Estate**  
Viewcrest Road, Bellingham, WA

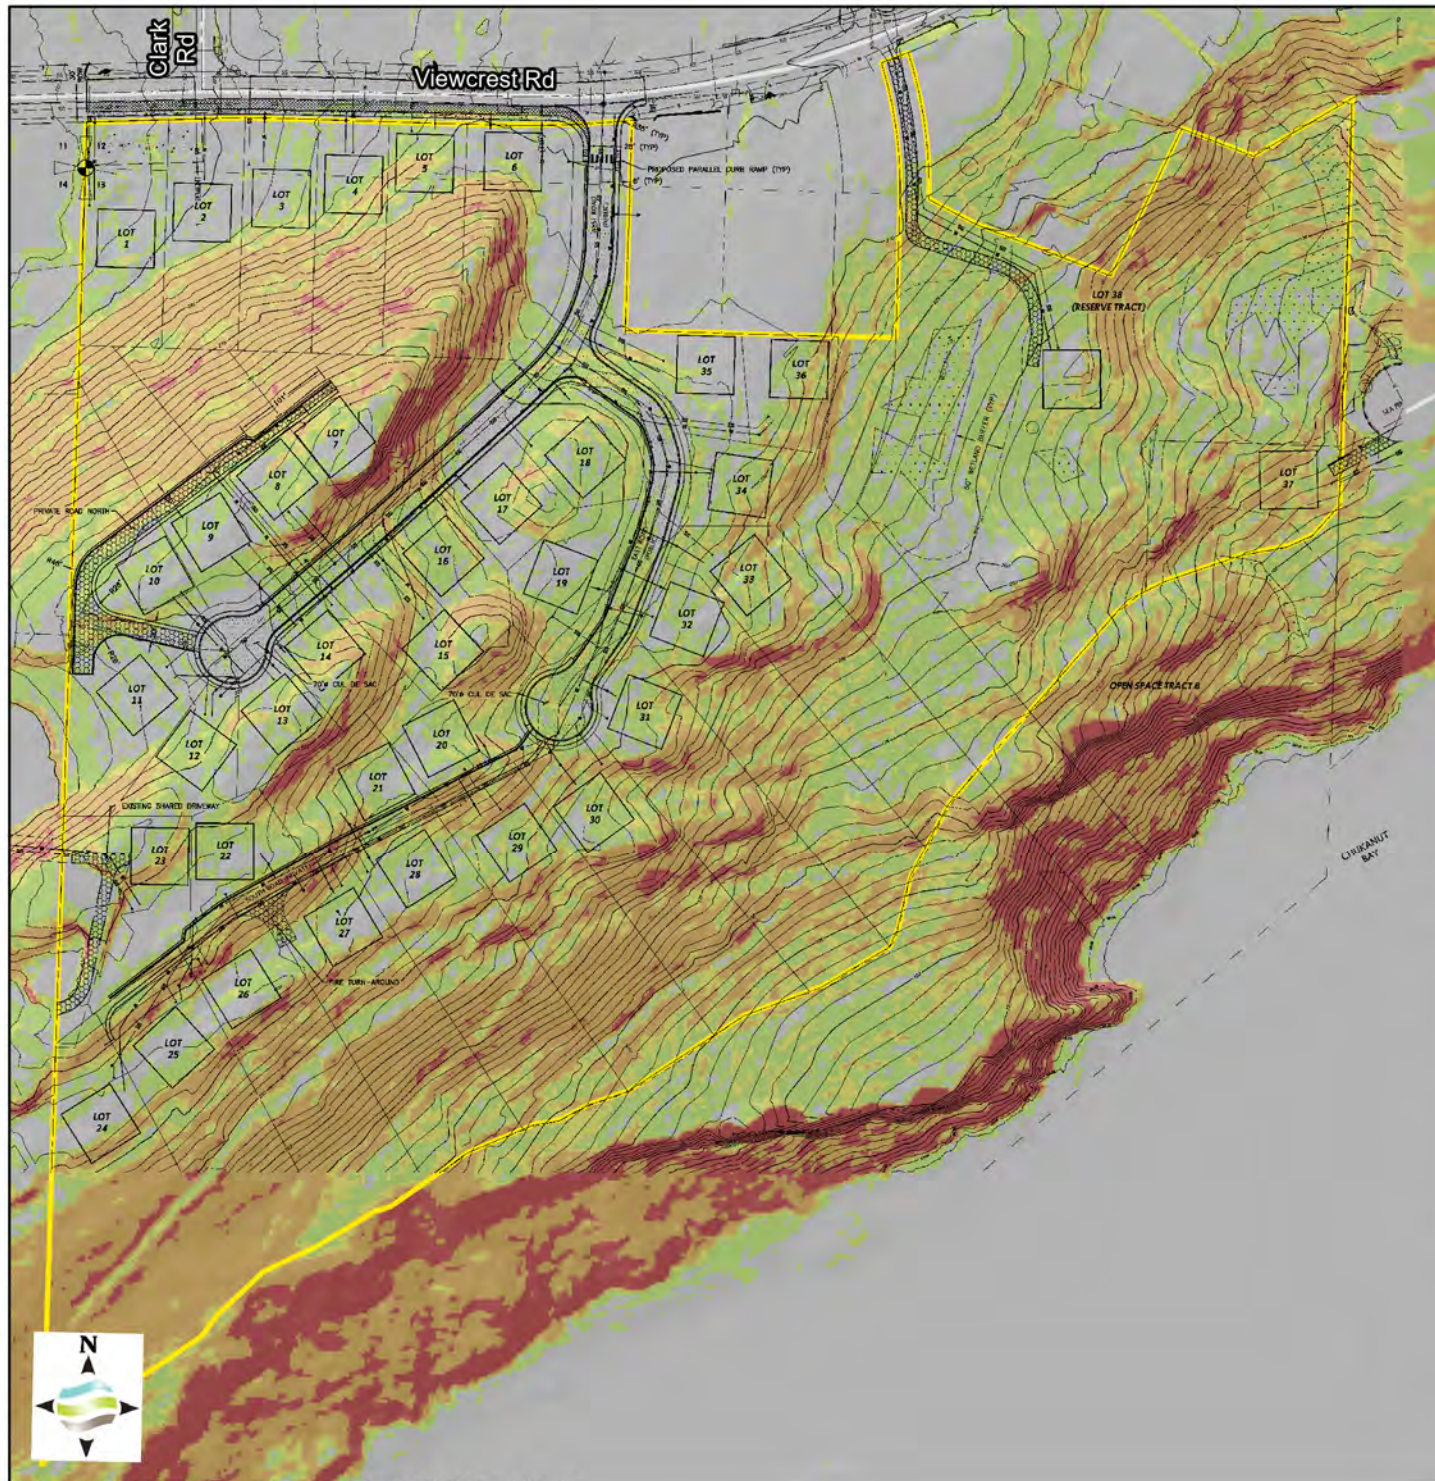
## Figure 3A

The results of our detailed GIS-based topographic analysis are shown in Figures 3a and 3b. This detailed approach demonstrates that a majority of the site interior has grades of under 15% or between 15% and 30% (not regulated by critical area code), shown in light green and yellow shading, respectively. Small scattered areas within otherwise gentle topography are shown as exceeding 30% grade; however, the isolated occurrences are likely to reflect small surface variations on the scale of a few feet that are not indicative or relevant to development regulation. We conclude that the site generally does not contain EHAs that are not associated with and more appropriately classified as LHA areas (either *potential* or *identified*).

Areas over 40% grade are shown on Figures 3a and 3b as orange, and grades over 80% in red. ***The site contains various slope features within the plat development area that are correctly classified as potential LHAs.*** The steepest grades within the project area occur on the southeast faces of hillsides, and generally correspond to areas of bedrock exposure. Some isolated and small but steep features appear to be related to historical primitive road cuts. In Section 4, we present the findings of visual field review of steep slopes and steep rock exposures; and we provide interpretations of site stability based on a combination of reconnaissance findings and field data.

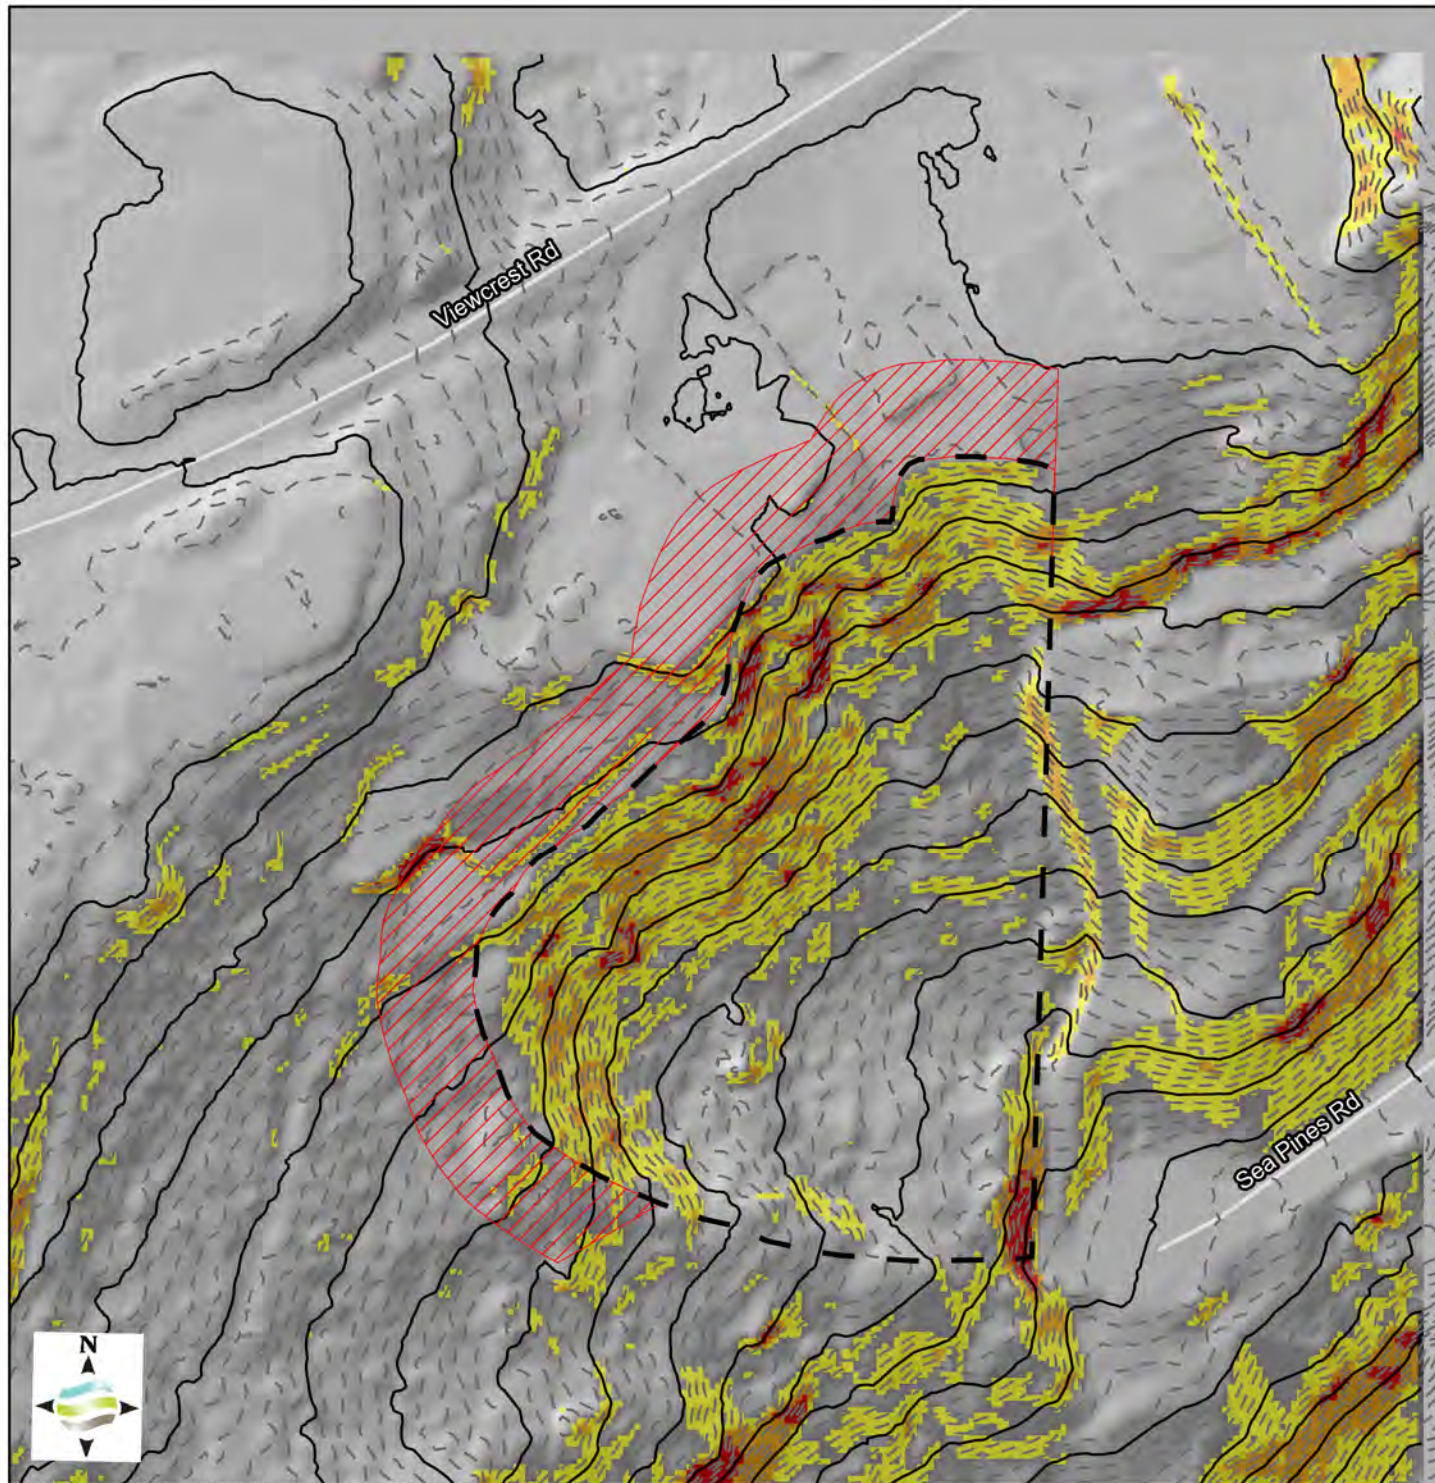
## Figure 4

Two features of special significance were evident in initial image review. These include: 1) the main southeast shoreline bluff slope, and 2) an area of bowl-shaped topography at the northeast corner of the property. Figure 4 presents site-wide LiDAR imagery including delineation and annotation of the areas noted below.

- 2) The northeast corner of the project area, to the west and northwest of the Sea Pines Road terminus, exhibits geomorphic features indicative of a historical landslide feature (Figures 4 & 5). However, the actual history of the feature is not known. Signs of potential historical mass wasting activity include a concave and convergent topography, arcuate slope crest, and steeper upper scarp with lower-angle interior slope. The presence of wetlands within the interior basin is also consistent with this interpretation. With exception of its northernmost areas downhill from other off-site residences (lots not in project area), the crest is somewhat diffuse below and adjacent to the project development area, indicating some time since formation of the landform. We infer that this is likely a historical mass wasting feature with local crest reactivation or episodic retreat occurrences at its north end. The likely cause(s) of the feature at its location are not clear. It is plausible that the area originally held thicker soil deposits than elsewhere, and may have been influenced by concentrated runoff, or subsurface groundwater concentration (given the wetland presence). It is also possible that the feature originally dates back to the time of late-stage glacial recession, when surface conditions were more volatile. We have delineated the approximate boundaries of the feature (Figures 4 & 5), and the preliminary plat layout has been adjusted to allow for avoidance of its extent plus an assumed standard 50-foot landslide hazard buffer. Based on the presumed avoidance, no further review is necessary at this time. The feature can be reviewed and investigated in detail in the future if necessary to reexamine the standard buffer assumed and applied for the plat application.

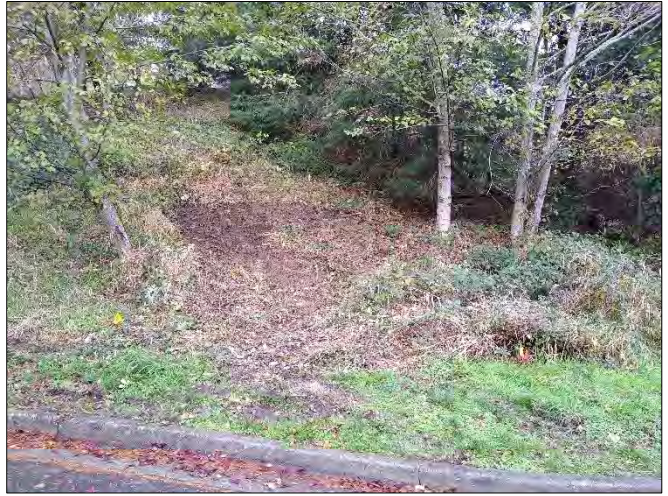
**Photo 2: TP1 Location**

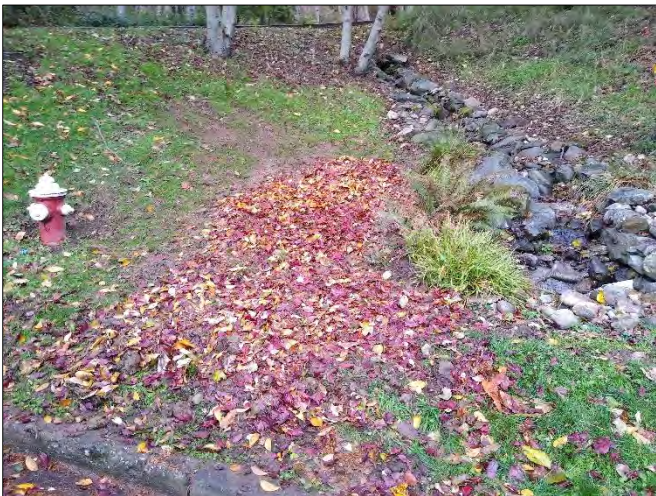
**Photo 5: TP2 Location & Site Restoration**

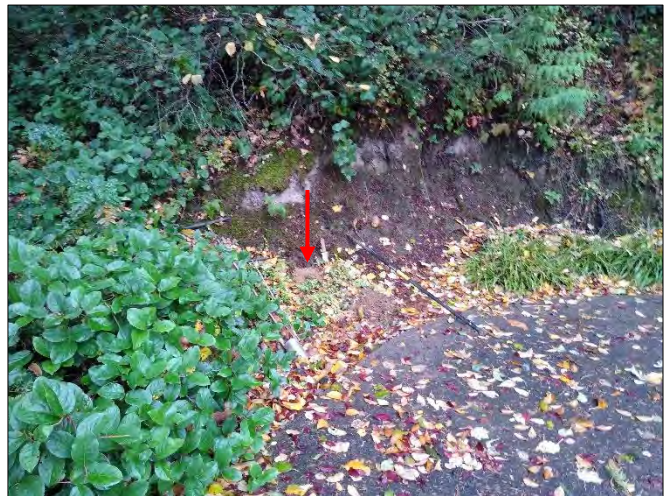
**Photo 6: HA-1 Location**

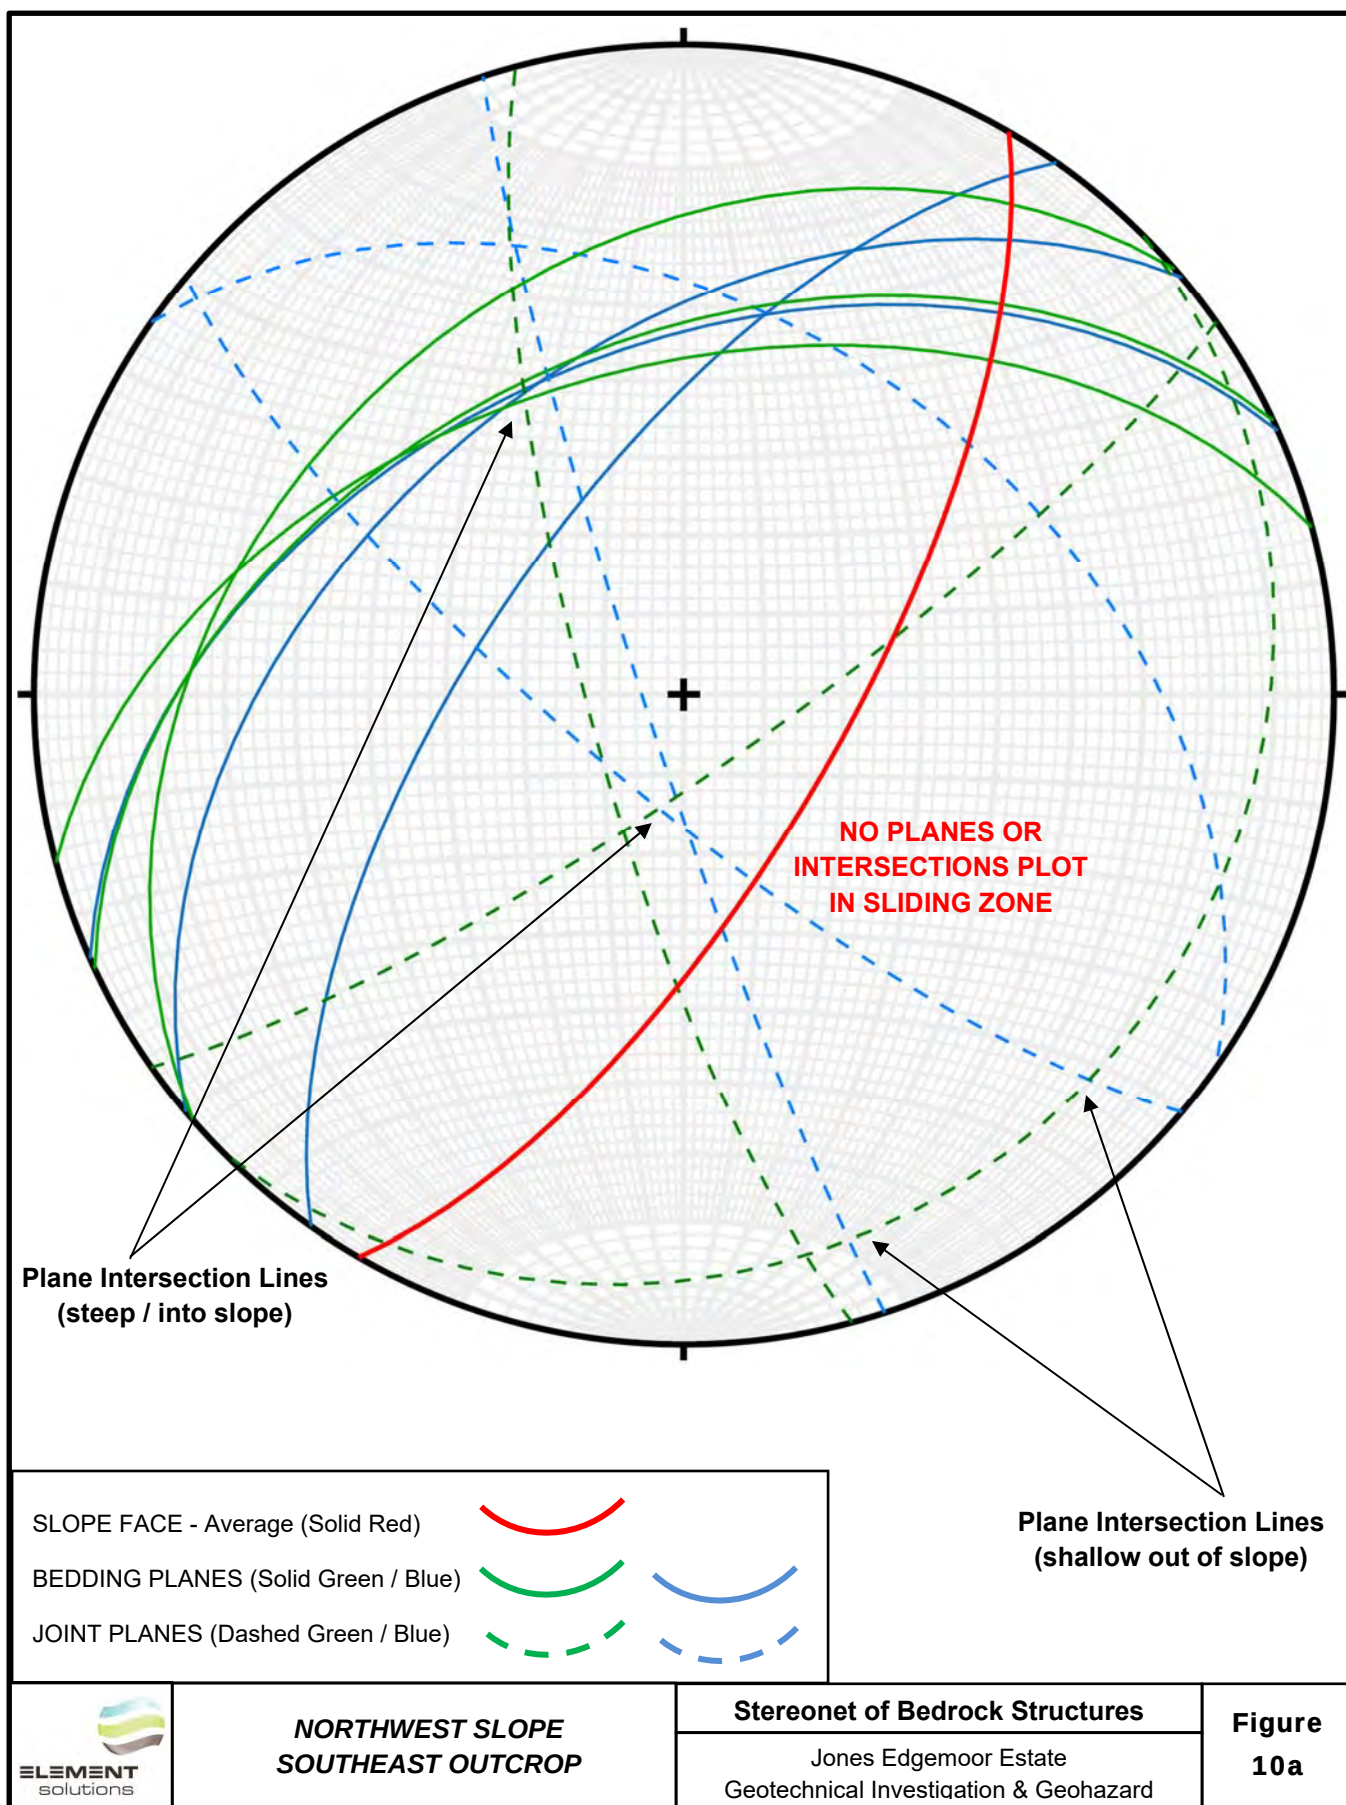
Generally speaking, the major bedding orientation (dipping northwest, into hillsides) is favorable for site slope stability. We examined this relationship and variations on the outcrop scale. Bedding on the large northwest cliff face ranged in strike from 220 to 255 degrees (360 Azimuth). Dip of bedding at the northwest outcrop was between 40 and 60 degrees (Figure 10a). Bedding on the smaller west-central outcrops was either broadly similar (west location) or progressively east-west striking (east location). Both outcrops exhibited bedding that was relatively steeper than at the northwest cliff; measured dips ranged from 55 to 65 degrees (Figure 10b). Converse to the bedding, outcrop faces were oriented NNE-SSW or NE-SW and moderately steep to steep overall facing to the southeast. ***At all locations, bedding is oriented nearly opposite to the exposed face.***

In the outcrops, the ***main joint pattern was observed to be steeply to moderately dipping west or southwest and striking NNW-SSE or NW-SE. The dominant orientation is normal or oblique to the exposure faces, and is close to orthogonal to average bedding.*** At the northwest cliff face (Stereonet Figure 10a), the main joints were near-vertical and one companion joint was measured (same strike, dipping opposite direction to NE). At the central outcrops, the main joint planes were typically steeply to moderately dipping to the SW (Stereonet Figure 10b). Joint structures are shown as dotted planes with bedding as solid lines in the attached Stereonet diagrams.

We examined potential wedge failure modes resulting from joint-to-bedding and joint-to-joint interactions at the site. The ***main intersection of bedding and joints plots in the northwest quadrant of the Stereonets, and plunges moderately to steeply northwest*** (Figures 10a & 10b), thus into the steep outcrops. Other intersections with bedding and shallow joint planes are all at low angles which do not pose a risk of sliding. While this avoids direct wedge failure, we note that the steep intersections could contribute to small-scale rock fall in the opposite direction when paired with other factors including cliff exposure.
