Preliminary Stormwater Management Report

THE WOODS AT VIEWCREST

**GEOTECHNICAL INVESTIGATION
& GEOHAZARD REPORT
JONES EDGEMOOR ESTATE
PROPOSED 38-LOT PLAT DEVELOPMENT
VIEWCREST ROAD, BELLINGHAM, WA**

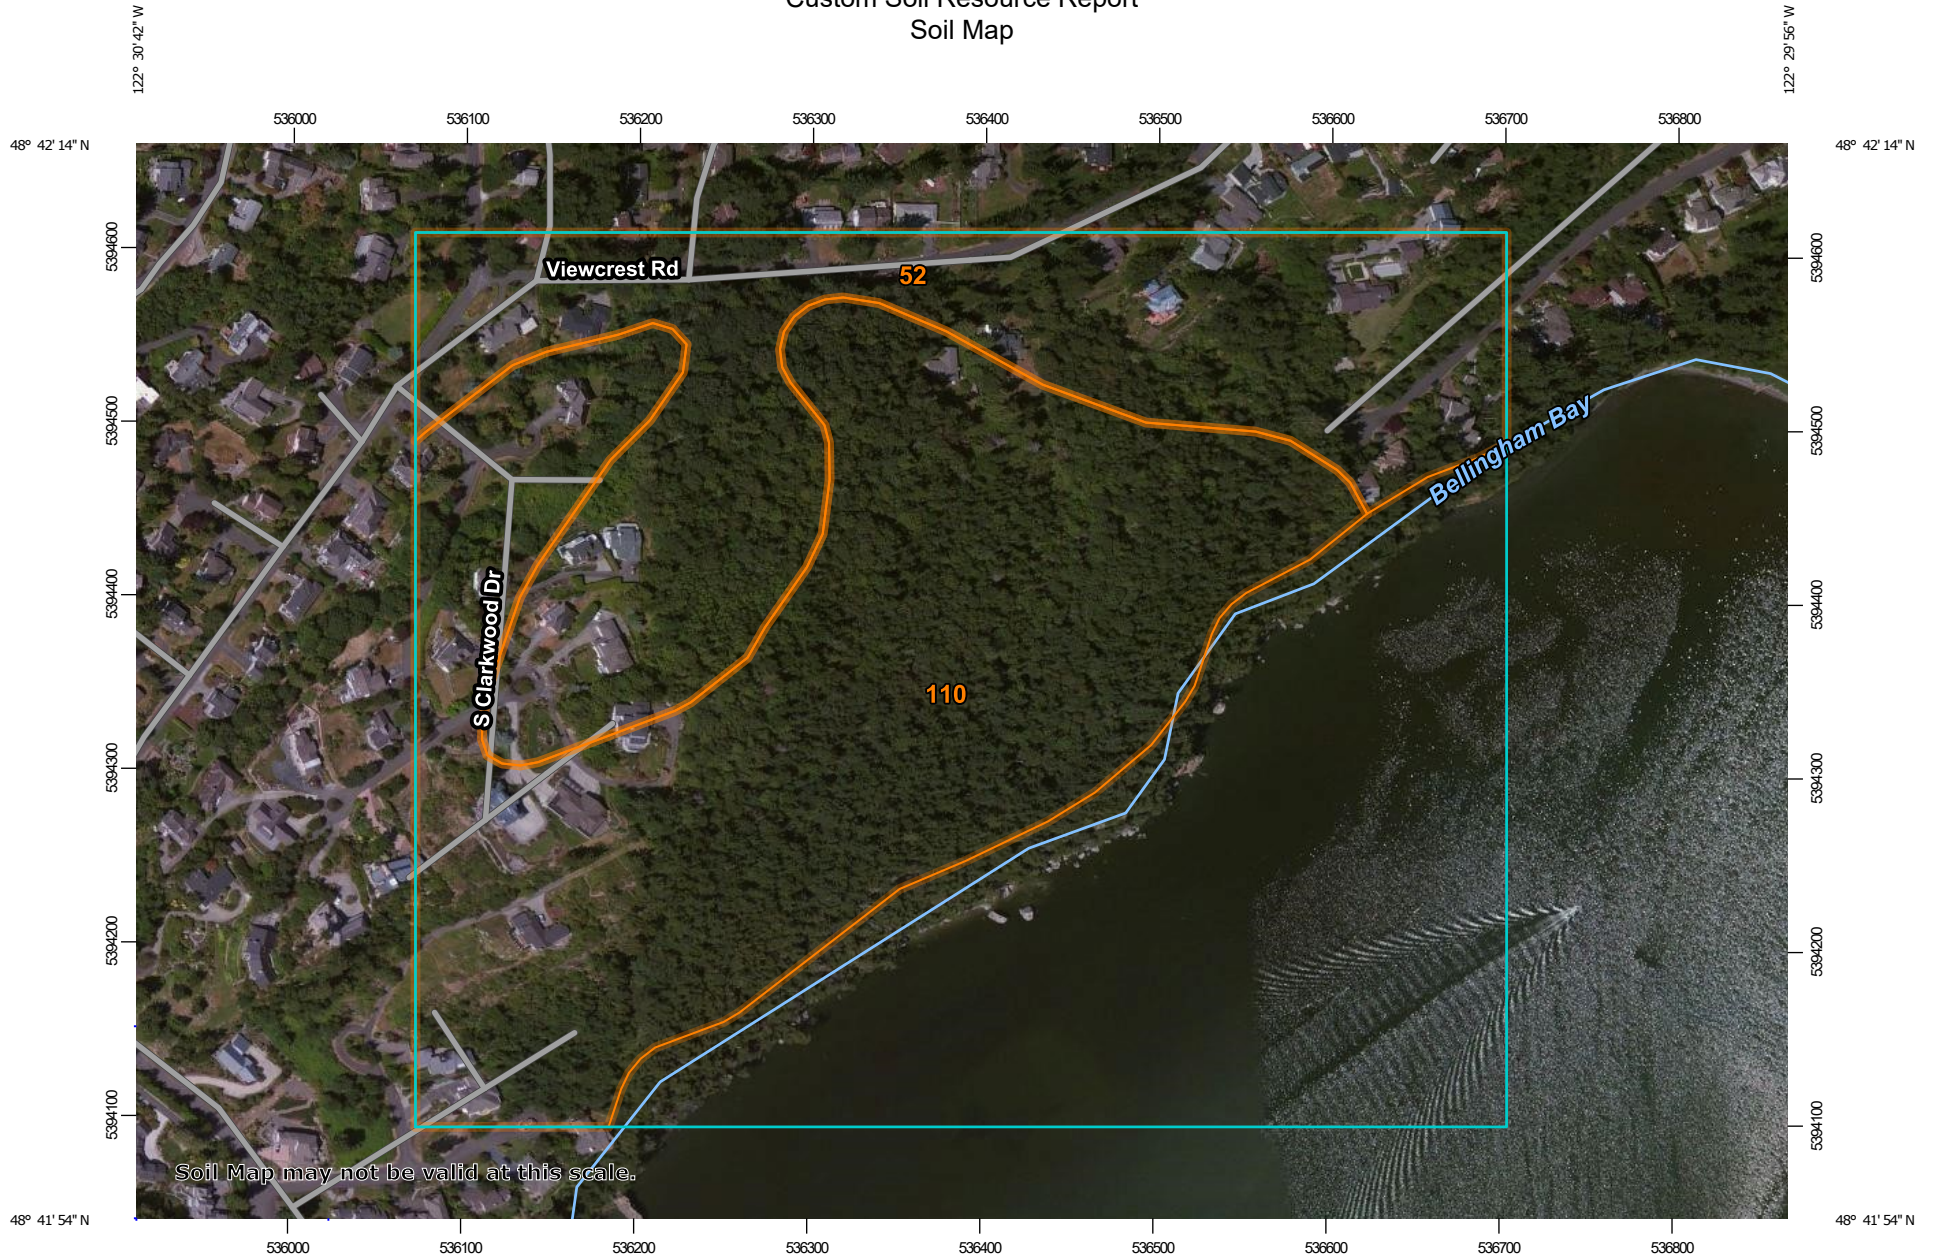
Custom Soil Resource Report Soil Map

Map Scale: 1:4,360 if printed on A landscape (11" x 8.5") sheet.

In the vicinity of the proposed site improvements soils consist of mainly of Everett-Urban loam (unit 52) with a hydrologic soil group rating B per the NRCS Web Soil Survey. Small areas of the project site are composed of Nati loam (Unit 110) with a hydrologic soil group rating C per NRCS Web Soil Survey. The complete NRCS soil survey can be found in Appendix 8.2

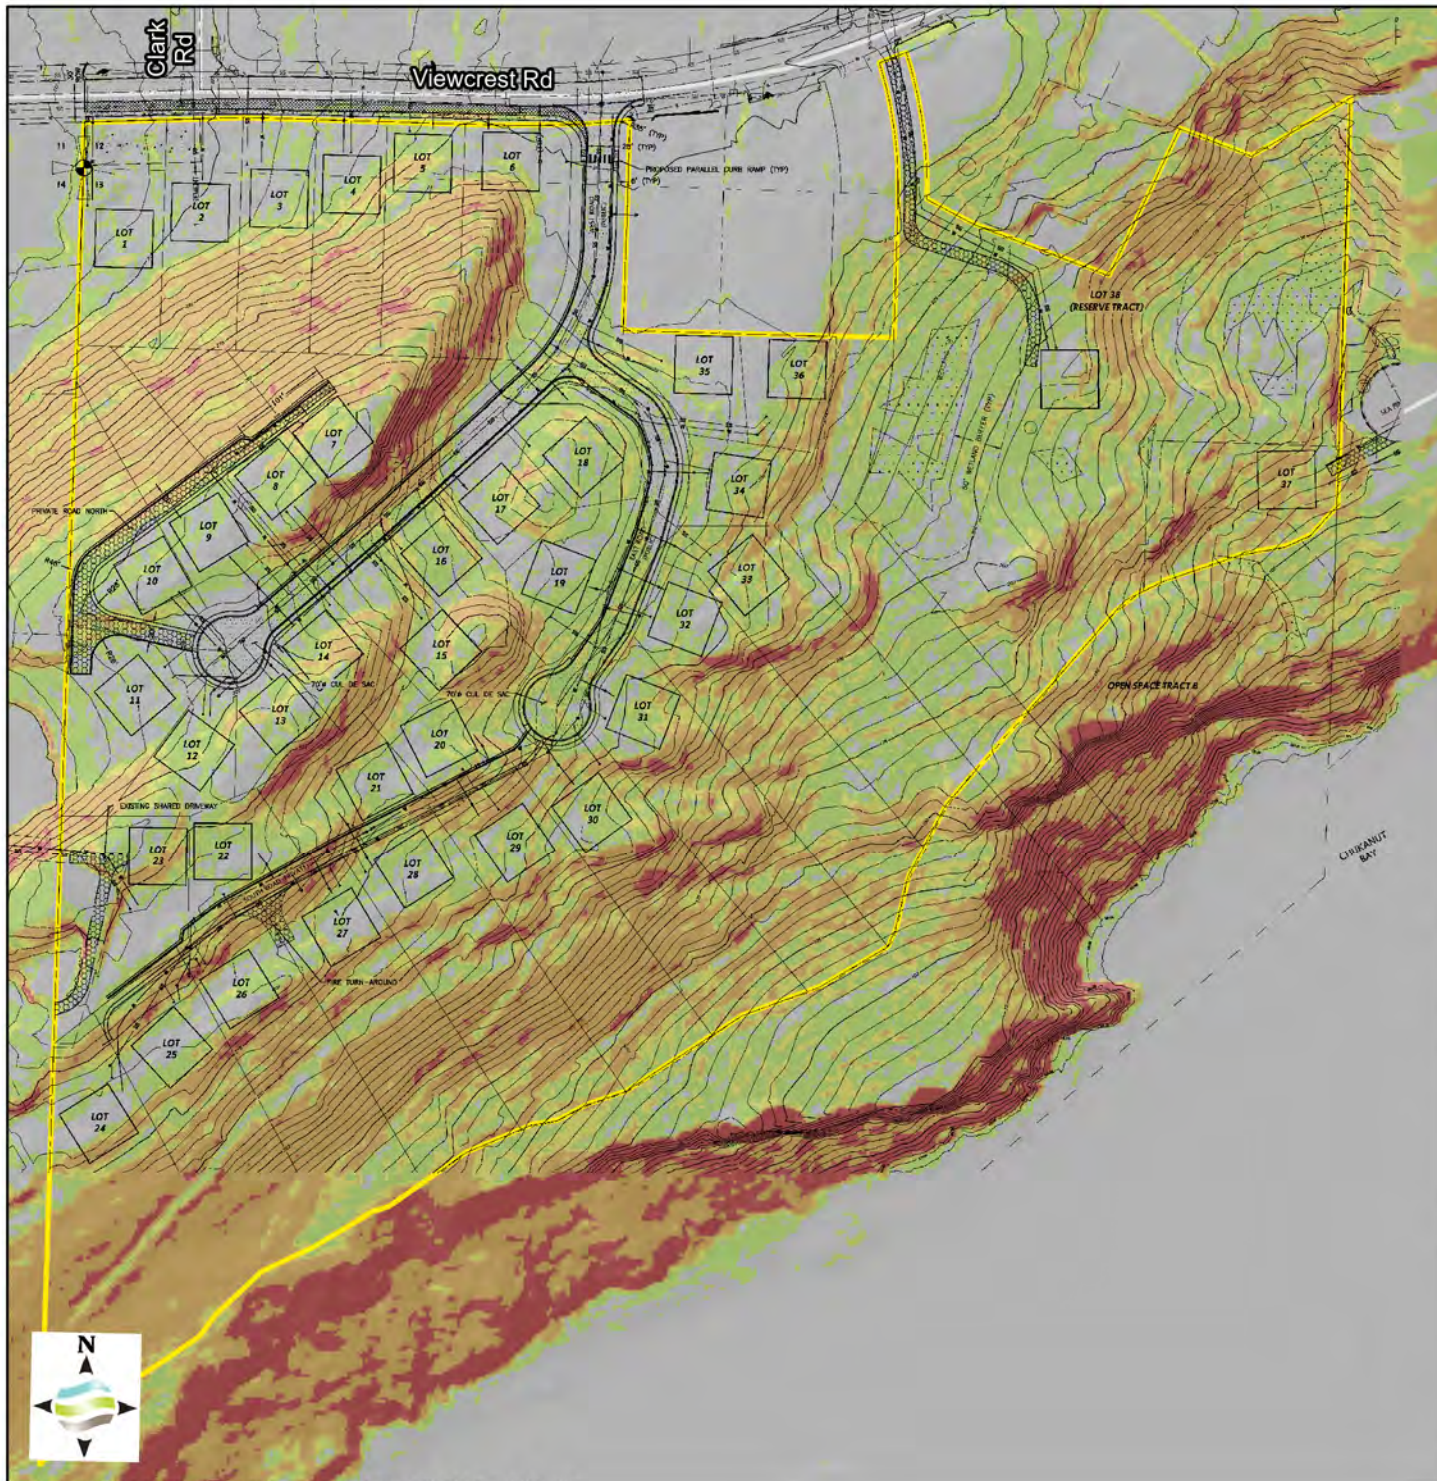
Figure 3B
 Jones - Edgemoor Estate
 Percent Slope Map

- Study Area
 - Roads
- Percent Slope**
- 0 - 15
 - 15 - 30
 - 30 - 40
 - 40 - 80
 - 80+

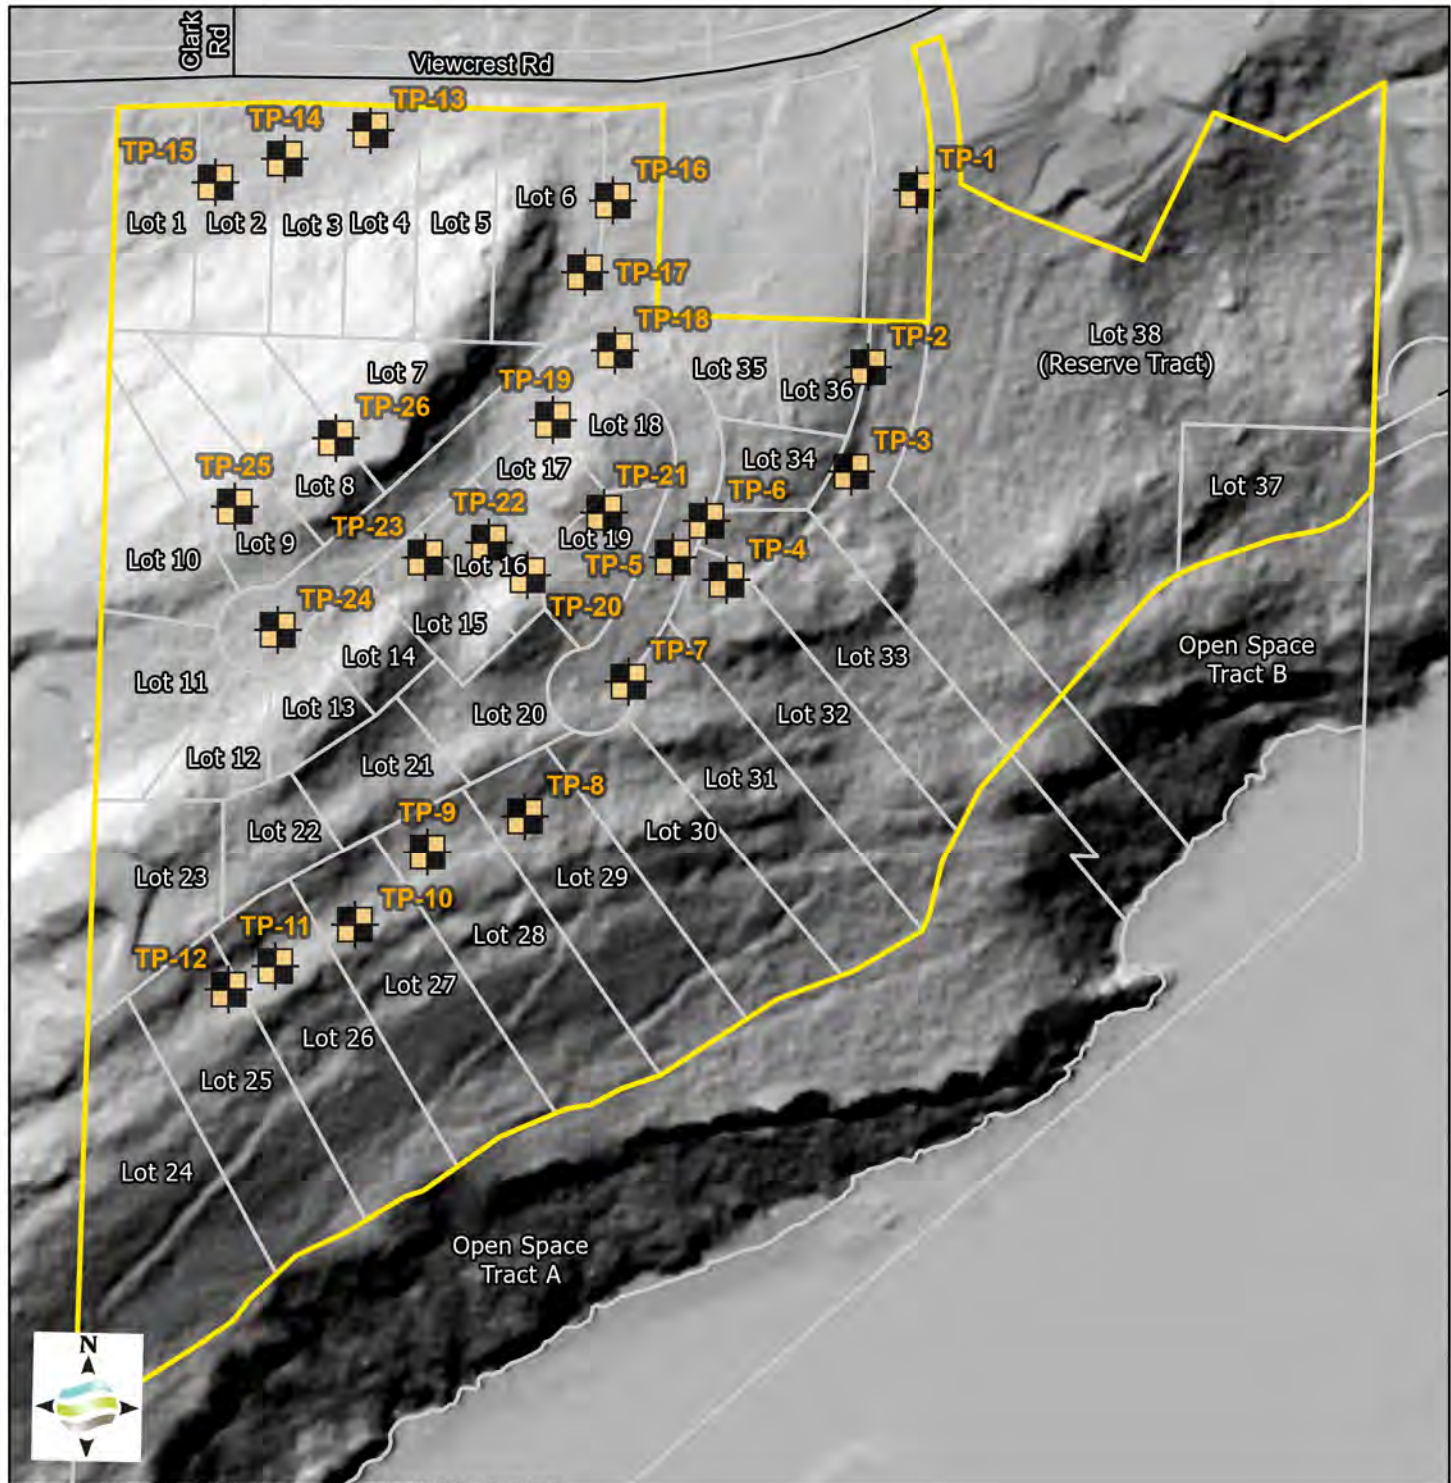
Figure 6

- Lot Layout
- Study Area
- Test Pits
- Roads

Site surface characteristics within the project area were evaluated in the field during reconnaissance by the geotechnical team prior to and at the time of the field explorations. A total of twenty-six (26) test pits were completed, on June 30 and July 1, 2020, to directly observe and evaluate the subsurface conditions throughout the interior of the project site. Test pits were excavated by a subcontractor, using a Yanmar EX35-5 mini excavator, to termination depths ranging from 2.0 feet to 8.0 feet below the existing ground surface (bgs). Exploration locations were selected based on access and to provide optimal representative coverage of the site as conditions allowed. Test pit locations are indicated on Figure 6, Appendix II. Detailed exploration logs and laboratory testing reports are also attached in Appendix II. Select photos of representative conditions observed in test pit excavations are shown in Exhibit A.

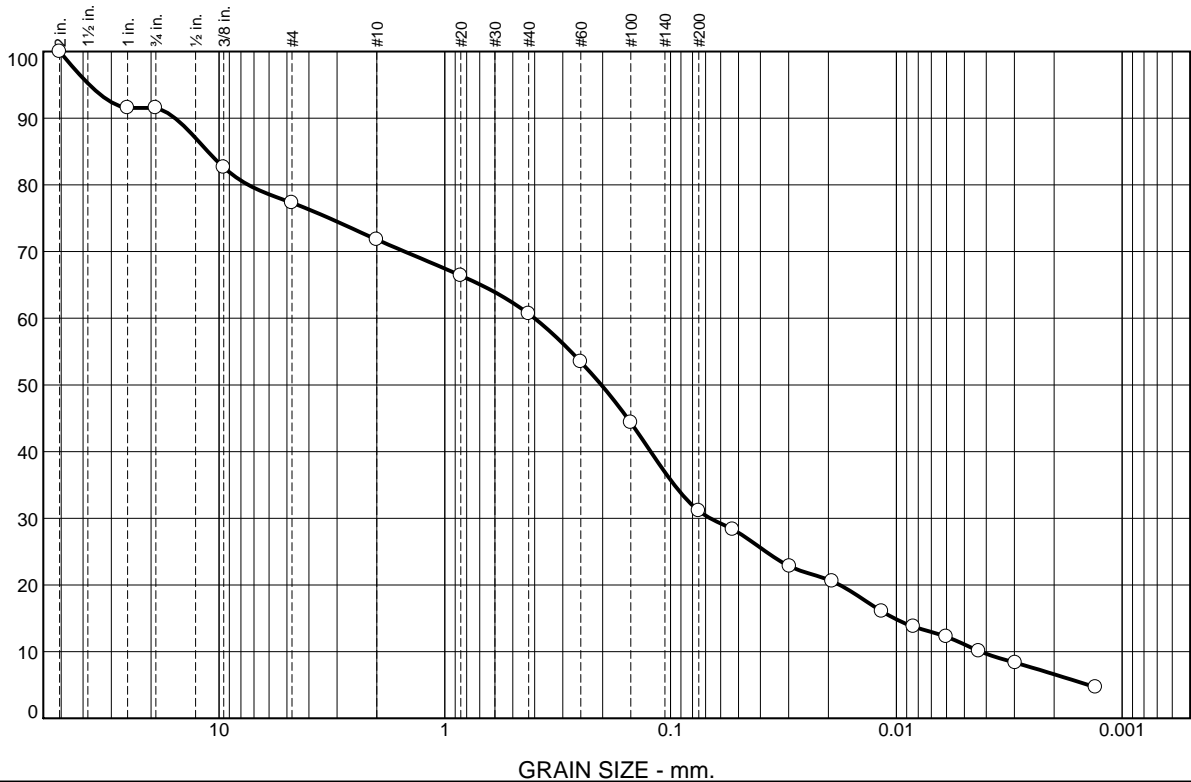
Sieve Analysis w/Hydrometer Test Report - D422/D1140

% +3"	% Gravel		% Sand			% Fines	
	Coarse	Fine	Coarse	Medium	Fine	Silt	Clay
0	8	15	5	11	30	20	11

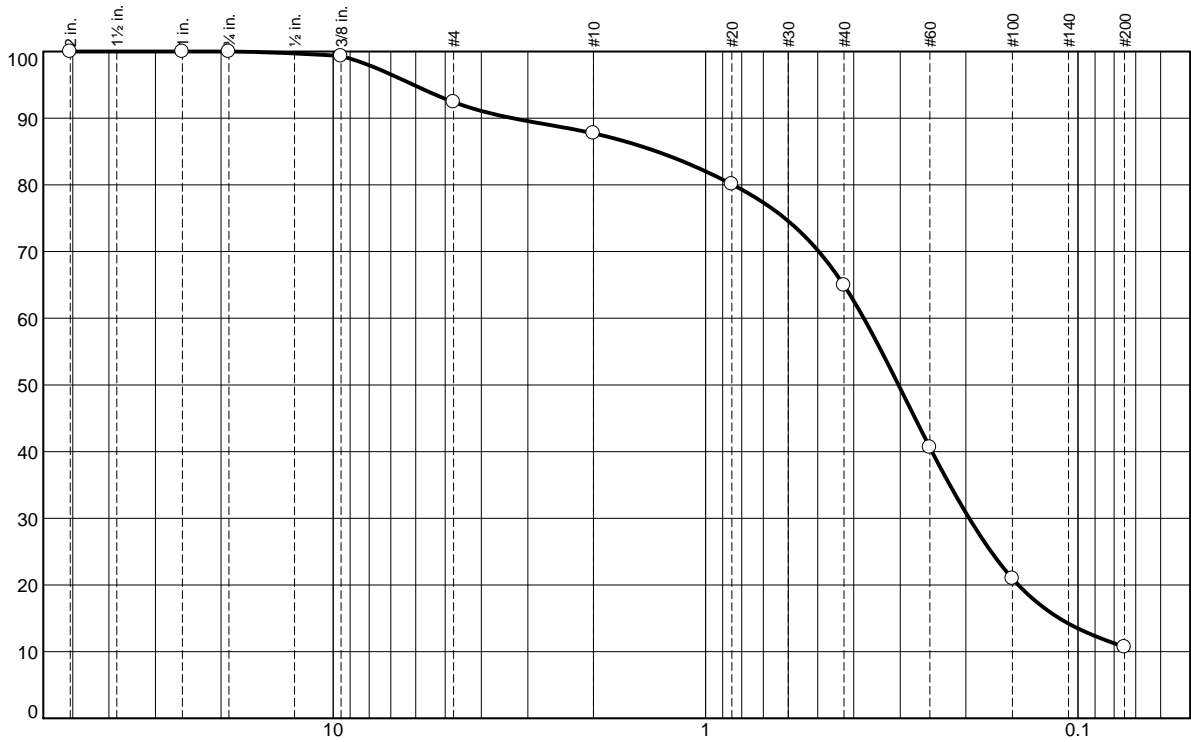
Sieve Analysis Test Report - ASTM C136/C117

% +3"	% Gravel		% Sand			% Fines Silt
	Coarse	Fine	Coarse	Medium	Fine	
0	0	8	4	23	54	11

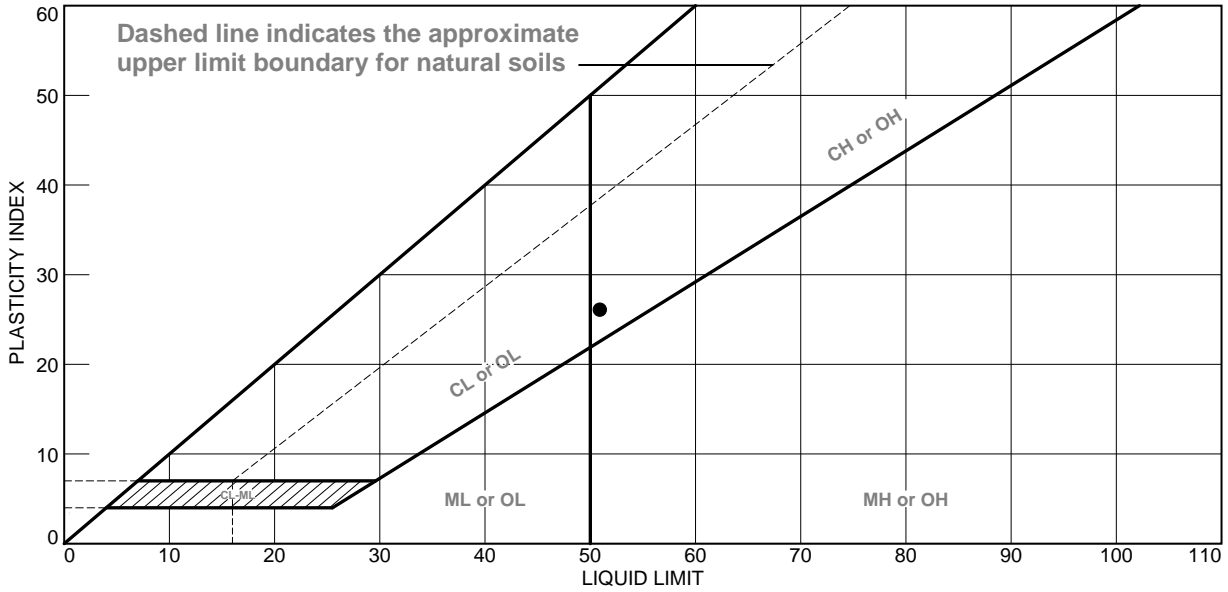
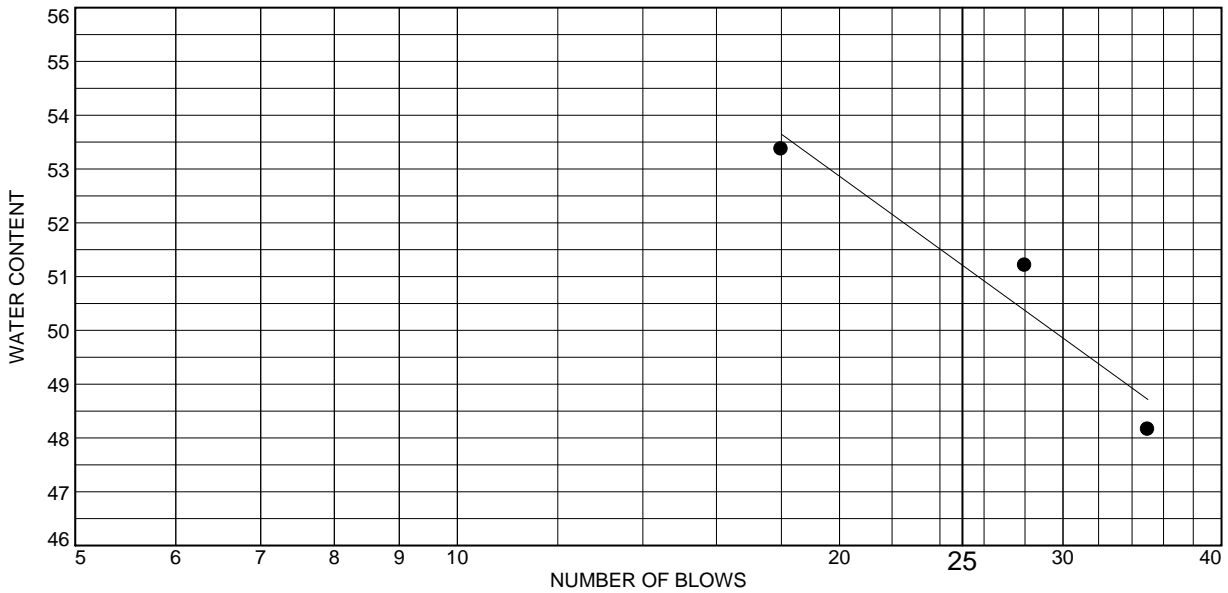
LIQUID AND PLASTIC LIMITS TEST REPORT

MATERIAL DESCRIPTION	LL	PL	PI	%<#40	%<#200	USCS
Native Material poorly graded sand with silt	51	25	26		20

Project No. 20-0587 **Client:** Element Solutions
Project: Jones-Edgemoor Estates
 Whatcom County, WA
Location: Native Material - Sampled by Client from TP-8 @ 4'
Sample Number: 1168

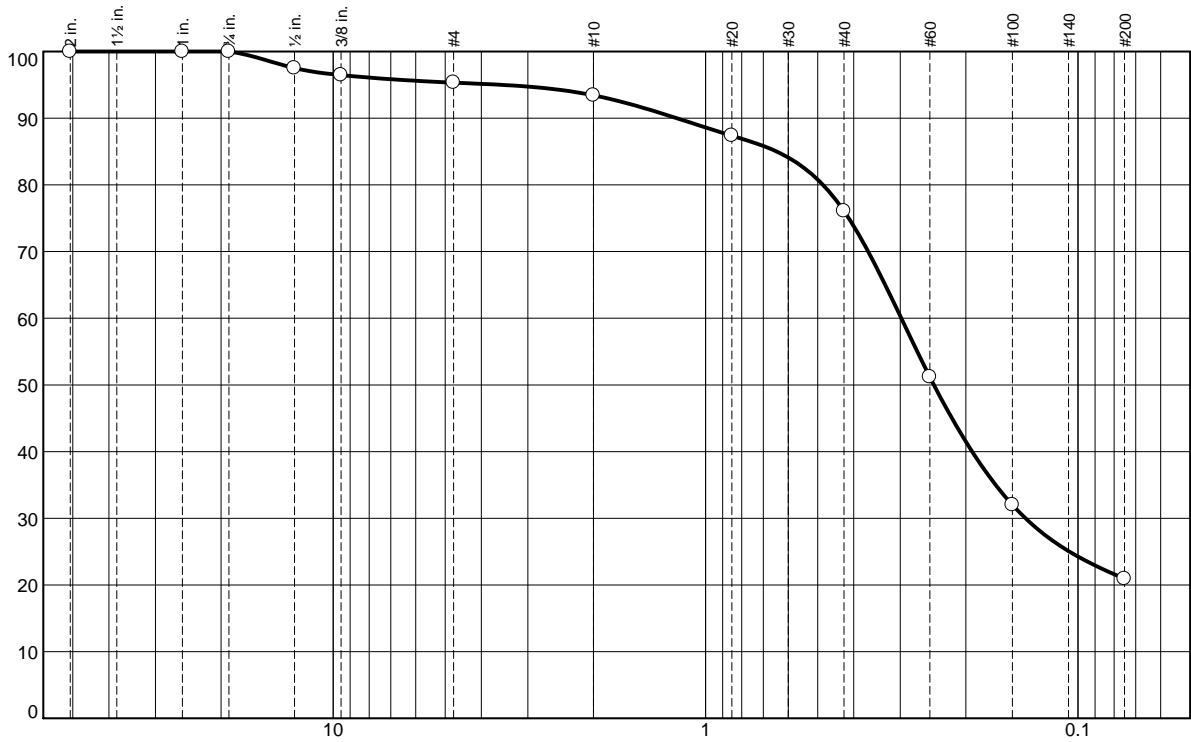
Sieve Analysis Test Report - ASTM C136/C117

% +3"	% Gravel		% Sand			% Fines
	Coarse	Fine	Coarse	Medium	Fine	Silt
0	0	5	2	17	55	21

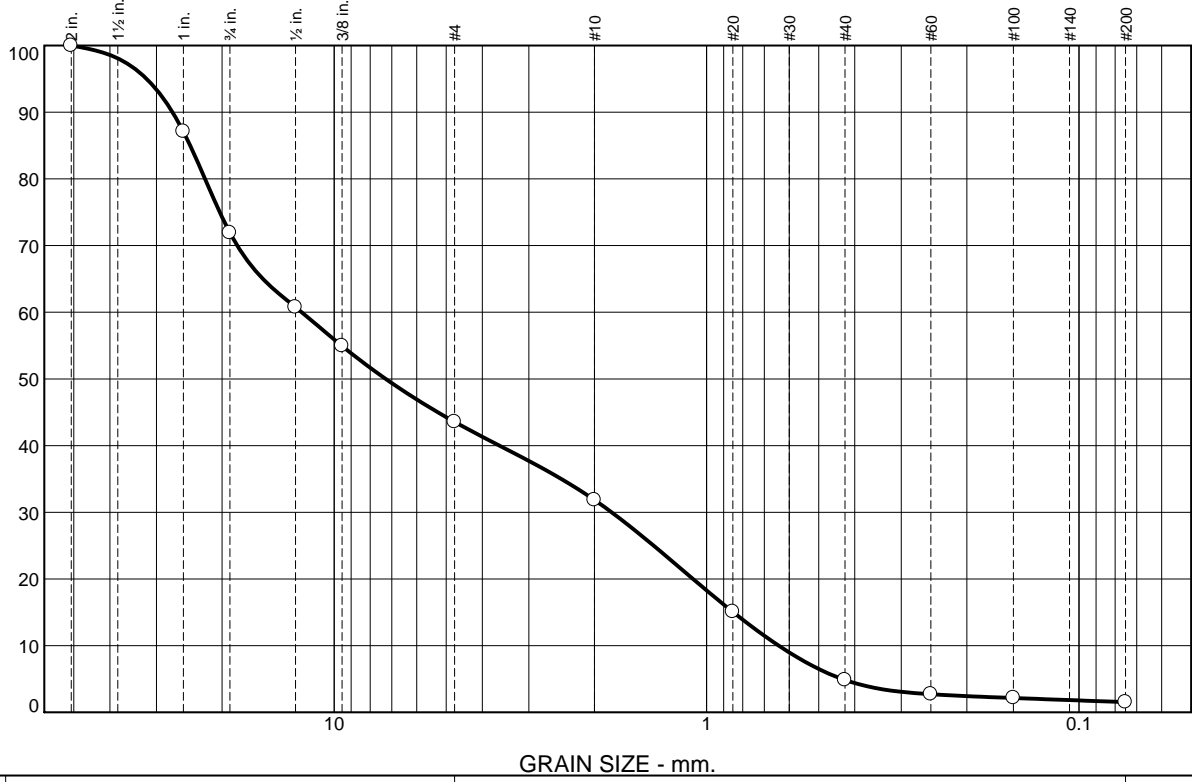
Sieve Analysis Test Report - ASTM C136/C117

% +3"	% Gravel		% Sand			% Fines Silt
	Coarse	Fine	Coarse	Medium	Fine	
0	28	28	12	27	3	2

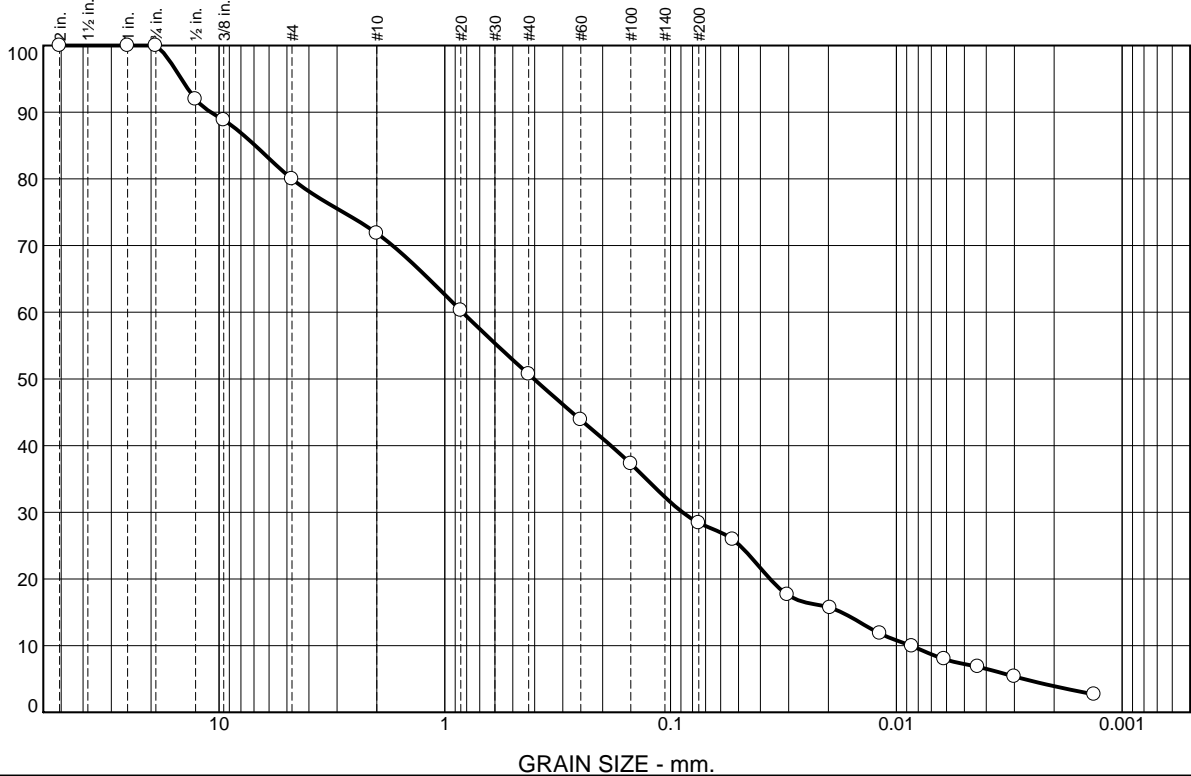
Sieve Analysis w/Hydrometer Test Report - D422/D1140

% +3"	% Gravel		% Sand			% Fines	
	Coarse	Fine	Coarse	Medium	Fine	Silt	Clay
0	0	20	8	21	23	21	7

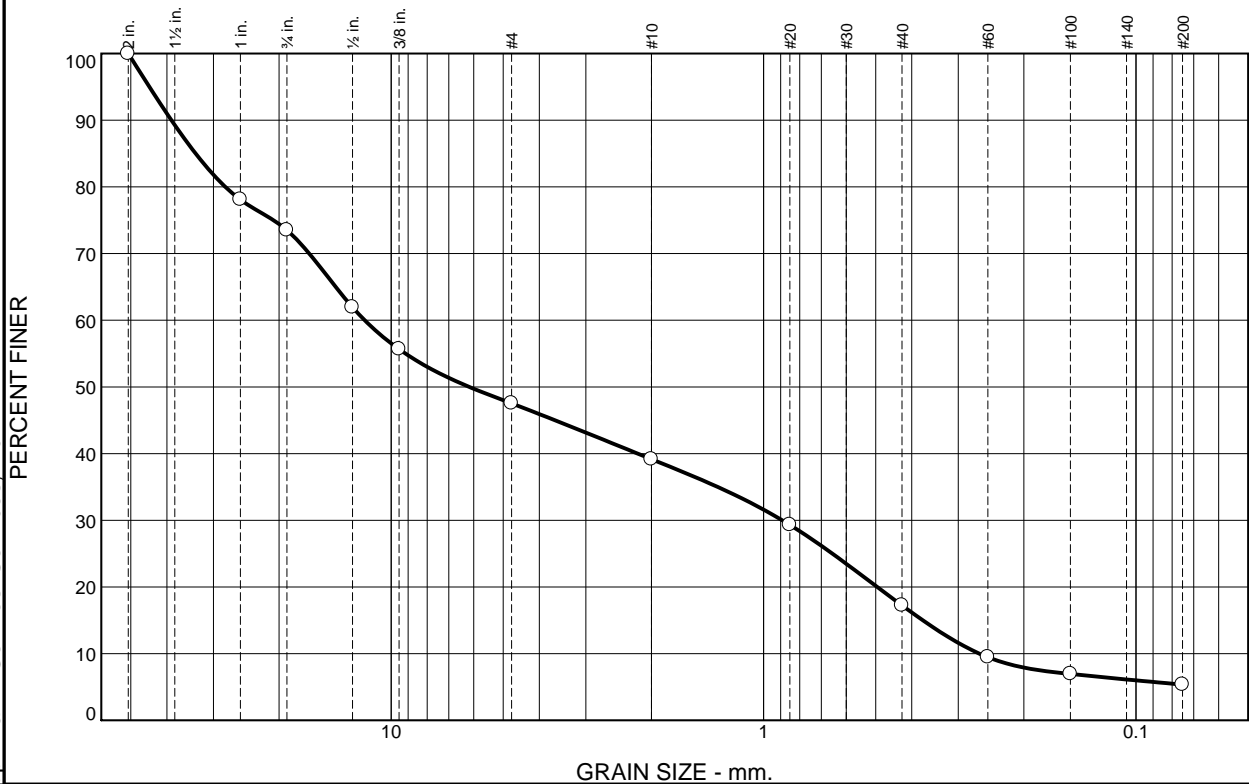
Sieve Analysis Test Report - ASTM C136/C117

% +3"	% Gravel		% Sand			% Fines
	Coarse	Fine	Coarse	Medium	Fine	Silt
0	26	26	9	22	12	5

SIEVE SIZE	PERCENT FINER	SPEC.* PERCENT	PASS? (X=NO)
2"	100		
1"	78		
3/4"	74		
1/2"	62		
3/8"	56		
#4	48		
#10	39		
#20	29		
#40	17		
#60	9		
#100	7		
#200	5.3

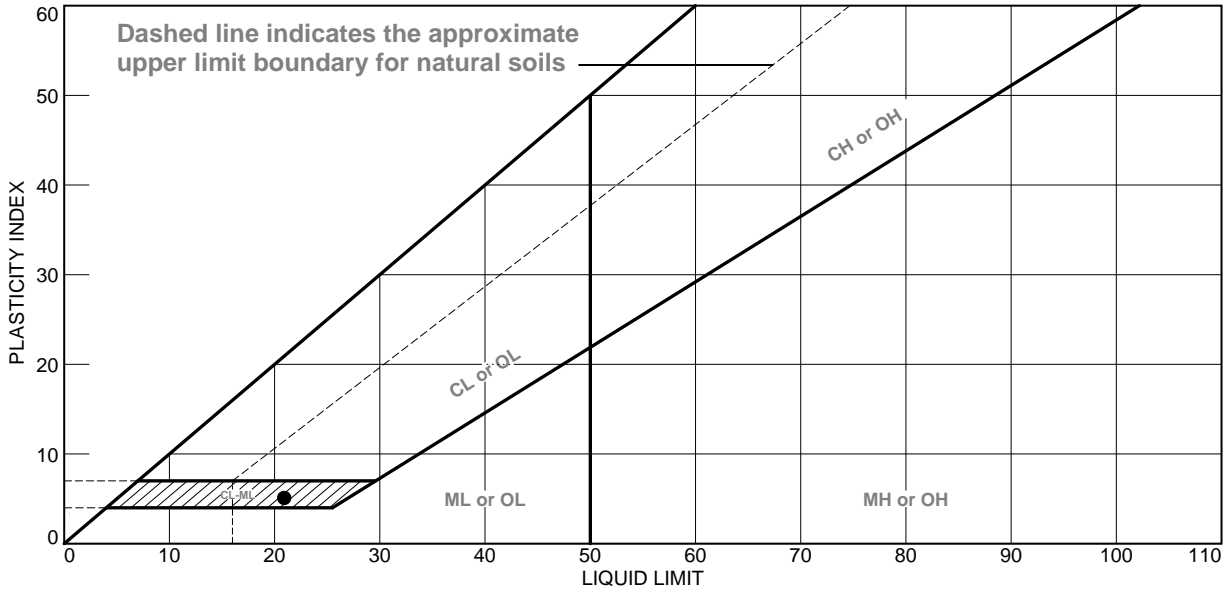
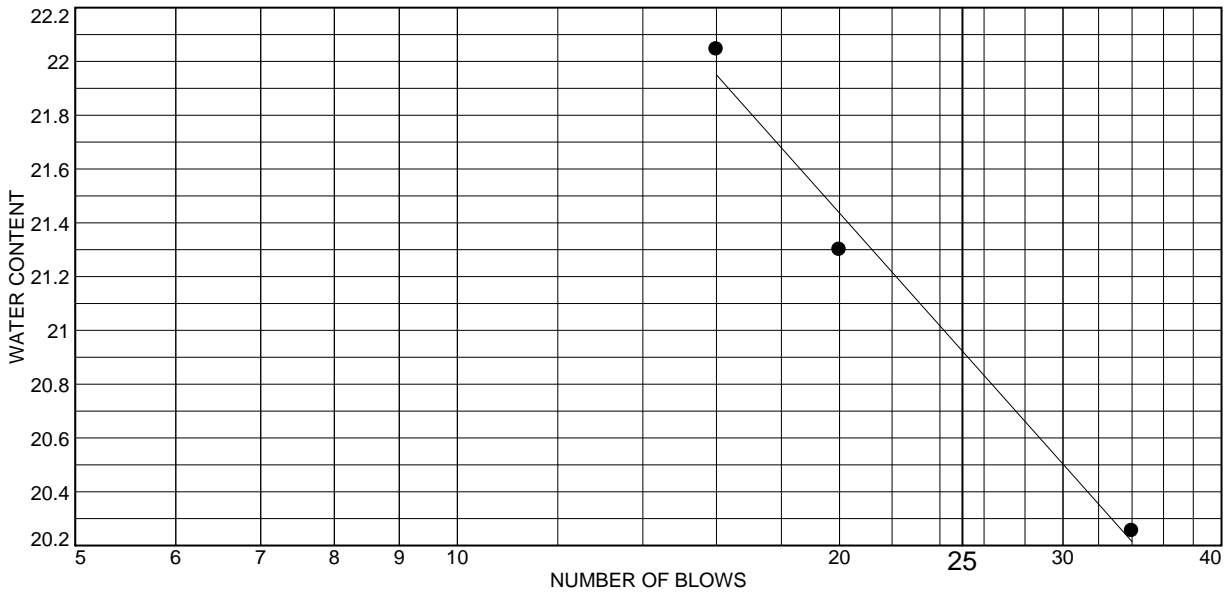
LIQUID AND PLASTIC LIMITS TEST REPORT

MATERIAL DESCRIPTION	LL	PL	PI	%<#40	%<#200	USCS
Native Material poorly graded sand with silt	21	16	5	71	39	SC-SM

Project No. 20-0587 **Client:** Element Solutions
Project: Jones-Edgemoor Estates
 Whatcom County, WA
Location: Native Material - Sampled by Client from TP-16 @ 4.5'
Sample Number: 1175

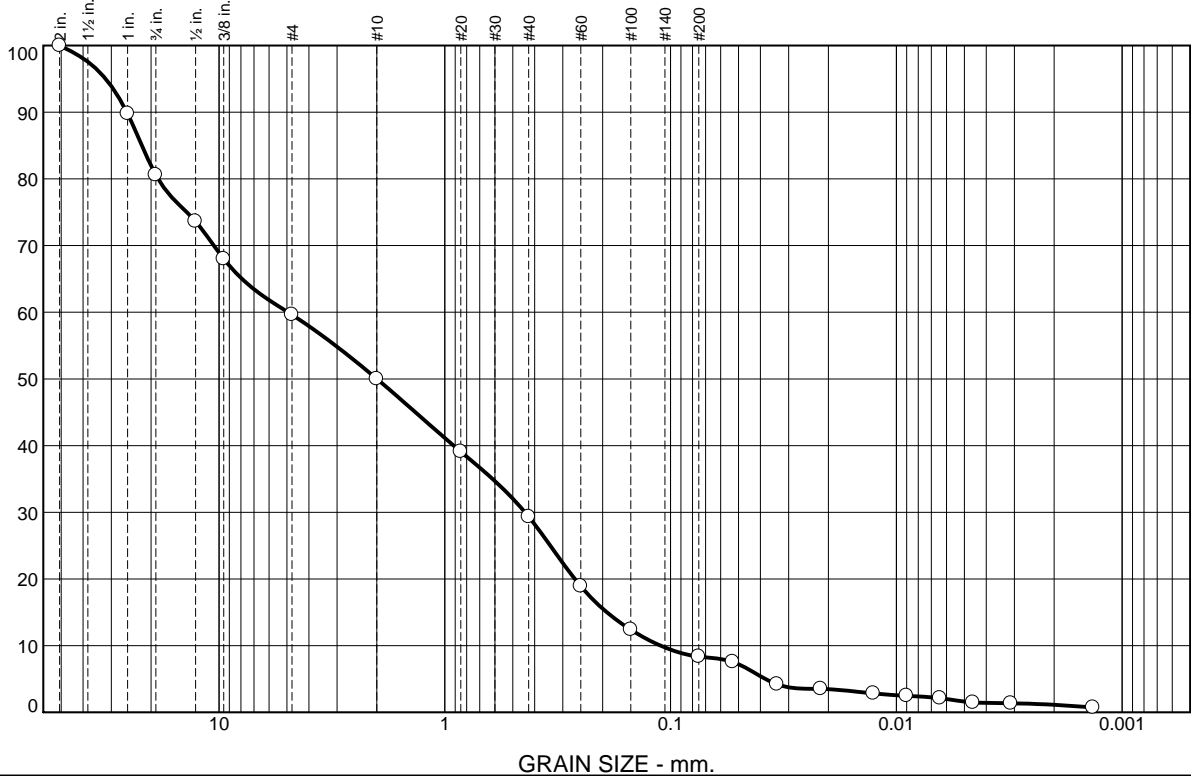
Sieve Analysis w/Hydrometer Test Report - D422/D1140

% +3"	% Gravel		% Sand			% Fines	
	Coarse	Fine	Coarse	Medium	Fine	Silt	Clay
0	19	21	10	21	21	6	2

SIEVE SIZE	PERCENT FINER	SPEC.* PERCENT	PASS? (X=NO)
2"	100		
1"	90		
3/4"	81		
1/2"	74		
3/8"	68		
#4	60		
#10	50		
#20	39		
#40	29		
#60	19		
#100	12		
#200	8.3		
#270	7.6		
0.0338 mm.	4.2		
0.0216 mm.	3.5		
0.0126 mm.	2.8		
0.0090 mm.	2.5		
0.0064 mm.	2.1		
0.0046 mm.	1.5		
0.0031 mm.	1.3		
0.0013 mm.	0.7

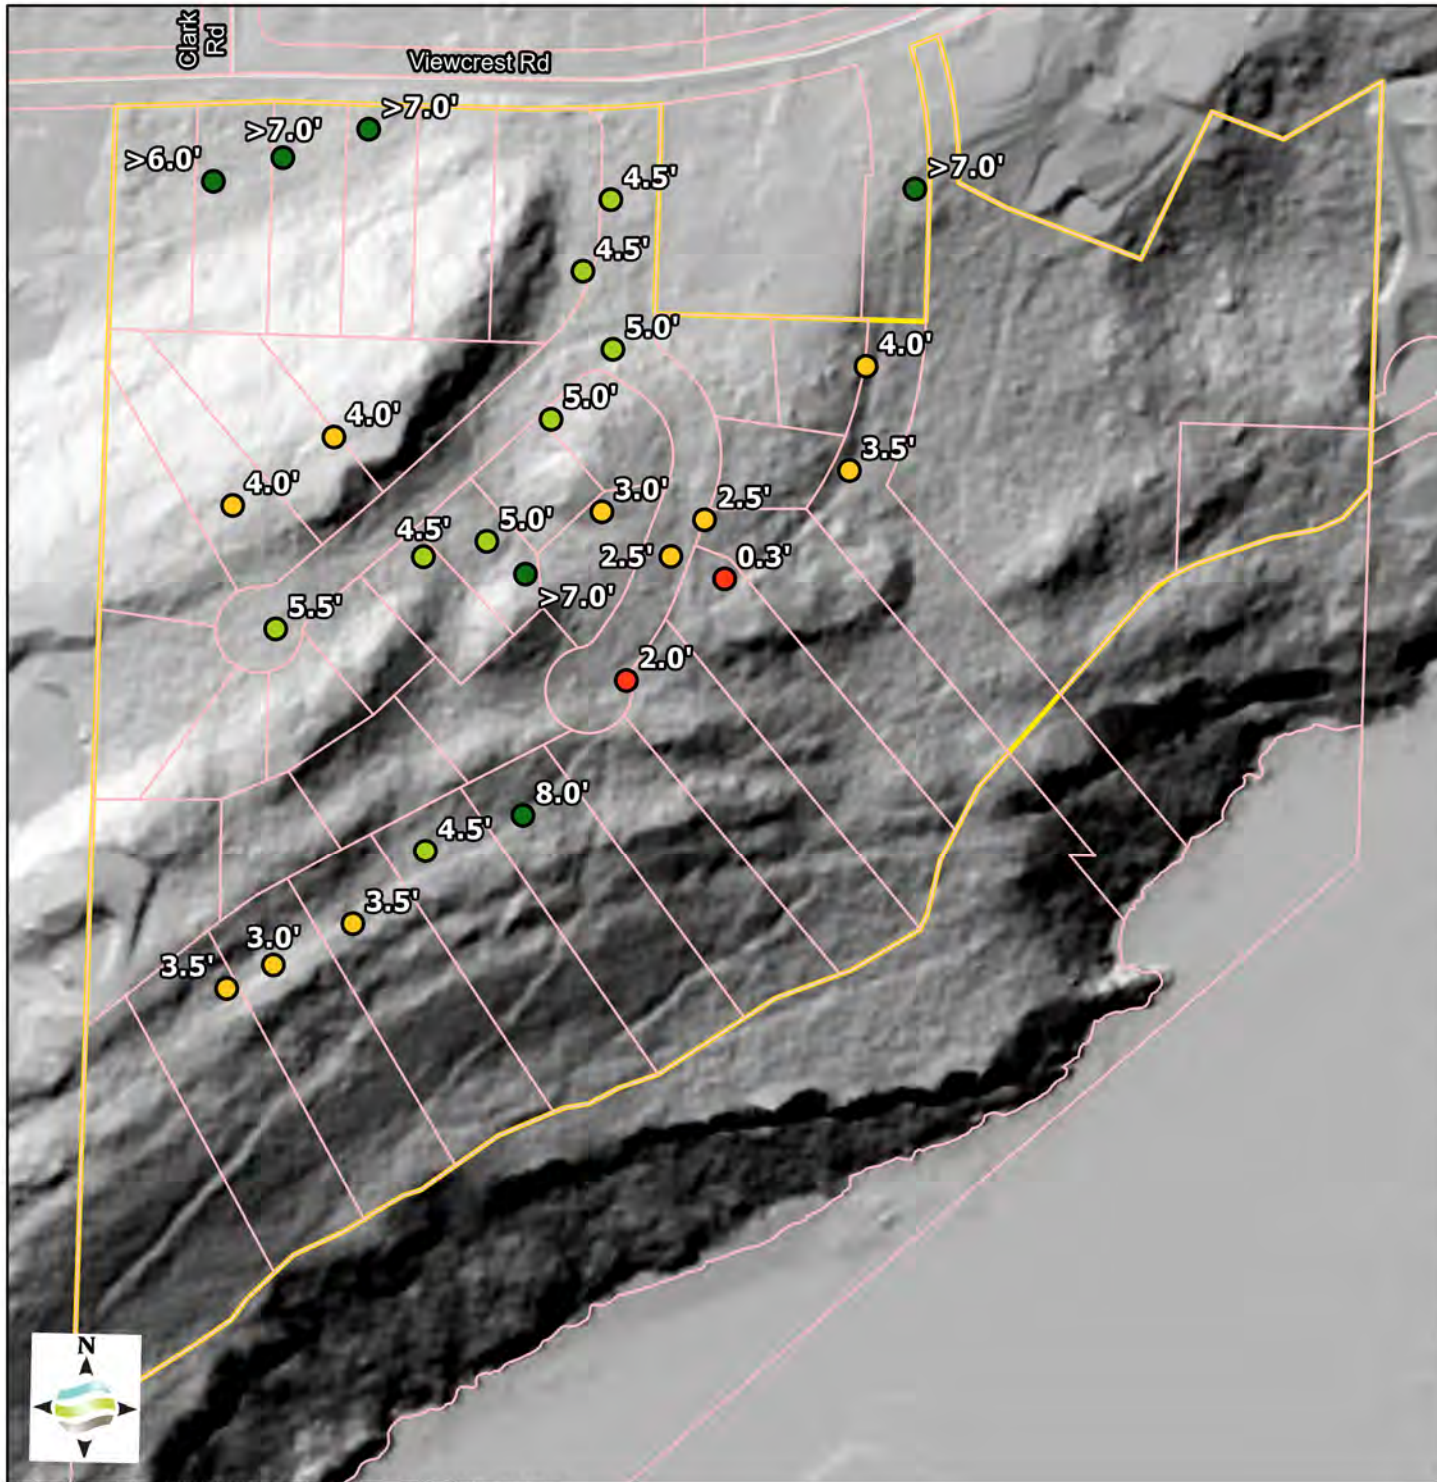
Figure 7
 Jones - Edgemoor Estate
 Approximate Depth to Bedrock Map

- Lot Layout
- Study Area
- Roads

Bedrock: Apparent intact sandstone bedrock of the Chuckanut formation was encountered in a majority of test pits across the study area. In the southeast part of the project area, along the primitive NE-SW access corridor (TP2 - TP12), the depth to bedrock was consistently less than 4.5 feet, with exception of TP8 where bedrock was encountered at 8.0 feet bgs. The depth to bedrock was only slightly greater along the proposed "West Road" corridor and in the central region of the site, where refusal was generally met at around 5.0 feet bgs or less. Extracted rock samples were comprised of angular, dry, tan, poorly-graded sand to silty sand. The inferred bedrock conditions are consistent with the Padden Member of the Chuckanut Formation, mapped in and around the study area and exposed in scattered outcrops. See Figure 7 for a summary of depth to bedrock by exploration location.

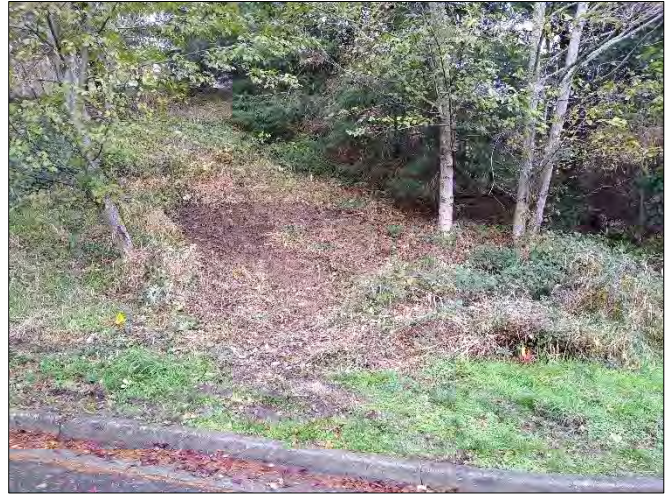
Photo 2: TP1 Location

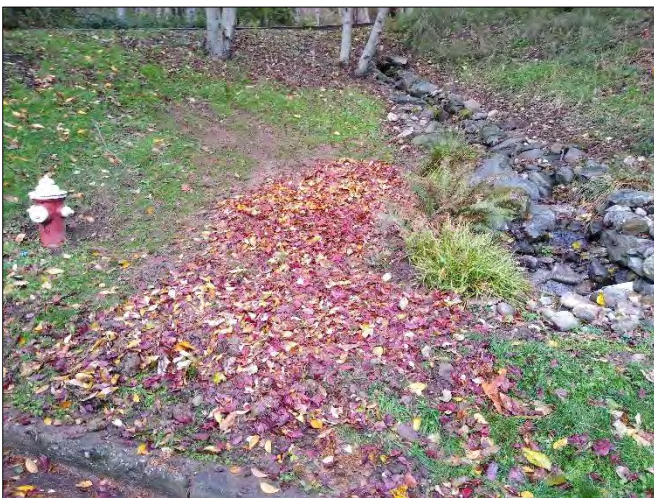
Photo 5: TP2 Location & Site Restoration

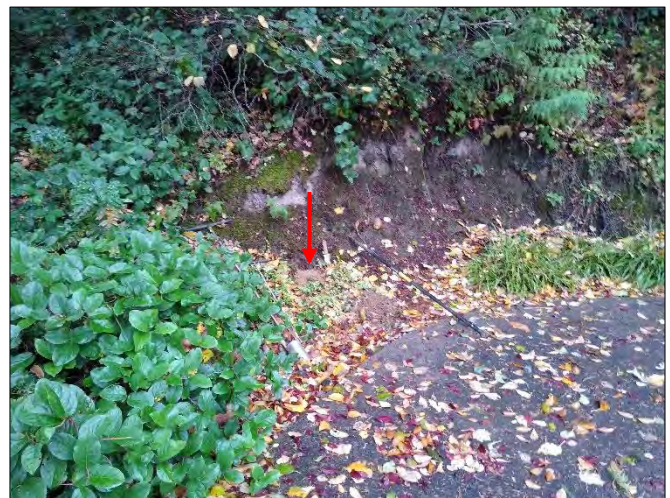
Photo 6: HA-1 Location

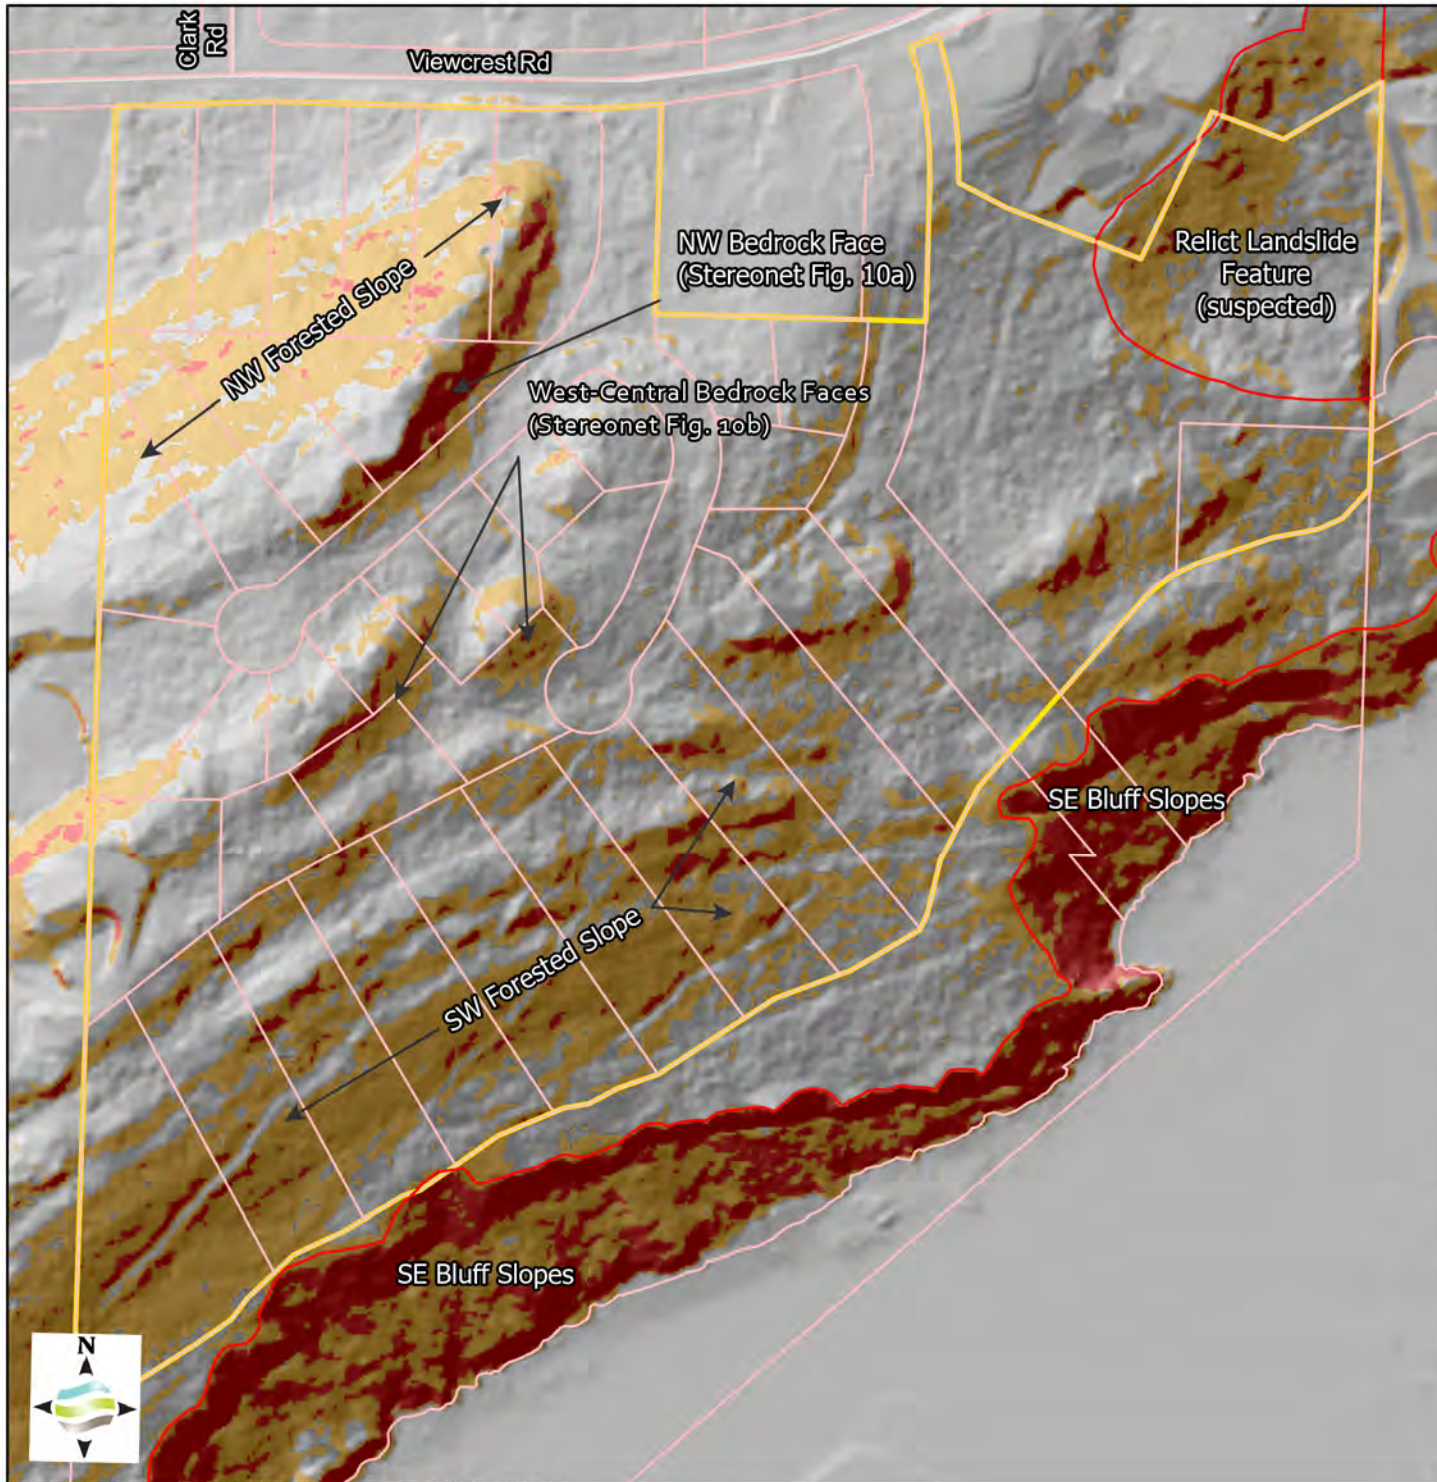
- 1) Figure 9 – Project Overview LiDAR Map with Shading and Geologic Hazard Areas Annotated
- 2) Exhibit C – Field Photos of Geohazard Slope Features and Rock Exposures
- 3) Figure 10a – Stereonet of Bedrock Structures – Northwest Hill Cliff Face
Figure 10b – Stereonet of Bedrock Structures – West-Central Rock Outcrops

- Lot Layout
- Study Area
- Roads

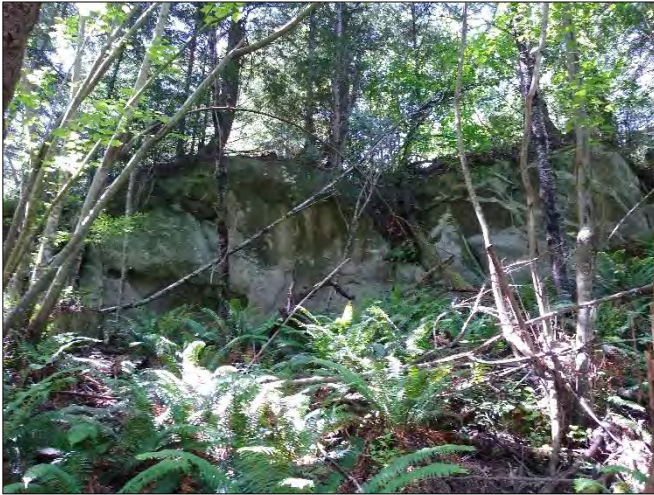
Photo 7: West-Central Bedrock Faces; West Outcrop
