Preliminary Stormwater Management Report

THE WOODS AT VIEWCREST

**GEOTECHNICAL INVESTIGATION
& GEOHAZARD REPORT
JONES EDGEMOOR ESTATE
PROPOSED 38-LOT PLAT DEVELOPMENT
VIEWCREST ROAD, BELLINGHAM, WA**

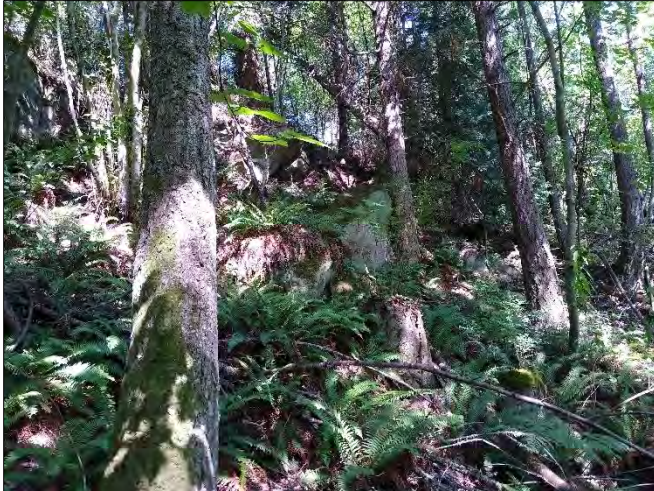
Photo 9: West-Central Bedrock Faces; West Outcrop, Northern Slope Area

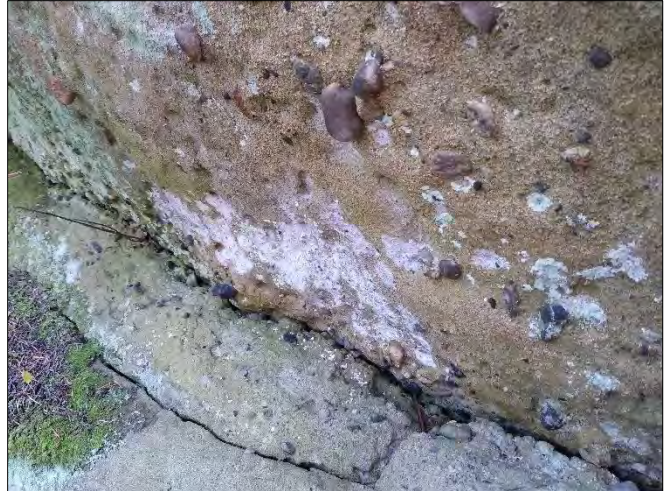
Photo 10: Conglomerate Bedrock Exposure; SW Project Area

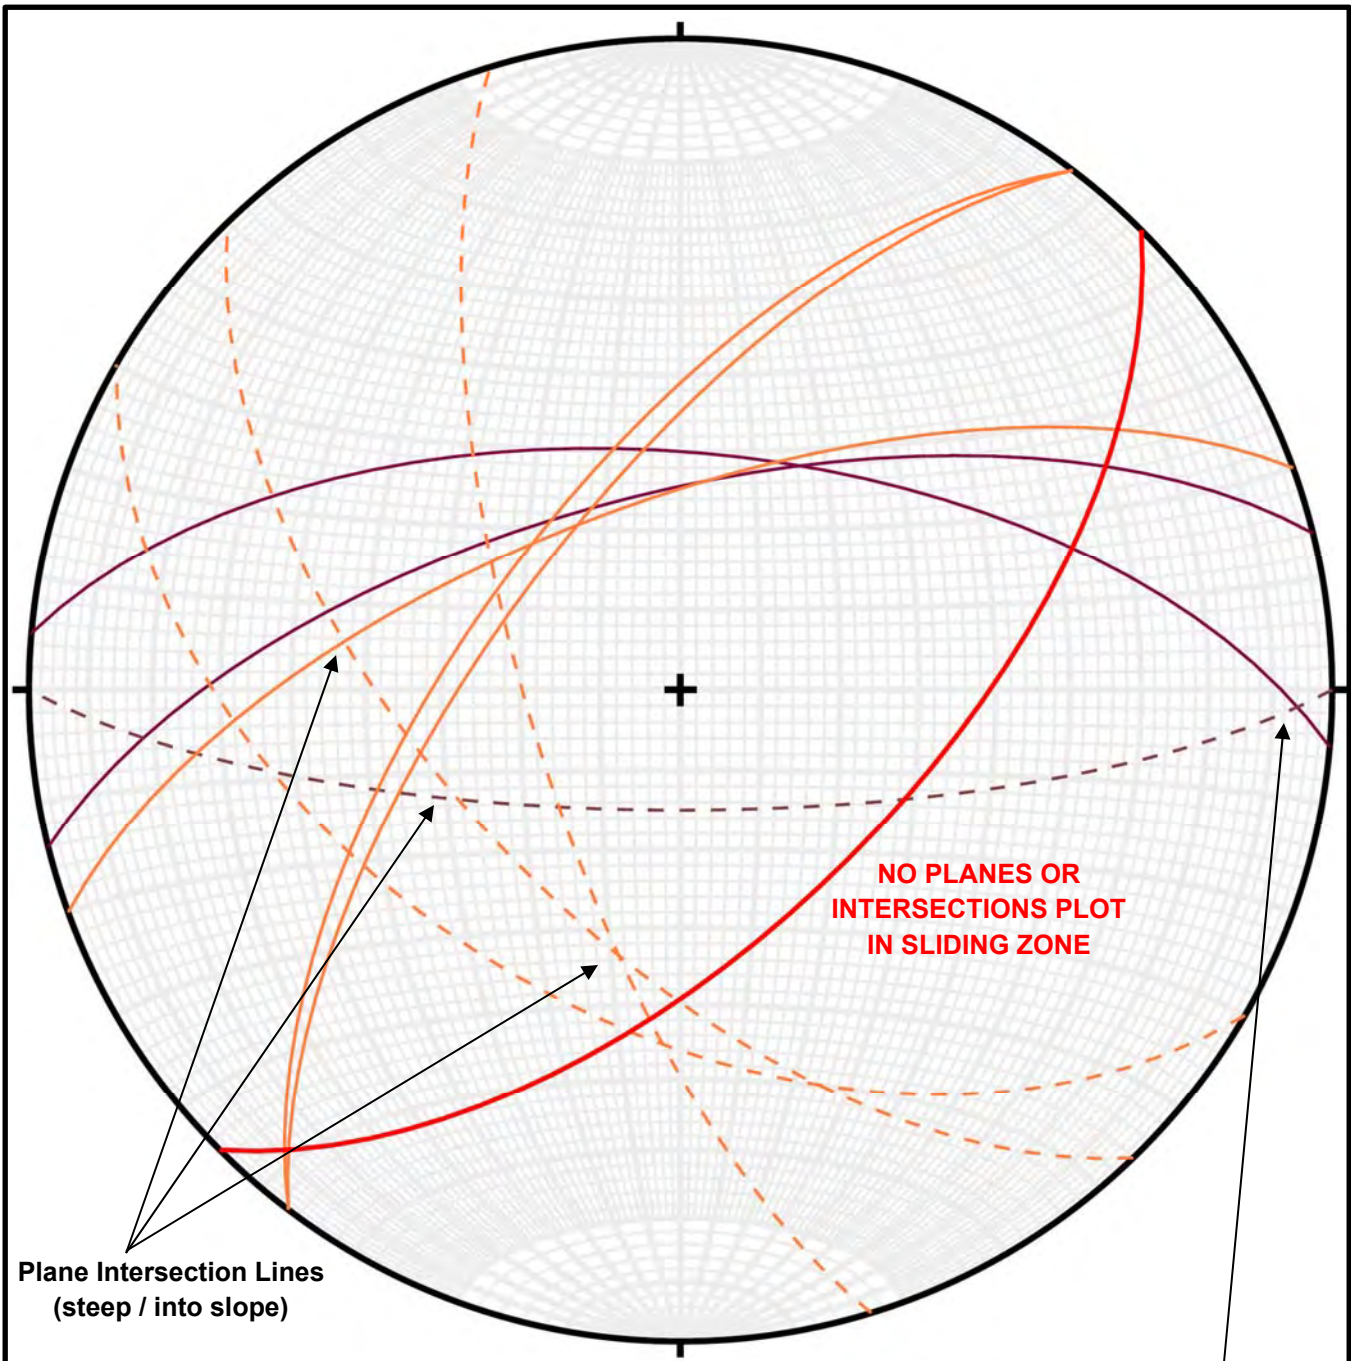
Plane Intersection Lines
(shallow out of slope)

SLOPE FACE - Average (Solid Red)	
BEDDING PLANES (Solid Green / Blue)	
JOINT PLANES (Dashed Green / Blue)

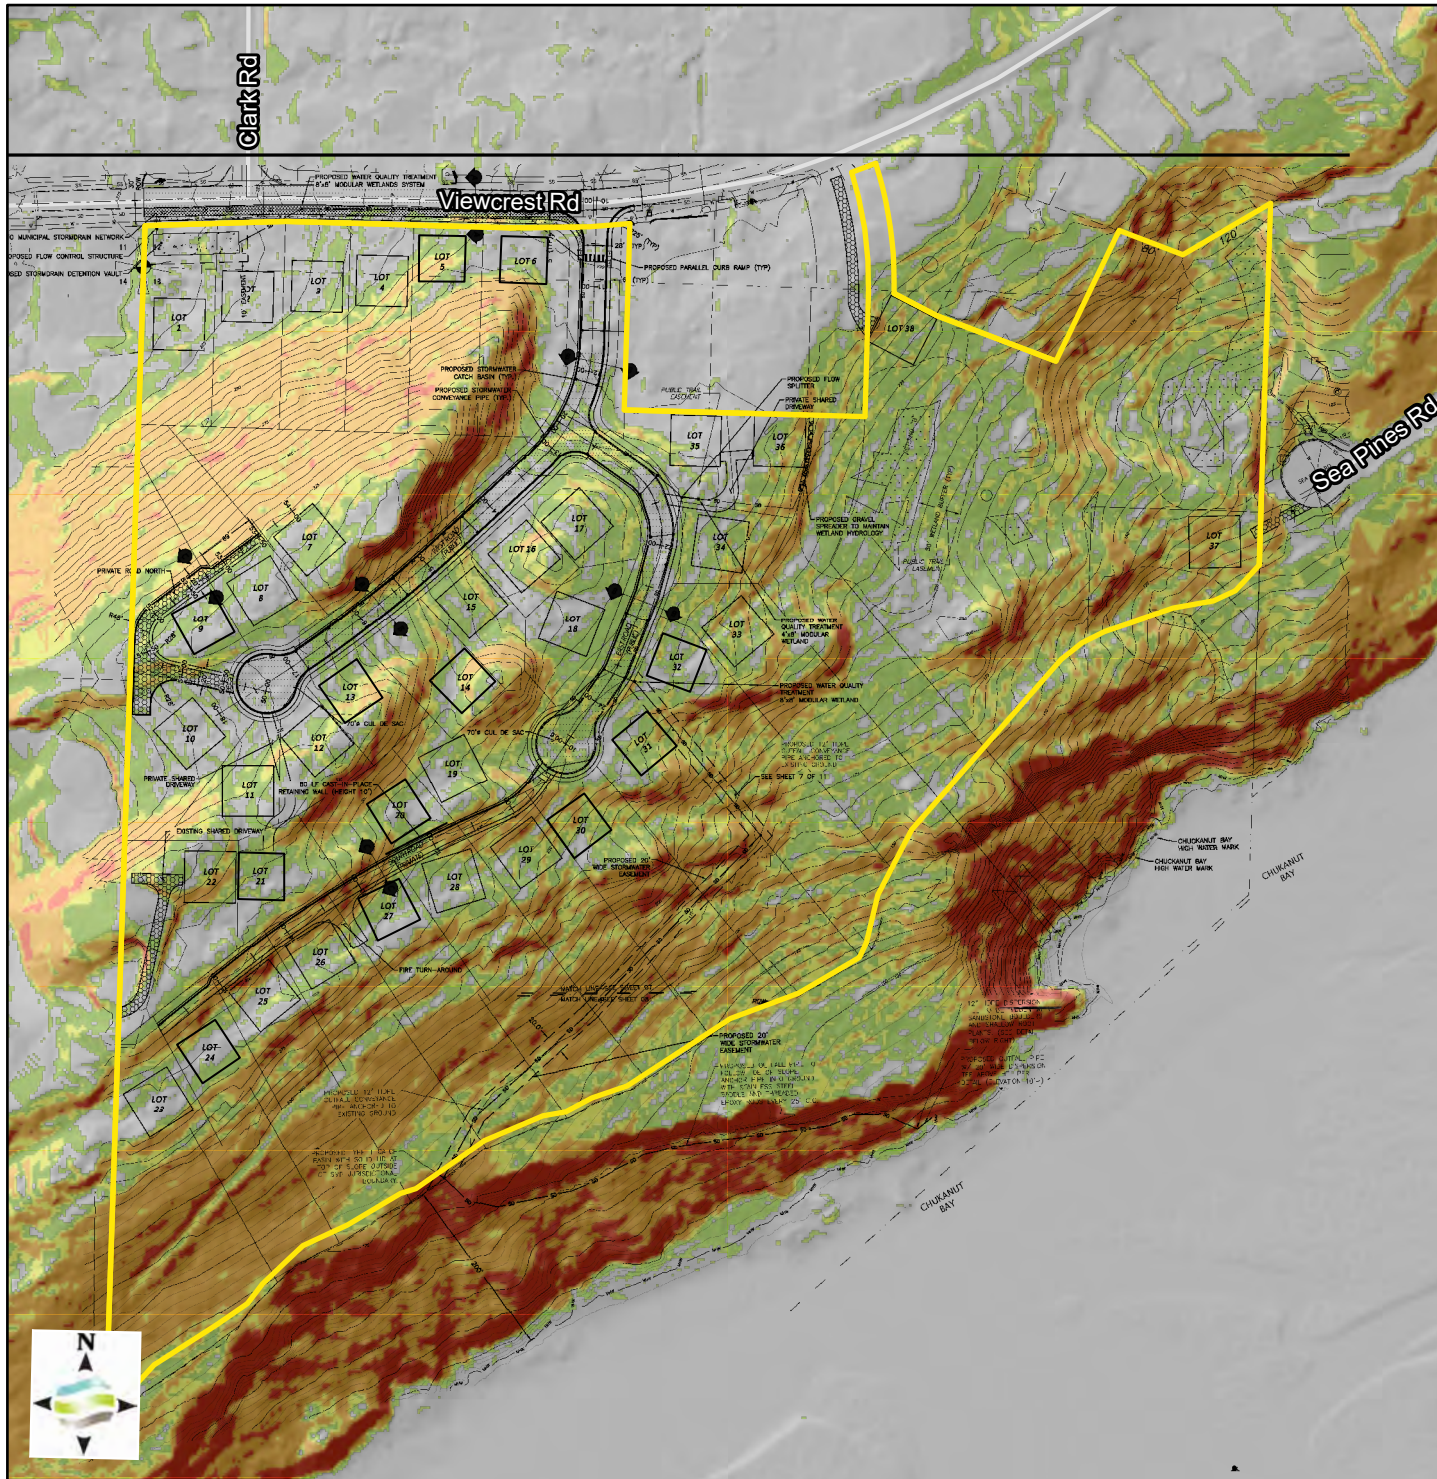
- Development Area
 - Roads
- percent_slope
- 0 - 15
 - 15 - 30
 - 30 - 40
 - 40 - 80
 - 80 +

Figure 1
 Viewcrest Plat
 Jones Edgemoor GHA Review
 Percent Slope Map - Entire Study Area

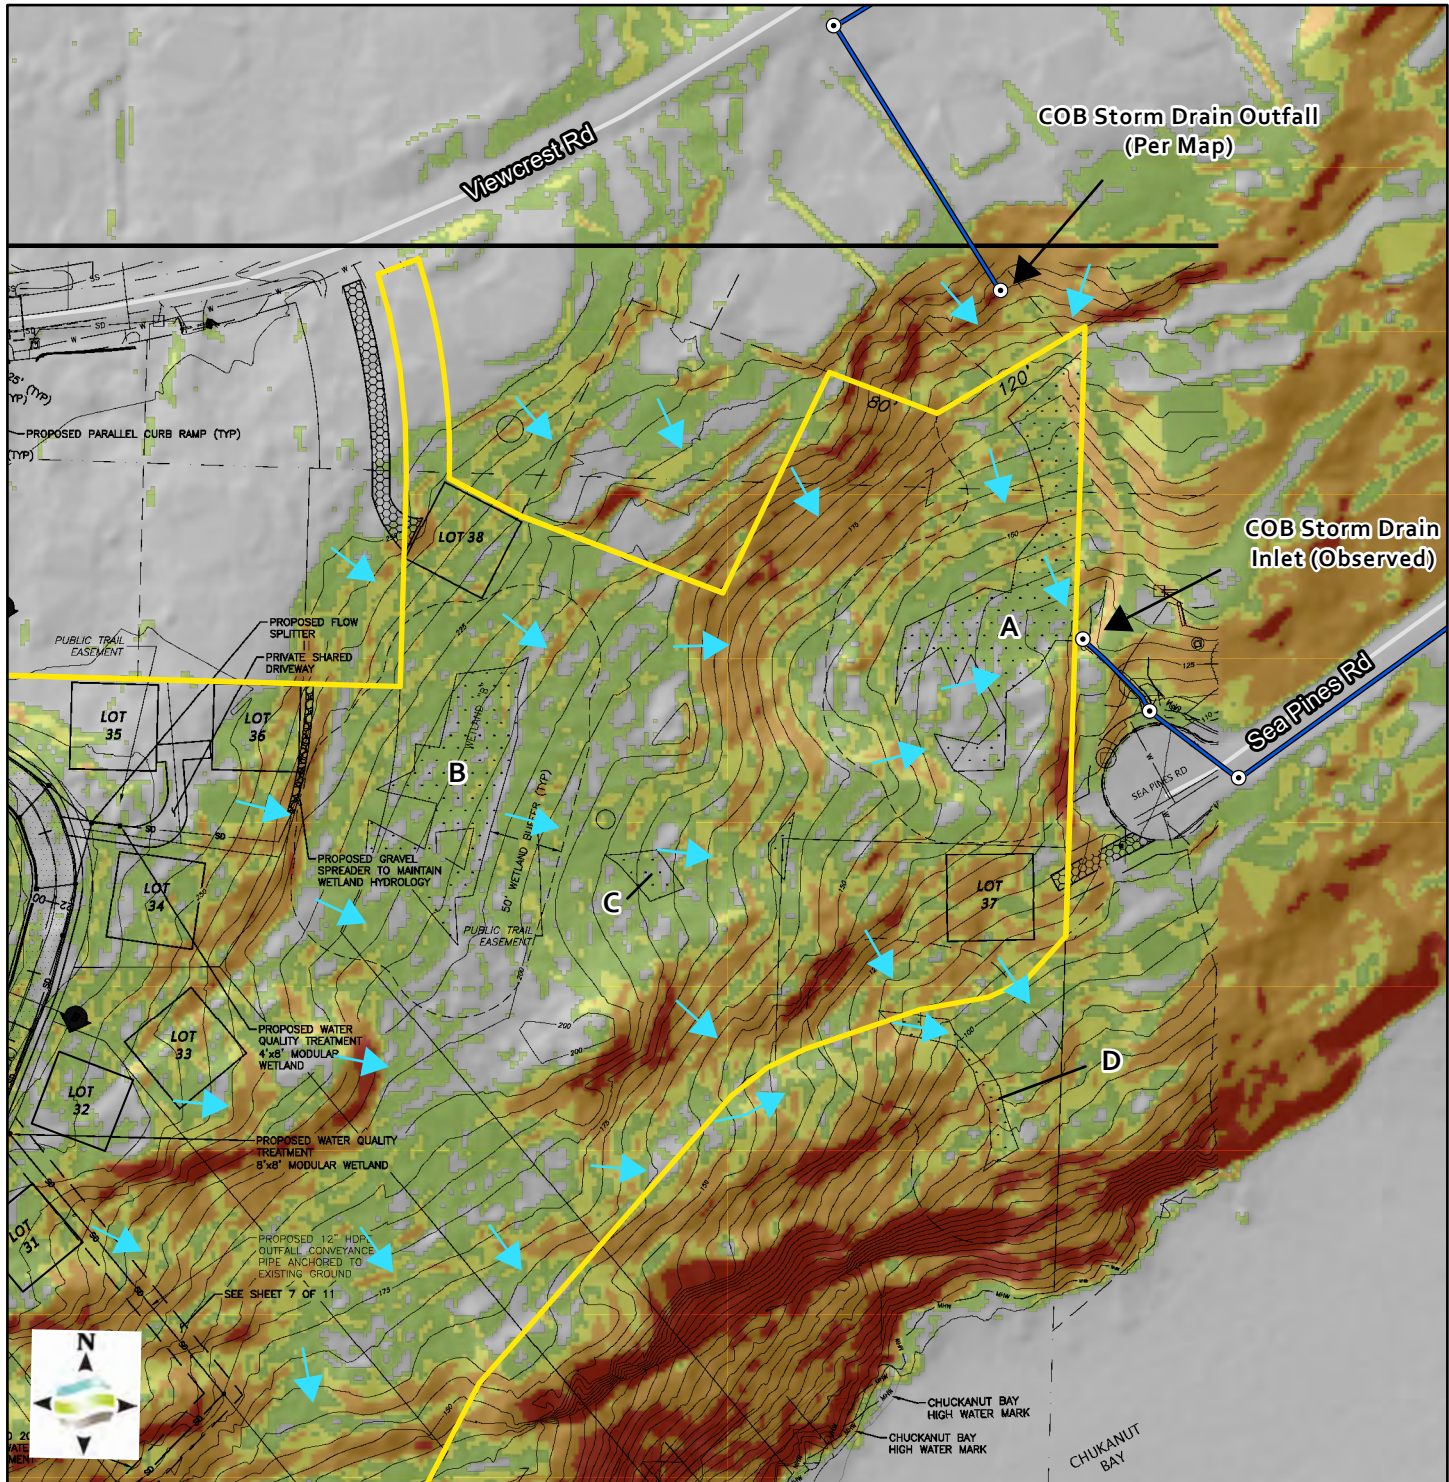
- Development Area
- Roads
- percent_slope
 - 0 - 15
 - 15 - 30
 - 30 - 40
 - 40 - 80
 - 80 +
- ➔ Interpreted Surface Water Flow Path

Figure 2
 Viewcrest Plat
 Jones Edgemoor GHA Review
 NorthEast Region
 Date: 10/18/2024

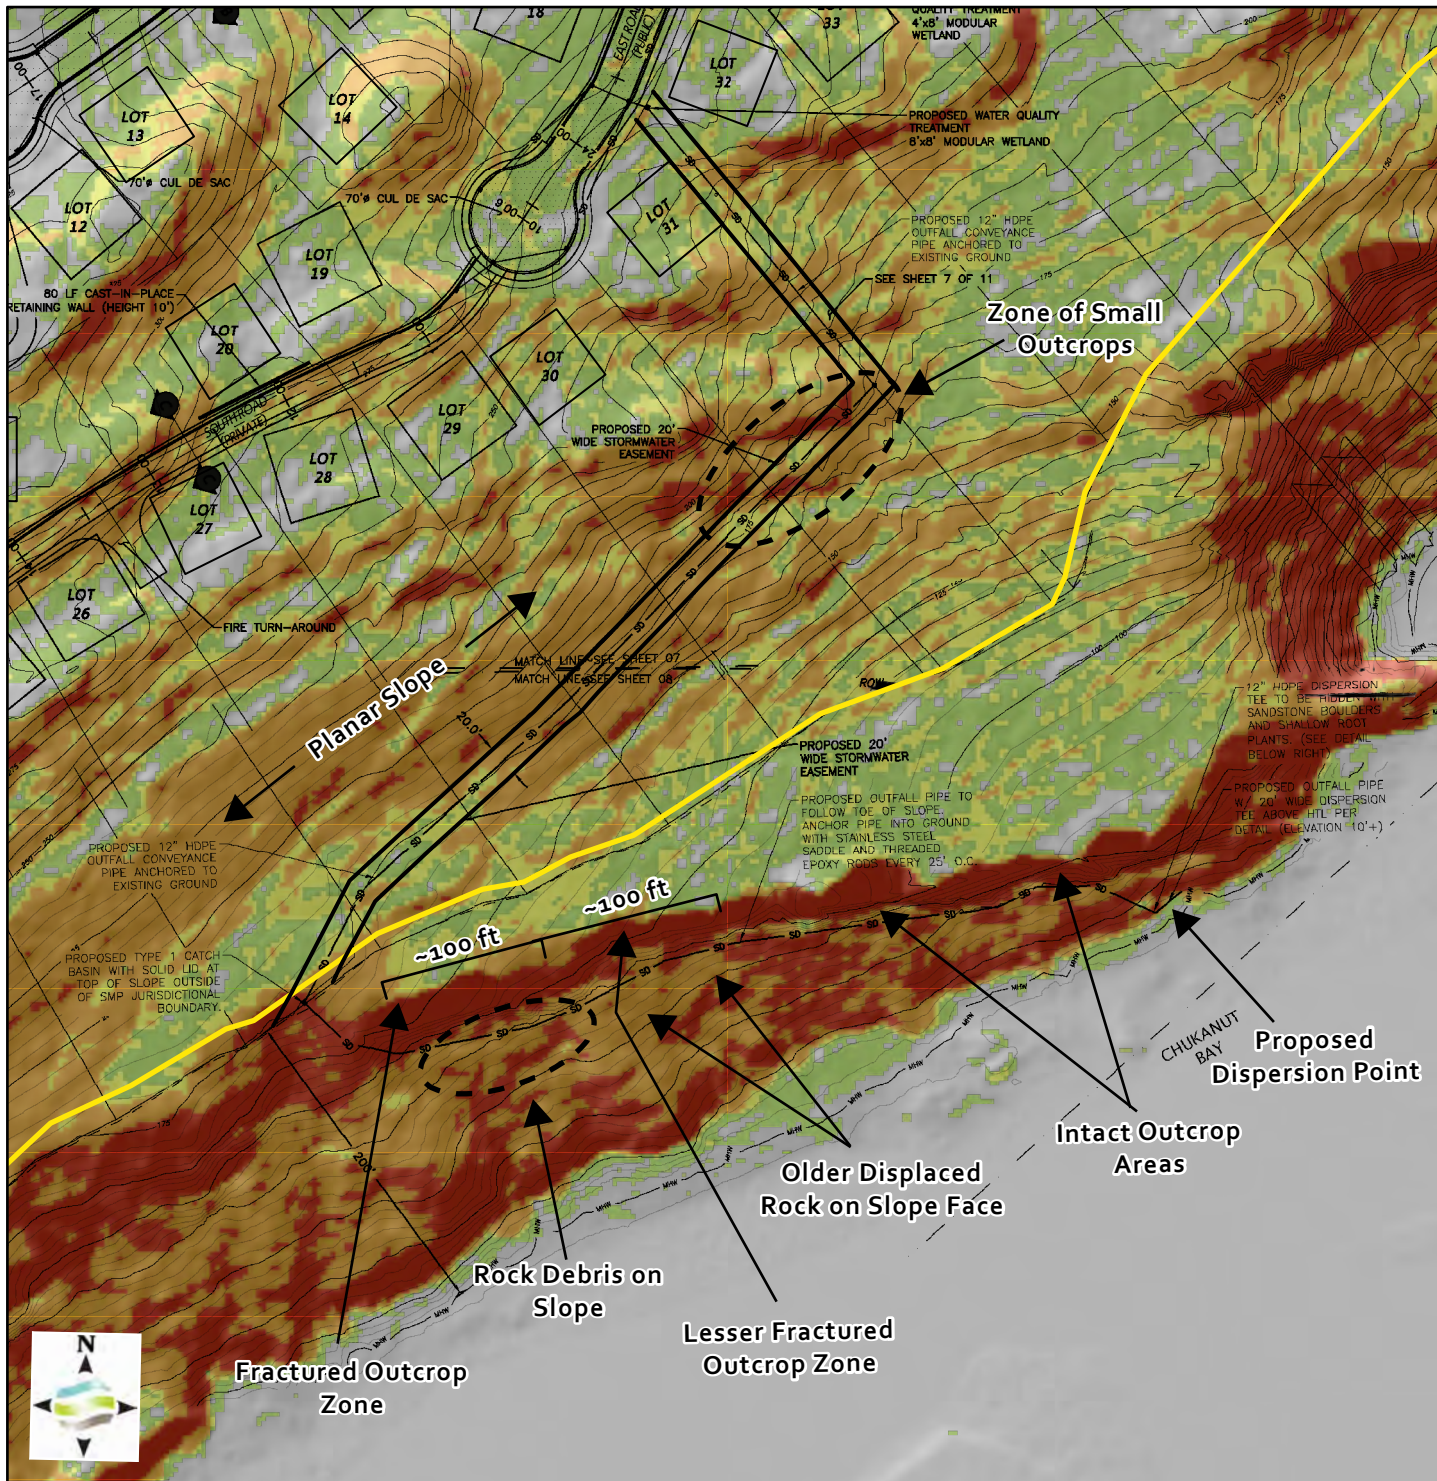
— Development Area
 — Roads

Weather conditions at the time of the visit were sunny and dry. Vegetation allowed for adequate access along the area of interest. A draft version of the attached Southern Region map (Figure 3) was produced overlaying outfall drawings on GIS slope-shade data to easily identify features in the field. The GIS map was loaded into a GPS-based application (Avenza) for continuous location tracking. As we traversed along the alignment, we observed surrounding slope stability conditions. We also assessed for potential

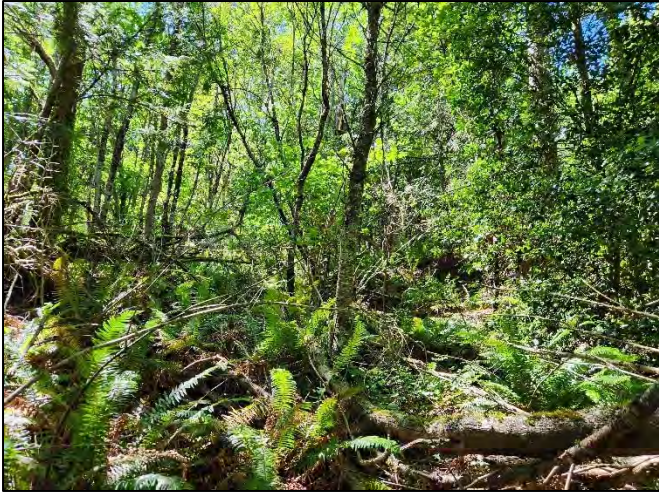
Photo 1: Upper slope conditions near top of SW outfall path, looking uphill.

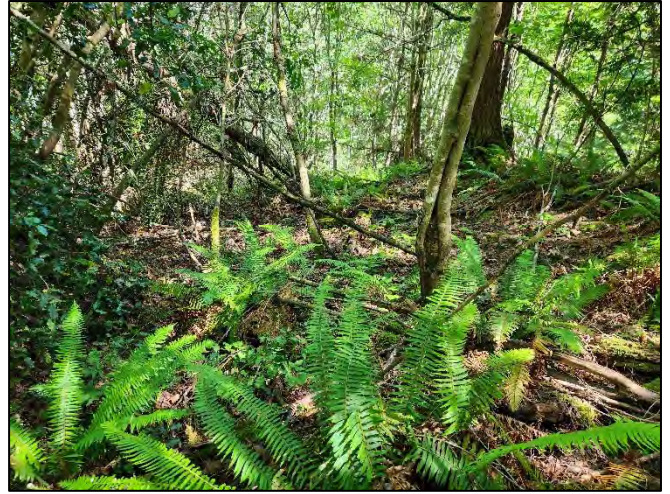
Photo 2: Upper slope conditions near top of SW outfall path, looking downhill.

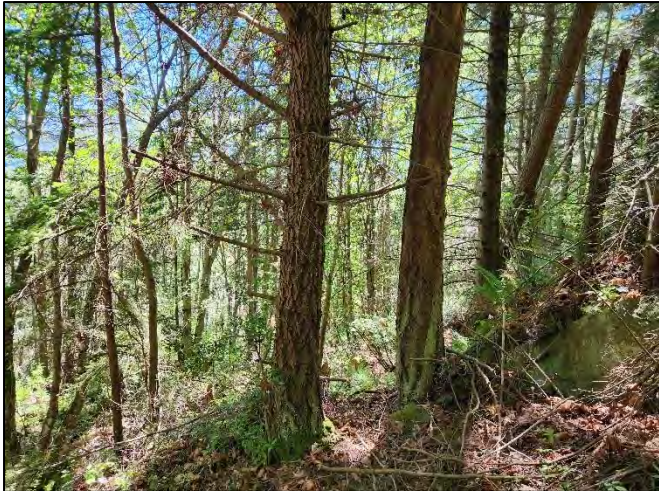
Photo 3: View to southwest from turn in alignment along proposed path with rock outcrop to right.

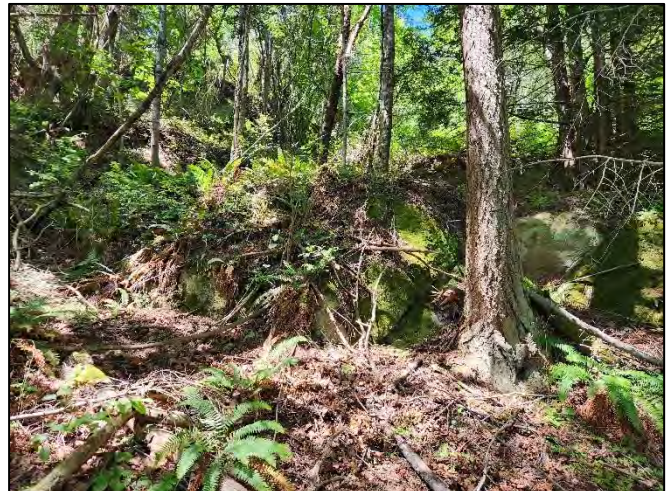
Photo 4: Looking uphill toward area of outfall path passing from right to left through extent of outcrop.

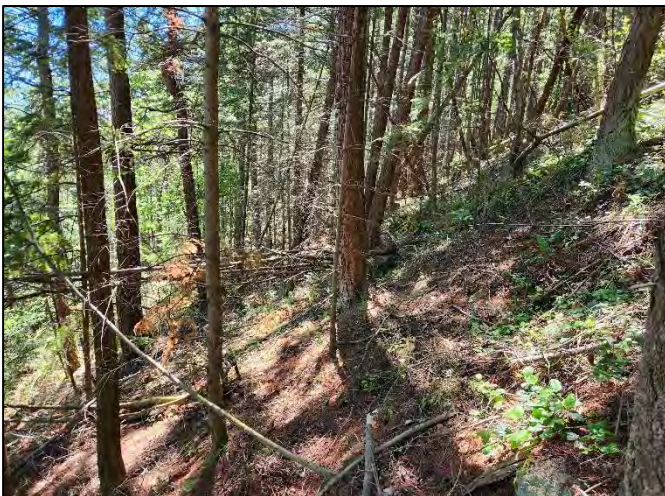
Photo 5: View along main outfall path across planar slope. Looking SW. Taken near end of outcrop zone.

Past the zone of small outcrops, the main southeast slope face is a broadly planar feature with minor local variation. Conditions are typically mature tree cover with varying degrees of underbrush and forest litter (Photos 5 & 6). Trees are generally growing with straight trunks indicating soil creep is not significant, but there is some evidence of leaning or fallen trees that suggests shallow rooting (likely in thin soils over bedrock). No evidence of slope erosion, sloughing, or failures was seen along the proposed alignment or on the slope face above/below. The slope becomes progressively more moderate to the southwest. At the location of the proposed top-of-bluff catch basin, topography is gentle and mature forest vegetation covers the zone between the upland slope face and lower bluff (Photos 7 & 8).

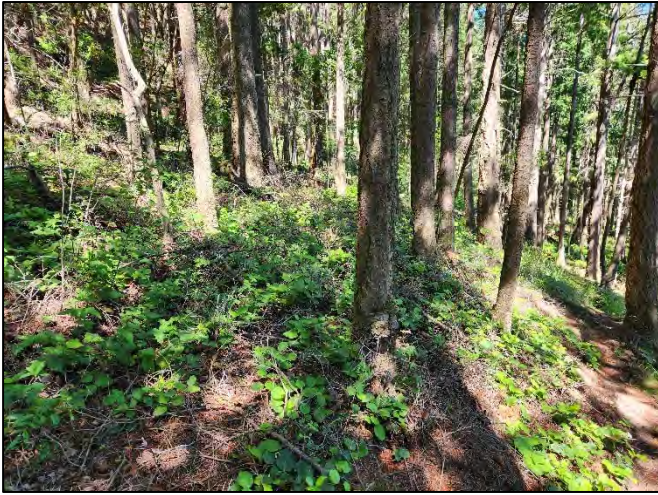
Photo 7: Looking at location of catch basin proposed near top of bluff (out of photo to right).

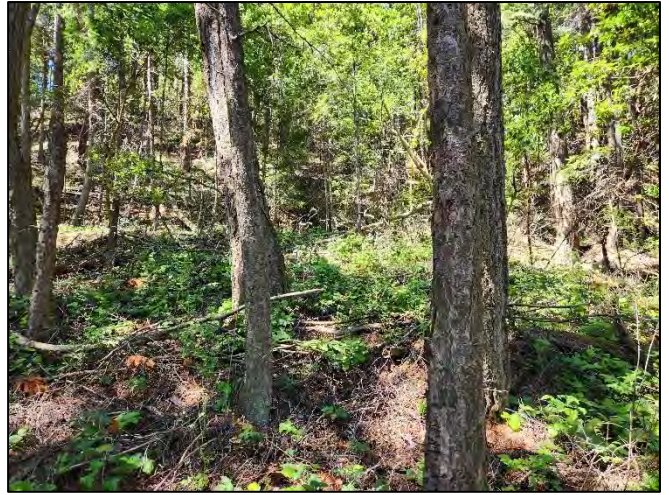
Photo 8: View uphill from location of catch basin. No evidence of slope activity and mature vegetation.

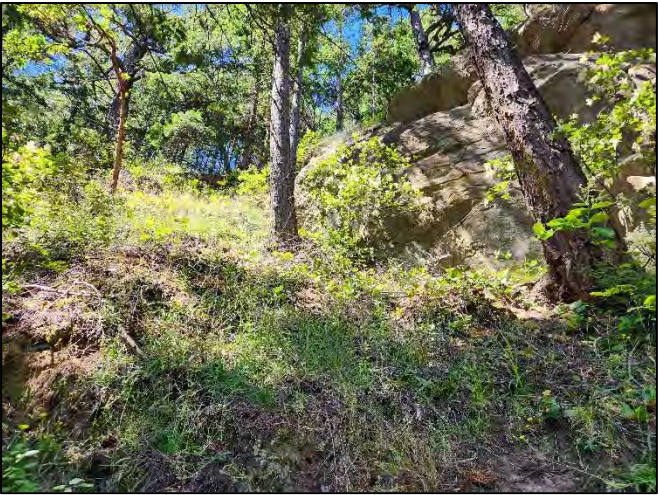
Photo 9: Looking up at slope face at entry of outfall onto lower bluff.

The location of the pipe entry onto the bluff slope is a planar section with little brush, grassy ground-cover, and several mature trees (Photo 9). The proposed alignment avoids a steeper erosion-prone area

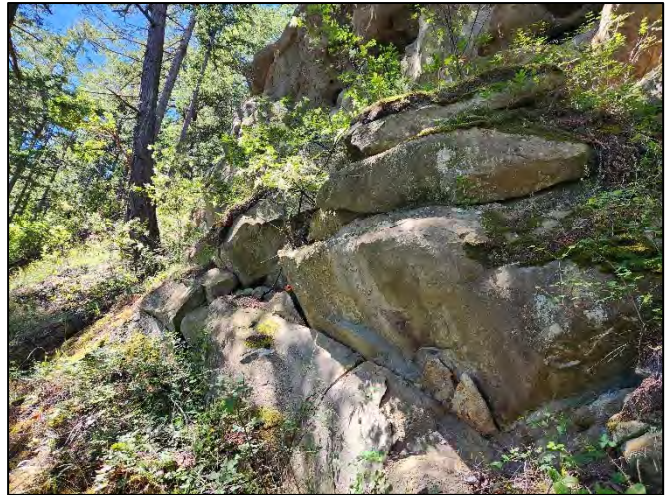
Photo 10: Fractured area of sandstone outcrop with loose rock exposed.

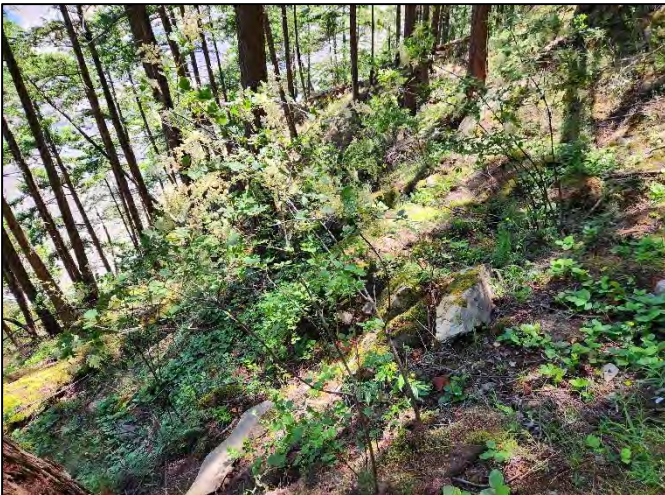
Photo 11: Slope face below fractured outcrop. Note rock fall debris in foreground.

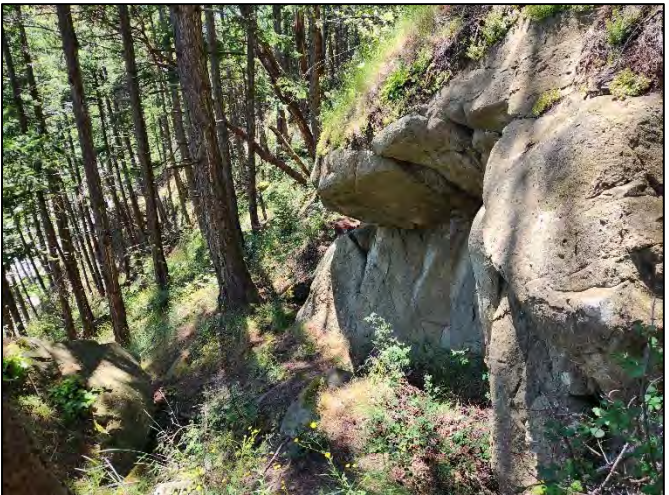
Photo 12: Sandstone outcrop becomes more competent / less fractured to east.

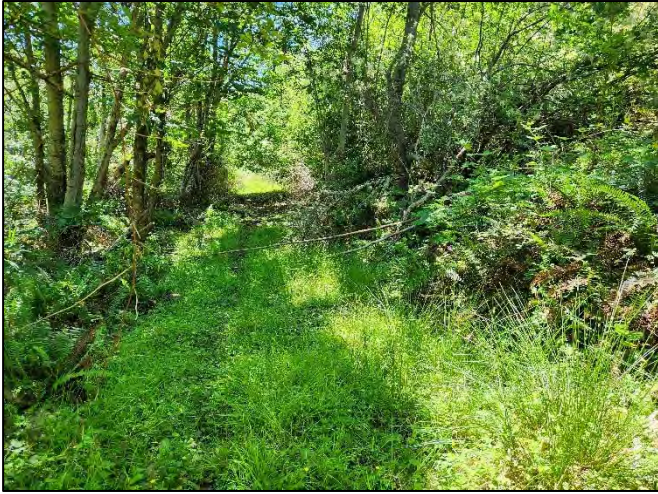
Photo 1: View along area of proposed dispersion spreader at west edge of Lot 38. (6-24-24)

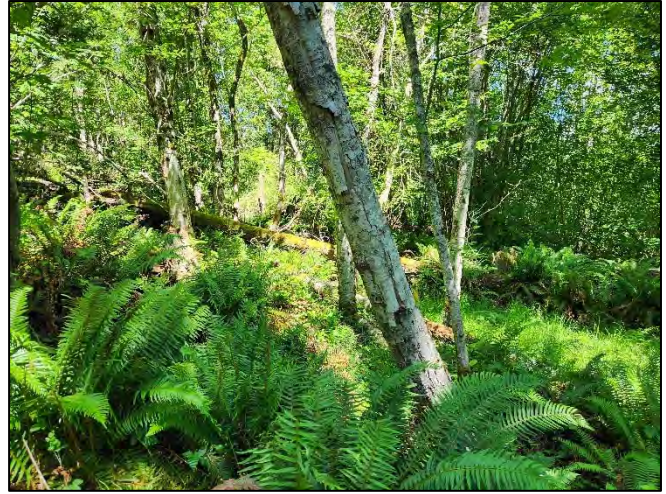
Photo 2: View to North across Wetland "B" area downhill to east of planned dispersion area. (6-24-24)

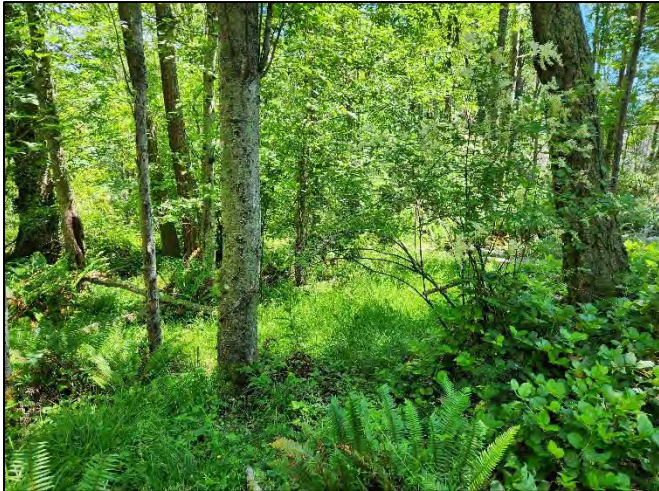
Photo 3: View to East downhill from Wetland "B" toward small Wetland "C" and forest area. (6-24-24)

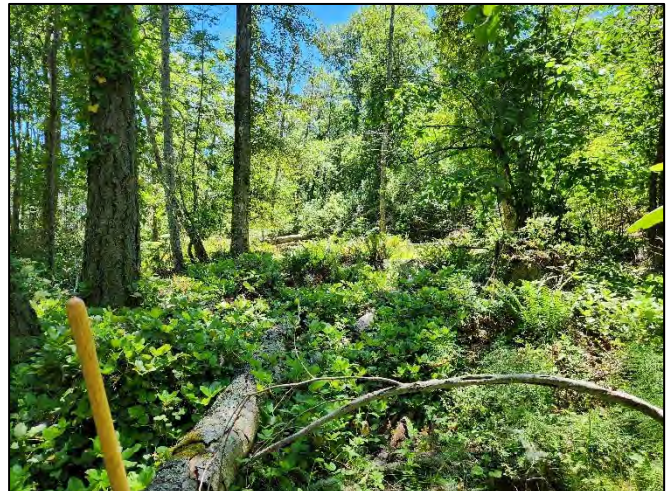
Photo 4: Gentle forested upland area to south of Wetland "B". (6-24-24)

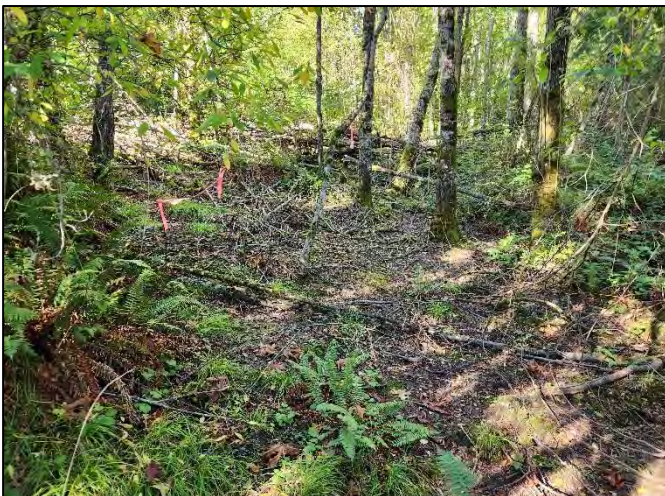
Photo 5: Small Wetland "C" area, looking to northwest. (10-7-24)

This area was traversed again in October, finding no obvious change in conditions among Wetland “B” and surrounding extents. Ground was locally moist to wet after some early fall rain events but free water was not encountered. The small Wetland “C” was also located and observed to be a pocket of limited brush with some wet-zone vegetation and locally moist ground, appearing to coincide with swale-like topography between two ridge forms (Photos 5 & 6). This feature is isolated among otherwise typical forest areas, and no free water or evidence of significant flow was observed.

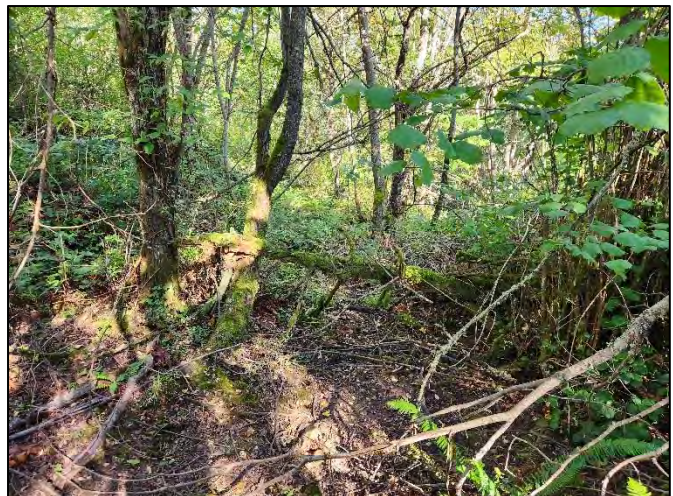
Photo 6: Small Wetland "C" area, looking downhill to east along minor convergence in grades. (10-7-24)

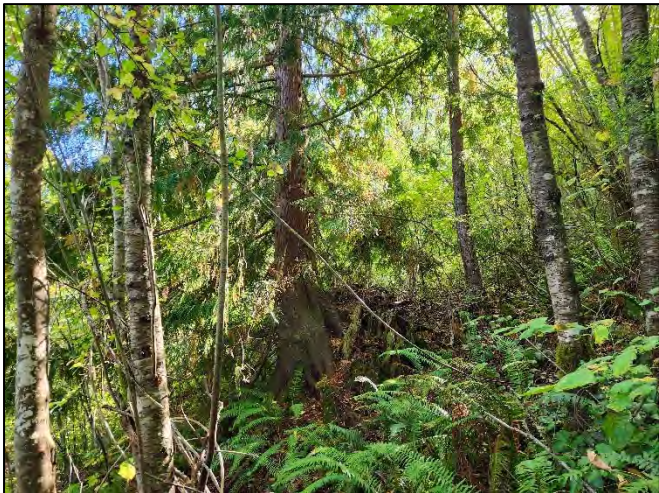
Photo 9: LHA slope crest along south area of slope, looking South downhill of proposed Lot 38. (10-7-24)

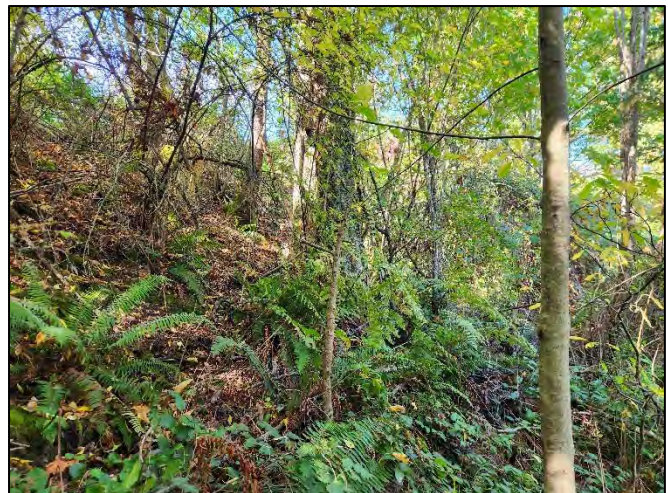
Photo 10: LHA slope face. Looking North toward middle of slope. (10-7-24)

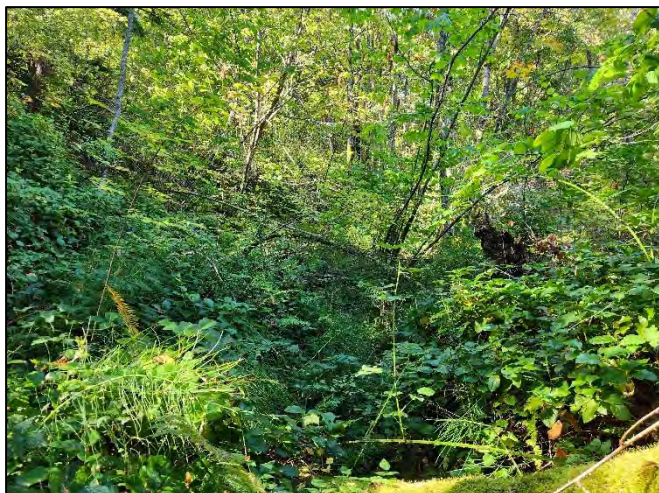
Photo 11: View Northwest through LHA basin / Wetland "A" area from South end. (10-7-24)

The convergent basin below the LHA slopes consists of lower surface grades leading into the low-lying Wetland “A” area. The transitional lower slope zone was covered in heavy brush and not accessed, but was viewed from within the basin bottom (Photos 11 & 12). We observed ground conditions becoming progressively moist to wet northeastward. Vegetation also changes to wet zone grasses and plants approaching the east site boundary (Photo 14) which is paralleled by a driveway embankment (Photo

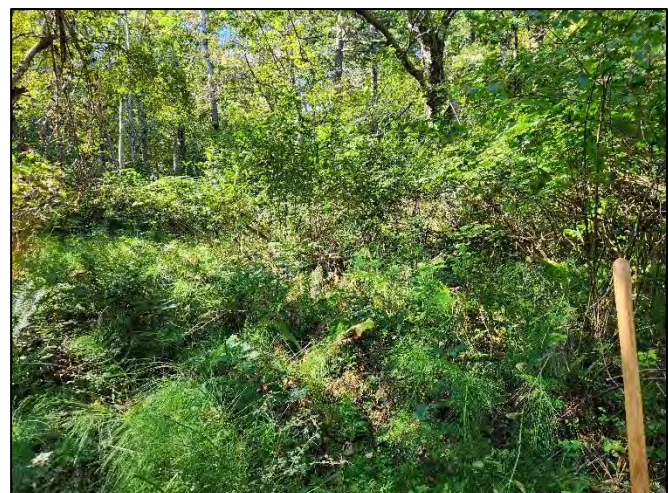
Photo 12: Conditions in middle of LHA basin / Wetland "A" area. (10-7-24)

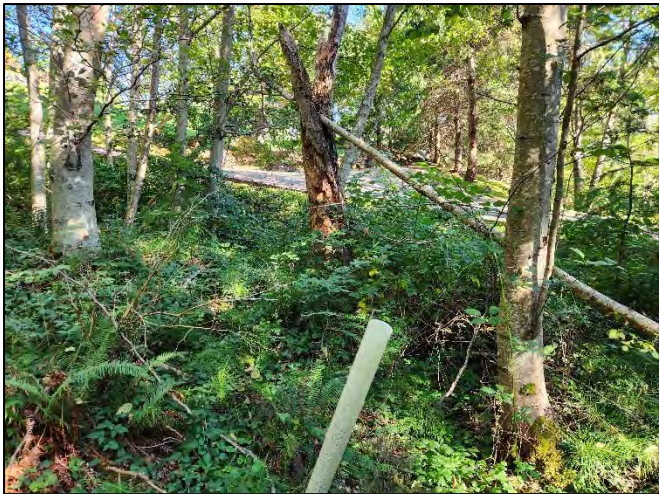
Photo 15: Within east side of LHA basin, looking east toward SFR driveway embankment. (10-7-24)

15) that effectively confines the basin on that side. At the low-point east margin of the basin, we found the mapped public Storm Drain inlet that leads into the Sea Pines Road system (Photo 16). City of Bellingham maps indicate an outfall for a public storm drain system from Viewcrest Drive located just uphill from the site's northeast corner (shown on Figure 2). We could not access this area from within the site (Photo 13). The presence of the mapped wetland extending well up the slope toward this outfall suggests the conditions are related. It is plausible, if not likely, that the SD outfall is a primary contributor to Wetland "A", and that the accumulation of water in this basin is controlled by the downhill inlet. We did not find or directly observe other seeps in the area.

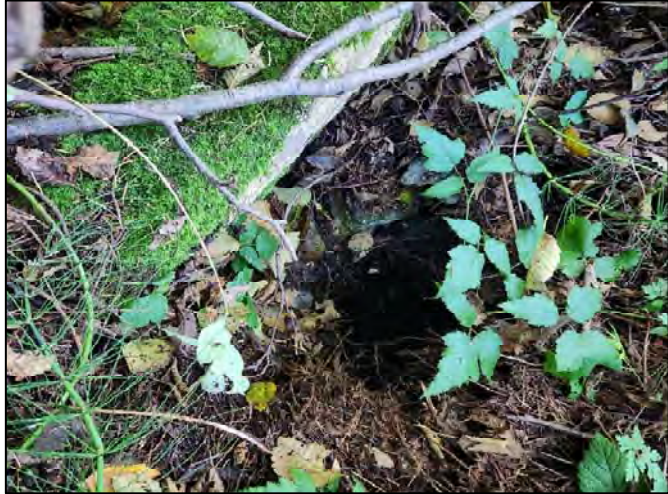
Photo 16: Found SD inlet at East edge of LHA basin and site, leads to Sea Pines Road utility. (10-7-24)

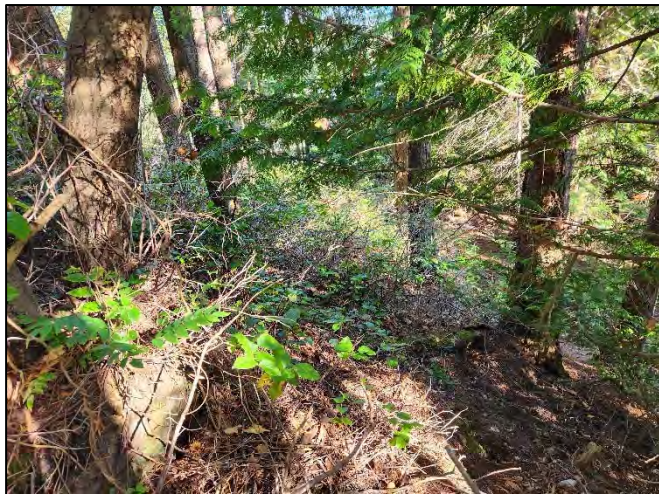
Photo 17: Moderate forested slope conditions at Lot 37 building zone, looking West. (10-7-24)

The anticipated Lot 37 building area is located directly south of Wetland "A" by approximately 60 feet. The building zone is separated from the wetland basin by a topographic ridge-form that flanks the south side of the basin. The moderate, forested slope face to the south of the ridge form is characteristic of general upland forest areas within the project site (Photos 17 & 18). We saw stable grades and vegetation there, and no sign of wetness or runoff associated with nearby Wetland "A".

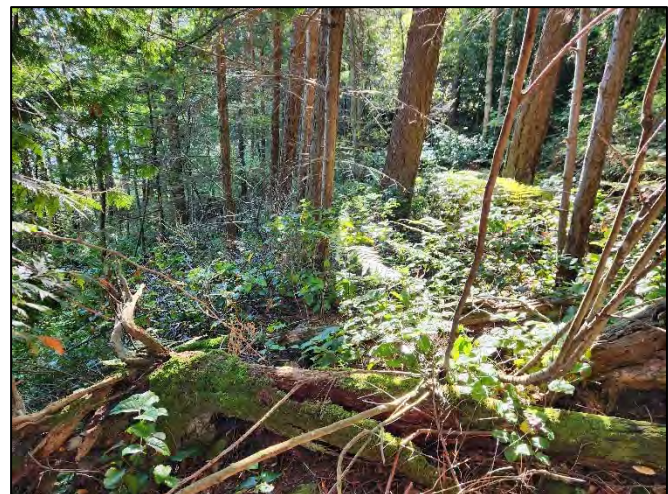
Photo 18: Moderate forested slope conditions at Lot 37 building zone, looking Southeast. (10-7-24)

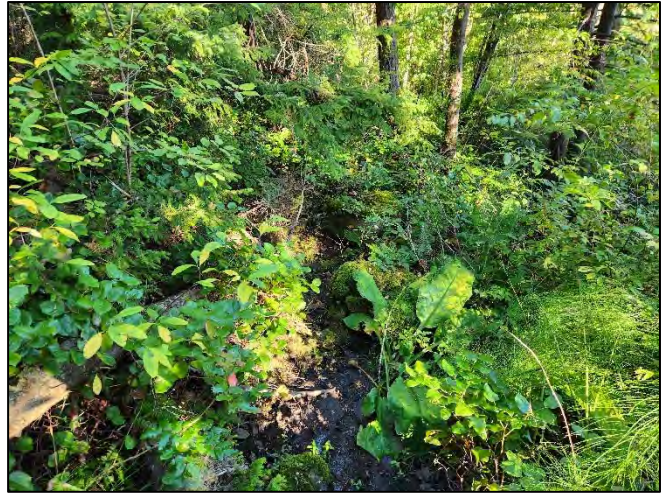
Photo 20: View down-gradient along strip of Wetland "D". (10-7-24)

We located the top of the mapped wetland, finding wet ground exposed where a large tree had fallen in the past (Photo 19). Nearby rock exposures suggest bedrock is shallow in this area, limiting root depth and contributing to perched water conditions. We followed the upper half of the feature downhill until heavy brush became impassable. The feature was slightly lower compared to flanking slope areas, confining its extent. The feature typically had dark, moist to wet organic soils amid wet zone plants (Photo 20). Minor free water was present, although there was no consistent flow or channelization seen at the time of our visit. The lower end of Wetland "D" was found from below. At its terminus, the wet zone flora ends abruptly into typical brushy undergrowth approaching the lower slope (Photo 21). Along the nearby bluff slope crest, bedrock is exposed and patchy cover soils did not have signs of erosion from excess water flow (Photo 22). We interpret that any excess wet conditions emanating from the Wetland "D" feature are reabsorbed into the ground along the gentle upland grades before reaching the rocky bluff crest.

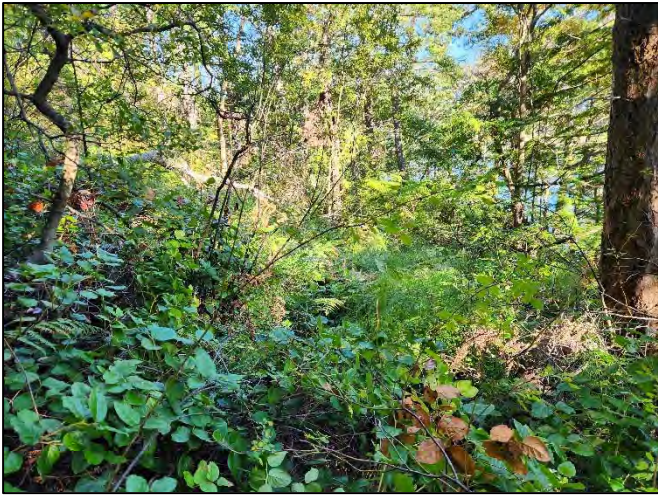
Photo 21: Downhill terminus of Wetland "D" above bluff slope. (10-7-24)

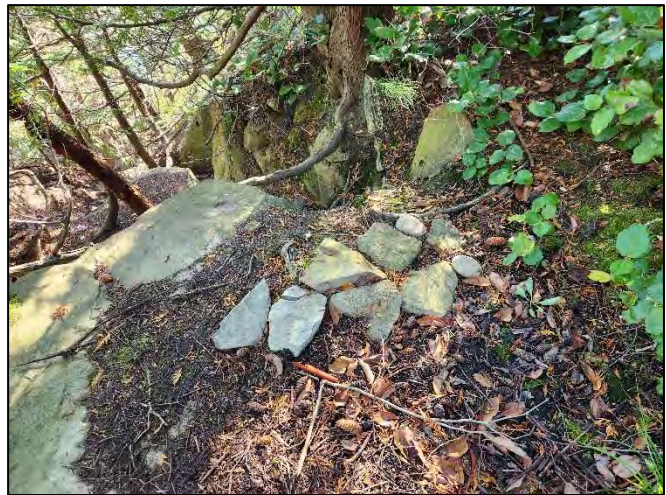
Photo 22: Rocky bluff slope crest near end of Wetland "D". (10-7-24)

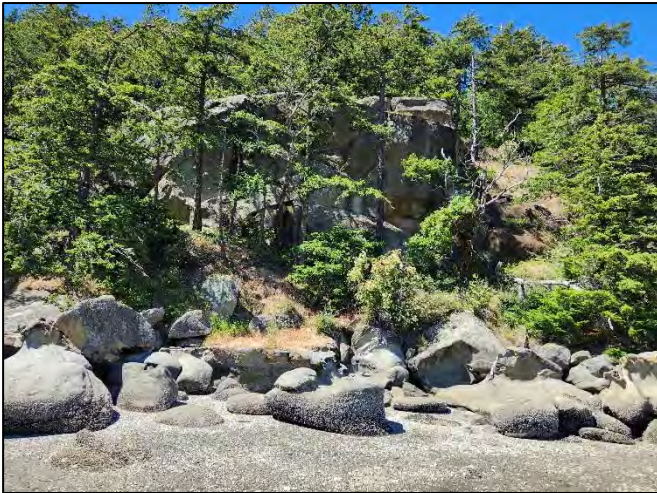
Photo 1: View of site shoreline from tidal zone at proposed dispersion area.

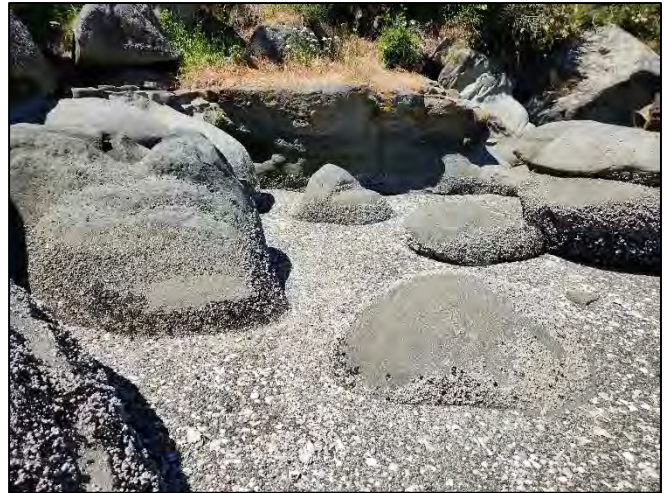
Photo 2: Dispersion is proposed atop the flat "table" outcrop situated among a rocky area.

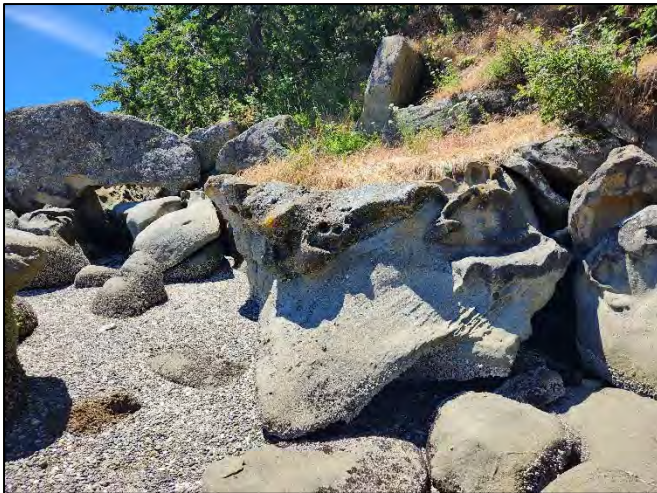
Photo 3: Profile view of dispersion outcrop and upper tidal conditions below.

Upper tidal sediments around and below the dispersion outcrop are composed of sand and gravel with low fines content, based on surface observation and shallow potholing (Photos 3 & 4). The coarse upper tidal sediments extend for several tens of feet out from the rocky shoreline (varying locally) as grade falls gradually at around a 3% to 5% common decline. Past the upper tidal zone is a relatively thin transitional margin (10 to 15 feet wide) composed of mixed coarse and fine sediment, then the lower tidal flat is reached (Photos 5 & 6). Lower tidal sediment is predominantly fine-grained material with rare cobbles and small boulders.

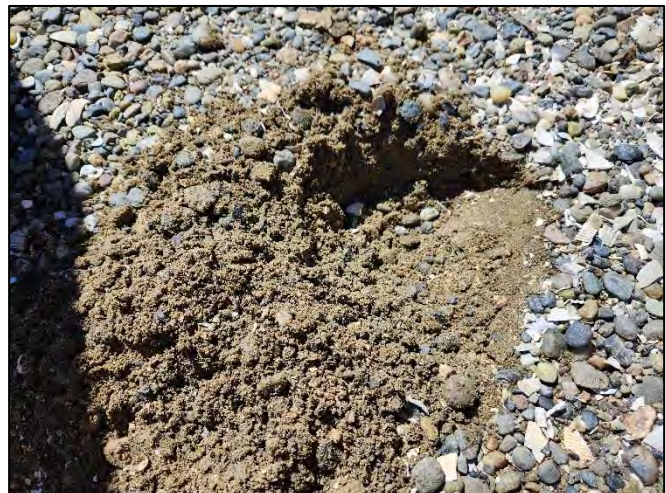
Photo 4: Upper tidal sediments consist of coarse-grained sand and gravel.

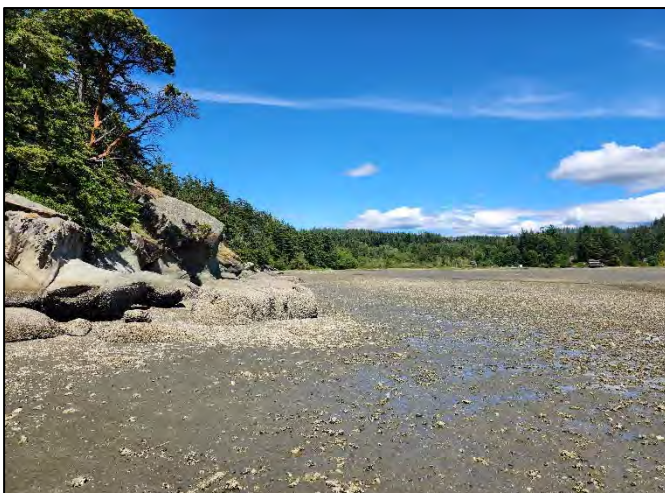
Photo 5: View to east from near dispersion area showing lower tidal conditions

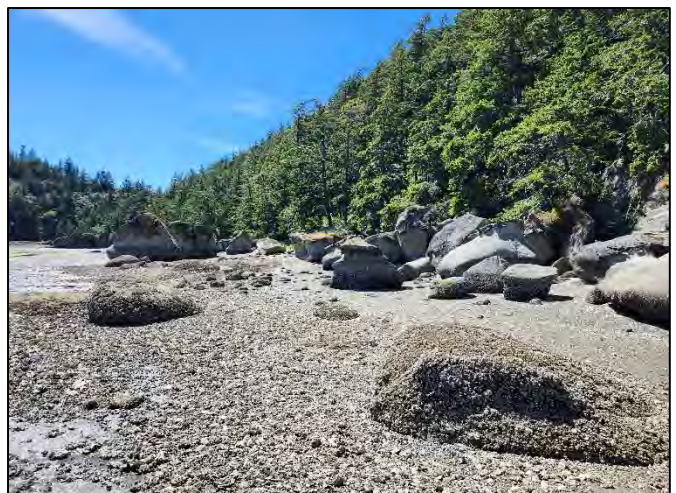
Photo 6: View to southwest from near dispersion area showing transition zone between upper and lower tidal areas.
