Preliminary Stormwater Management Report

THE WOODS AT VIEWCREST

**GEOTECHNICAL INVESTIGATION
& GEOHAZARD REPORT
JONES EDGEMOOR ESTATE
PROPOSED 38-LOT PLAT DEVELOPMENT
VIEWCREST ROAD, BELLINGHAM, WA**

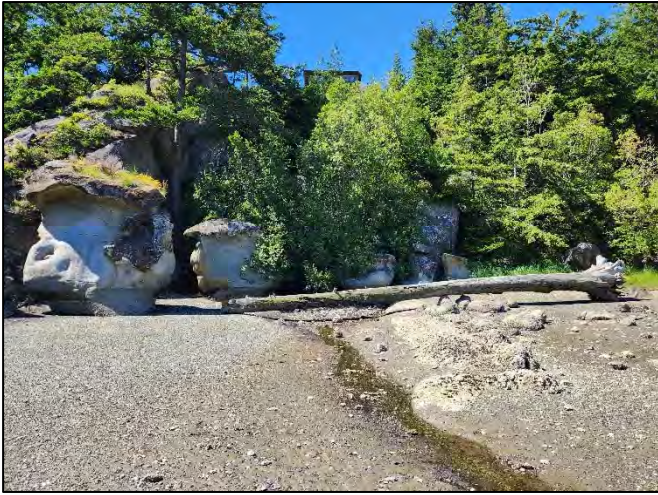
Photo 7: View of shoreline at location of existing stormwater release below Arbutus Place.

consisting of coarse-grained sediments and local bedrock, are similar to that of the project location (Photo 7). A localized drainage “apron” around 10 feet wide emerges from the shoreline at the OHWM. The apron narrows quickly away from the shoreline; after approximately 20 feet it transitions to a discrete flow channel (Photo 8). The channel is a shallow and broad feature with gradual sides that progressively becomes smaller with distance from the shoreline (Photo 9). After about 100 feet, the channel becomes very shallow with little to no confining profile as it traverses the lower tidal zone and turns broadly left to head toward the main outer tidal area (Photo 10). After another approximately 50 feet, the channel feature is indistinguishable and remaining flows distribute over a broad area resembling general tidal conditions.

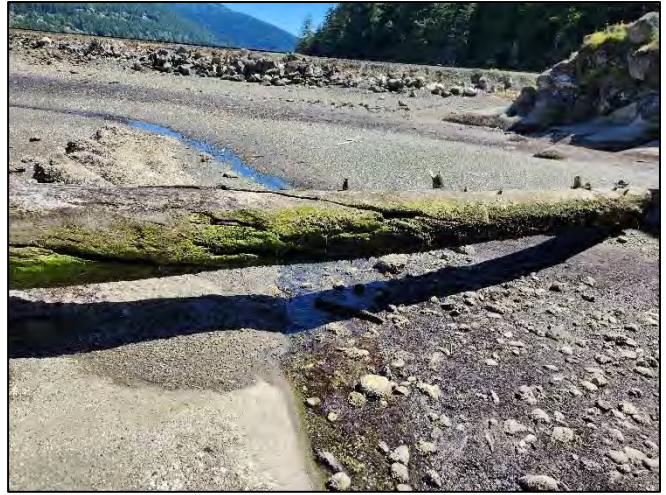
Photo 8: View out from shoreline next to emergence point of existing release.

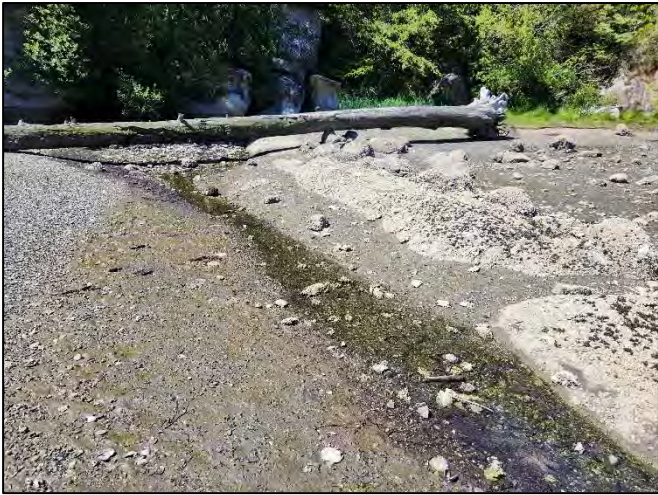
Photo 9: Closer view of flow channel conditions through upper tidal area.

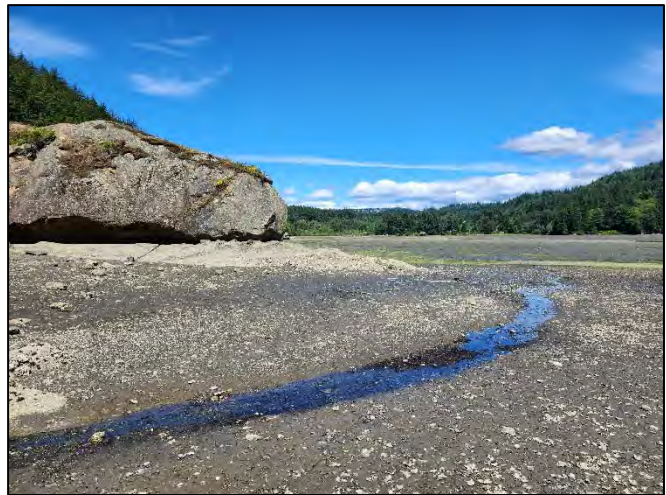
Photo 10: View of channel through transitional zone heading into lower tidal area where it becomes indistinguishable.

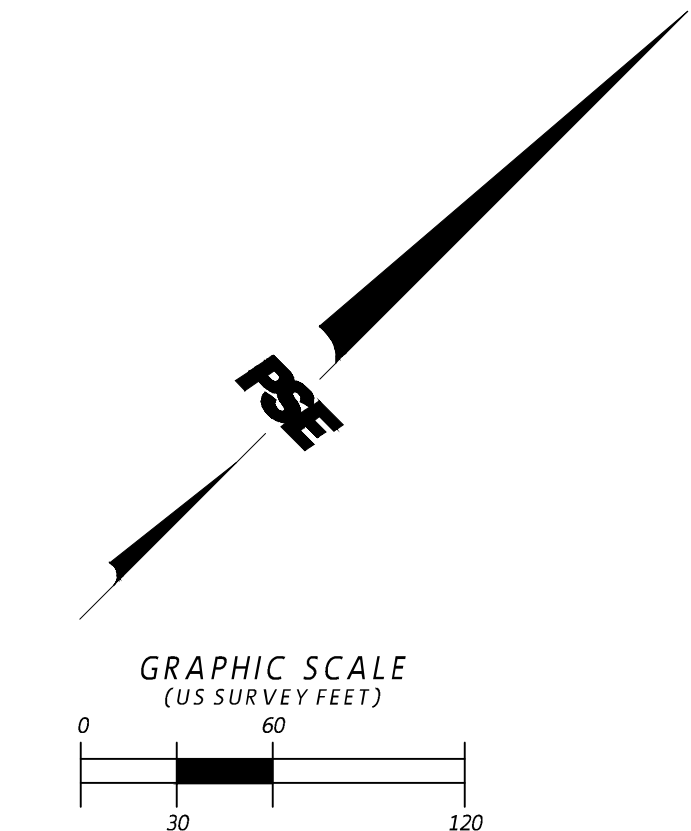
8.4 BASIN MAP

TDA 1

- TOTAL AREA = 307,109 SF/7.04 AC
- MUNICIPAL WATERSHED: BELLINGHAM BAY
- TDA OUTFALL: VIEWCREST RD STORM SEWERS

TDA 2

- TOTAL AREA = 768,668 SF/17.61 AC
- MUNICIPAL WATERSHED: BELLINGHAM BAY
- TDA OUTFALL: CHUCKANUT BAY

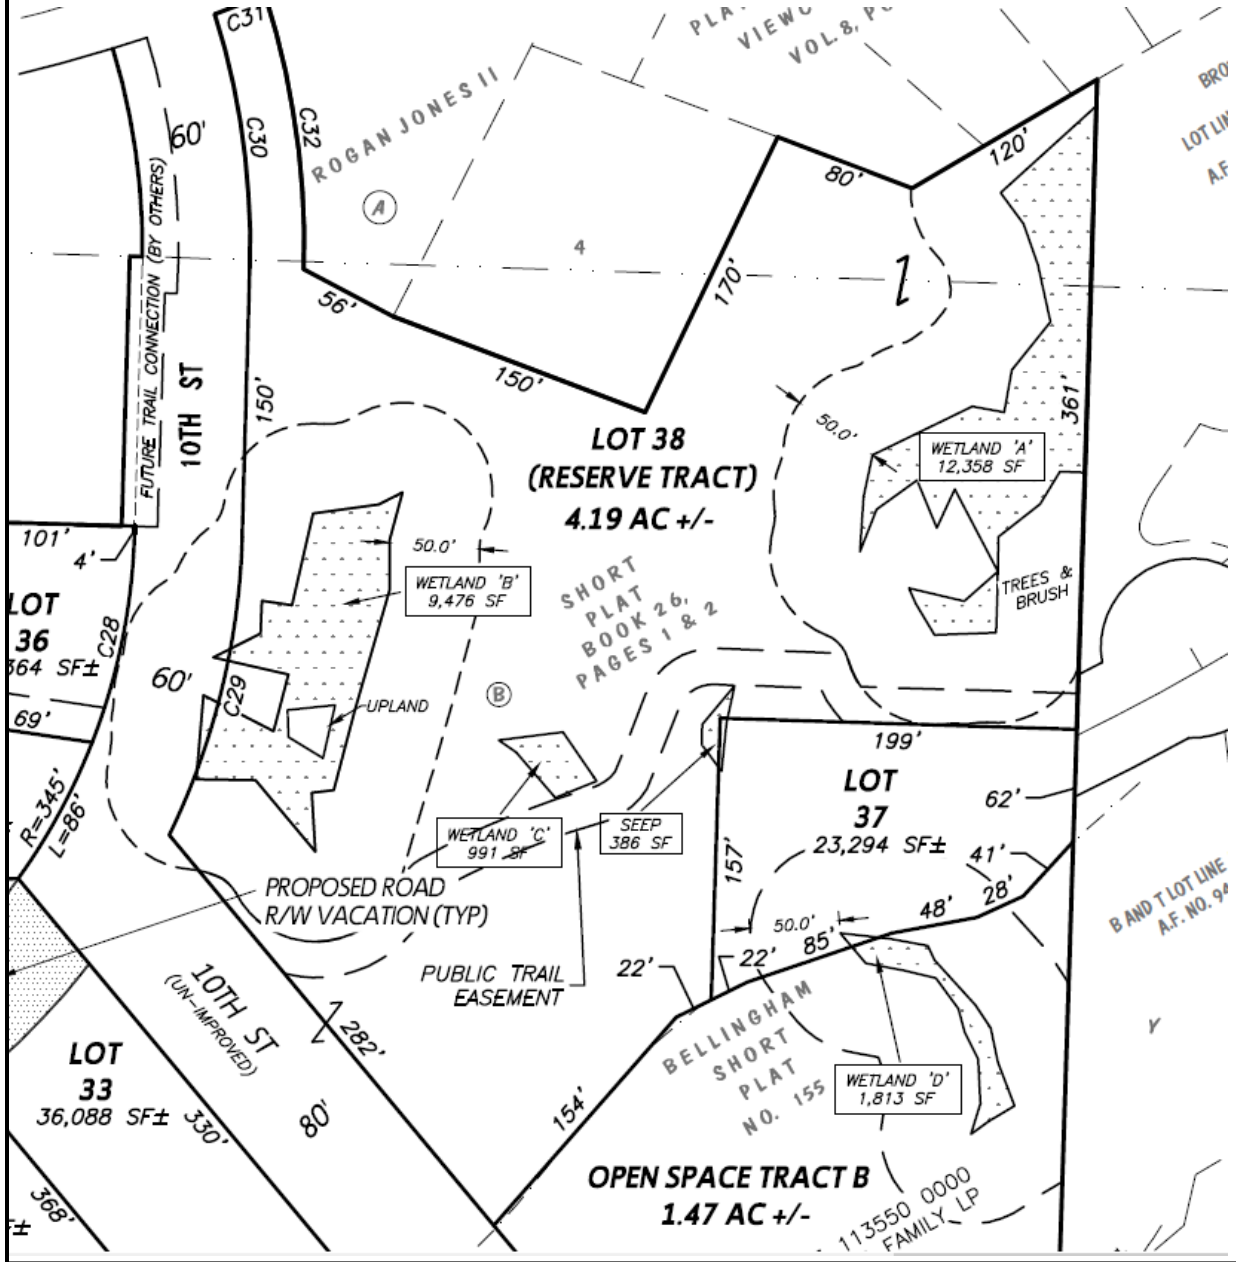
<p>NORTHWEST</p>	<p>Wetlands Survey Map (PSE)</p> <p>The Woods at Viewcrest Critical Areas Update</p>	<p>Figure 3</p> <p>SEPT 2022</p>
--	---	--

The 2010 report identified one slope wetland (Wetland A) in the northeastern corner of the site. NES observed Wetland A and also identified three additional slope wetlands (Wetlands B, C, and D) located in the nearby vicinity (Figure 2). NES collected data documenting wetland vegetation, soils, and hydrology indicators in each wetland (see attached data sheets). NES delineated and marked the wetland boundaries in the field with pink flagging. The flags were surveyed by Pacific Survey and Engineering, Inc. (PSE) to produce Figure 3.

Consistent with the 2010 report, a groundwater seep was observed in the central portion of the review area (Figure 3, Appendix B). Groundwater surfacing from a slight cut in topography flows downslope along an unvegetated trail. Water infiltrates into the ground without a surface connection to a downstream water or wetland. No defined channel exists, and the seep does not meet the criteria to be designated as a stream per BMC 16.55.470(A)(4) and WAC 222-16-031. Furthermore, as documented in SP 102 (data sheets attached) this area did not contain hydric soil indicators and therefore does not meet wetland criteria.

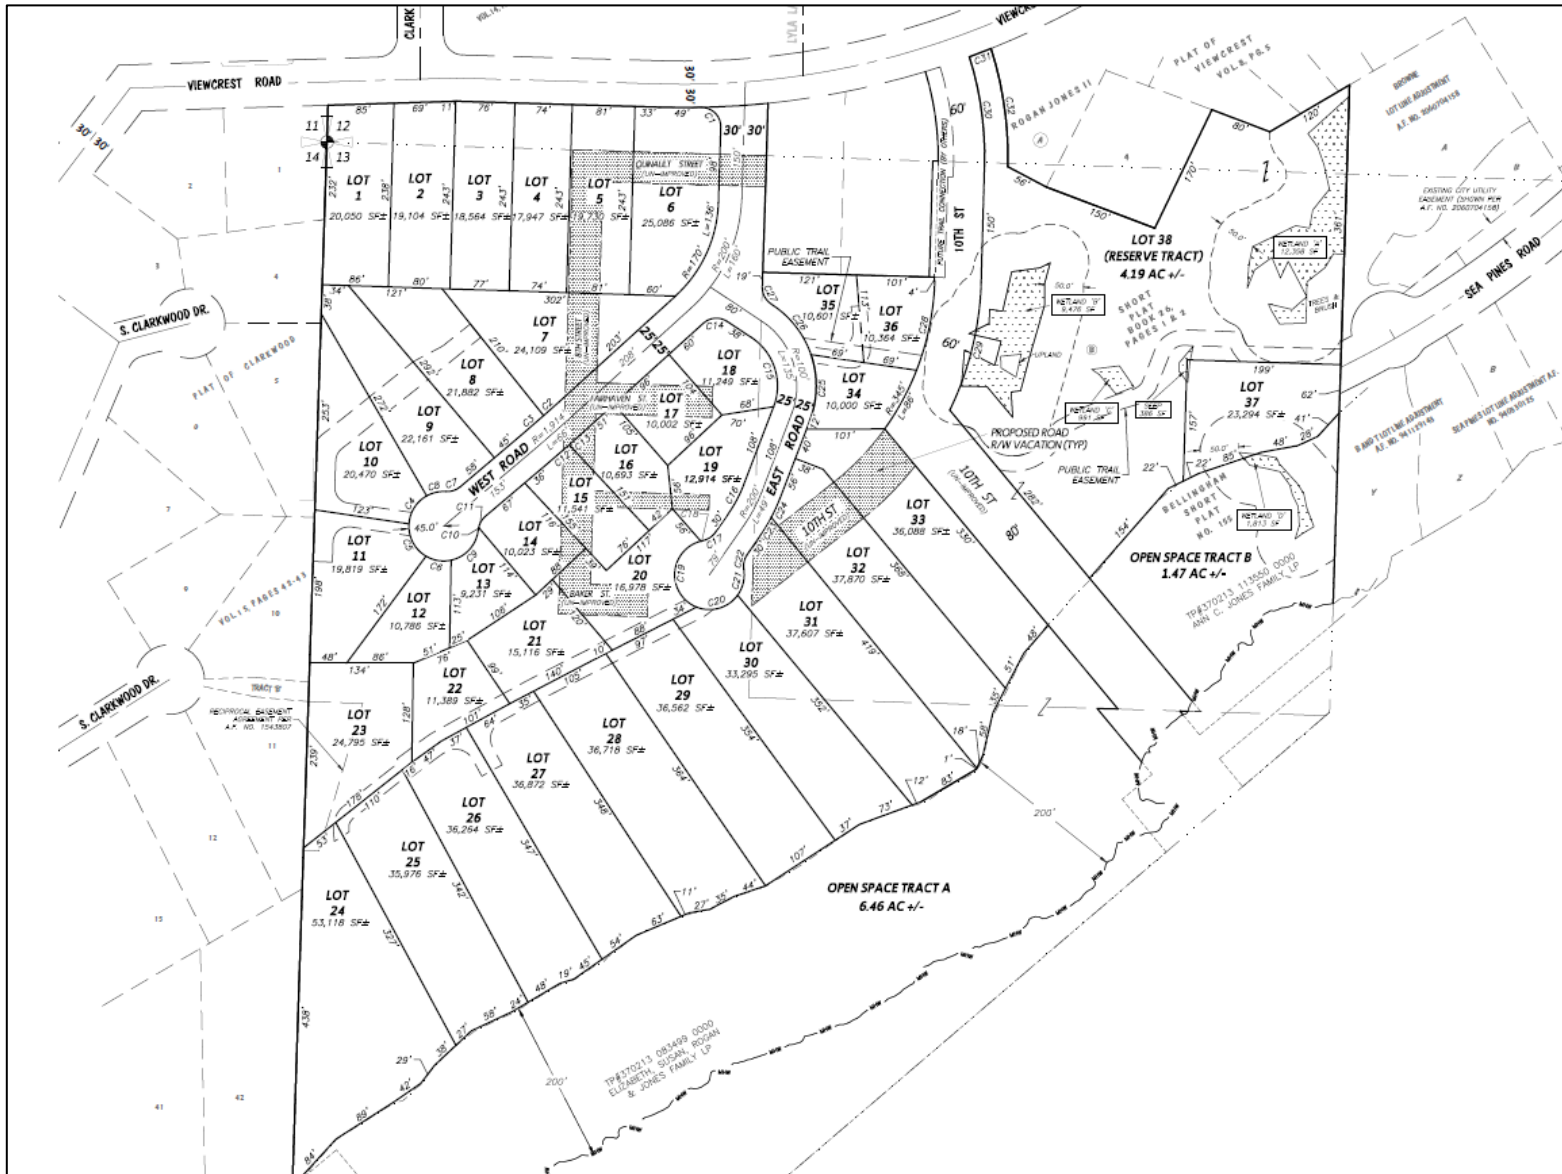
<p>Preliminary Plat (PSE)</p> <p>The Woods at Viewcrest</p> <p>Critical Areas Update</p>	<p>Figure 4</p> <p>SEPT 2022</p>
--	---	--

Note: This memorandum updates and replaces the June 3, 2022 memo to incorporate the current lot configuration reflected in Figures 3 & 4. This is the sole revision; there are no changes to the critical areas information contained herein.

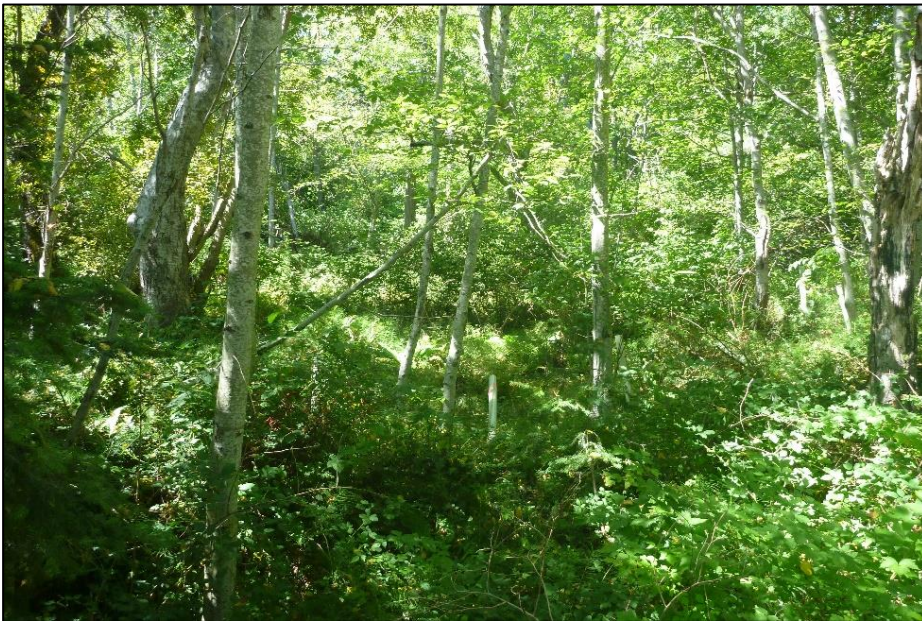
Overview of Wetland A, looking west

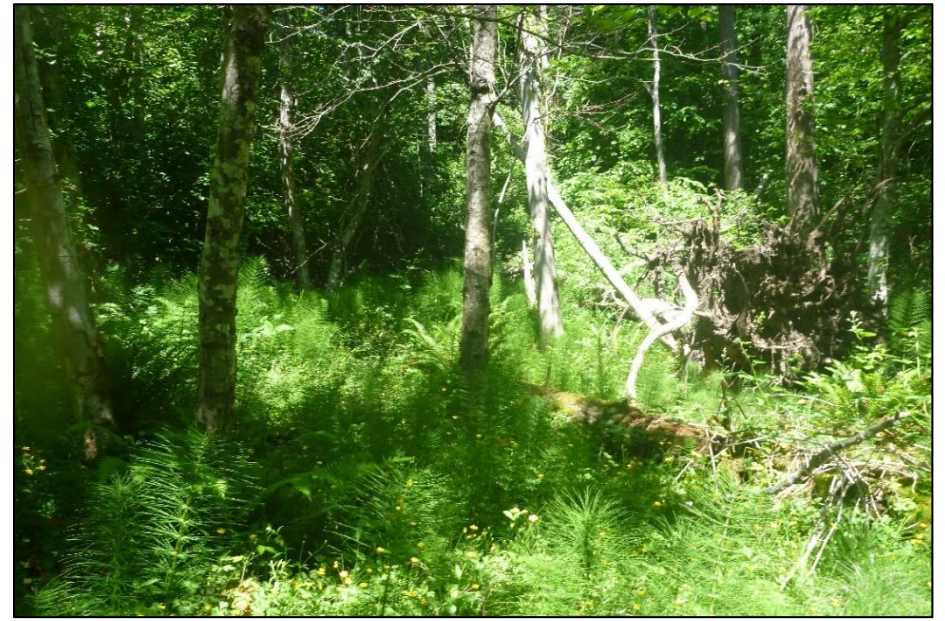
Overview of Wetland A, looking northwest

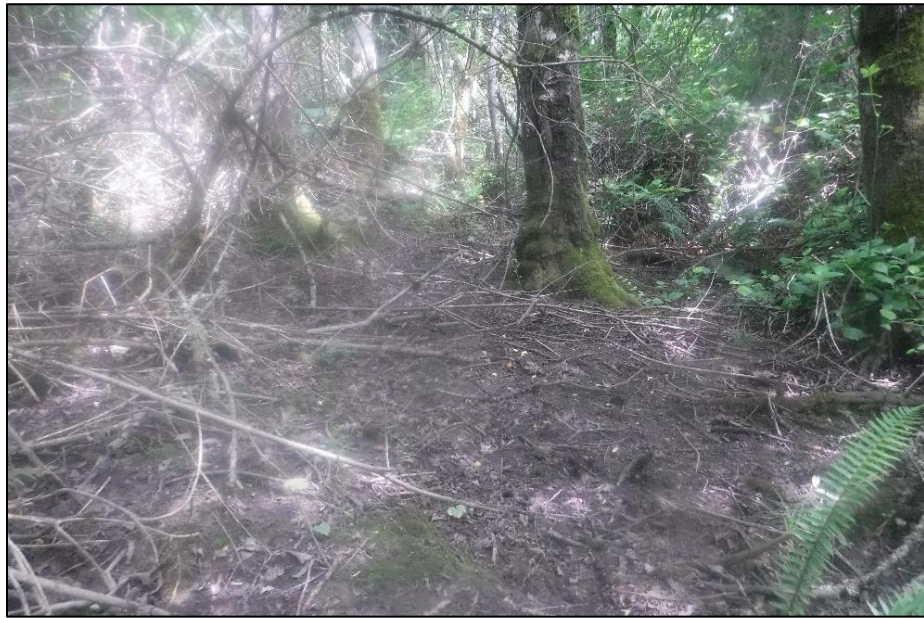
Overview of Wetland C

The wetland was dry at the time of the site visits but appears to be seasonally saturated only. The wetland is located on an approximate five percent grade. Water from the wetland appears to outlet to the south and infiltrate into the forested upland.

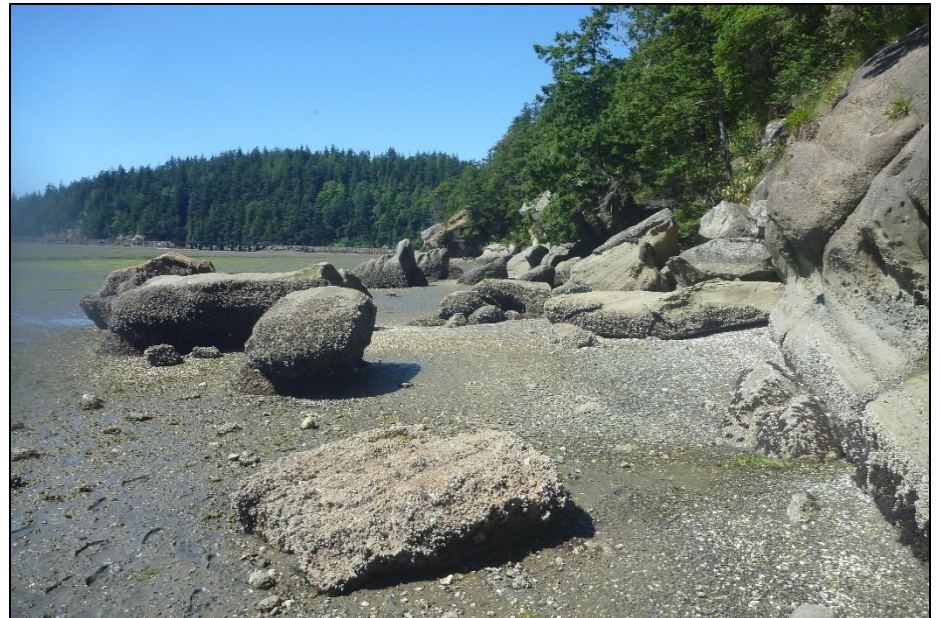
Overview of Mud Bay shoreline and OHWM

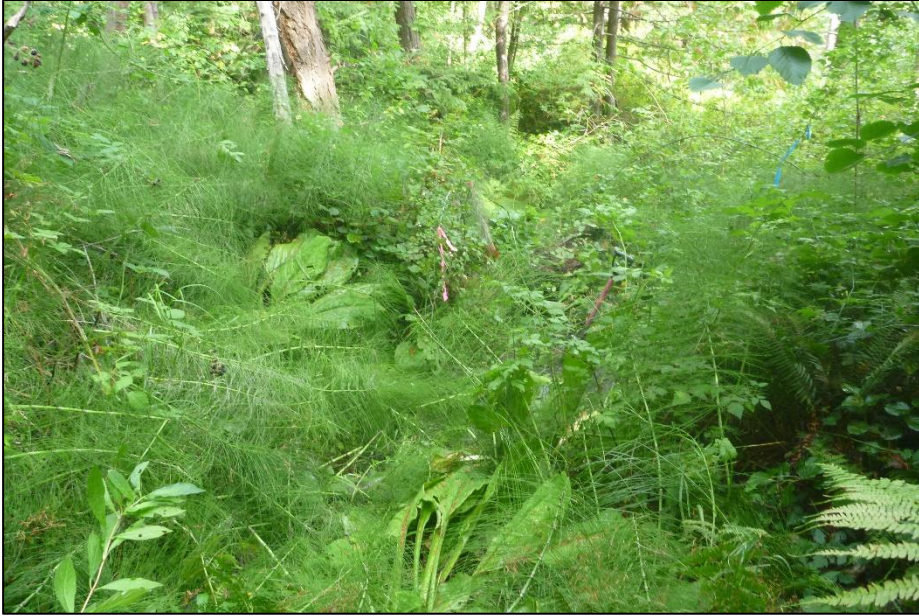
Overview of Wetland D

Hydrology within Wetland D is similar to the other site wetlands with inputs including surface runoff and groundwater surfacing along the hillside. Water within Wetland D flows downslope to a rock headwall/boulder formation towards the grade break near the southern boundary of the review area. No surface connection to Chuckanut Bay was observed.

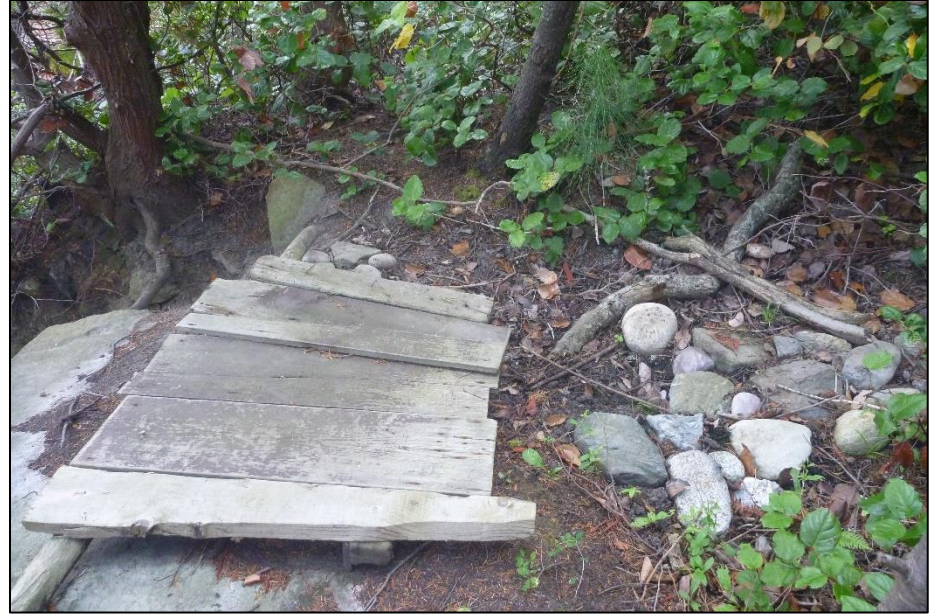
Detail of Wetland D outlet

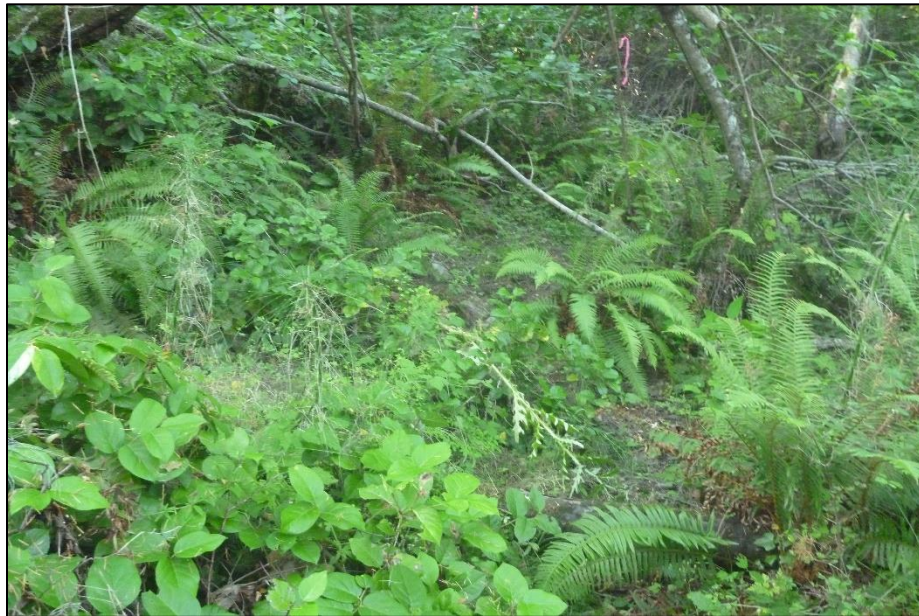
Overview of seep

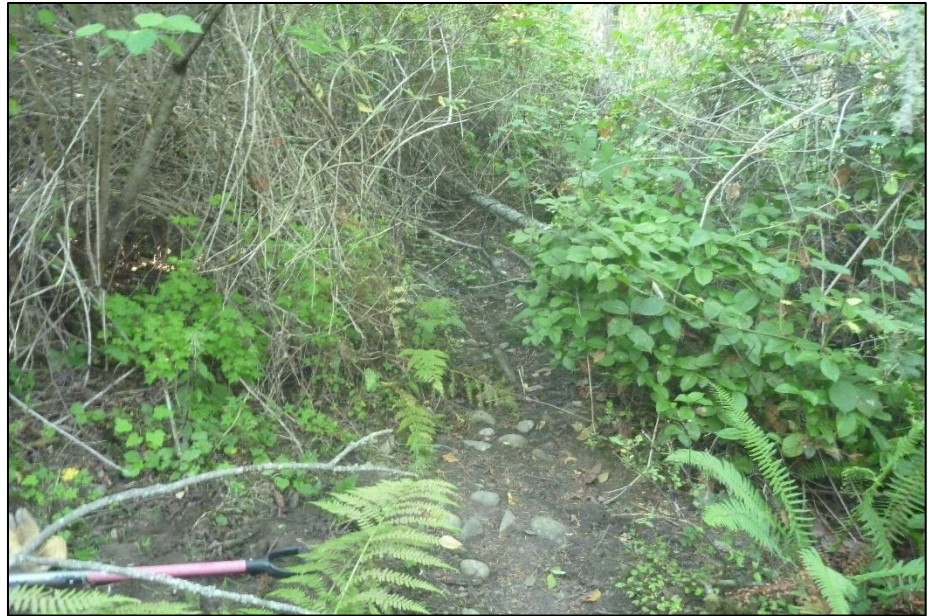
Seep from downslope

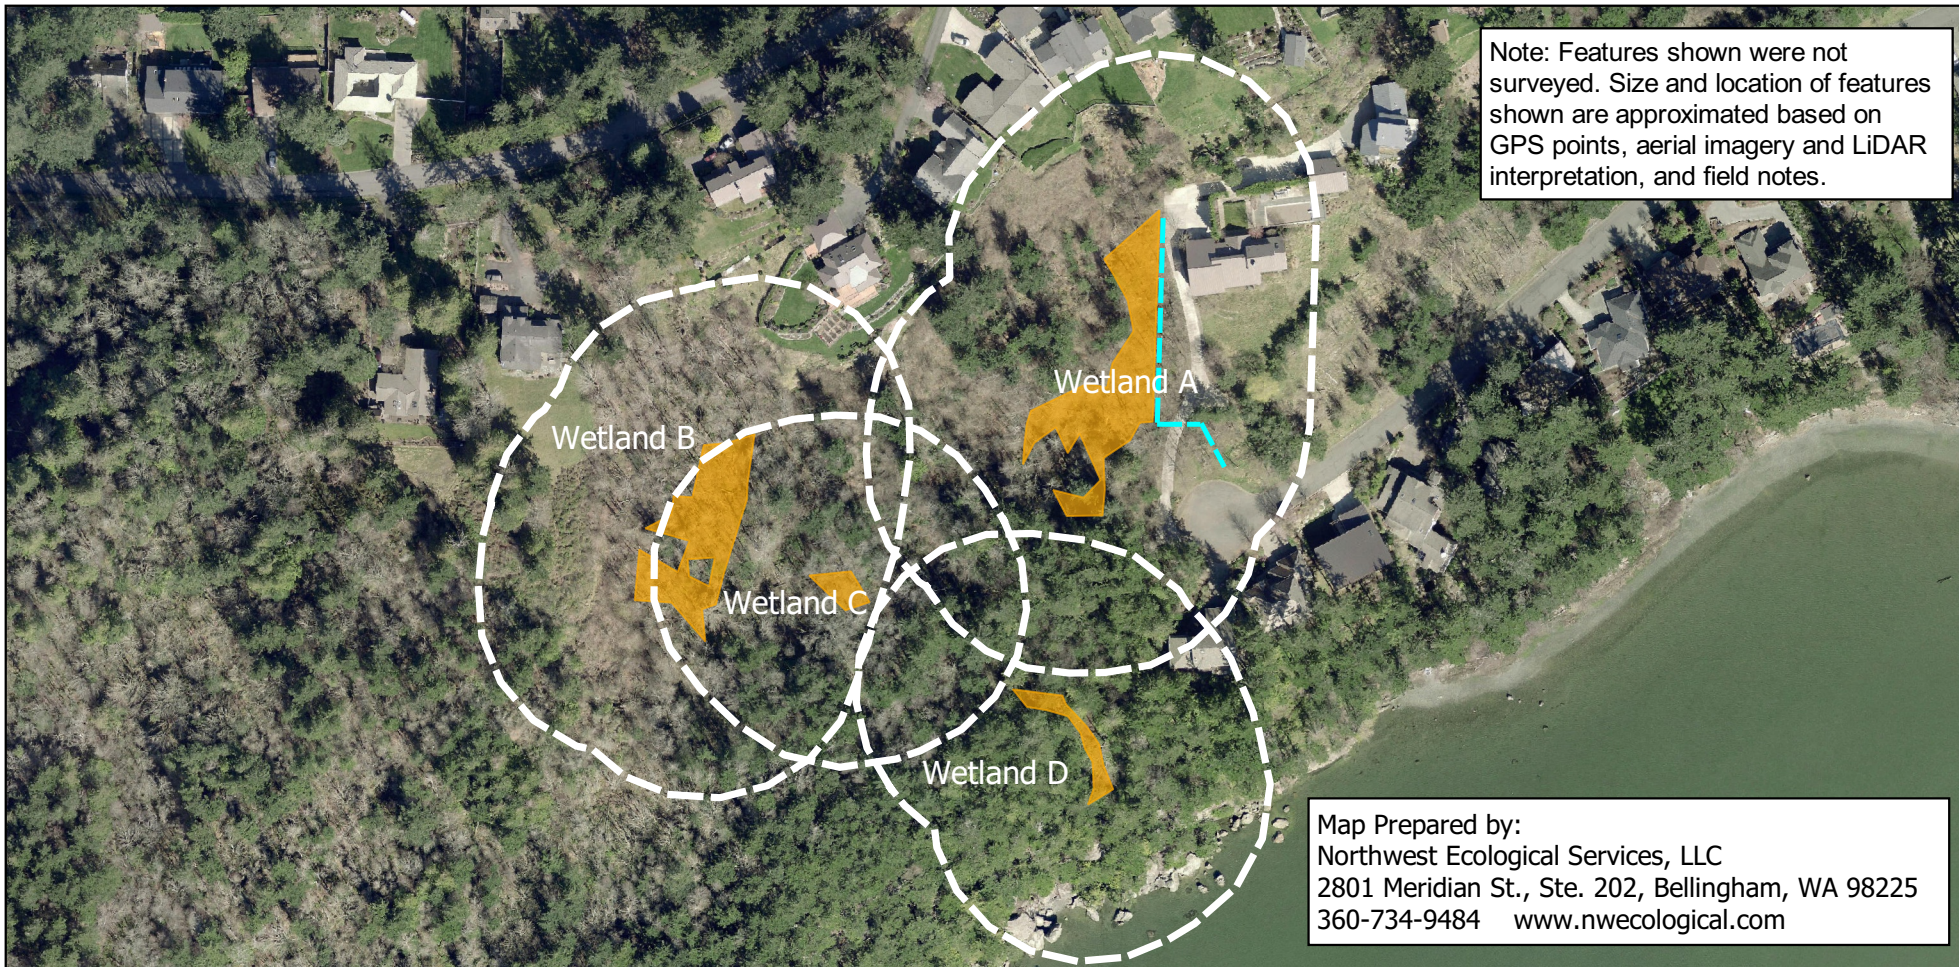
<p>ECOLOGICAL</p> <p>NORTHWEST</p>	<p>Wetland Rating Figure: Vegetation Map</p> <p>The Woods at Viewcrest Wetland Delineation Update</p>	<p>Attachment A</p> <p>FEB 2022</p>
--	---	---

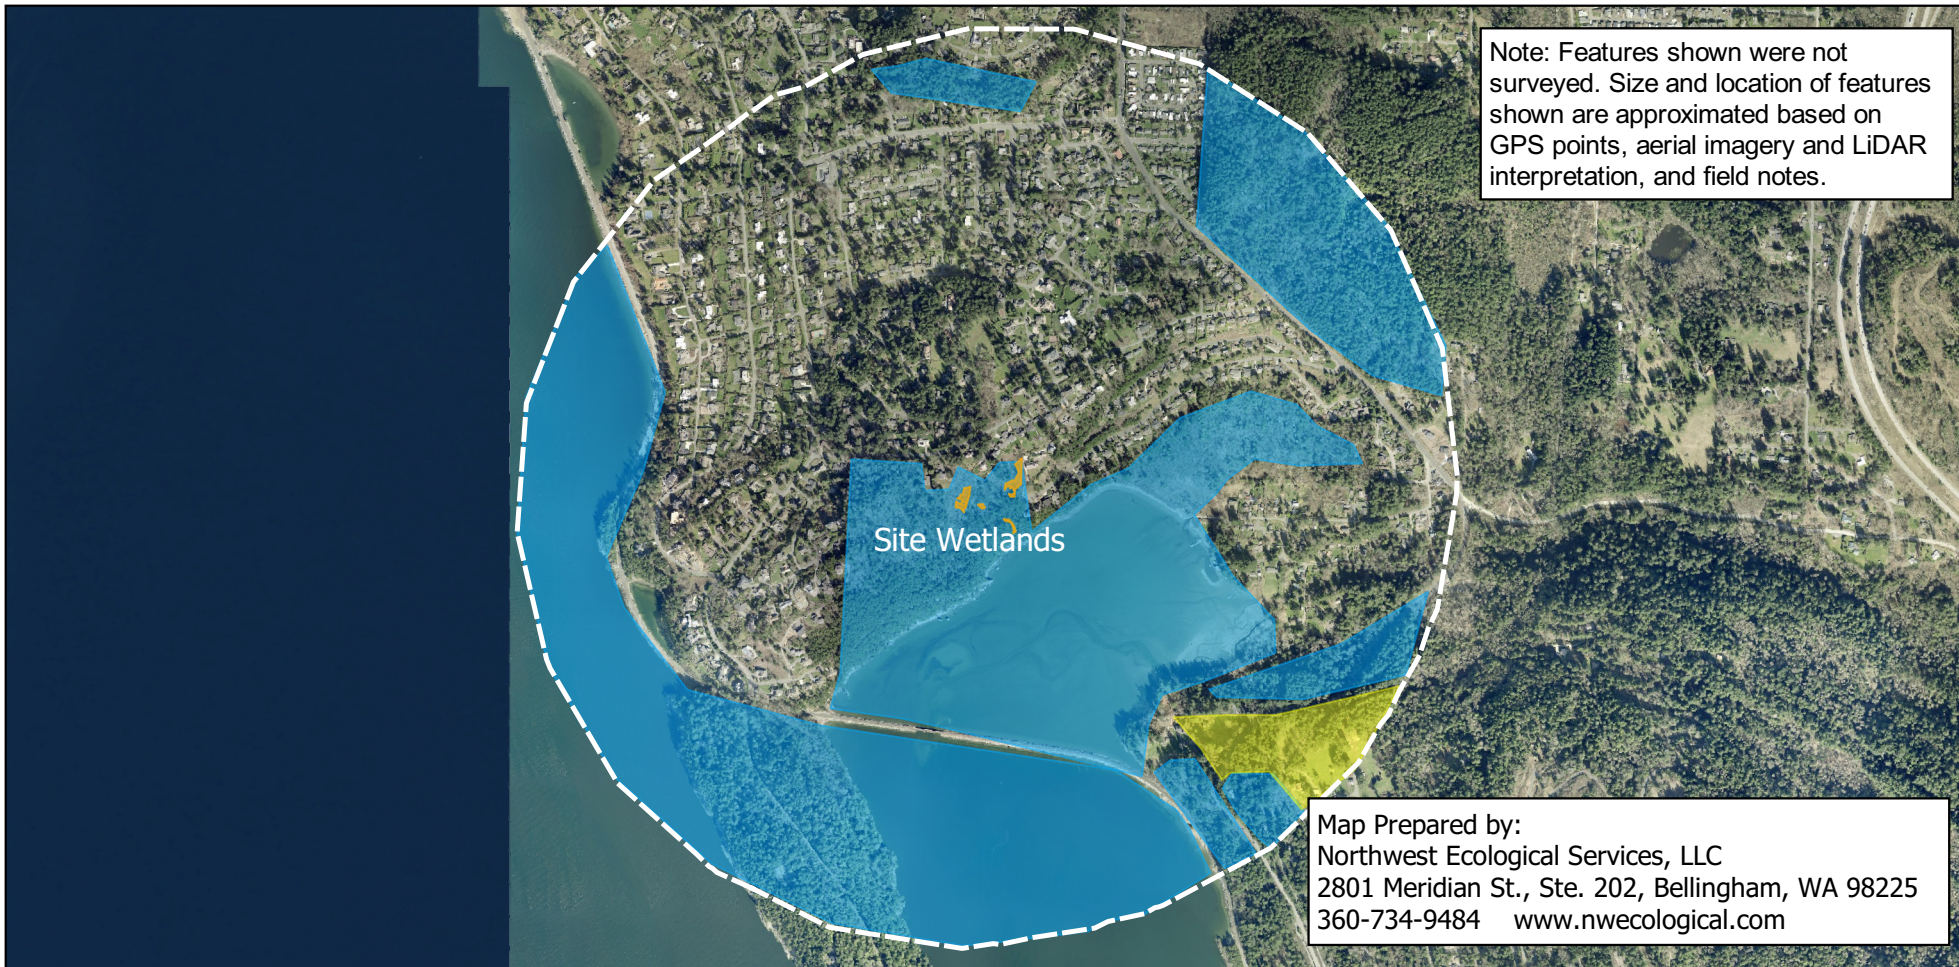
<p>Wetland Rating Figure: Hydrology Map</p> <p>The Woods at Viewcrest Wetland Delineation Update</p>	<p>Attachment B</p> <p>FEB 2022</p>
---	---	--

Note: Features shown were not surveyed. Size and location of features shown are approximated based on GPS points, aerial imagery and LiDAR interpretation, and field notes.
