## Asset Overview Report

**Region:** Parks

**Asset:** Arne Hanna Aquatic Center

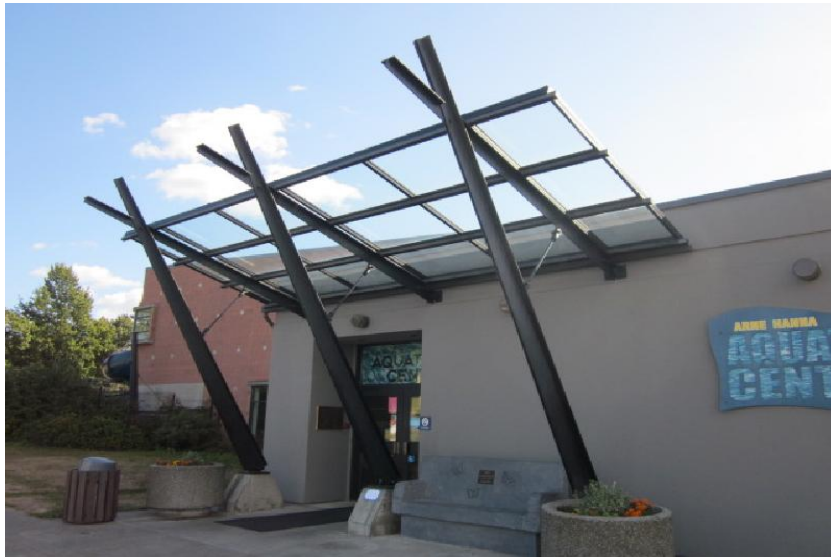
Exterior View - Arne Hanna Aquatic Center, Main Entry

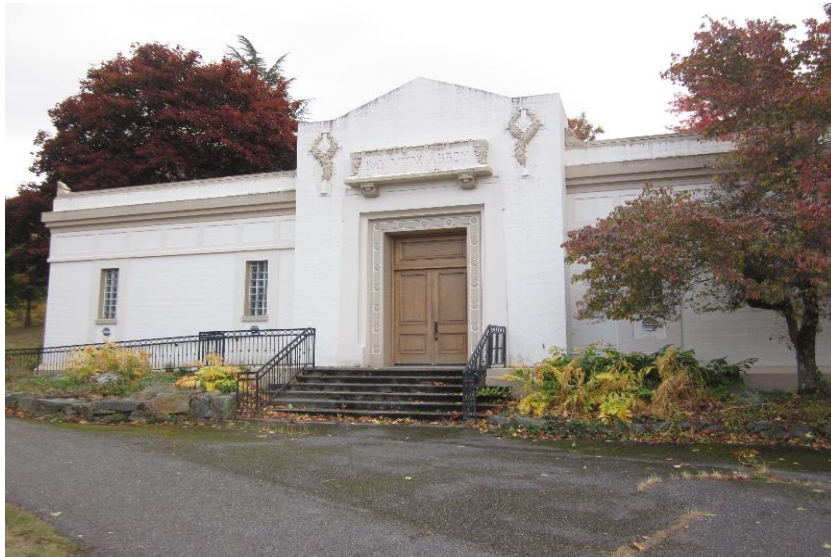
Bayview Cemetery Mausoleum

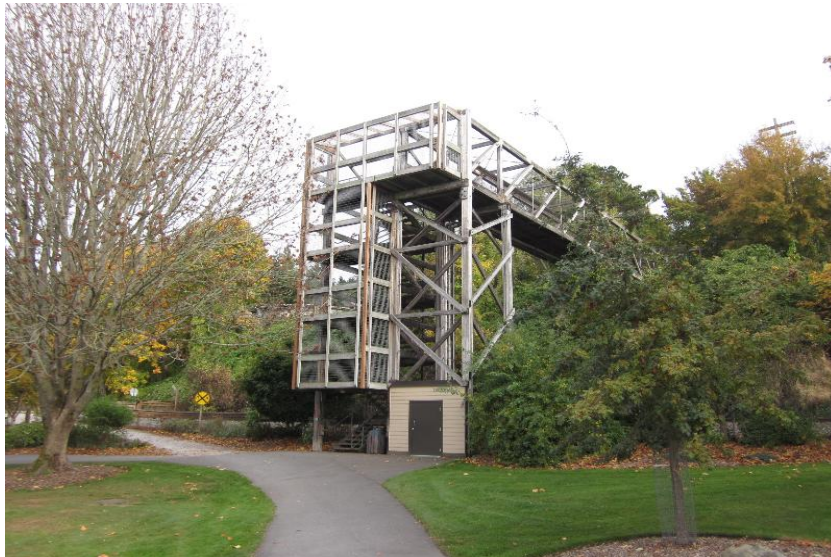
Boulevard Park Overpass

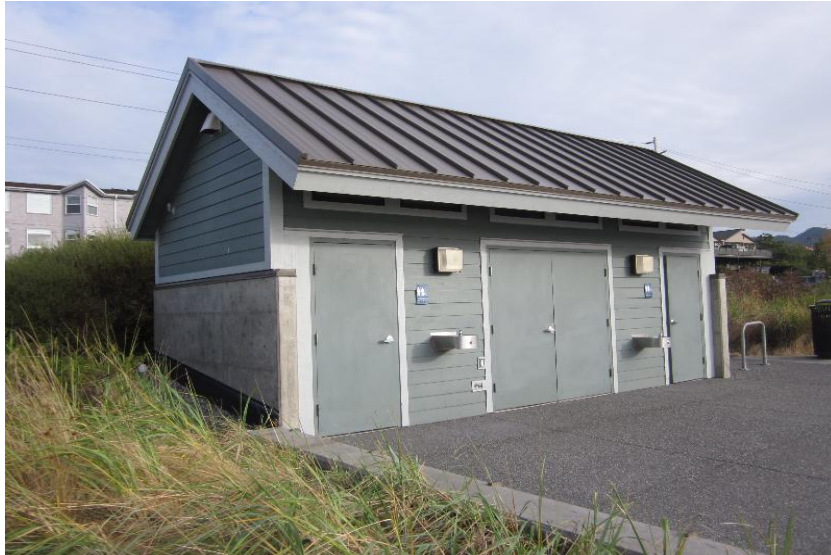
Taylor Dock Restrooms

| System Name | Description |
|---|---|
| A1011 - Wall Foundations-Foundation Wall and Footings - Perimeter | Basic foundation for building - includes strip and pier footings and foundation walls. System also includes perimeter drainage and damp-roofing. |

| System Name | Description |
|---|---|
| D2010 - Plumbing Fixtures-Drinking Fountains | Plumbing fixtures include wall-mounted stainless steel water coolers. |
| D2010 - Plumbing Fixtures-Restroom Fixtures - Lavatories (Stainless Steel) | The restroom fixtures include stainless steel lavatories. |
| D2010 - Plumbing Fixtures-Restroom Fixtures - Water Closets (Stainless Steel) | The restroom fixtures include stainless steel water closets. |

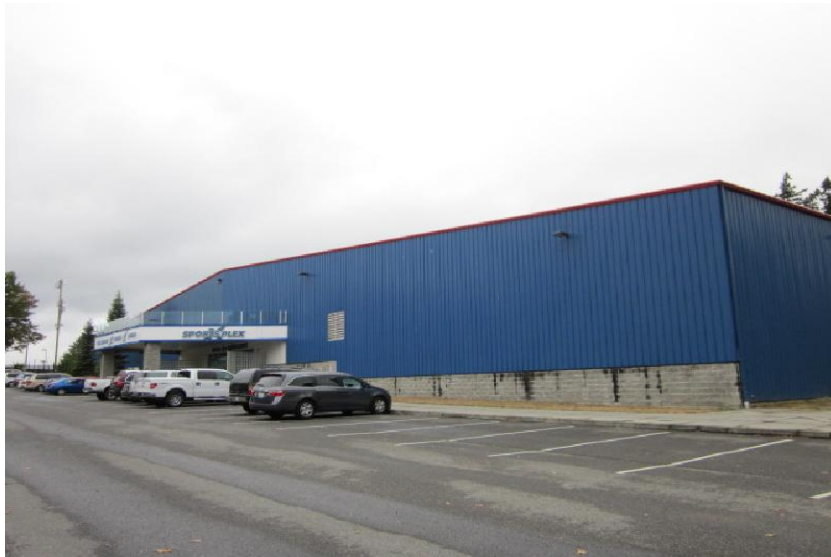
Exterior View - Civic Complex Sportsplex, East Elevation

| System Name | Description |
|---|---|
| A1011 - Wall Foundations-Foundation Wall and Footings (Building Interior) | Basic foundation for building without basement - to include strip footing, foundation wall and damp proofing. System applies at the interior load-bearing walls. |
| A1011 - Wall Foundations-Foundation Wall and Footings (Building Perimeter) | Basic foundation for building without basement - to include strip footing, foundation wall and damp proofing. |

| System Name | Description |
|---|---|
| B2010 - Exterior Walls-Paint Walls (Exterior) | The linear metal exterior wall finishes consist of paint. System includes painting of overhead door units. Overall the system condition is reasonable; the Observed Years Remaining has been adjusted accordingly. |
| B3010 - Roof Coverings-Paint (Roof) | The roof covering includes painted, linear-metal roofing. Overall the system condition is reasonable; the Observed Years Remaining has been adjusted accordingly. |

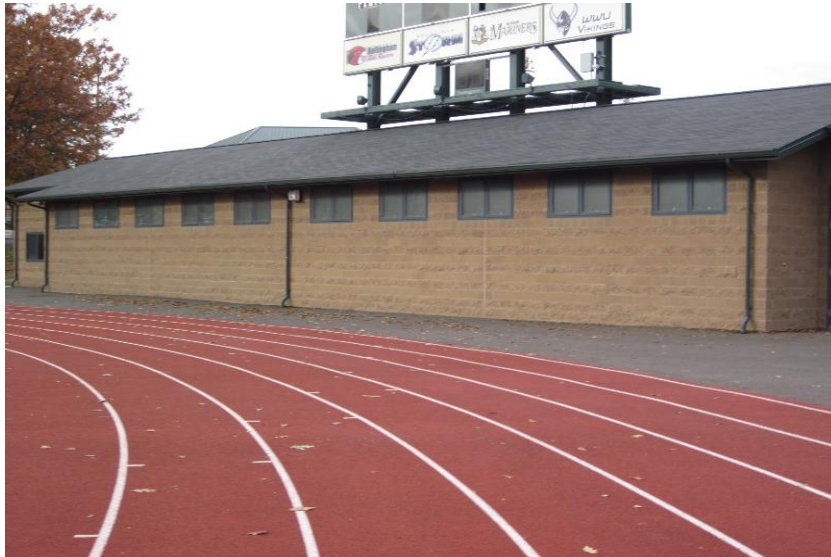
Civic Field Free Standing Locker Room

| System Name | Description |
|---|---|
| A1011 - Wall Foundations-Footings - Perimeter | Basic foundation for building - includes strip footings. |

| System Name | Description |
|---|---|
| D2010 - Plumbing Fixtures-Drinking Fountains | Plumbing fixtures include wall-mounted stainless steel water coolers. |

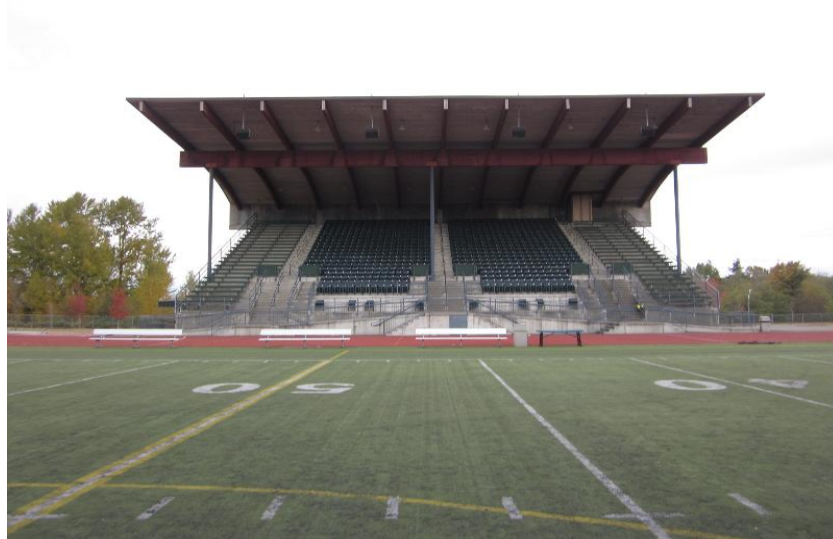
Civic Field North Grandstand

| System Name | Description |
|---|---|
| A1011 - Wall Foundations-Foundation Wall and Footings - Perimeter | Basic foundation for building - includes strip and pier footings and foundation walls. System also includes perimeter drainage and damp-roofing. |

| System Name | Description |
|---|---|
| D2010 - Plumbing Fixtures-Drinking Fountains | Plumbing fixtures include wall-mounted stainless steel duel height water coolers. |

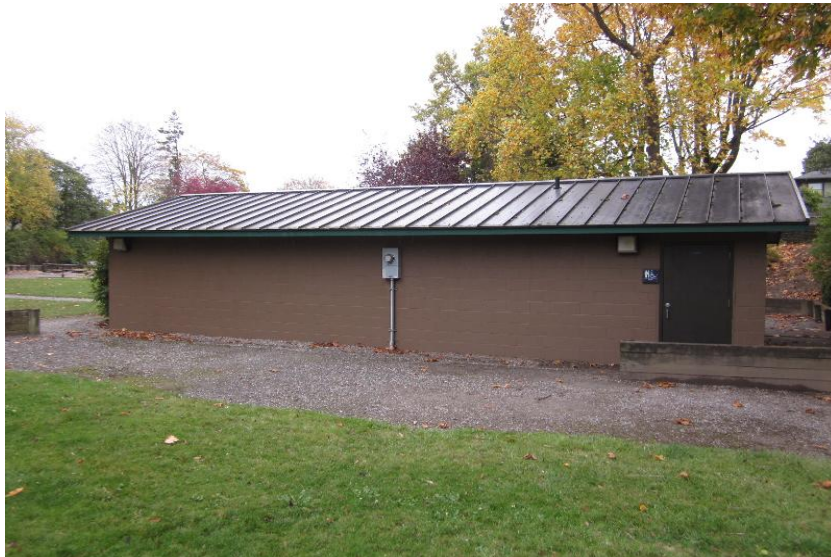
Broadway Park Restrooms

| System Name | Description |
|---|---|
| A1011 - Wall Foundations-Footings - Perimeter | Basic foundation for building - includes strip footings. |

| System Name | Description |
|---|---|
| B2010 - Exterior Walls-Paint (Exterior) | Exterior wall and trim finishes a standard exterior paint finish. Overall the system condition is reasonable; the Observed Years Remaining has been adjusted accordingly. |
| B2030 - Exterior Doors-Overhead Sectional Units | Exterior door systems includes a sectional, overhead aluminum doors at the entrance to the storage area. Overall the system condition is reasonable; the Observed Years Remaining has been adjusted accordingly. |
| B2030 - Exterior Doors-Swinging Doors - 3 x 7 Hollow Metal (Exterior) | Exterior door assemblies include metal doors and frames, and have standard exit-door hardware. Unit cost for the system is based on hollow metal door and frame assemblies as the standard. Overall the system condition is reasonable; the Observed Years Remaining has been adjusted accordingly. |
| C3010 - Wall Finishes-Paint (Walls) | Interior wall finishes include standard paint finish on CMU walls. Overall the system condition is reasonable; the Observed Years Remaining has been adjusted accordingly. |
| D2010 - Plumbing Fixtures-Restroom Fixtures - Lavatories (Stainless Steel) | The restroom fixtures include stainless steel lavatories. Overall the system condition is reasonable; the Observed Years Remaining has been adjusted accordingly. |
| D2010 - Plumbing Fixtures-Restroom Fixtures - Water Closets (Stainless Steel) | The restroom fixtures include stainless steel water closets. Overall the system condition is reasonable; the Observed Years Remaining has been adjusted accordingly. |
| D5012 - Low Tension Service and Dist.-Main Electrical Service - 200A 208Y/120V | The building includes a typical 200A 120/208V electrical service, which includes incoming feeders, main panel, and metering. Overall the system condition is reasonable; the Observed Years Remaining has been adjusted accordingly. |
| D5020 - Lighting and Branch Wiring-Lighting | Exterior lighting consists of wall mounted fixtures. Overall the system condition is reasonable; the Observed Years Remaining has been adjusted accordingly. |

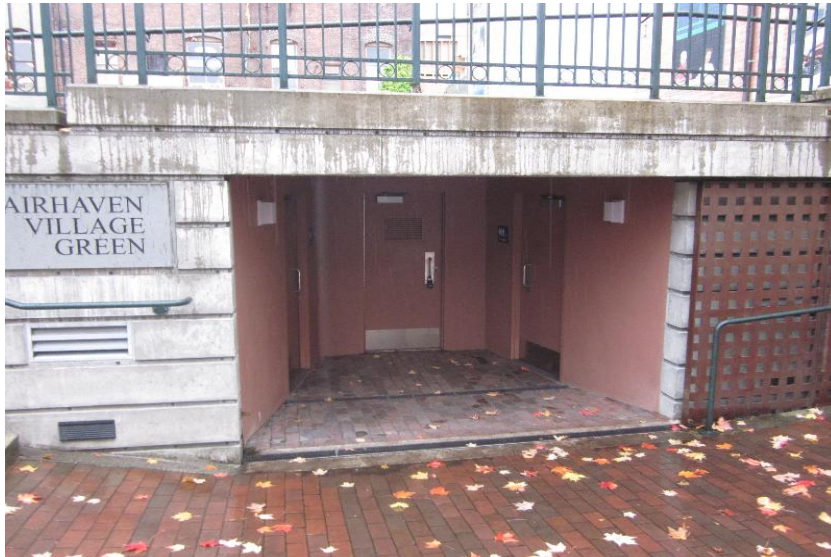
Fairhaven Village Green Restrooms

| System Name | Description |
|---|---|
| A1011 - Wall Foundations-Footings - Perimeter | Basic foundation for building - includes strip footings. |

| System Name | Description |
|---|---|
| C3010 - Wall Finishes-Paint (Walls) | Interior wall finishes include standard paint finish. Overall the system condition is reasonable; the Observed Years Remaining has been adjusted accordingly. |
| D2010 - Plumbing Fixtures-Restroom Fixtures - Lavatories (Stainless Steel) | The restroom fixtures include stainless steel lavatories. |
| D2010 - Plumbing Fixtures-Restroom Fixtures - Water Closets (Stainless Steel) | The restroom fixtures include stainless steel water closets. |
| D2020 - Domestic Water Distribution-Water Heater - Electric | The domestic hot water is provided by an 20-gallon electric water heater. Overall the system condition is reasonable; the Observed Years Remaining has been adjusted accordingly. |

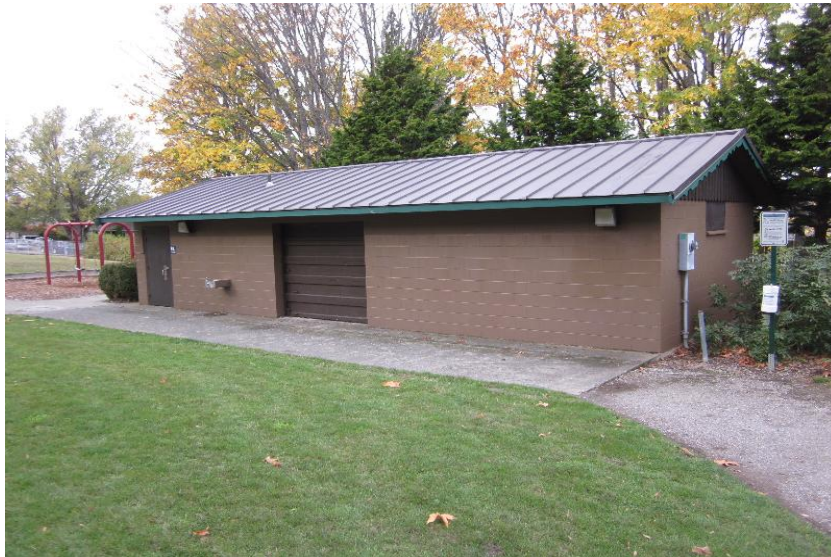
Forest and Cedar Restroom and Storage

| System Name | Description |
|---|---|
| A1011 - Wall Foundations-Footings - Perimeter | Basic foundation for building - includes strip footings. |

| System Name | Description |
|---|---|
| B2010 - Exterior Walls-Paint (Exterior) | Exterior wall and trim finishes a standard exterior paint finish. Overall the system condition is reasonable; the Observed Years Remaining has been adjusted accordingly. |
| D2010 - Plumbing Fixtures-Restroom Fixtures - Lavatories (Stainless Steel) | The restroom fixtures include stainless steel lavatories. |

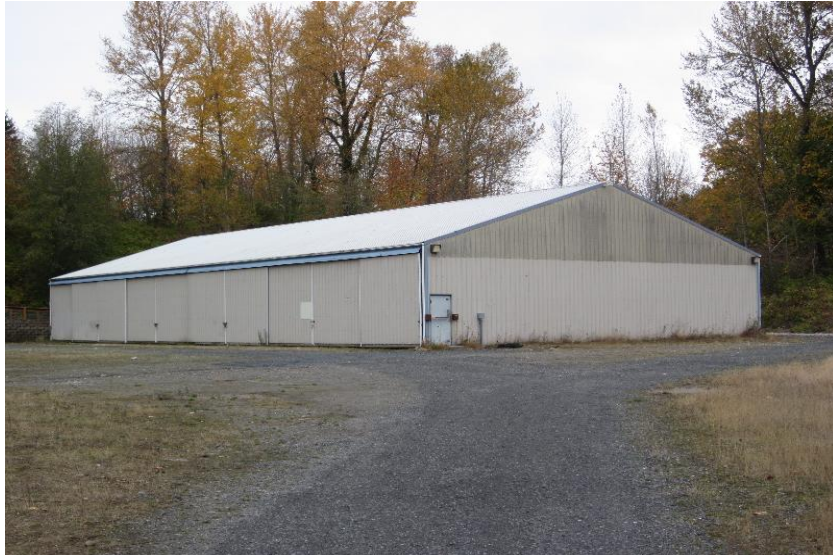
Squalicum Creek Park Storage Building

| System Name | Description |
|---|---|
| B2030 - Exterior Doors-Sliding Doors - Wood (Barn Type) | Exterior door assemblies include a sliding wood door with hardware. Overall the system condition is reasonable; the Observed Years Remaining has been adjusted accordingly. |
| D3050 - Terminal and Package Units-Unit Heaters - Electric (Each) | Heating is provided by suspended, electric unit heaters. Overall the system condition is reasonable; the Observed Years Remaining has been adjusted accordingly. |
| D5012 - Low Tension Service and Dist.-Main Electrical Service - 200A 208Y/120V | The building includes a typical 200A 120/208V electrical service, which includes incoming feeders, main panel, and metering. Overall the system condition is reasonable; the Observed Years Remaining has been adjusted accordingly. |

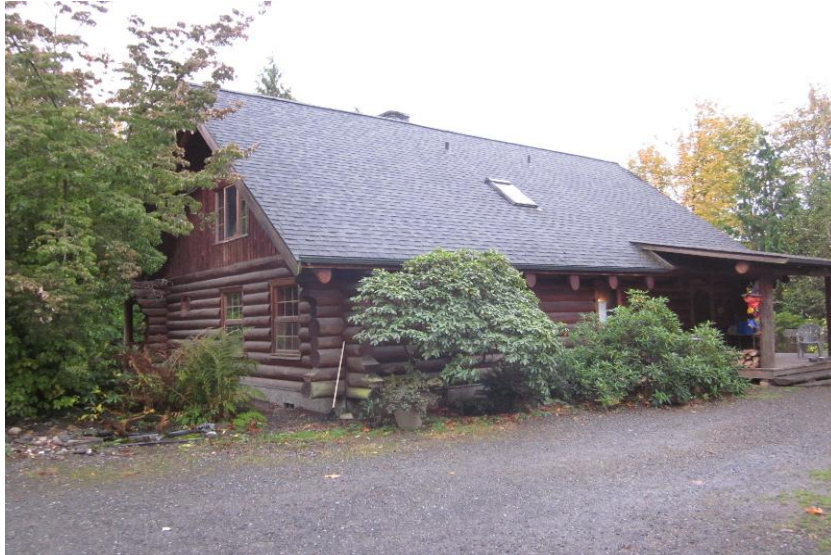
Van Wyck Park Residence

| System Name | Description |
|---|---|
| A1011 - Wall Foundations-Foundation Wall and Footings - Perimeter | Basic foundation for building - includes strip and pier footings and foundation walls. System also includes perimeter drainage and damp-roofing. |

| System Name | Description |
|---|---|
| B2020 - Exterior Windows-Wood Windows - Double Glazed | The building fenestration includes double-glazed wood window assemblies. Overall the system condition is reasonable; the Observed Years Remaining has been adjusted accordingly. |
| B3010 - Roof Coverings-Asphalt Shingled Roofing | The roof covering consists entirely of asphalt shingles. Overall the system condition is reasonable; the Observed Years Remaining has been adjusted accordingly. |
| B3021 - Glazed Roof Openings-Skylights | The building includes 3 skylights. Overall the system condition is reasonable; the Observed Years Remaining has been adjusted accordingly. |
