Asset Overview Report

Region: Parks

Asset: Arne Hanna Aquatic Center

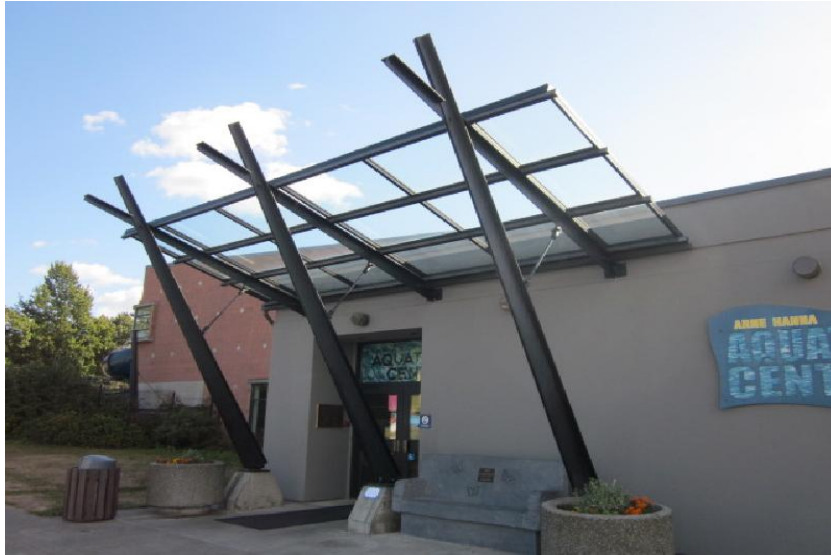
Exterior View - Arne Hanna Aquatic Center, Main Entry

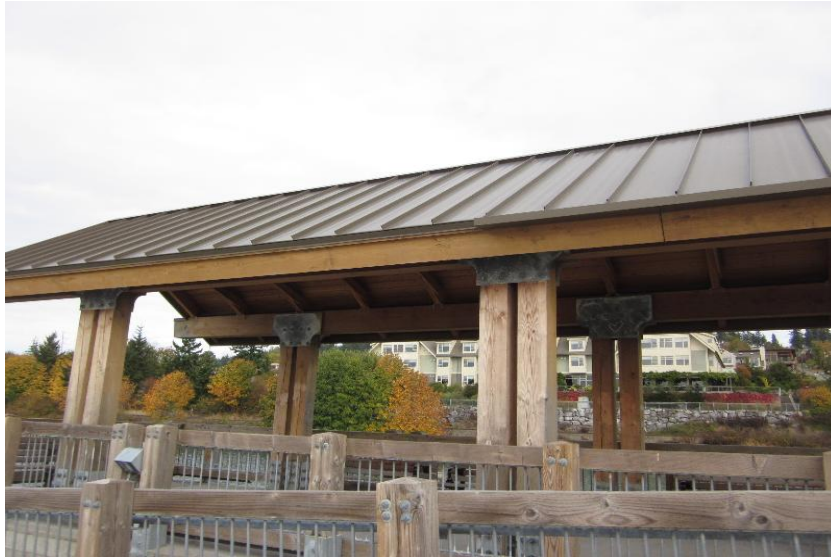
Taylor Dock Floating Dock and Picnic Pavilion

System Name	Description
A - Substructure-Pile Foundation - (Floating Dock)	The building structure is supported by approximately 5 metal piles approximately 20-inches in diameter.
A1030 - Slab on Grade-Concrete Slab - (Pavillion)	The floor of the building is a reinforced concrete slab-on-grade throughout. The system includes rigid insulation at the perimeter of the slab.
B10 - Superstructure-Dock - (Floating Dock)	The asset includes a floating 10 X 40 dock with pontoons, concrete, and treated wood.
B1014 - Ramps-Accessible Ramp - (Pavilion)	The pavilion includes a concrete handicap ramp.
B1020 - Roof Construction-Wood-Frame Roof - (Pavillion)	The roof superstructure consists of a Heavy Timber constructed roof system.
B2015 - Balcony Walls and Handrails-Guardrail - (Pavillion)	Guard rails include wood rails with metal pickets spaced approximately 4" centers. Estimated cost based on an equivalent.

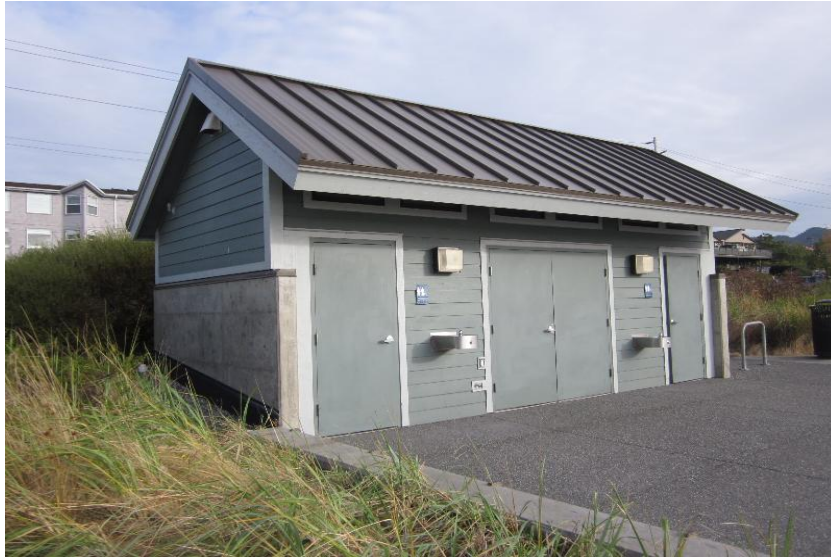
Taylor Dock Restrooms

System Name	Description
A1011 - Wall Foundations-Foundation Wall and Footings - Perimeter	Basic foundation for building - includes strip and pier footings and foundation walls. System also includes perimeter drainage and damp-roofing.
A1030 - Slab on Grade-Concrete Slab-On-Grade	The floor of the building is a reinforced concrete slab-on-grade throughout. The system includes rigid insulation at the perimeter of the slab.
B1020 - Roof Construction-Wood-Frame Roof	The roof superstructure consists of a heavy timber wood-framed components supported on bearing walls and/or columns. System includes sheathing and insulation and an allowance for columns.
B2010 - Exterior Walls-Paint (Exterior)	Exterior wall and trim finishes a standard exterior paint finish.
B2010 - Exterior Walls-Wood Siding (Exterior) - Wood-Frame Backup	The exterior wall assemblies include wood lap siding with a wood-frame stud backup assembly. Refer to separate system for interior wall finishes such as GWB and paint.

C3010 - Wall Finishes-Fiber Reinforced Plastic (FRP)	Interior wall finishes include embossed, fiberglass reinforced plastic (FRP) paneling.
C3020 - Floor Finishes-Ceramic Tile (Floor)	The building floor finishes include porcelain type ceramic tile installed in restrooms, showers and wet areas.
C3030 - Ceiling Finishes-GWB Ceilings Taped and Finished	The system includes gypsum wallboard throughout the facility. Refer to separate system for paint finishes.
C3030 - Ceiling Finishes-Paint (Ceiling)	Ceiling finishes include the painted surface of the drywall ceilings. Overall the system condition is reasonable; the Observed Years Remaining has been adjusted accordingly.
D2010 - Plumbing Fixtures-Custodial/Utility Sinks	The plumbing fixtures include custodial/utility sinks.
D2010 - Plumbing Fixtures-Drinking Fountains	Plumbing fixtures include wall-mounted stainless steel water coolers.
D2010 - Plumbing Fixtures-Restroom Fixtures - Lavatories (Stainless Steel)	The restroom fixtures include stainless steel lavatories.

D2010 - Plumbing Fixtures-Restroom Fixtures - Water Closets (Stainless Steel)	The restroom fixtures include stainless steel water closets.
D2020 - Domestic Water Distribution-Domestic Water Distribution	The building domestic water distribution system is comprised of mostly copper piping.
D2030 - Sanitary Waste-Sanitary Waste - Gravity Discharge	The building includes an average sanitary waste system, with gravity discharge to the municipal system.
D3040 - Distribution Systems-Exhaust System - Restroom	HVAC ventilation systems include exhaust fans with ductwork and propeller type fans.
D3050 - Terminal and Package Units-Unit Heaters - Electric (Each)	Heating is provided by wall mounted electric unit heater in the restrooms and plumbing storage room.

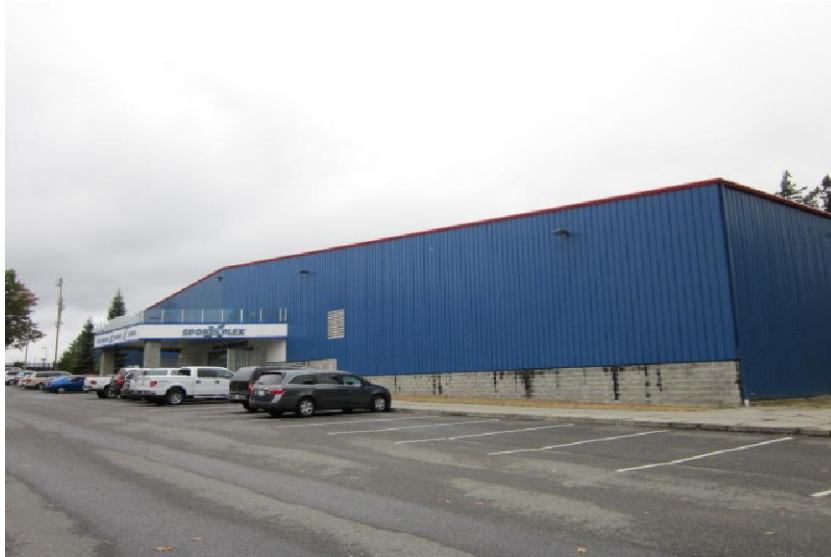
Exterior View - Civic Complex Sportsplex, East Elevation

System Name	Description
A1011 - Wall Foundations-Foundation Wall and Footings (Building Interior)	Basic foundation for building without basement - to include strip footing, foundation wall and damp proofing. System applies at the interior load-bearing walls.
A1011 - Wall Foundations-Foundation Wall and Footings (Building Perimeter)	Basic foundation for building without basement - to include strip footing, foundation wall and damp proofing.
A1030 - Slab on Grade-Structural Slab on Grade	The building substructure includes a light industrial type structural slab on grade. System assumed to be continuous beneath the Soccer Fields.
B10 - Superstructure-Steel Building with Metal Cladding and Metal Roof	Single-story, rigid-frame, pre-engineered steel building with a clear-span of approximately 70 feet and 13' eave height. System includes colored, ribbed siding and roof covering, framing for door openings and insulation.

B2031 - Glazed Doors and Entrances-Swinging Doors - 3 x 7 Storefront Entry	Exterior doors include metal, storefront-type door and frame assemblies with standard school hardware. System includes transom and side lights where they occur. System also includes the matching interior doors at each entrance where they occur.
B3010 - Roof Coverings-Paint (Roof)	The roof covering includes painted, linear-metal roofing. Overall the system condition is reasonable; the Observed Years Remaining has been adjusted accordingly.
B3010 - Roof Coverings-SBS Modified Bitumen (BUR)	Roof covering system at the entrance canopy assumed to be and SBS modified bitumen system.
B3016 - Gutters and Downspouts-Gutters and Downspouts	Eaves gutters and downspouts are located at the lowest edges of the roof.
C1010 - Partitions-Dashboards - Soccer and Ice Skating	The Skating Rink and Soccer Field have perimeter dash boards. Estimated cost based on the unit cost per lineal foot of the perimeter of the ice rink as a standard.

C3010 - Wall Finishes-Paint Walls (Interior) - 2012	The metal-panel interior wall finishes consist of paint.
C3020 - Floor Finishes-Carpet - Athletic (Soccer Fields)	The Soccer Fields have athletic carpet finishes.
C3020 - Floor Finishes-Carpeting - Sheet	The building has carpeting floor finishes. Installation date not verified.
C3020 - Floor Finishes-Ceramic Tile (Floor)	The building floor finishes include porcelain type ceramic tile installed in restrooms, showers and wet areas. System includes the Brick paving (interior and exterior) at the main entry. Overall condition is reasonable; Observed Years Remaining adjusted accordingly.
C3020 - Floor Finishes-Concrete Floor - Painted or Sealed	The building includes painted concrete floor finishes. Overall condition is reasonable; Observed Years Remaining adjusted accordingly.
C3020 - Floor Finishes-Rubber Sheet Goods	The building floor finishes include areas of sheet vinyl and related base. Overall the system condition is reasonable; the Observed Years Remaining has been adjusted accordingly.

D3040 - Distribution Systems-HVAC Dehumidifier	The HVAC system includes dehumidification serving the ice surface.
D3050 - Terminal and Package Units-Furnace - Gas Fired	The HVAC system includes a warm air furnaces serving the office areas and locker rooms.
D3060 - Controls and Instrumentation-DDC System	HVAC controls include DDC system for simple HVAC control, large component control, minimal sensing devices.
D40 - Fire Protection-Sprinkler System	The fire protection systems include a light hazard, sprinkler system. This system includes backflow protection and standpipes but does not include a fire pump.
D5012 - Low Tension Service and Dist.-Distribution Equipment, Panelboards, and Feeders - 800A 480Y/277V & 208Y/120V	The electrical distribution system for this building includes an average concentration of panelboards, feeders, and associated equipment for an 800A 480V service.
D5012 - Low Tension Service and Dist.-Main Electrical Service - 800A 480Y/277V	The building includes a typical electrical service, which includes incoming feeders, main panel, and metering.

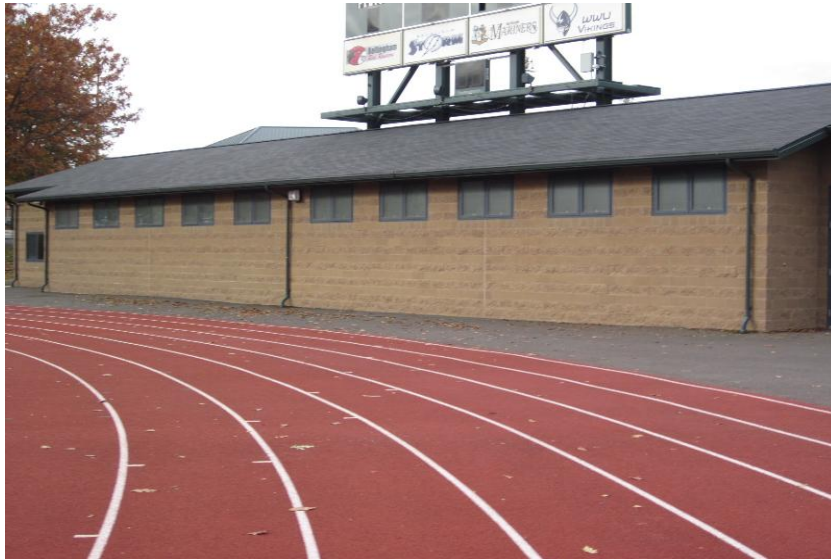
Civic Field Free Standing Locker Room

System Name	Description
A1011 - Wall Foundations-Footings - Perimeter	Basic foundation for building - includes strip footings.
A1030 - Slab on Grade-Concrete Slab-On-Grade	The floor of the building is a reinforced concrete slab-on-grade throughout. The system includes rigid insulation at the perimeter of the slab.
B1015 - Exterior Stairs and Fire Escapes-Exterior Stairs - Concrete	Exterior concrete stairs (6' wide x 5 risers) with railing.
B2010 - Exterior Walls-CMU - Split Face (Exterior)	The exterior wall assemblies include split face concrete masonry units.
B2020 - Exterior Windows-Aluminum Windows - Double Glazed	The building fenestration includes aluminum-framed exterior units with insulating glass.
B2030 - Exterior Doors-Swinging Doors - 3 x 7 Half Glass (Exterior)	Exterior door assemblies include metal doors wit half glass and frames, and have standard exit-door hardware. Unit cost for the system is based on hollow metal door and frame assemblies as the standard.

C1030 - Fittings-Restroom Accessories	Typically the restroom accessories include paper towel dispenser and disposal, grab bars, mirrors, sanitary napkin dispenser and soap and toilet tissue dispensers. System cost based on an average of approximately \$1000 per restroom.
C3030 - Ceiling Finishes-GWB Ceilings Taped and Finished	The system includes gypsum wallboard throughout the facility. Refer to separate system for paint finishes.
C3030 - Ceiling Finishes-Paint (Ceiling)	Ceiling finishes include the painted surface of the drywall ceilings. Overall the system condition is reasonable; the Observed Years Remaining has been adjusted accordingly.
C3030 - Ceiling Finishes-Wood Fiber Acoustic Ceiling	Ceiling systems include wood fiber acoustical panels for the ceiling in the team rooms.
D2010 - Plumbing Fixtures-Custodial/Utility Sinks	The plumbing fixtures include custodial/utility sinks.
D2010 - Plumbing Fixtures-Drinking Fountains	Plumbing fixtures include wall-mounted stainless steel water coolers.

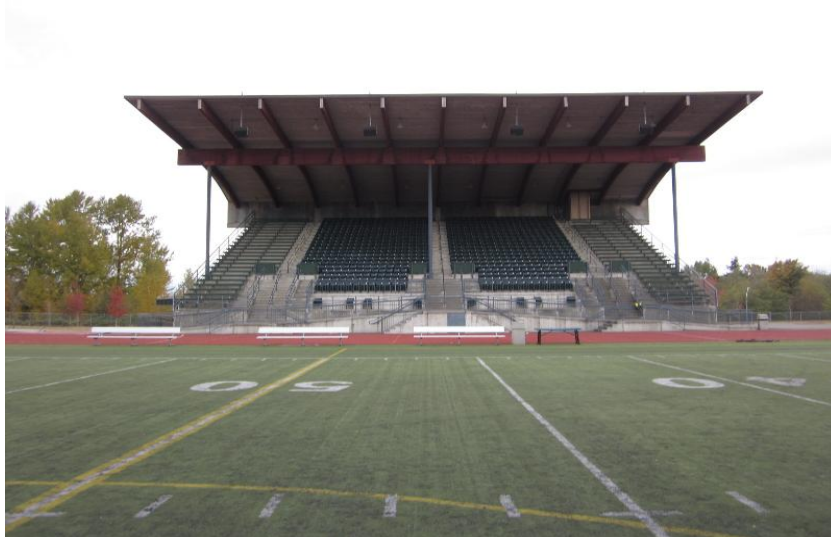
Civic Field North Grandstand

System Name	Description
A1011 - Wall Foundations-Foundation Wall and Footings - Perimeter	Basic foundation for building - includes strip and pier footings and foundation walls. System also includes perimeter drainage and damp-roofing.
A1030 - Slab on Grade-Concrete Slab-On-Grade	The floor of the building is a reinforced concrete slab-on-grade throughout. The system includes rigid insulation at the perimeter of the slab.
B10 - Superstructure-Multi-Story - Concrete	Multi-story structure with reinforced concrete construction.
B1014 - Ramps-Accessible Ramp - Exterior Concrete	Concrete in place, handicapped ramp w/cheek walls & rails both sides, 5' wide.
B1015 - Exterior Stairs and Fire Escapes-Exterior Stairs - Concrete	Exterior concrete stairs with railing.

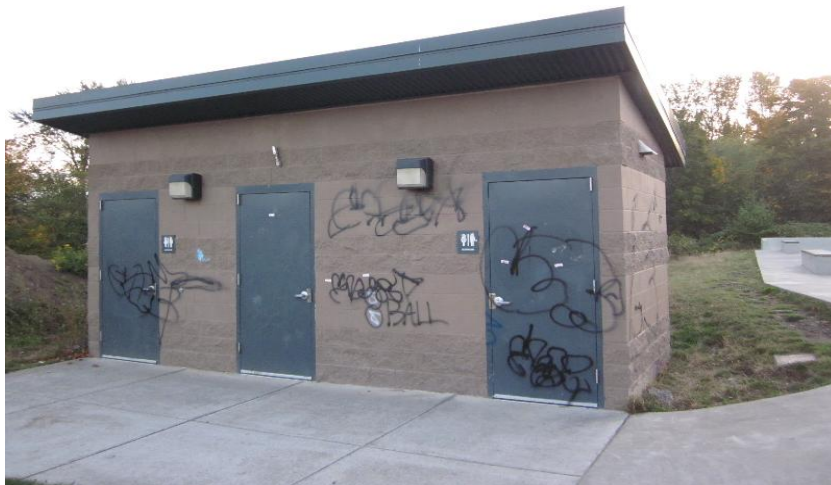
Civic Field Skatepark Restroom

System Name	Description
A1011 - Wall Foundations-Footings - Perimeter	Basic foundation for building - includes strip footings.
A1030 - Slab on Grade-Concrete Slab-On-Grade	The floor of the building is a reinforced concrete slab-on-grade throughout. The system includes rigid insulation at the perimeter of the slab.
B1020 - Roof Construction-Wood-Frame Roof	The roof superstructure consists of wood-framed components (trusses) supported on bearing walls and/or columns. System includes sheathing and insulation and an allowance for columns.
B2010 - Exterior Walls-CMU - Split Face (Exterior)	The exterior wall assemblies include split face concrete masonry units.
B2030 - Exterior Doors-Swinging Doors - 3 x 7 Hollow Metal (Exterior)	Exterior door assemblies include metal doors and frames, and have standard exit-door hardware. Unit cost for the system is based on hollow metal door and frame assemblies as the standard.

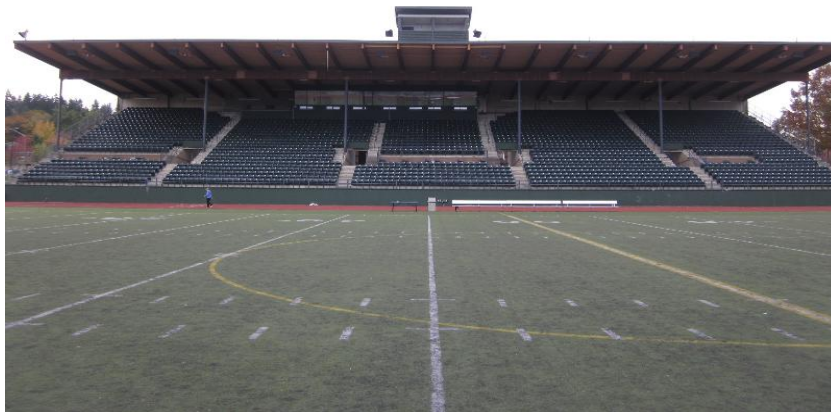
Civic Field South Grandstand

System Name	Description
A1011 - Wall Foundations-Foundation Wall and Footings - Perimeter (Basement - Locker Rooms)	Basic perimeter foundation for building with basement - includes strip footings and foundation walls.
A1011 - Wall Foundations-Foundation Wall and Footings - Perimeter (Crawl Space)	Basic foundation for building with crawlspace - includes strip and pier footings and foundation walls.
A1030 - Slab on Grade-Concrete Slab-On-Grade	The floor of the building is a reinforced concrete slab-on-grade throughout. The system includes rigid insulation at the perimeter of the slab.
B10 - Superstructure-Multi-Story - Concrete	Multi-story structure with reinforced concrete construction.
B1014 - Ramps-Accessible Ramp - Exterior Concrete	Concrete in place, handicapped ramp w/cheek walls & rails both sides, 5' wide.

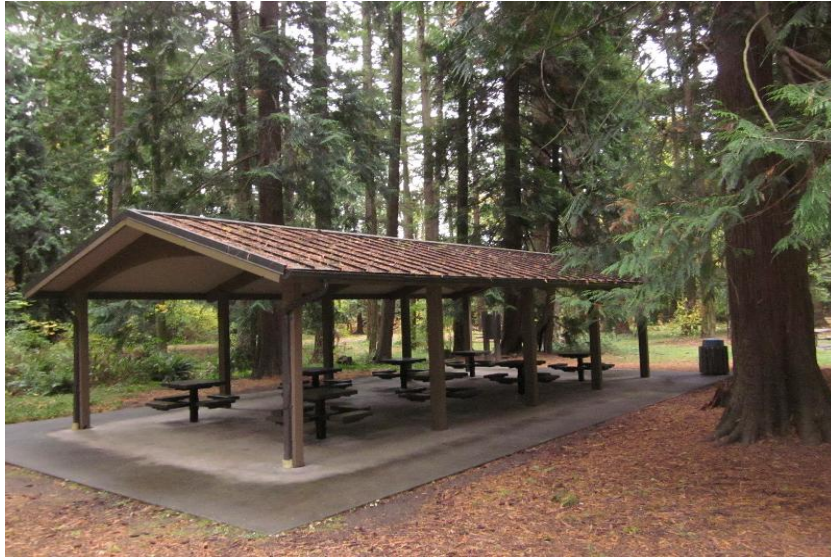
Cornwall Park South Picnic Shelter

System Name	Description
A1011 - Wall Foundations-Footings - Perimeter	Basic perimeter foundation for building without crawlspace - includes strip footings.
A1030 - Slab on Grade-Concrete Slab-On-Grade	The floor of the building is a reinforced concrete slab-on-grade. The slab (24x48) is larger than the roofing system.
B1020 - Roof Construction-Wood-Frame Roof	The roof superstructure consists of wood-framed components supported on bearing columns. System includes sheathing/battens and an allowance for columns. Roof structure (20x40) is slightly smaller than building slab.
B30 - Roofing-Metal Roofing	The roof covering consists of a preformed metal roofing system, such as corrugated steel or aluminum. Roof structure is slightly smaller than building slab.
B3016 - Gutters and Downspouts-Gutters	Aluminum gutters and down-spouts are located at the lowest edges of the roof.

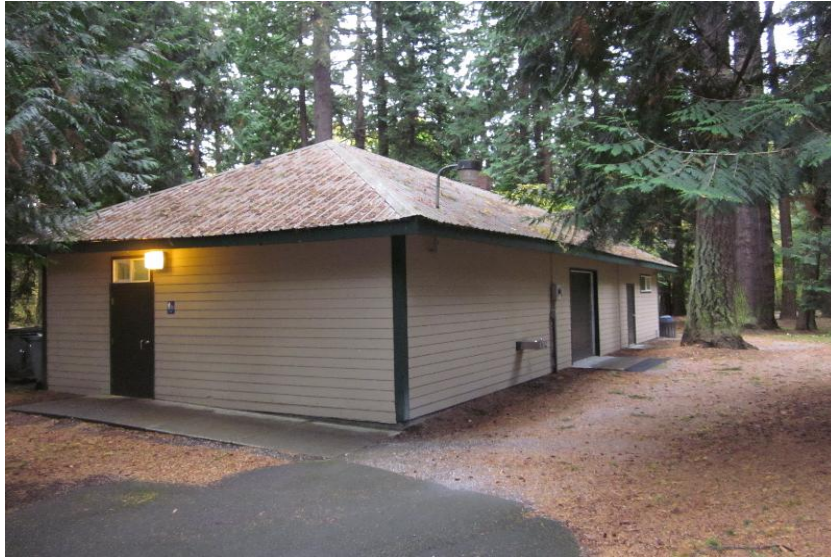
Cornwall Park South Restrooms

System Name	Description
A1011 - Wall Foundations-Footings - Perimeter	Basic perimeter foundation for building with without crawlspace - includes strip footings.
A1030 - Slab on Grade-Concrete Slab-On-Grade	The floor of the building is a reinforced concrete slab-on-grade throughout. The system includes rigid insulation at the perimeter of the slab.
B1020 - Roof Construction-Wood-Frame Roof	The roof superstructure consists of wood-framed components supported on bearing walls and/or columns. System includes sheathing and an allowance for columns.
B2010 - Exterior Walls-Fiber Cement Siding (Exterior) - Wood-Frame Backup	The exterior wall assemblies include (Hardiplank),a fiber cement siding, with a wood-frame stud backup assembly.
B2010 - Exterior Walls-Paint (Exterior)	Exterior wall and trim finishes a standard exterior paint finish.
B2020 - Exterior Windows-Wood Windows -	The building includes double-glazed wood window assemblies for the restrooms. Overall the system condition is reasonable; the Observed Years Remaining has been

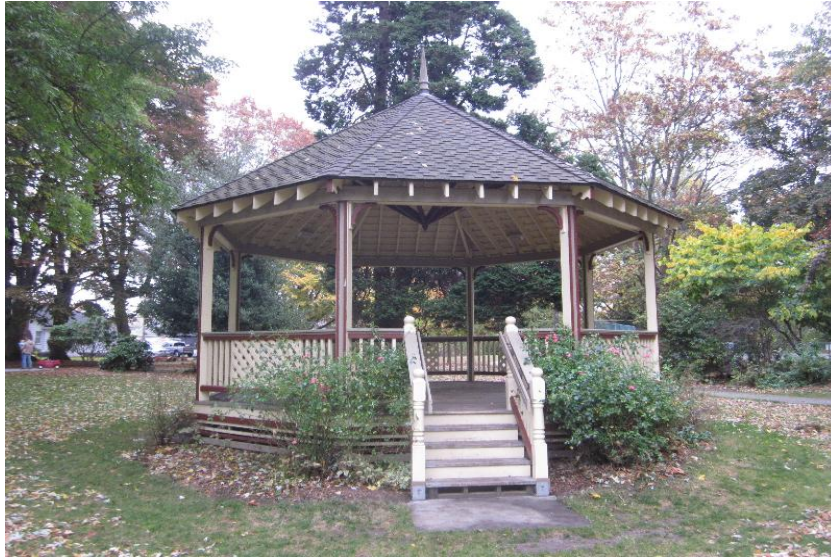
Elizabeth Park Gazebo

System Name	Description
A - Substructure-Concrete Footings - Pier	The building includes concrete pier footings.
B1020 - Roof Construction-Wood-Frame Roof	The roof superstructure consists of wood-framed components supported on posts/columns.
B2010 - Exterior Walls-Paint (Exterior)	Exterior wood finishes are of standard exterior paint. Overall the system condition is reasonable; the Observed Years Remaining has been adjusted accordingly.
B3010 - Roof Coverings-Asphalt Shingled Roofing	The roof covering consists entirely of asphalt shingles.
D5021 - Branch Wiring Devices-Branch Wiring - Equipment & Devices	Branch wiring for this building includes a average concentration of interior and exterior branch wiring, devices, and utilization equipment. Overall the system condition is reasonable; the Observed Years Remaining has been adjusted accordingly.

System Name	Description
G2049 - Miscellaneous Structures-Wood Deck - Treated	Wood deck, including pressure-treated framing, decking, posts, railings, stairs, and handicap ramp. Overall the system condition is reasonable; the Observed Years Remaining has been adjusted accordingly.

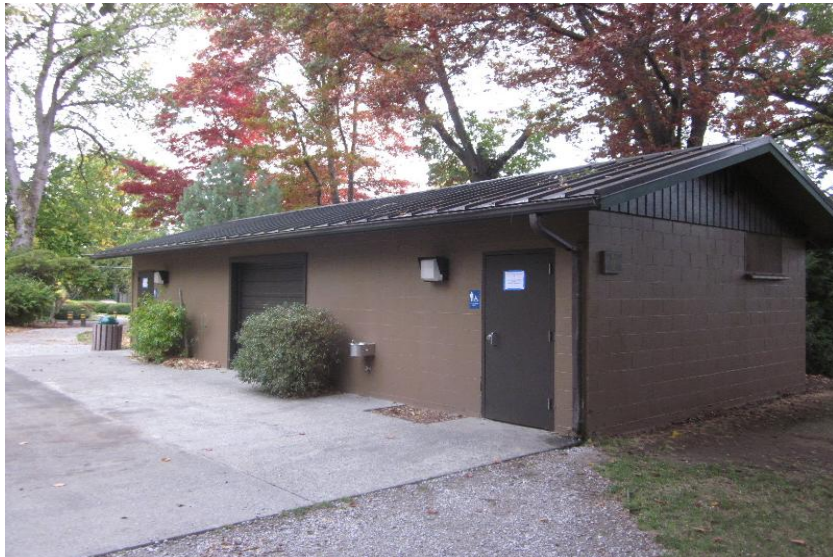
Elizabeth Park Restrooms

System Name	Description
A1011 - Wall Foundations-Footings - Perimeter	Basic foundation for building - includes strip footings.
A1030 - Slab on Grade-Concrete Slab-On-Grade	The floor of the building is a reinforced concrete slab-on-grade throughout. The system includes rigid insulation at the perimeter of the slab.
B1020 - Roof Construction-Wood-Frame Roof	The roof superstructure consists of wood-framed components supported on bearing walls and/or columns. System includes sheathing and insulation and an allowance for columns.
B2010 - Exterior Walls-CMU Block Walls - Painted	The exterior walls are of painted concrete block.

System Name	Description
B2010 - Exterior Walls-Paint (Exterior)	Exterior wall and trim finishes a standard exterior paint finish.
B2030 - Exterior Doors-Overhead Sectional Units	Exterior door systems include motorized, sectional, overhead aluminum doors at the entrance to each of the bays. Overall the system condition is reasonable; the Observed Years Remaining has been adjusted accordingly.
B2030 - Exterior Doors-Swinging Doors - 3 x 7 Hollow Metal (Exterior)	Exterior door assemblies include metal doors and frames, and have standard exit-door hardware. Unit cost for the system is based on hollow metal door and frame assemblies as the standard. Overall the system condition is reasonable; the Observed Years Remaining has been adjusted accordingly.
B30 - Roofing-Metal Roofing	The roof covering consists of a preformed metal roofing system, such as corrugated steel or aluminum.
C1010 - Partitions-CMU Block Walls - Painted	The interior walls are of painted concrete block.

C1030 - Fittings-Restroom Accessories	Typically the restroom accessories include paper towel dispenser and disposal, grab bars, mirrors, sanitary napkin dispenser and soap and toilet tissue dispensers. System cost based on an average of approximately \$1000 per restroom. Overall the system condition is reasonable; the Observed Years Remaining has been adjusted accordingly.
C3010 - Wall Finishes-Paint (Walls)	Interior wall finishes include standard paint finish. Overall the system condition is reasonable; the Observed Years Remaining has been adjusted accordingly.
C3030 - Ceiling Finishes-GWB Ceilings Taped and Finished	The system includes gypsum wallboard throughout the facility. Refer to separate system for paint finishes. Overall the system condition is reasonable; the Observed Years Remaining has been adjusted accordingly.
C3030 - Ceiling Finishes-Paint (Ceiling)	Ceiling finishes include the painted surface of the drywall ceilings. Overall the system condition is reasonable; the Observed Years Remaining has been adjusted accordingly.

D2010 - Plumbing Fixtures-Restroom Fixtures - Lavatories (Stainless Steel)	The restroom fixtures include stainless steel lavatories. Overall the system condition is reasonable; the Observed Years Remaining has been adjusted accordingly.
D2010 - Plumbing Fixtures-Restroom Fixtures - Urinals (Stainless Steel)	The restroom fixtures in the public restrooms include stainless steel wall hung urinals. Overall the system condition is reasonable; the Observed Years Remaining has been adjusted accordingly.
D2010 - Plumbing Fixtures-Restroom Fixtures - Water Closets	The restroom fixtures include vitreous china water closets. Overall the system condition is reasonable; the Observed Years Remaining has been adjusted accordingly.
D2020 - Domestic Water Distribution-Domestic Water Distribution	The building domestic water distribution system is comprised of mostly copper piping. Overall the system condition is reasonable; the Observed Years Remaining has been adjusted accordingly.

D2030 - Sanitary Waste-Sanitary Waste - Gravity Discharge	The building includes an average sanitary waste system, with gravity discharge to the municipal system.
D5012 - Low Tension Service and Dist.-Main Electrical Service - 100A 208Y/120V	The building includes a typical 100A 120/208V electrical service, which includes incoming feeders, main panel, and metering. Overall the system condition is reasonable; the Observed Years Remaining has been adjusted accordingly.
D5020 - Lighting and Branch Wiring-Lighting - Exterior	Exterior lighting consists of wall mounted fixtures. Overall the system condition is reasonable; the Observed Years Remaining has been adjusted accordingly.

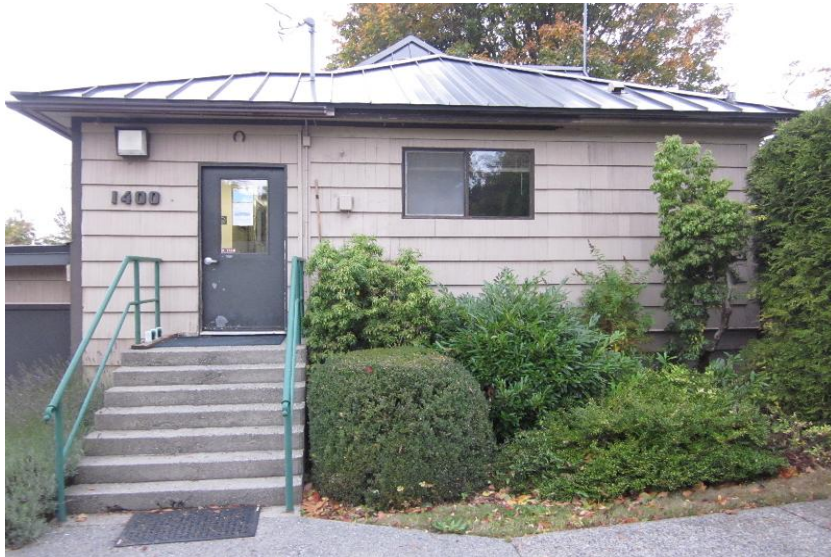
Parks Operations Office

System Name	Description
A1011 - Wall Foundations-Foundation Wall and Footings - Perimeter (Basement)	Basic perimeter foundation for building with basement - includes strip footings and foundation walls. System also includes underdrains and damp-proofing. Overall the system condition is reasonable; the Observed Years Remaining has been adjusted accordingly.
A1011 - Wall Foundations-Foundation Wall and Footings - Perimeter (Crawl Space)	Basic foundation for building with crawlspace - includes strip and pier footings and foundation walls. Overall the system condition is reasonable; the Observed Years Remaining has been adjusted accordingly.
A1030 - Slab on Grade-Concrete Slab-On-Grade	The floor of the addition is a reinforced concrete slab-on-grade throughout. Overall the system condition is reasonable; the Observed Years Remaining has been adjusted accordingly.

System Name	Description
A1030 - Slab on Grade-Concrete Slab-On-Grade (Addition)	The floor of the addition is a reinforced concrete slab-on-grade throughout.
A1031 - Standard Slab on Grade-Porches - Concrete	The building contains exterior porches with reinforced concrete at exterior front and side entrance doors. Overall the system condition is reasonable; the Observed Years Remaining has been adjusted accordingly.
B1010 - Floor Construction-Wood-Frame Floor	The structure consists of wood-framed components supported on bearing walls and/or columns. System includes sheathing and acoustic insulation and an allowance for columns. Overall the system condition is reasonable; the Observed Years Remaining has been adjusted accordingly.
B1015 - Exterior Stairs and Fire Escapes-Exterior Stairs - Concrete	Exterior concrete stairs (6' wide x 5 risers) with railing. Overall the system condition is reasonable; the Observed Years Remaining has been adjusted accordingly.

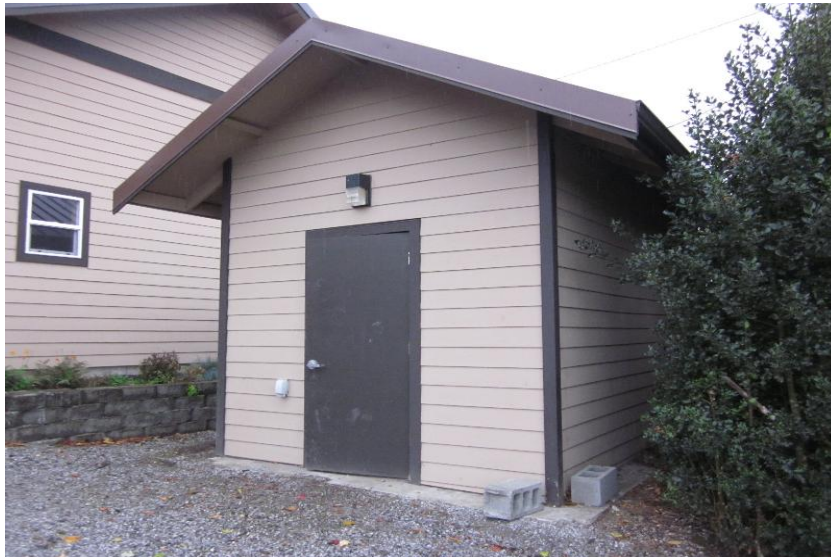
Parks Operations Pesticide Storage

System Name	Description
A1011 - Wall Foundations-Footings - Perimeter	Basic foundation for building - includes strip footings. System also includes perimeter drainage and damp-roofing.
A1030 - Slab on Grade-Concrete Slab-On-Grade	The floor of the building is a reinforced concrete slab-on-grade throughout. The system includes rigid insulation at the perimeter of the slab.
B1020 - Roof Construction-Wood-Frame Roof	The roof superstructure consists of wood-framed components (trusses) supported on bearing walls and/or columns. System includes sheathing and insulation and an allowance for columns.
B2010 - Exterior Walls-Fiber Cement Siding (Exterior) - Wood-Frame Backup	The exterior wall assemblies include wood lap siding with a wood-frame stud backup assembly. Refer to separate system for interior wall finishes such as GWB and paint.
B2010 - Exterior Walls-Paint (Exterior)	Exterior wall and trim finishes a standard exterior paint finish.

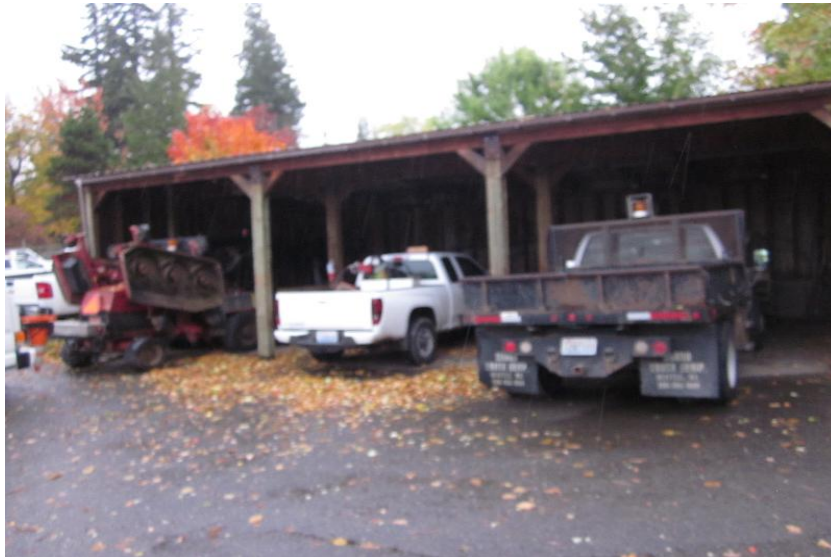
Parks Operations Tractor Shed

System Name	Description
A1011 - Wall Foundations-Foundation Wall and Footings - Perimeter	Basic foundation for building - includes strip and pier footings and foundation walls. System also includes perimeter drainage and damp-roofing.
B1020 - Roof Construction-Wood-Frame Roof	The roof superstructure consists of wood-framed components supported on bearing walls and/or columns. System includes sheathing and an allowance for columns.
B2010 - Exterior Walls-Wood Siding (Exterior) - Wood-Frame Backup	The exterior wall assemblies include T1-11 wood siding with a wood-frame stud backup assembly.
B30 - Roofing-Metal Roofing	The roof covering consists of a preformed metal roofing system, such as corrugated steel or aluminum.
B3016 - Gutters and Downspouts-Gutters and Downspouts	Aluminum gutters and down-spouts are located at the lowest edges of the roof.

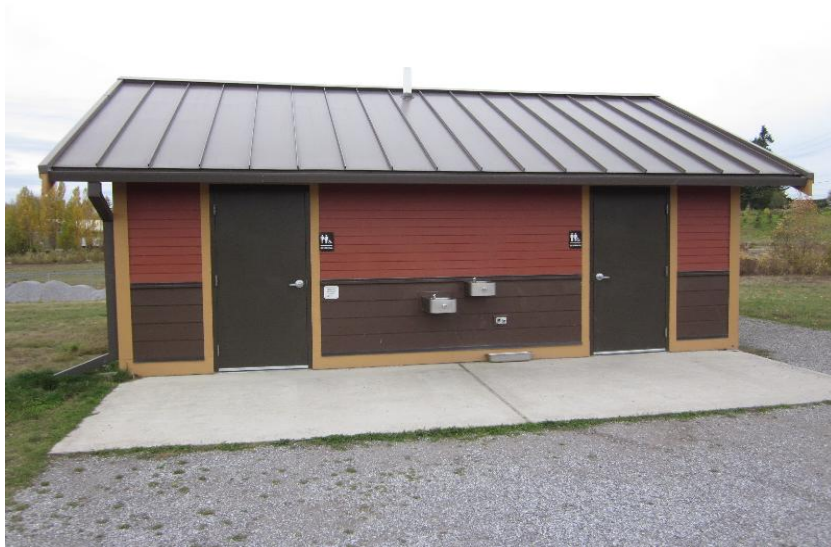
Squalicum Creek Park Restroom

System Name	Description
A1011 - Wall Foundations-Footings - Perimeter	Basic foundation for building - includes strip footings.
A1030 - Slab on Grade-Concrete Slab-On-Grade	The floor of the building is a reinforced concrete slab-on-grade throughout. The system includes rigid insulation at the perimeter of the slab.
B1020 - Roof Construction-Wood-Frame Roof	The roof superstructure consists of wood-framed components (trusses) supported on bearing walls and/or columns. System includes sheathing and insulation and an allowance for columns.
B2010 - Exterior Walls-Fiber Cement Siding (Exterior) - Wood-Frame Backup	The exterior wall assemblies include Hardiplank lap siding with a wood-frame stud backup assembly.
B2010 - Exterior Walls-Paint (Exterior)	Exterior wall and trim finishes a standard exterior paint finish.

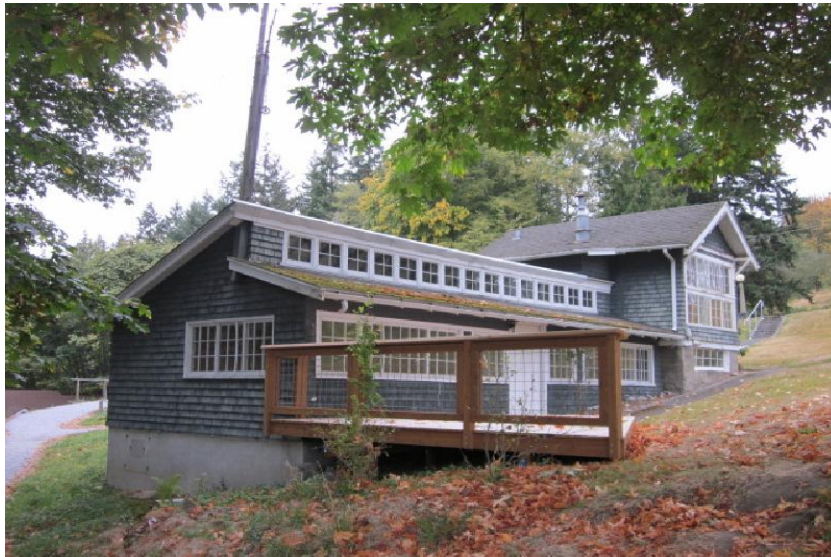
Woodstock Farm Studio

System Name	Description
A1011 - Wall Foundations-Foundation Wall and Footings - Perimeter	Basic perimeter foundation for building with basement - includes strip footings and foundation walls. System also includes underdrains and damp-proofing.
A1012 - Column Foundations and Pile Caps-Interior Foundations (Crawlspace)	The interior crawlspace foundations typically consist of concrete piers and footings.
B1010 - Floor Construction-Floor Assemblies - Wood Joists and Subfloor	Floor assembly includes wood floor joists and wood subfloor.
B1015 - Exterior Stairs and Fire Escapes-Access Stairs - Wood (Exterior)	A wood-frame stairway is located at the east end of the building. Unit cost based on 14-riser flight of stairs. Overall the system condition appears reasonable; the observed-years-remaining has been adjusted accordingly.
