# Preliminary Stormwater Management Report

THE WOODS AT VIEWCREST

February 28<sup>th</sup>, 2022

Pacific Surveying and Engineering Services, Inc.  
909 Squaticum Way, Suite 11  
Bellingham, Washington 98225  
(360) 671-7387  
[www.psesurvey.com](http://www.psesurvey.com)

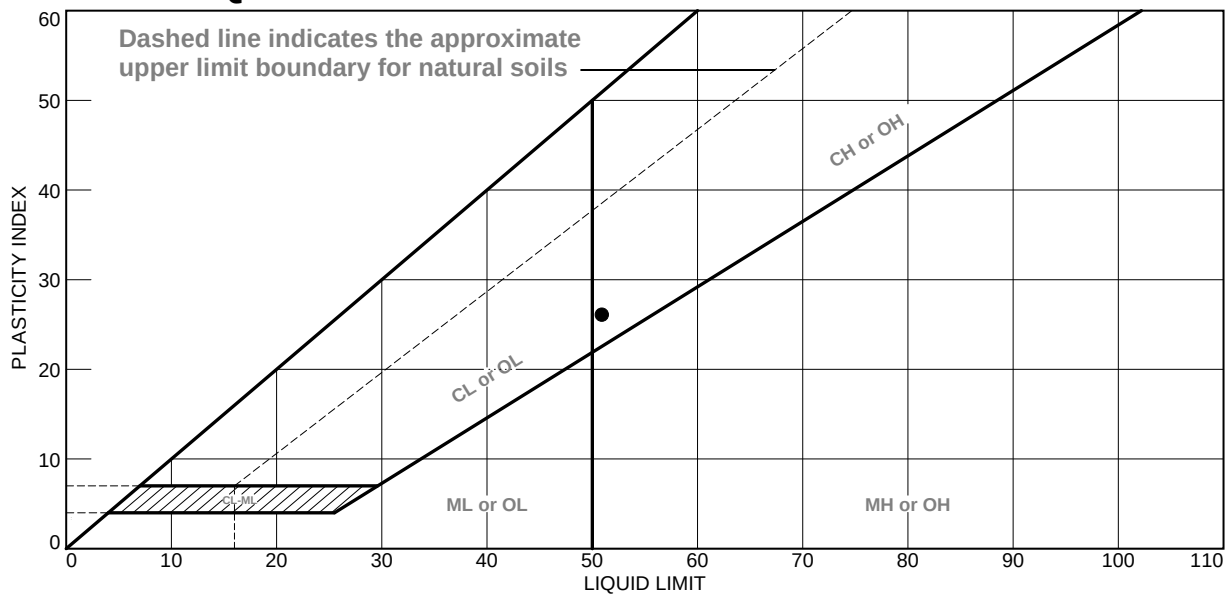
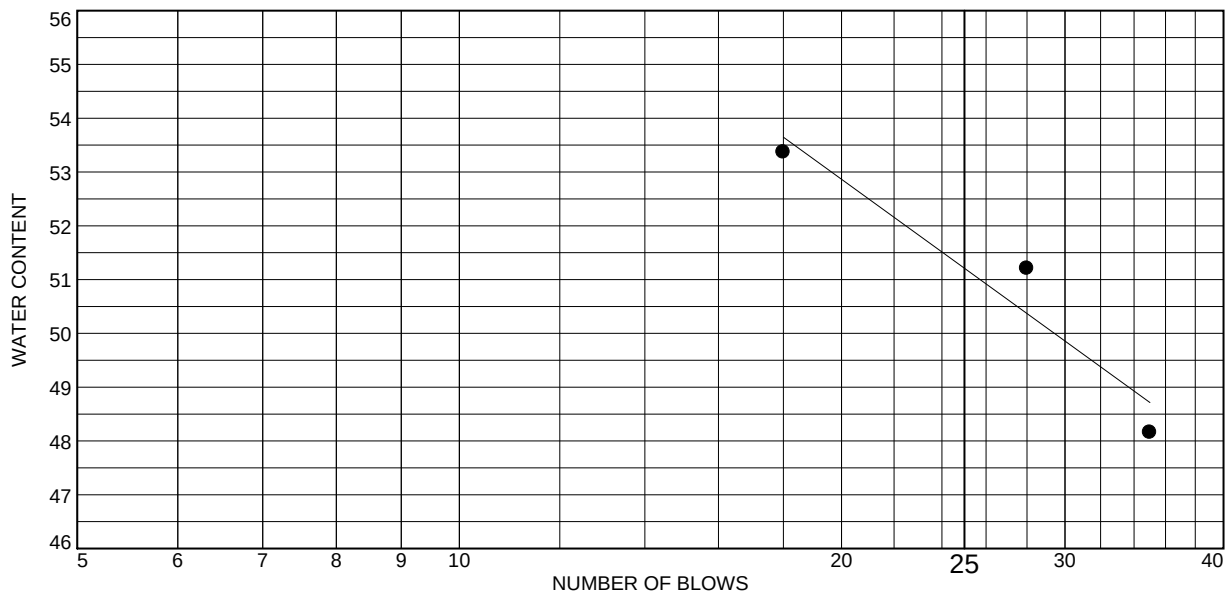
## LIQUID AND PLASTIC LIMITS TEST REPORT

| MATERIAL DESCRIPTION | LL | PL | PI | %<#40 | %<#200 | USCS |
|---|---|---|---|---|---|---|
| Native Material<br>poorly graded sand with silt | 51 | 25 | 26 | | 20 | |

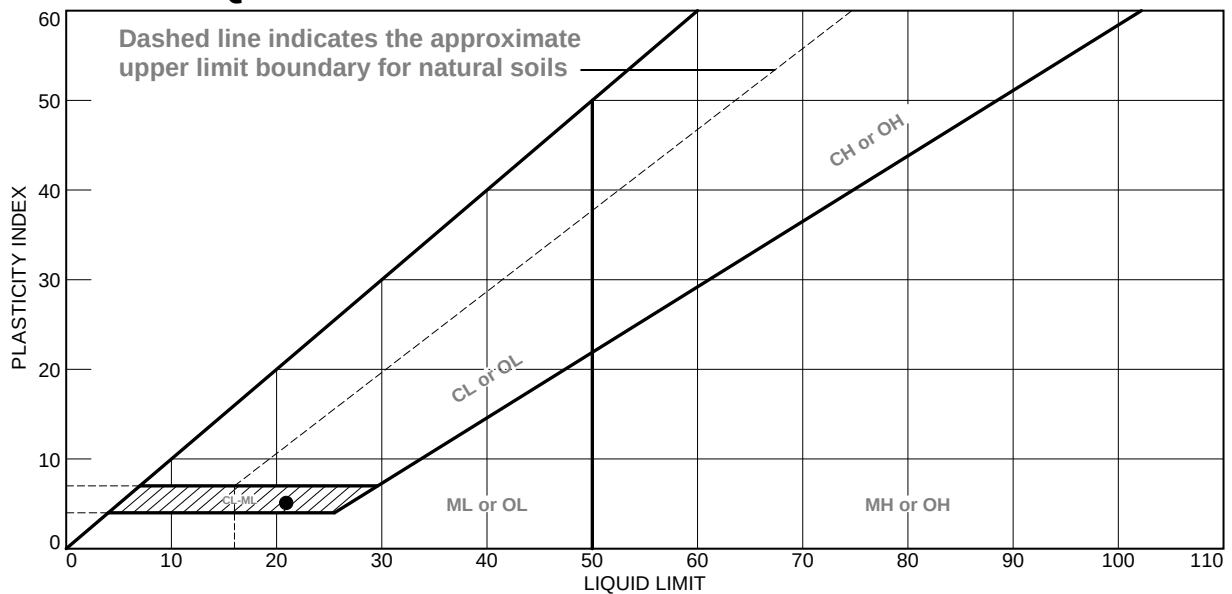
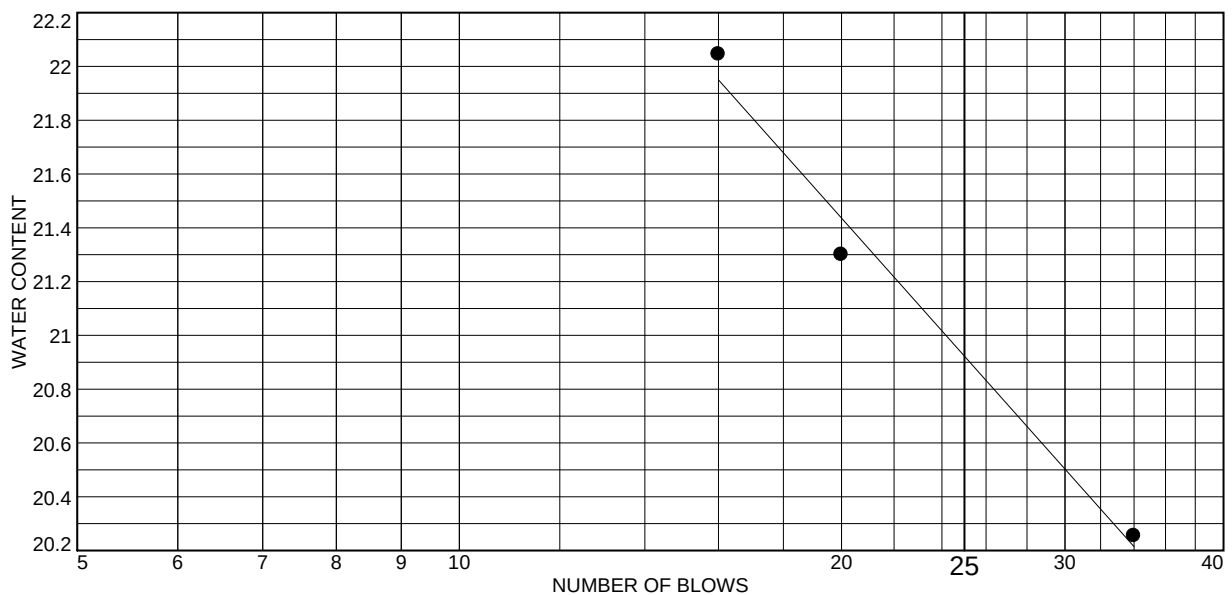
## LIQUID AND PLASTIC LIMITS TEST REPORT

| MATERIAL DESCRIPTION | LL | PL | PI | %<#40 | %<#200 | USCS |
|---|---|---|---|---|---|---|
| Native Material<br>poorly graded sand with silt | 21 | 16 | 5 | 71 | 39 | SC-SM |

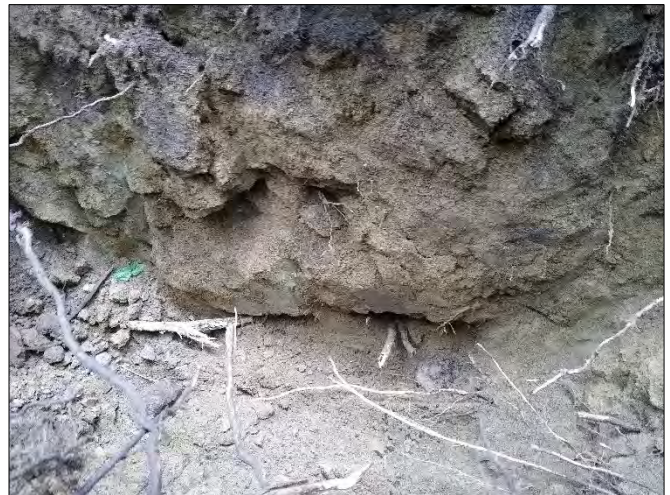
**Photo 10:** TP25; Sandy Eluvium Over Dense Sandstone Bedrock

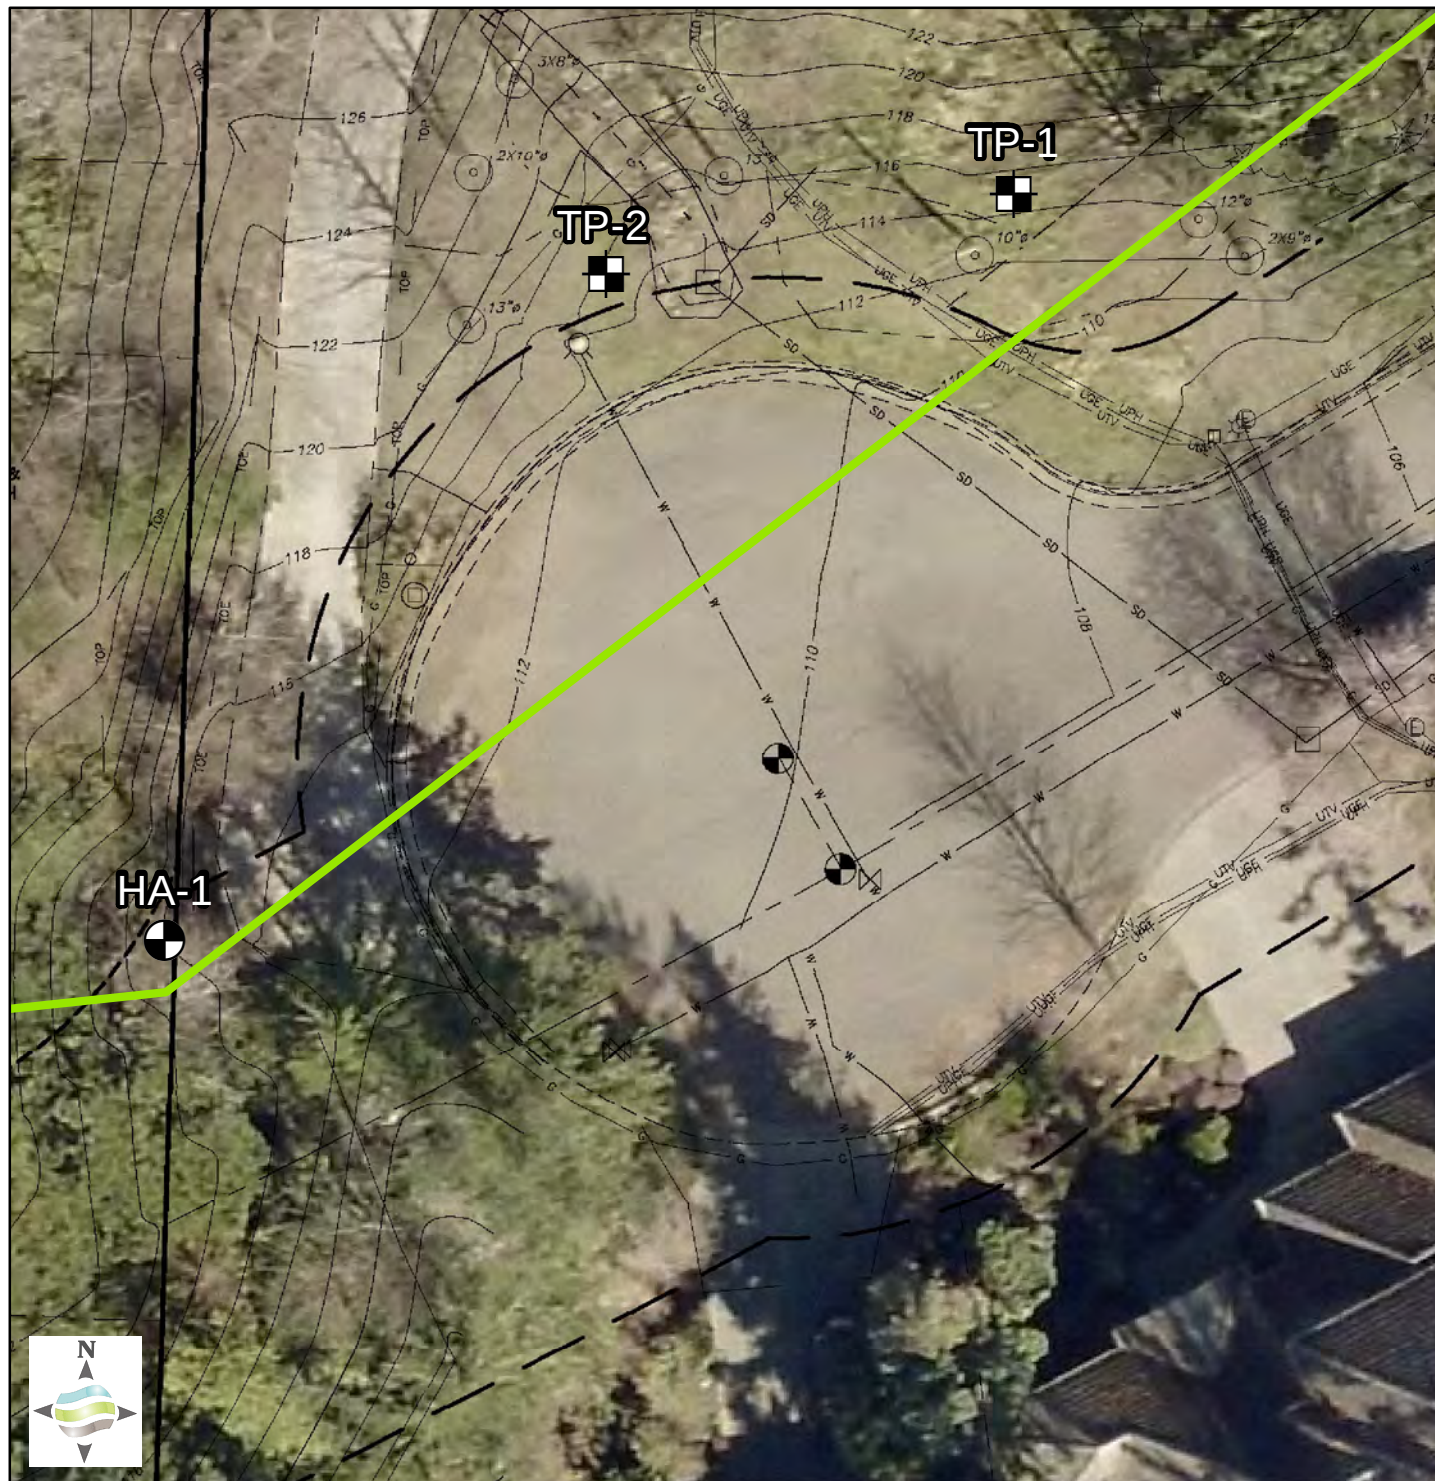
## Figure 7

Jones - Edgemoor Estate  
 Approximate Depth to Bedrock Map

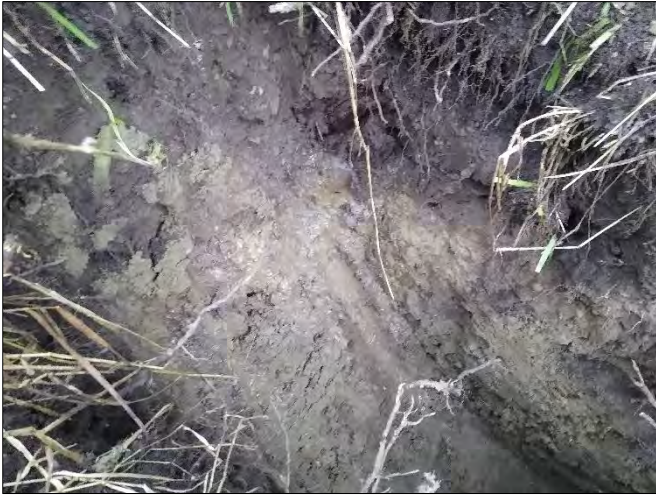
**Photo 1: TP1**

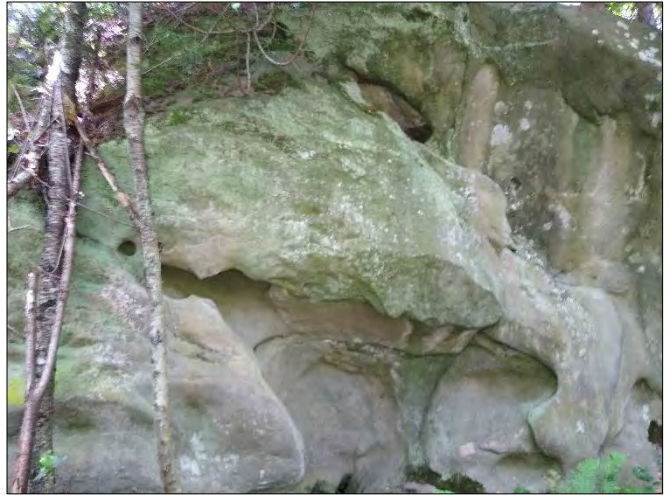
**Photo 8:** West-Central Bedrock Faces; West Outcrop

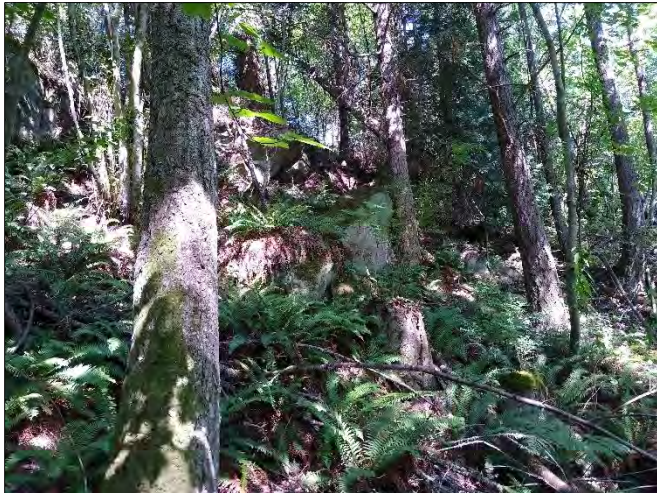
**Photo 9:** West-Central Bedrock Faces; West Outcrop, Northern Slope Area

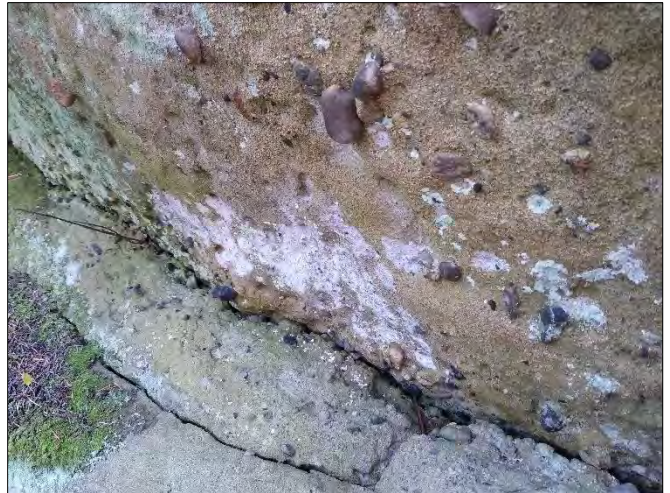
**Photo 10:** Conglomerate Bedrock Exposure; SW Project Area

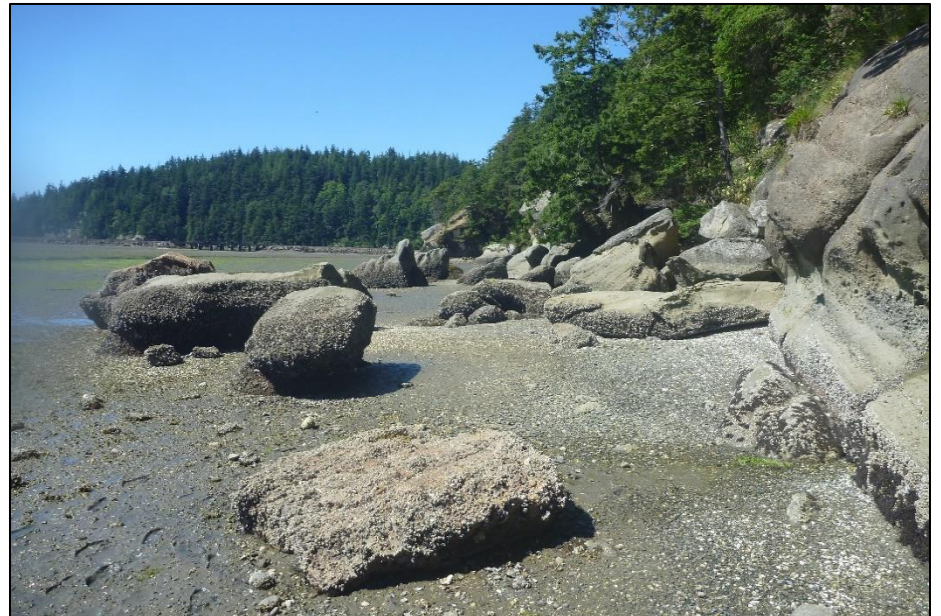
Overview of Mud Bay shoreline and OHWM

Chuckanut Bay is located along the entire southern boundary of the site. The ordinary high water mark (OHWM) along this shoreline is defined by exposed sandstone bedrock located at the toe of a moderately steep slope. The unvegetated bedrock wall is six to ten feet tall. The OHWM was not marked in the field (it would require spray painting the rock), but was mapped in Figure 2 using aerial imagery, LiDAR, and field notes. The beach and intertidal zone were unvegetated and the substrate consisted of a mix of cobble, gravel, and silt. Chuckanut Bay is mapped by WDFW to contain hardshell clam and shorebird concentrations (Priority Species/Habitats). No other Priority habitats or species are mapped or were identified on site.
