Preliminary Stormwater Management Report

THE WOODS AT VIEWCREST

GEOTECHNICAL INVESTIGATION & GEOHAZARD REPORT JONES EDGEMOOR ESTATE PROPOSED 38-LOT PLAT DEVELOPMENT VIEWCREST ROAD, BELLINGHAM, WA

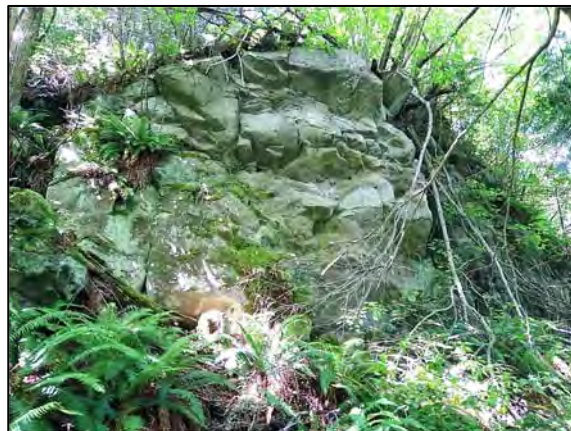
Photo 1: Bedrock Cliff Face; Northwest Slope

The cliff area along the northwest hill represents the greatest exposure and highest hazard potential for associated rock-fall (Photo 1, above). At its steepest point, the elevation drops about 37 feet over a horizontal distance of ~25 feet for an average slope ratio approaching 1:1.5 (H:V) along the cliff face. Grades range up to approximately vertical, and are locally overhanging on the variable outcrop faces. We observed these features to be highly influenced by the regularity and orientation of rock structures dictating their stability and character. Section 4.3 below provides a review of bedrock features and structures.

The opposite southeast side of the northwestern hill exhibits a steep or cliff-like face with prominent bedrock outcrops. Similar conditions are present to a lesser magnitude along the southeast faces of multiple smaller hills in the central project area. The cliff-formed faces are typically continuous for around 10 to 20 feet maximum and interspersed or bordered with vegetated steep slopes. Small scale rock-fall was observed along the southeastern side of two of the prominent ridge features in the central region of this area, interpreted to be occurring at a low rate of regularity. Detached bedrock blocks were not observed to have traveled far from their points of origin on the outcrops.

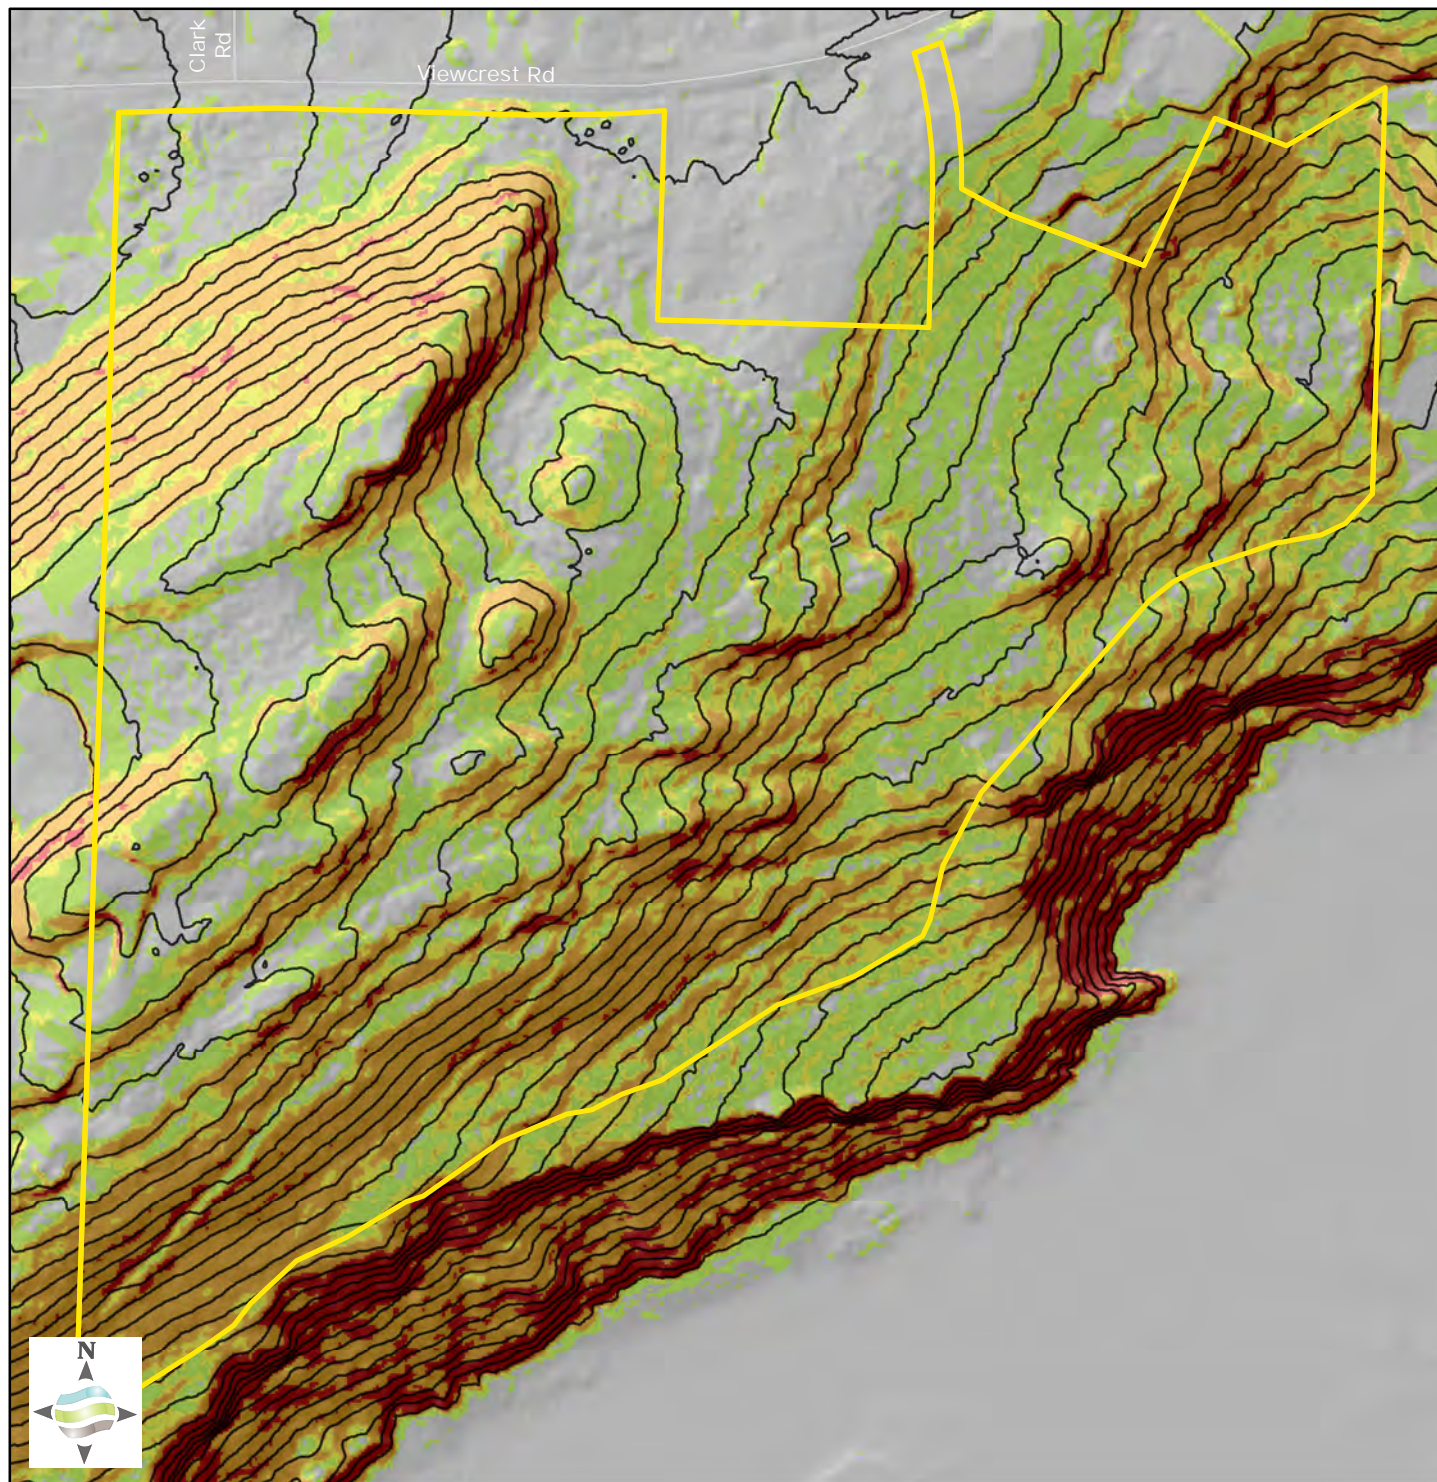
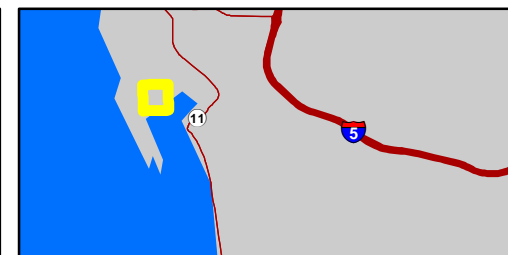
Jones - Edgemoor Estate
 Percent Slope Map

Data Credits:
 [Parcels] Whatcom County 2018
 [Roads] COB 2018
 [Lidar] COB 2013

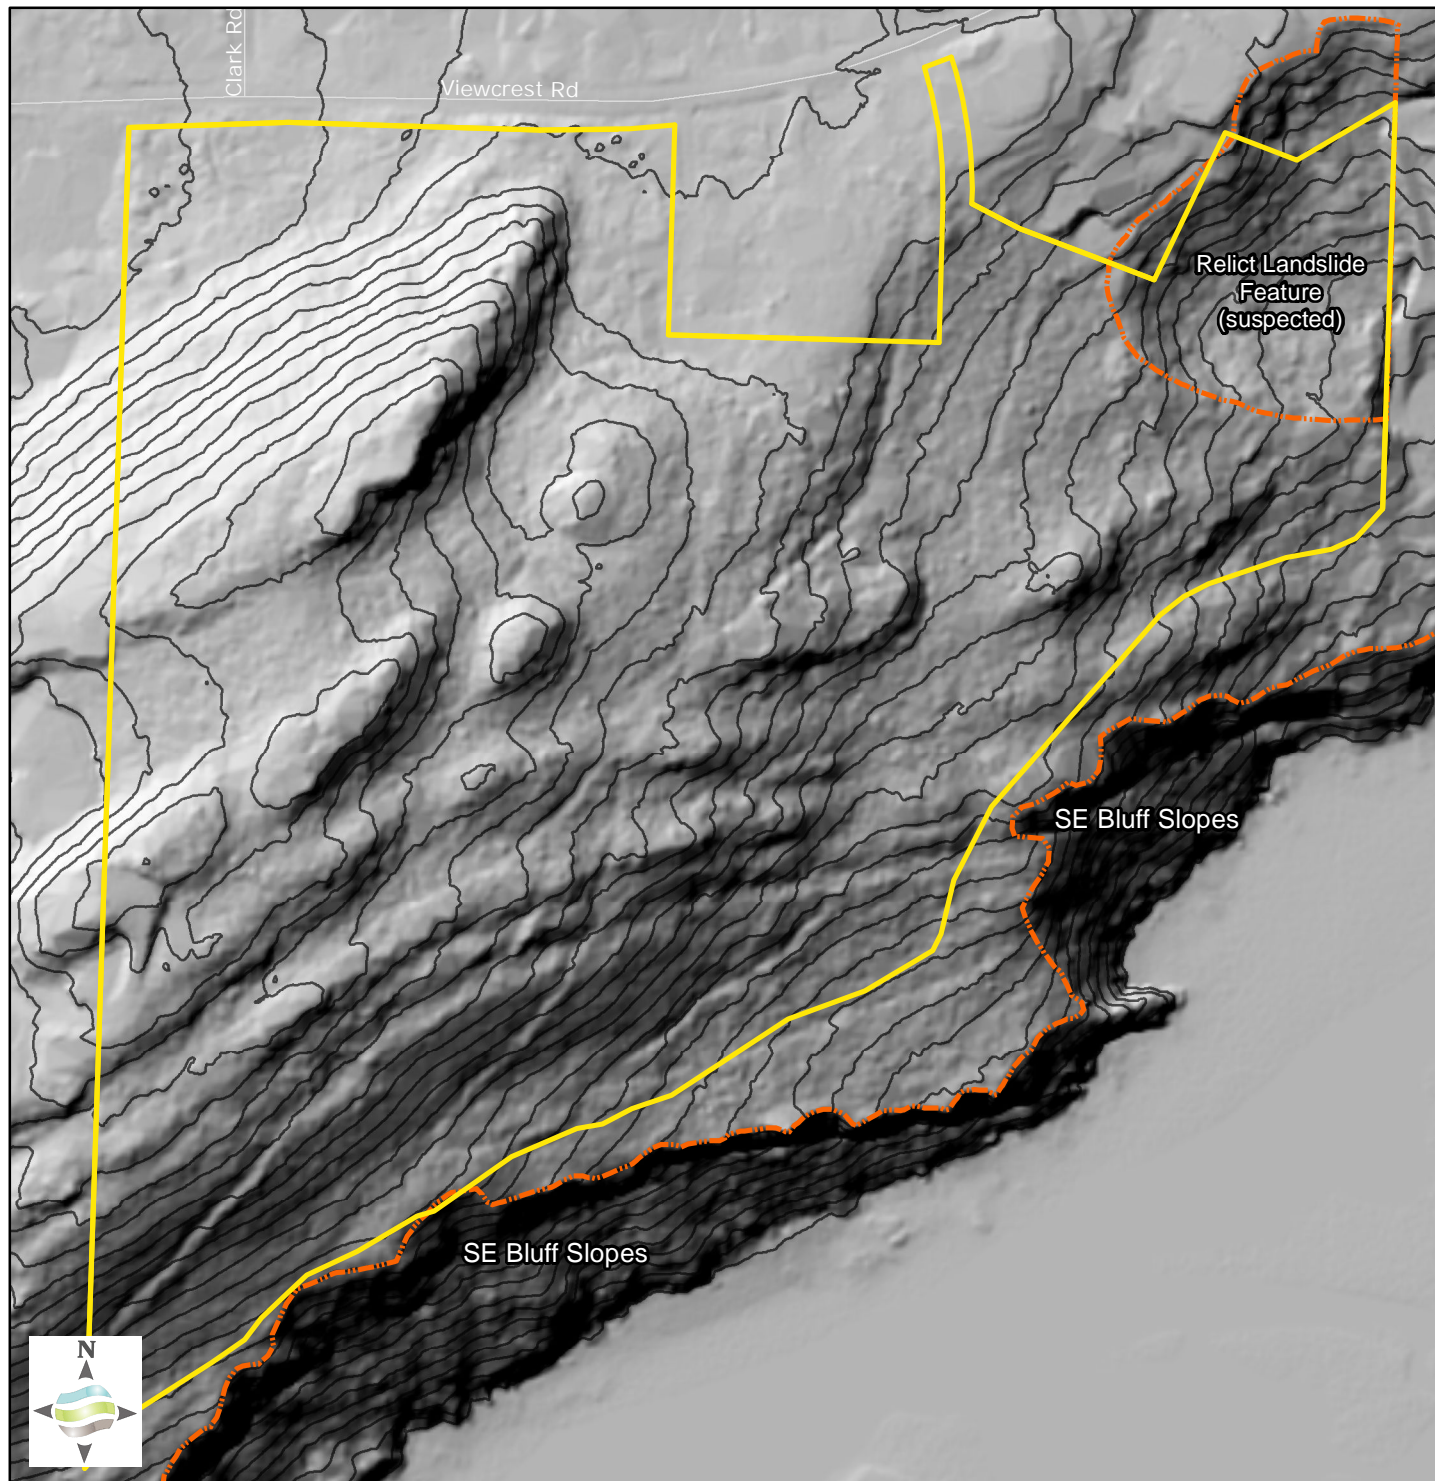
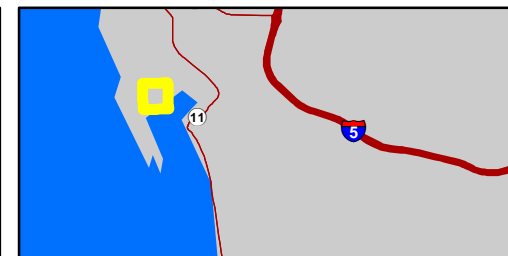
Jones - Edgemoor Estate
 LiDAR Overview w/ Feature Annotation

- Study Area
- - - Landslide Hazard Area (LHA)
- 10ft-Contours
- Roads

Upon reviewing slope gradient and LiDAR maps, we identified several features for particular focus during reconnaissance. The features occur *within and bordering the proposed development area*, are indicated on the annotated site map (Figure 9, Appendix III), and include:

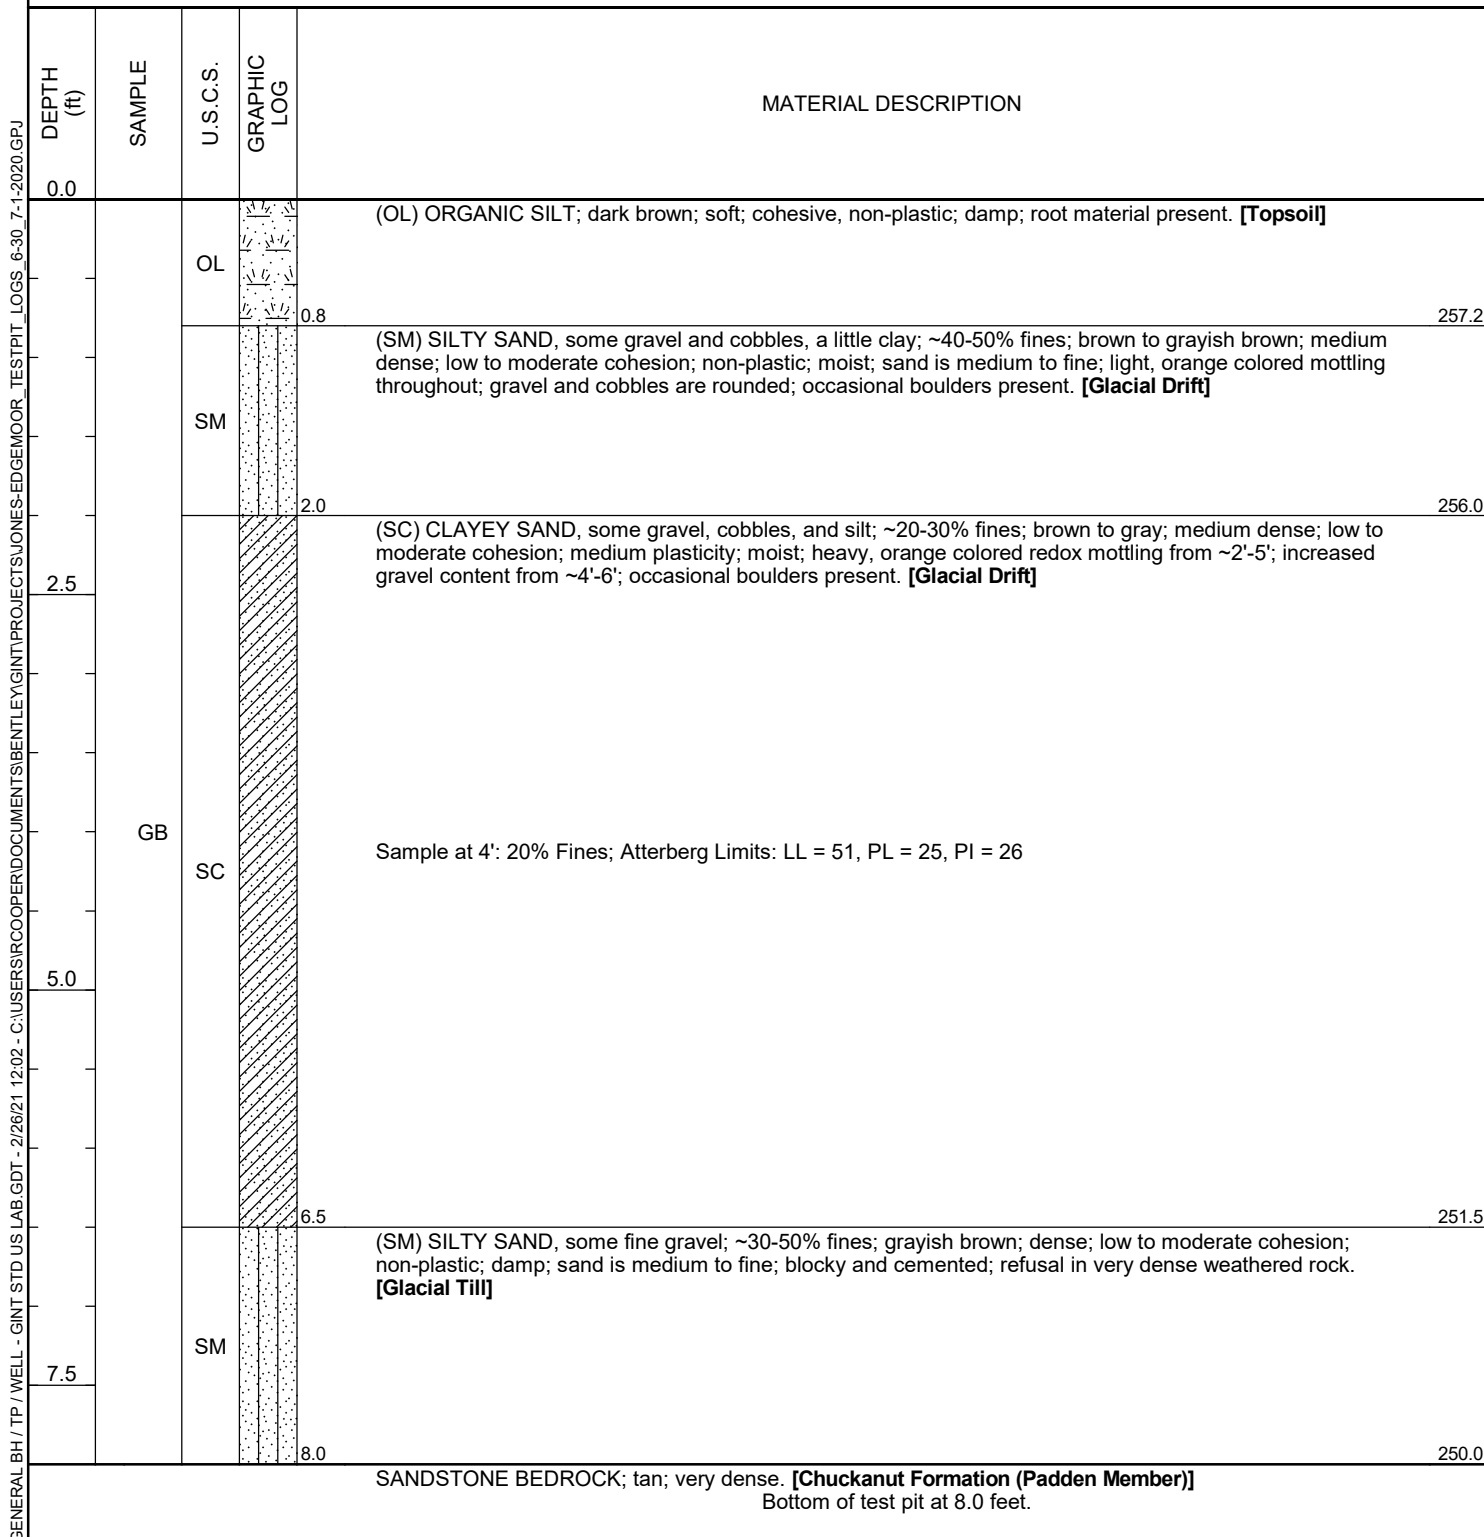
CLIENT <u>Ann C Jones, Family LP</u>	PROJECT NAME <u>Edgemoor Property</u>
PROJECT NUMBER <u>2020094</u>	PROJECT LOCATION <u>Viewcrest Road, Bellingham, WA</u>
DATE STARTED <u>6/30/20</u> COMPLETED <u>6/30/20</u>	GROUND ELEVATION <u>258' NAVD 88</u> TEST PIT SIZE <u>15 sqft</u>
EXCAVATION CONTRACTOR <u>Ryan Bradley</u>	GROUND WATER LEVELS:
EXCAVATION METHOD <u>Yanmar compact excavator</u>	AT TIME OF EXCAVATION <u>---</u>
LOGGED BY <u>RC</u> CHECKED BY <u>JG</u>	AT END OF EXCAVATION <u>---</u>
NOTES <u>No groundwater or free water seepage observed.</u>	AFTER EXCAVATION <u>---</u>

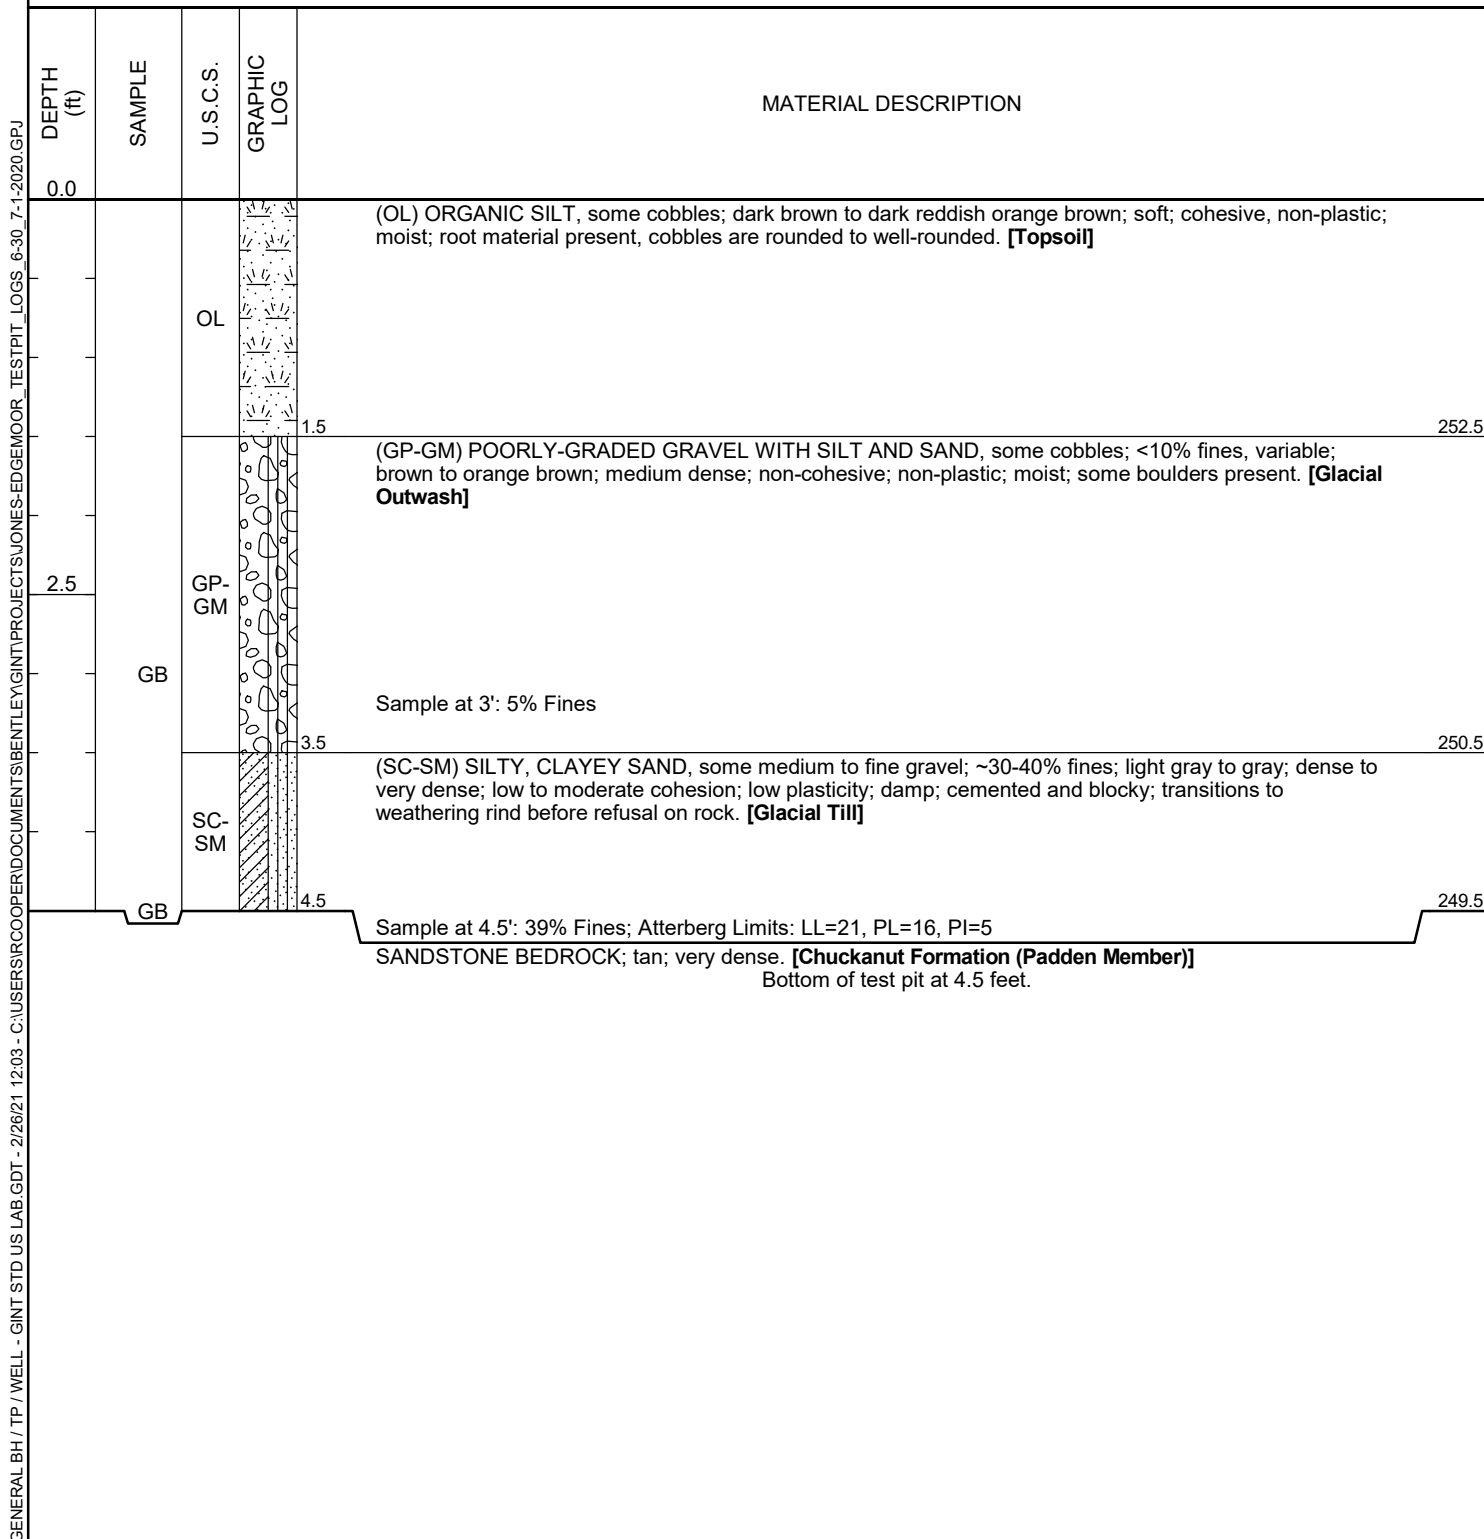
CLIENT <u>Ann C Jones, Family LP</u>	PROJECT NAME <u>Edgemoor Property</u>
PROJECT NUMBER <u>2020094</u>	PROJECT LOCATION <u>Viewcrest Road, Bellingham, WA</u>
DATE STARTED <u>7/1/20</u> COMPLETED <u>7/1/20</u>	GROUND ELEVATION <u>254' NAVD 88</u> TEST PIT SIZE <u>15 sqft</u>
EXCAVATION CONTRACTOR <u>Ryan Bradley</u>	GROUND WATER LEVELS:
EXCAVATION METHOD <u>Yanmar compact excavator</u>	AT TIME OF EXCAVATION <u>---</u>
LOGGED BY <u>RC</u> CHECKED BY <u>JG</u>	AT END OF EXCAVATION <u>---</u>
NOTES <u>No groundwater or free water seepage observed.</u>	AFTER EXCAVATION <u>---</u>

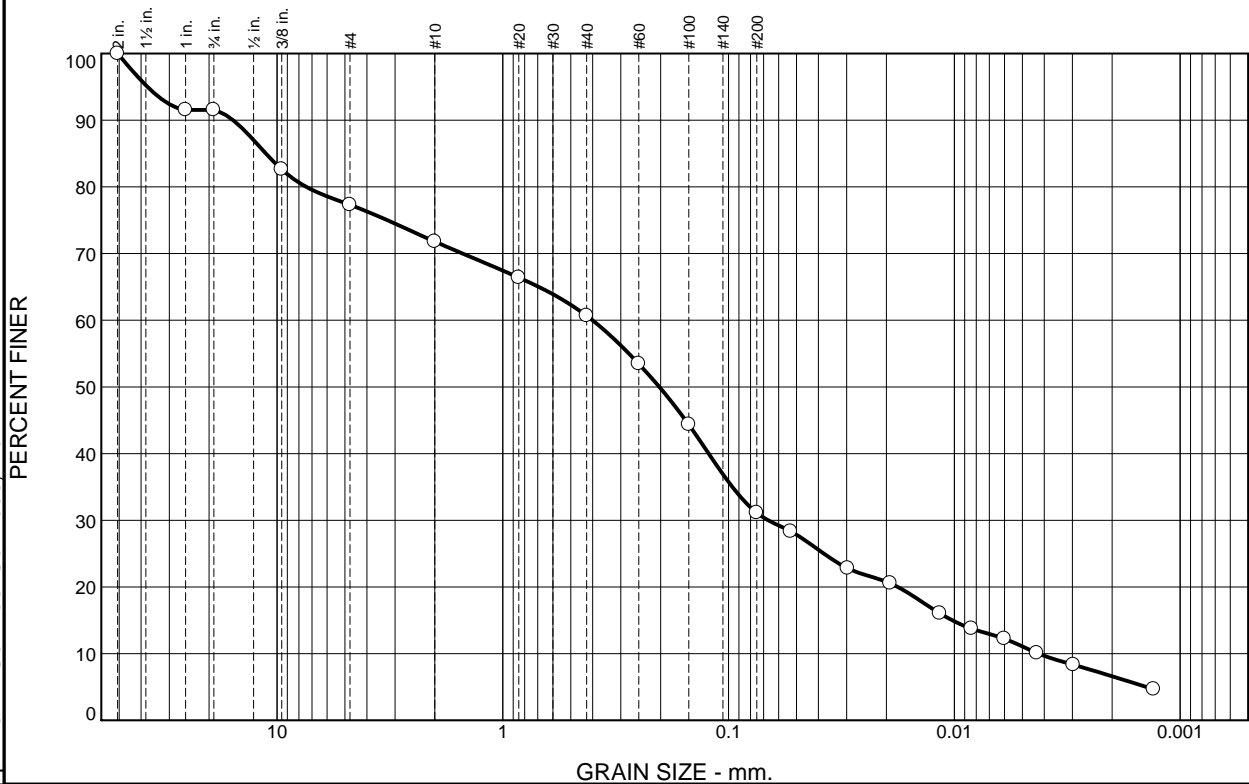
Sieve Analysis w/Hydrometer Test Report - D422/D1140

% +3"	% Gravel		% Sand			% Fines	
	Coarse	Fine	Coarse	Medium	Fine	Silt	Clay
0	8	15	5	11	30	20	11

SIEVE SIZE	PERCENT FINER	SPEC.* PERCENT	PASS? (X=NO)
2"	100		
1"	92		
3/4"	92		
3/8"	83		
#4	77		
#10	72		
#20	66		
#40	61		
#60	53		
#100	44		
#200	31		
#270	28		
0.0297 mm.	23		
0.0192 mm.	21		
0.0116 mm.	16		
0.0084 mm.	14		
0.0060 mm.	12		
0.0043 mm.	10		
0.0030 mm.	8.3		
0.0013 mm.	4.7

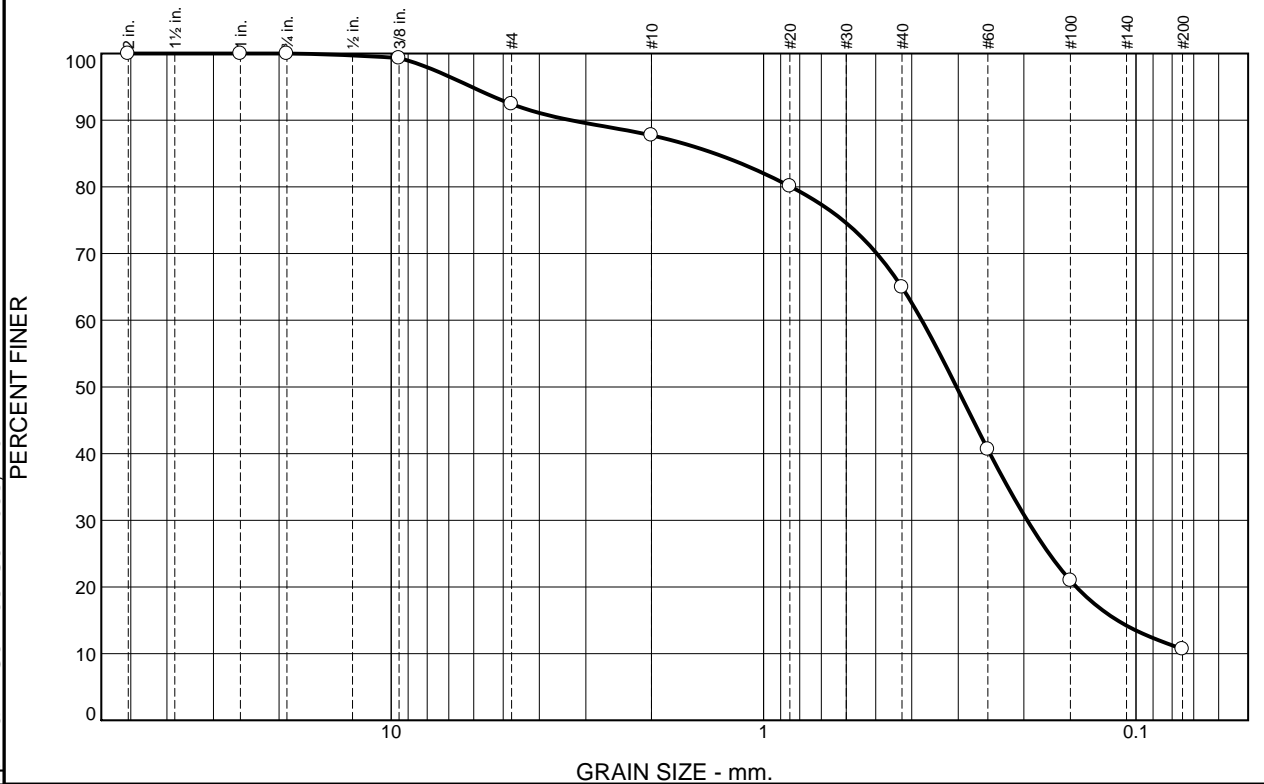
Sieve Analysis Test Report - ASTM C136/C117

% +3"	% Gravel		% Sand			% Fines Silt
	Coarse	Fine	Coarse	Medium	Fine	
0	0	8	4	23	54	11

SIEVE SIZE	PERCENT FINER	SPEC.* PERCENT	PASS? (X=NO)
2"	100		
1"	100		
3/4"	100		
3/8"	99		
#4	92		
#10	88		
#20	80		
#40	65		
#60	41		
#100	21		
#200	11

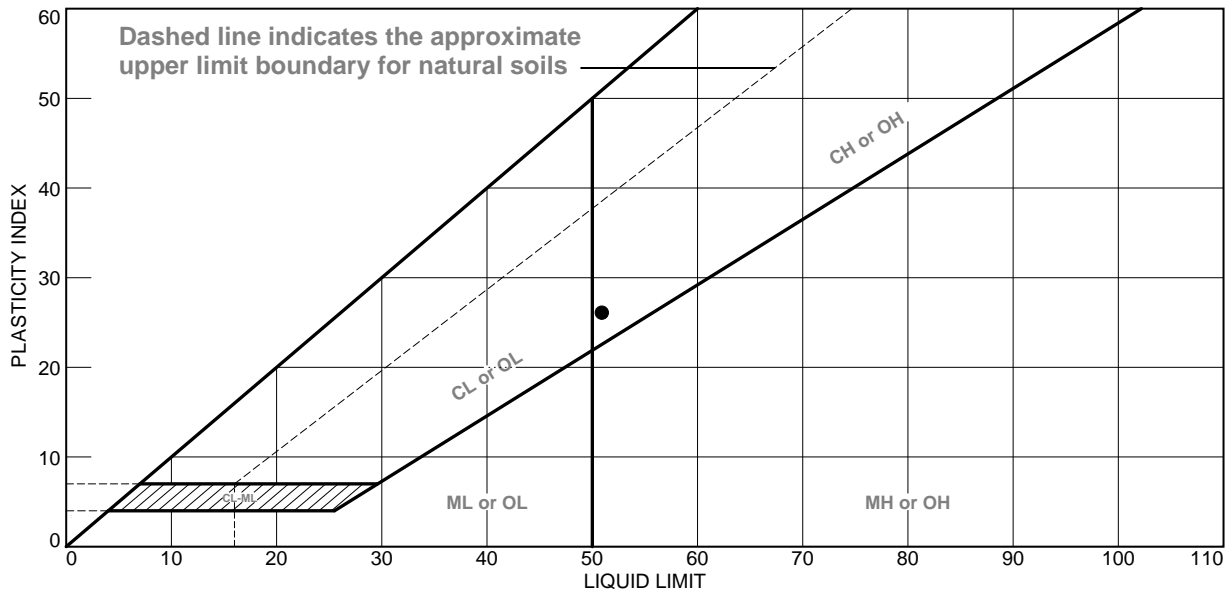
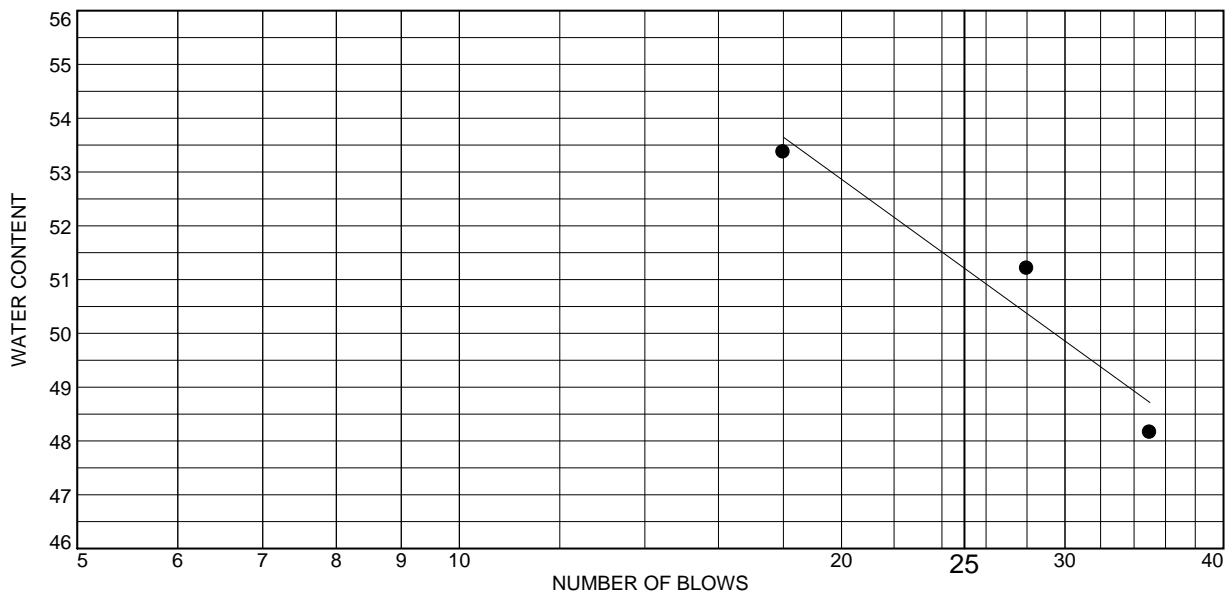
LIQUID AND PLASTIC LIMITS TEST REPORT

MATERIAL DESCRIPTION	LL	PL	PI	%<#40	%<#200	USCS
Native Material poorly graded sand with silt	51	25	26		20

Project No. 20-0587 **Client:** Element Solutions
Project: Jones-Edgemoor Estates
Whatcom County, WA
Location: Native Material - Sampled by Client from TP-8 @ 4'
Sample Number: 1168

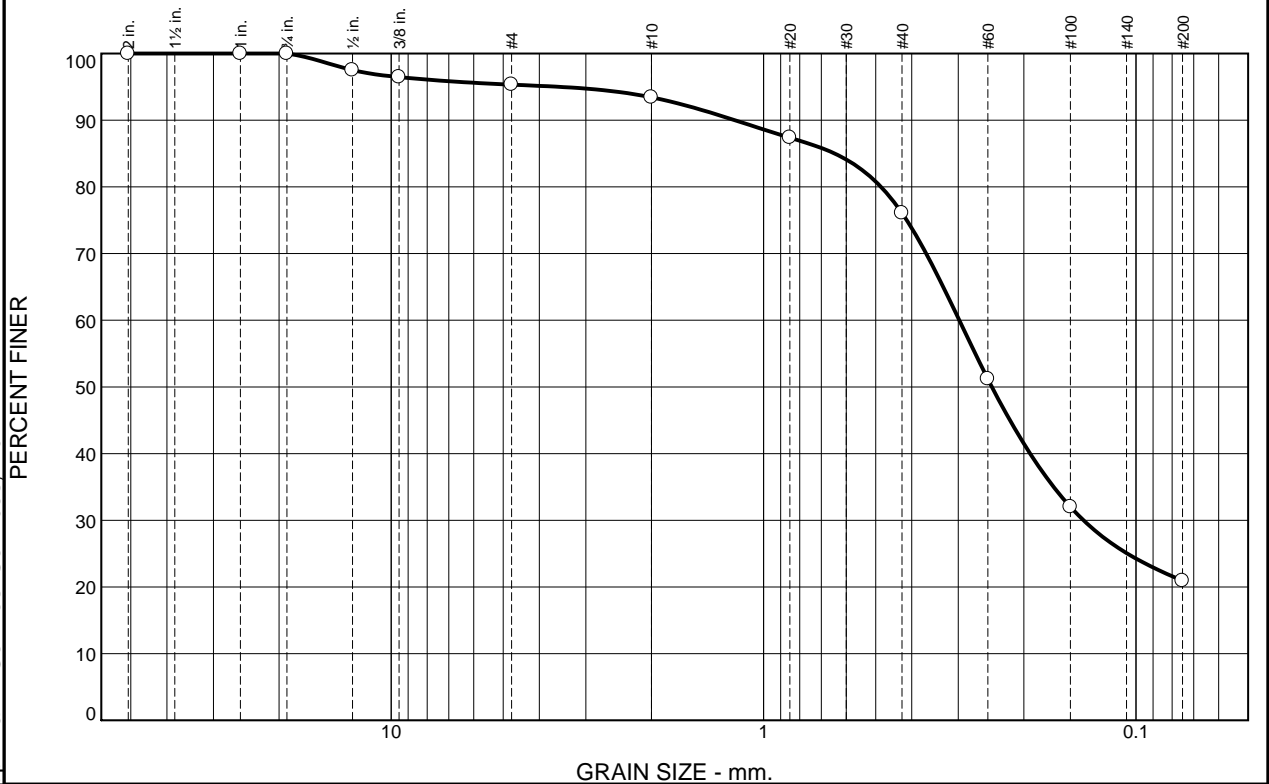
Sieve Analysis Test Report - ASTM C136/C117

% +3"	% Gravel		% Sand			% Fines Silt
	Coarse	Fine	Coarse	Medium	Fine	
0	0	5	2	17	55	21

SIEVE SIZE	PERCENT FINER	SPEC.* PERCENT	PASS? (X=NO)
2"	100		
1"	100		
3/4"	100		
1/2"	98		
3/8"	96		
#4	95		
#10	93		
#20	87		
#40	76		
#60	51		
#100	32		
#200	21

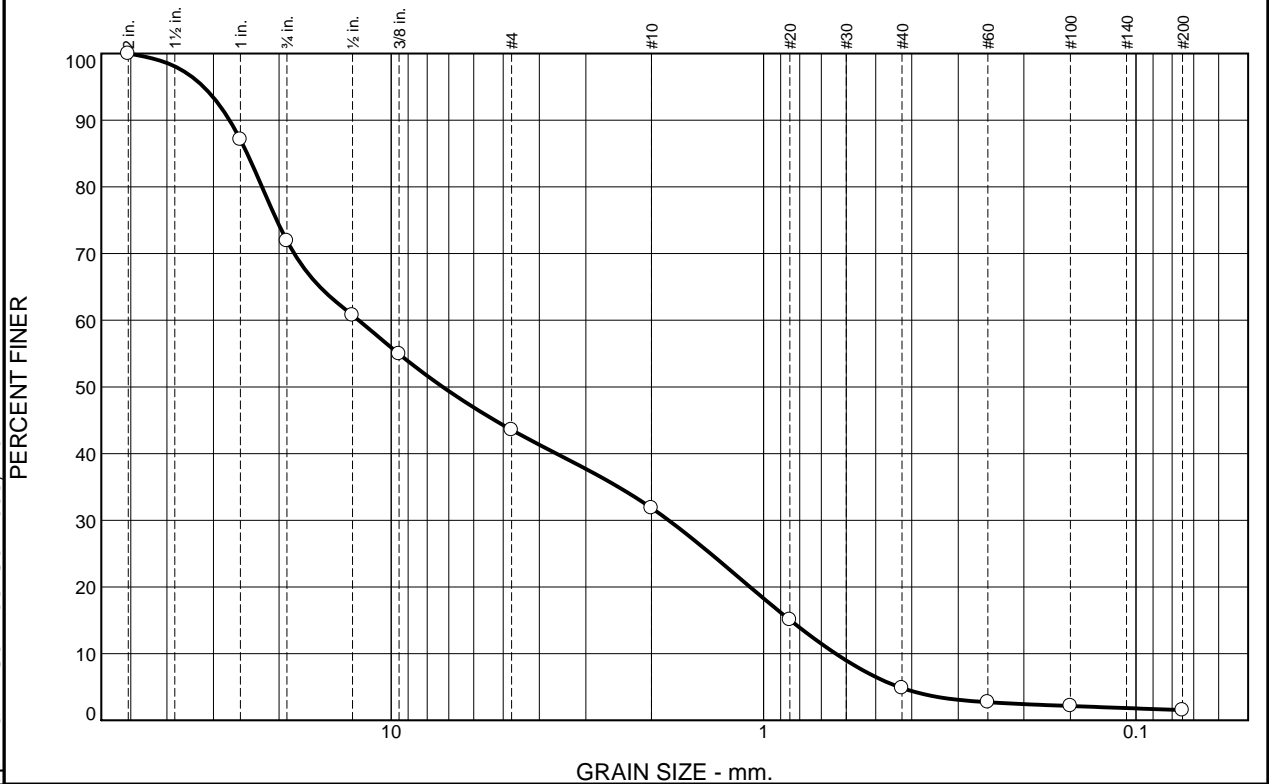
Sieve Analysis Test Report - ASTM C136/C117

% +3"	% Gravel		% Sand			% Fines Silt
	Coarse	Fine	Coarse	Medium	Fine	
0	28	28	12	27	3	2

SIEVE SIZE	PERCENT FINER	SPEC.* PERCENT	PASS? (X=NO)
2"	100		
1"	87		
3/4"	72		
1/2"	61		
3/8"	55		
#4	44		
#10	32		
#20	15		
#40	5		
#60	3		
#100	2		
#200	1.5

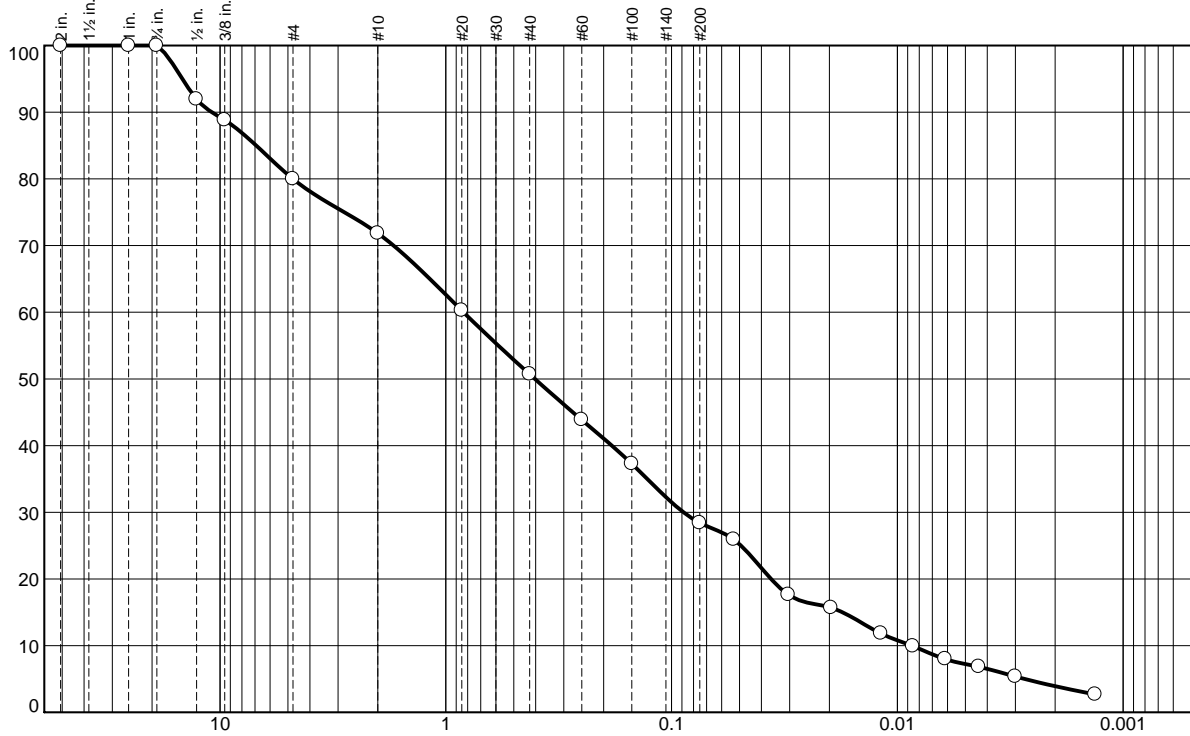
Sieve Analysis w/Hydrometer Test Report - D422/D1140

% +3"	% Gravel		% Sand			% Fines	
	Coarse	Fine	Coarse	Medium	Fine	Silt	Clay
0	0	20	8	21	23	21	7

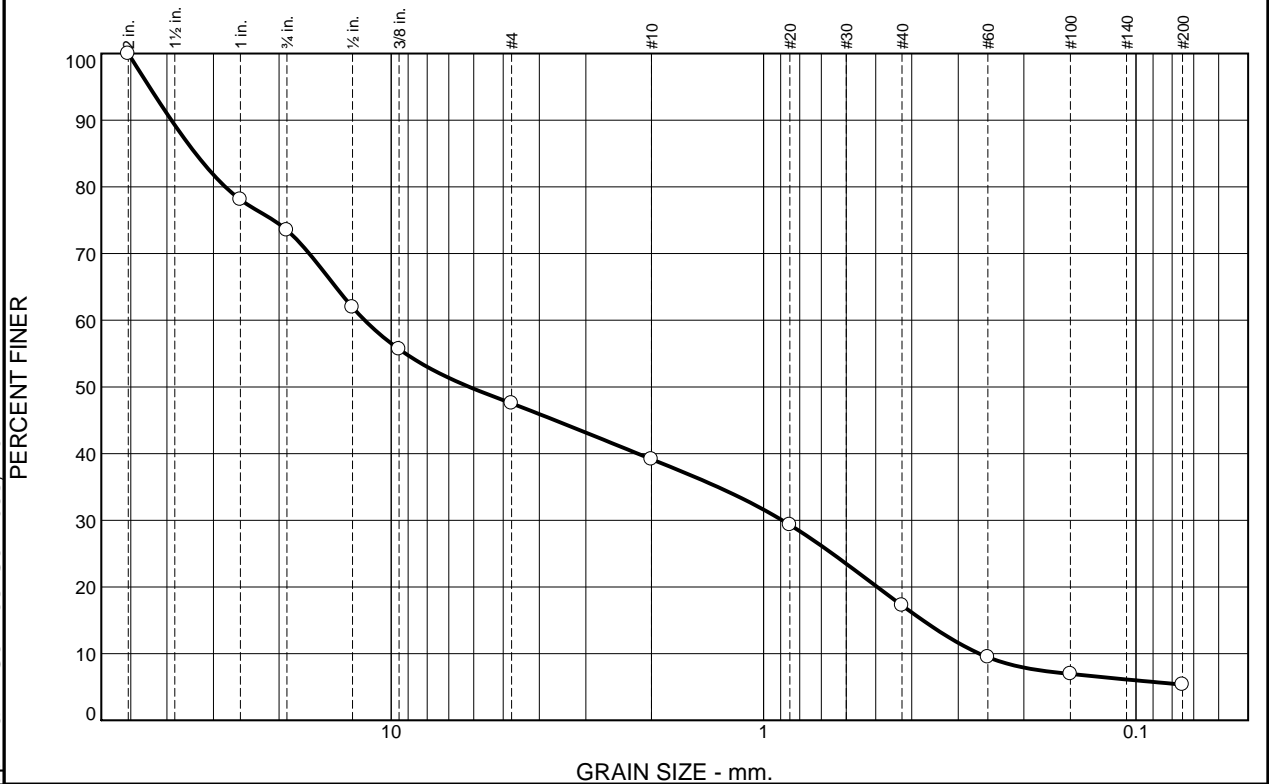
Sieve Analysis Test Report - ASTM C136/C117

% +3"	% Gravel		% Sand			% Fines Silt
	Coarse	Fine	Coarse	Medium	Fine	
0	26	26	9	22	12	5

SIEVE SIZE	PERCENT FINER	SPEC.* PERCENT	PASS? (X=NO)
2"	100		
1"	78		
3/4"	74		
1/2"	62		
3/8"	56		
#4	48		
#10	39		
#20	29		
#40	17		
#60	9		
#100	7		
#200	5.3

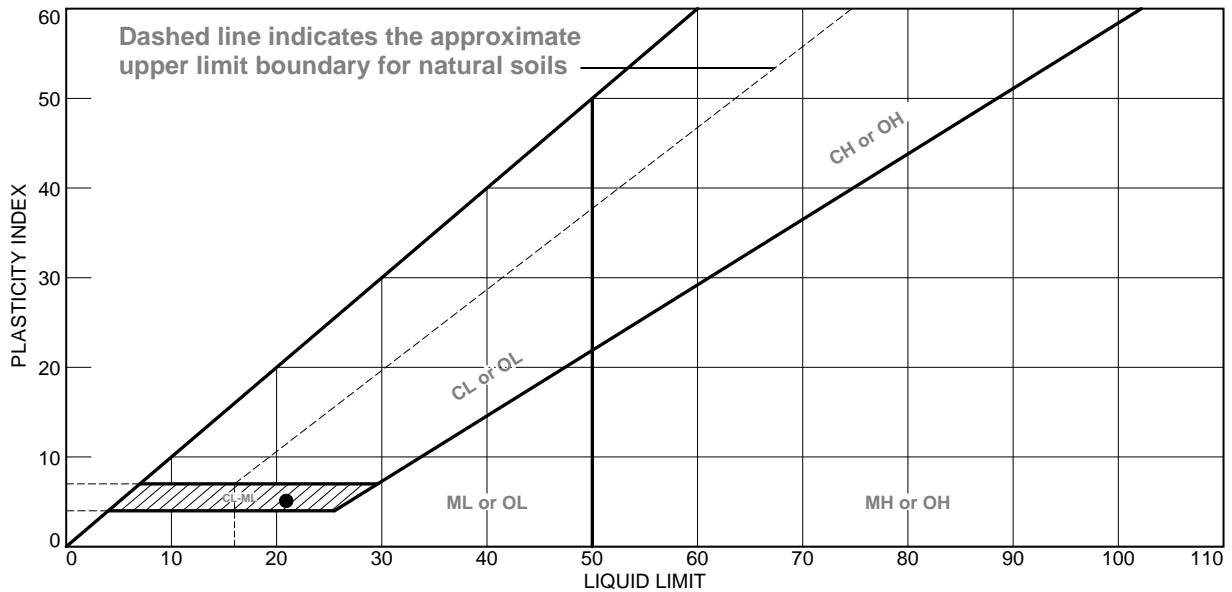
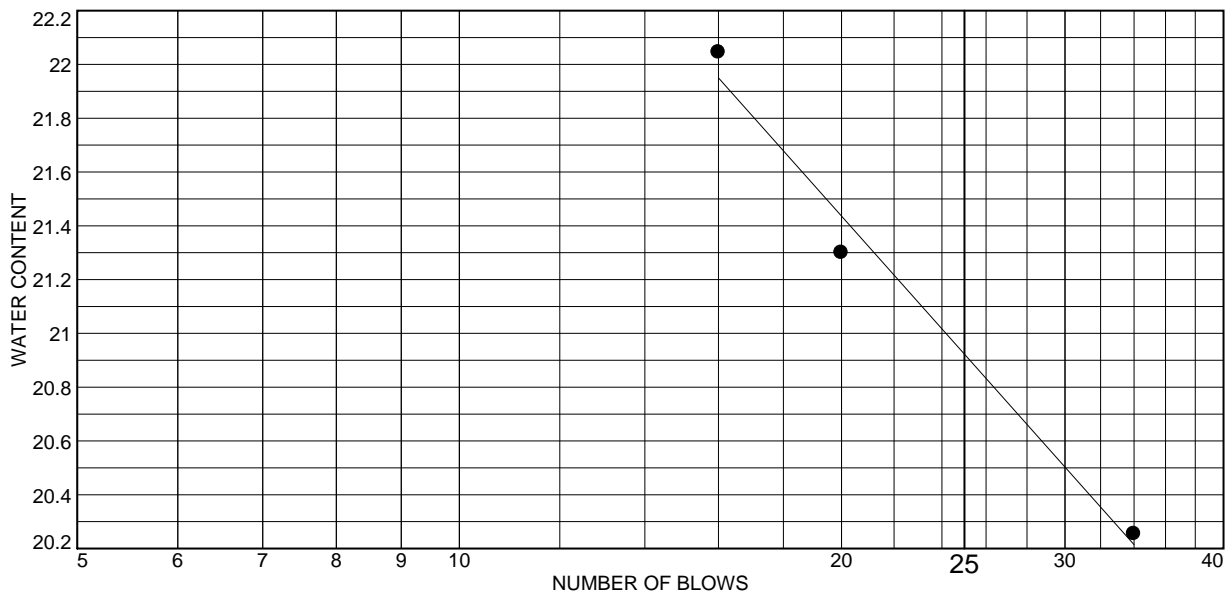
LIQUID AND PLASTIC LIMITS TEST REPORT

MATERIAL DESCRIPTION	LL	PL	PI	%<#40	%<#200	USCS
Native Material poorly graded sand with silt	21	16	5	71	39	SC-SM

Project No. 20-0587 **Client:** Element Solutions
Project: Jones-Edgemoor Estates
Whatcom County, WA
Location: Native Material - Sampled by Client from TP-16 @ 4.5'
Sample Number: 1175

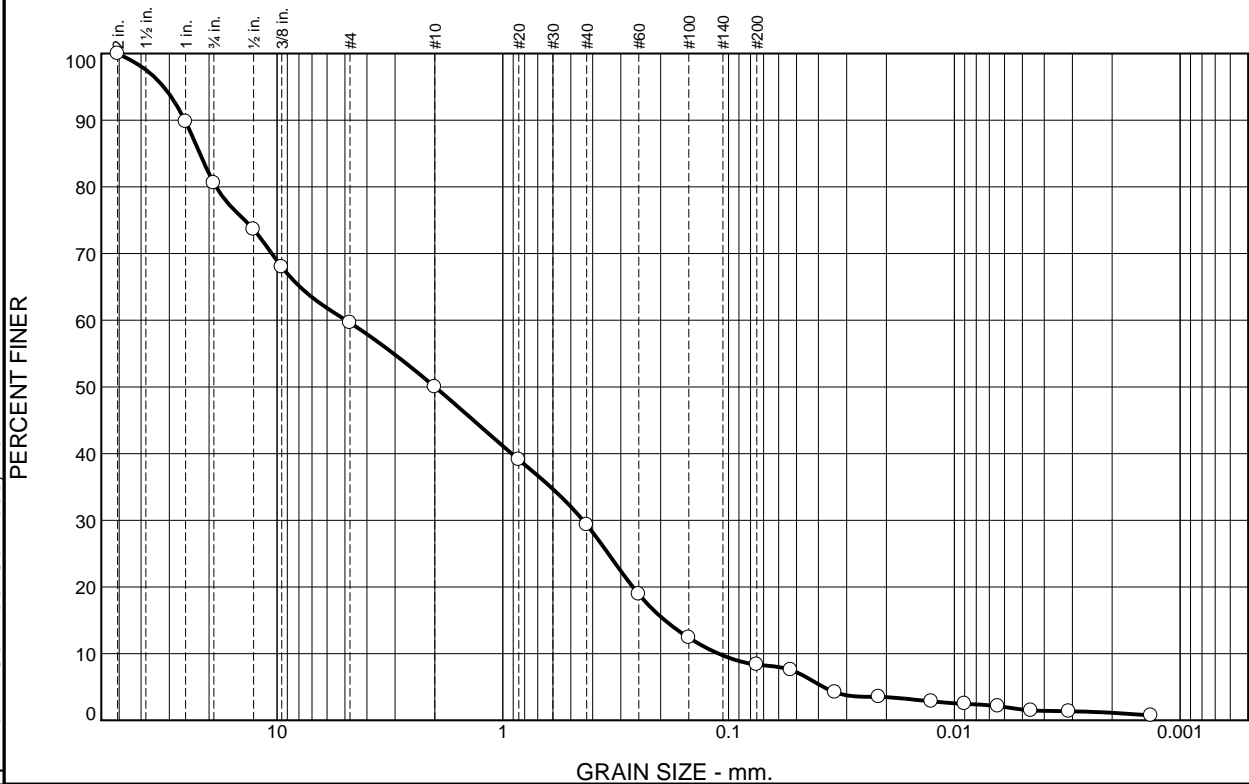
Sieve Analysis w/Hydrometer Test Report - D422/D1140

% +3"	% Gravel		% Sand			% Fines	
	Coarse	Fine	Coarse	Medium	Fine	Silt	Clay
0	19	21	10	21	21	6	2

SIEVE SIZE	PERCENT FINER	SPEC.* PERCENT	PASS? (X=NO)
2"	100		
1"	90		
3/4"	81		
1/2"	74		
3/8"	68		
#4	60		
#10	50		
#20	39		
#40	29		
#60	19		
#100	12		
#200	8.3		
#270	7.6		
0.0338 mm.	4.2		
0.0216 mm.	3.5		
0.0126 mm.	2.8		
0.0090 mm.	2.5		
0.0064 mm.	2.1		
0.0046 mm.	1.5		
0.0031 mm.	1.3		
0.0013 mm.	0.7

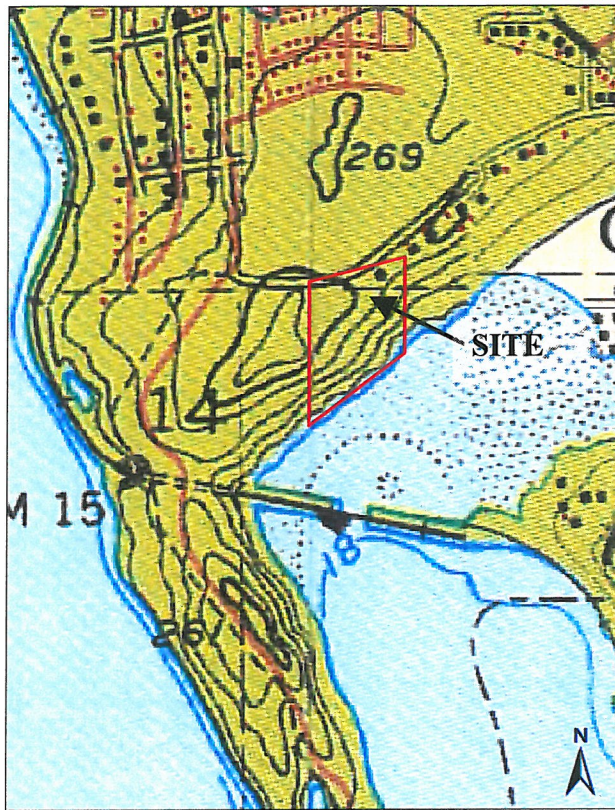
FIGURE 2: The geology of the site is mapped as Chuckanut Formation (TKc) (Easterbrook 1976). Numerous outcrops of sandstone were at the site. The more resistant and massive beds often form substantial cliffs throughout the site. Bedding strike was roughly N80E (260 degrees) and dipped to the north at approximately 40 degrees. The site is located near or within the hinge of a large anticline that plunges to the northwest (See Figure 3).

The site was also affected by Pleistocene glaciations and deposits of till and drift mantle much of the site. Thickness of the glacial deposits appear to vary from several inches to possibly several feet. Holocene soils were observed to have developed and can be quite thick (over 1.5 feet observed) locally, especially in the swales occurring between resistant bedrock ridges.

The site is located on a landform consisting of Paleocene aged Chuckanut Formation (TKc) bedrock outcrops that have been folded, uplifted and eroded (Easterbrook, 1976; Figures 2 & 3). Chuckanut Formation geology consists of sandstone, conglomerate, shales, and locally sub-bituminous coals. Pleistocene glacial advances impacted the project area by causing erosion and mantling portions of the site with sediment. Holocene activity at the site has been dominated by development of soils, while erosion and mass wasting at the site are interpreted to be minor. Soils present at the site include: Chuckanut loam (Unit 26), Everett-Urban land complex (Unit 52), and Nati loam (Unit 110) (NRCS 2009, Figure 4).

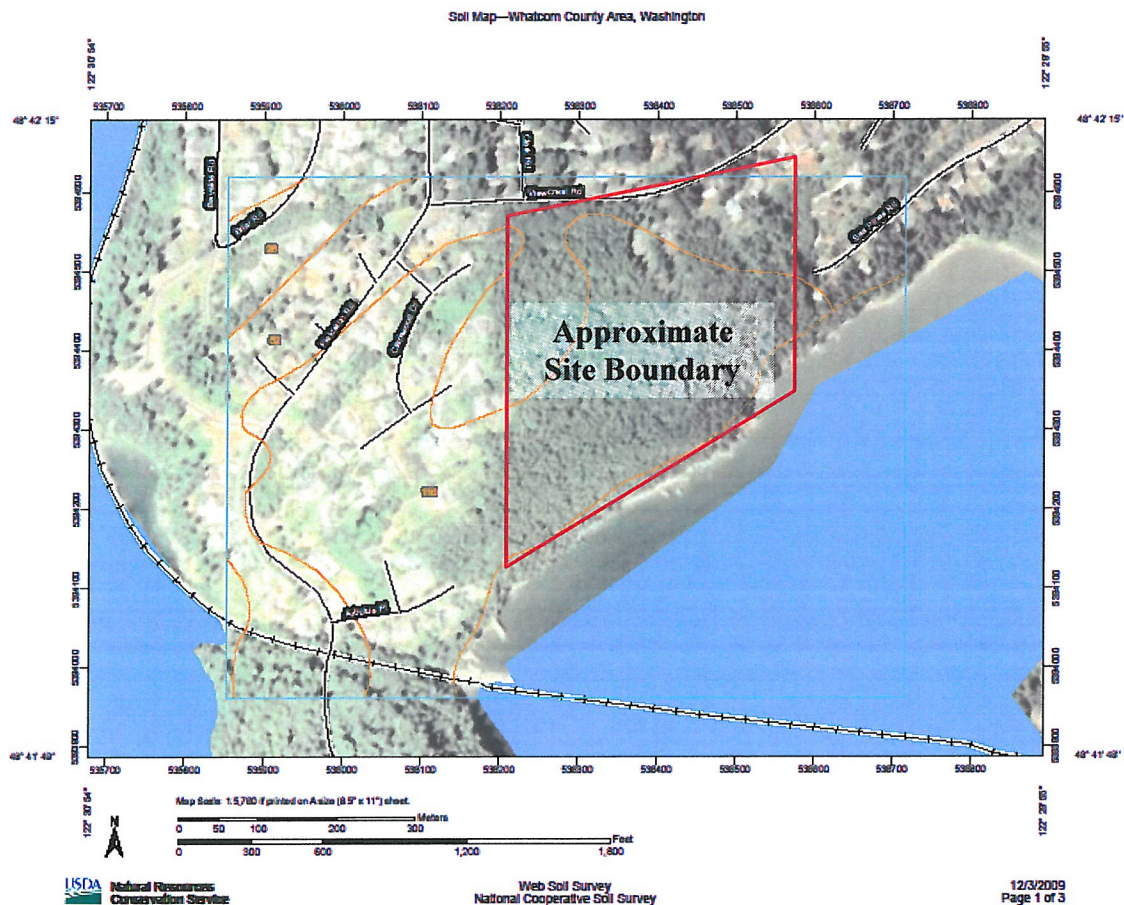
FIGURE 4: Natural Resources Conservation Services Soil Map Study (from Web Soil Survey, Version 6, Sep 22, 2009). Units present at the site include Nati Loam (Unit 110), Chuckanut Loam (Unit 26), and Everett-Urban Land Complex (Unit 52).
