Preliminary Stormwater Management Report

THE WOODS AT VIEWCREST

GEOTECHNICAL INVESTIGATION & GEOHAZARD REPORT JONES EDGEMOOR ESTATE PROPOSED 38-LOT PLAT DEVELOPMENT VIEWCREST ROAD, BELLINGHAM, WA

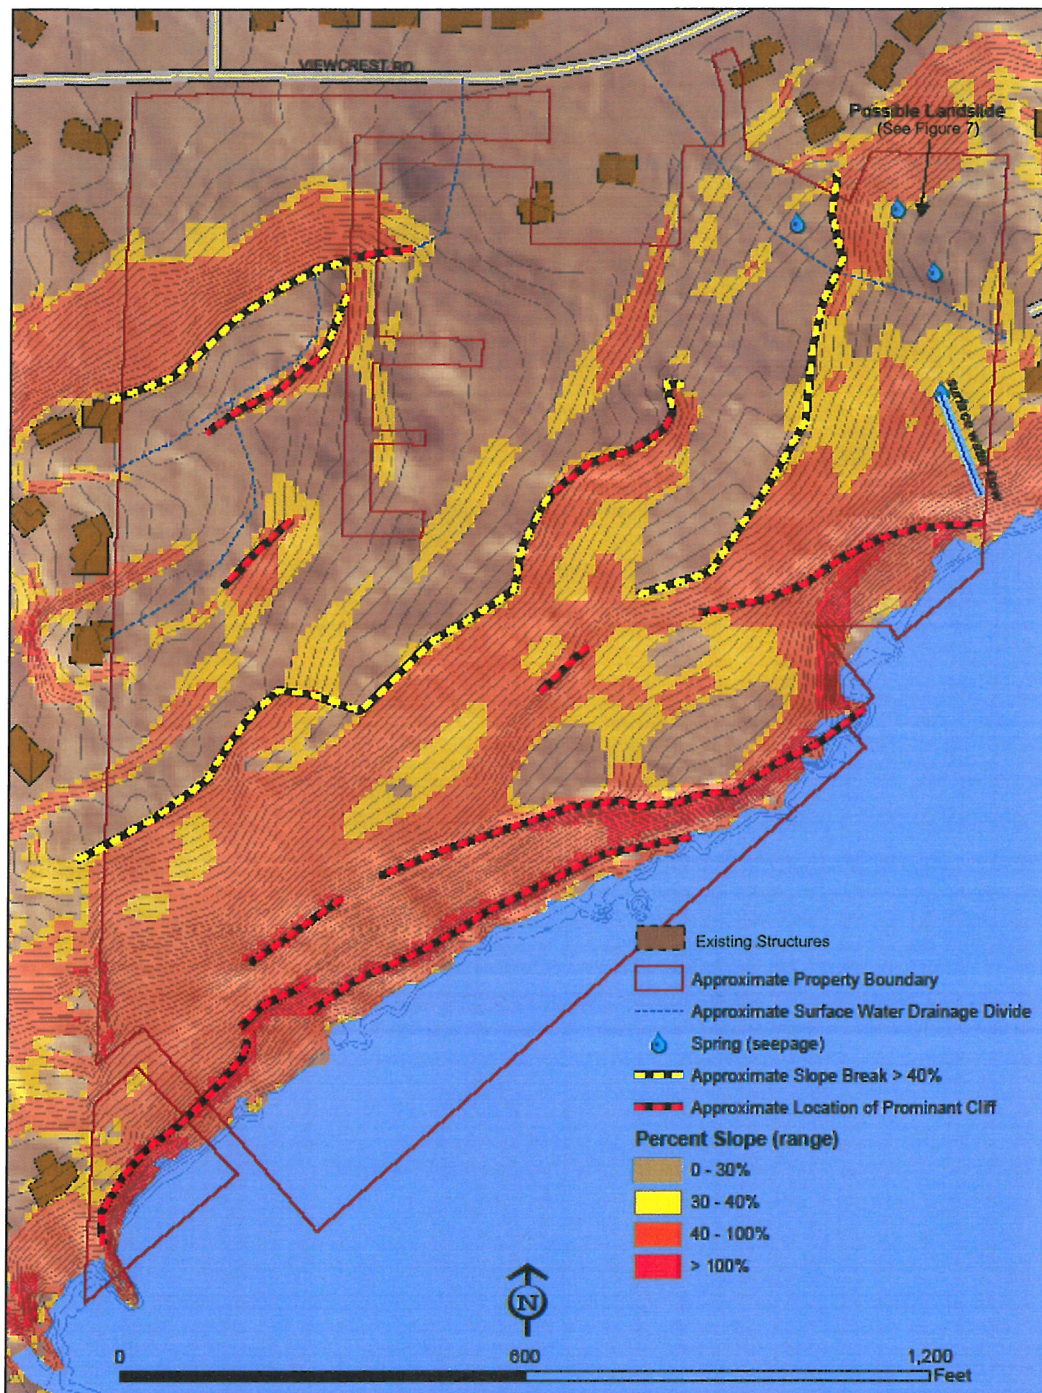
FIGURE 5: Slope assessment. Contours (5-foot interval) and Percent-Slope raster were generated from 2004 photogrammetry (City of Bellingham). The reconnaissance-level field investigation was conducted December 4th, 2009. The reference to the possible landslide is discussed in the Figure 7.

The site has considerable variations in topography and includes flat, low to moderate sloping terrain, steep terrain and cliffs (Figure 5). The site topography has been locally altered or modified by historic road building, timber harvest activities, and adjacent residential development (primarily unconsolidated fill and debris piling). The majority of the site drains to Chuckanut Bay, however the northwest portion of the site drains toward Bellingham Bay.

Areas of slopes greater than 40 percent were observed on site. Much of the southern portion of the property and other local areas qualifies as having potential landslide hazard (Figure 5). In addition to steep topography, several vertical or near vertical bedrock cliffs were observed across the site. The bedding of the Chuckanut Formation dips approximately 40 degrees toward the north. Where the slopes face southerly, this means that the bedding dips into the slope. Where the

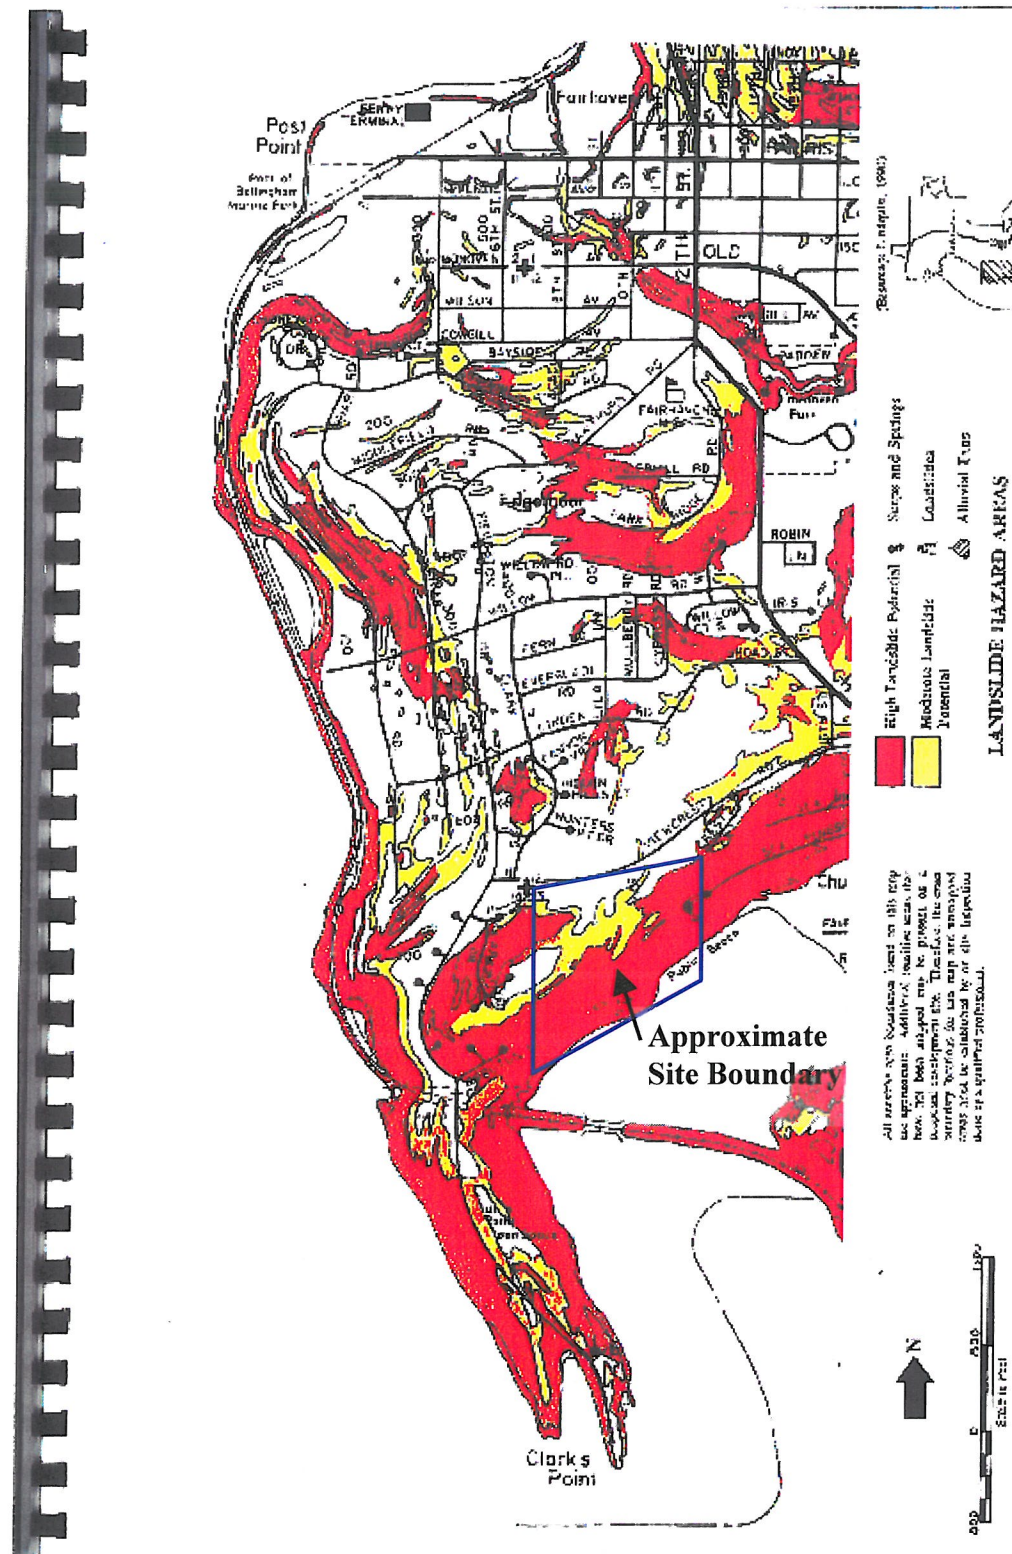
FIGURE 6: Fox et al 1991 "Geologic Hazards Area; Map Folio"

- Hillsides intersecting geologic contacts with a relatively permeable sediment overlying a relatively impermeable sediment or bedrock; and
 - Springs or ground water seepage.
2. Any area with a slope of forty percent or steeper and with a vertical relief of ten or more feet except areas composed of consolidated rock
 3. Slopes parallel or subparallel to planes of weakness in subsurface materials
 4. Areas depicted as landslide hazards by the City folio maps. Portions of the site have been identified as having High Landslide Potential (Fox et al, 1991) in that they have slopes greater than 30%, slopes exceeding 80%, and slopes greater than 15% that may be potentially unstable because of other factors (Figure 6).

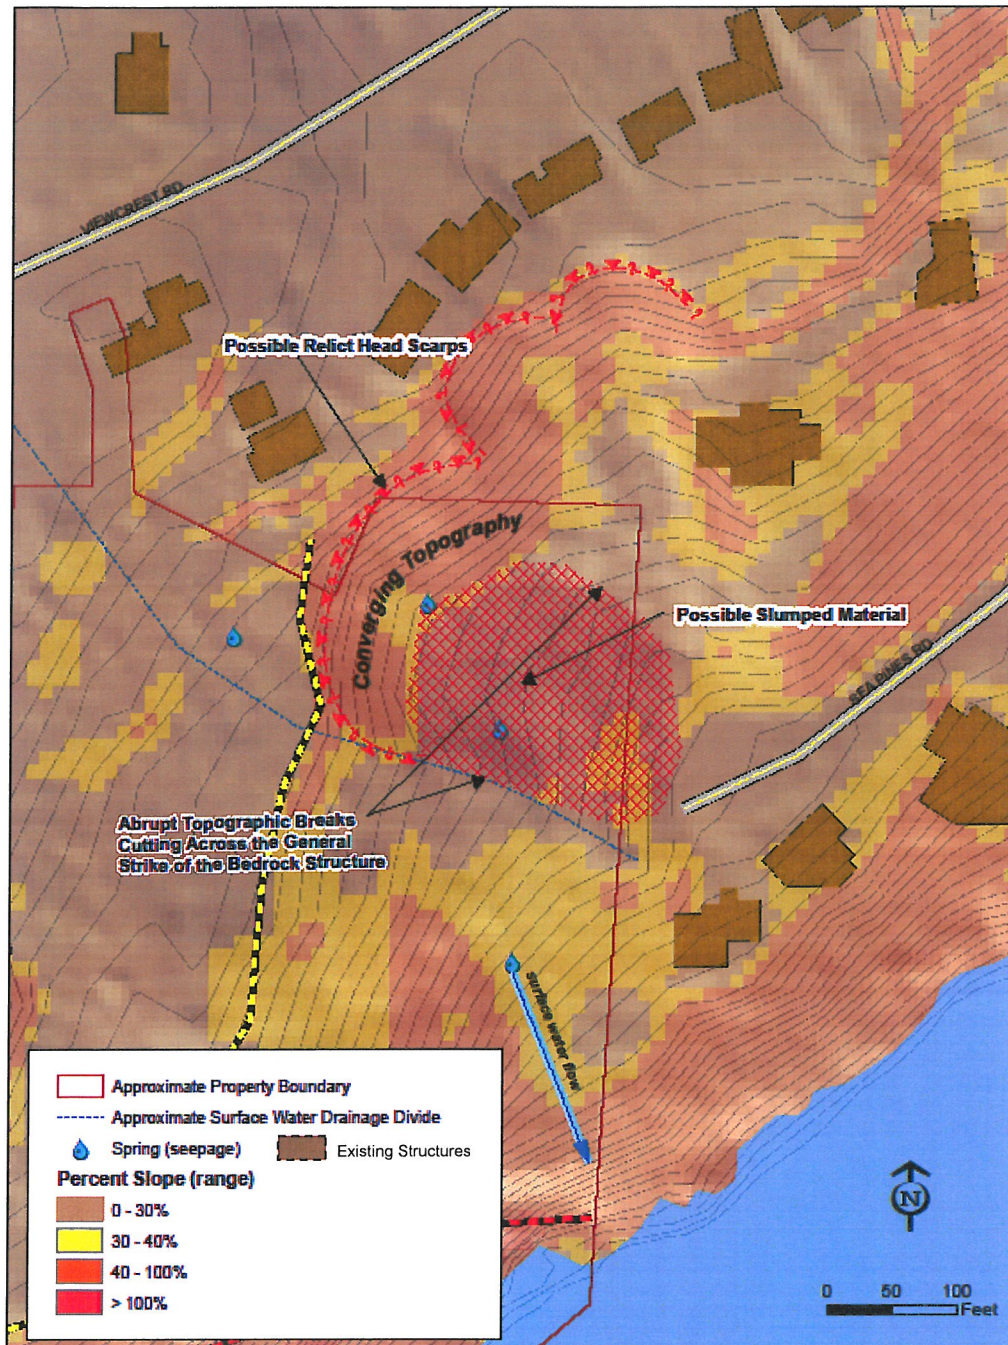
FIGURE 7: Geomorphology and field indicators suggest that this might be a relict earth-flow or slump-type landslide. Additional studies are recommended for this location if development was proposed on or adjacent to this landform.

Photo looking up the steeper arcuate topography that may be a scarp formed from downward movement of the mass shown in the previous image (See Figure 7).

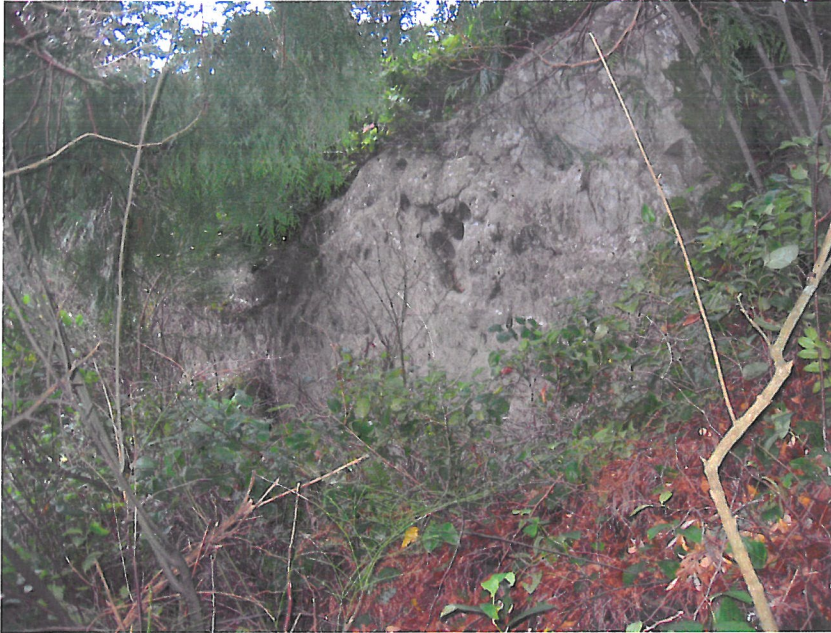
Photo looking uphill at a Chuckanut Formation sandstone bedrock outcrop creating a vertical cliff face approximately 10 feet in height.

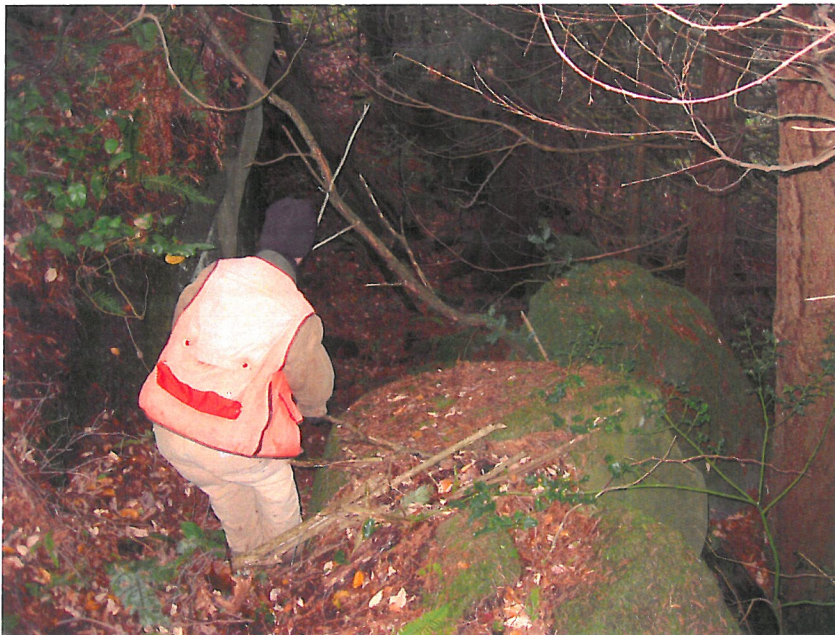
Photo of a bedrock cliff showing evidence of “toppling” of blocks that failed along jointing planes. The blocks did not travel beyond 20 feet down-slope from the outcrop from which they originated.

slopes face northerly (the ridge crest in the northwest portion of the site), dip slopes may occur, however none were observed exposed due to soil formation or glacial sediment mantling. Jointing of the Chuckanut Formation is common and evidence of topples and falls were observed at many of the cliff forming outcrops. No evidence of massive rotational or translational slope stability failures were observed during the field reconnaissance with the exception of a possible earth slump located at the eastern property margin (Figure 7). The interpretation of a possible earth slump is supported by the topographic expression (steep, arcuate scarps above a hummocky bench flanked by abrupt lateral topographic ridges perpendicular to bedrock ridges) and the presence of numerous seeps in converging topography. Additional analysis would be needed to confirm this hypothesis.

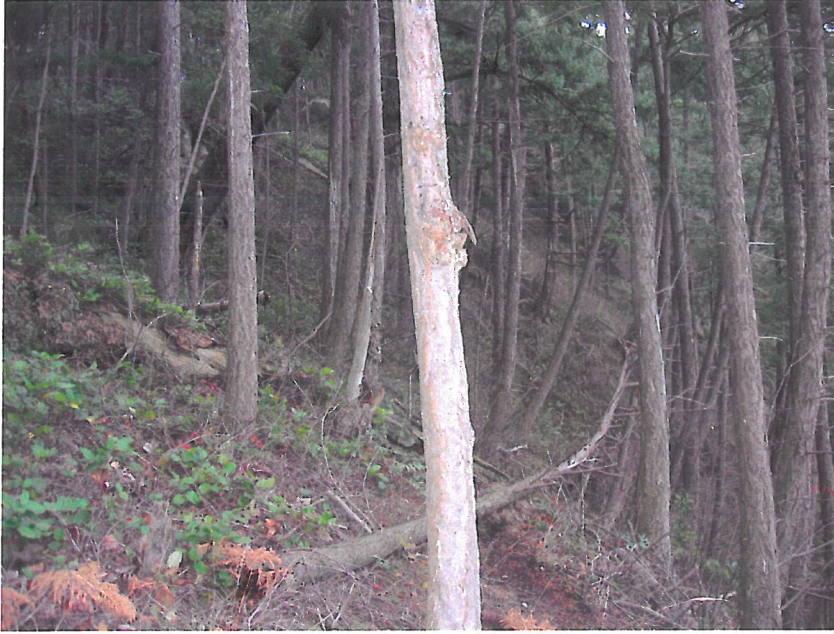
Photo showing a location in which minor soil creep was observed on slopes nearing 100%. In general, the site exhibited few locations with evidence of soil creep. The location of this photo is just above the beach 300 feet southwest of the southeast property corner.

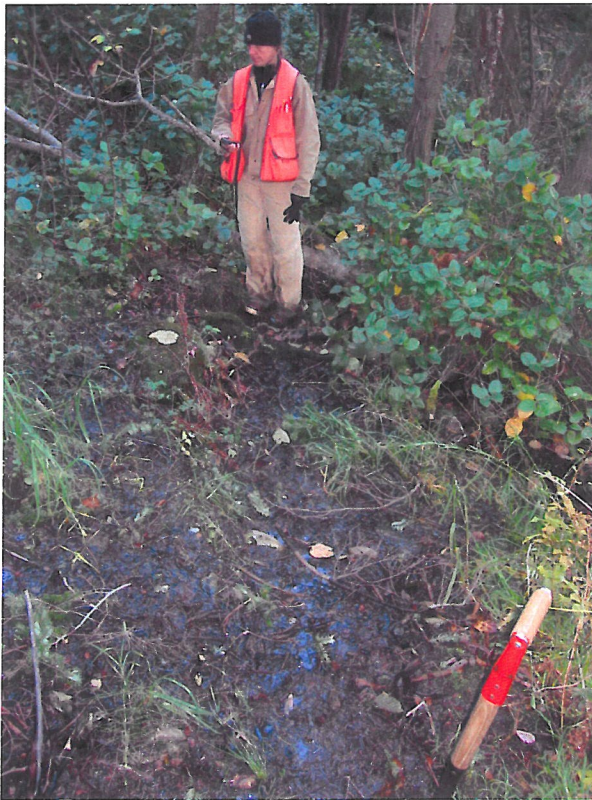
Photo documenting the source of seepage that developed into stream flow for a distance of approximately 160 feet before being infiltrated. This water source did not reach the beach as surface water. The seepage started in a shallow depression created by tip up of an approximately 24-inch diameter Western Red Cedar.

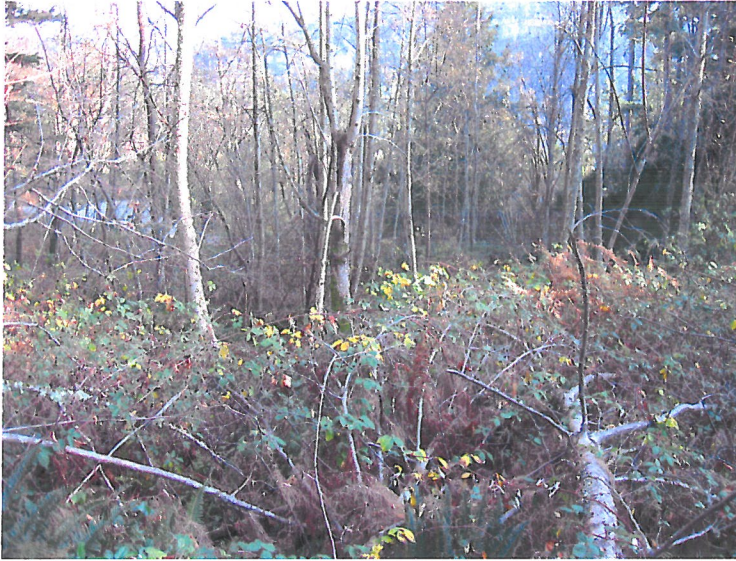
Photo looking down-slope across the topographic "bench" occurring below a steep "arcuate" topographic feature. Seepage was abundant in this location and the site was inhabited with small diameter alder, horsetail, and blackberry. This landform may be a slump or earthflow feature. Felling of trees occurred at this site likely in the past year or two.

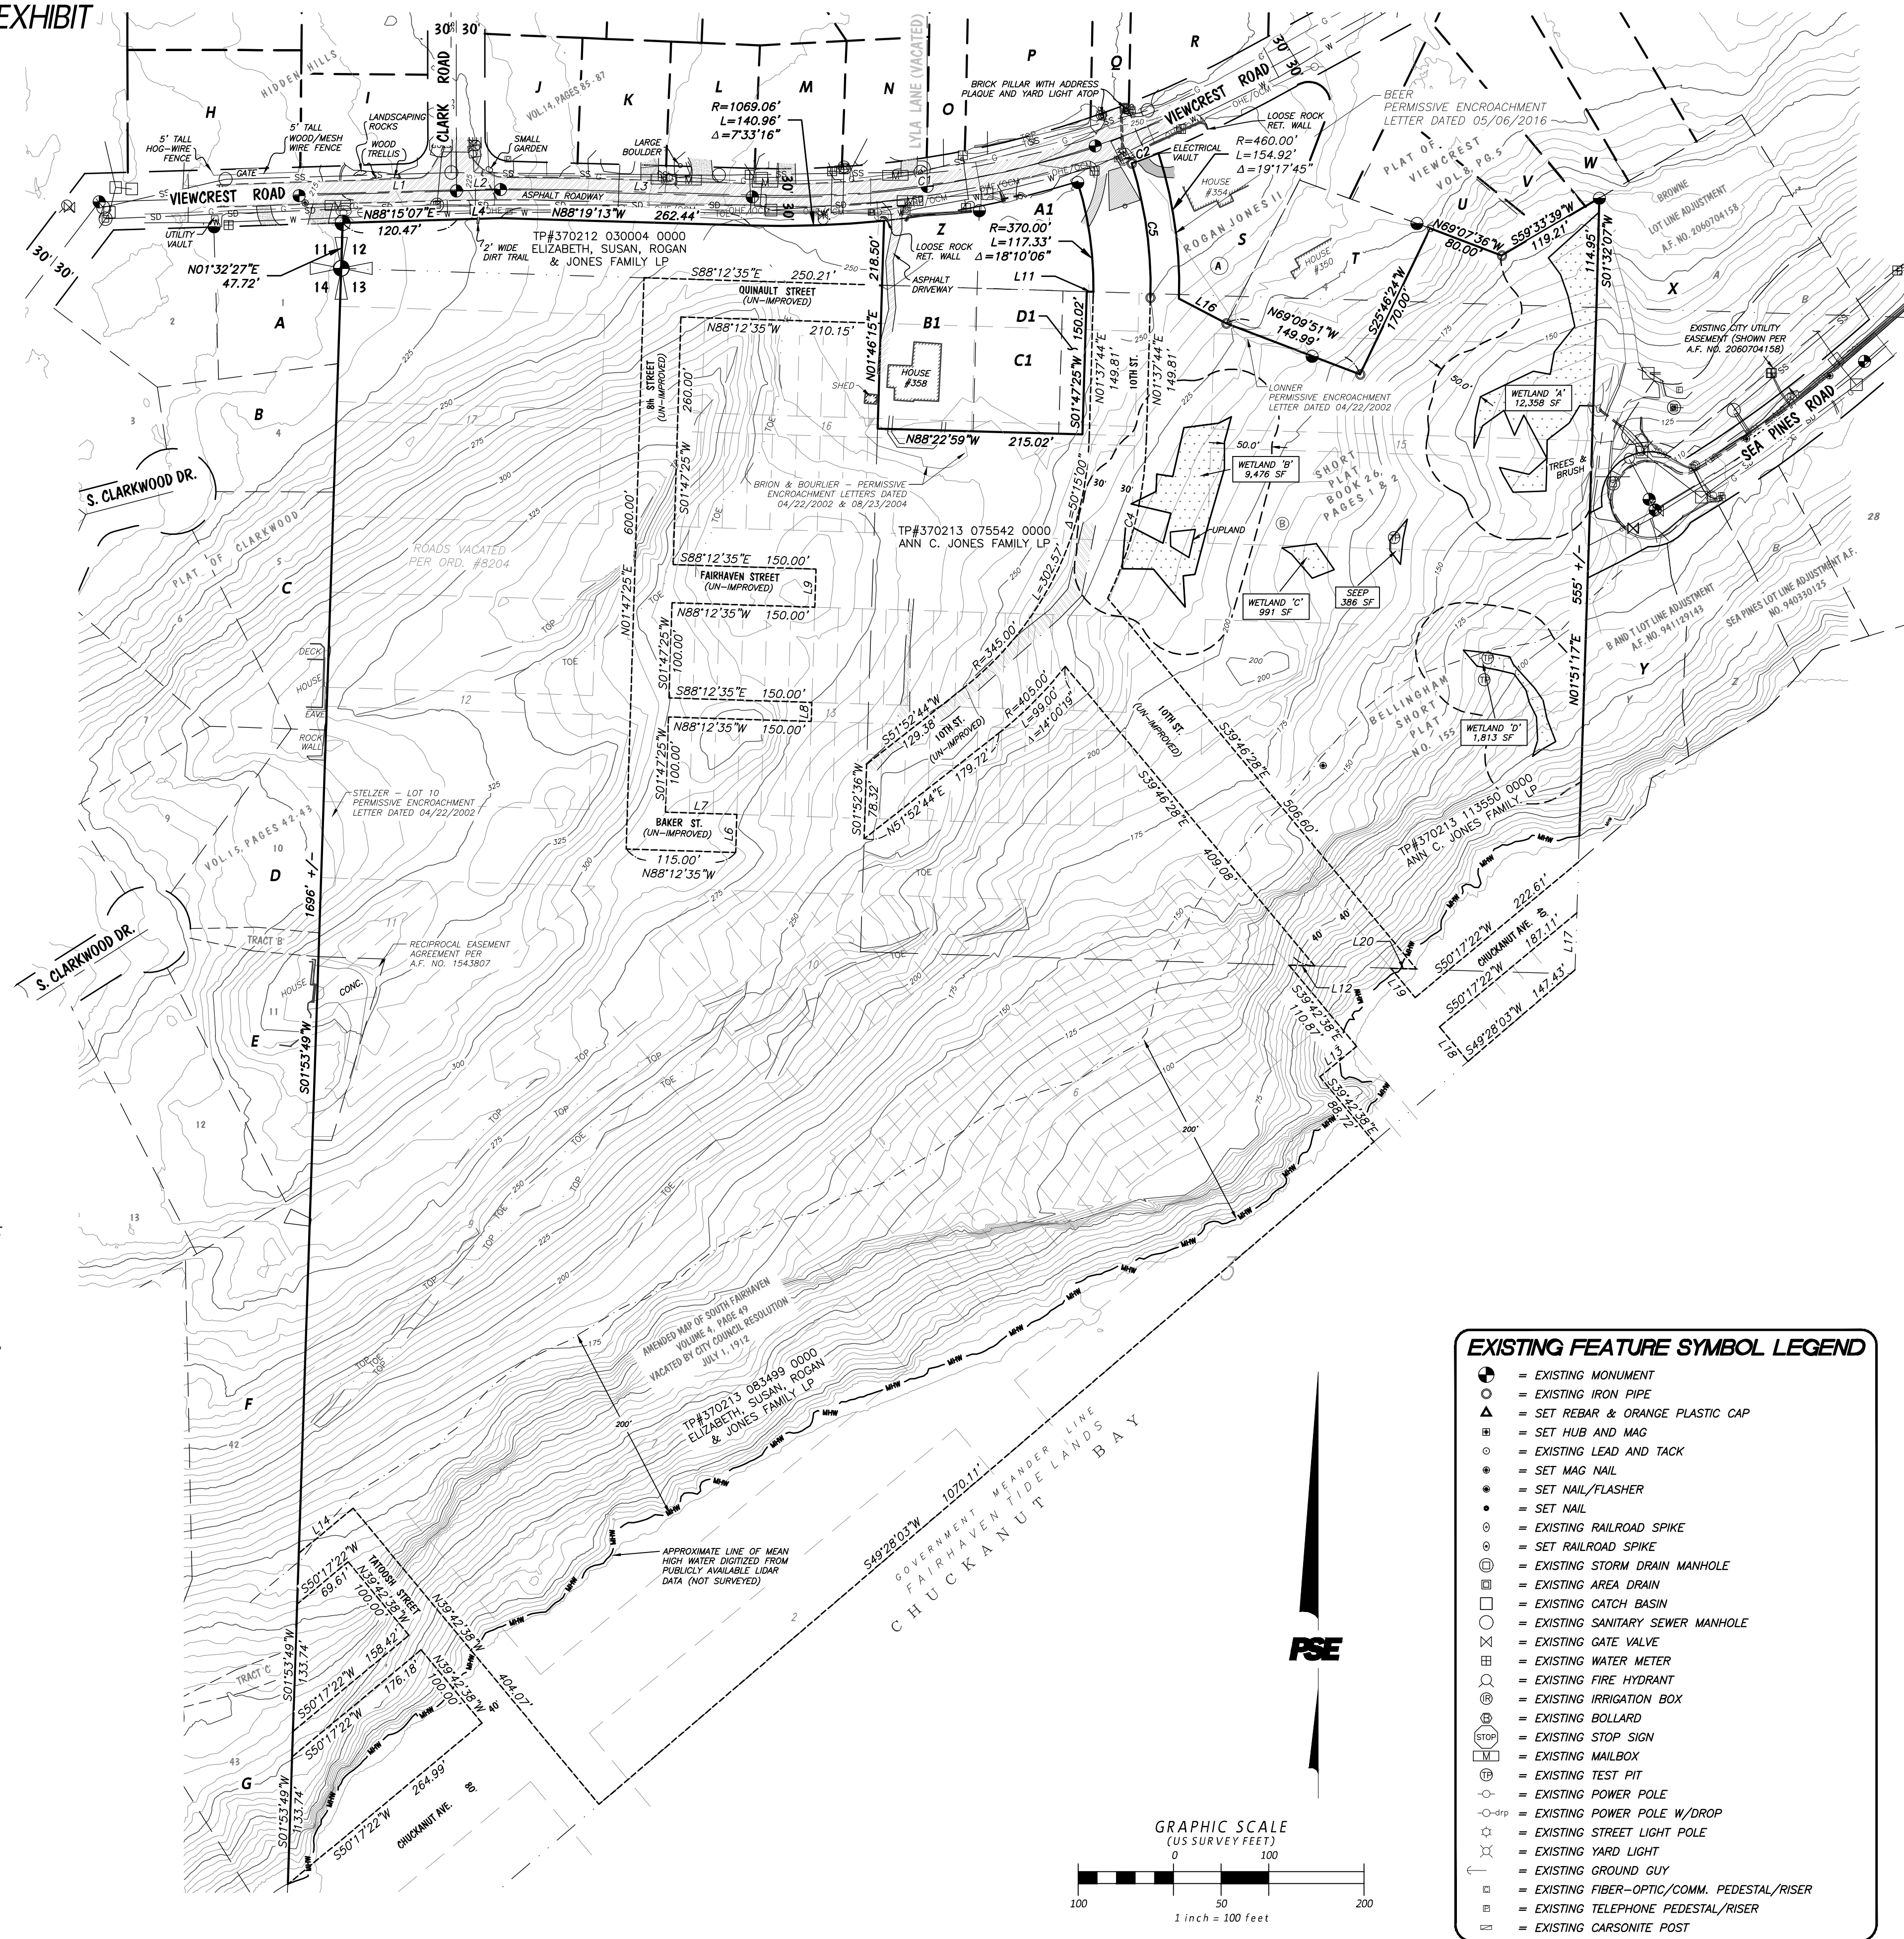
THE WOODS AT VIEWCREST - EXISTING CONDITIONS EXHIBIT

- WETLANDS SHOWN HEREON DELINEATED IN JUNE 2020 BY NORTHWEST ECOLOGICAL AND SURVEYED BY PACIFIC SURVEYING AND ENGINEERING IN JULY 2020.

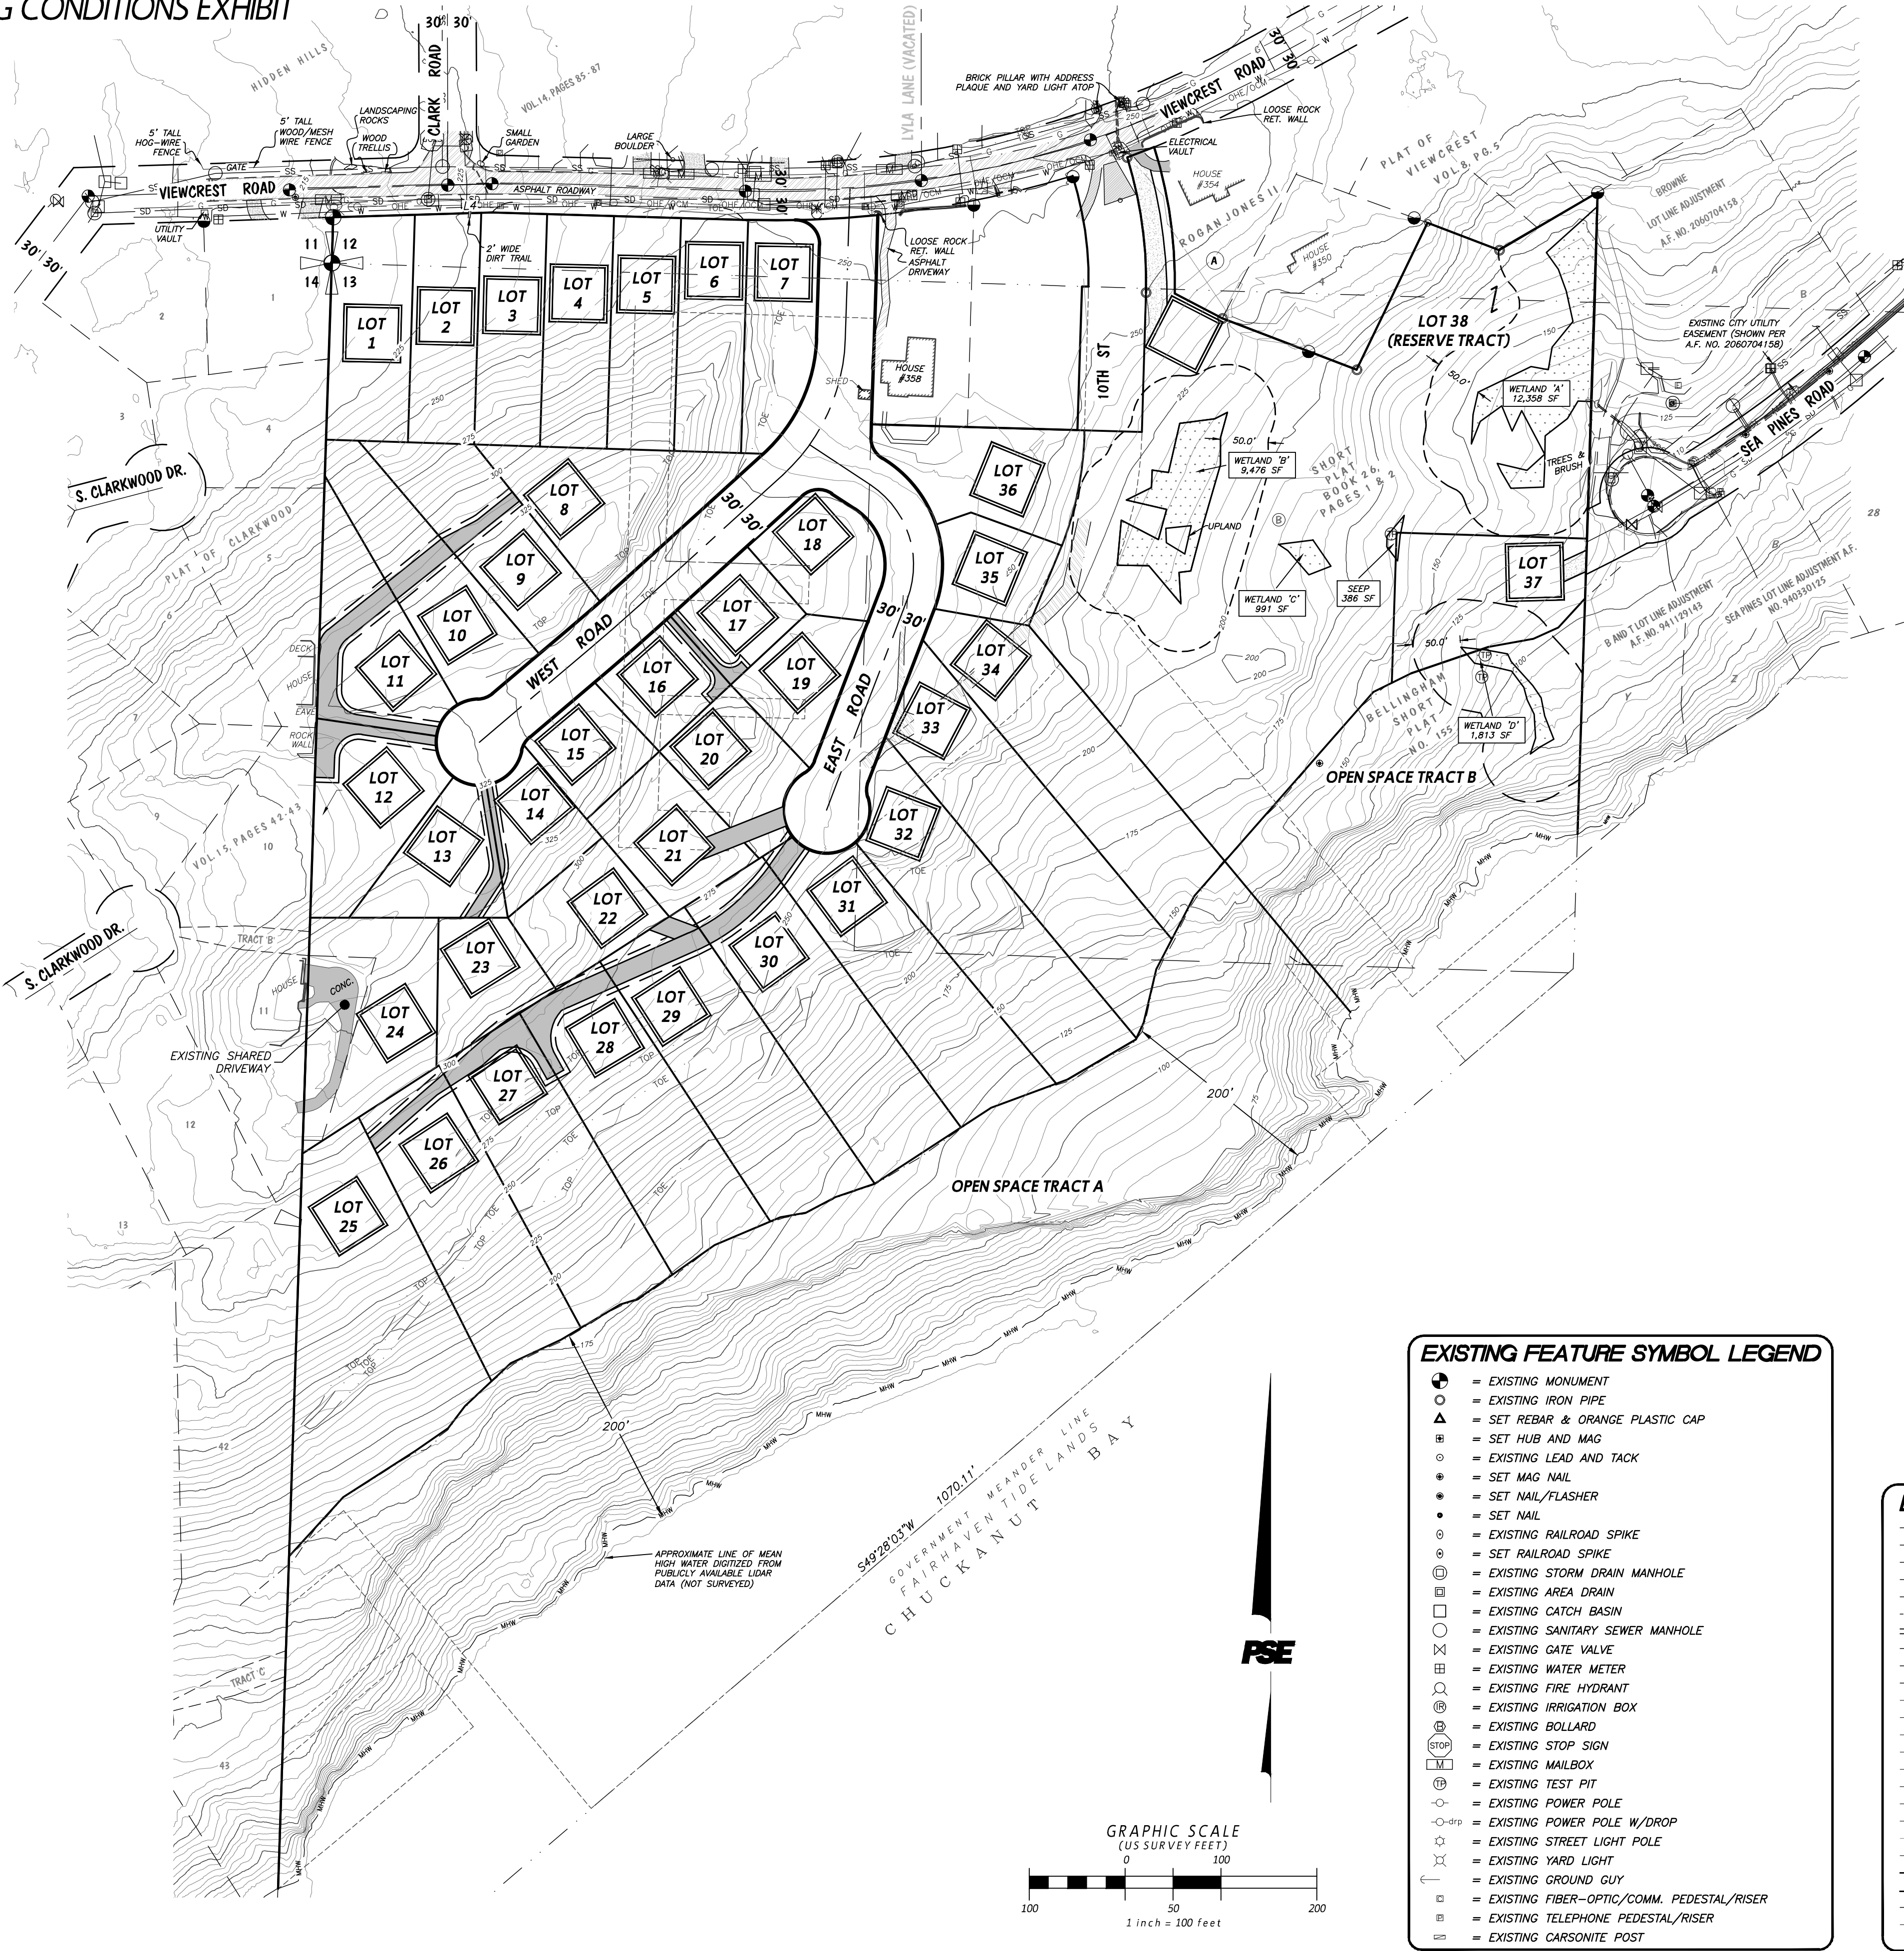
THE WOODS AT VIEWCREST - PROPOSED LOTS & EXISTING CONDITIONS EXHIBIT

LOT X  
60'X60' BUILDING ENVELOPE PURSUANT TO BMC 23.08.060.D.1. THIS AREA DOES NOT NECESSARILY REPRESENT THE ACTUAL BUILDING ENVELOPE, BUT RATHER IS INTENDED TO REPRESENT THAT THE NEW LOT HAS BEEN CONFIGURED TO MEET CITY OF BELLINGHAM "LOT DESIGN" CRITERIA.

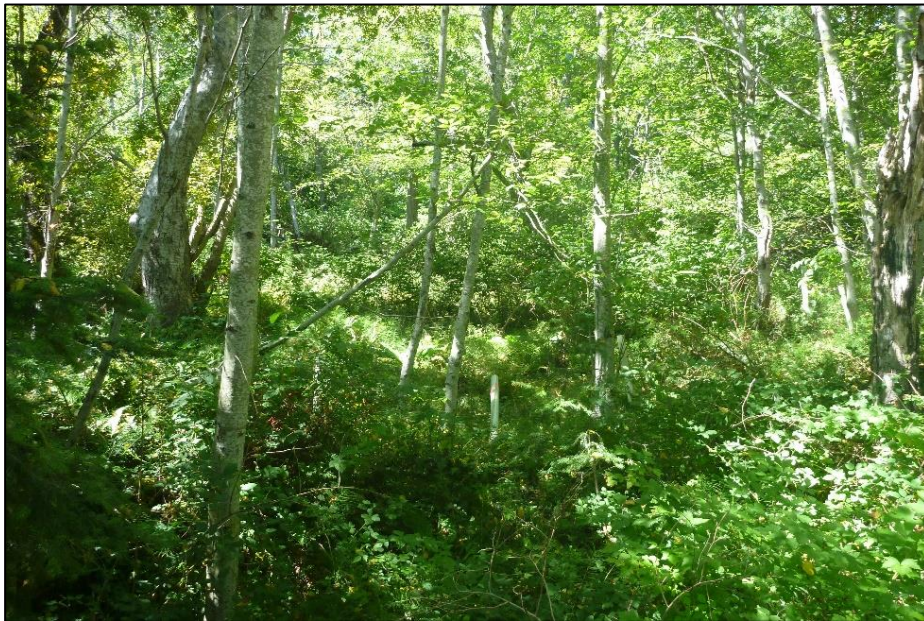
Overview of Wetland A, looking west

The 2010 report identified one slope wetland (Wetland A) in the northeastern corner of the site. NES observed Wetland A and also identified three additional slope wetlands (Wetlands B, C, and D) located in the nearby vicinity (Figure 2). NES collected data documenting wetland vegetation, soils, and hydrology indicators in each wetland (see attached data sheets). NES

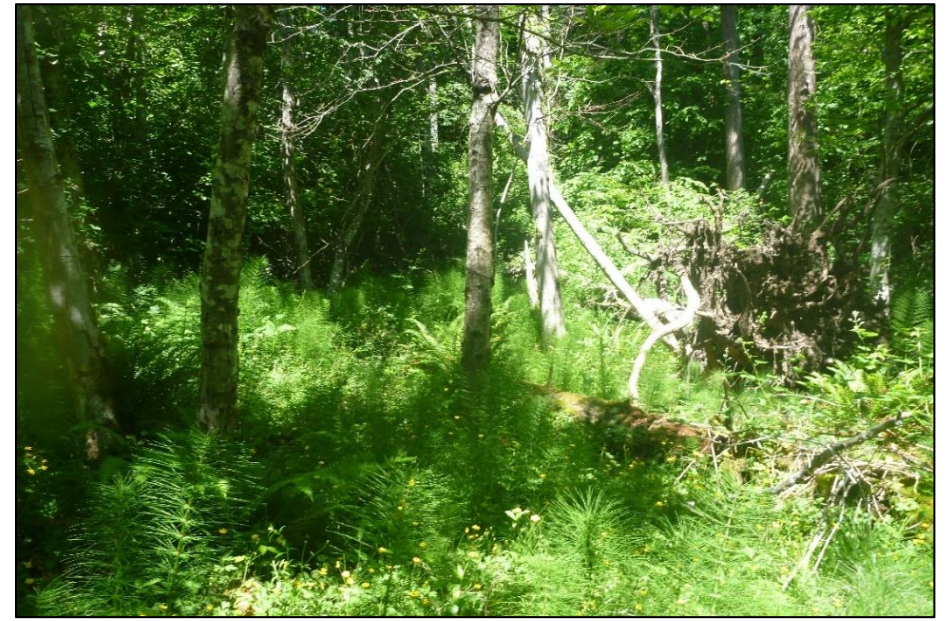
Overview of Wetland A, looking northwest

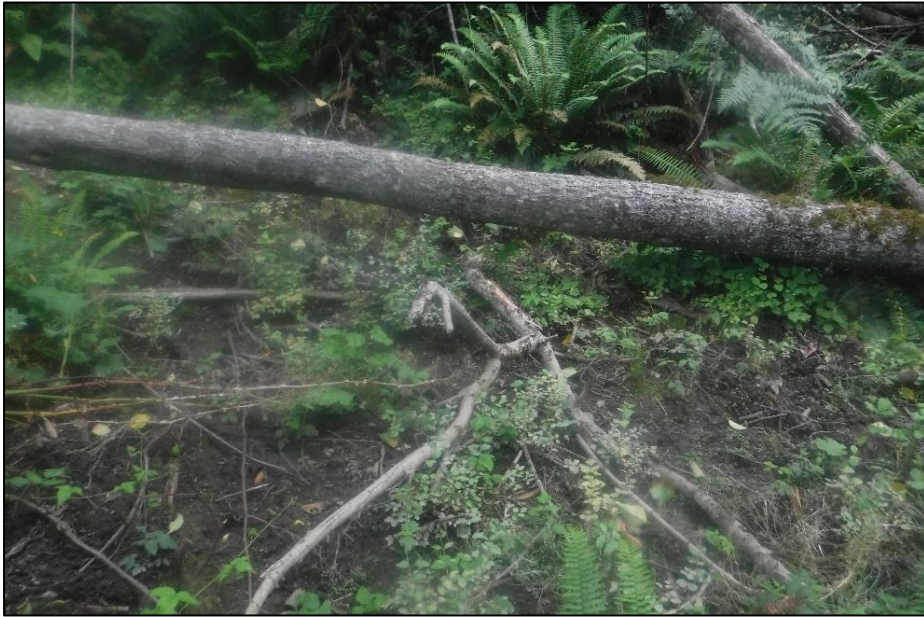
Detail of Wetland B

The wetland appears to be seasonally saturated only. Again, hydrology appears to be driven by surface runoff and a potentially a groundwater seep. Wetland B slopes down to the southeast to an old road grade, where water from the wetland appears to infiltrate.

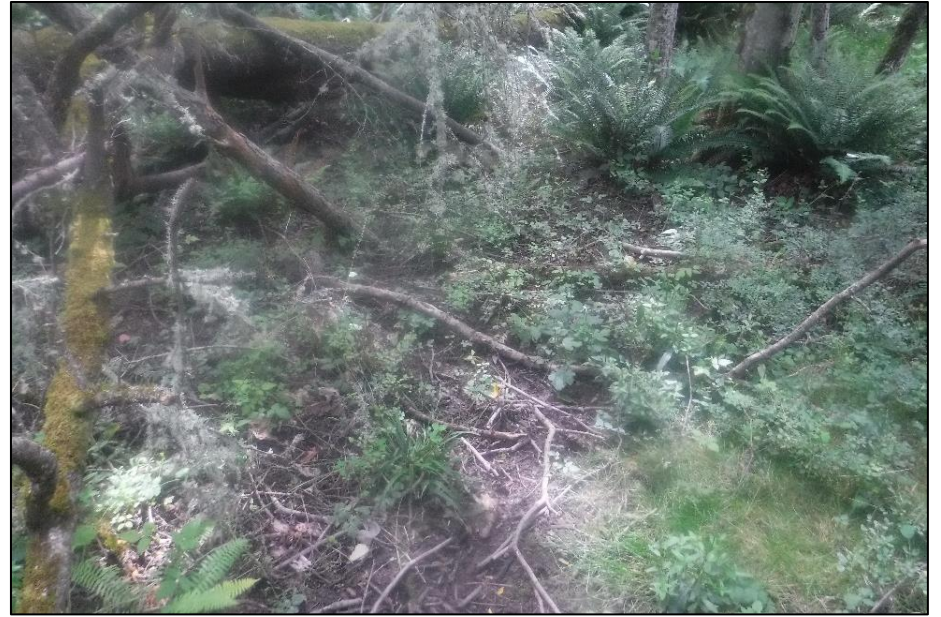
Detail of Wetland B

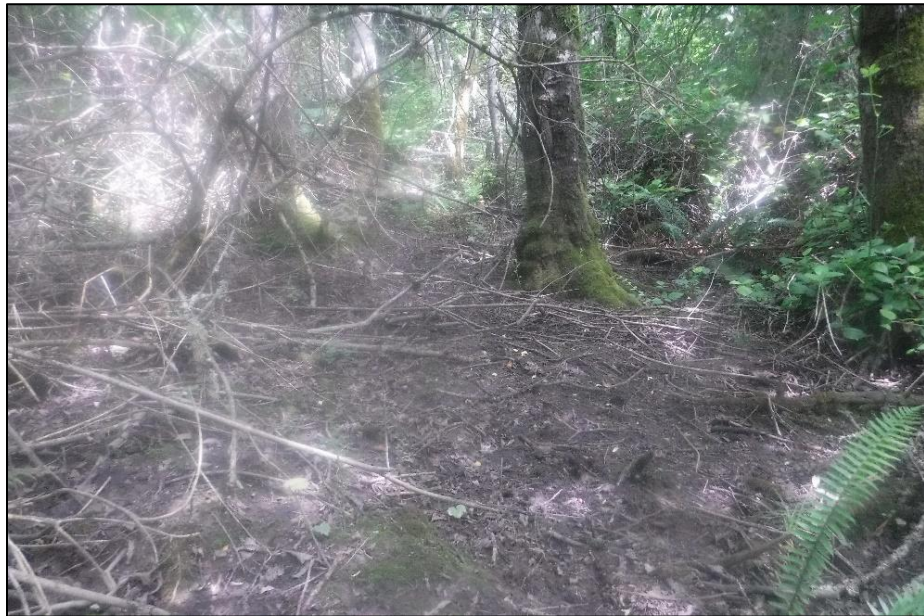
Overview of Wetland C

The wetland was dry at the time of the site visits but appears to be seasonally saturated only. The wetland is located on an approximate five percent grade. Water from the wetland appears to outlet to the south and infiltrate into the forested upland.

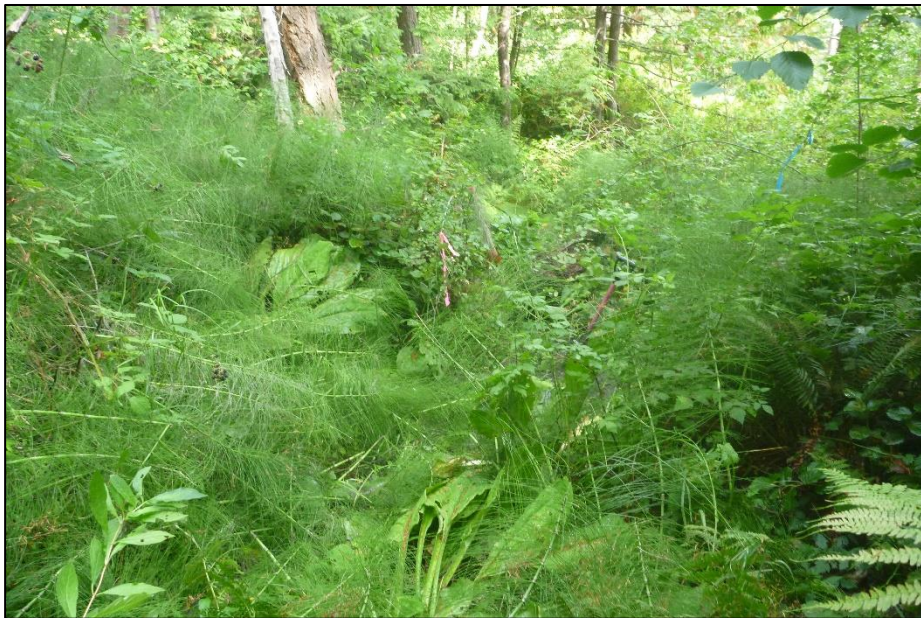
Overview of Wetland D

Hydrology within Wetland D is similar to the other site wetlands with inputs including surface runoff and groundwater surfacing along the hillside. Water within Wetland D flows downslope to a rock headwall/boulder formation towards the grade break near the southern boundary of the review area. No surface connection to Chuckanut Bay was observed.

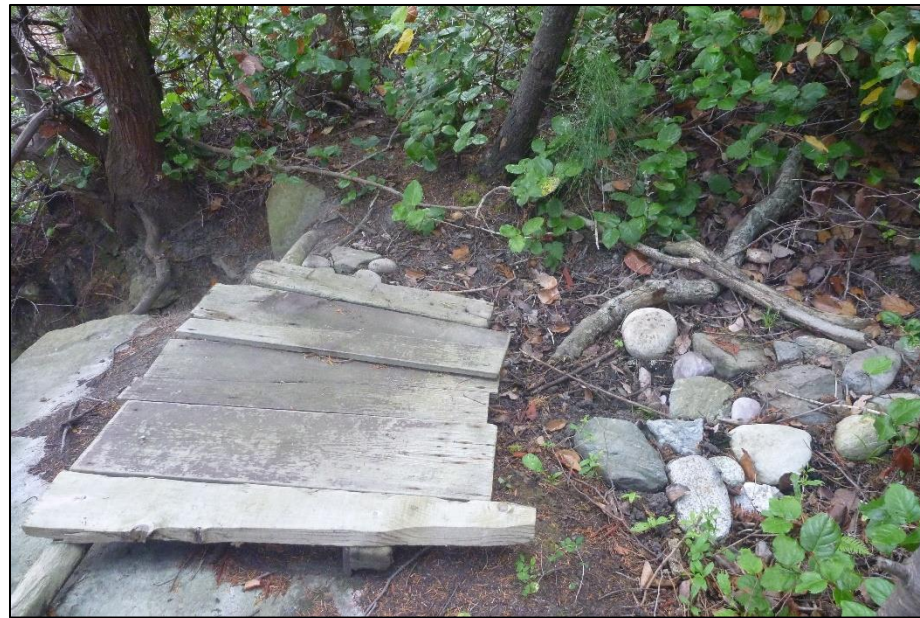
Detail of Wetland D outlet

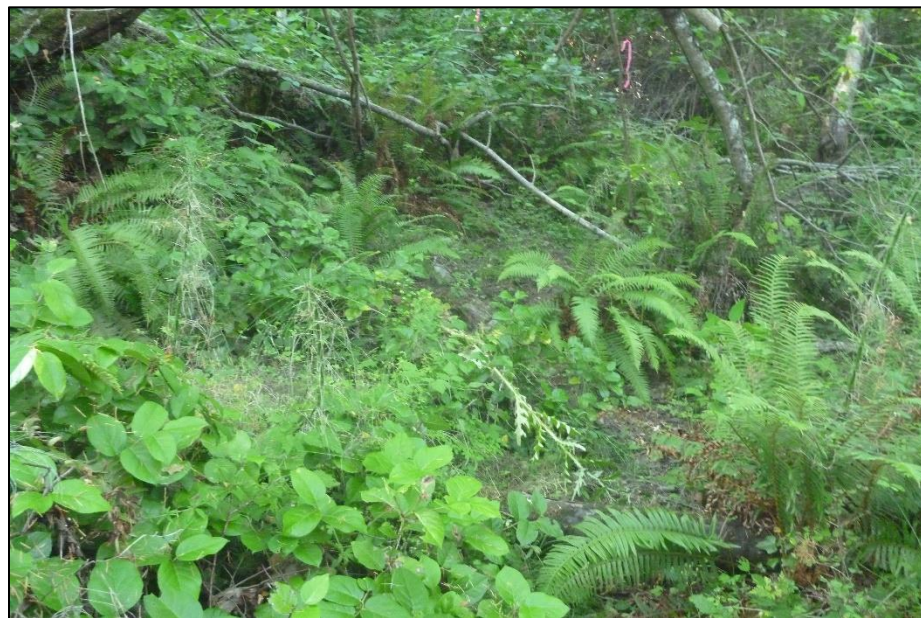
Overview of seep

A groundwater seep was observed in the central portion of the review area (Figure 3, Appendix B). Groundwater surfacing from a slight cut in topography flows downslope along an unvegetated trail. As documented in SP 102 (data sheets attached) this area did not contain hydric soil indicators and therefore does not meet wetland criteria.

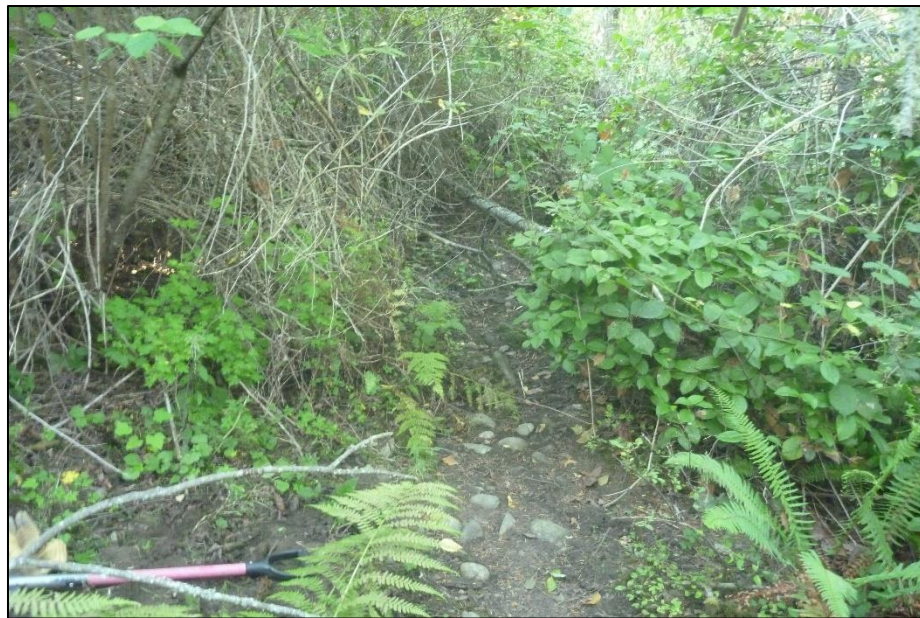
Seep from downslope
