Preliminary Stormwater Management Report

THE WOODS AT VIEWCREST

GEOTECHNICAL INVESTIGATION & GEOHAZARD REPORT JONES EDGEMOOR ESTATE PROPOSED 38-LOT PLAT DEVELOPMENT VIEWCREST ROAD, BELLINGHAM, WA

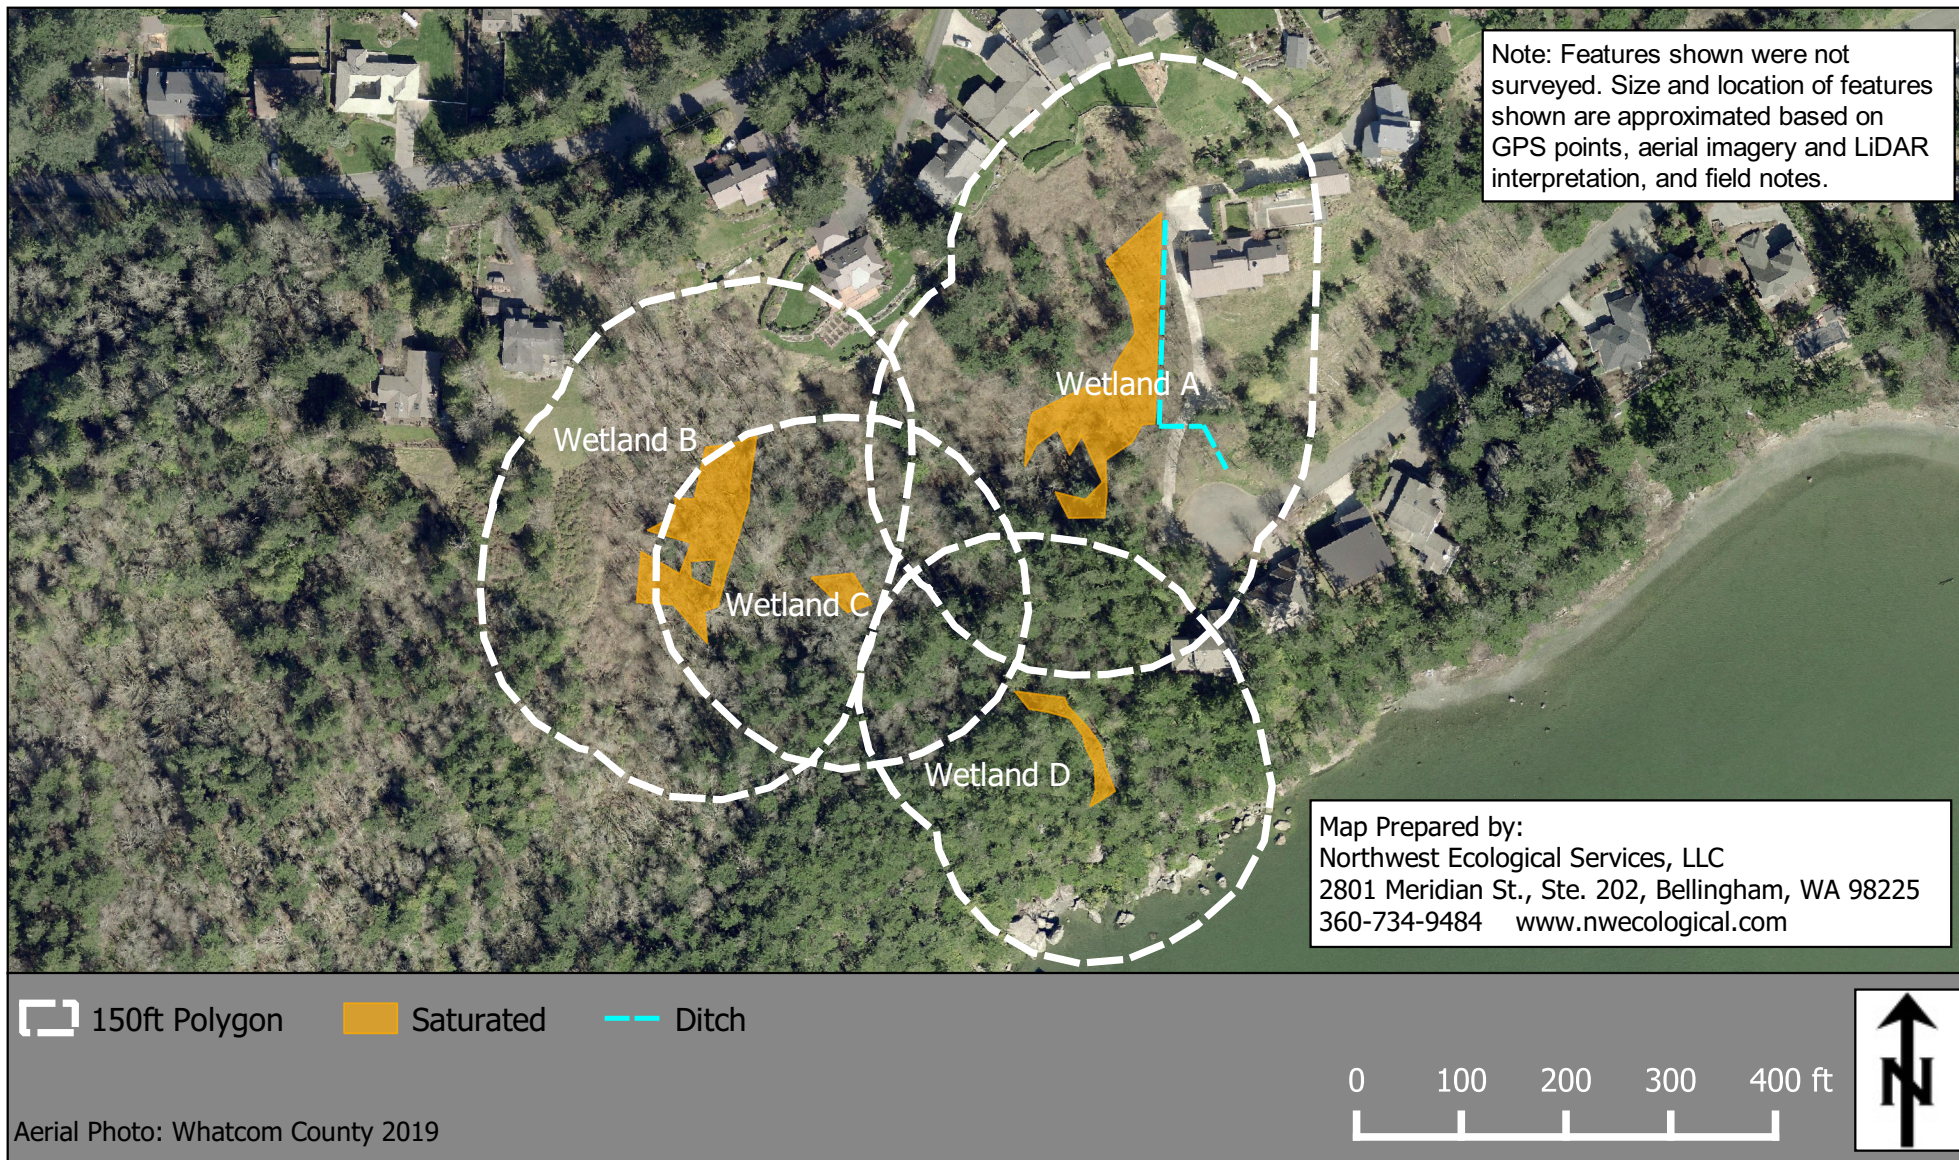
<p><b>Wetland Rating Figure: Hydrology Map</b></p> <p>The Woods at Viewcrest Wetland Delineation Update</p>	<p><b>Attachment B</b></p> <p><b>FEB 2022</b></p>
-------------------------------------------------------------------------------------	---------------------------------------------------------------------------------------------------------------------	---------------------------------------------------

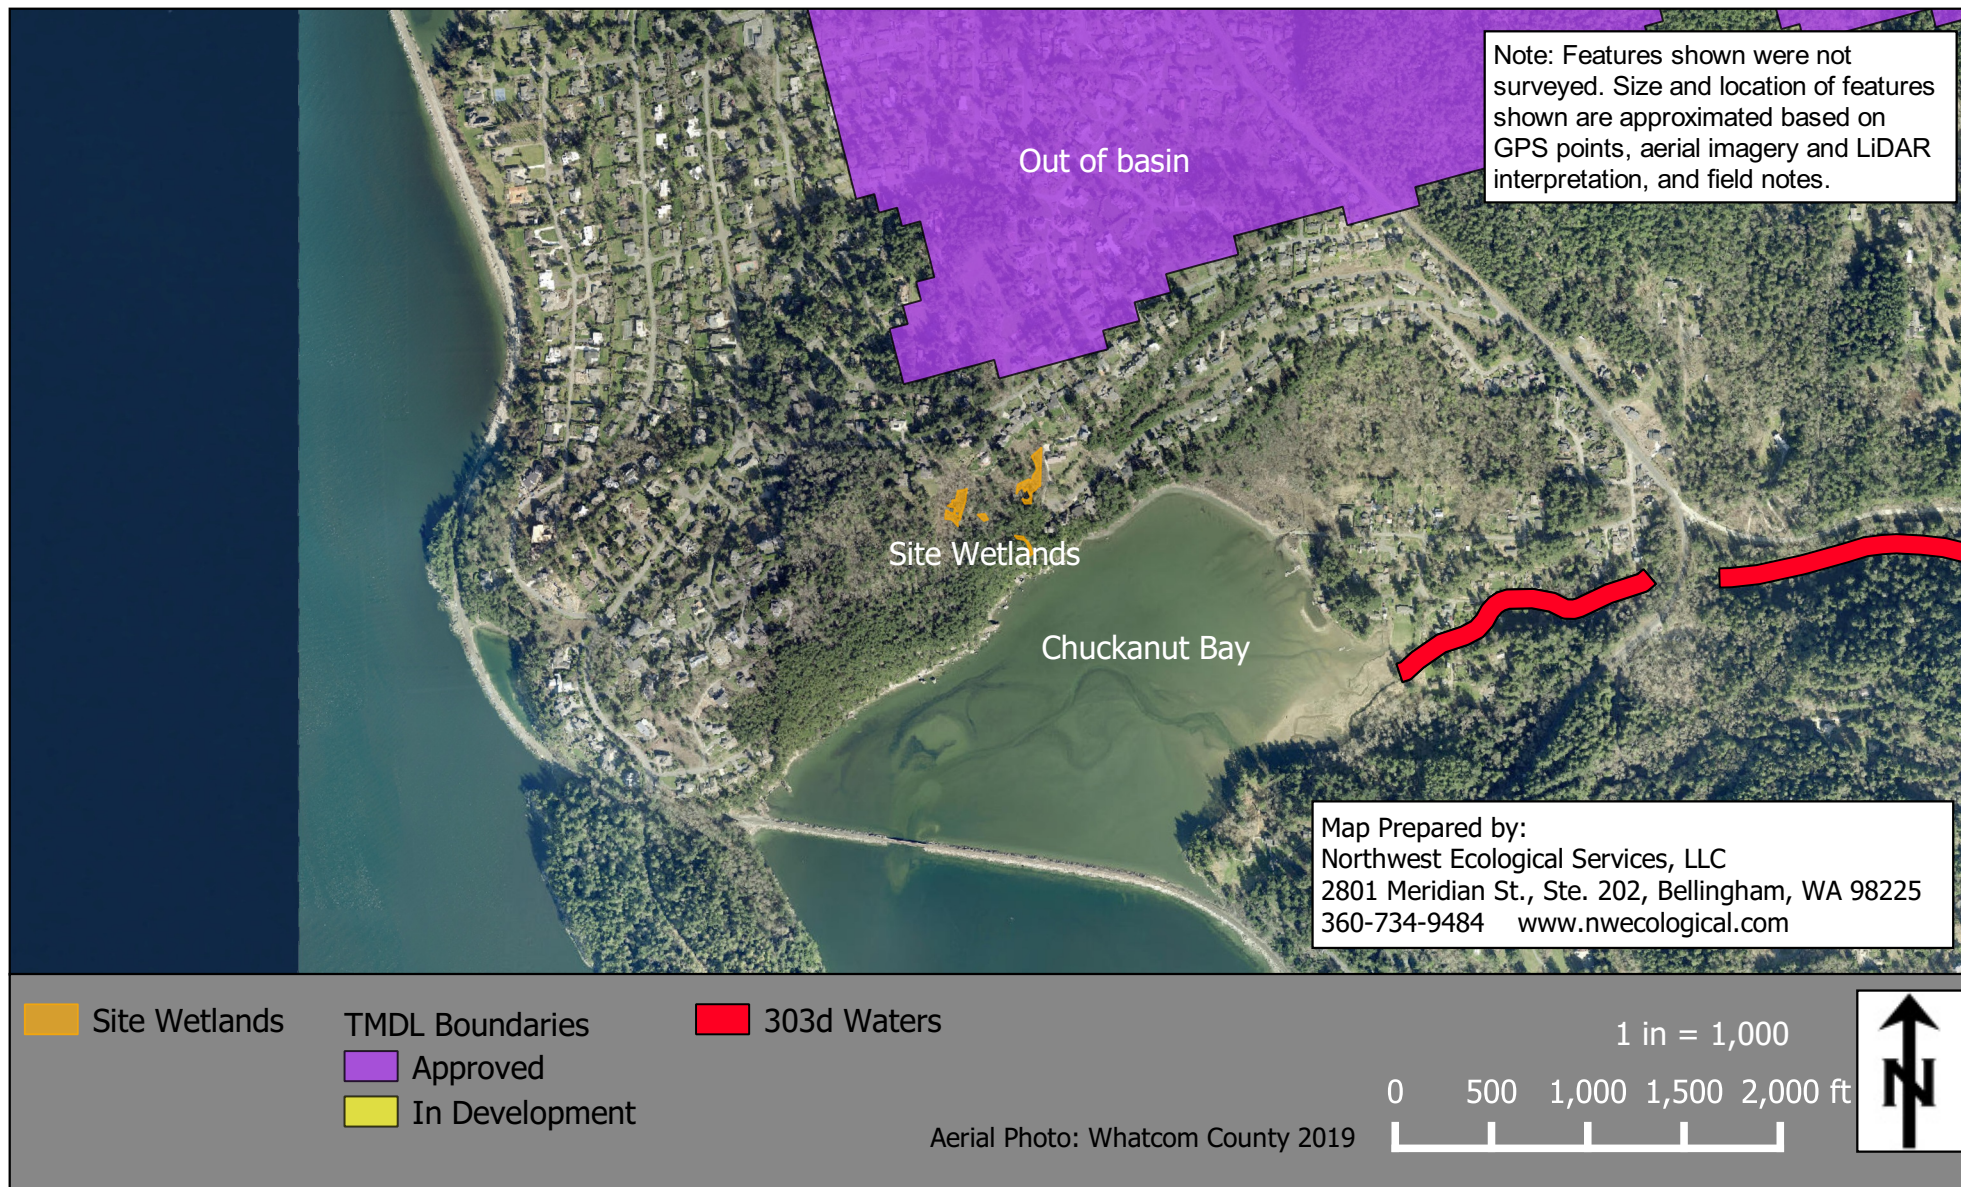
<p><b>Wetland Rating Figure: Water Quality Map</b></p> <p>The Woods at Viewcrest Wetland Delineation Update</p>	<p><b>Attachment D</b></p> <p><b>FEB 2022</b></p>
-------------------------------------------------------------------------------------	-------------------------------------------------------------------------------------------------------------------------	---------------------------------------------------
