## Joint Aquatic Resources Permit Application (JARPA) Form [\[help\]](#)

Boulevard/Cornwall Overwater Pedestrian Walkway Project

Gina Gobo Austin, City of Bellingham Parks and Recreation, Design and Development Division

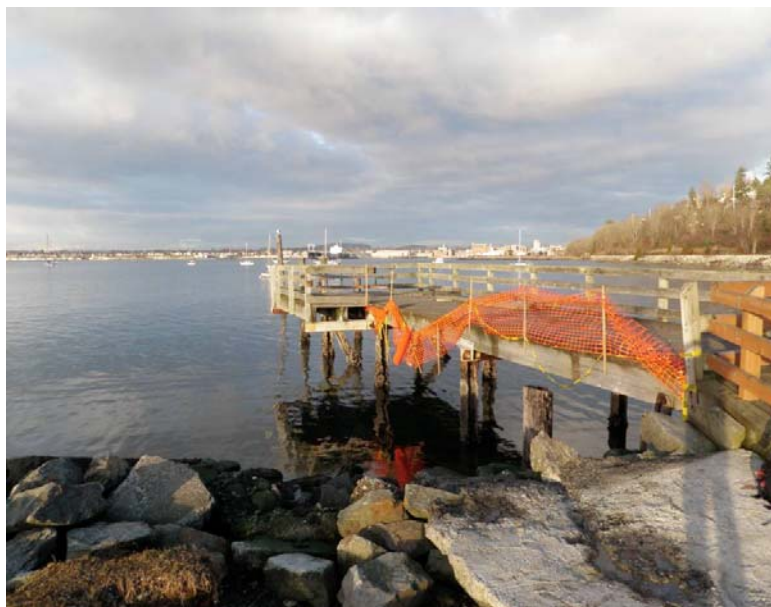
An existing wharf and pier are located at the north end of Boulevard Park in the approximate location of the southern terminus of the proposed overwater pedestrian walkway (Photo 1). The pier, previously used for public viewing and boat moorage, is in structurally unsafe condition and is closed to the public. The overwater portion of the pier is supported by pier bents supported by 1-foot by 1-foot timber caps and eight corroded steel H-piles. The overwater portion of the wharf is supported by approximately 87 creosote-treated timber piles. A low concrete wall topped with riprap supports the wharf on the landward side.

**Photo 1 – View from Boulevard Park of the existing pier where the southern end of the overwater pedestrian walkway will land (facing north)**

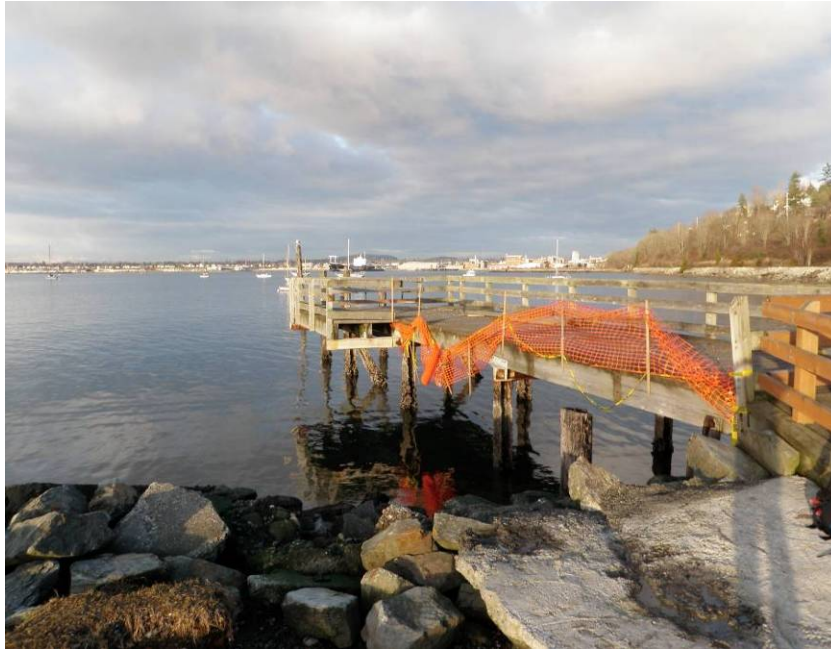
An existing wharf and pier are located at the north end of Boulevard Park in the location of the southern terminus of the proposed overwater walkway (Photo 2). The pier is in structurally unsafe condition and is closed to the public. The overwater portion of the pier is supported by pier bents supported by 1-foot by 1-foot timber caps and eight corroded steel

H-piles. The overwater portion of the wharf is supported by approximately 87 creosote-treated timber piles. A low concrete wall supports the wharf on the landward side.

**Photo 2 – View from Boulevard Park of the existing pier where the southern end of the overwater walkway will land (facing north)**

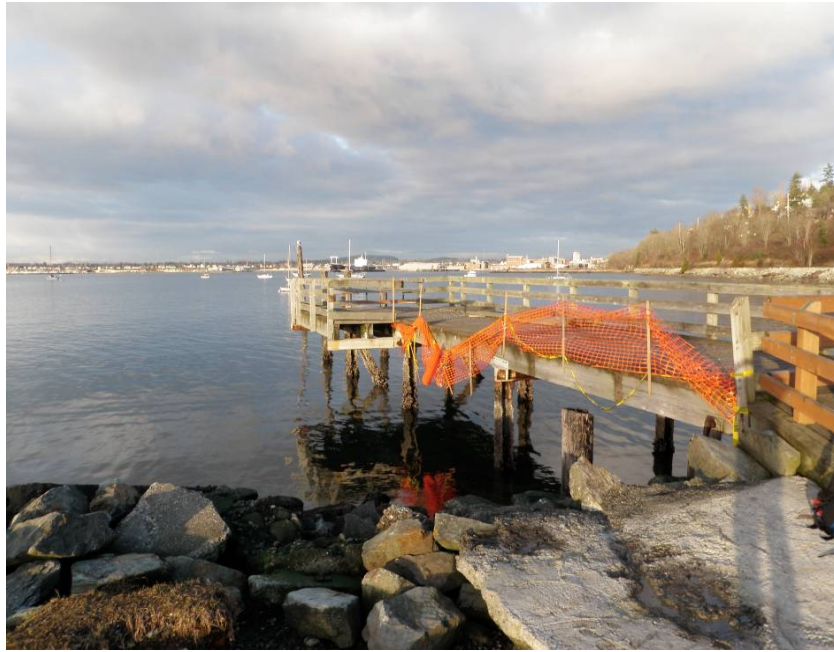
An existing wharf and pier are located at the north end of Boulevard Park in the approximate location of the southern terminus of the proposed overwater walkway (Photo 2). The pier is in structurally unsafe condition and is, therefore, closed to the public. The overwater portion of the pier is supported by pier bents supported by 1-foot by 1-foot timber caps and eight corroded steel H-piles. The overwater portion of the wharf is supported by approximately 87 creosote-treated timber piles. A low concrete wall topped with riprap supports the wharf on the landward side. The wharf, pier, and associated piles will be removed as part of the compensatory mitigation described in Section 5.

**Photo 2 – View from Boulevard Park of the existing pier where the southern end of the overwater walkway will land (facing north)**

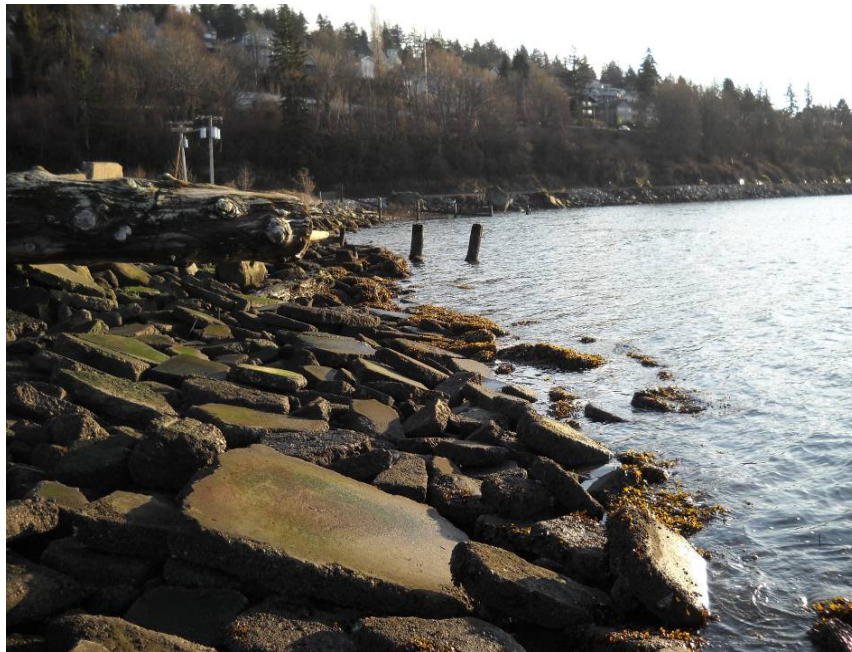
Five derelict creosote-treated piles are located immediately offshore of the southwest corner of the property in the vicinity of the proposed walkway (Photo 3). These piles will be removed as part of the compensatory mitigation described in Section 5.

**Photo 3 – View of the former Cornwall Avenue Landfill site where the north abutment of the proposed overwater walkway will land (facing southeast)**

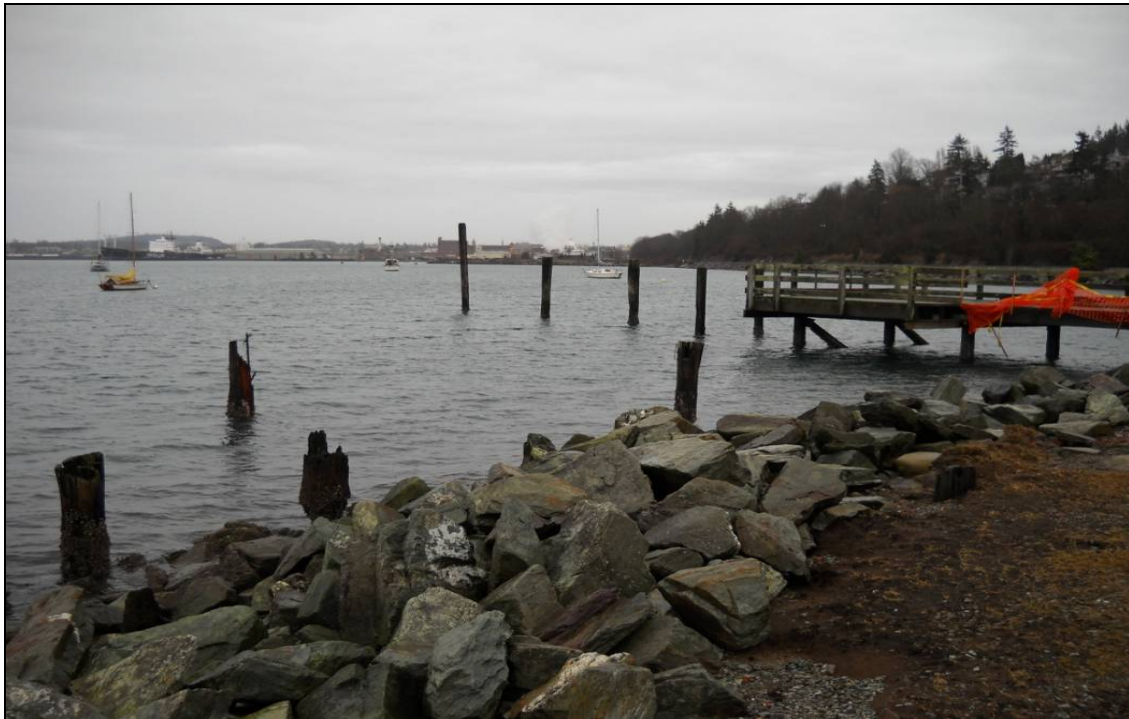
Eighteen old pilings are present in the vicinity of the proposed south abutment location. Fourteen of the pilings are close to the existing dock in Boulevard Park and a few additional outliers are located within approximately 200 feet of this structure (see Figure 10). Thus, while some of these pilings are located in the project area, most of them are located just outside of it. Most of the pilings are located in the intertidal zone, although a group of five piles are present in the shallow subtidal area just beyond the northern end of the dock (see Figure 11). All of the pilings are in poor condition. Most are either cut off or broken. Moreover, all of the pilings appear to have been treated with creosote and are now considered to an environmental concern.

Figure 11 Old pilings in the vicinity of the southern end of the Boulevard/Cornwall Overwater Pedestrian Walkway Project Area. Note the existing dock in the right middle distance. View is to the northeast.

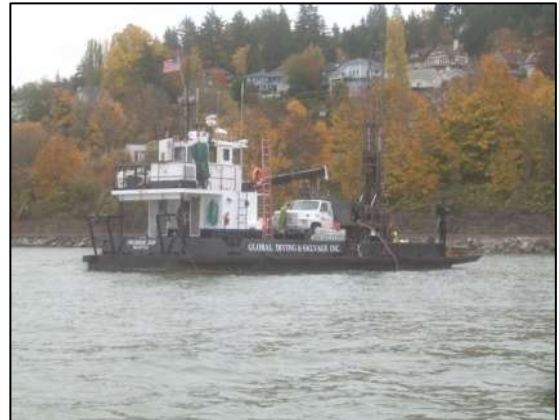
Subsurface conditions were explored by drilling six borings (BL-1 through BL-6) along the proposed alignment of the walkway. The borings were completed to depths of 45 to 102.5 feet below the mudline the week of October 19 to 23, 2009 using subcontracted truck-mounted drilling equipment and a barge. The approximate locations of the explorations are shown in Figure 2. As discussed previously, the depth of the water ranged from 20 to 34 feet due to tides and location. A generalized cross section of the subsurface conditions is presented in Figure 3. An explanation of our boring logs is shown in Figure 4. Logs of the explorations have been provided as Figures 5 through 10.

Six geotechnical borings were completed from an anchored barge using a subcontracted truck-mounted drill rig.

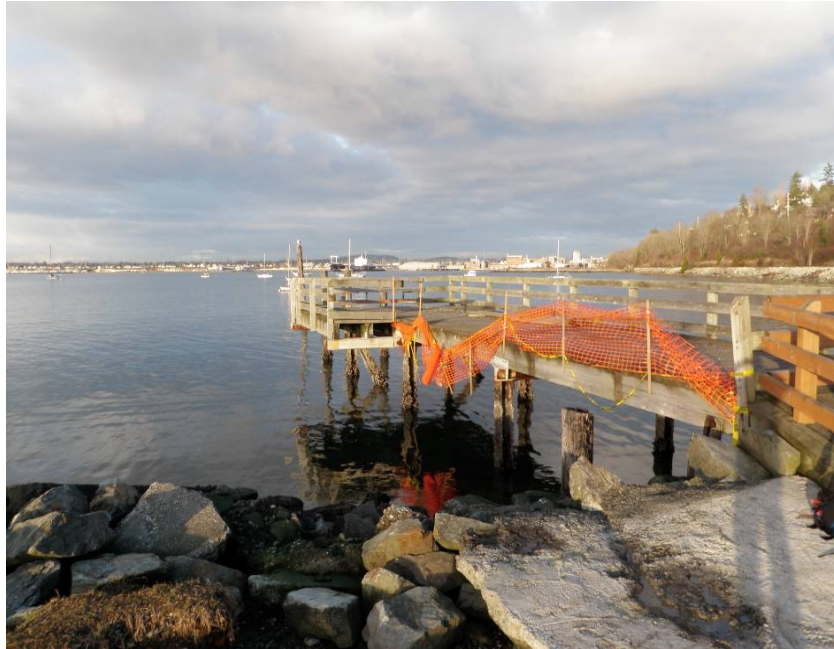
H-piles. The overwater portion of the wharf is supported by approximately 87 creosote-treated timber piles. A low concrete wall supports the wharf on the landward side.

**Photo 2 – View from Boulevard Park of the existing pier where the southern end of the overwater walkway will land (facing north)**
