**MTC Project No.: 16W021**

# GEOTECHNICAL ENGINEERING INVESTIGATION

## LITTLE SQUALICUM ESTUARY

LITTLE SQUALICUM PARK

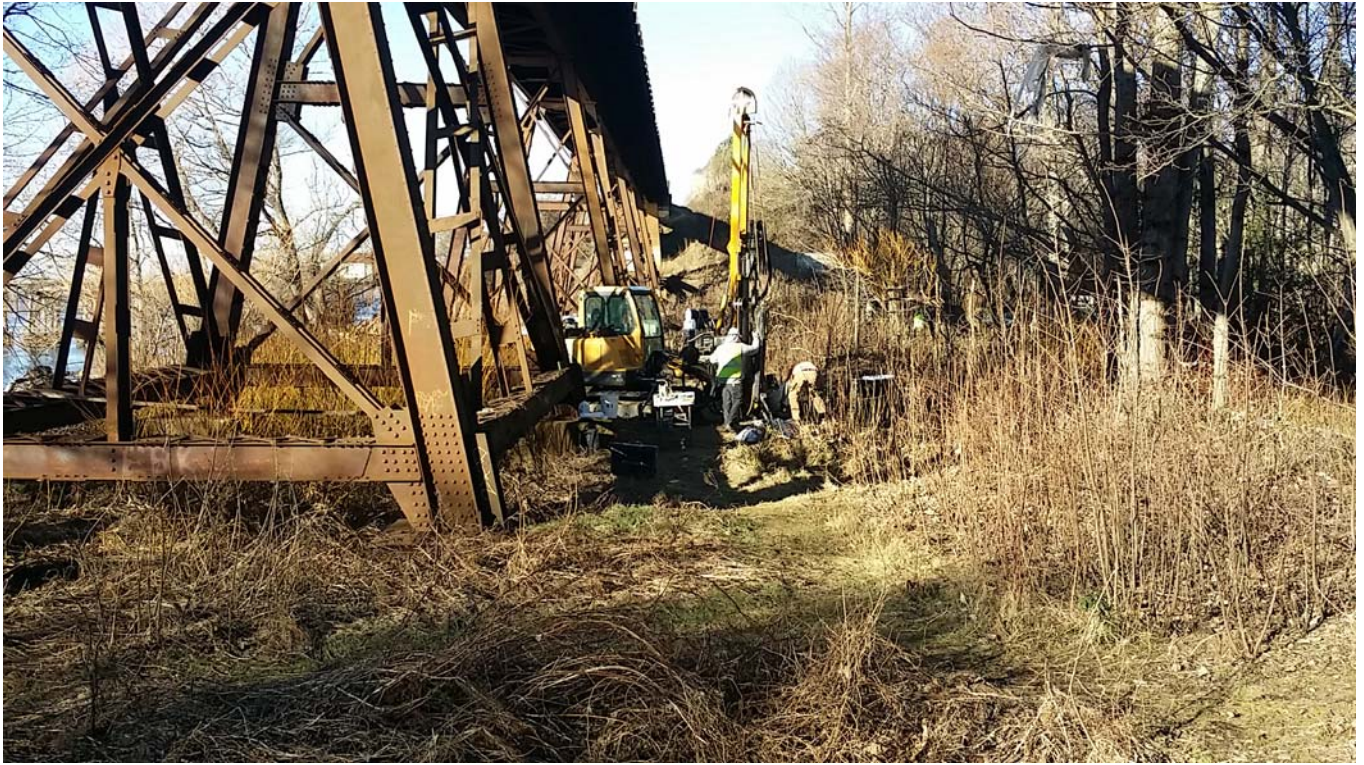
**Photo A:** View facing northwest at borehole B-1 adjacent to BNSF railroad bridge in the vicinity of proposed pedestrian bridge abutment support structure.

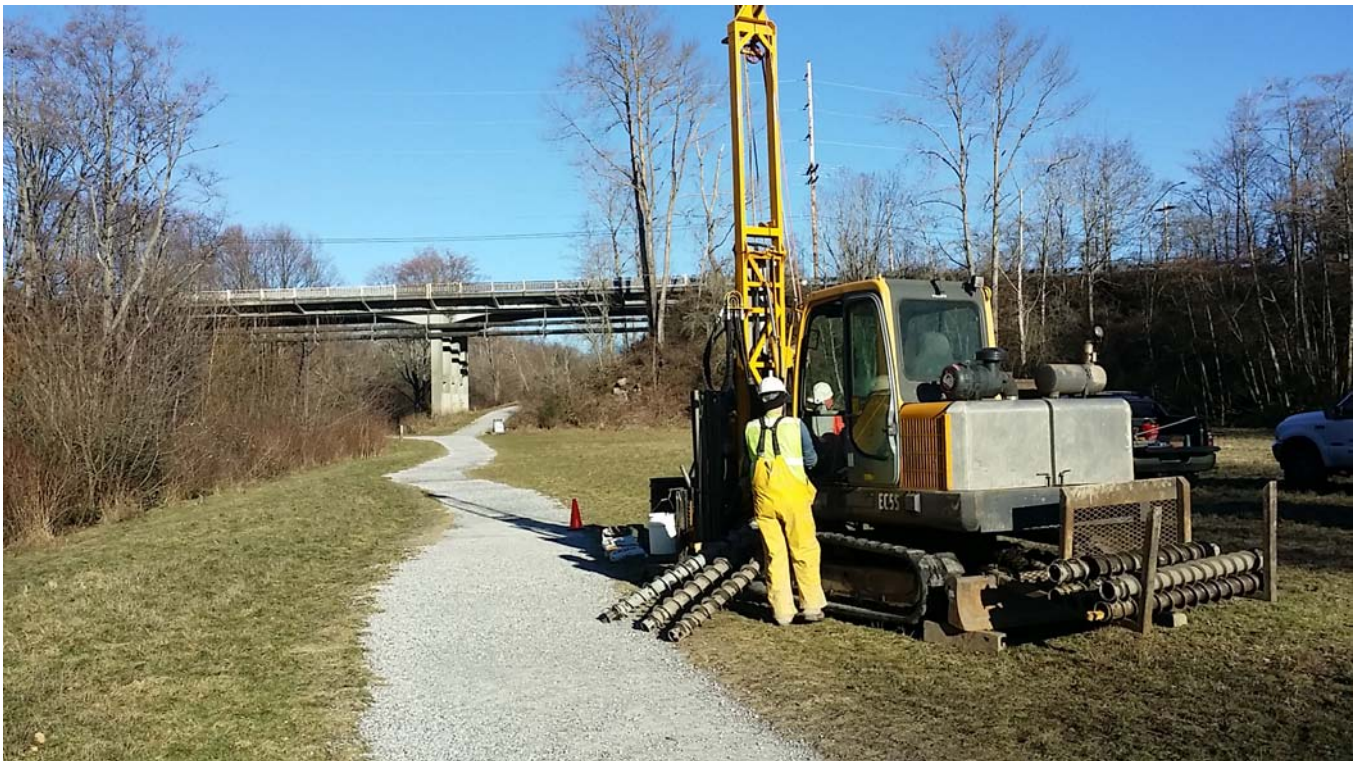
**Photo B:** View facing northeast at borehole B-3 within the location of proposed box culvert structure. Marine Drive overpass bridge is in left-center of photo background, with northeast park area beyond.

The location of the proposed box culvert corresponds to boring B-3, the findings of which form the basis for the recommendations below. Native silty sand with gravel to sand to silty sand soils of typically medium density encountered at likely footing grades at the box culvert location appear generally suitable for direct shallow support of foundations and support of structural development fills, assuming loads are typical for the type and materials of construction. This presumes all cover deposits consisting of uncontrolled fills and peat soils are stripped prior to fill application and foundation construction, and coarse-grained subgrades are recompacted as possible to a suitably firm condition or replaced if necessary. Stripping depth is anticipated to range from 10 to 12 feet BPG based on conditions at exploration location B-3, and proposed structure parameters for anticipated footing grades. As noted above, occurrence of groundwater is of concern at depth in this locality of the project area near base of excavations, and remediation plans via overexcavation and/or ground stabilization should be in place in case of encountering unsuitably loose, organic, or excessively saturated conditions at foundation grades.

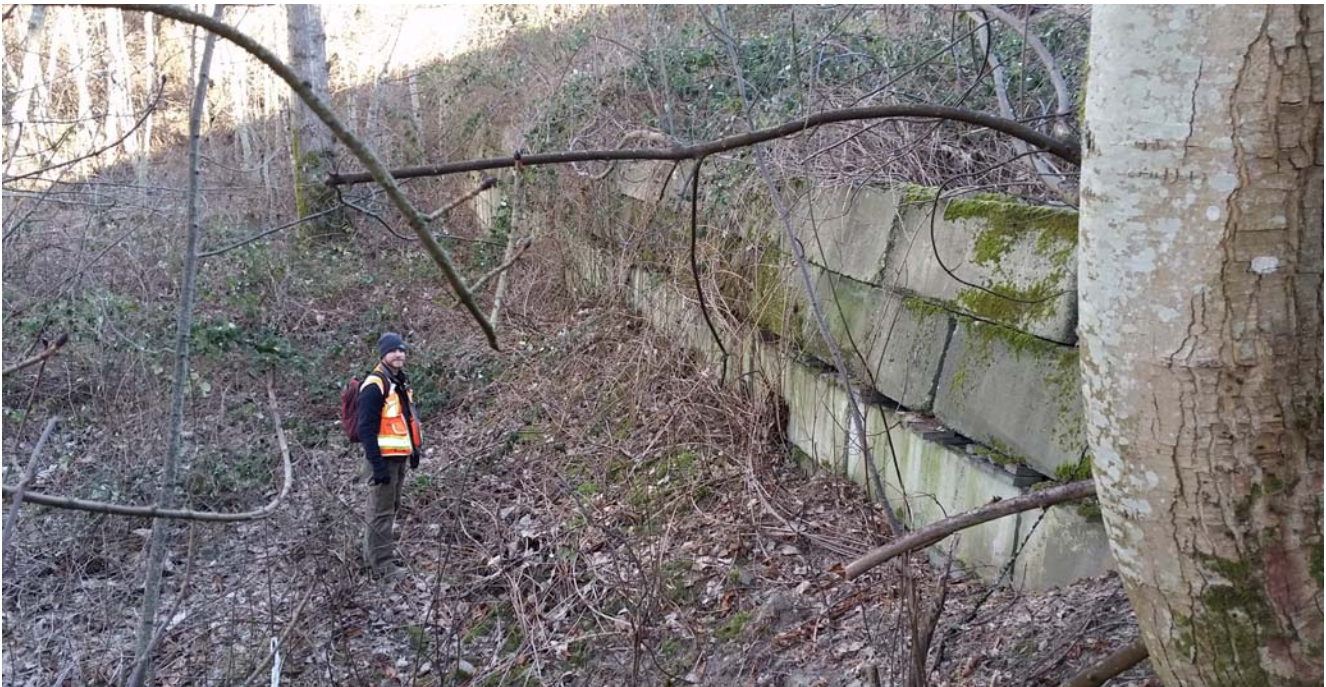
**Photo C:** View facing NE at ecology block wall. Note deformation and improvised repairs at the top of the second lift of blocks. First course of blocks is mostly obscured by soils and vegetation.

The retaining wall structure observed during geohazard reconnaissance is located on private land adjacent to the northeast corner of the project area, south of Marine Drive. The ecology block wall strikes approximately northeast and is about 70 feet long. The top of the wall was observed exposed roughly 7 feet above present grade with four lifts of blocks in majority, and contained some visible geogrid biaxial fabric between lifts. The lowest assumed base level was partially to mostly buried below present grade. The wall showed some signs of deformation near its central area with gaps and openings toward the northwest between block levels. Improvised repairs consisting of narrow concrete paver blocks had been inserted within the gaps. The area uphill and behind the wall is overgrown thickly with blackberry brambles and is an approximately level pad with the dimensions of 70 feet by 20 feet. The construction and maintenance history of the wall is unknown. The project design team and municipalities will be tasked with determining the proper course of action in this bordering area of the park.

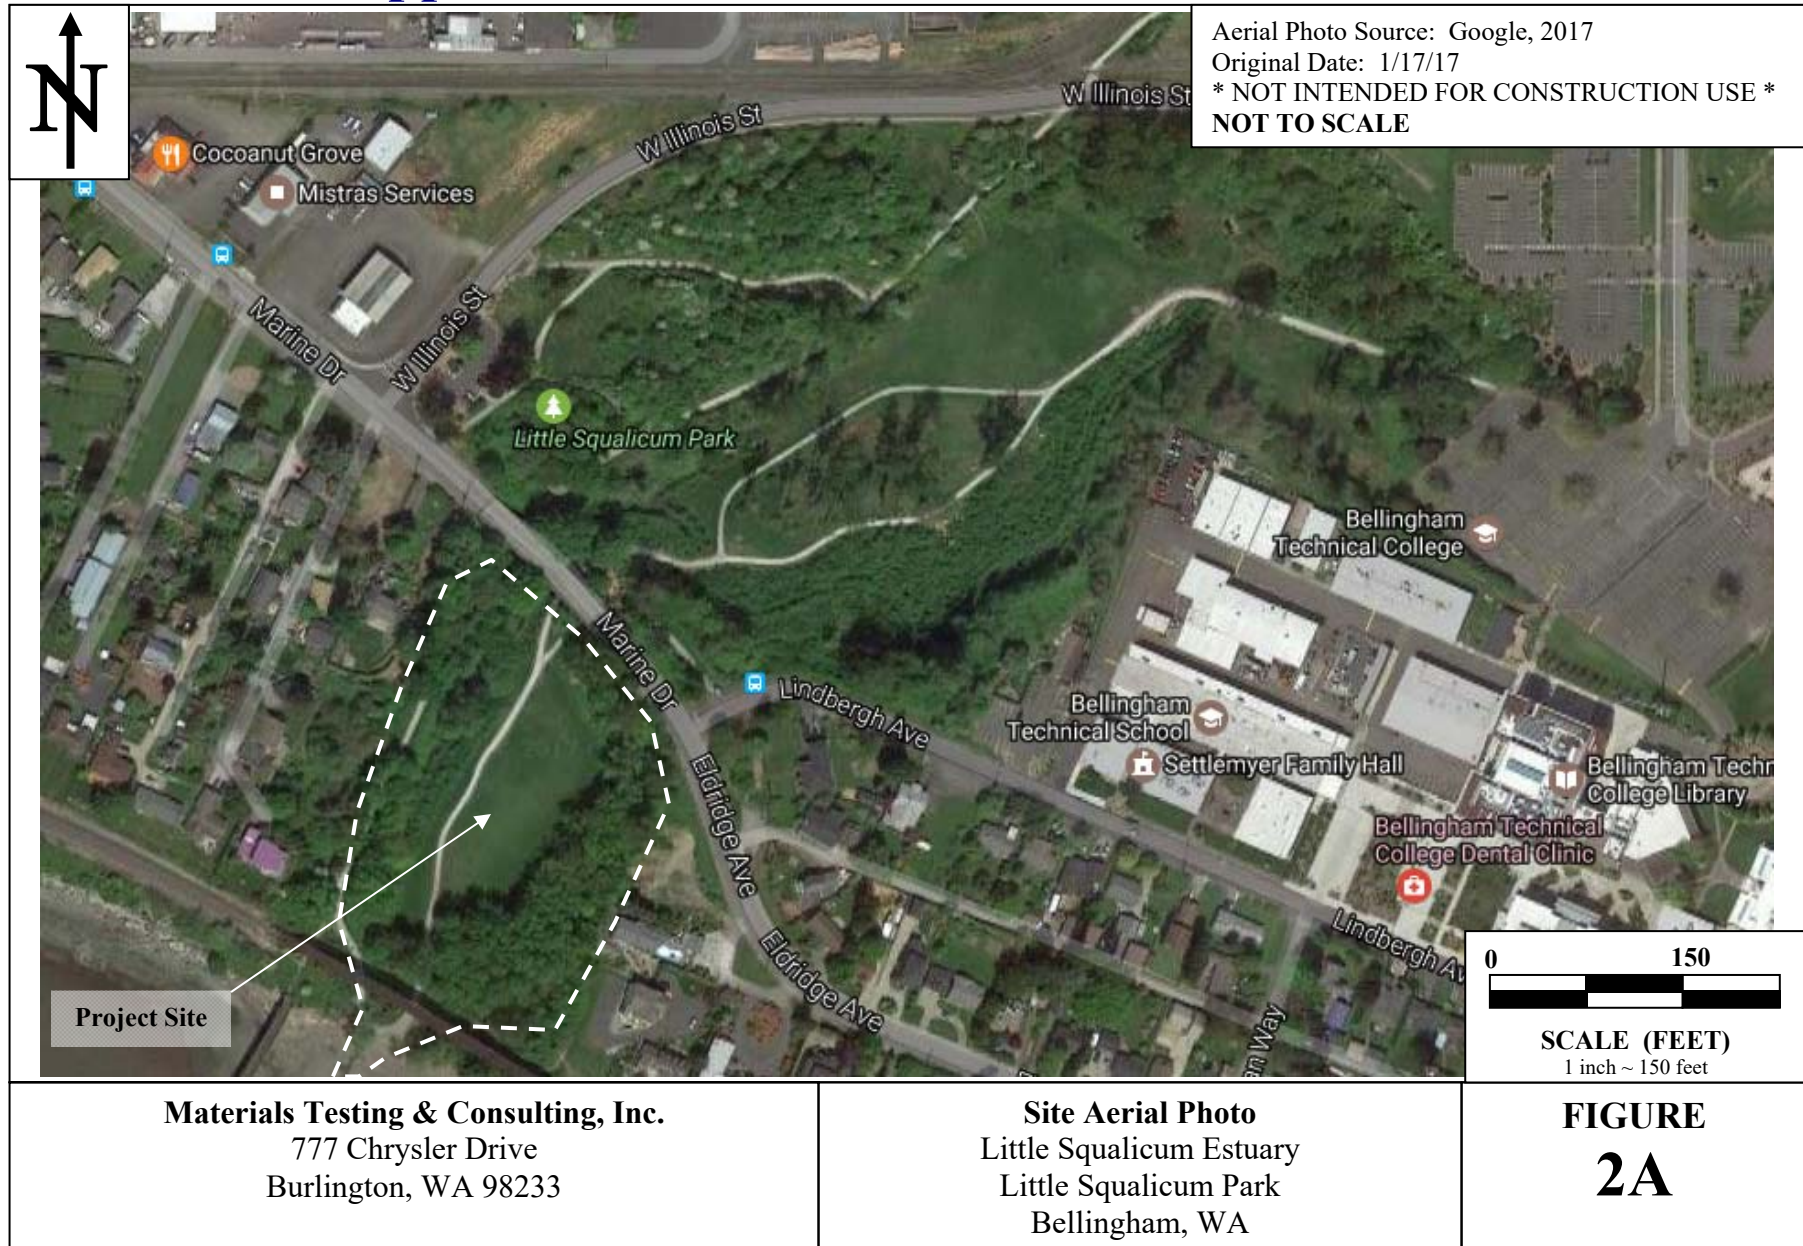
FIGURE  
2B

Figure 1. Pre-Construction sampling memorandum, sampling locations. Contours shown depict proposed grade elevations in feet.
