Results of Comprehensive Restoration Prioritization - Sub-Watershed Tiers

Figure 11. Chuckanut Creek Sub-watershed: HRTA Tier 1 Summary

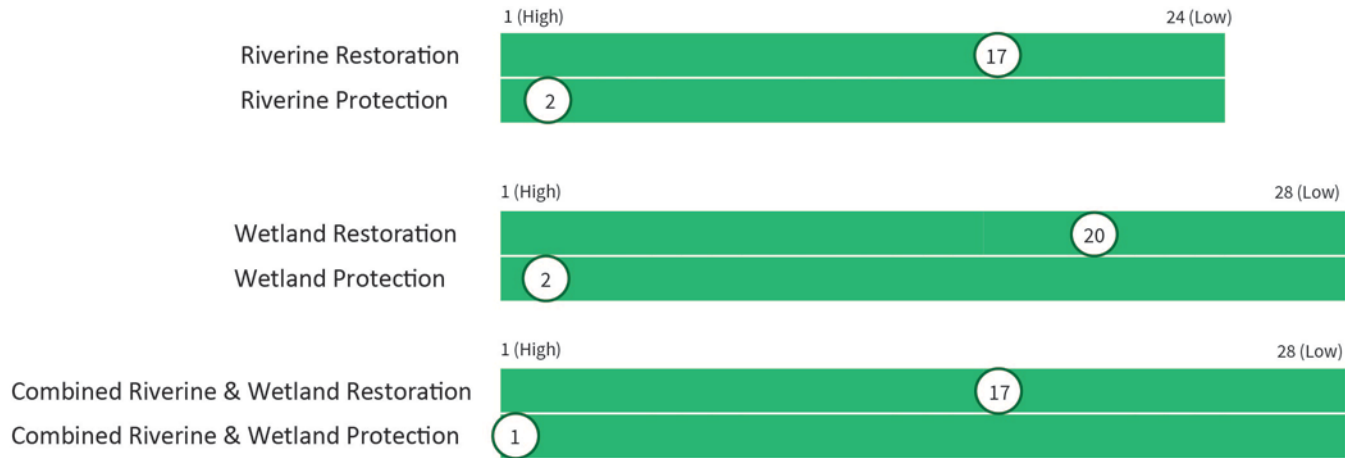
Secondary Prioritization Rankings (Relative Rank Score for Restoration and Protective Actions)  
(excerpt from Tables 35, 36, and 41)

Tier 1 Forest Blocks for Restoration: None  
Tier 1 Forest Blocks for Protection: Blocks 004 and 006

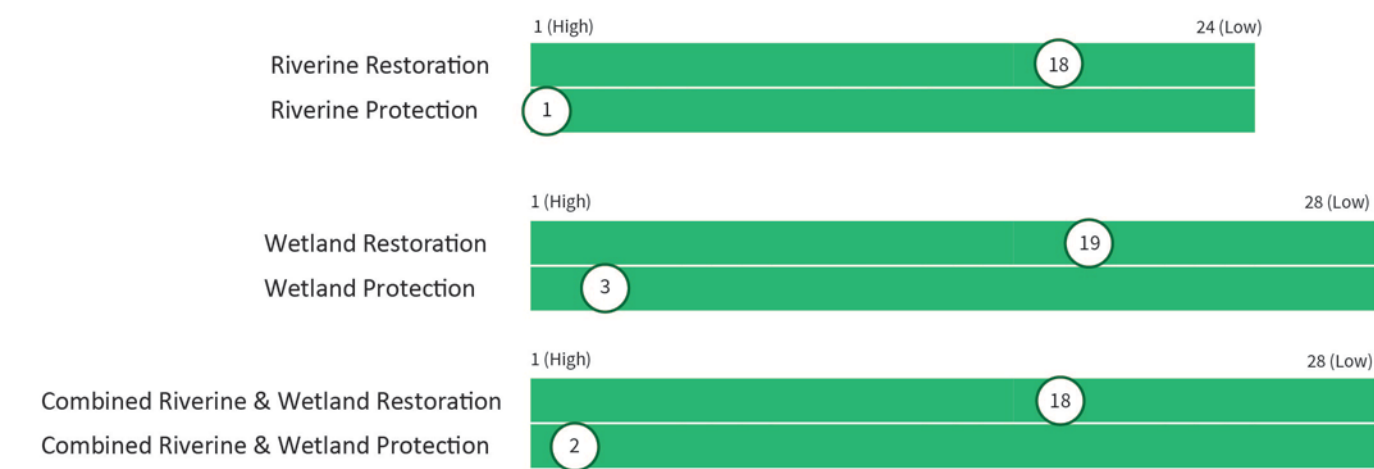
Secondary Prioritization Rankings (Relative Rank Score for Restoration and Protective Actions)

Tier 1 Forest Blocks for Restoration: None

Tier 1 Forest Blocks for Protection: Block 060
