Physical Plant Inspection of Comcast Communications in the City of Bellingham, Washington

May 2010

Inspected by
Kramer.Firm, Inc.

**PHYSICAL PLANT SAFETY INSPECTION
OF COMCAST CABLE COMMUNICATIONS
IN THE CITY OF BELLINGHAM, WASHINGTON**

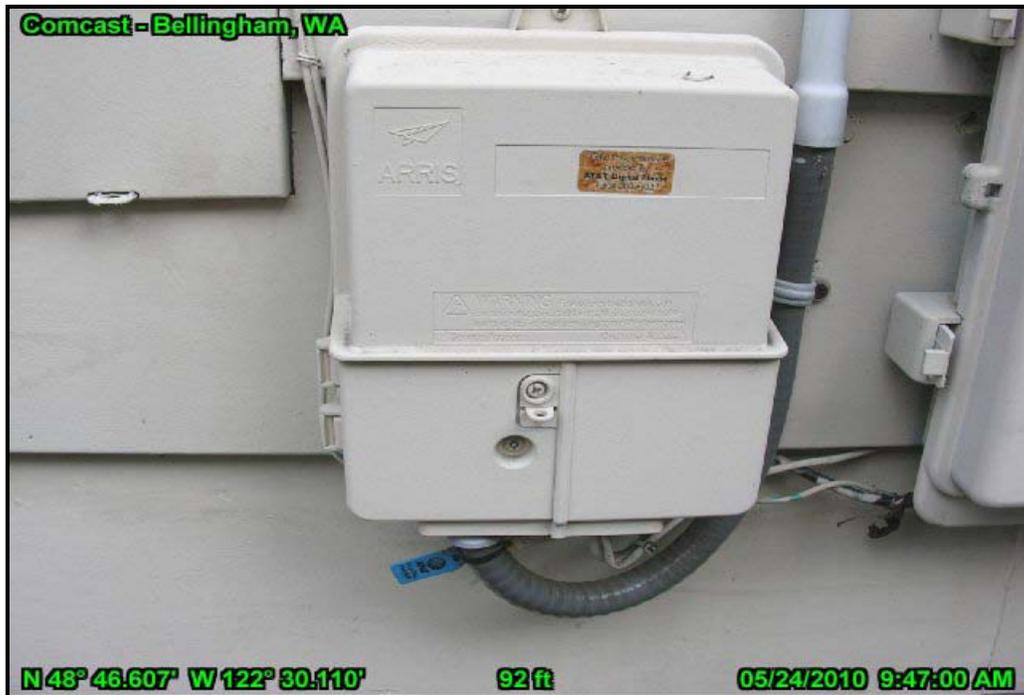
Comcast and its predecessor, AT&T Broadband have apparently abandoned in place hundreds of obsolete (NIU) Network Interface Units on the sides of homes and apartment buildings following their switch to Voice-over-IP technology (VOIP). To the extent that the units are hardwired to some buildings and still attached to the power utility, some of these units may be drawing power from the affected customer's utility service. These apparently abandoned units are also occupying space on the customer's property when their presence is no longer justified and should be removed.

Figure 12: Arris Cornerstone Digital Telephone NIU. Apparently abandoned in place.

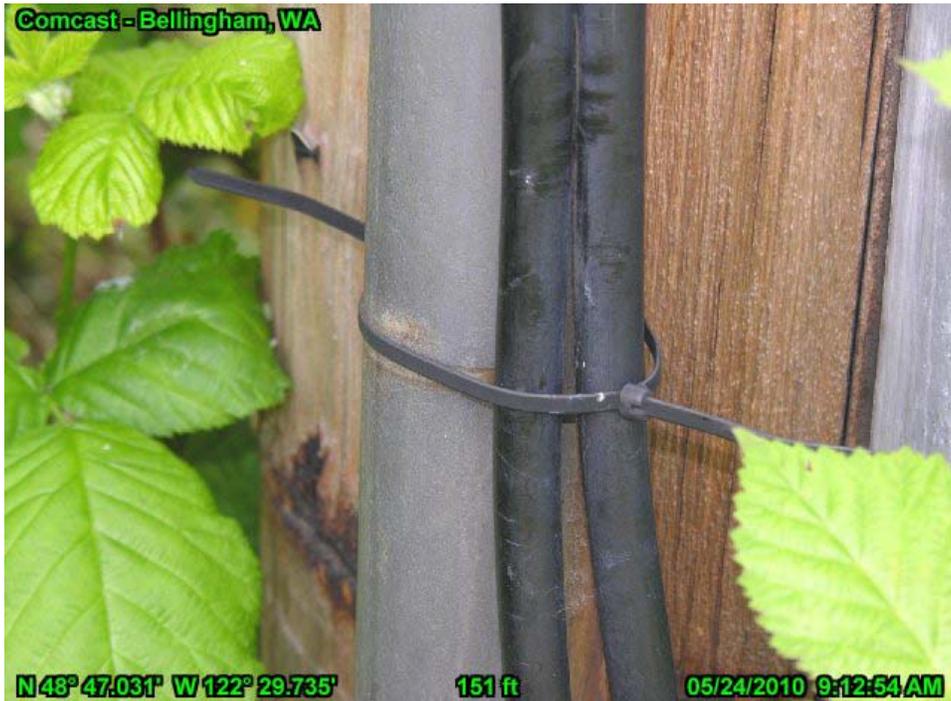
Corner of Pana Vista and Sterling Drive
Distribution cables ty-wrapped to power riser conduit.

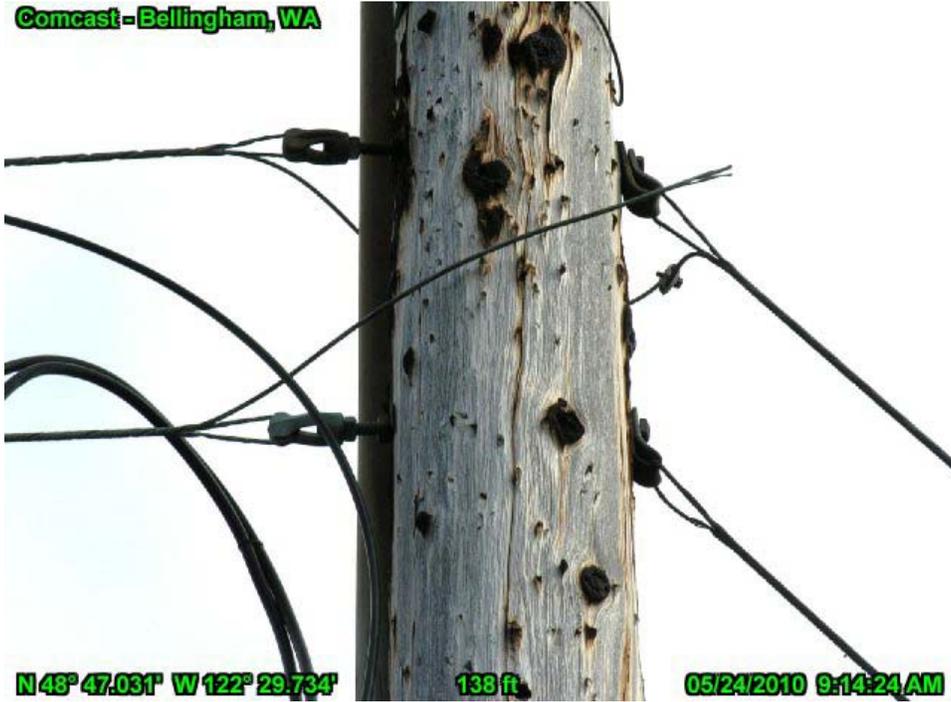
Corner of Pana Vista and Sterling Drive.
Strand wire not secured or bonded to down guy

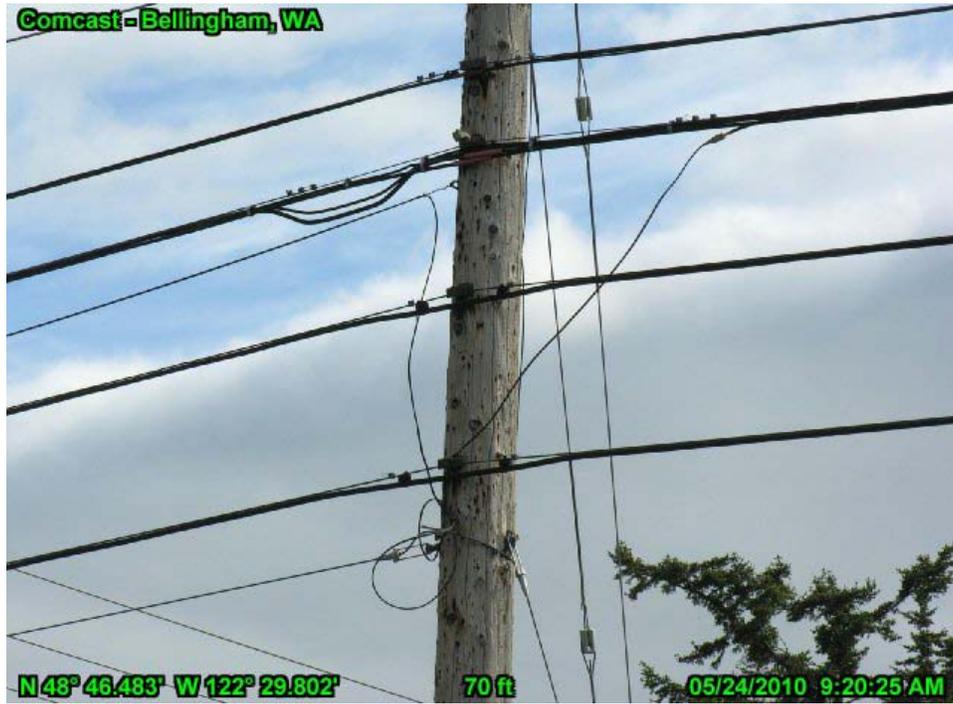
3224 Northwest Avenue. Temporary drop connected to "500 to F" connector. Line is disconnected now. Interferes with climbing space. Needs to be removed.

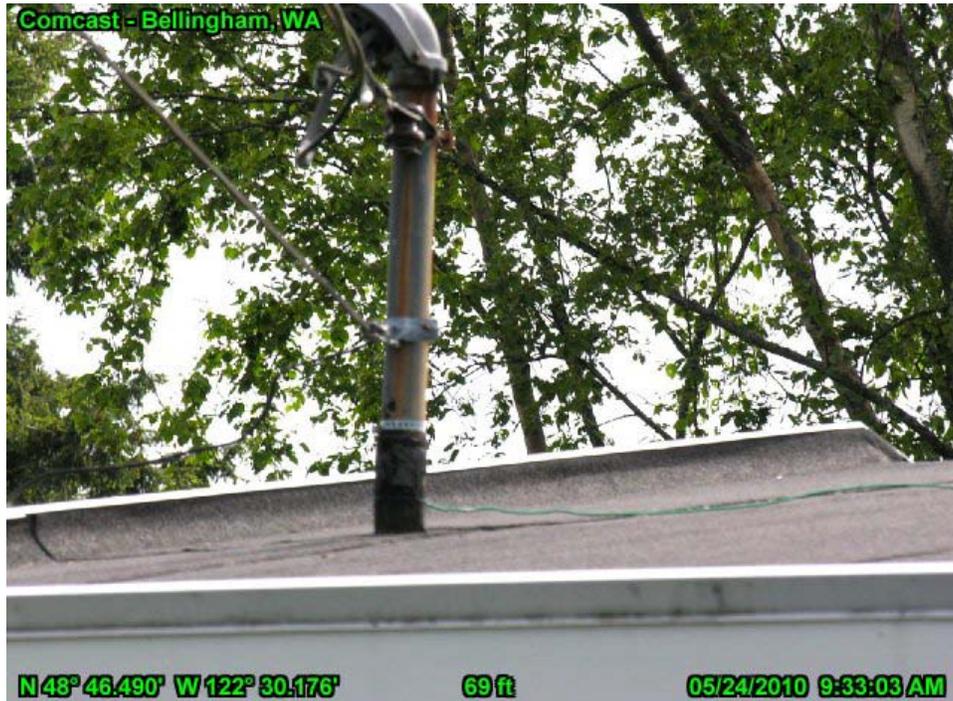
3214 Firwood
Cable drop attached to the power mast.

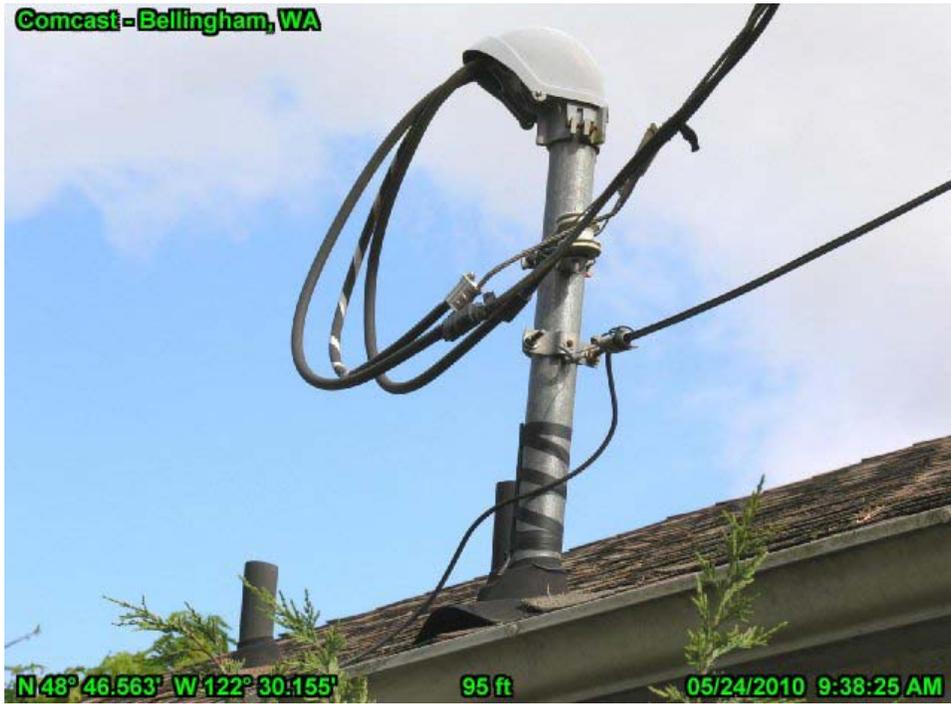
3245 Firwood
Cable drop attached to the power mast.

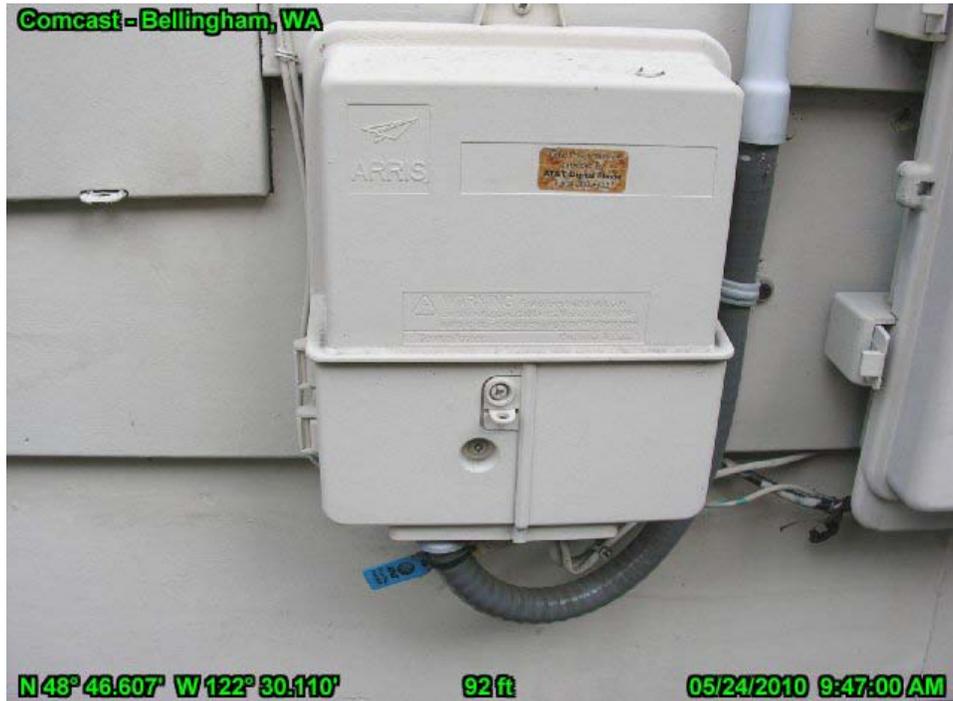
2728 Maplewood.

Apparently abandoned Arris residential cornerstone NIU. No longer in service.

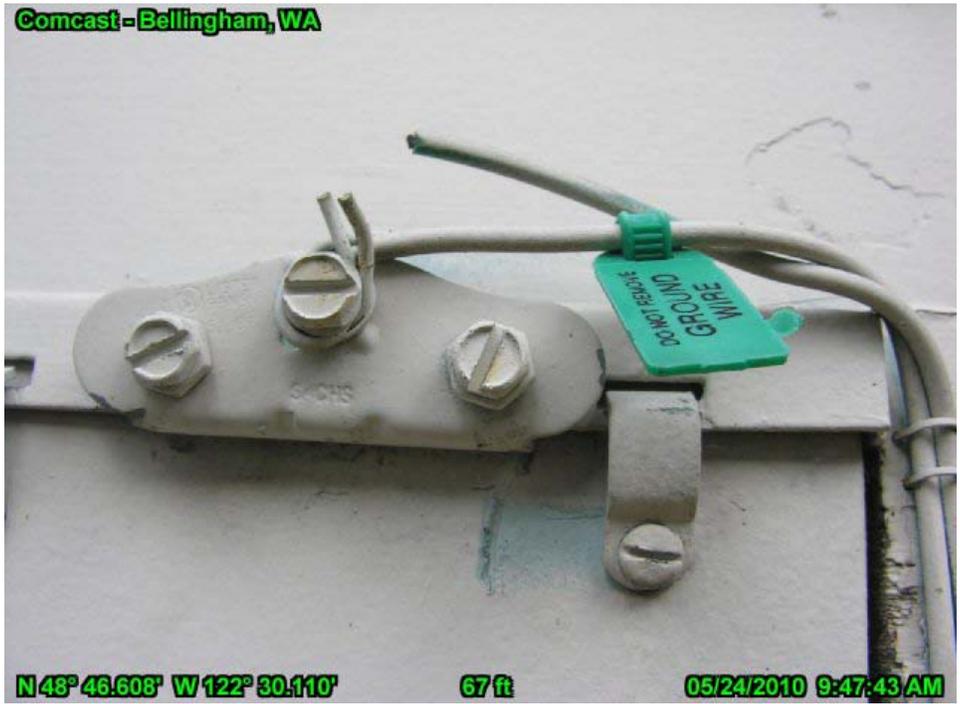
2724 Maplewood Avenue. Ground wire broken at meter clamp.

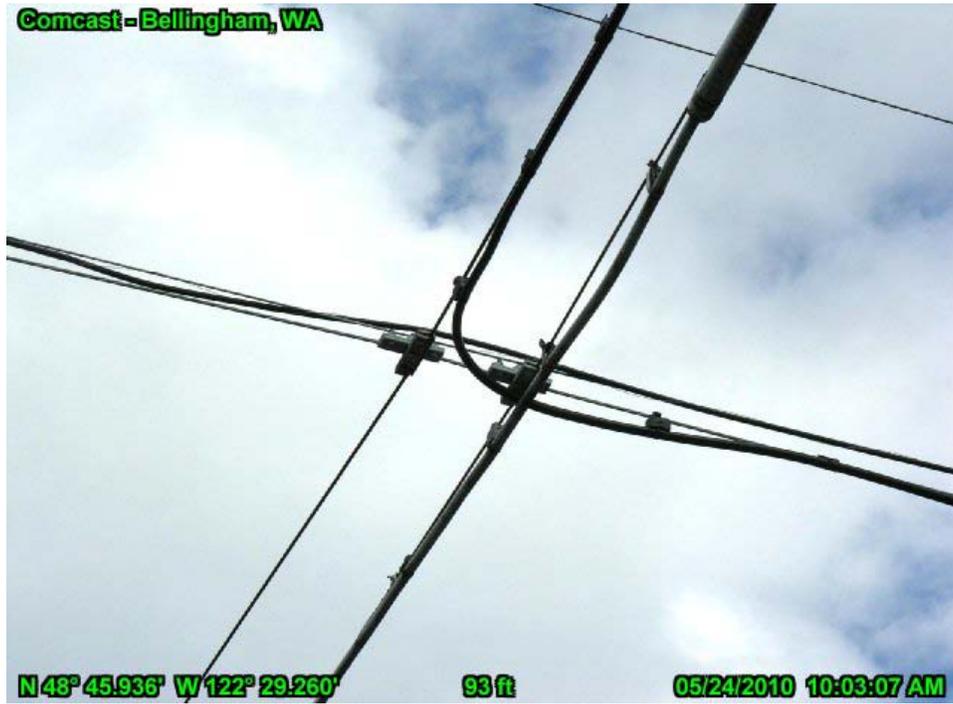
Connecticut Avenue between Elm and Kulshan in the alley
Cable crossover is lying on top of telephone. No vertical standoff.

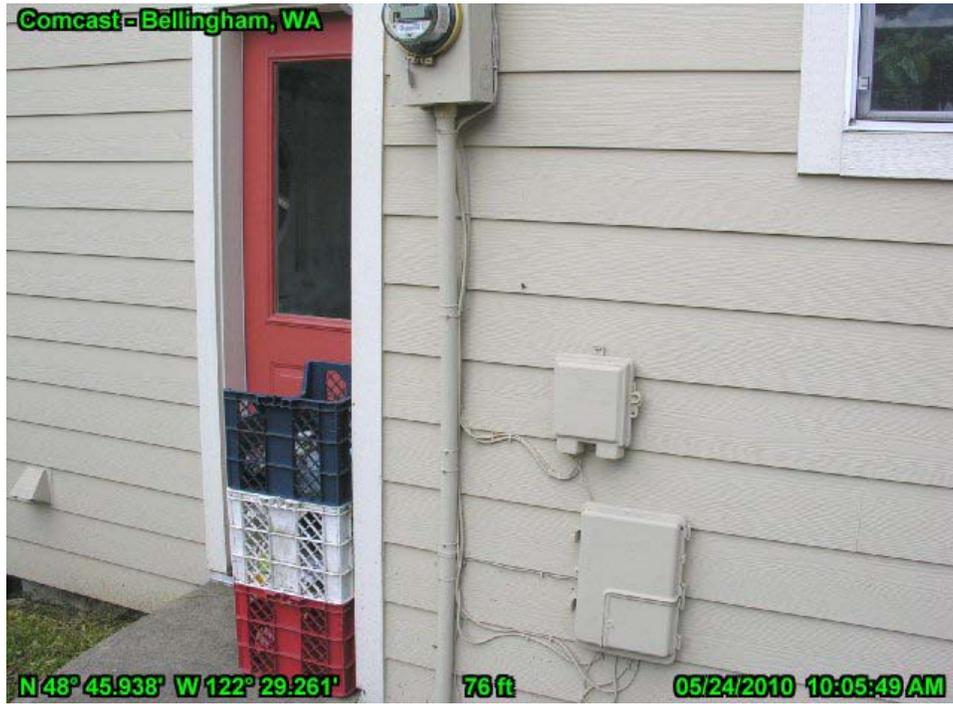
2823 Elm Street. Cable drops hit the power mast, wiring ty-wrapped to the power Mast conduit. Ground wire not secured.

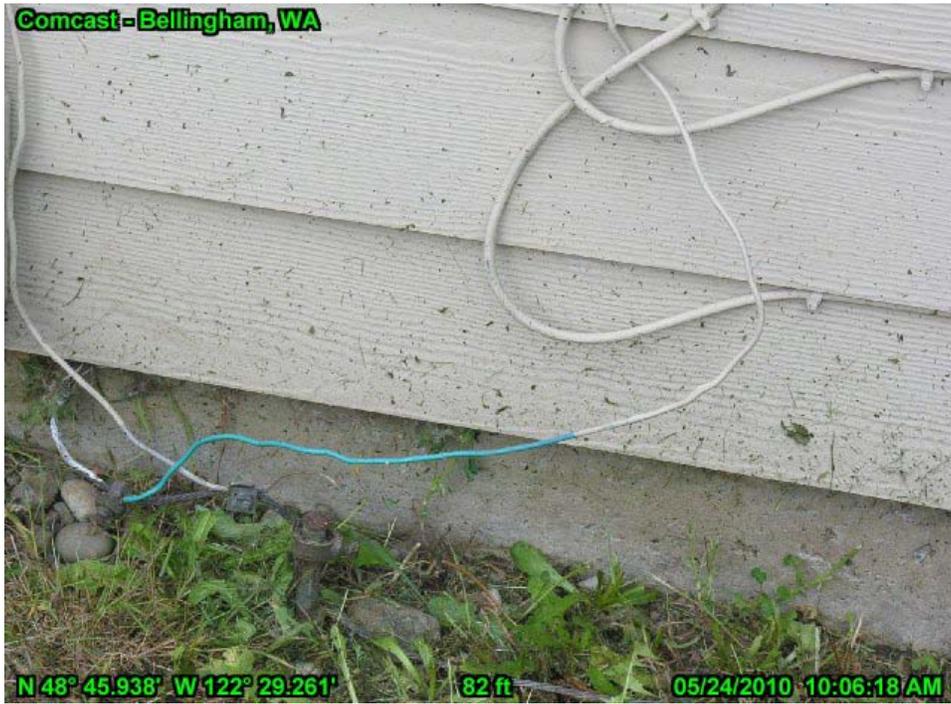
2823 Elm Street. Cable drops hit the power mast, wiring ty-wrapped to the power mast conduit. Ground wire not secured.

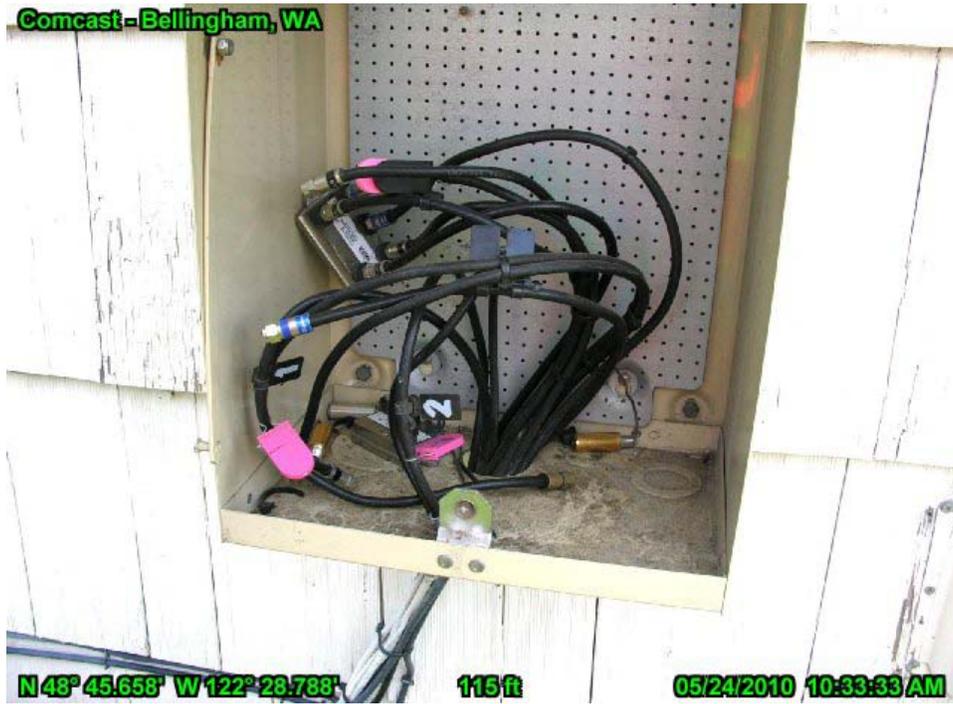
Rear of 2300 G Street. Not grounded.

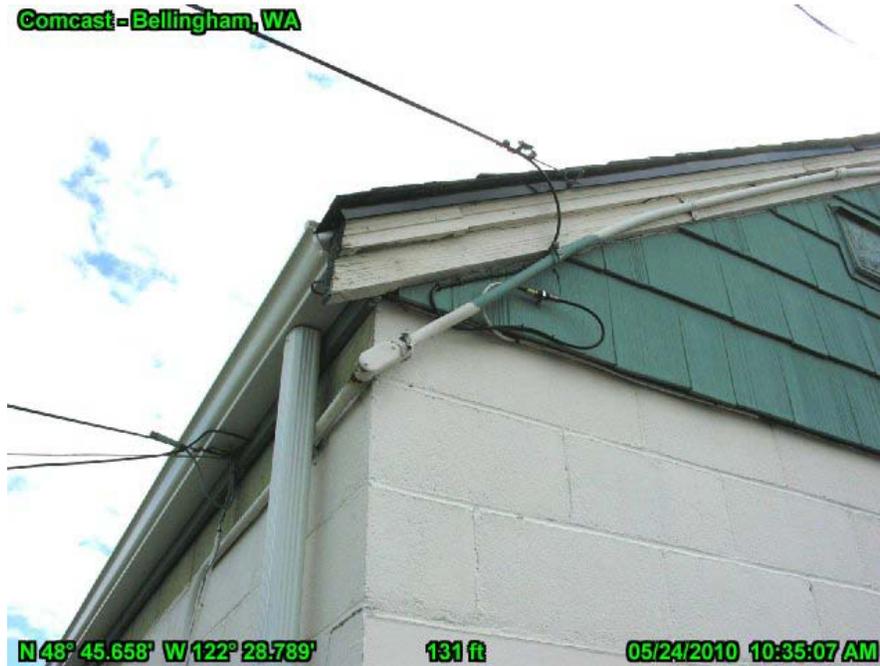
Rear of 2302 G Street. Apartment above Garage. Grounded to the power mast conduit.
Multiple pipe connections between ground and meter.

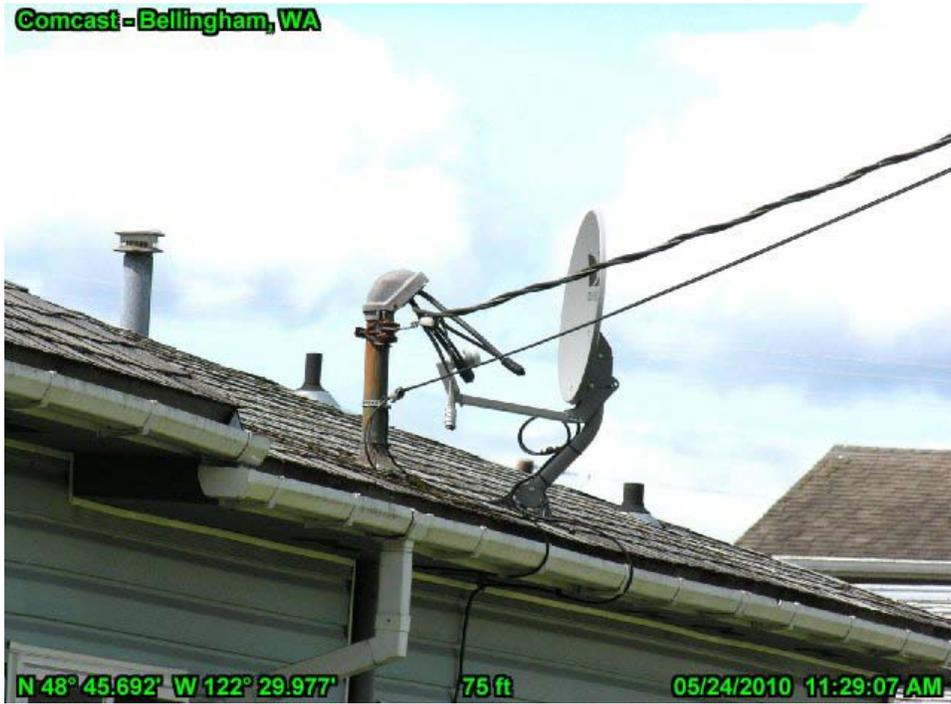
2339 West Street
Drop attached to the power mast

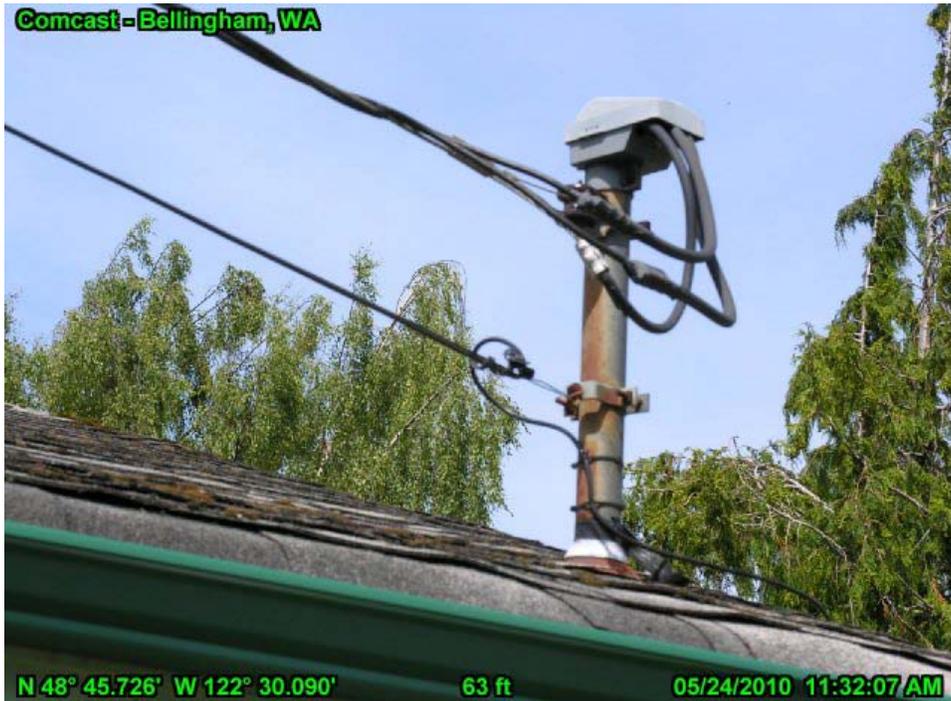
2410 Monroe Street
Cable drop attached to the power mast.

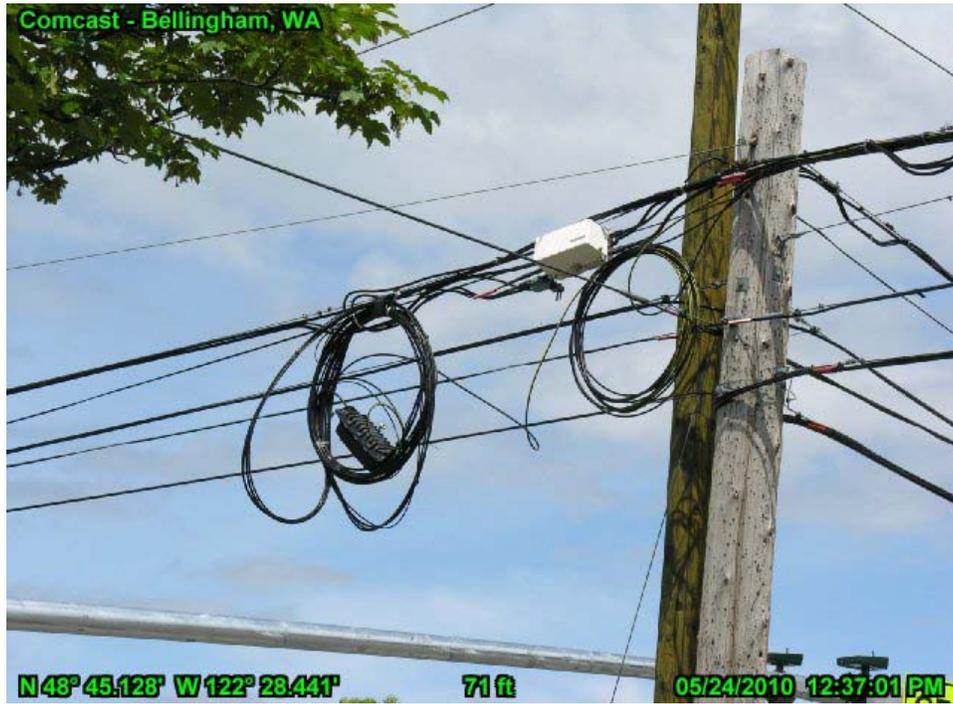
Corner of Railroad Ave and York St
Fiber optic enclosure tied up to strand.

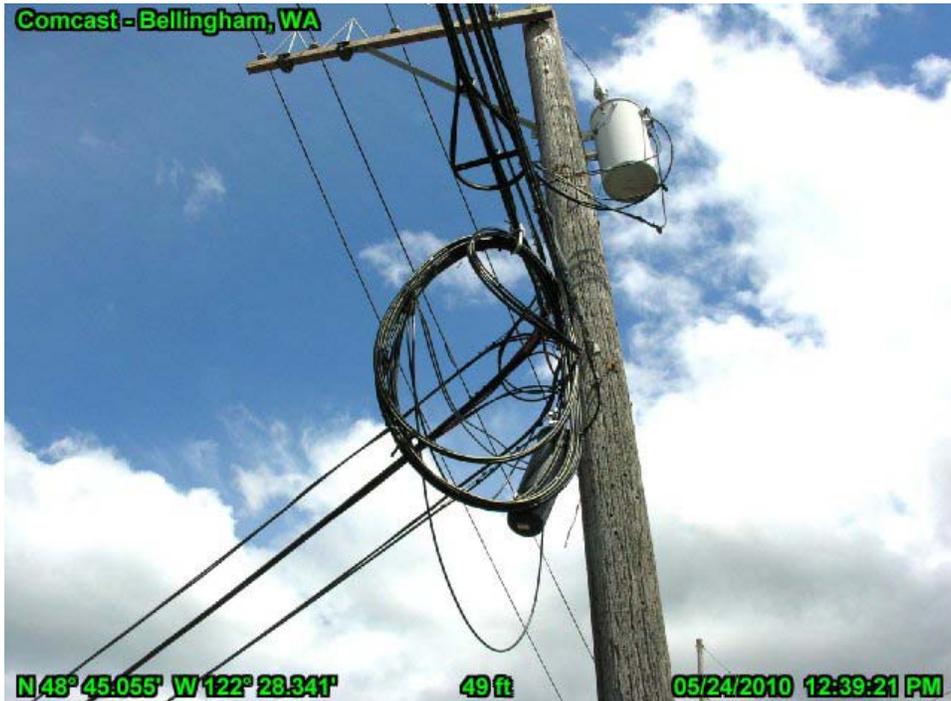
Next to the Firestone store on North State Street.
Fiber optic enclosure and cables tied to strand.

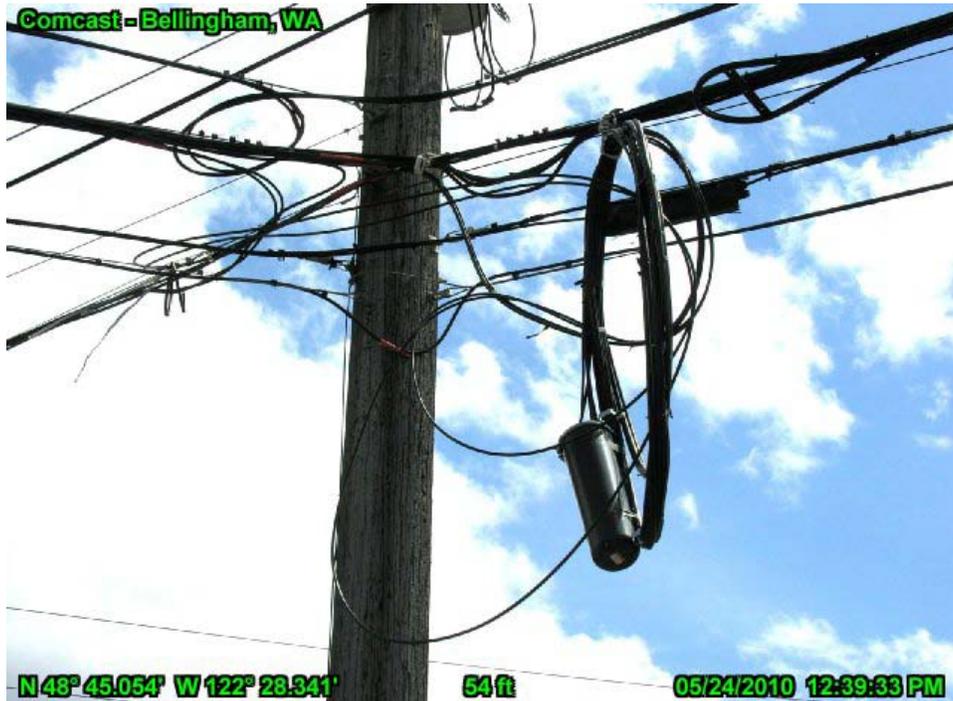
Behind the Firestone store on North State Street.
Fiber optic enclosure and fibers hanging from strand.

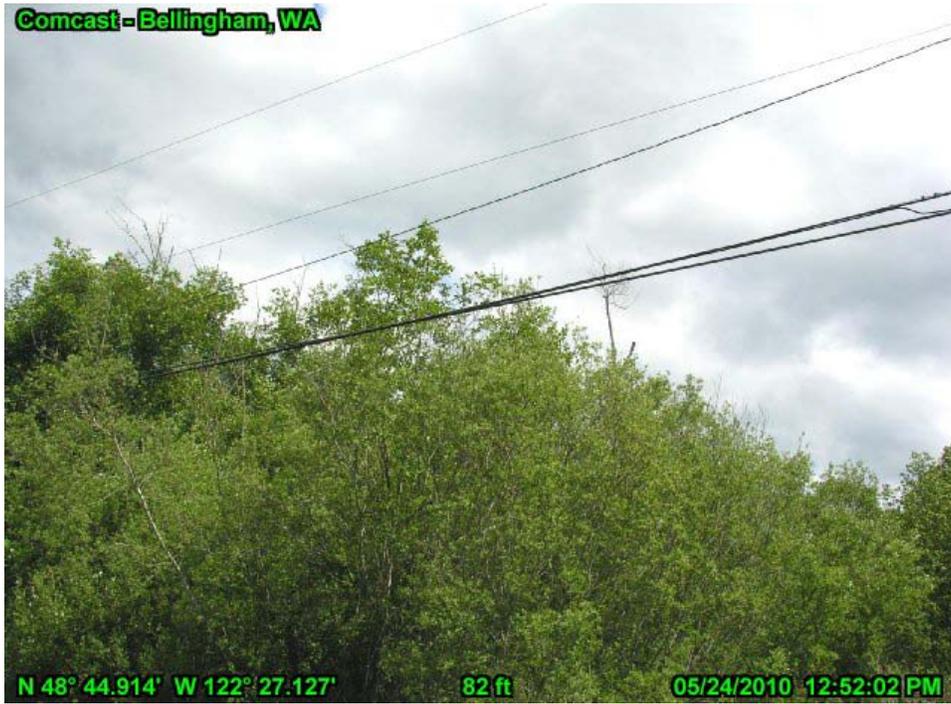
1521 St. Paul.

Multiple spans of cable sagging below telephone.

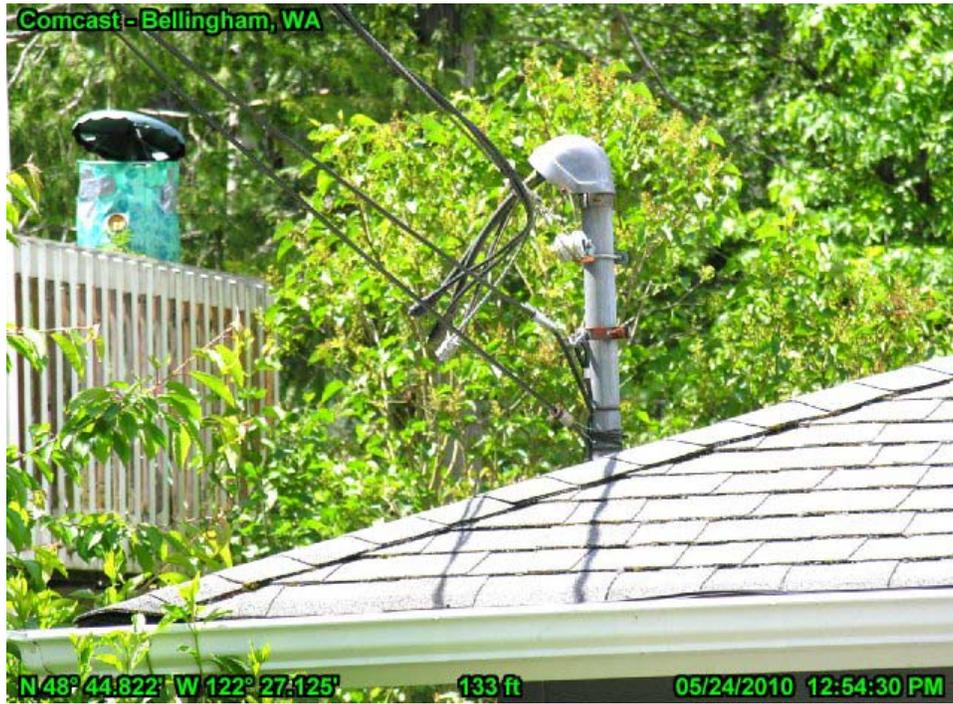
1339 St. Paul

Cable drop attached to the power mast.

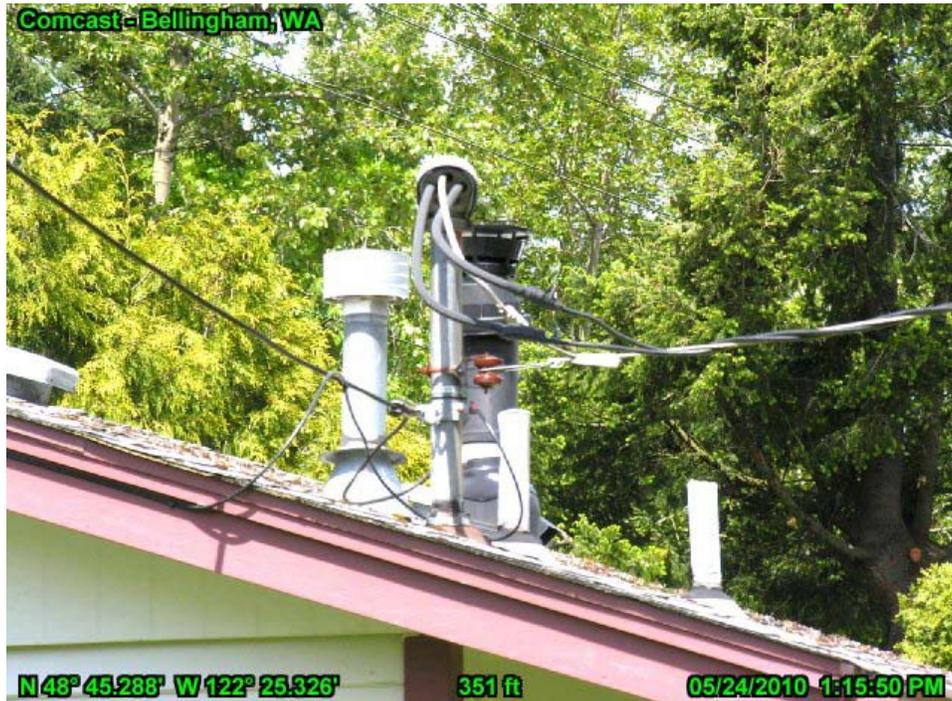
Corner of Electric and Ohio Streets
Cable drop attached to power riser

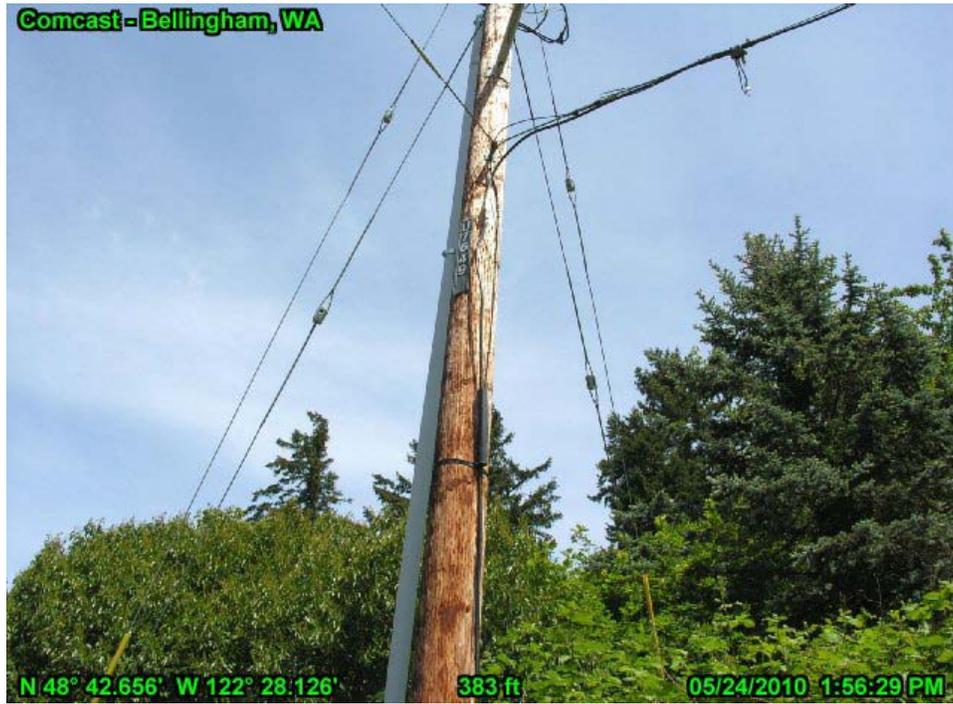
Corner of 37th Street and South Street
Cable riser not secured to pole.

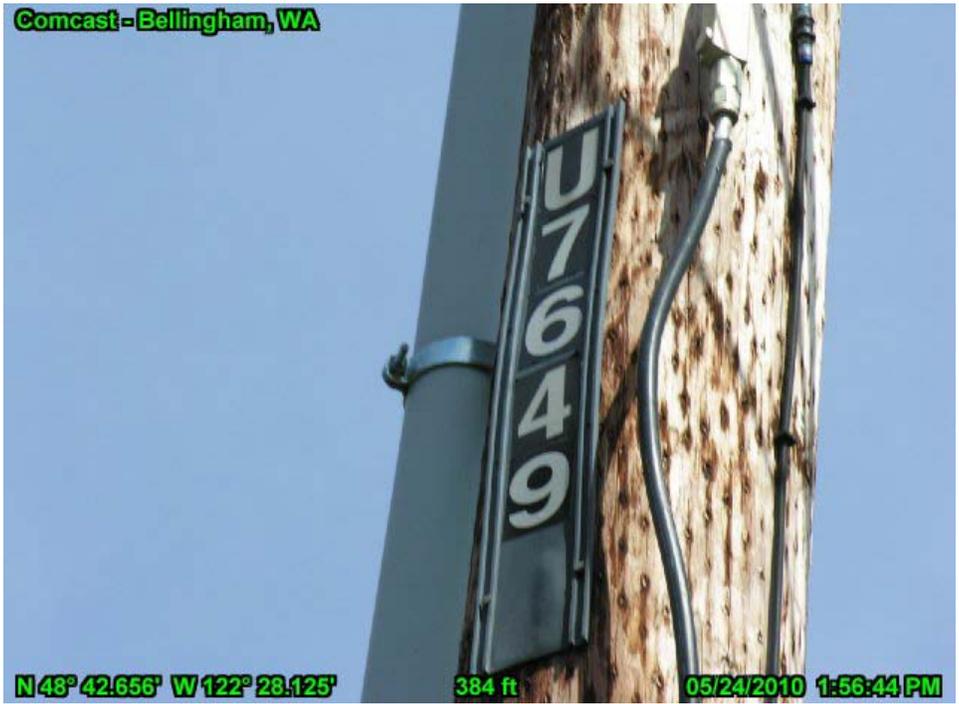
Corner of 37th Street and South Street
Cable riser not secured to pole.

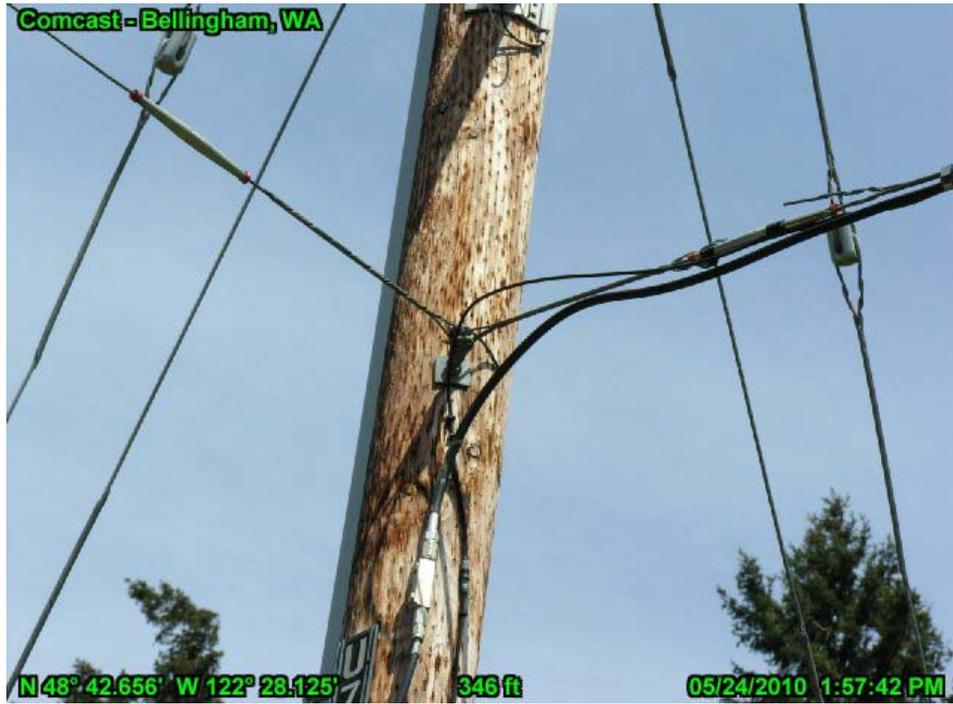
Corner of 37th Street and South Street

Poor pole change out. "Preforms" and deadens not properly attached.
Cables and connections not shrunk. Shrink tubing has slipped down the pole.

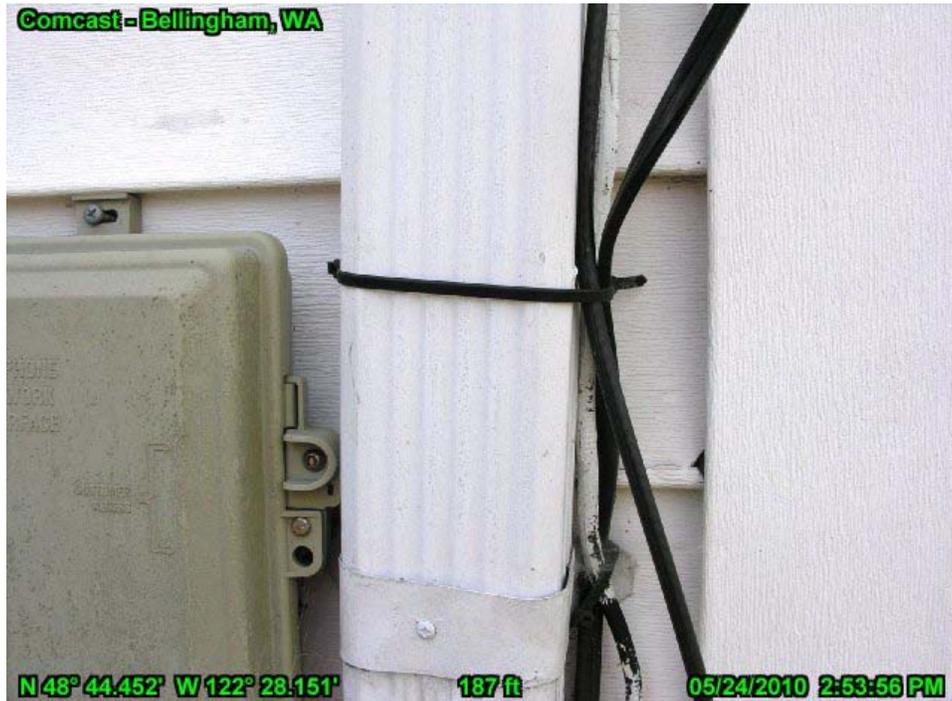
Corner of Grants and Edwards.
Cable wiring secured to rain downspout.

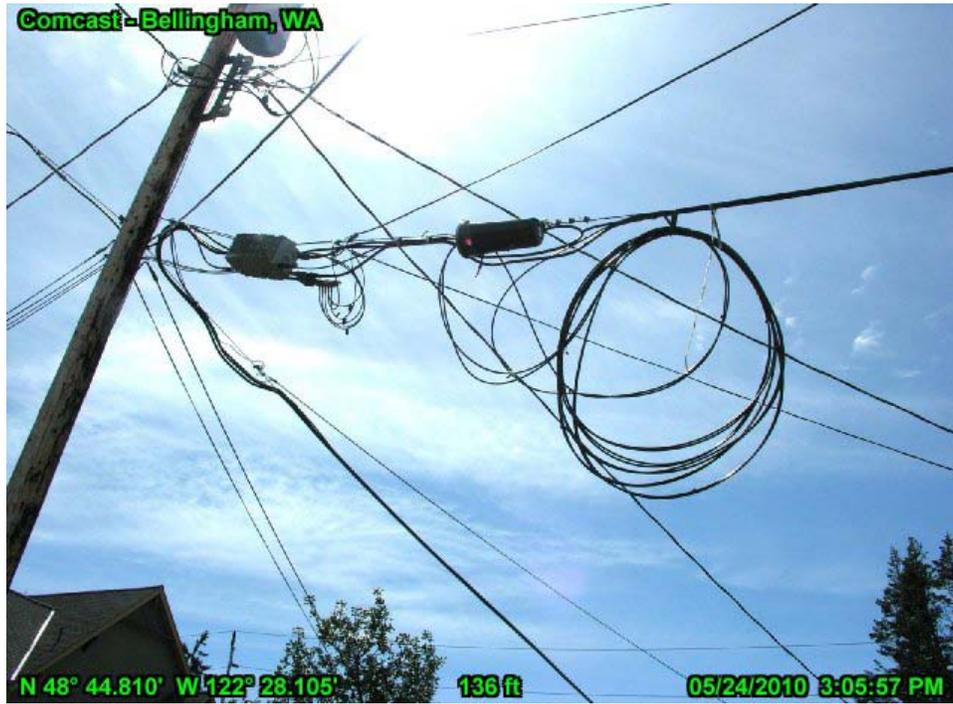
Potter between Humboldt and Grant Streets
Fiber optic coils tied up to strand. Incomplete splicing work.

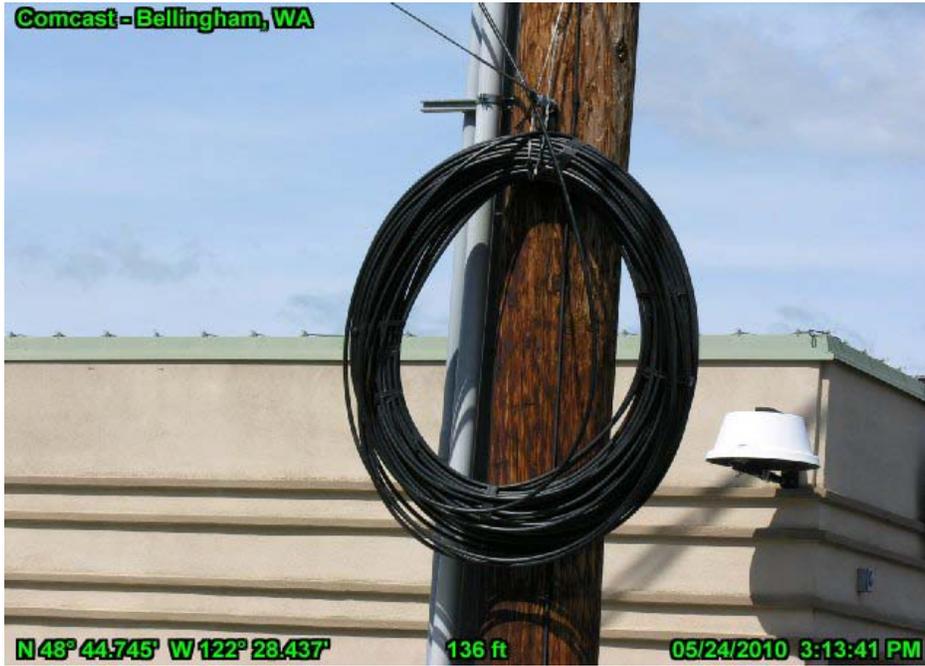
Alley between E Holly and East Chestnut South of High Street.
Fiber coil hanging from pole step.

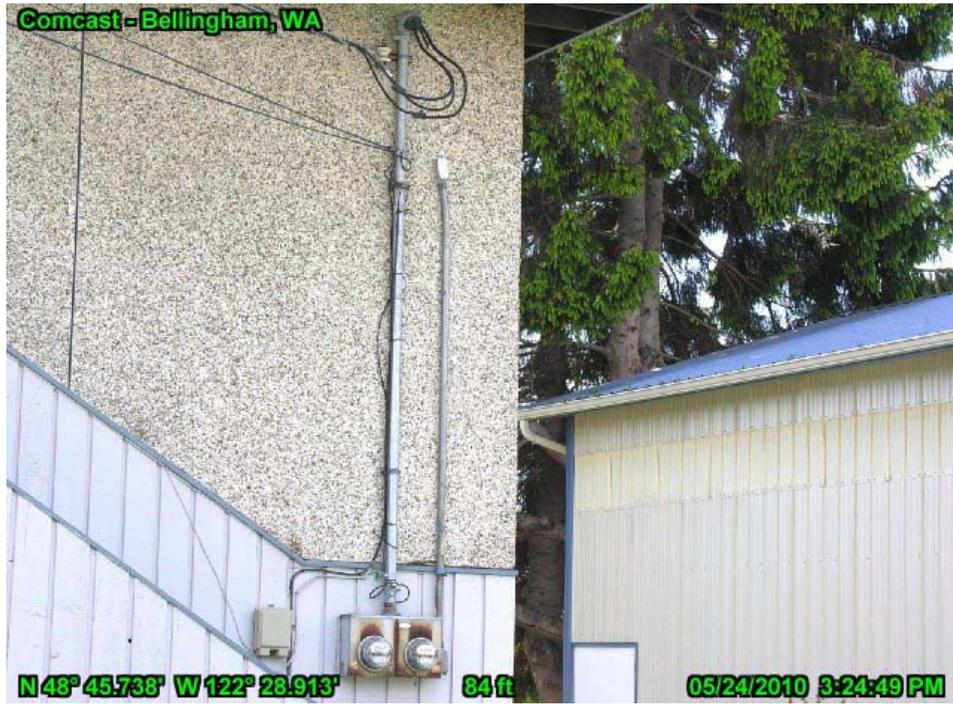
9223 I Street

Cable wiring ty-wrapped to power riser conduits. Attachment point too close to power.

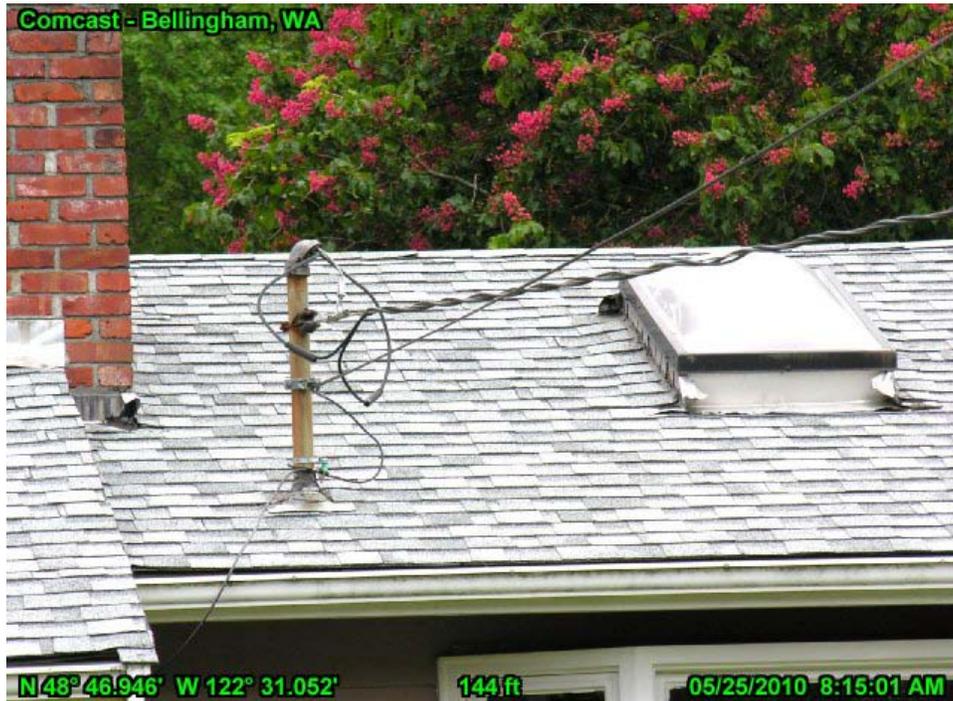
3218 McCleod Rd.
Cable drop attached to the power mast

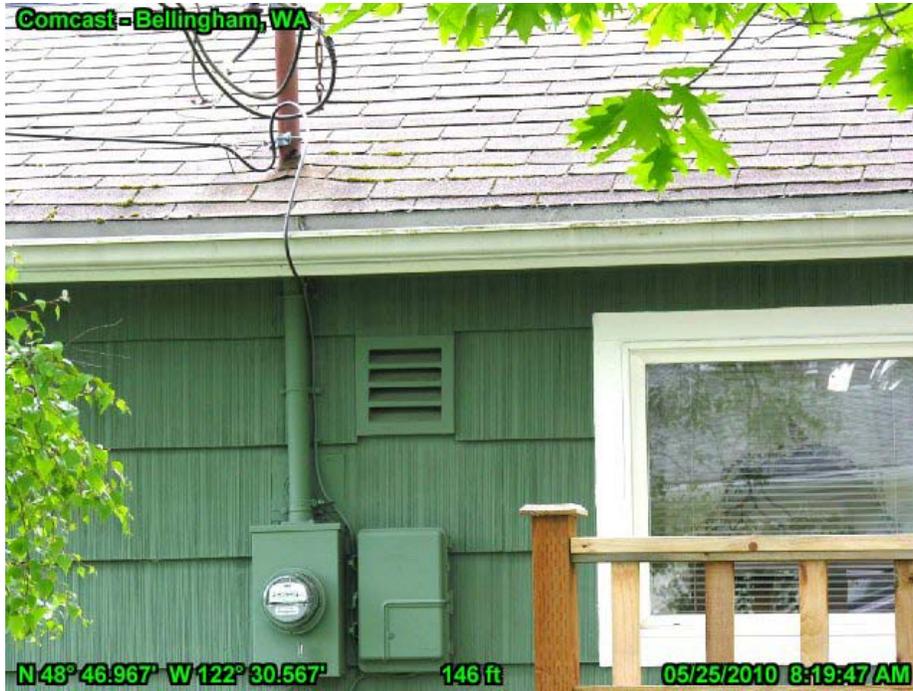
2938 McCleod Road
Cable drop attached to the power mast.

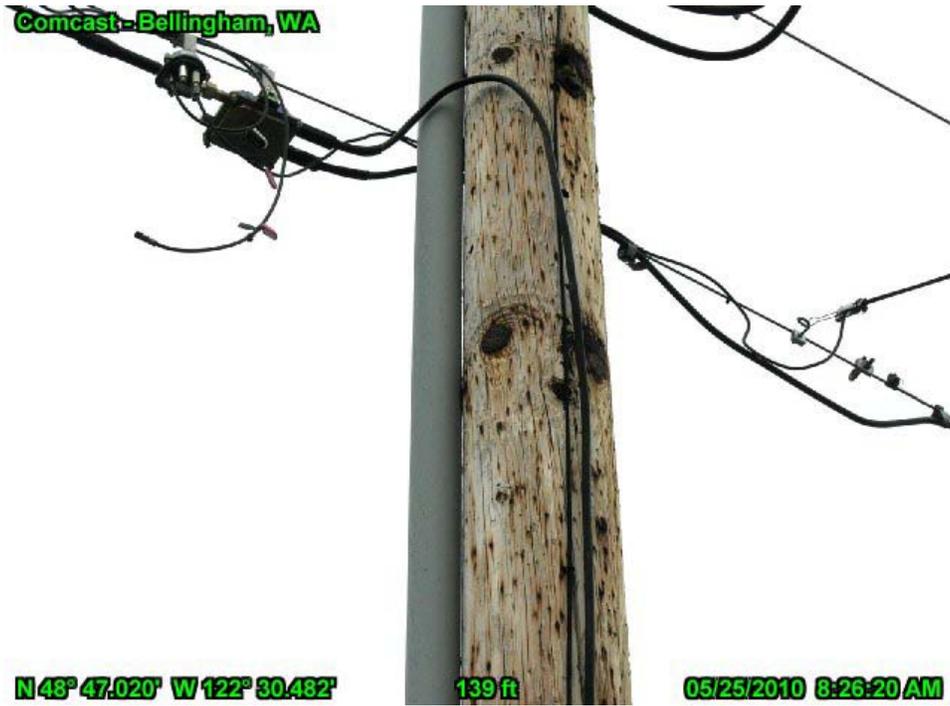
3624 Home Drive
Cable riser not attached to pole.

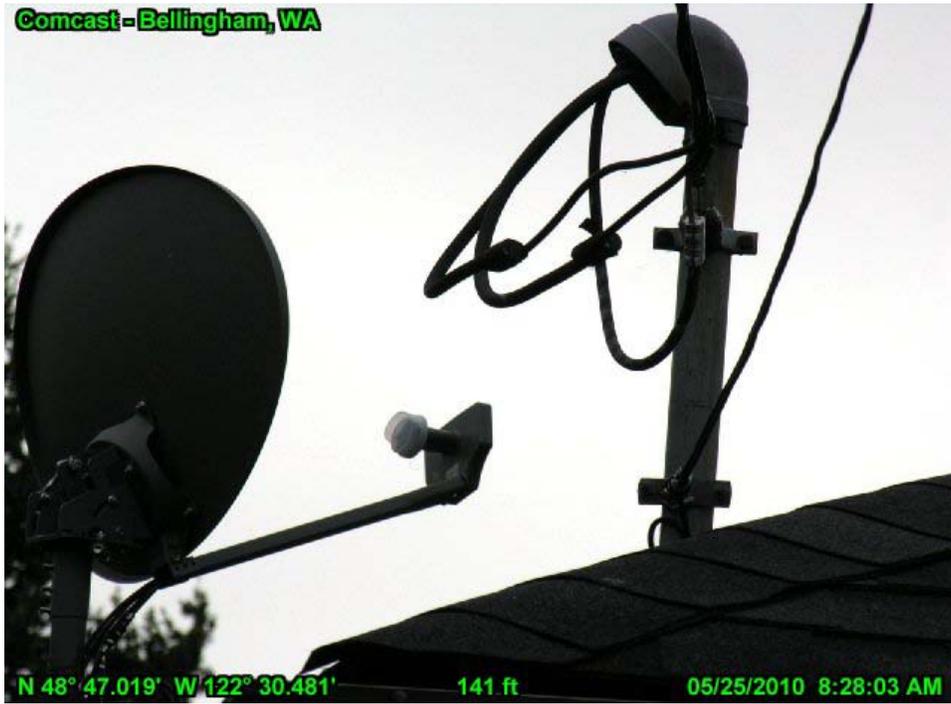
3624 Home Drive.
Cable drop attached to the power mast.

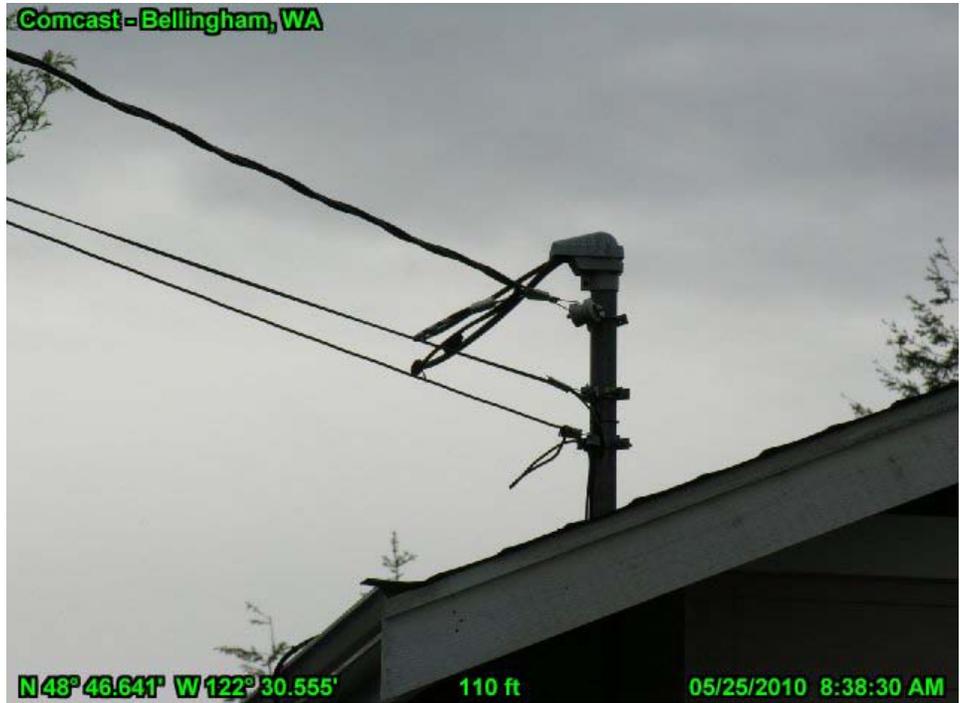
2904 Cherrywood Avenue
Cable drop attached to the power mast.
