Physical Plant Inspection of Comcast Communications in the City of Bellingham, Washington

May 2010

Inspected by
Kramer.Firm, Inc.

**PHYSICAL PLANT SAFETY INSPECTION
OF COMCAST CABLE COMMUNICATIONS
IN THE CITY OF BELLINGHAM, WASHINGTON**

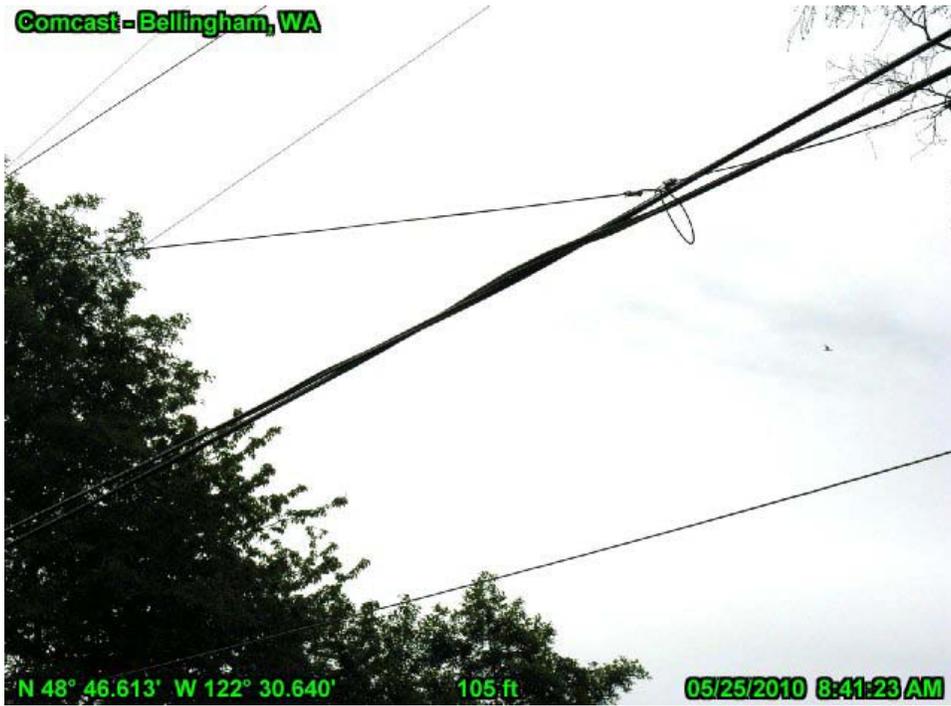
3017 Cottonwood Avenue
Telephone cable wrapped around CATV Cable.

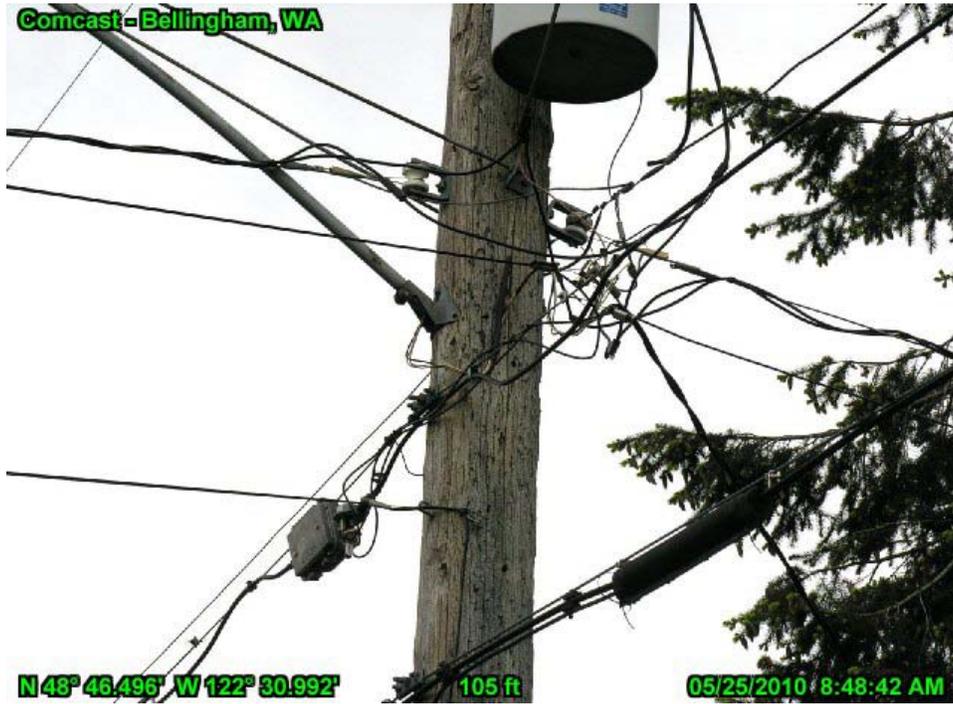
3224 Laurelwood Avenue

Cable strand mounted too close to power transformer and drops.

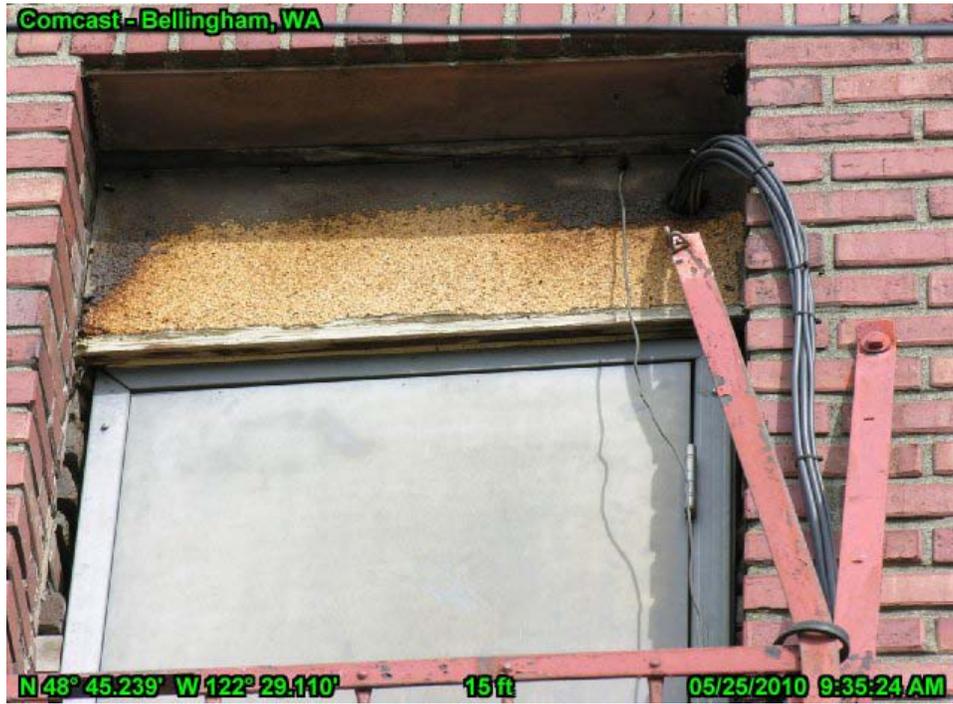
721-1/2 Holly Street.

Multiple drops enter building without being grounded.

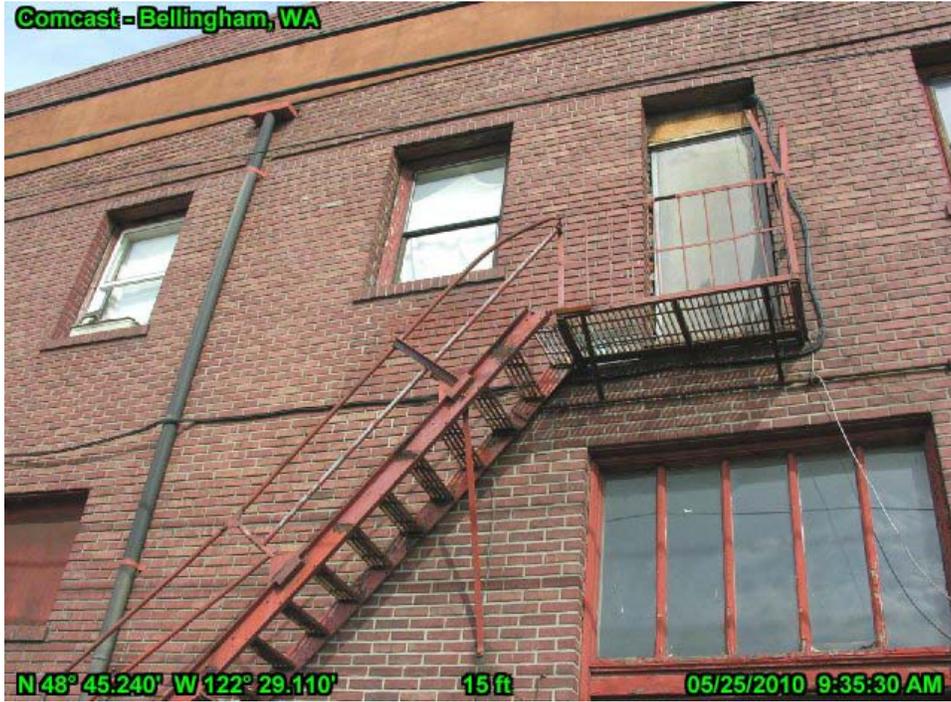
721-1/2 Holly Street

Multiple drops enter building without being grounded.

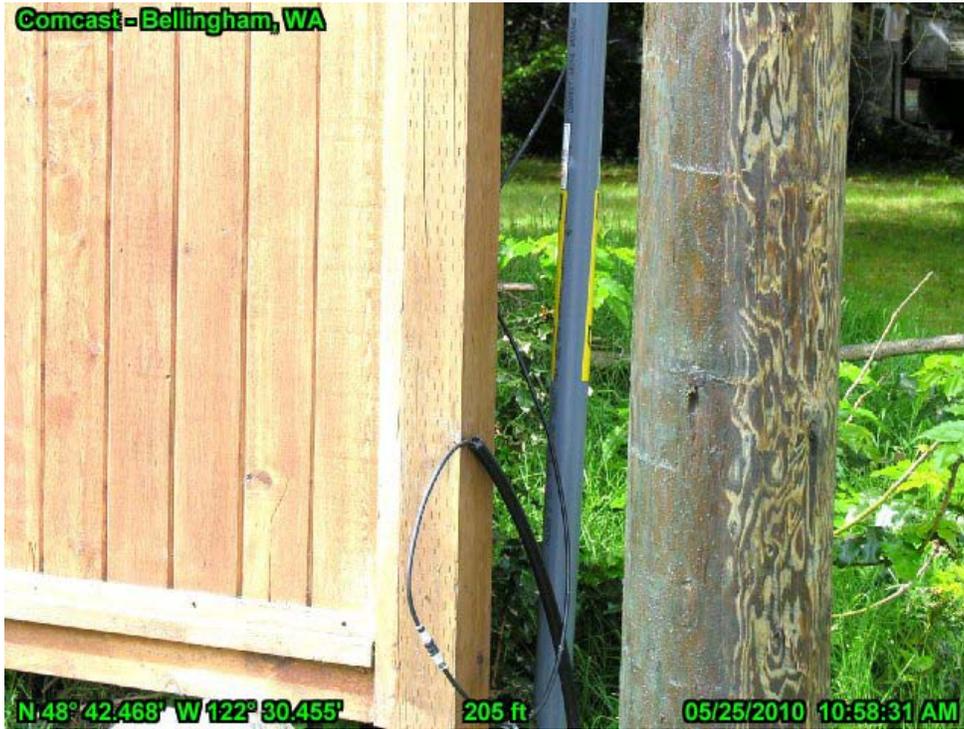
510 Everglade Road
Drop riser not secured to pole.

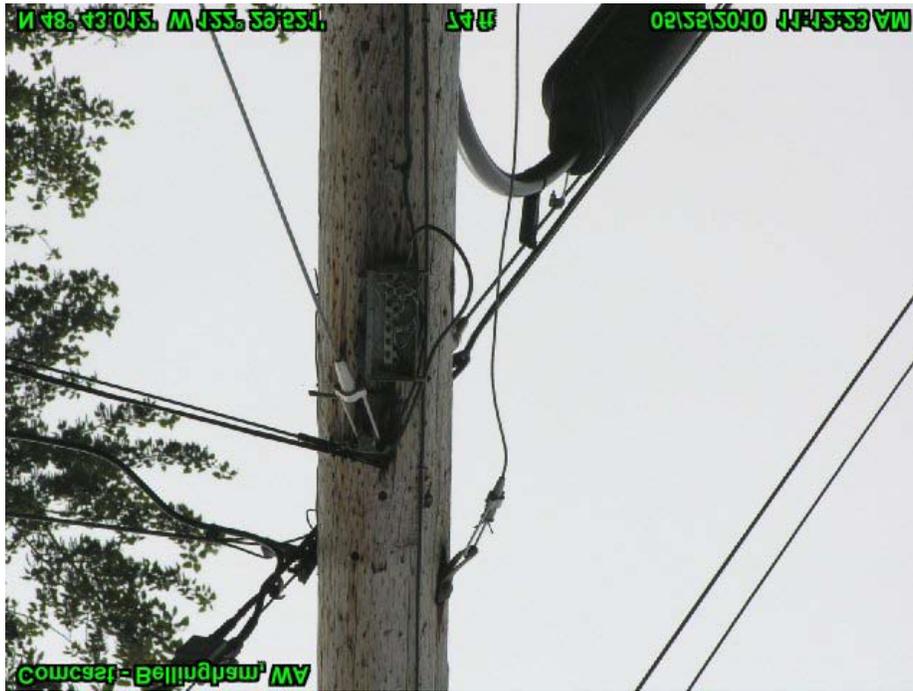
20th and Wilson.
Down guy not anchored. Pole leaning.

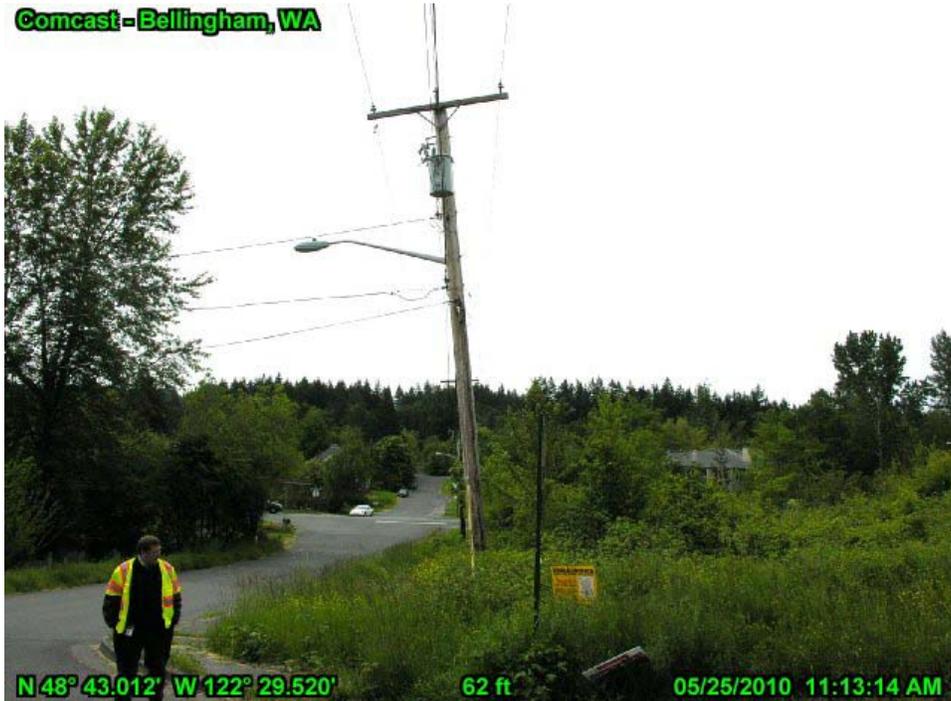
20th and Wilson Rd.
Down guy not anchored. Pole leaning.

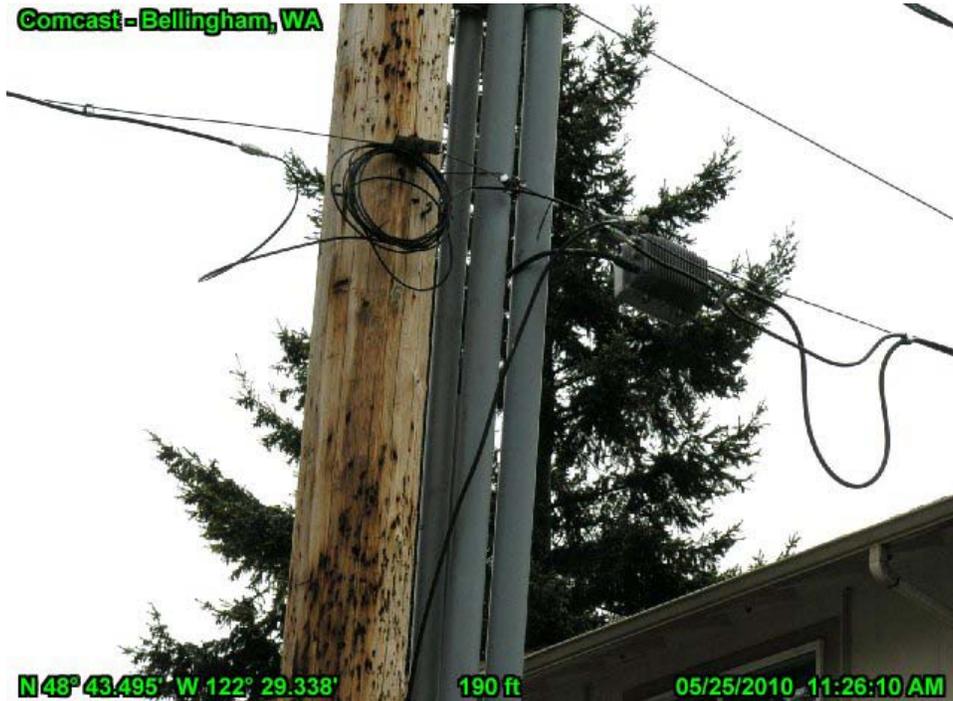
917 to 927 - 22nd Street. Damaged cable sections. Broken cables, lashing, taps.

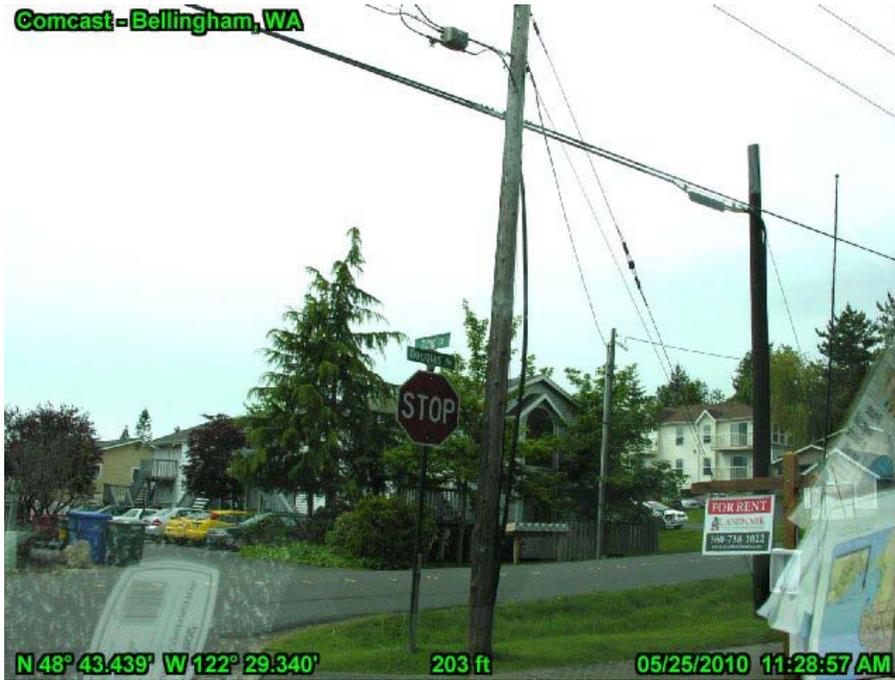
22nd and Douglas
PVC riser goes up the pole with no attachments.

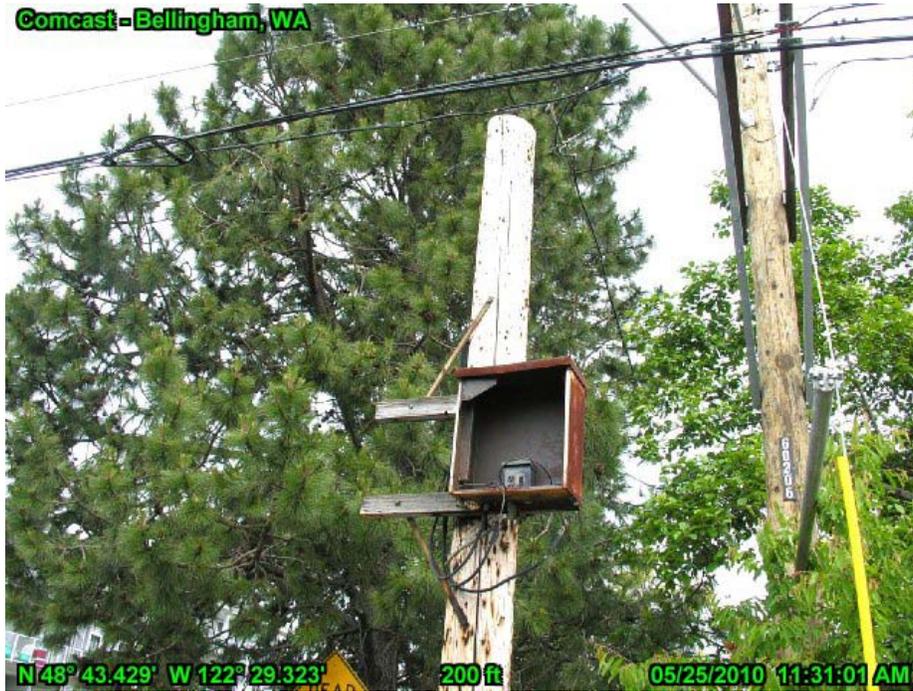
Corner of 22nd and Douglas
Apparently abandoned amplifier can and pole stub.

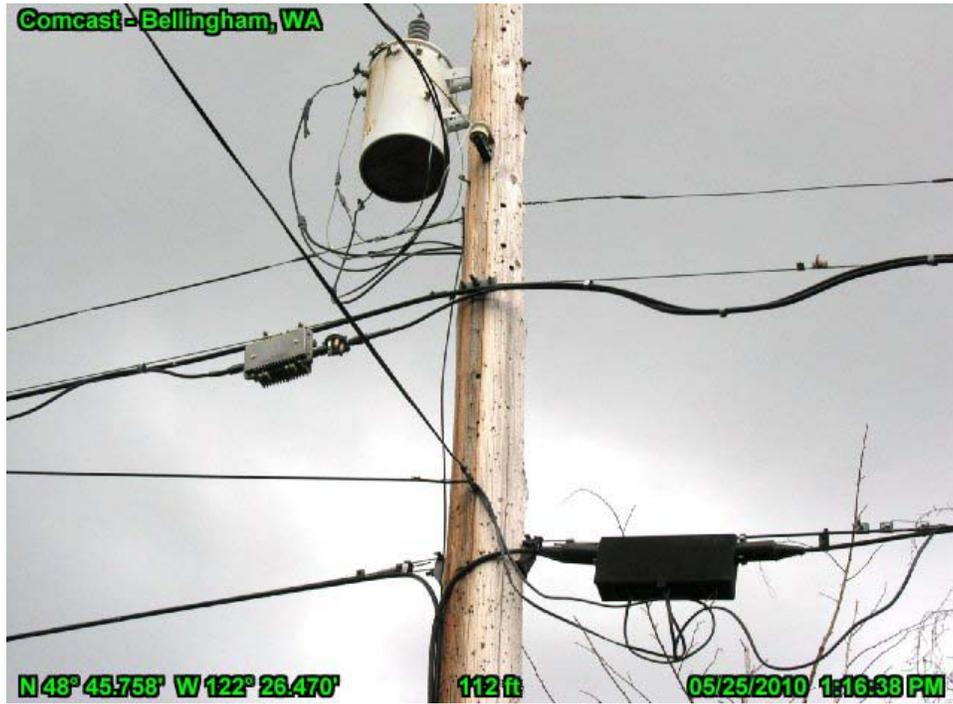
Superior and Alabama Streets.
Cable attachment too close to power.

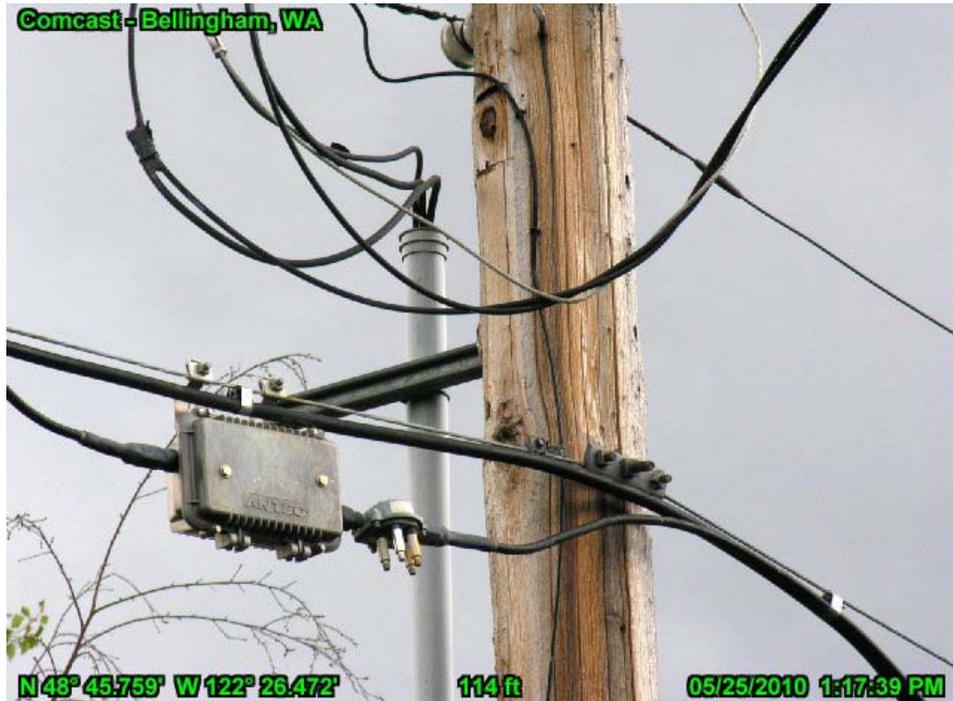
Superior Street just South of Alabama.
Cable strand mounted too close to power.

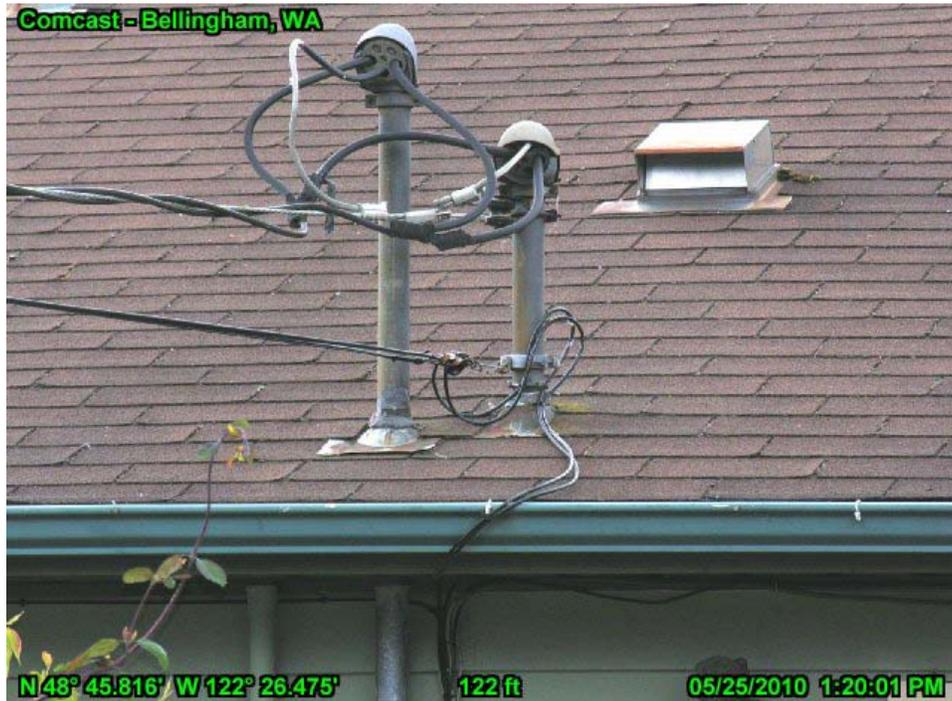
Comcast installers frequently make use of the electrical utility power riser above the roof for making cable drop attachments. The National Electrical Code in Section 820-10(C) prohibits the attachment of any cable drops to an above-the-roof mast containing electrical conductors. This is the most significant and wide-spread violation observed during the inspection throughout all portions of the Bellingham franchise area.

2517 Superior Street
Cable drop attached to the power mast.

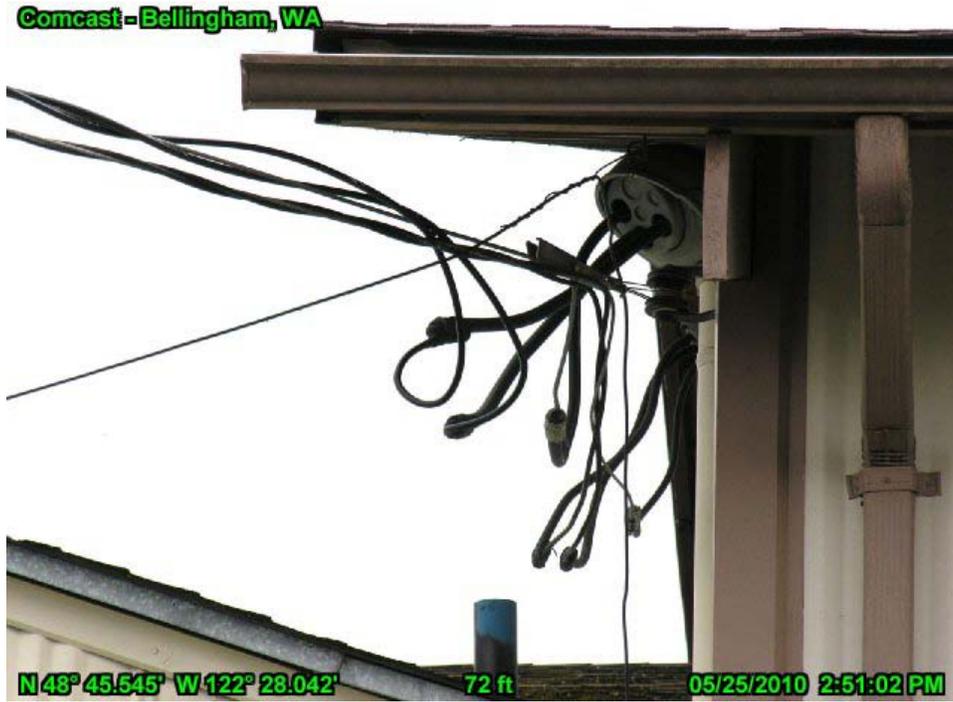
2138 Virginia Street
Old 59 drop tangled in power at the house.

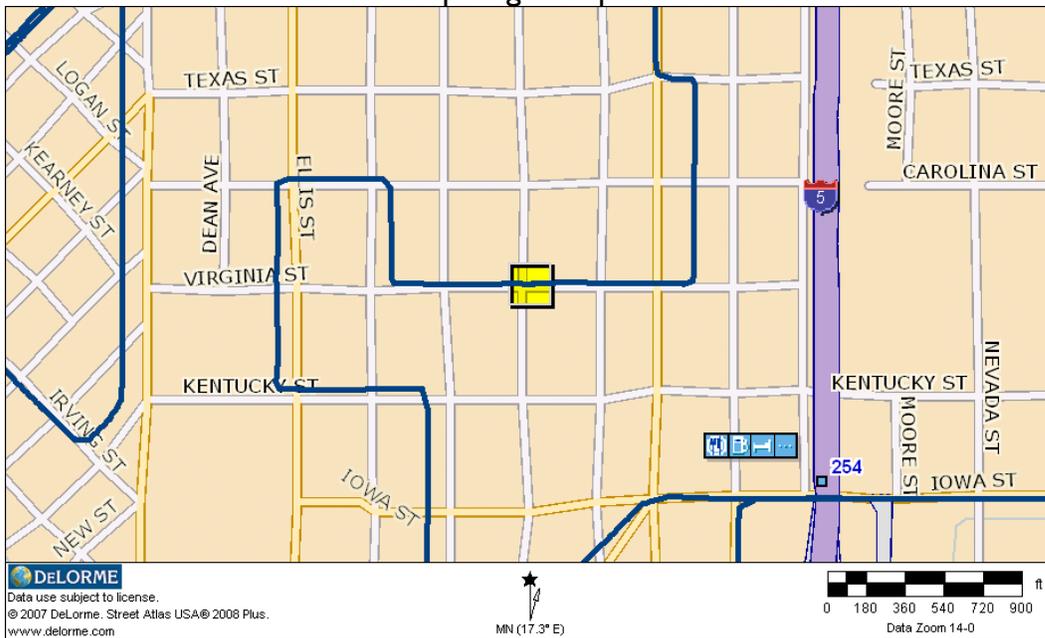
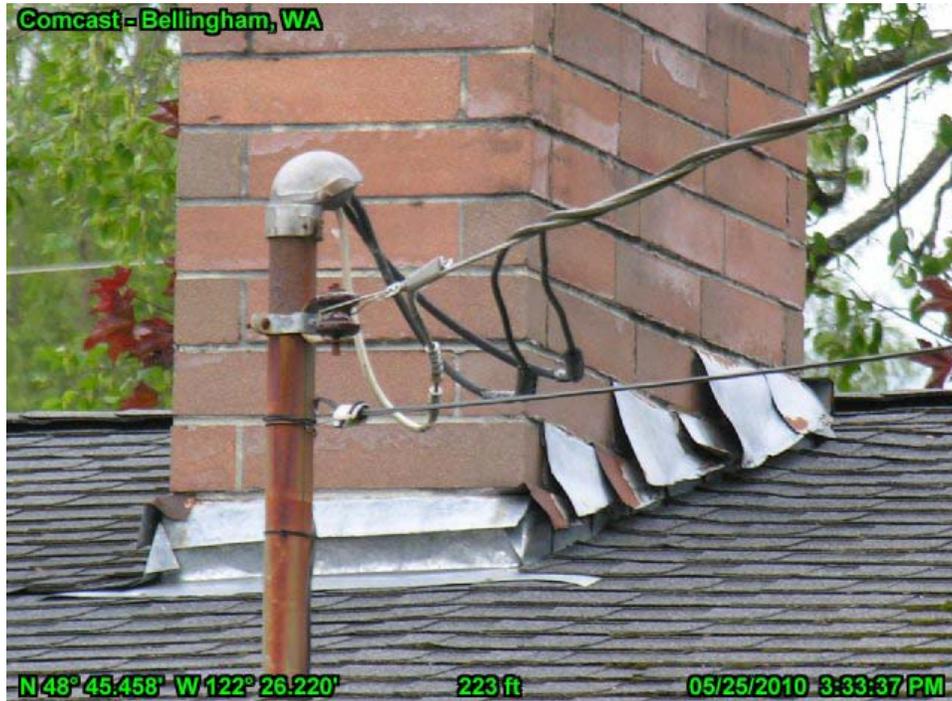
8104 St. Clair Street Cable drop attached to the power mast above the roof. Less than 1 foot clearance from power.

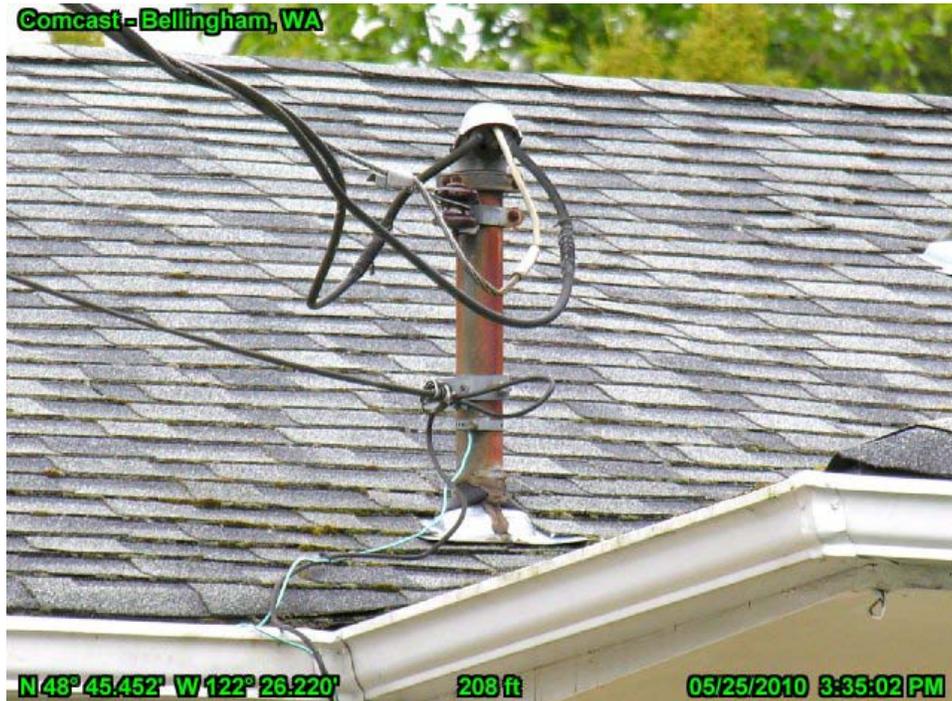
2032 St. Clair Street Cable drop attached to the power mast. Grounded to the cable mast above the roof line. Less than 1 foot clearance from power.

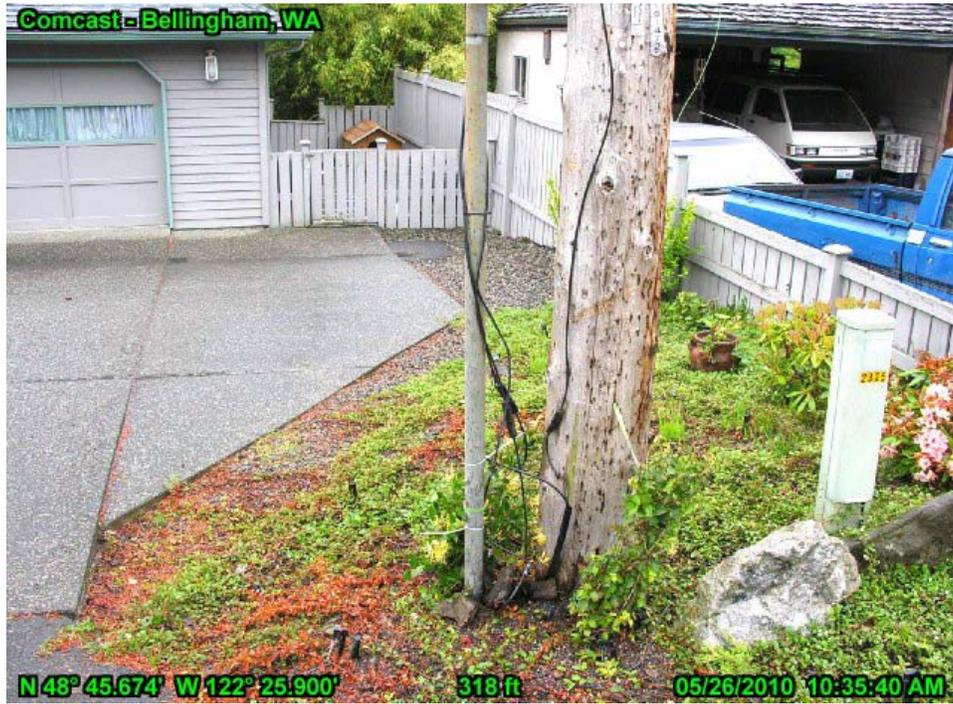
2325 Vining Street. Cable drop risers secured to power conduit

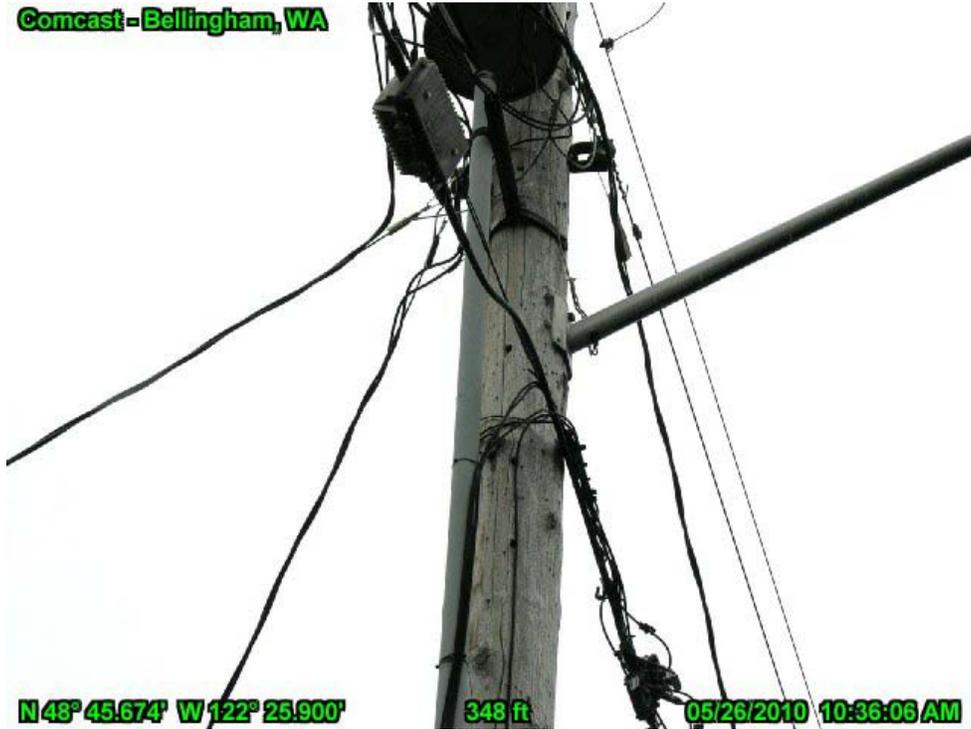
2325 Vining Street. Cable drop risers secured to power riser conduit.

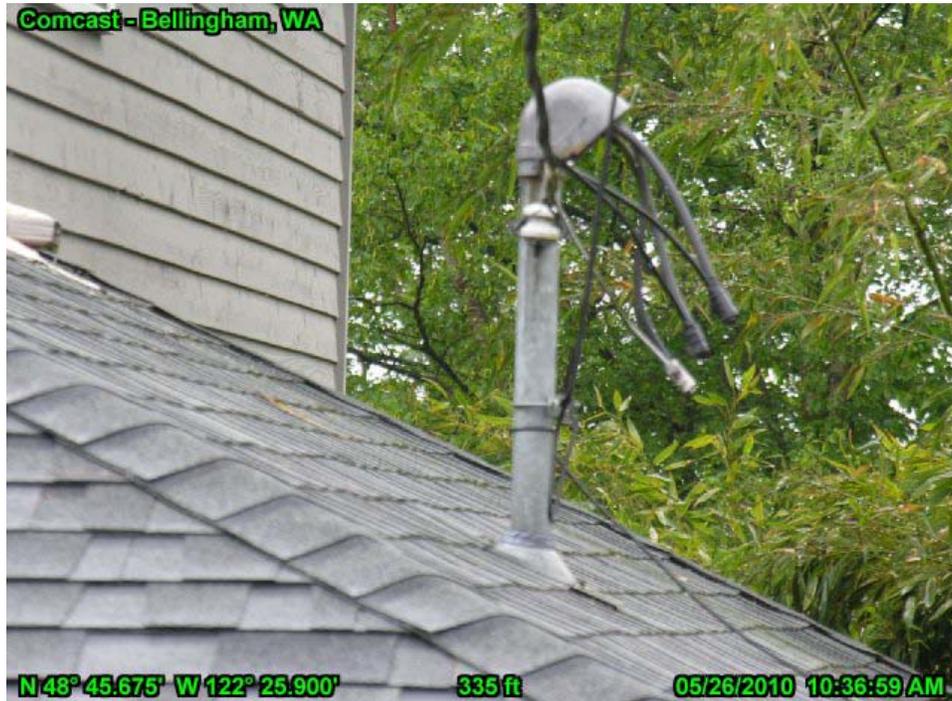
2325 Vining Street. Cable drop attached to the power mast.
