POST POINT WASTEWATER TREATMENT PLANT Pipe Hanger Failure Investigation

Bellingham, Washington

December 7, 2017

WJE No. 2017.3338

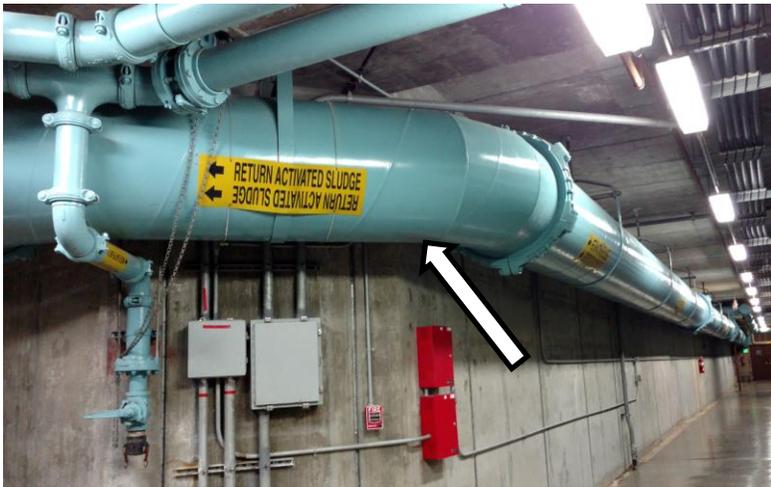
Figure 1. Corridor with 30 inch diameter RAS Pipe (arrow) suspended from ceiling (lid). Photo provided to WJE by Carollo.

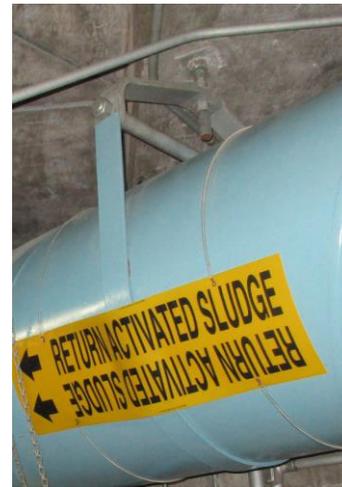
Figure 2. Typical pipe hanger. Photo provided to WJE by Carollo.

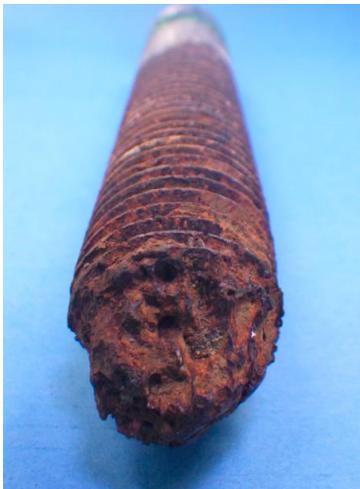
Corrosion that occurred caused loss of cross sectional area of the threaded rod, nut, and nut to rod interface. All thirteen failed rods observed in the storage yard, i.e., 100 percent of observed rods, exhibited corrosion and section loss at their tip where they were connected to a nut. In addition to the top of the rod corroding and diminishing in cross section (Figure 22), the nuts connected to the rod were also observed to have diminished cross section due to corrosion (Figure 23). All three nuts observed, i.e., 100 percent of observed nuts, including the nut recovered from Pothole No. 2 (Figure 21) and nuts from unfailed rods at Pothole Nos. 3 and 4, had corrosion and section loss (Figure 17 and 18).

Figure 22. Corroded top of threaded rod with loss of cross section from Rod Sample C.

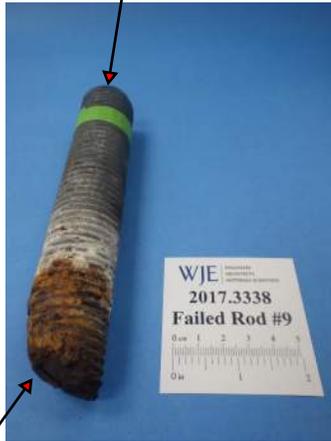
Failed Rod 9_A

Corroded end of rod with section loss was tip in contact with soil.

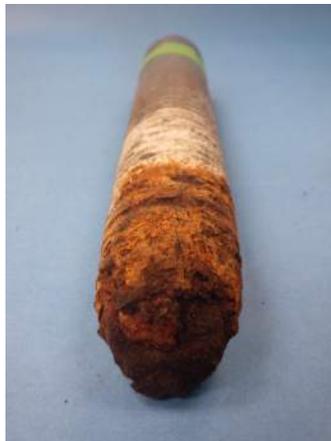
Failed Rod 9_C

Commentary note: corroded end rod was tip in contact with soil.

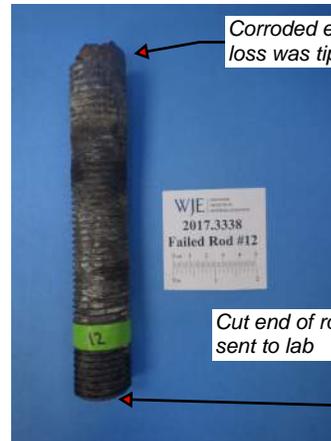
Failed Rod 12_A

Commentary note: corroded end rod was tip in contact with soil.

Corroded end of rod with section loss was tip in contact with soil.

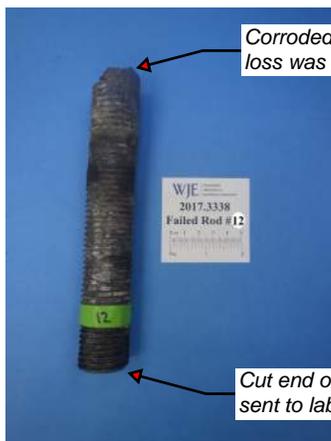
Failed Rod 12_AA-corrected

Corroded end of rod with section loss was tip in contact with soil.

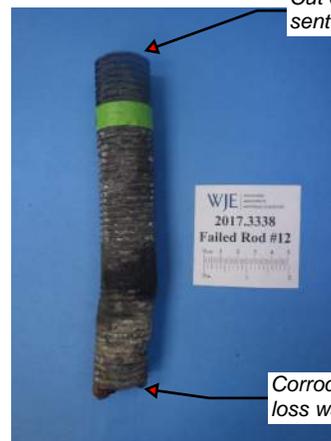
Failed Rod 12_B

Corroded end of rod with section loss was tip in contact with soil.

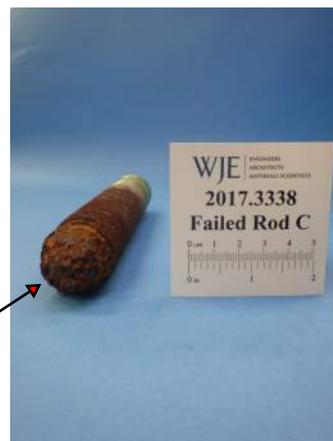
Failed Rod C_C

Corroded end of rod with section loss was tip in contact with soil.

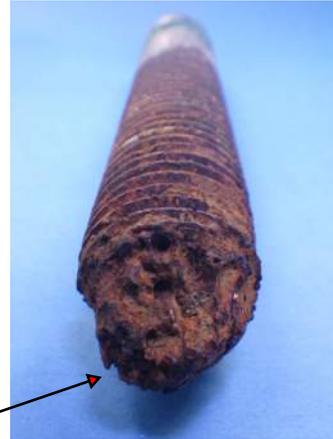
Failed Rod C_E

Corroded end of rod with section loss was tip in contact with soil.

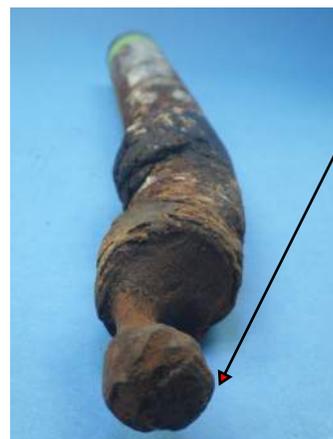
Failed Rod E_D

Corroded end of rod with section loss was tip in contact with soil.

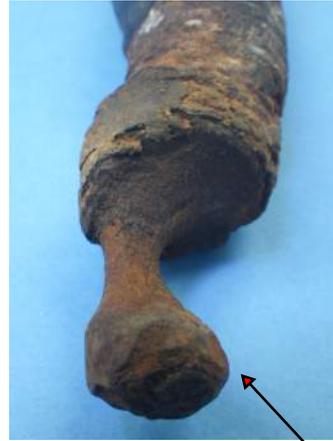
Failed Rod E_F

*Corroded end of rod
with section loss was
tip in contact with soil.*

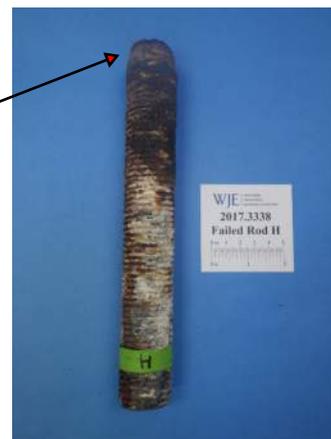
Failed Rod H_A

*Corroded end of rod
with section loss was
tip in contact with soil.*

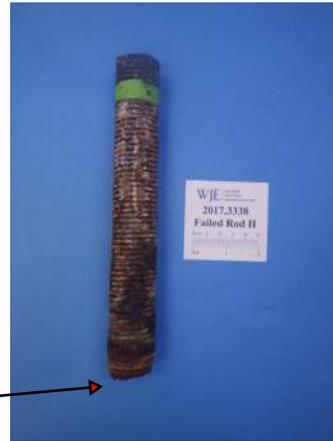
Failed Rod H_C

Corroded end of rod with section loss was tip in contact with soil.

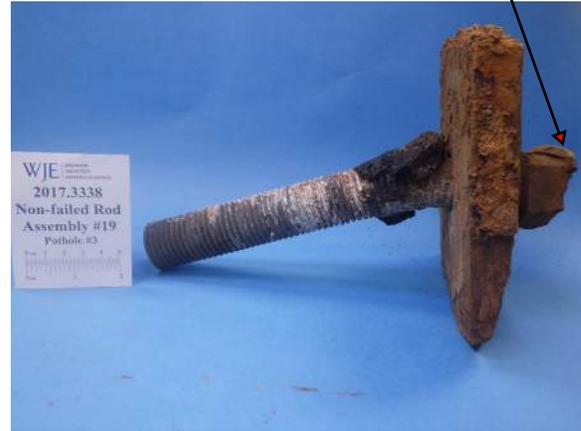
Non-failed Rod Assembly 19

Corroded end of rod with section loss was tip in contact with soil.
