APPENDIX

Date: January 22, 2020

Subject: City of Bellingham Reservoirs Inspection and Repairs
Marietta Site

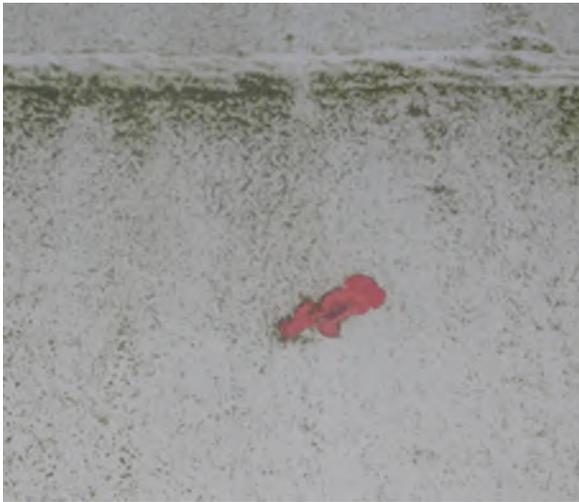
Top coat damage on side wall

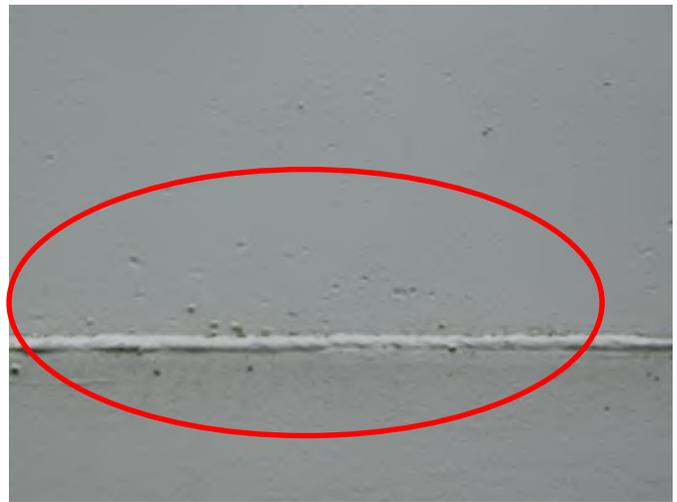
Small fabrication dimples and weld splatter

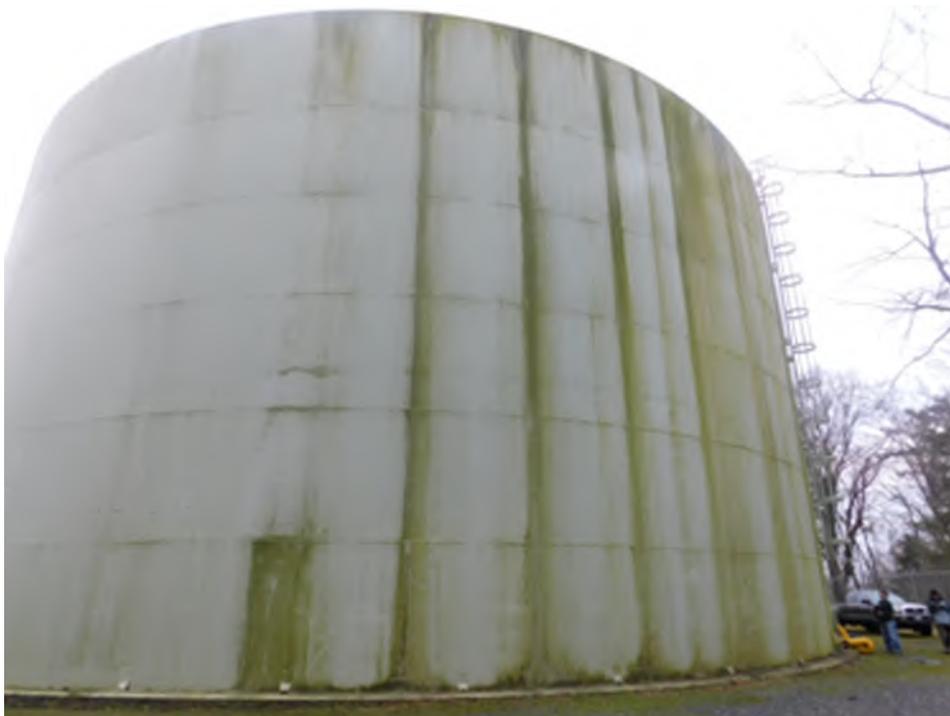
Heavy organic material growth

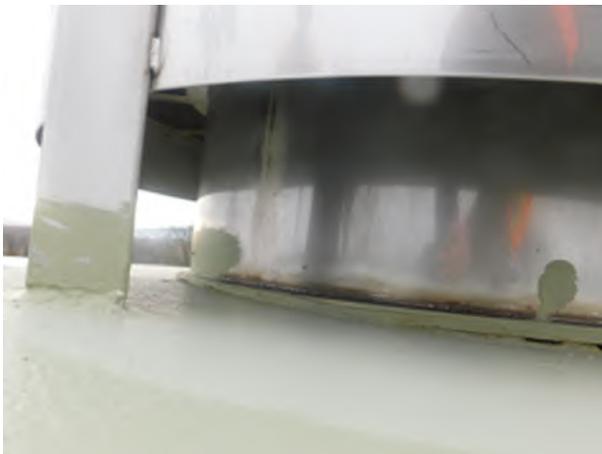
The roof vent and collar are constructed of aluminum. There is no evidence of corrosion or rust staining on this equipment.

Aluminum vent, no corrosion

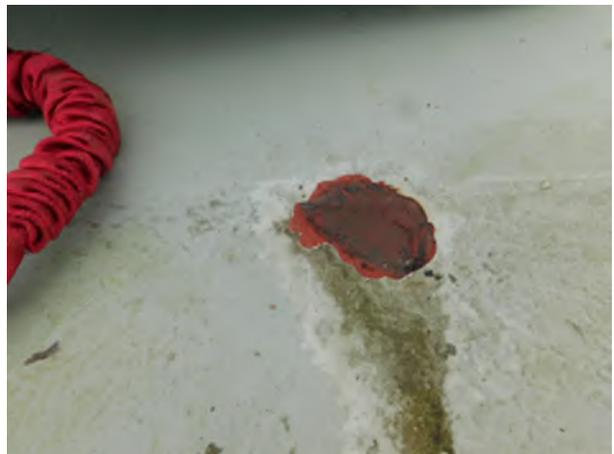
Coating failure on roof near access hatch

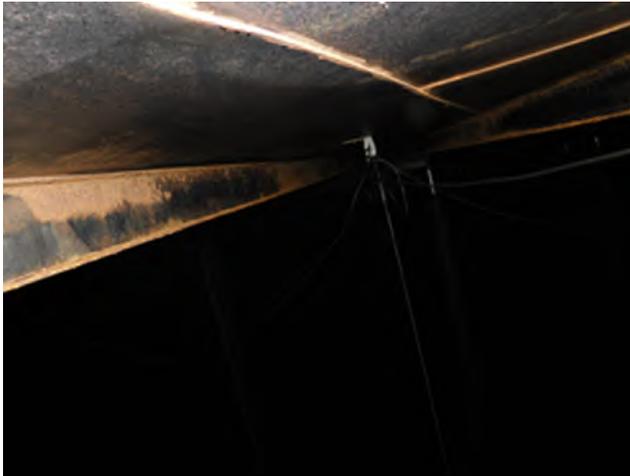
Overlapped roof plate, not seal welded

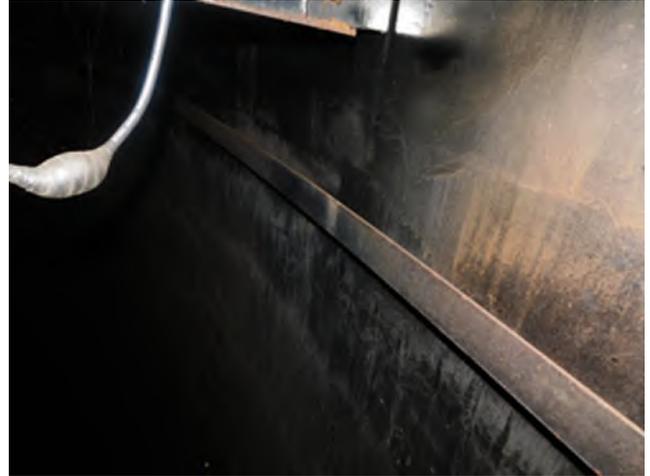
Painters rail, no corrosion on edges

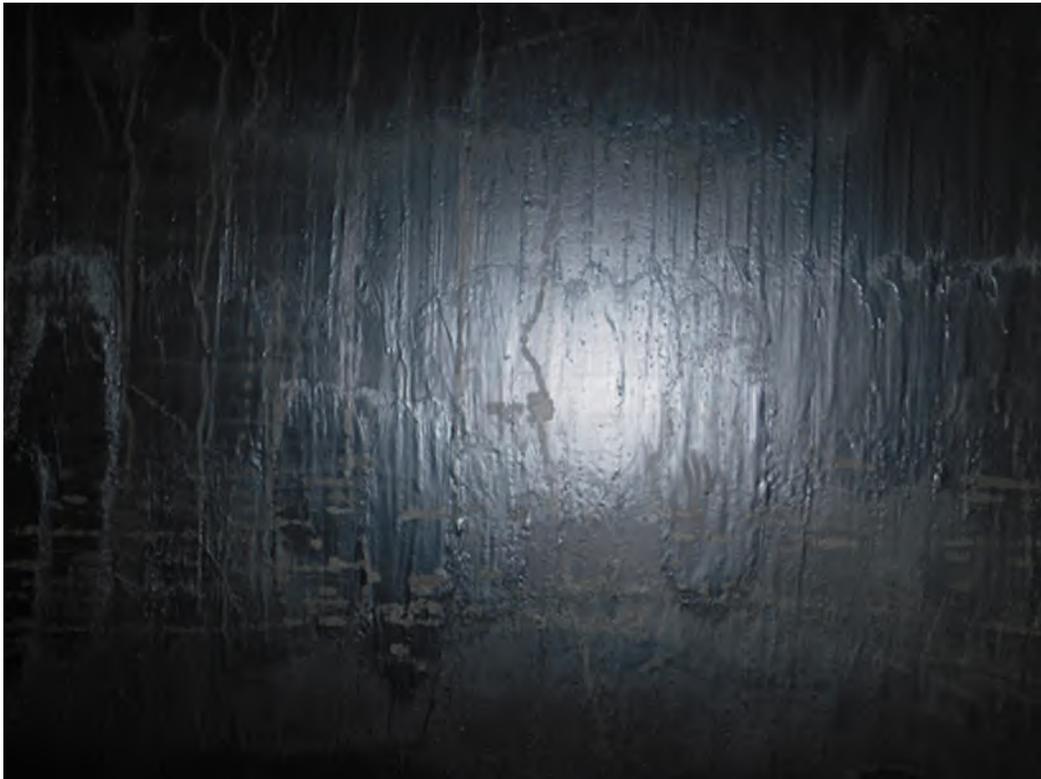
Floor – flood coated

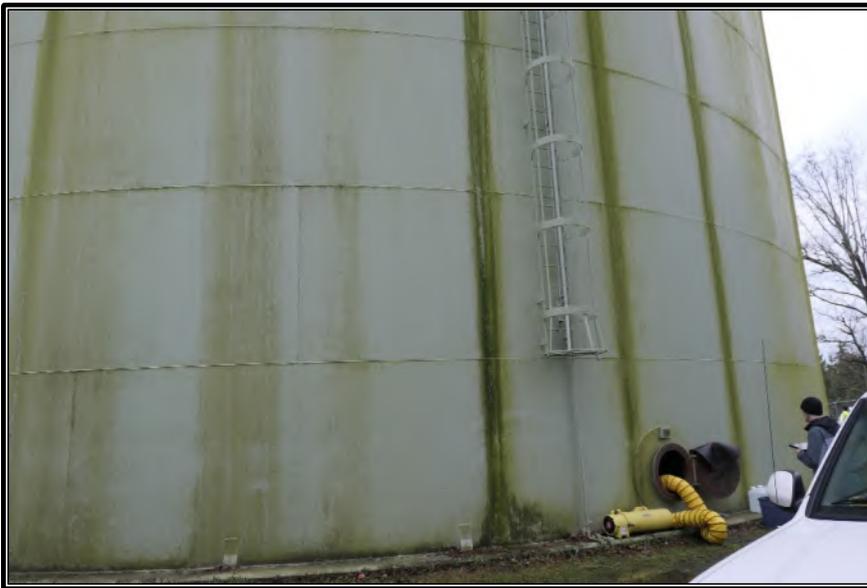
Figure 2-8: Marietta Reservoir – Access Ladder and Wall Staining

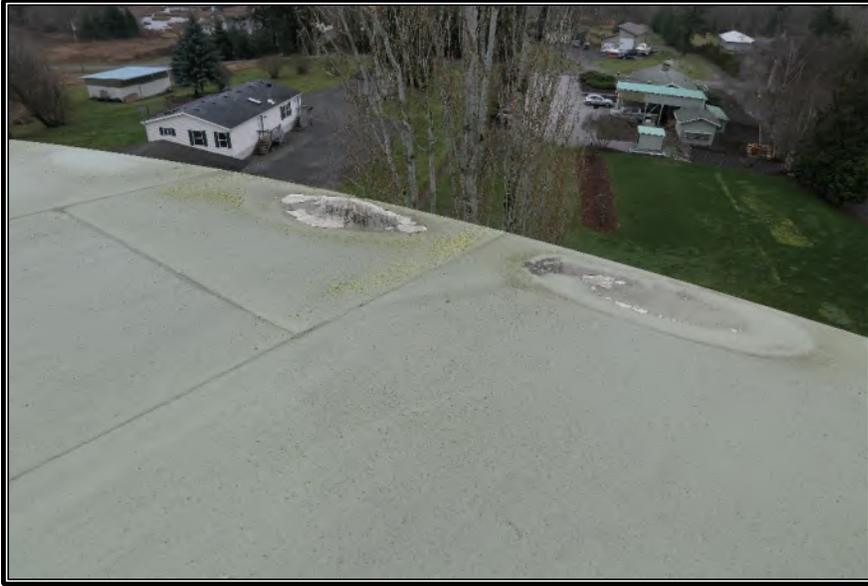
Figure 2-11: Marietta Reservoir – Roof - Areas of ponding at edge depressions

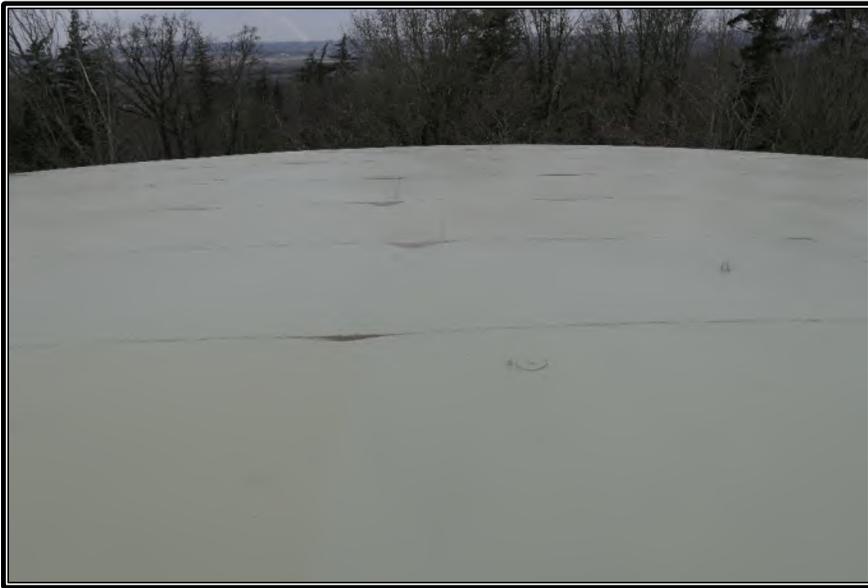
Figure 2-12: Marietta Reservoir – Roof - Areas of water retention due to plate lapping

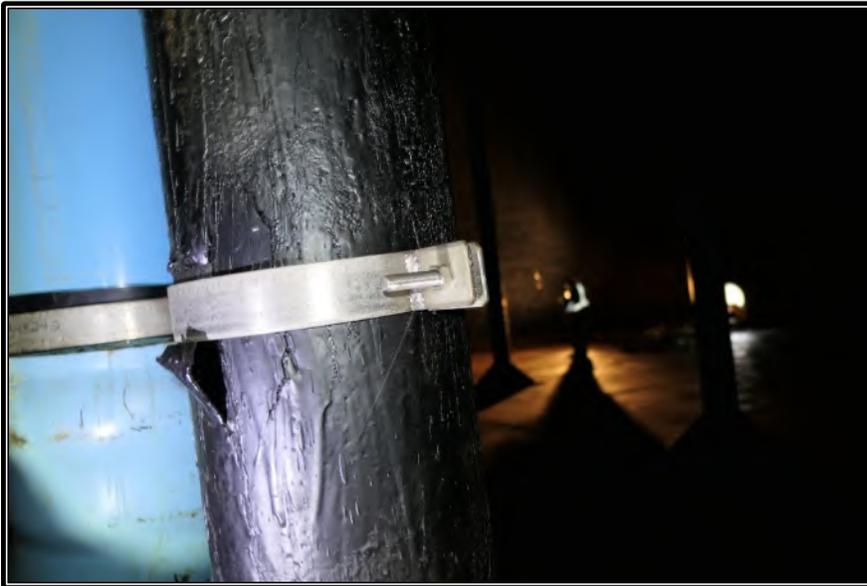
Figure 2-18: Marietta Reservoir – Failure of coal-tar coating on column due to inlet pipe attachment

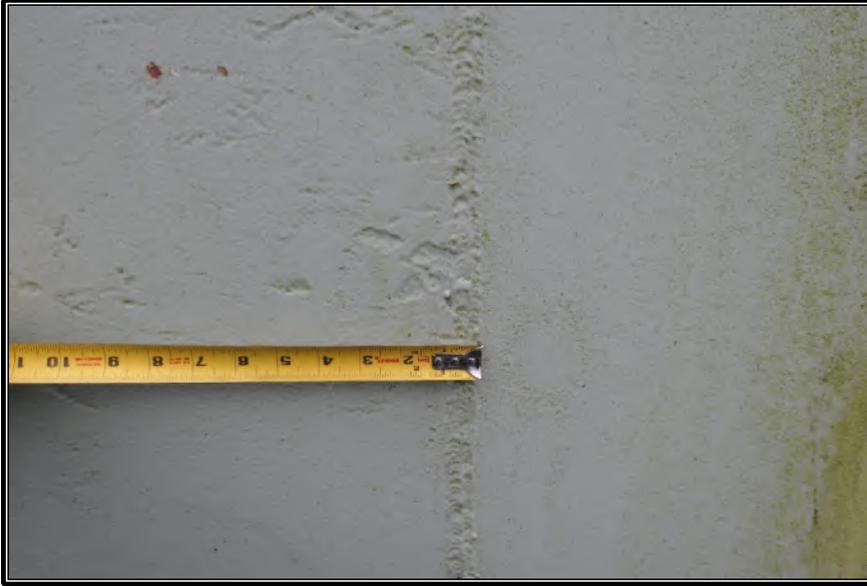
Figure 2-21: Marietta Reservoir – Exterior shell – Non-smooth well line and pockmarking on plate surface

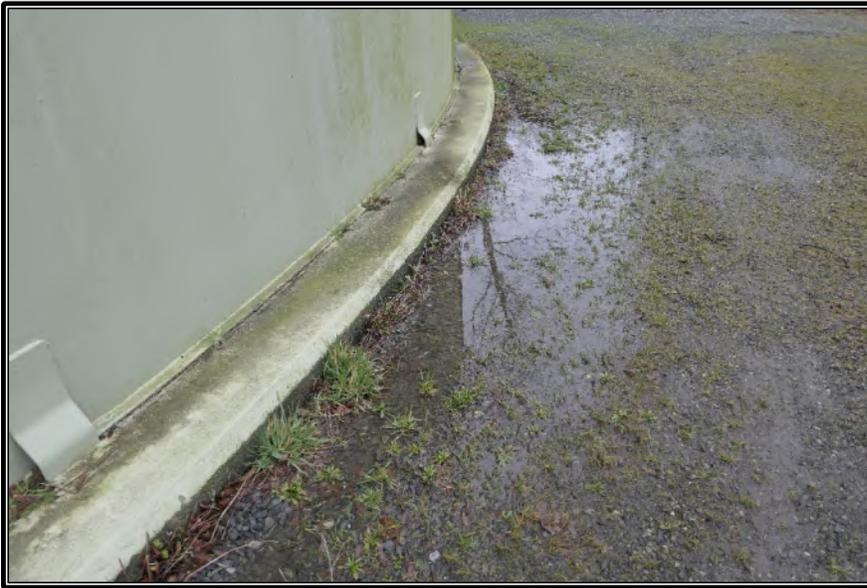
Figure 2-22: Marietta Reservoir – Standing water along foundation edge

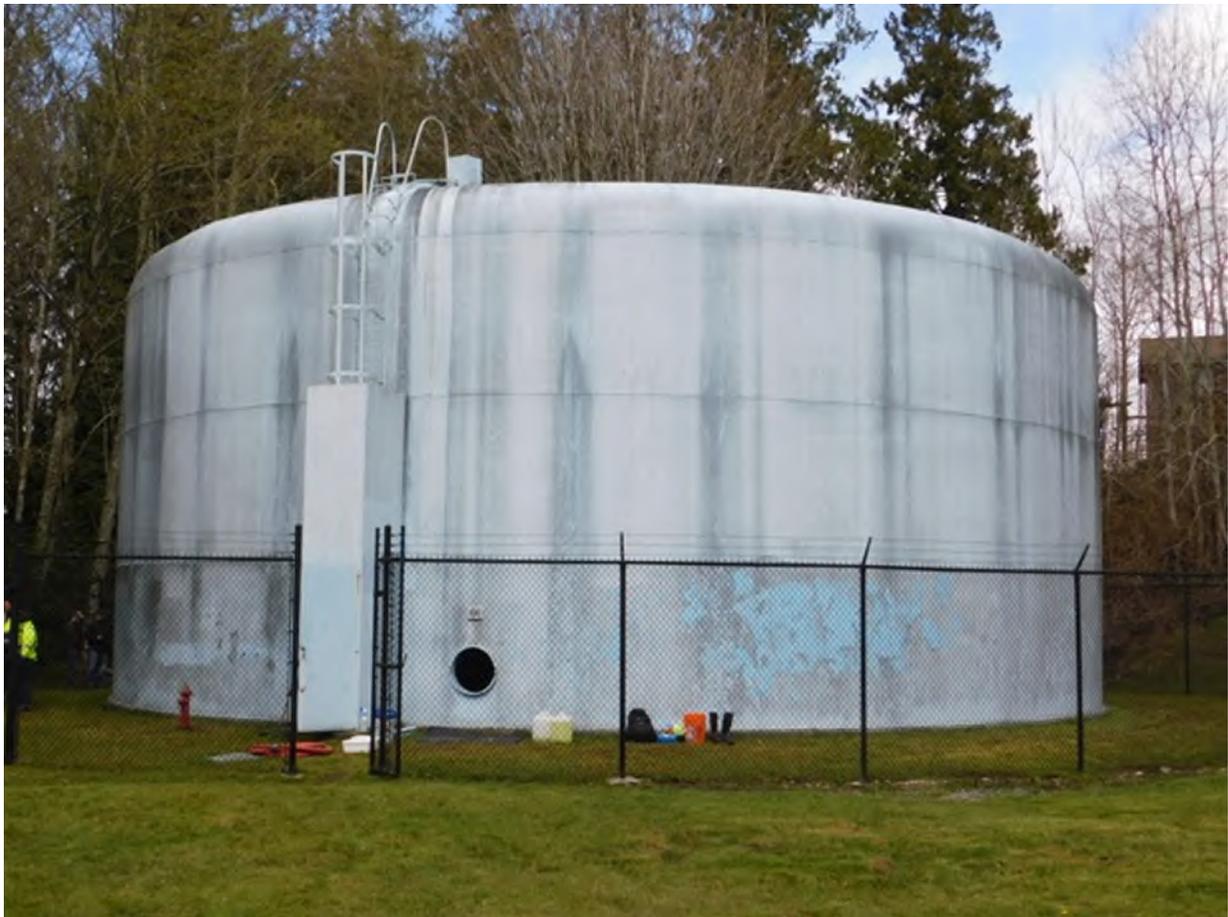
Lake Padden Tank

The tank chime is in good condition with only minor surface rust at areas of coating loss. The concrete grouting between the tank chime and the ring wall has failed in several locations and should be repaired

The roof welds are in good condition and are oriented on the steel plates such that rain water will run off as opposed to collect at the lap joint areas. No visible signs of pitting are present.

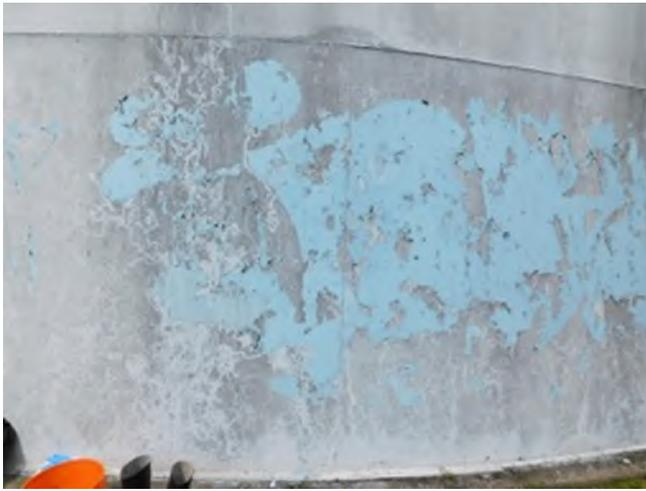
Missing top coat on sidewall

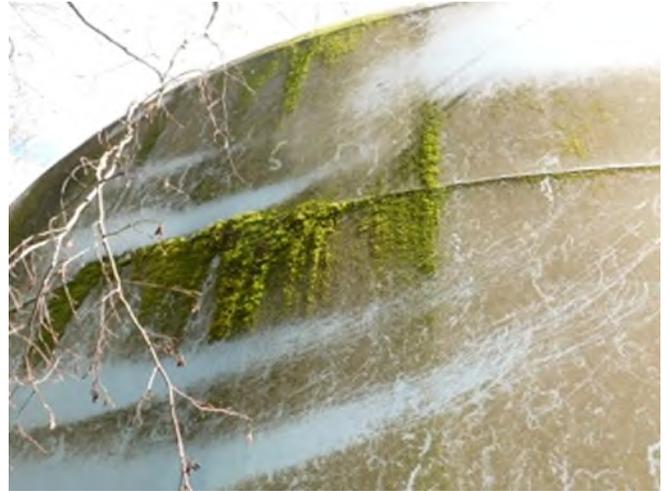
Organic growth on sidewall

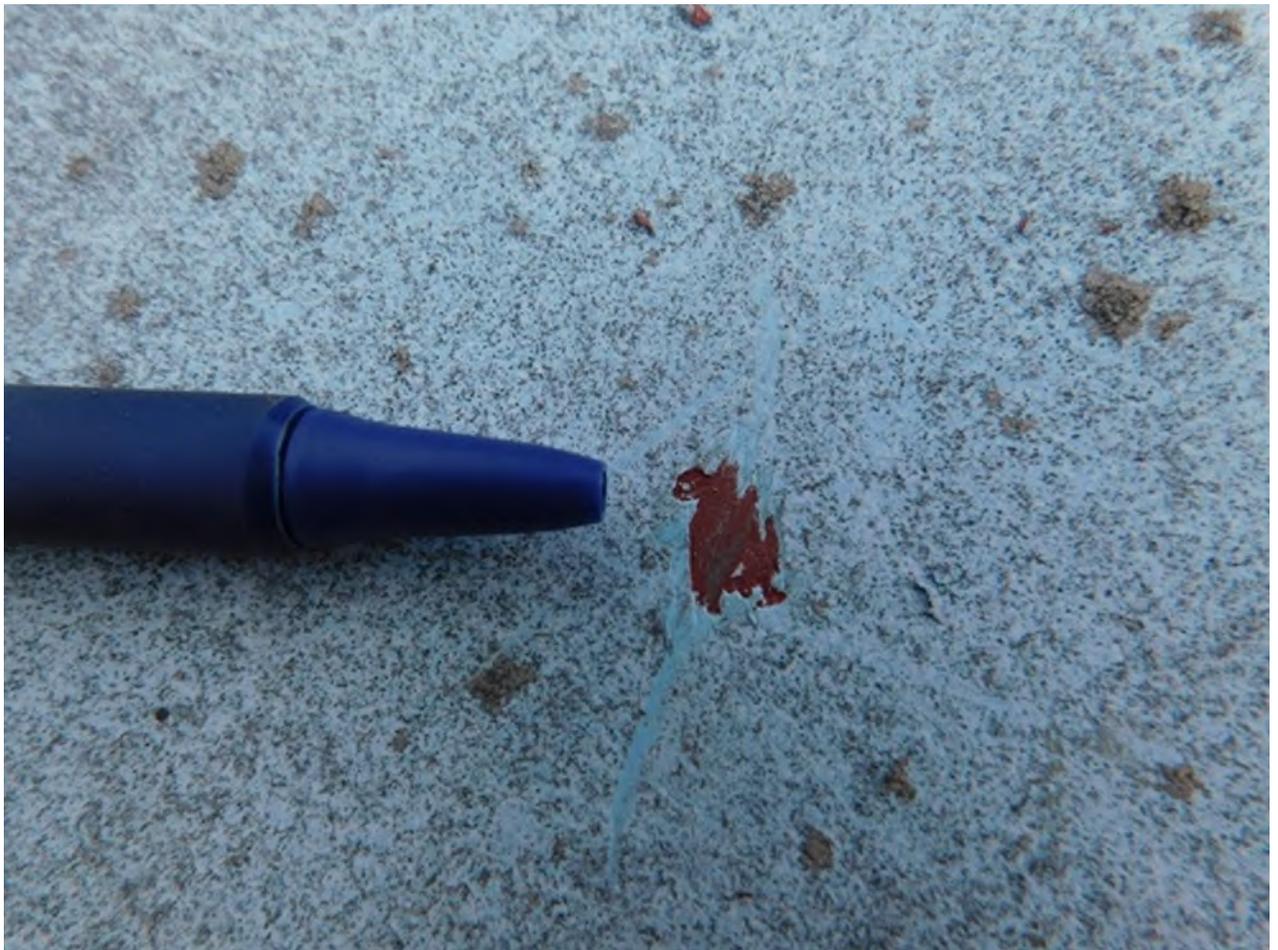
Area of top coat easily scraped off with a knife

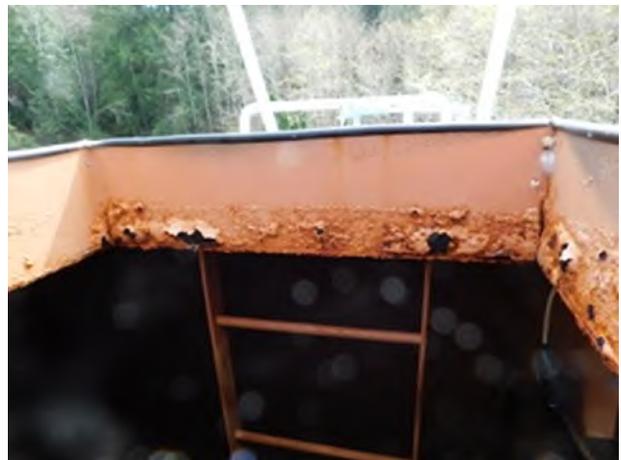
Coating failure on roof access hatch

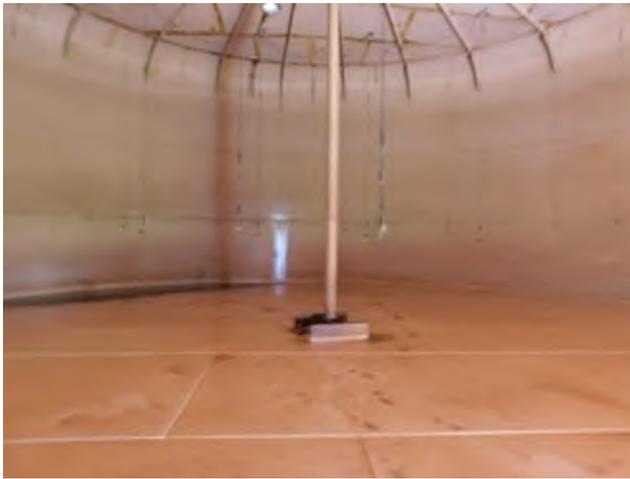
The roof shows rust staining at all roof plate overlaps, typical for these non-seal welded areas. The structural components surrounding the access hatch and areas above the water level are experiencing general surface corrosion and crevice corrosion at steel overlap areas. Exposed steel locations below the waterline are in very good condition with no observed pitting. This is due to the operation of the cathodic protection system.

Tank interior floor, sidewalls and center column

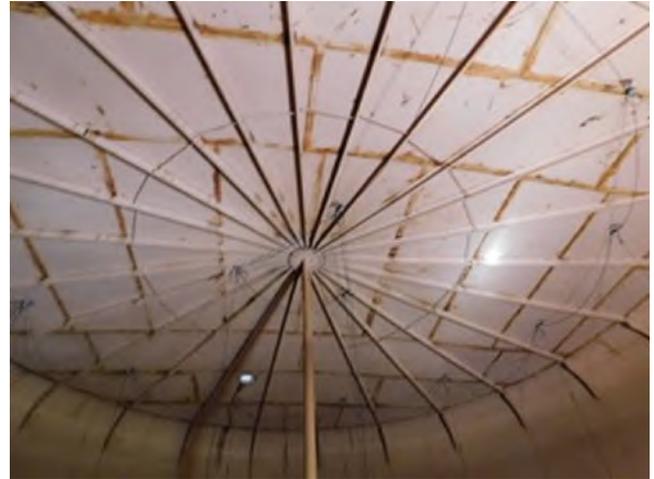
Interior roof, rust staining at all non-seal welded overlaps

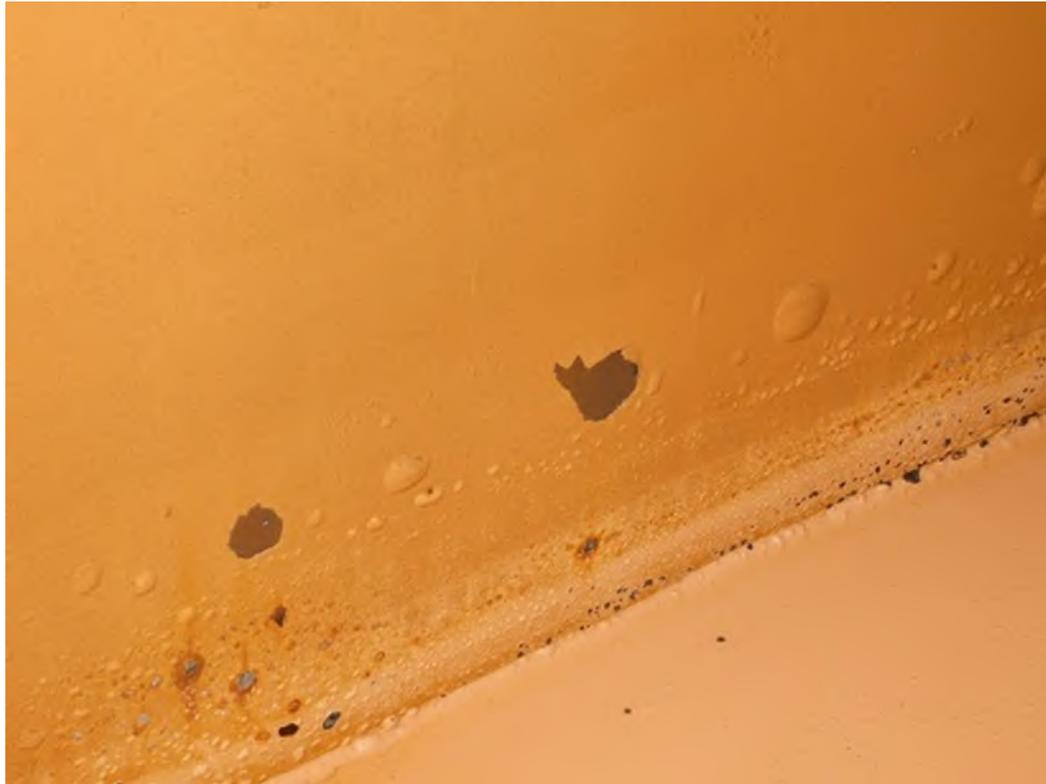
Sidewall – blistering on the first 4” of coating, typical around entire circumference

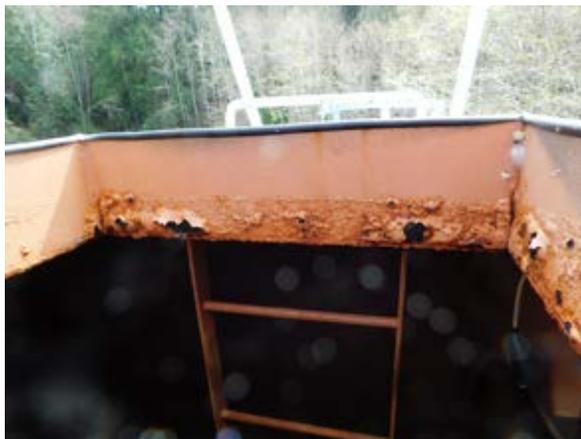
Coating loss and corrosion at roof hatch

As shown in the above pictures, there is a significant amount of coating losses and crevice corrosion at the non-seal welded locations. Without repair, this condition will continue resulting in significant damage to the steel, particularly in-between roof plates and the overlap areas between the roof beams and steel roof plate.

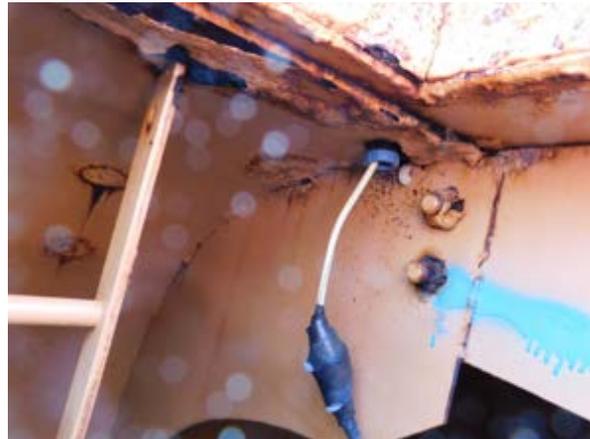
Corrosion at roof plate overlap near access hatch

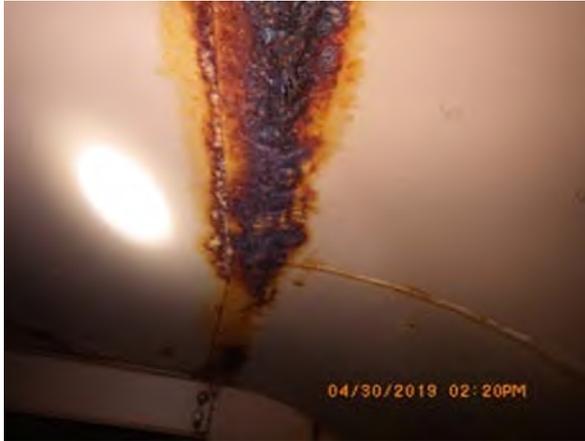
Crevice corrosion at knuckle/roof plate

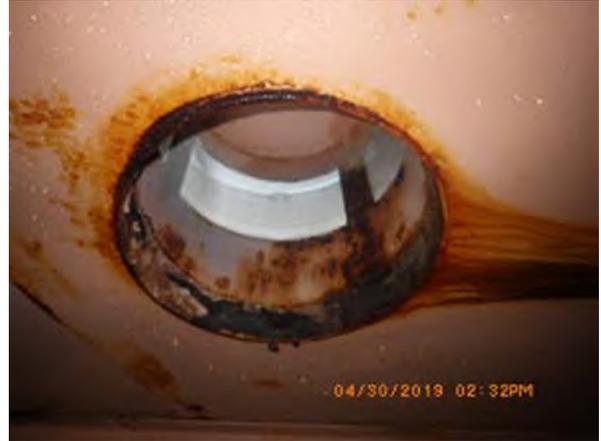
Corrosion around vent opening

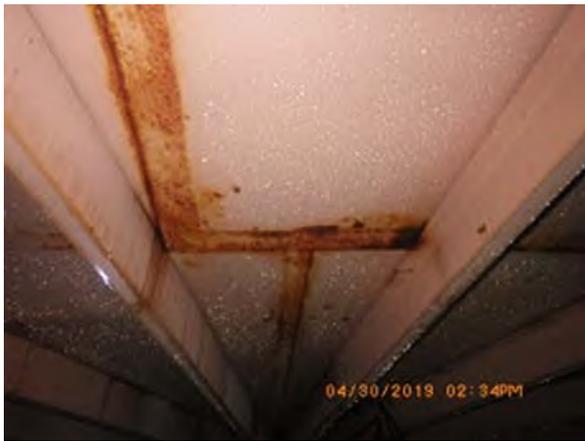
Coating loss at roof plate overlap

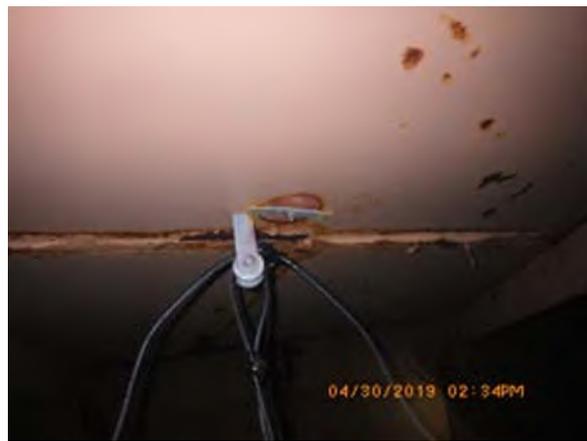
Corrosion and coating loss at anode hanger

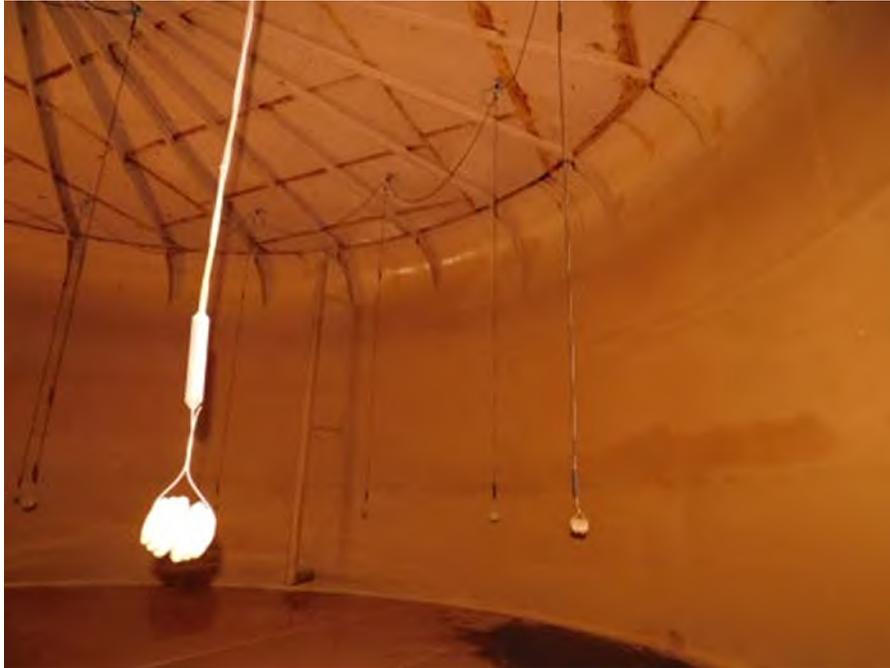
Mixed metal oxide anode strings suspended from roof

Results of the rectifier checkout and potential measurements are included in Tables 2 and 3 at the end of this report. Initial testing showed that corrosion protection criteria was not being

met at all tested locations. The rectifier output was then increased to provide additional current. After adjustment, the collected data indicates that corrosion control criteria is being met at all locations with the exception of the bottom 4-feet of the tank. After an appropriate polarization period, typical 24 – 48 hours, the tank should meet criteria at all locations.

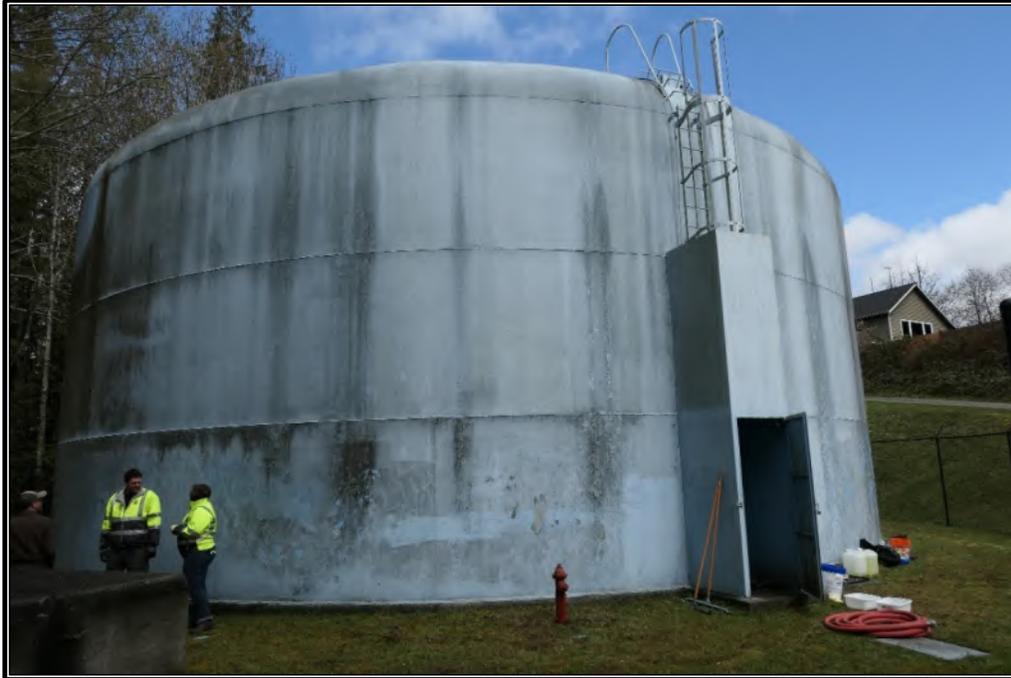
Figure 2-6: Padden Reservoir – Access Ladder and Wall Staining (South Side)

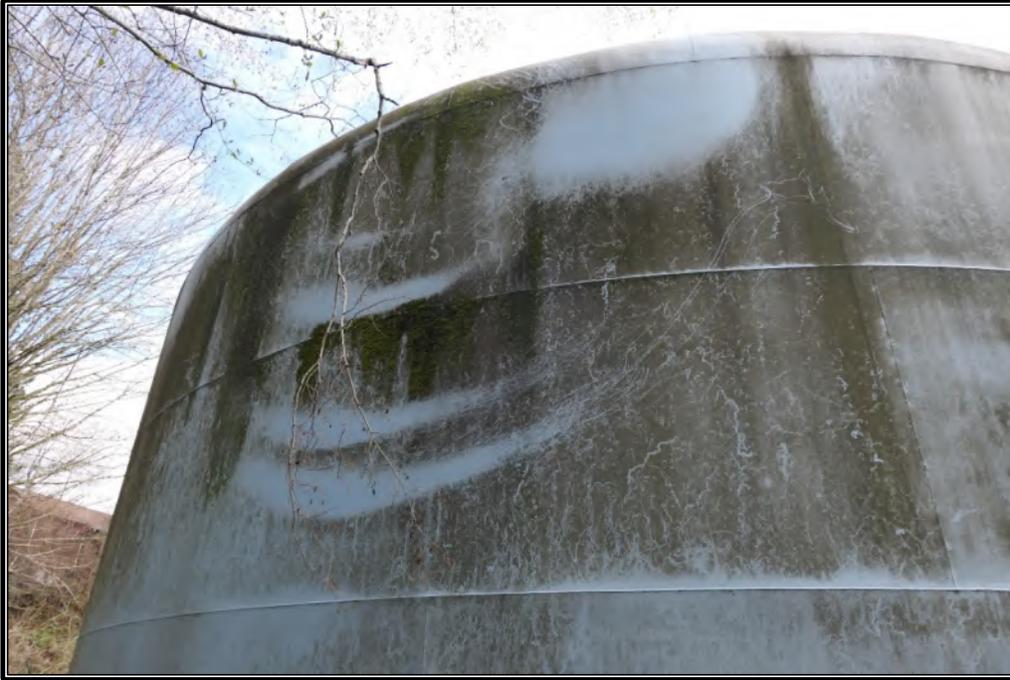
Figure 2-8: Padden Reservoir – Staining, Moss Growth, and Branch Rubbing (West Side)

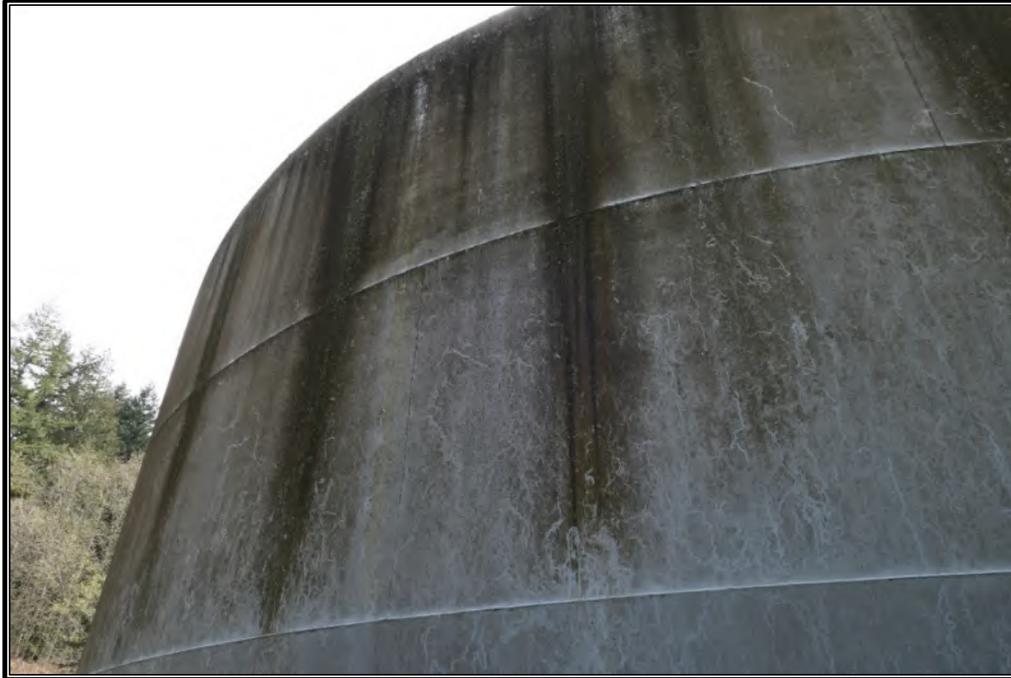
Figure 2-10: Padden Reservoir – Shell Staining (North Side)

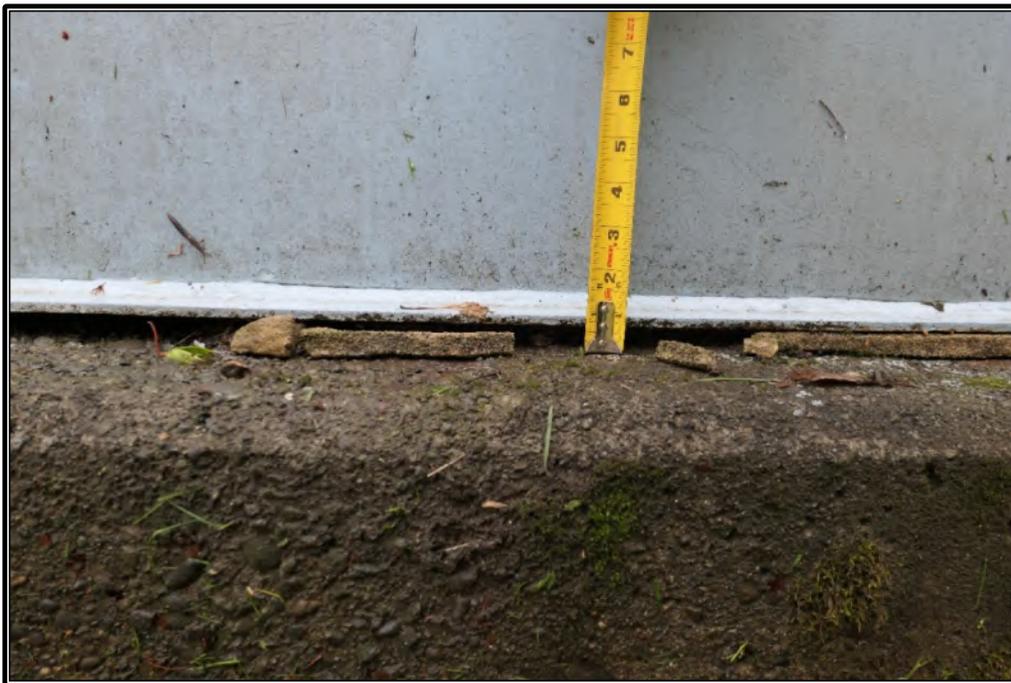
Figure 2-11: Padden Reservoir – Failure of Grout at Base (multiple locations noted)

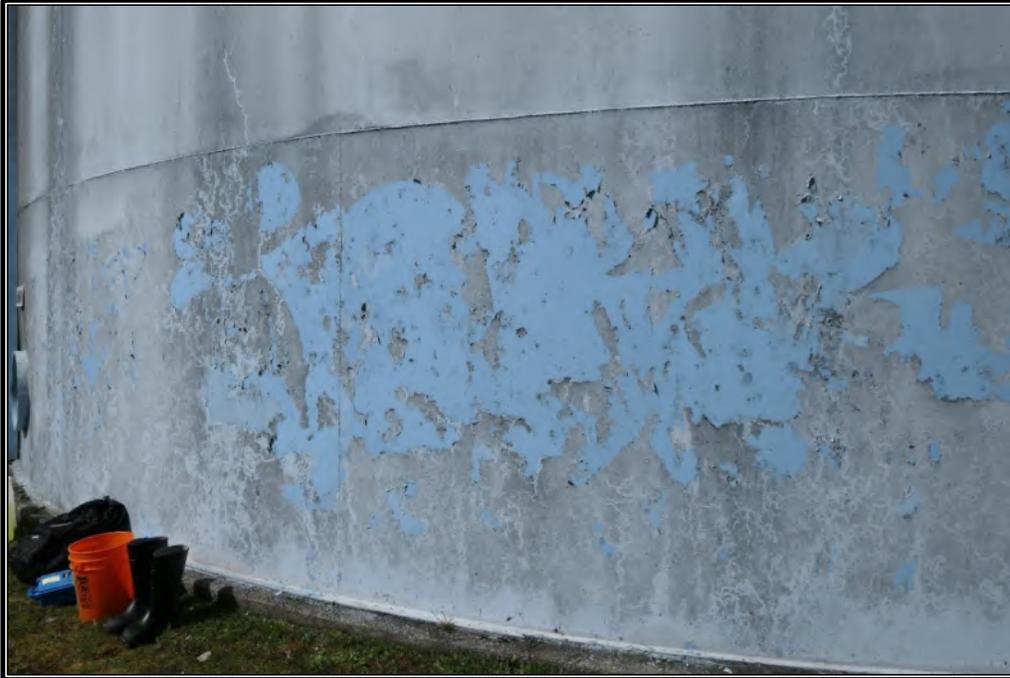
Figure 2-12: Padden Reservoir – Coating Delamination from Base Layer (Southeast Side)

Poor. Significant amount of rust on W. & N. side with loss of primary coating to base on E. & S. sides. Multiple areas of delam. and chipping

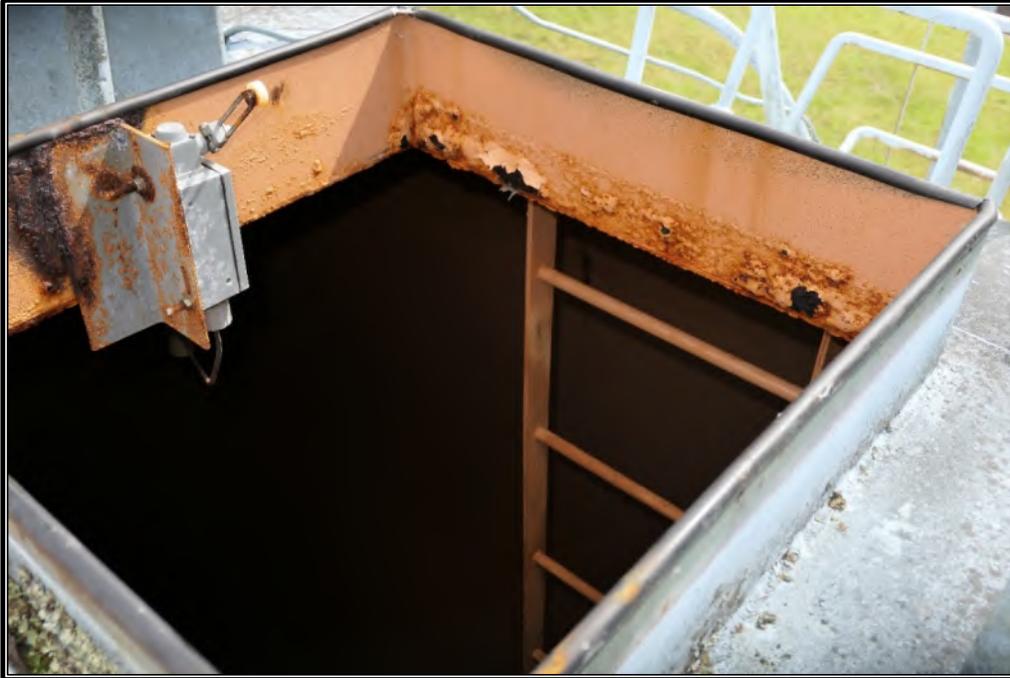
Figure 2-14: Padden Reservoir – Roof Access Hatch and Corrosion

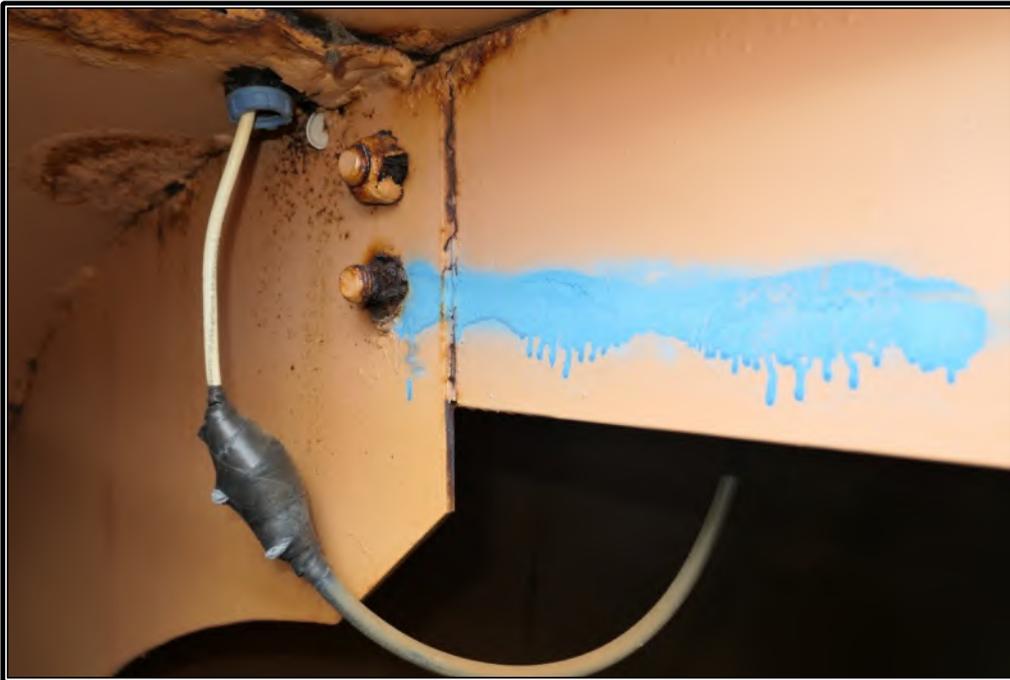
Figure 2-15: Padden Reservoir – Rafter End by Roof Hatch, Corrosion and Missing Nut

Bottom of Roof Plate/Framing/Coatings Condition: Multiple loc. of corrosion at joint lines. Rafter ends have corroded/missing bolts. Condensation/corrosion at vent.

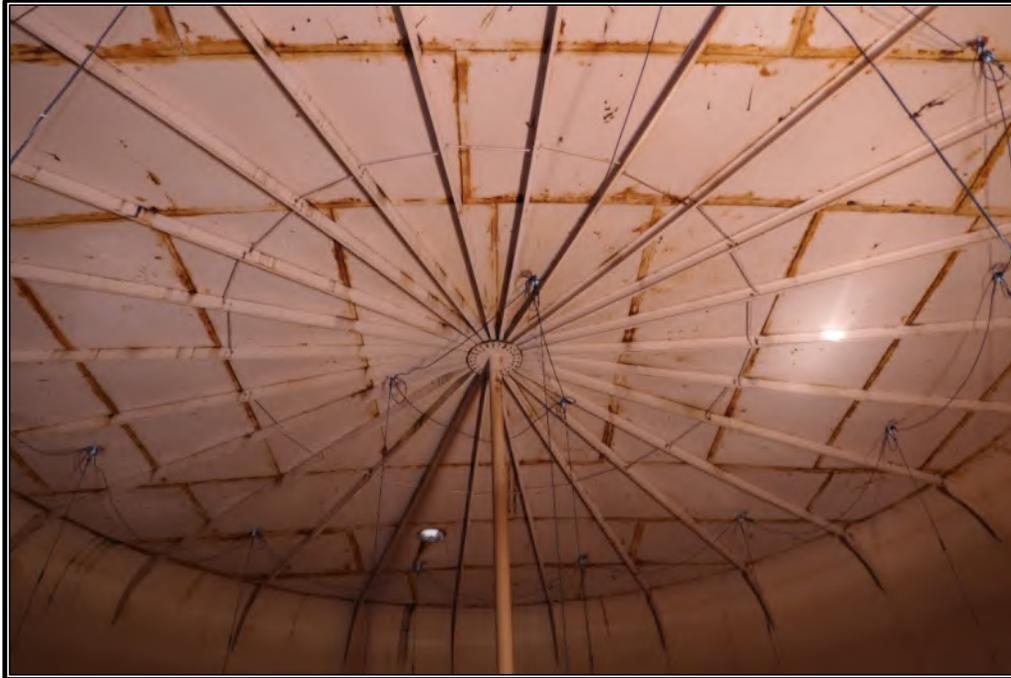
Figure 2-16: Padden Reservoir – Roof Layout, Corrosion Noted Along Plate Seams

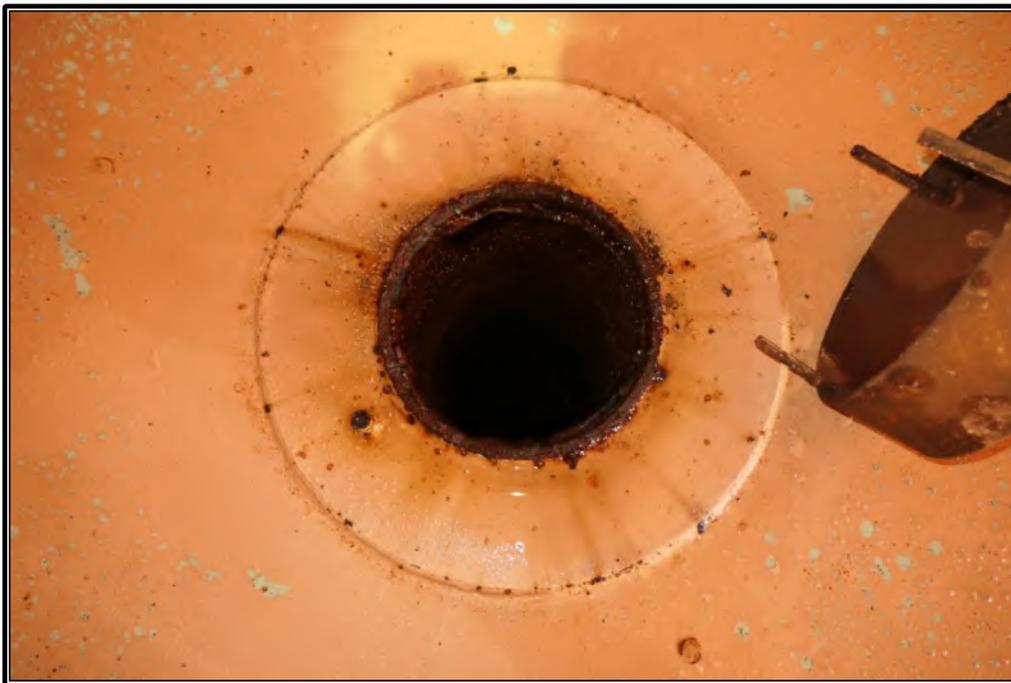
Figure 2-17: Padden Reservoir – Inlet/Outlet/Drainpipe Corrosion (Pipe Collar to Right)

Ladder/Pipes/Overflow Conditions: Ladder: good; Overflow: good;
Outlet: corrosion in pipe

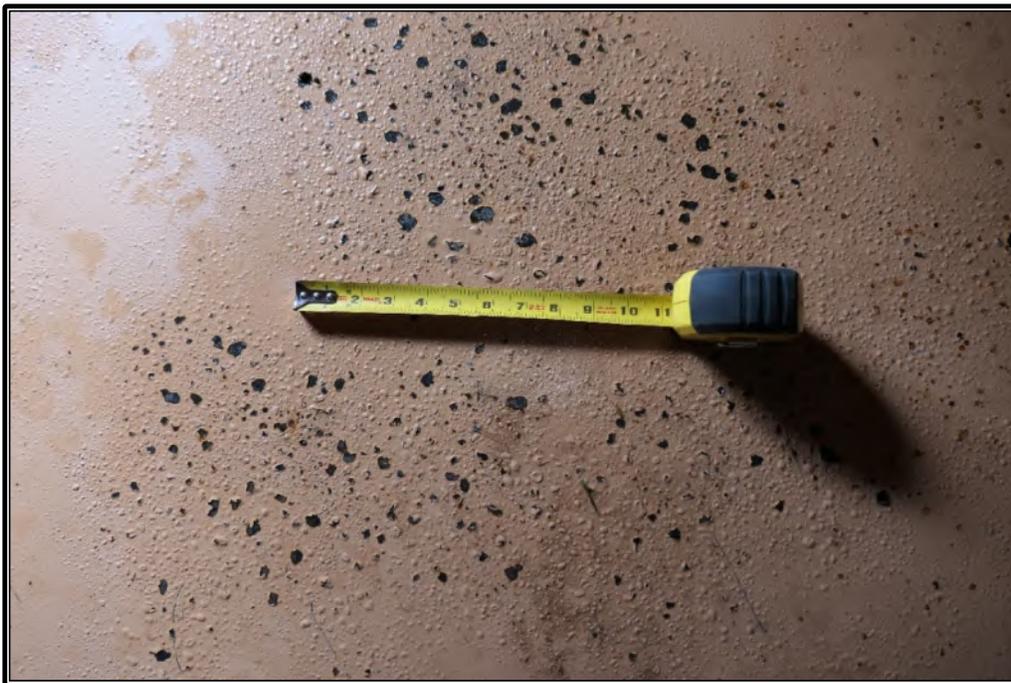
Figure 2-19: Padden Reservoir – Floor Plate, Coating Bubbling (multiple locations noted)

Floor Plate Condition/Thickness/Coatings: Coating is blistering but underlying steel good.

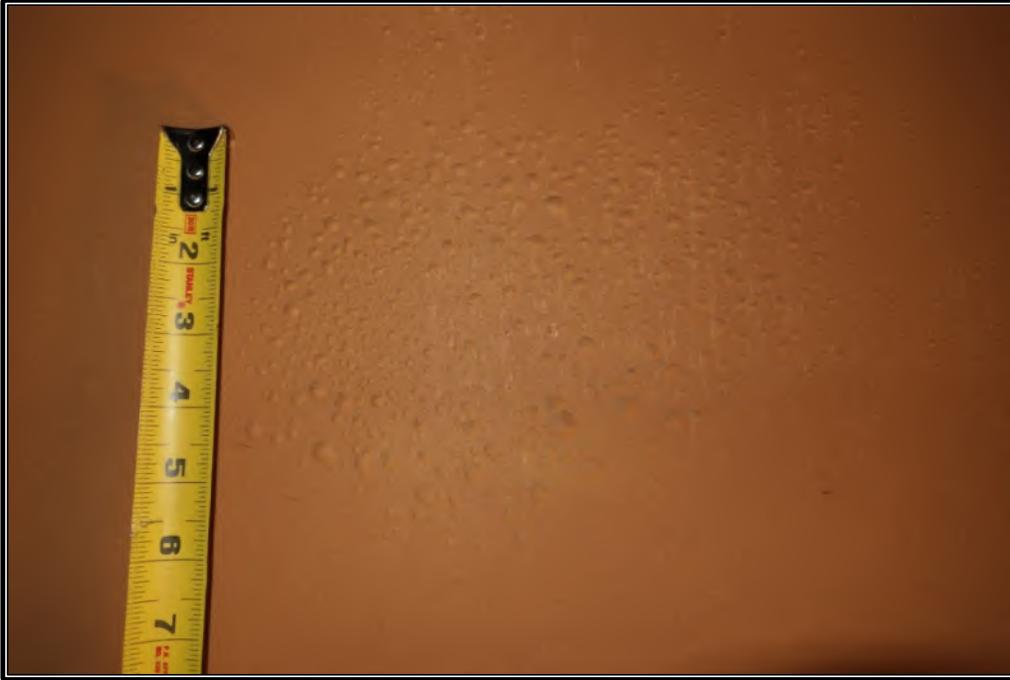
Figure 2-20 Padden Reservoir – Wall Plate, Coating Bubbling (multiple locations noted)

Condition of Interior Shell and Coatings: SP system too high causing paint to blister but underlying steel good.

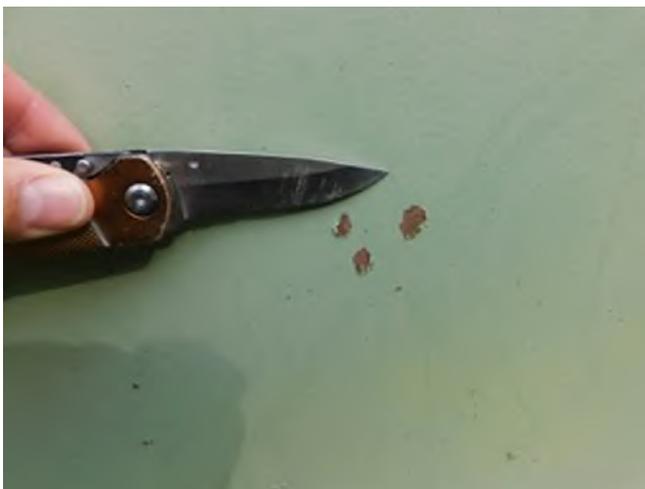
Missing top coat on sidewall

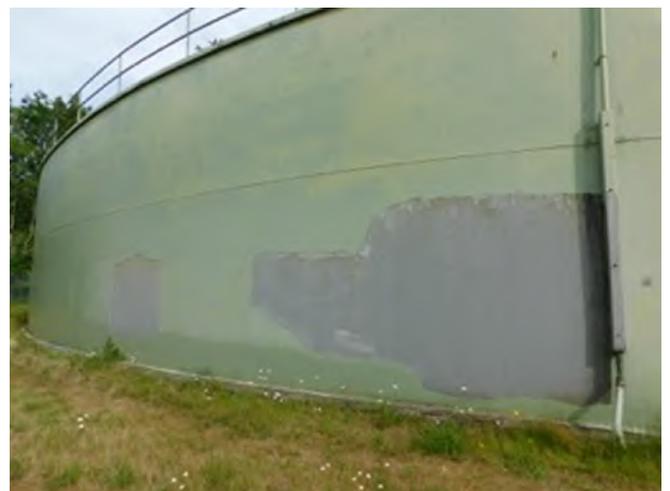
Areas of overcoat to cover graffiti
