APPENDIX

Date: January 22, 2020

Subject: City of Bellingham Reservoirs Inspection and Repairs
Marietta Site

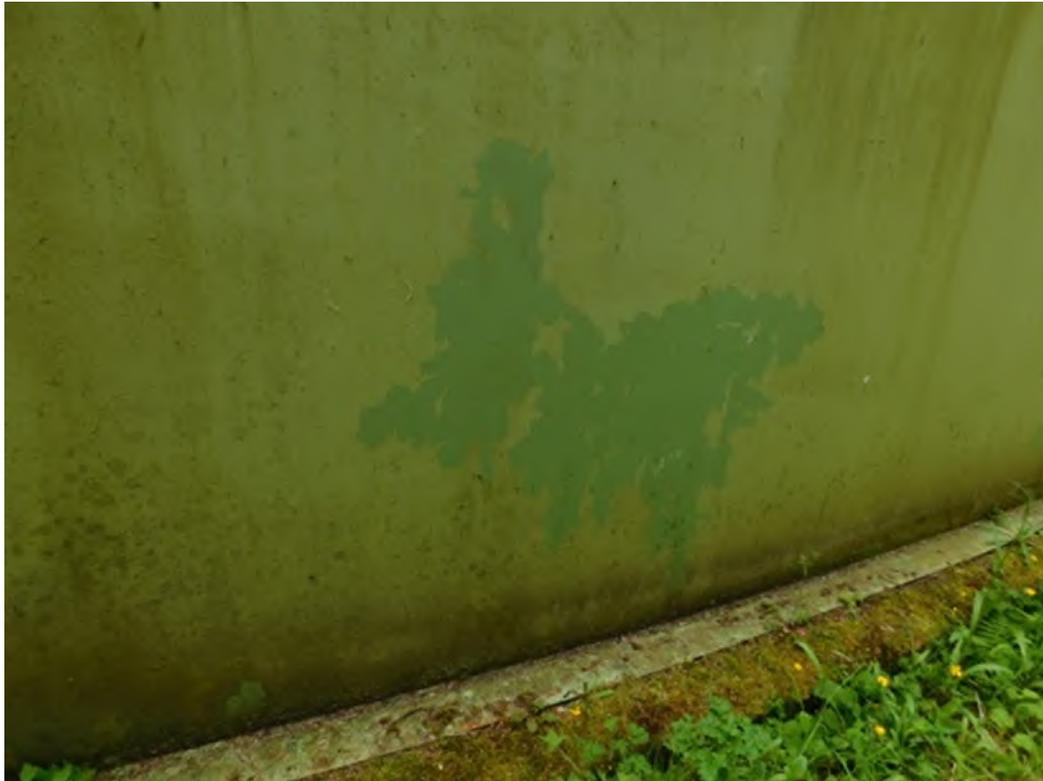
Overcoat to cover graffiti blistered and peeling off of original coating

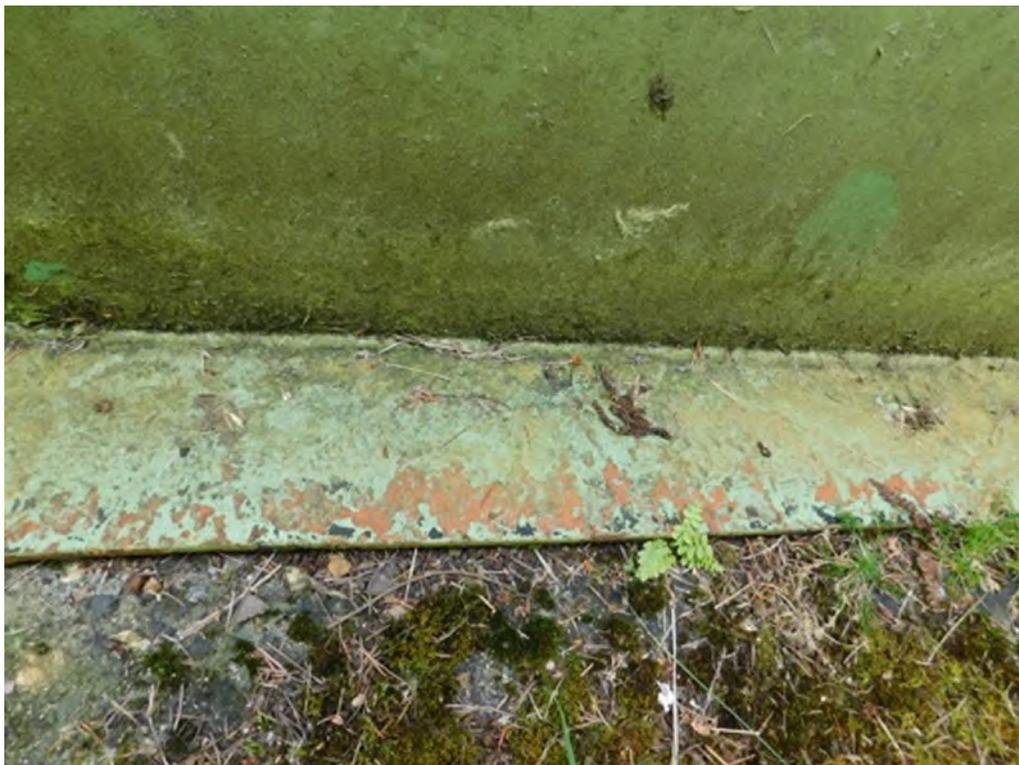
Top coat loss on Chime

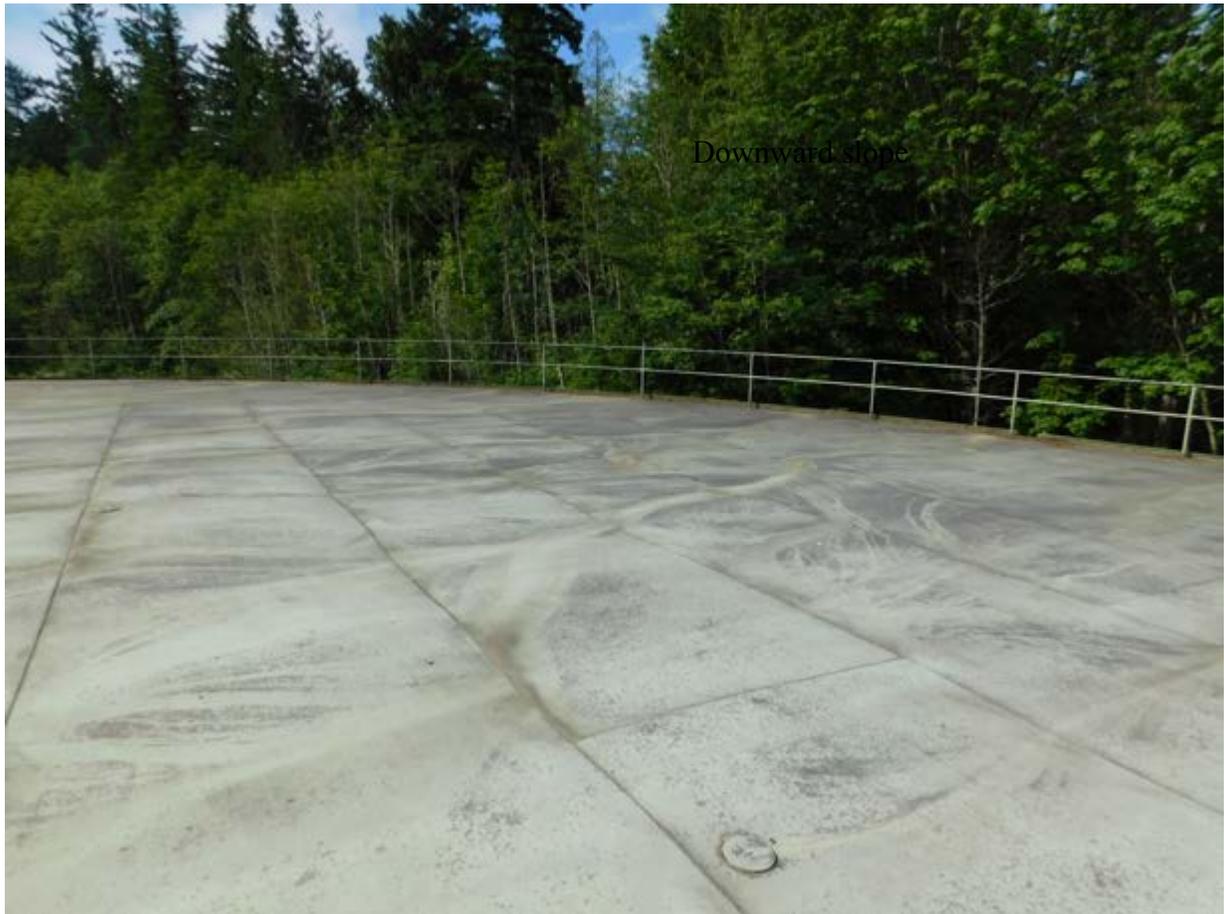
There is an accumulation of dirt on the roof coating that should be removed. The handrails are experiencing approximately 10% topcoat damage with the exposed steel showing rust staining.

Tank exterior roof, most surfaces covered with debris

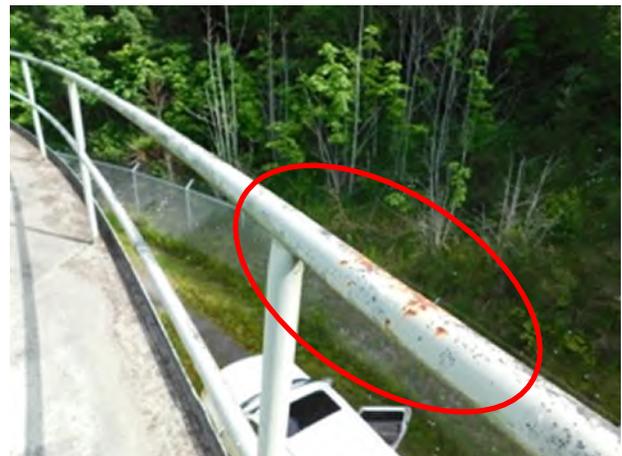
Coating loss on roof railing with exposed steel

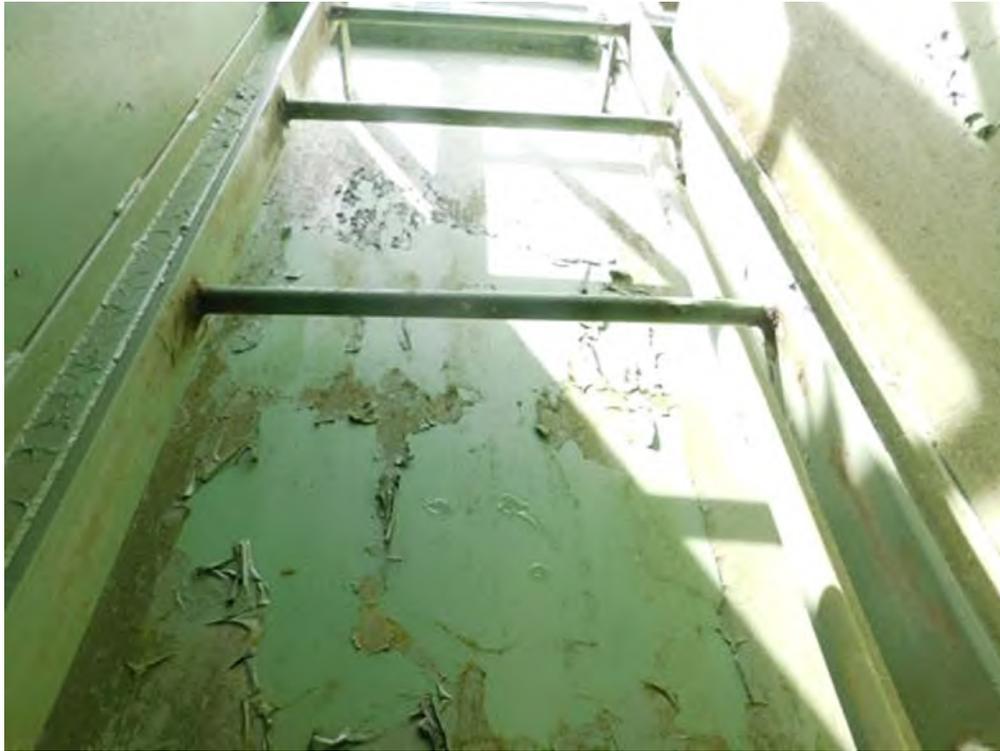
Coating delamination at roof ladder

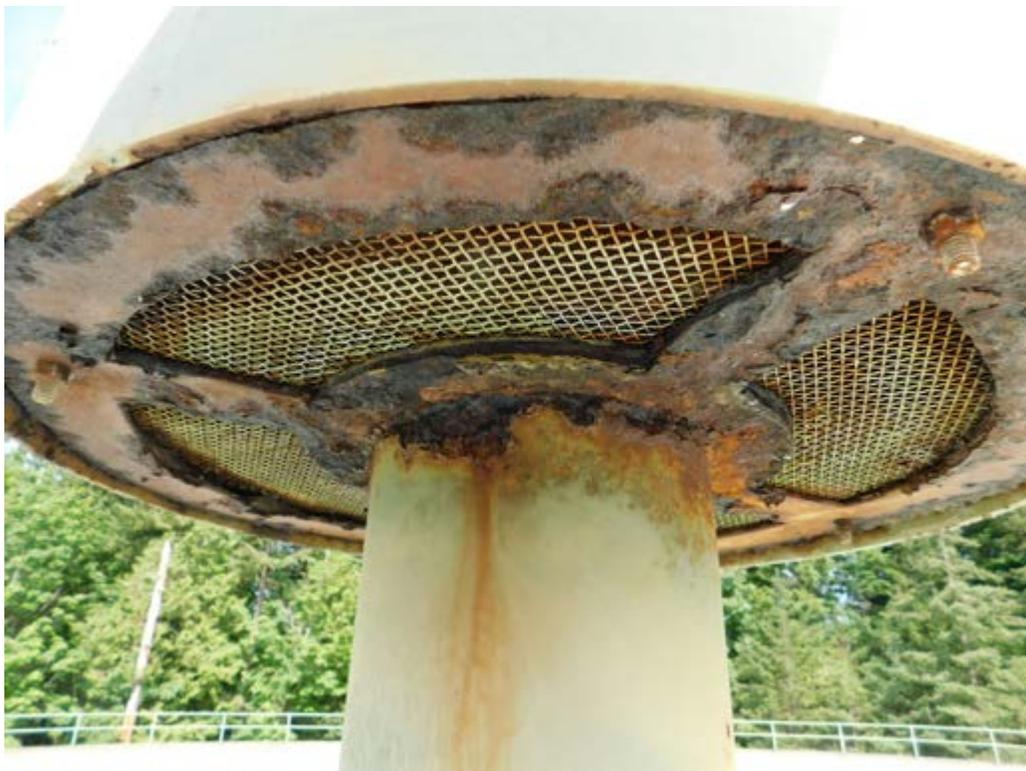
Significant corrosion damage at roof vent

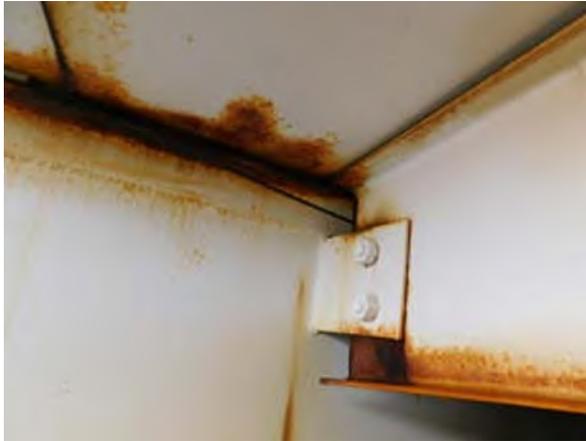
Coating losses are evident on most of the support beam edges and edges of steel plating. In addition, areas of roof plate overlap show coating losses at most locations. These sites are prone to corrosion if a stripe coating is not applied during the coating process. As wet coatings cure, they tend to pull back from the corners and edges exposing the underlying steel. The application of a stripe coat provides an additional layer of coating thickness and protection against these losses.

Coating loss at beam and wall edges

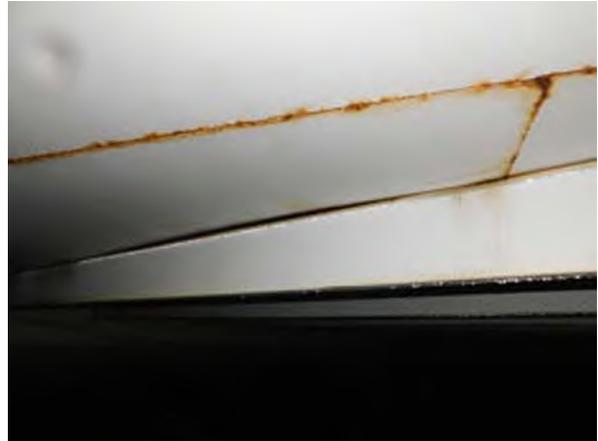
Coating loss at roof plate edges

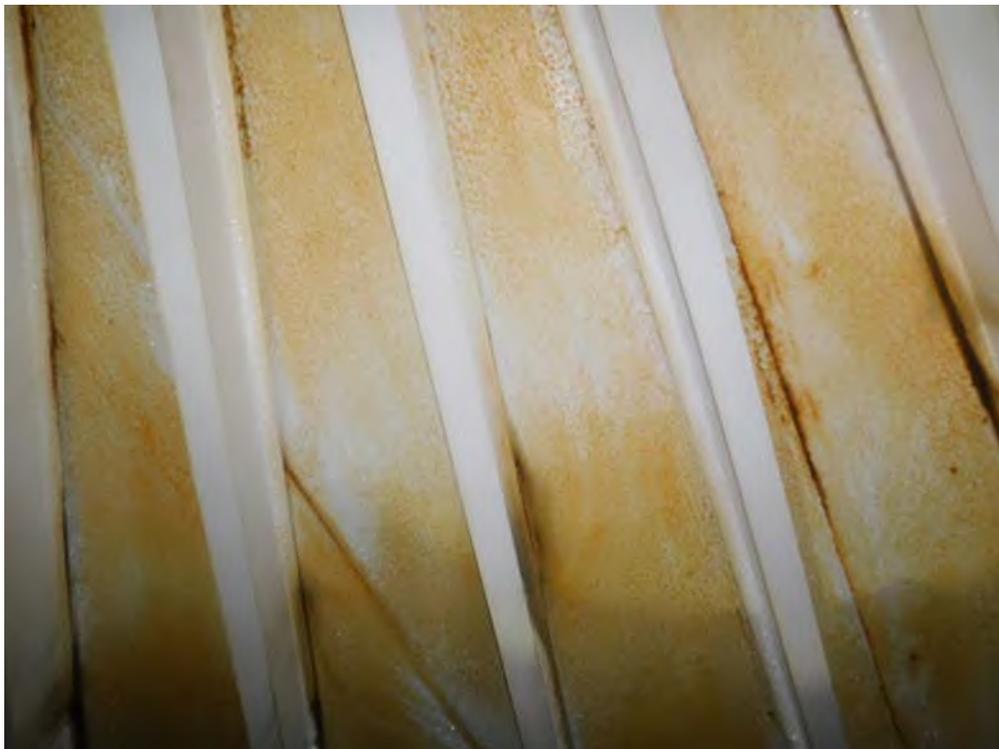
Rust staining of roof plates

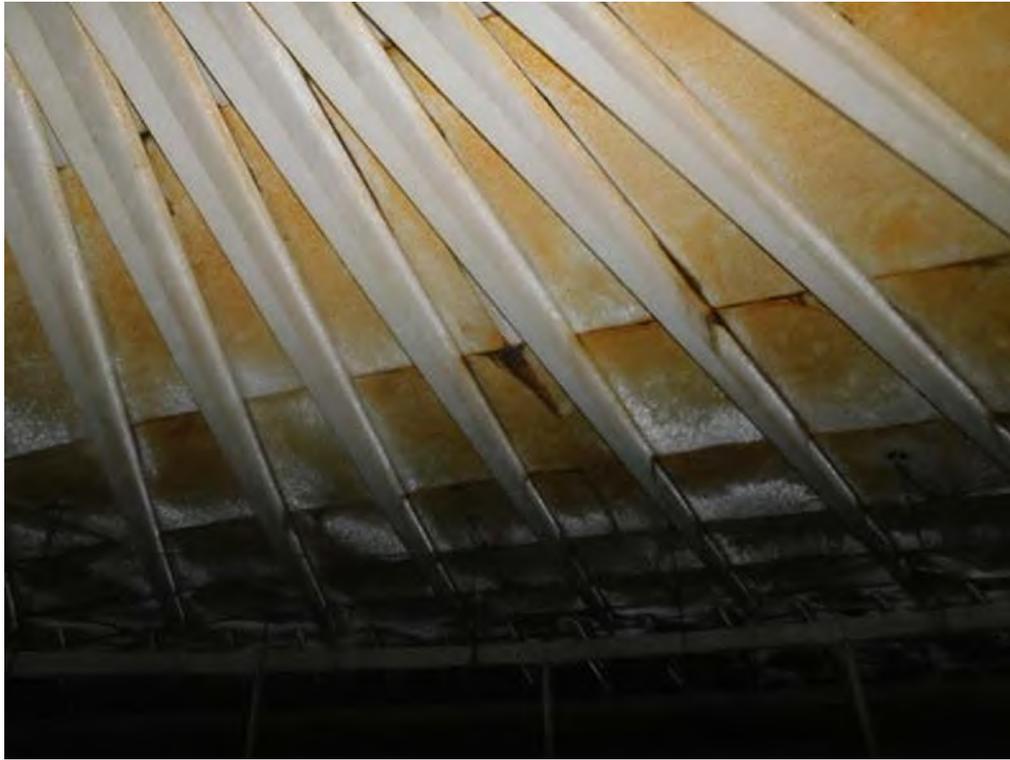
Rust staining of roof plates

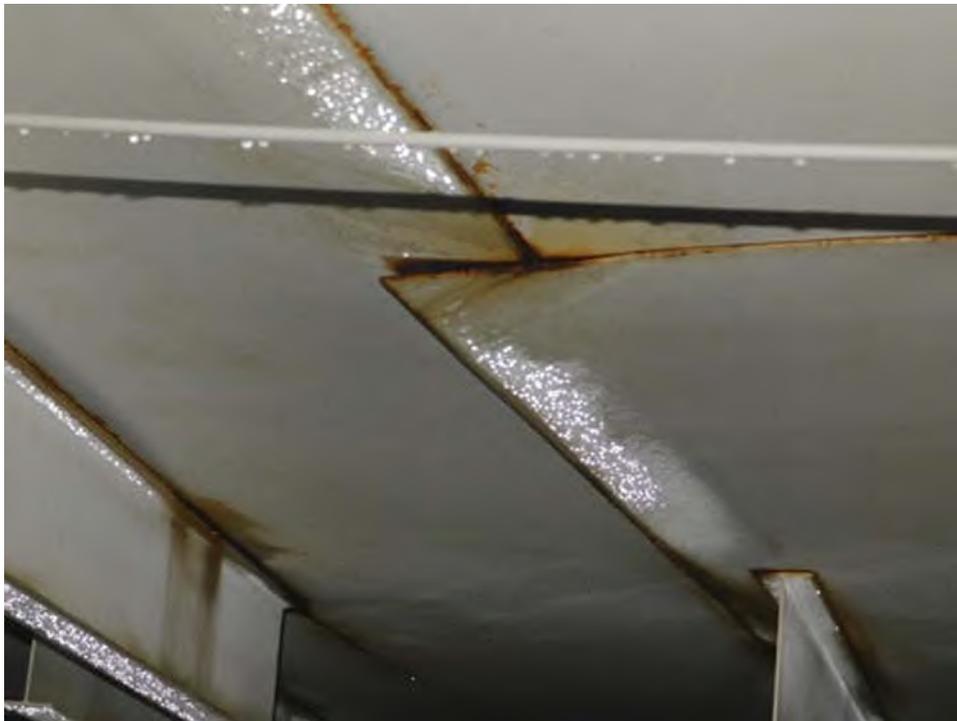
Deflected roof plate

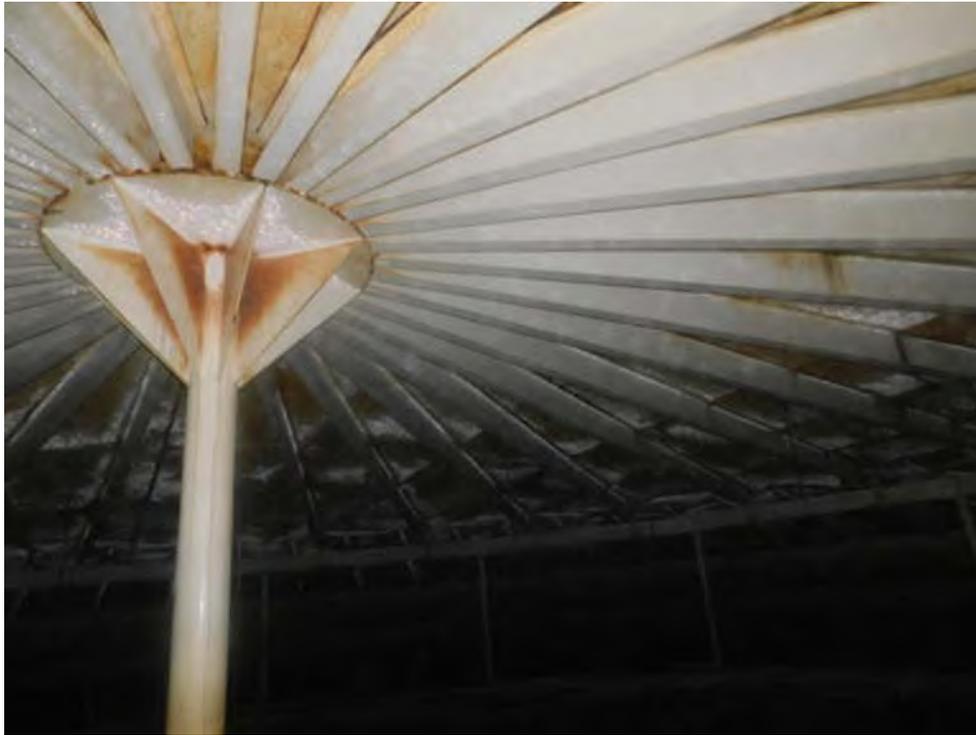
Rust staining at center column

The roof shows rust staining at all roof plate overlaps, typical for these non-seal welded areas. The structural components surrounding the access hatch and areas above the water level are experiencing general surface corrosion and crevice corrosion at steel overlap areas.

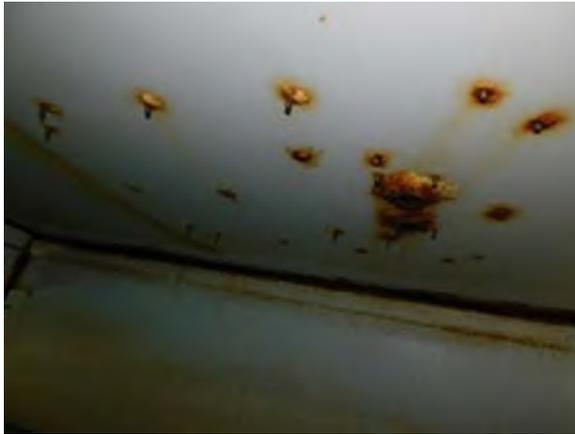
Fasteners drilled through roof with corrosion damage

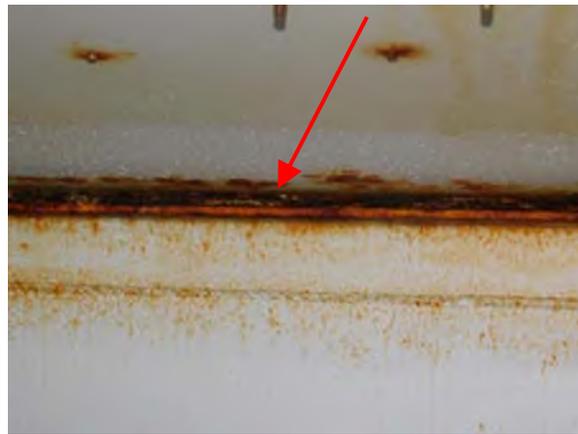
Pack rust between beam and roof plate

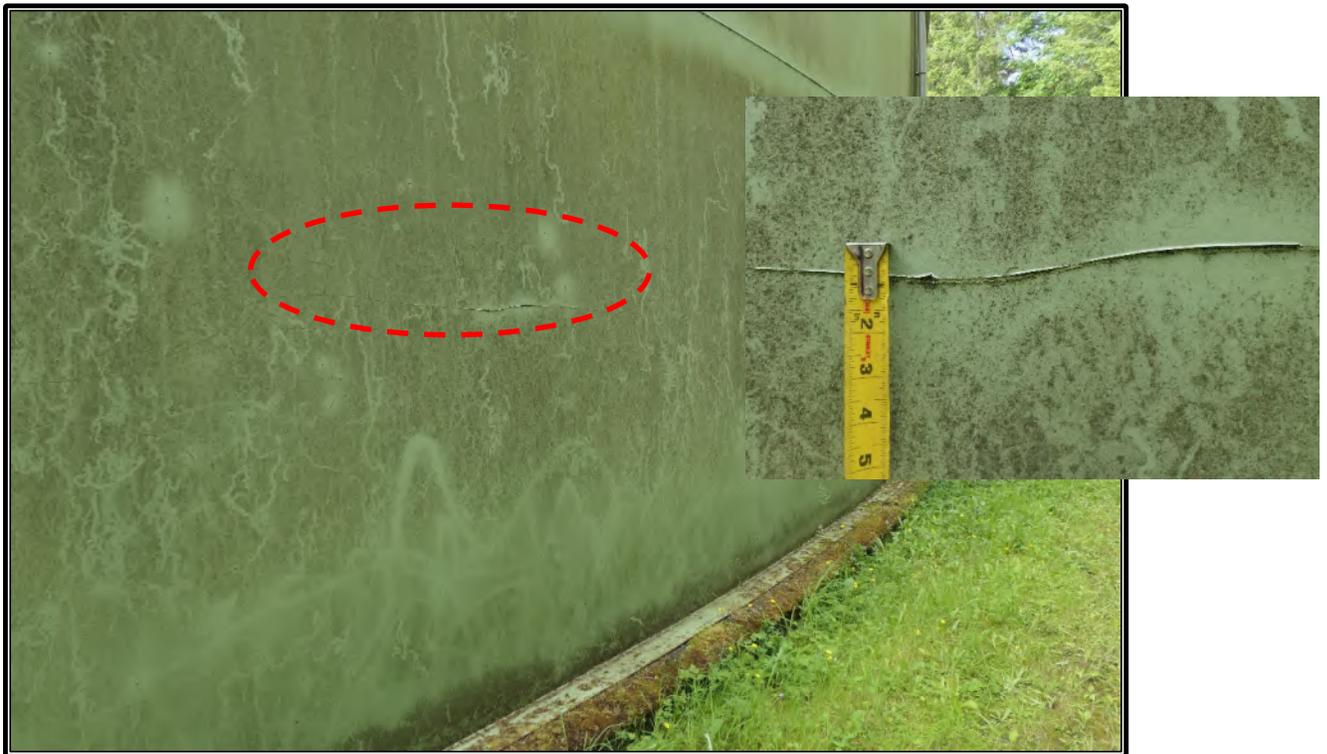
Figure 2-13: Whatcom Falls 1 Reservoir – Sidewall with scratch in coating (north side)

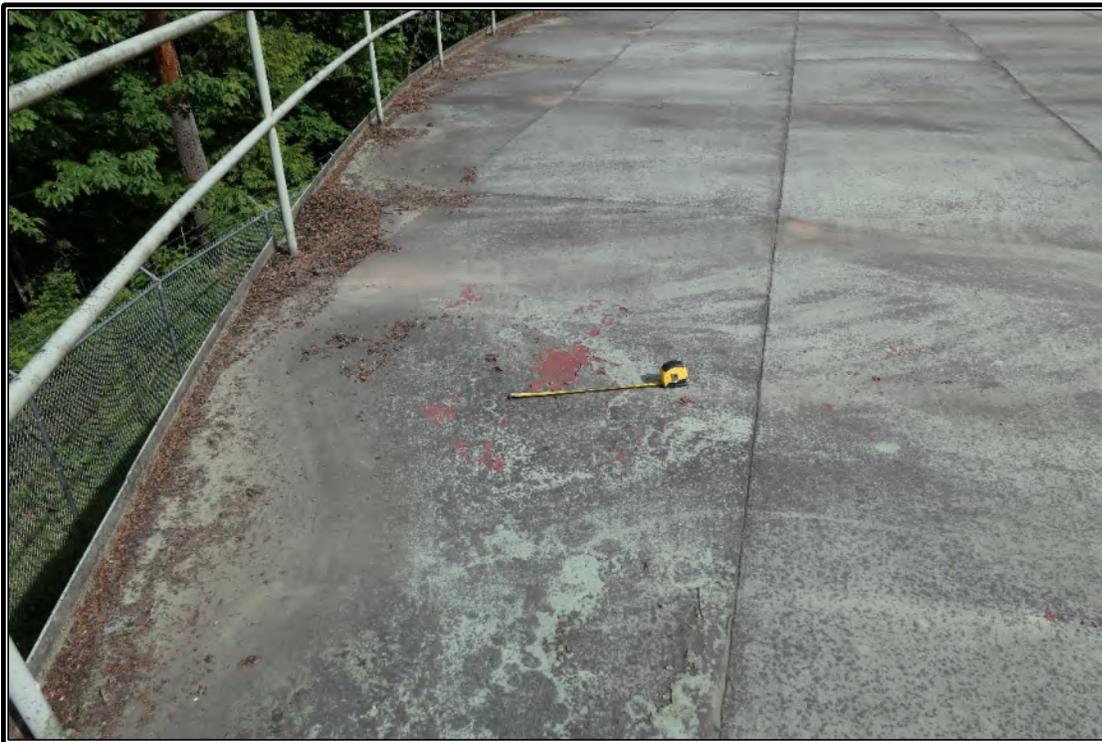
Figure 2-17: Whatcom Falls 1 Reservoir – Roof with debris build-up (west side)

Around the exterior of the reservoir, PSE recommends a cleaning of the reservoir's shell and removal of any vegetation growing between the floor plate and top of footing. PSE would recommend adding additional roof scuppers to further facilitate roof drainage and limit the collection of debris which could be deleterious to the roof coating.

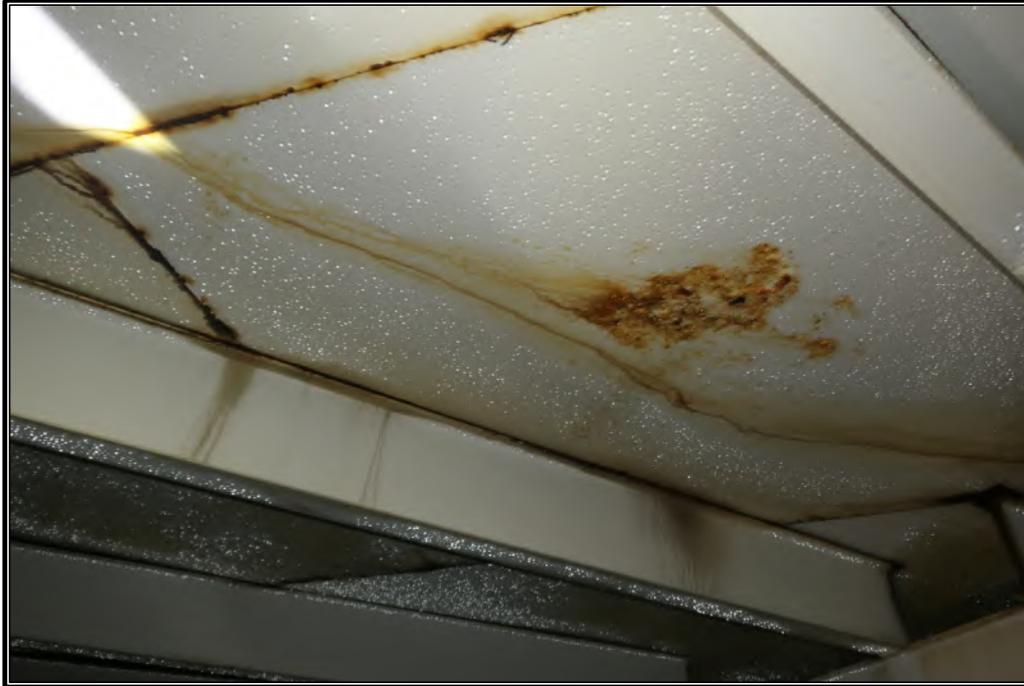
Figure 2-22: Whatcom Falls 1 Reservoir – Roof Plate, example of coating failure

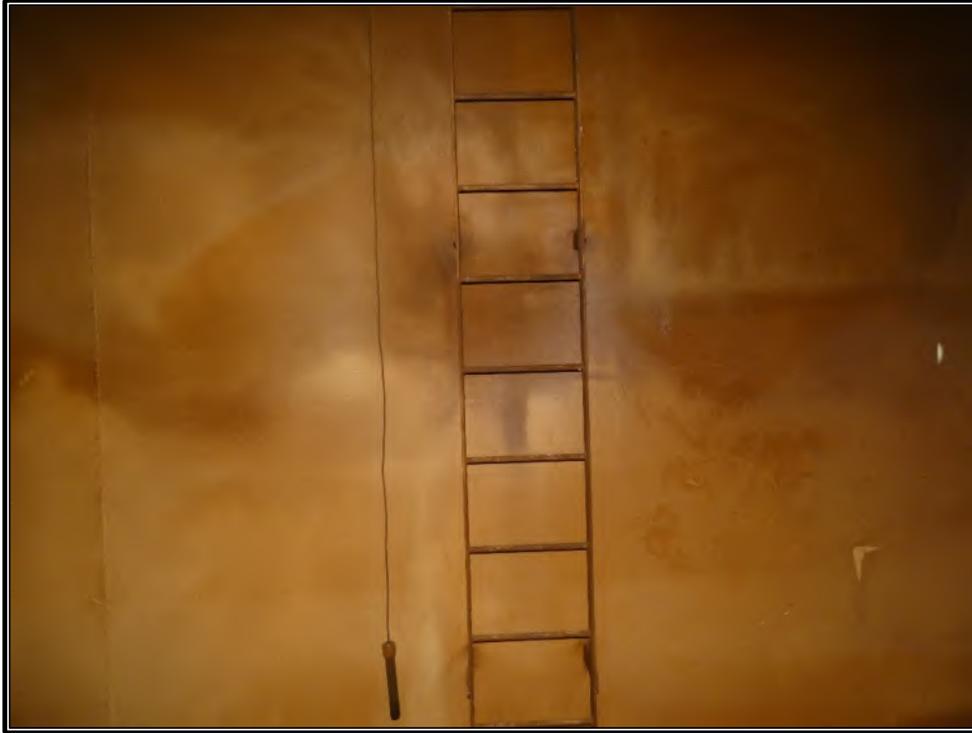
Figure 2-26 Whatcom Falls 1 Reservoir – Ladder and Wall (both wall and ladder show signs of heavy corrosion staining)

"Bath tub" ring of corrosion staining around wall of res.
stain appears to fade about 2' below rafters,
likely where typical max. operation level located.

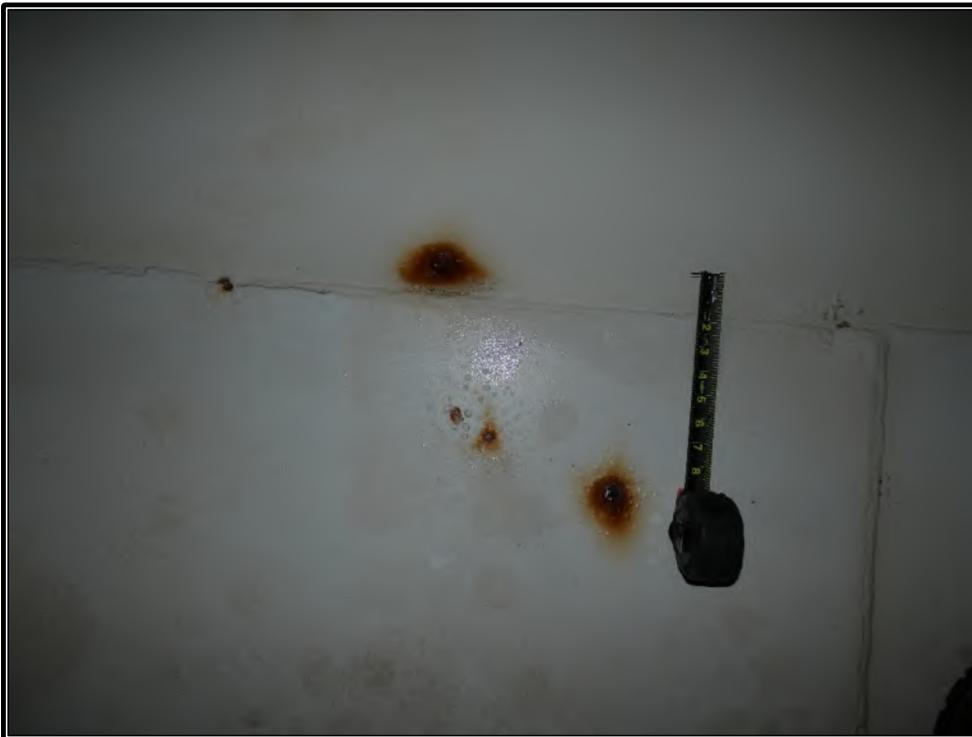
Figure 2-27 Whatcom Falls 1 Reservoir – Instance of Coating Failure and Corrosion on Floor

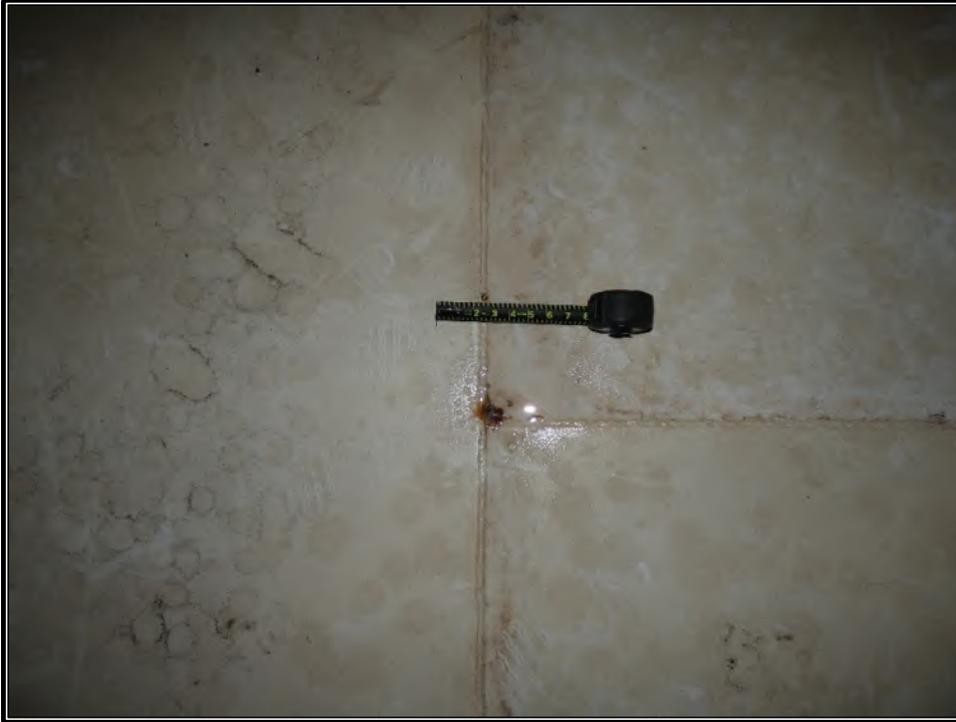
Figure 2-28 Whatcom Falls 1 Reservoir – Instance of Coating Failure and Corrosion on Floor at Plate Joint

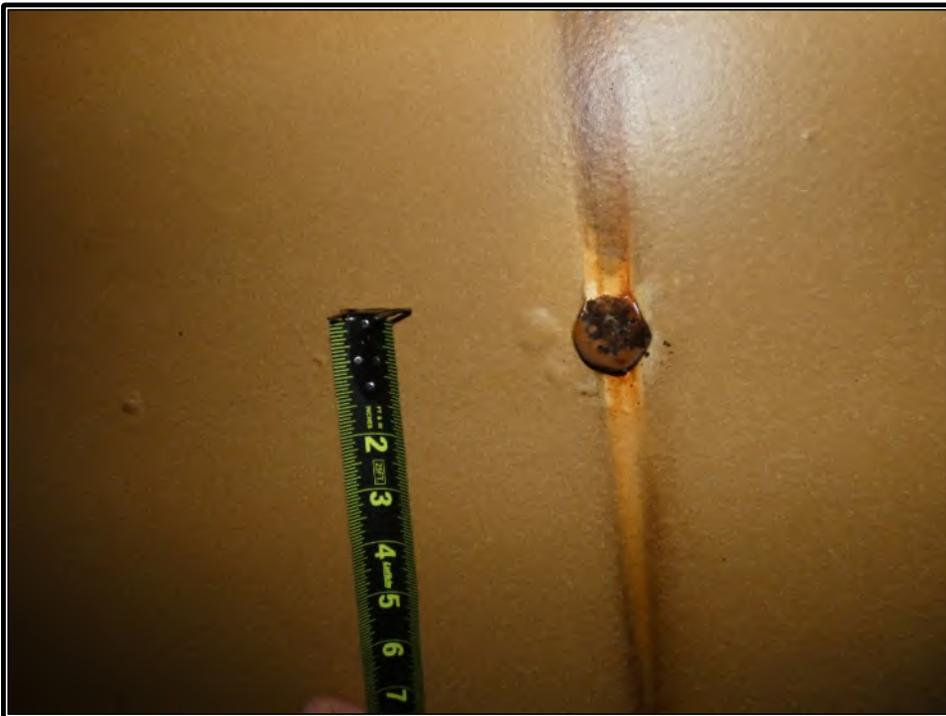
Figure 2-29 Whatcom Falls 1 Reservoir – Instance of Coating Failure and Corrosion on Wall

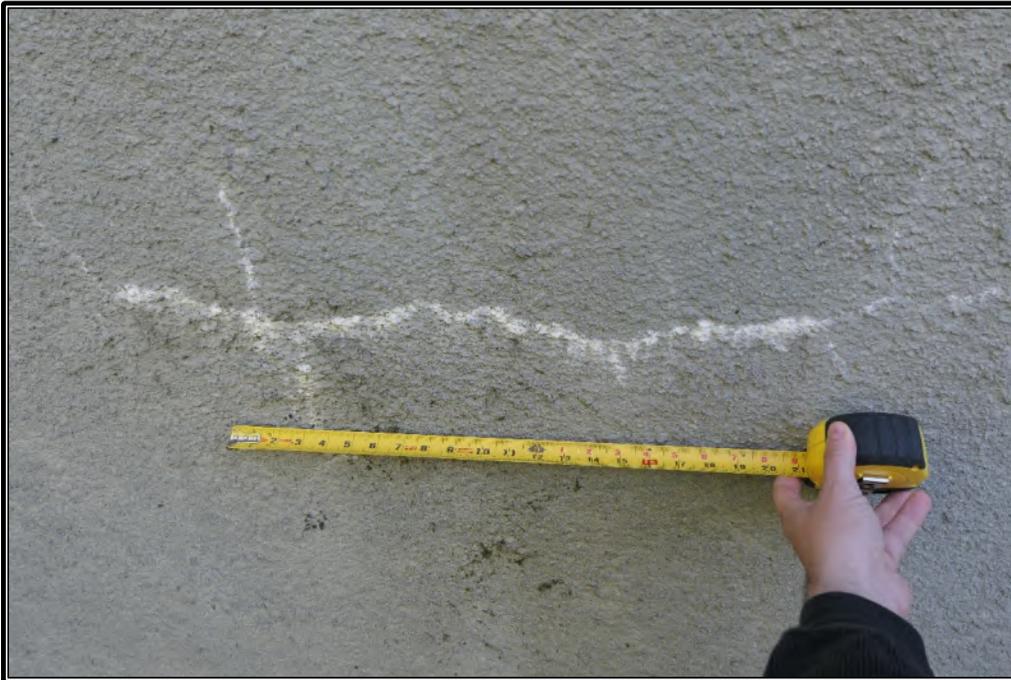
Figure 2-10: Dakin 2 - Instance of Efflorescing noted in Shotcrete

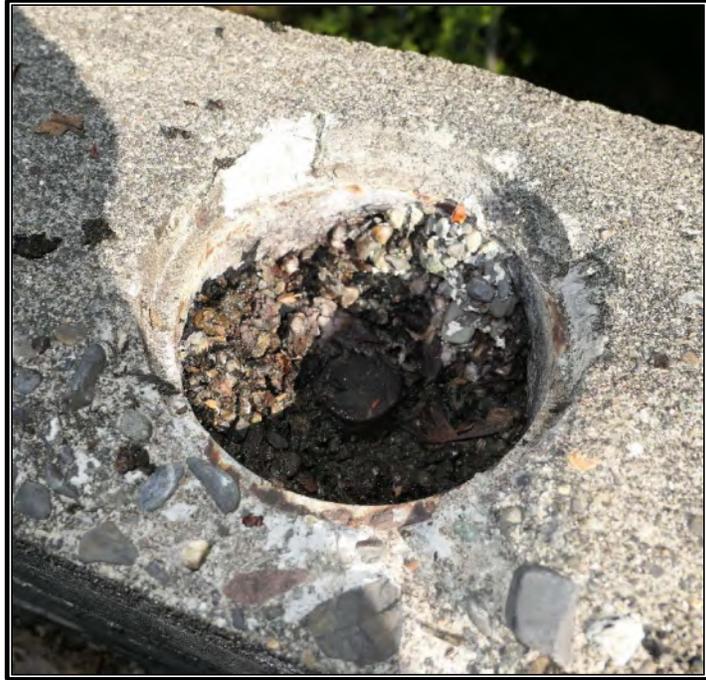
Figure 2-13: Dakin 2 - Failed Concrete Threadbar Cap, Threadbar can be seen in hole

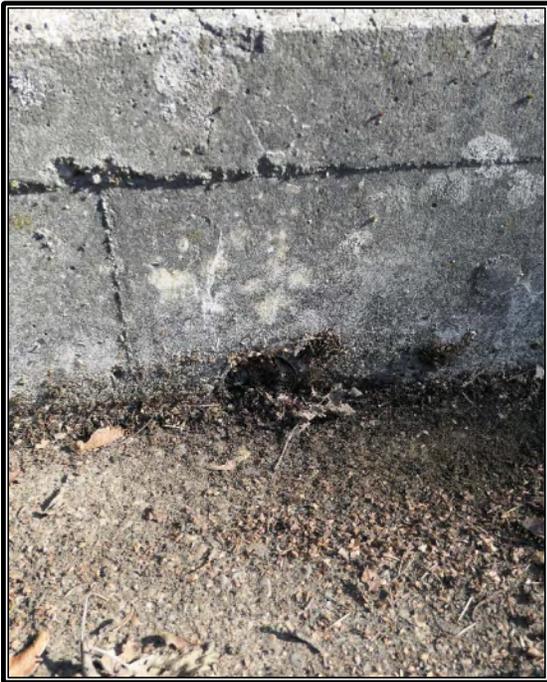
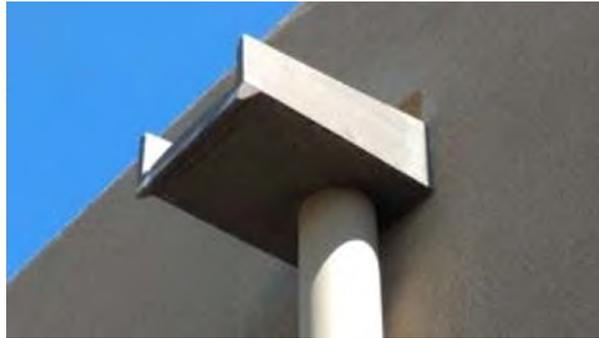
Figure 2-14: Dakin 2 - Blocked Roof Drain. Retrofit drain should allow for overflow if its main pipe is blocked (see example on right)

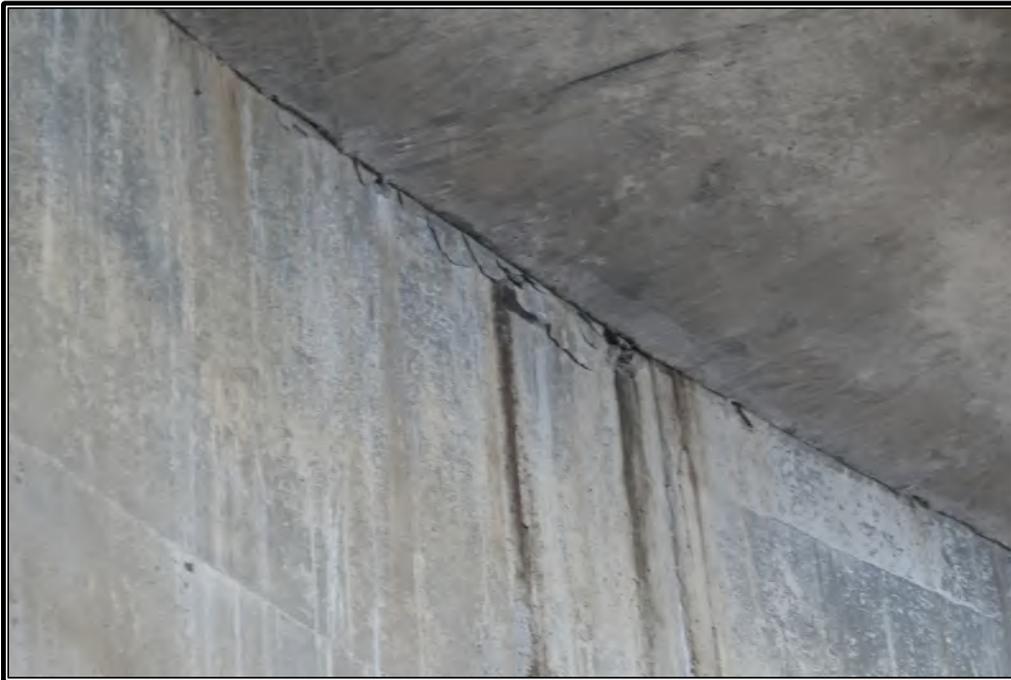
Figure 2-20: Dakin 2 - Spalled Concrete along Dome Roof and Wall Bearing Interface

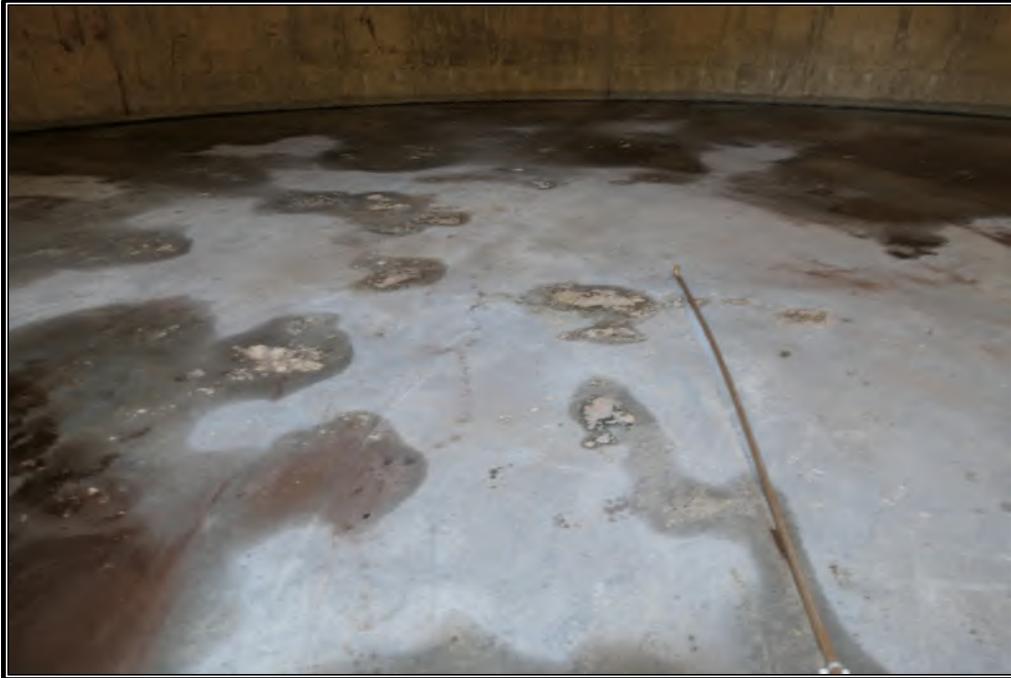
Figure 2-21: Dakin 2 - Mineralization along floor

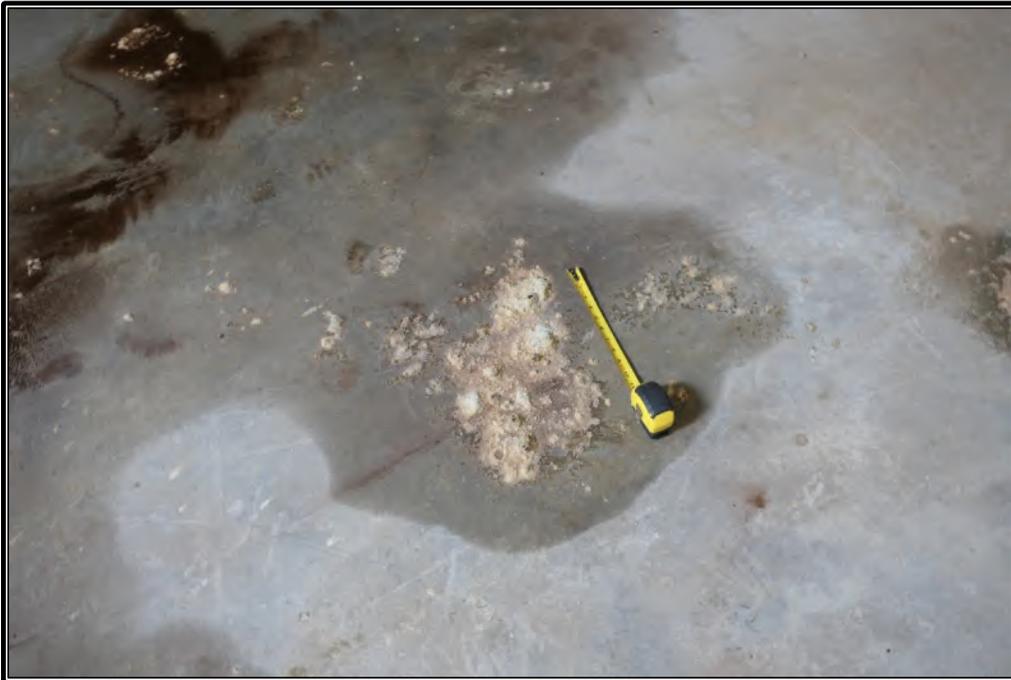
Figure 2-22: Dakin 2 - Close-up of Floor Mineralization

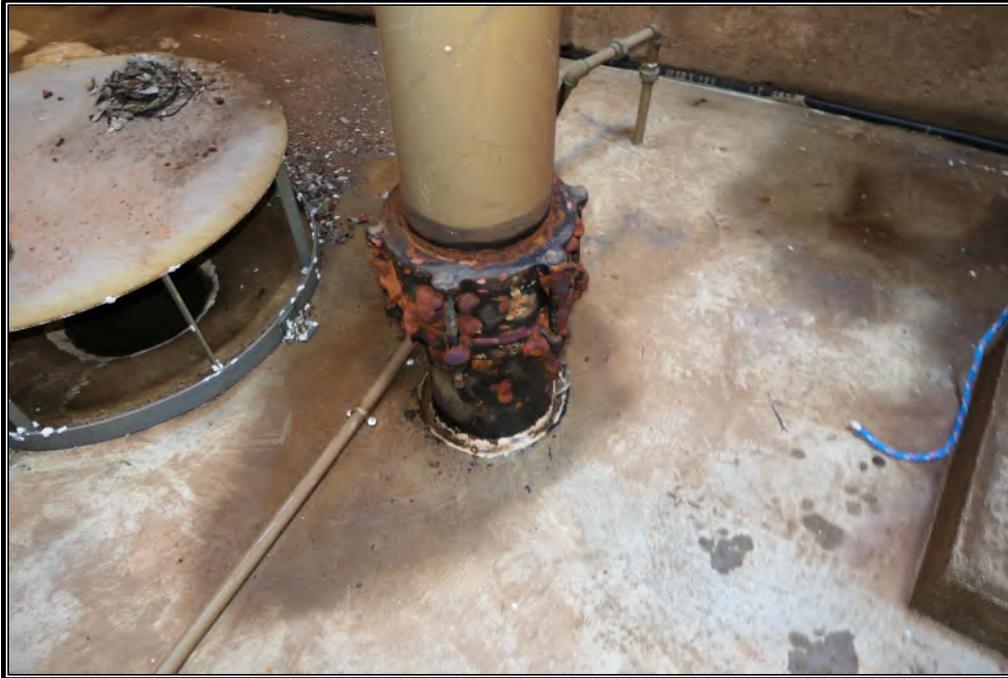
Figure 2-23: Dakin 2 - Corrosion carbuncles at base of overflow pipe.

5. As part of maintenance, any piping and ladder corrosion and mineralization should be removed.
6. The roof access hatch gutter drainage points should be screened to protect them. This will bring them into compliance with the Washington Department of Health requirements for the sanitary protection or reservoirs.

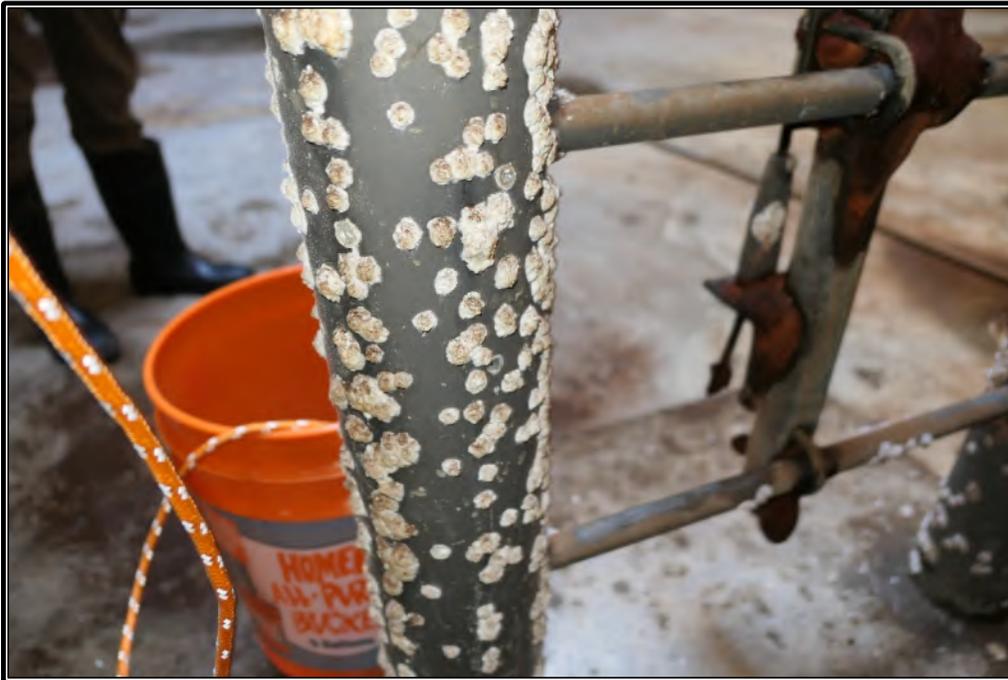
Figure 2-24: Dakin 2 - Mineralization on Ladder

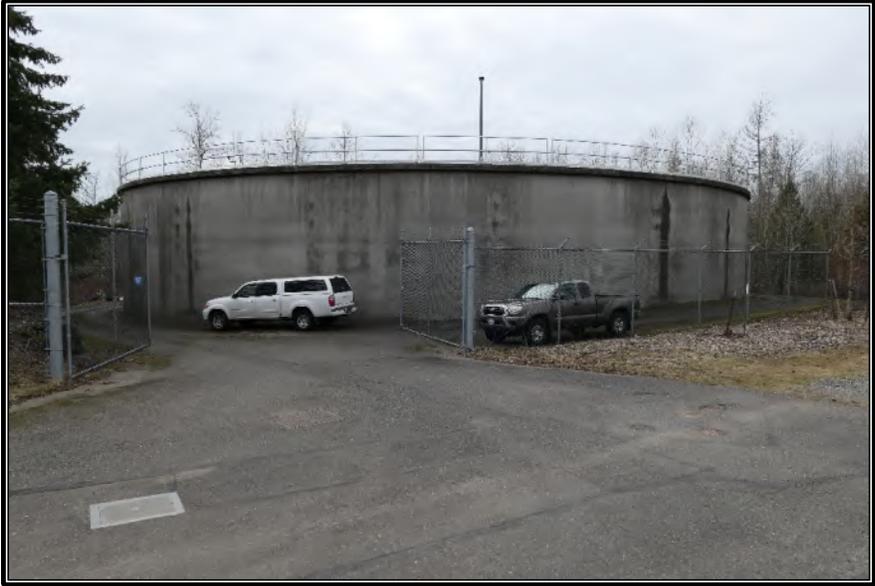
Figure 2-9: Reservoir North Elevation

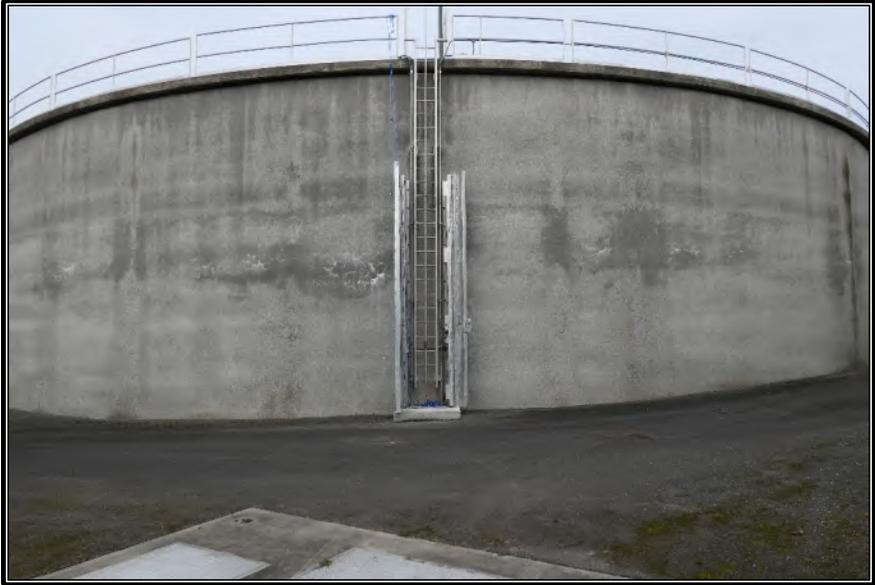
Figure 2-10: Reservoir South Elevation & Exterior Ladder

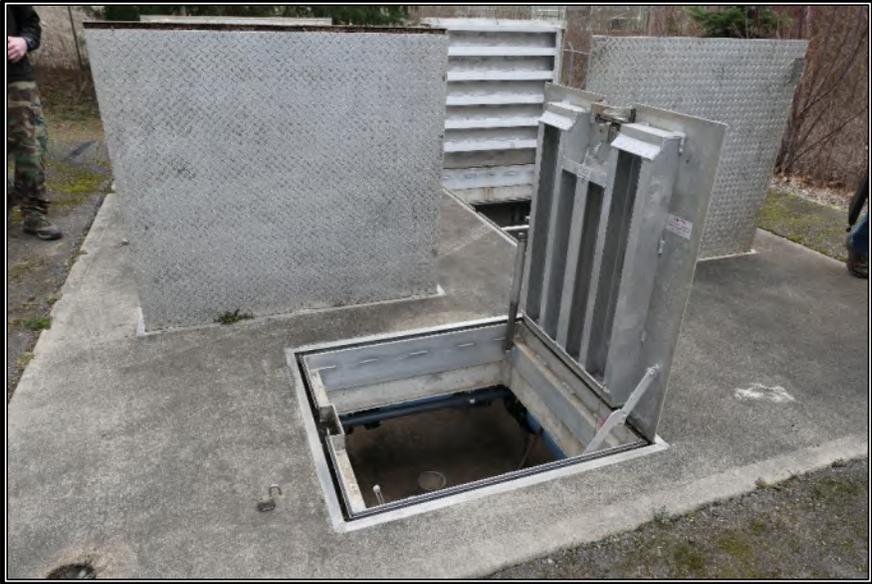
Figure 2-11: Pipe Vault, Located southeast of reservoir

14'x13'x7.5' Cir. Middle strip 28" wide. Roof Slab 13 1/2" thick
 Overall good condition. No issues w/ crack of water during obs.

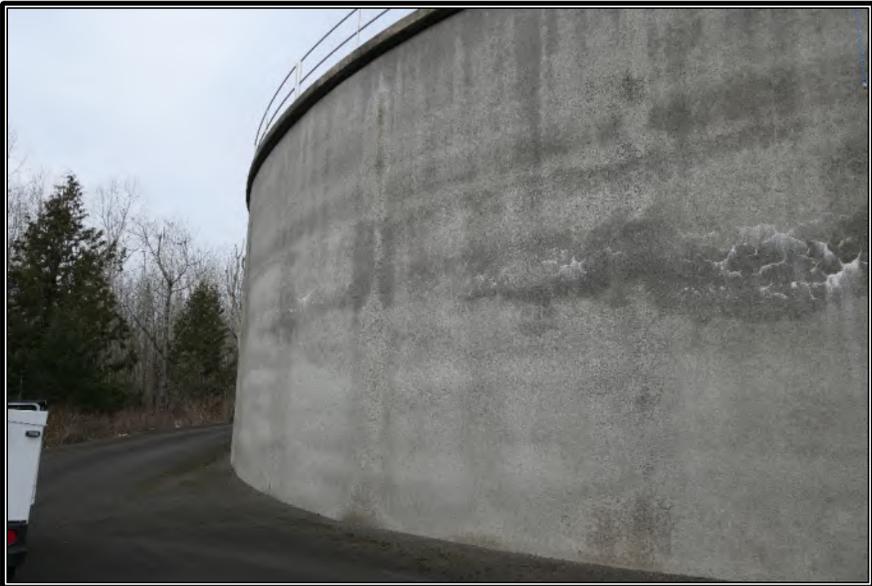
Figure 2-12: Typical Efflorescing in Shotcrete

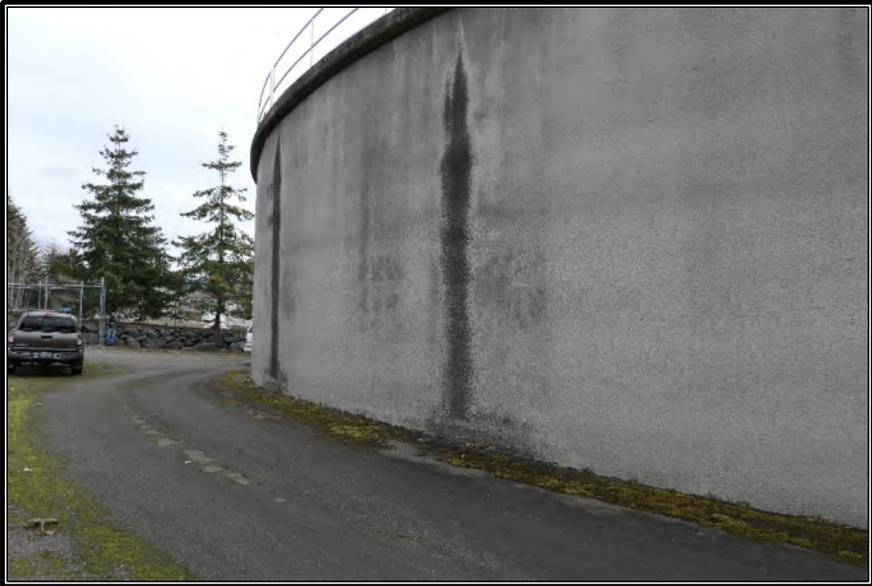
Figure 2-13: Location of Potential Delamination (points 1 (near) and 2 (far) located at water stained areas)

Exterior Shotcrete Condition: Gen. Good but on North side sounding
found area along roof drain point with potential delam issue,
Noted area 1 & 2, Cracking/cracking noted about 8' above
grade in multiple locations.

Sound shotcrete at regular intervals and record results: Loc 182 on N. side of res.
sounded and are potential areas of delam. and should
be repaired.
