APPENDIX

Date: January 22, 2020

Subject: City of Bellingham Reservoirs Inspection and Repairs
Marietta Site

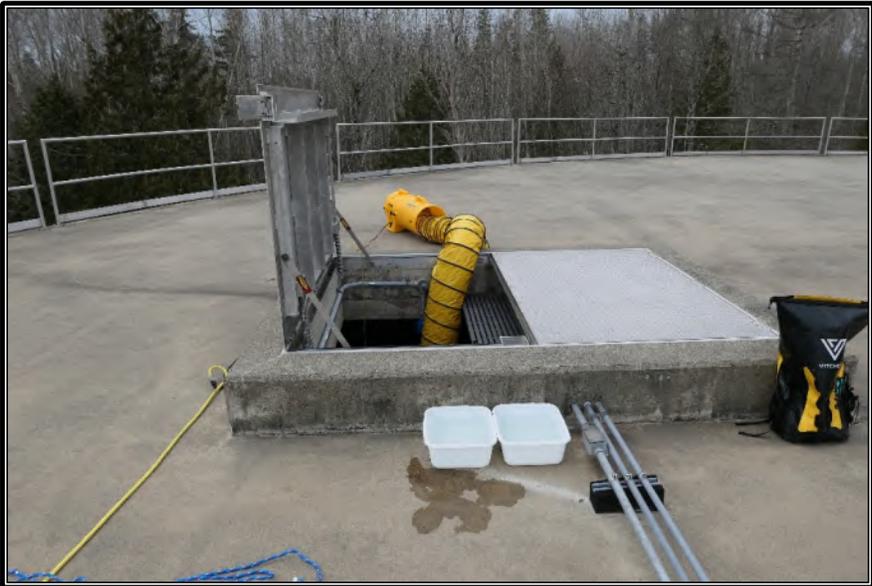
Figure 2-14: Hatch

Finally, the roof access hatch gutter drainage points should be screened to protect them. This will bring them into compliance with the Washington Department of Health requirements for the sanitary protection or reservoirs.

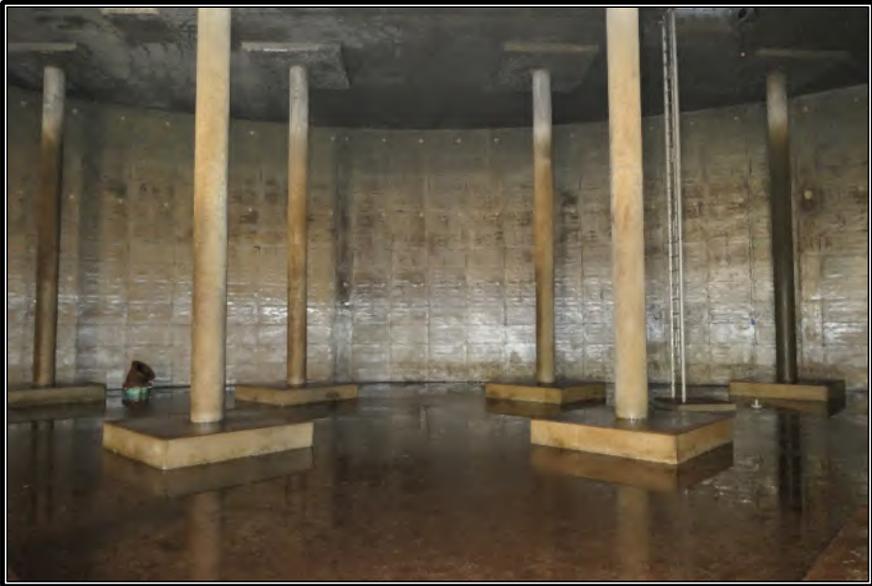
Figure 2-15:Interior Column Layout and Wall

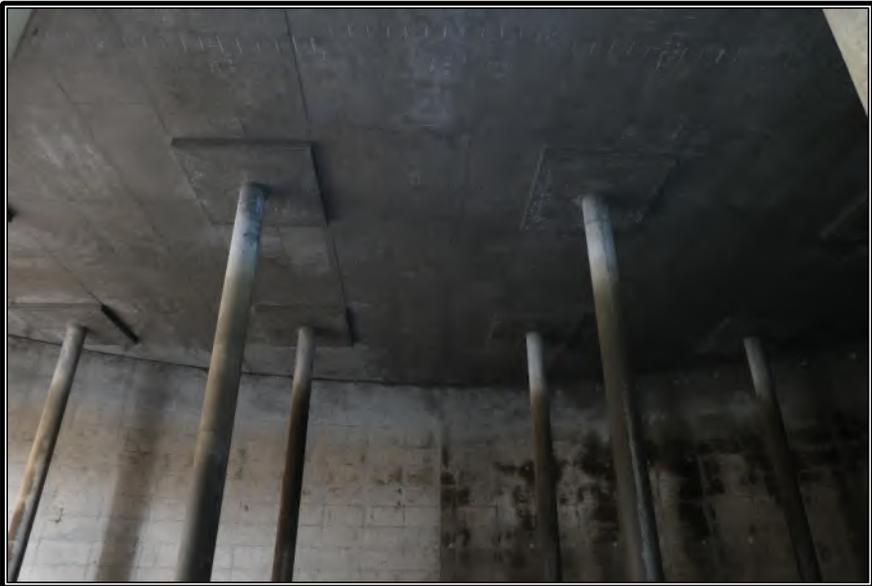
Figure 2-16:Interior Drop Panels and Roof

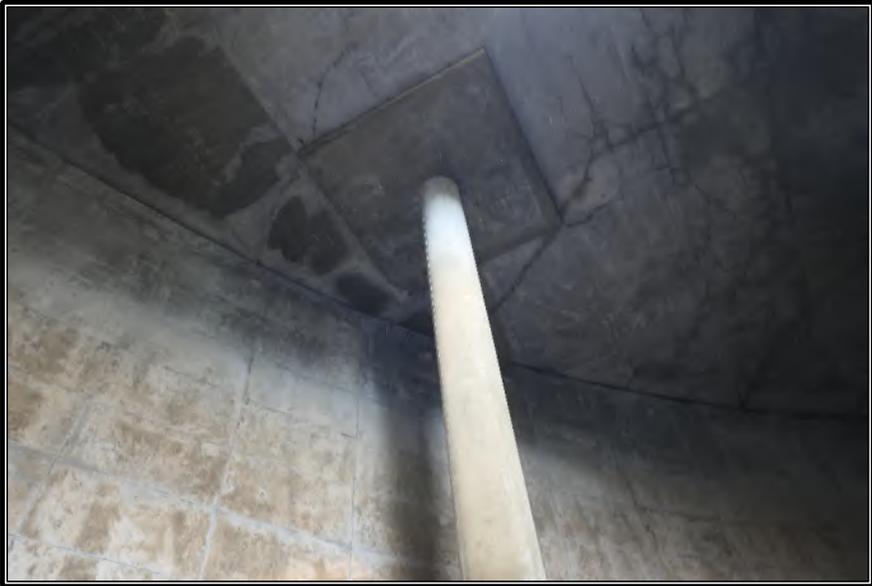
Figure 2-17: Typical Roof Cracking Along Sides of Drop Panel Near Roof Edge

Primary cracking note by drop panels nearest walls

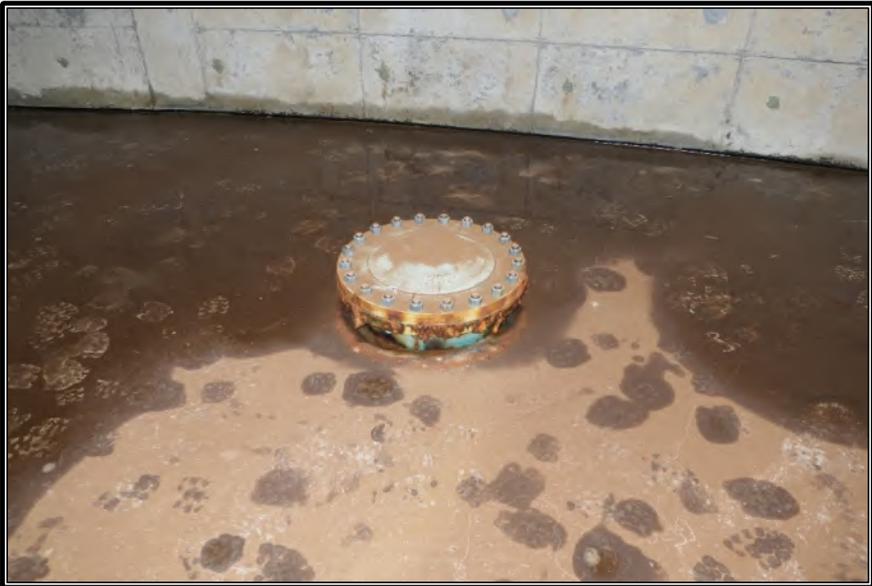
Figure 2-18: Capped Overflow

Note: No overflow pipe. Tank level set by zone.

PSE recommends the installation of an overflow pipe to meet the requirements of AWWA D110-13 Section 3.11.2.1. While the zone might generally be run at a level below the base of the roof, each individual reservoir should be able to vent water as necessary. Overfilling a reservoir can result in damage to the roof since they are not designed to withstand hydrostatic, uplift loads. As the overflow pipe is already in place, PSE would recommend attaching the remaining portions of the overflow assemble in order to alleviate any possibility of damage that might occur to the roof, due to overfilling of the reservoir.

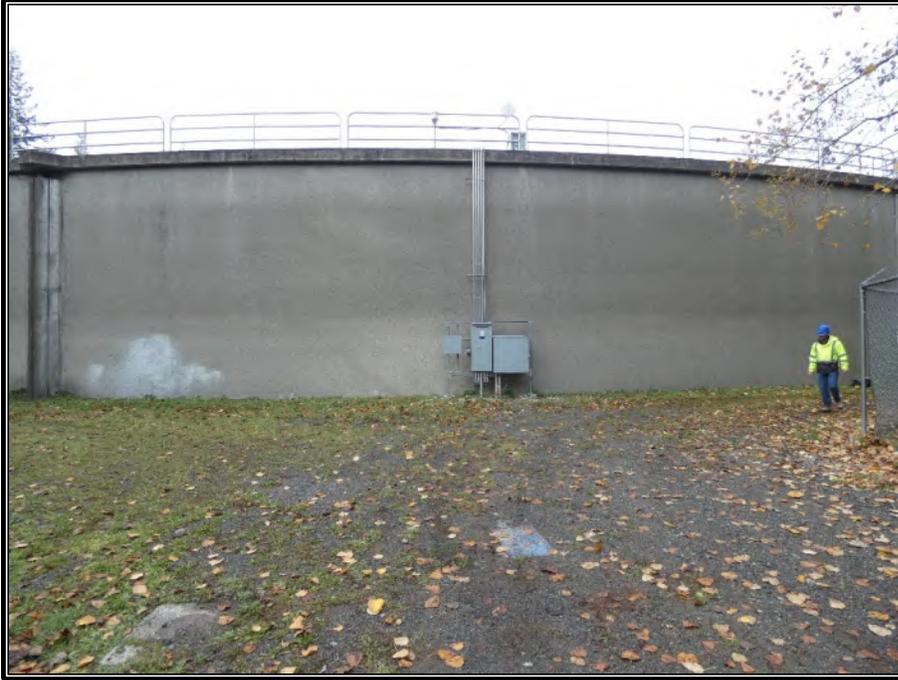
Figure 2-9: Whatcom Falls 2 - Reservoir South Elevation

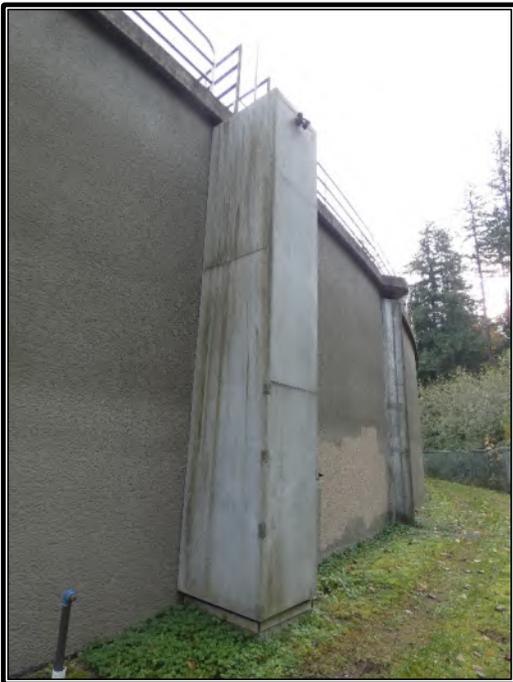
Figure 2-10: Whatcom Falls 2 - Reservoir South Elevation & Exterior Ladder

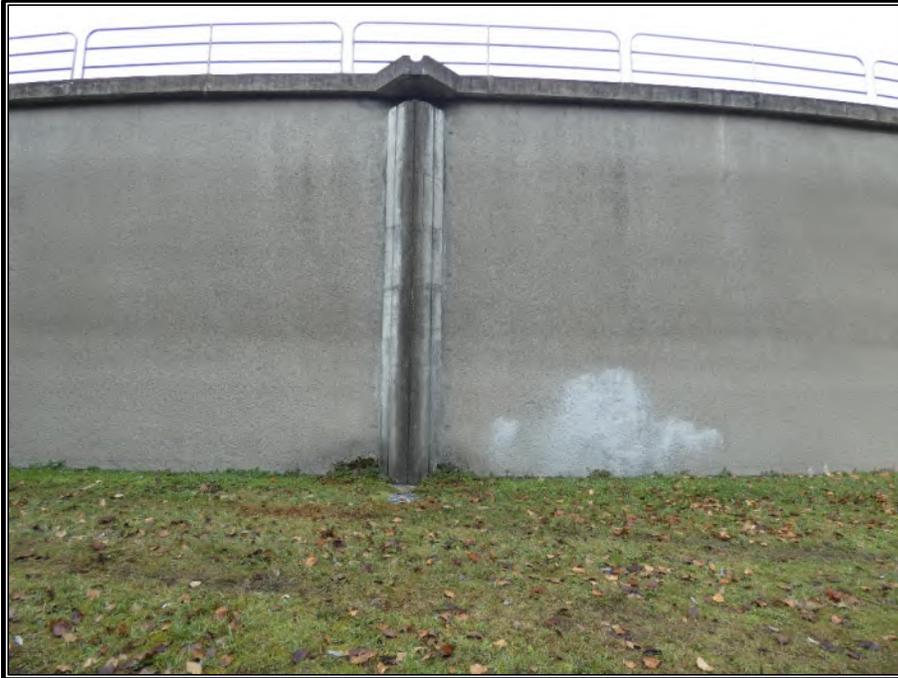
Figure 2-11: Whatcom Falls 2 – Reinforced Roof Drain

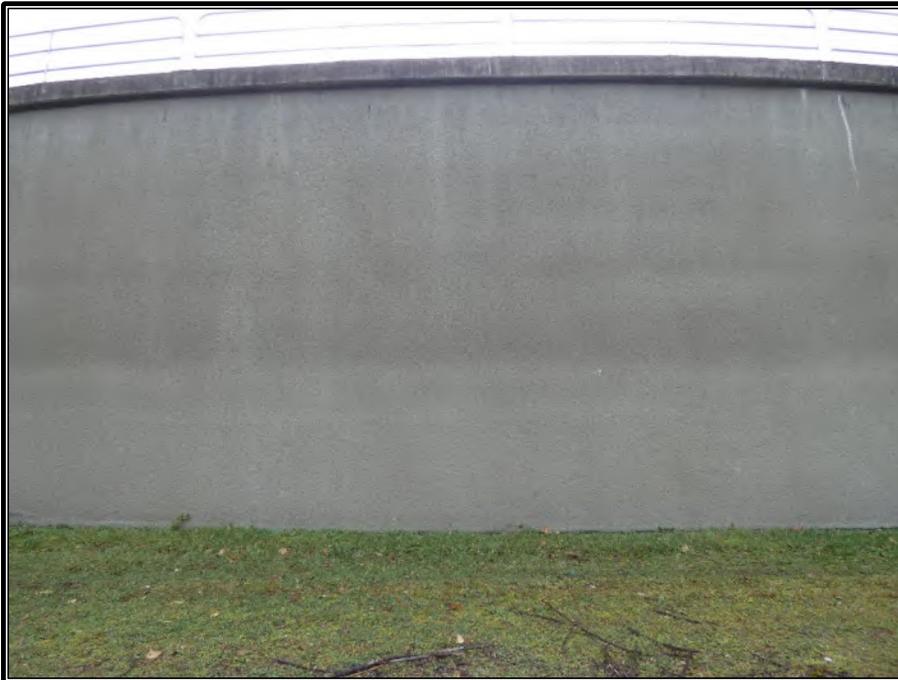
Figure 2-12: Whatcom Falls 2 – Wall Shotcrete (minor alligator cracking observed)

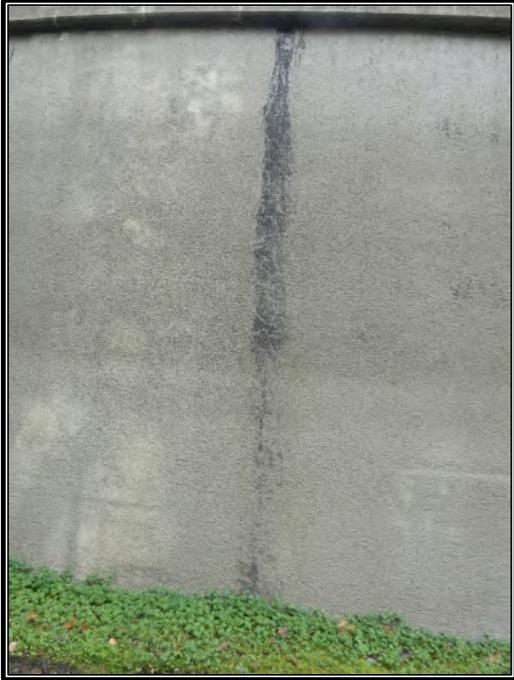
Figure 2-13: Whatcom Falls 2 – Location of Wall Discoloration (likely in line with shear can per Figure 2-15)

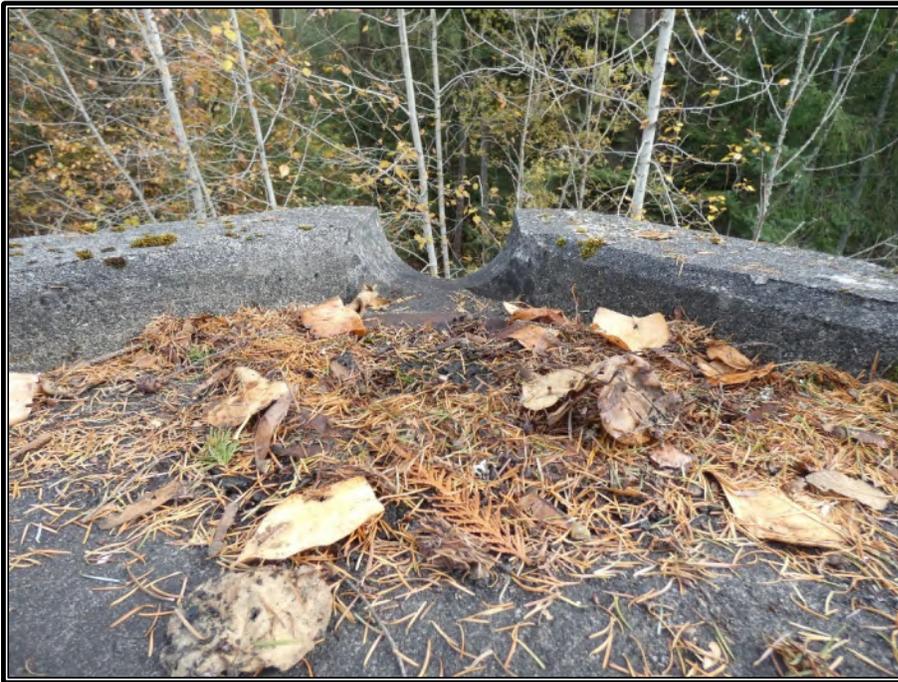
Figure 2-14: Whatcom Falls 2 – Blocked Drain and Core Demo'ed Parapet to Facilitate Drainage.

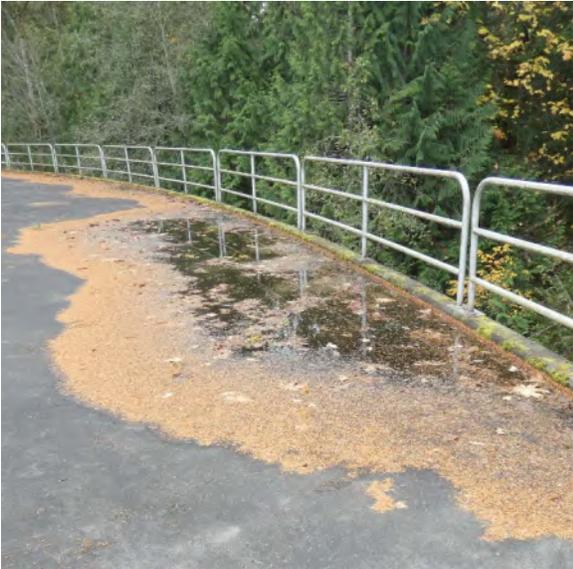
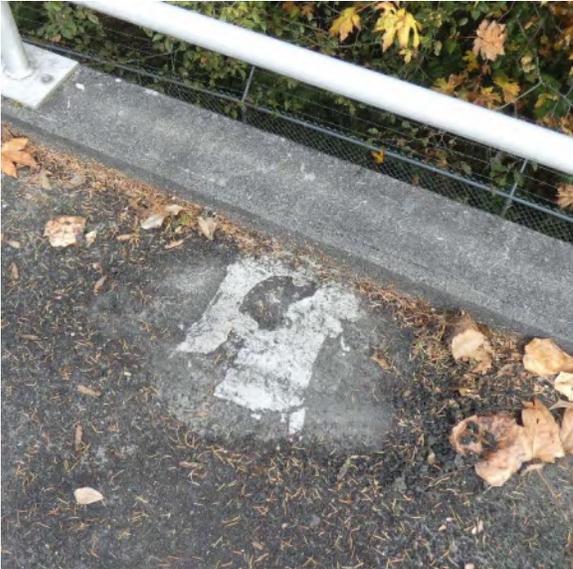
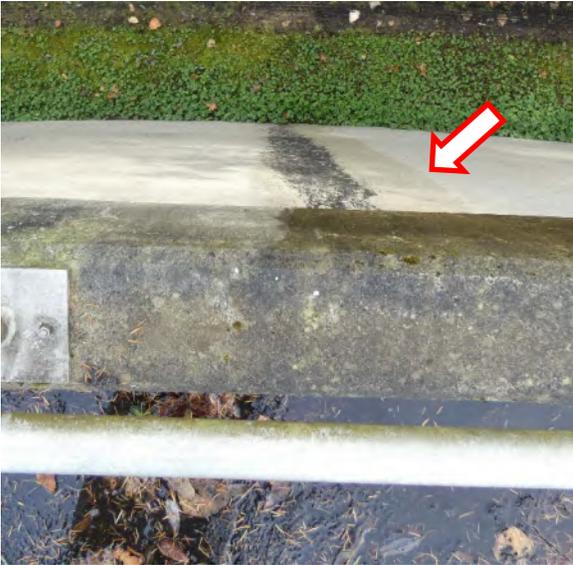
a) Location of Ponding

b) Top of Shear Can, with coating repair

c) Shear can near edge can allow for leakage

d) Water and staining emanating from underside of roof.

Figure 2-15: Whatcom Falls 2 - Potential Leakage Path Resulting from Ponding and Shear Can configuration.

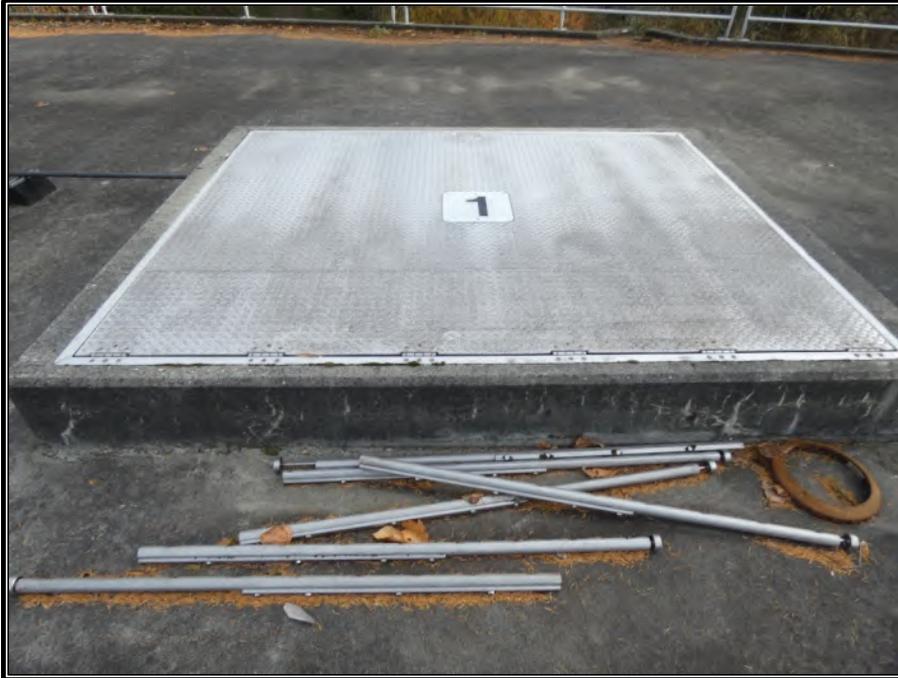
Figure 2-16: Whatcom Falls 2 – 6x6-foot Equipment Hatch.

The roof has multiple large and small access hatches located at various locations on the roof roughly corresponding to the baffle's route. These hatches include three 6x6-foot square equipment hatches, four 3x3-foot square access hatches, and an additional five 3x3-foot square vents. For these hatches the drawings call for 8-inch thick curbs around the perimeter of the hatch along with #3 rebar hoops. However, all the hatch curbs appear to have been constructed with two thinner sides and without the required hoop reinforcing. Per Figure 2-17 this appears to have resulted in cracking along the thinner sides and is likely due to freeze-thaw issues. For the appurtenances themselves, the vents appeared to meet current requirements for water quality. The equipment and access hatches, which have an edge inset into the curb, are considered high-maintenance designs per the Washington State Department of Health. The gutter-drains for these hatches should be screened to further protect them.

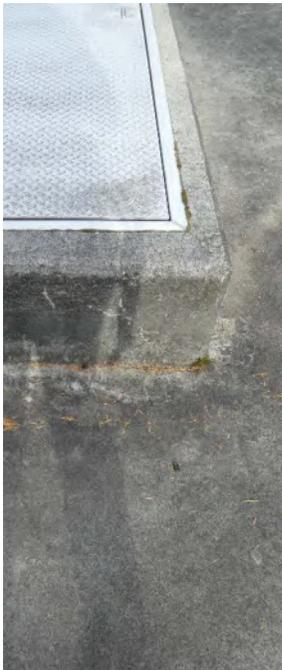
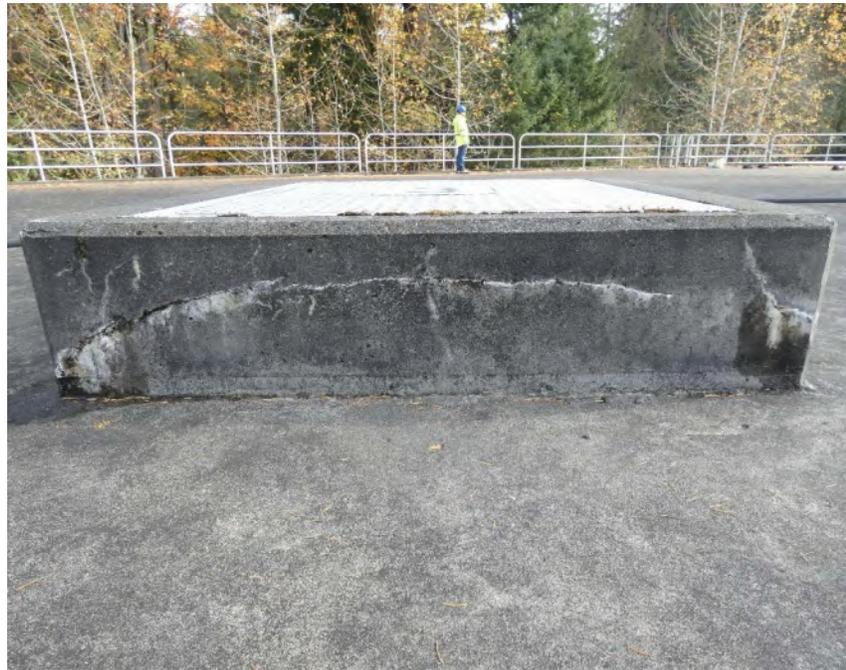
a) Difference between thicknesses along sides

b) Cracking along thin edge

Figure 2-17: Whatcom Falls 2 - Cracking noted in Hatch Curbs

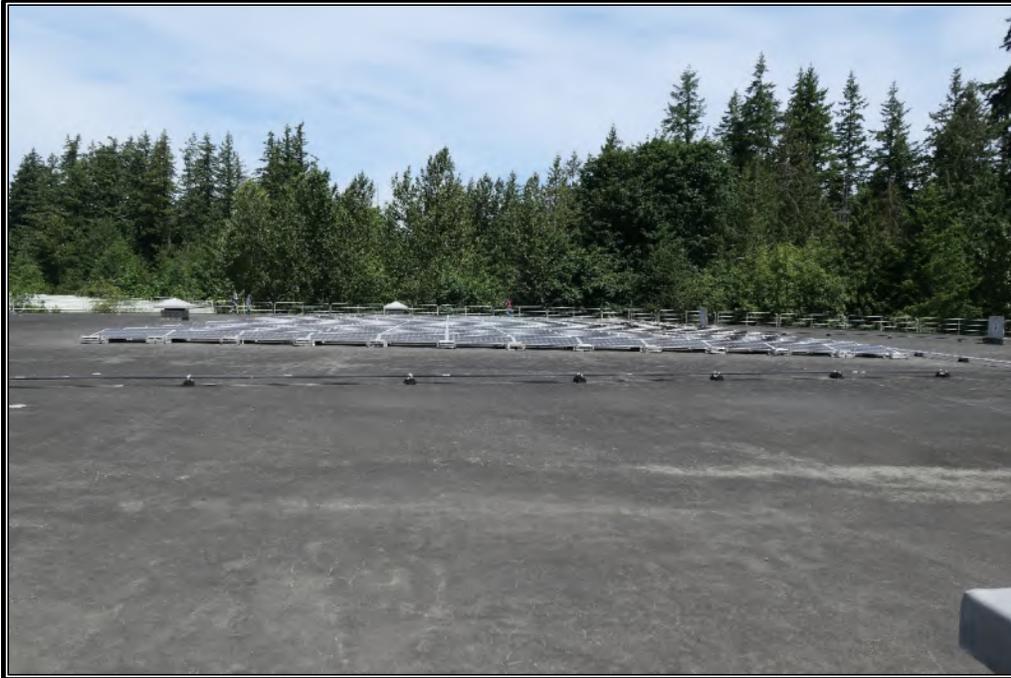
Figure 2-18: Whatcom Falls 2 - Roof Mounted Solar Panel Array

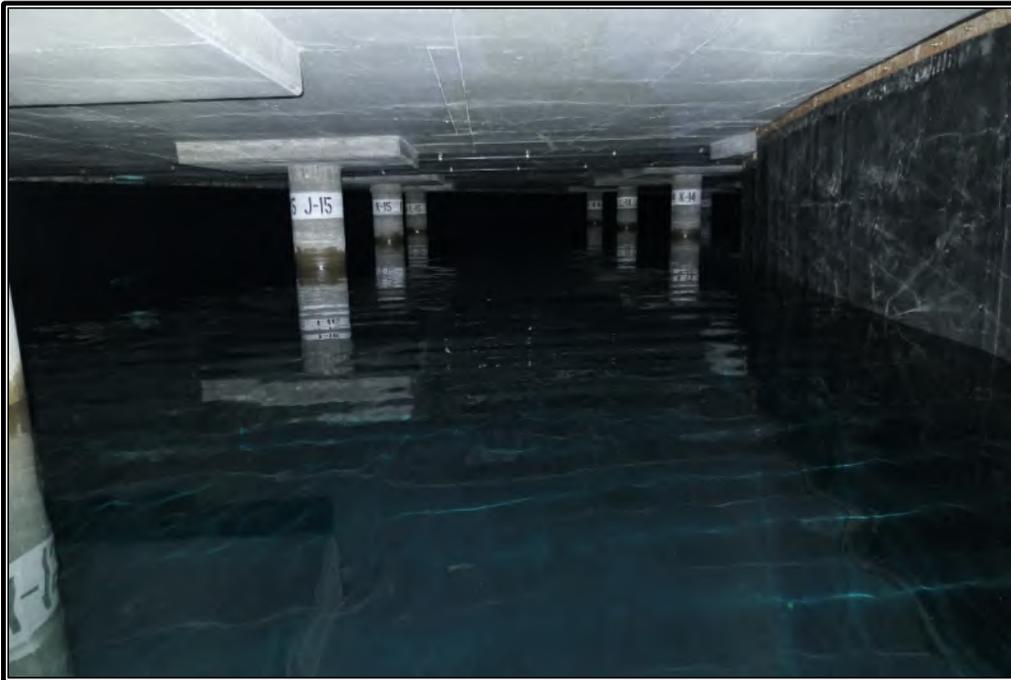
Figure 2-19: Whatcom Falls 2 - Interior Columns

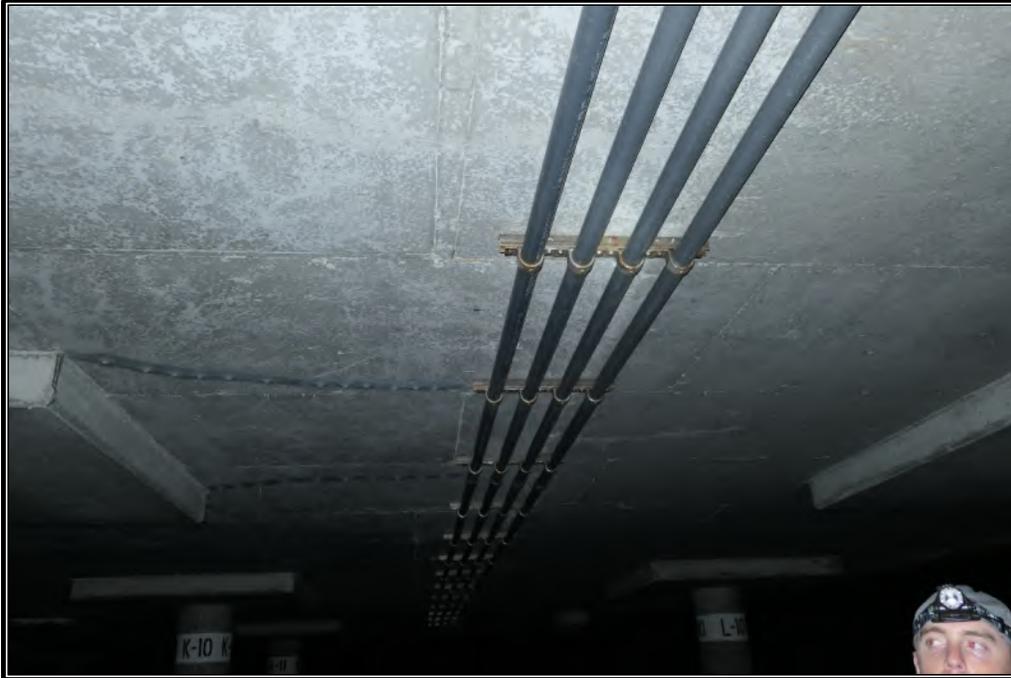
Figure 2-20: Whatcom Falls 2 - Roof Mounted Conduit

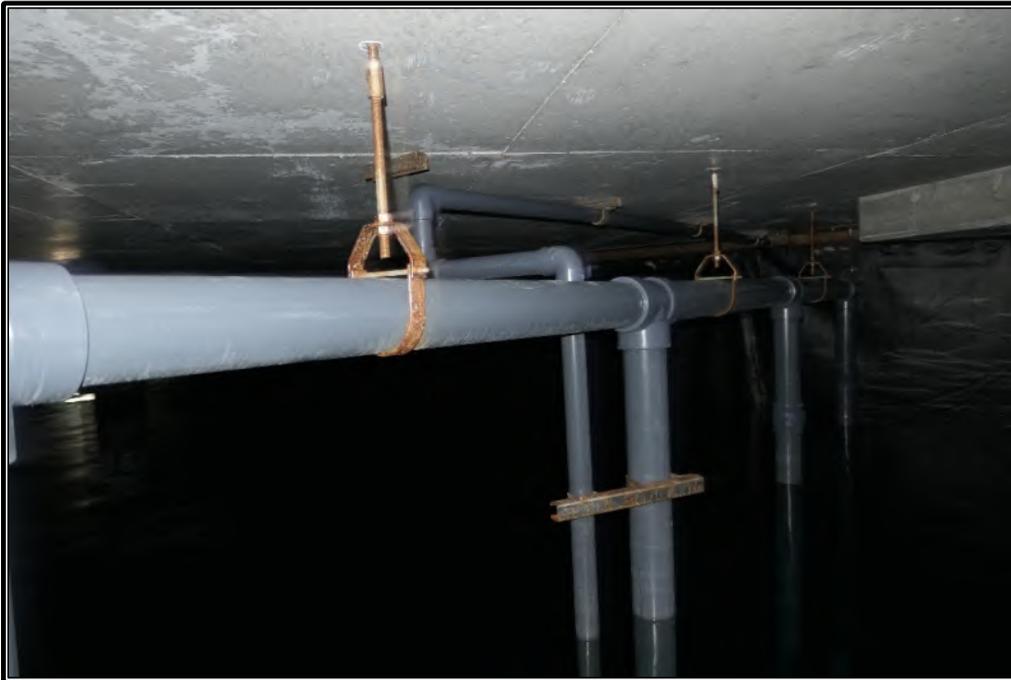
Figure 2-21: Whatcom Falls 2 - Components part of Chlorine Diffuser System

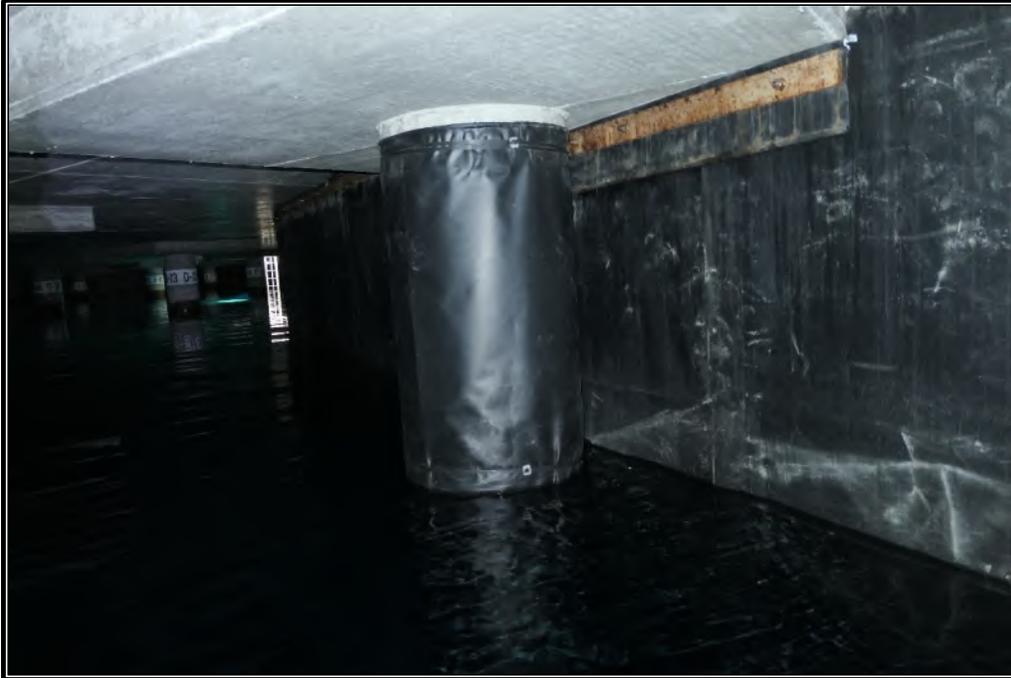
Figure 2-22: Whatcom Falls 2 – Baffle Adjacent and Anchored to Column

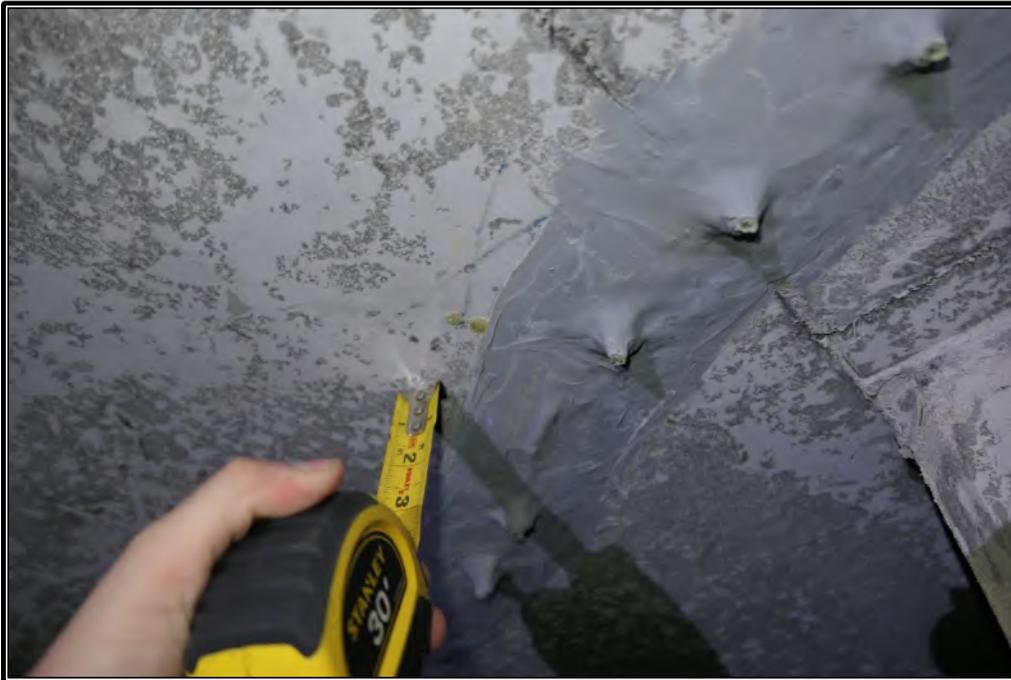
Figure 2-23: Whatcom Falls 2 – Previous Crack Sealing Work

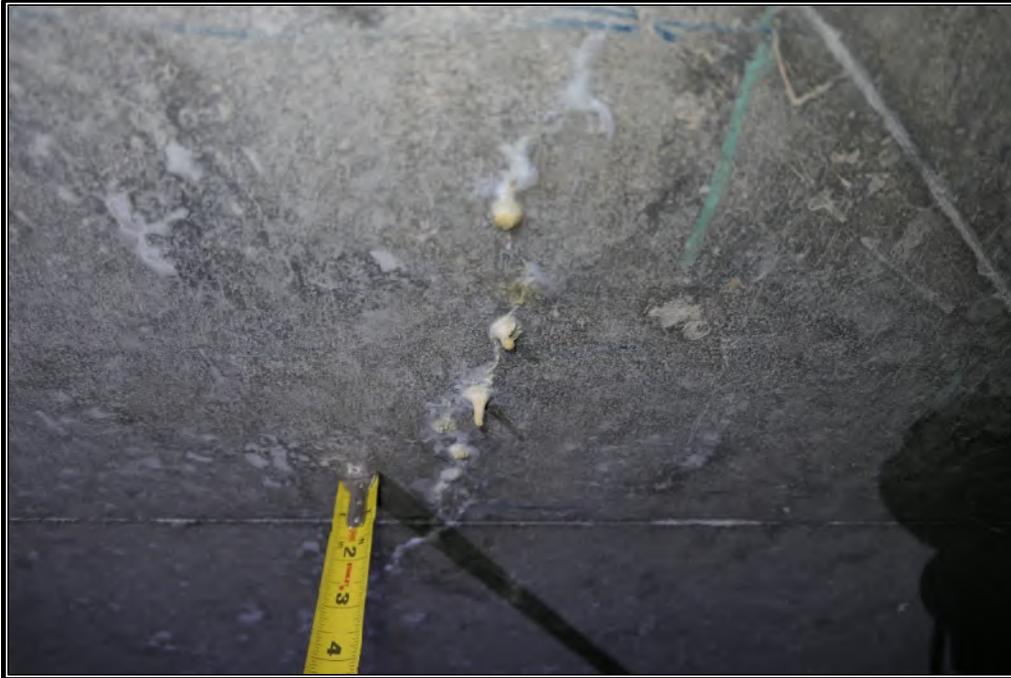
Figure 2-24: Whatcom Falls 2 – Mineralization Seeping through New Crack

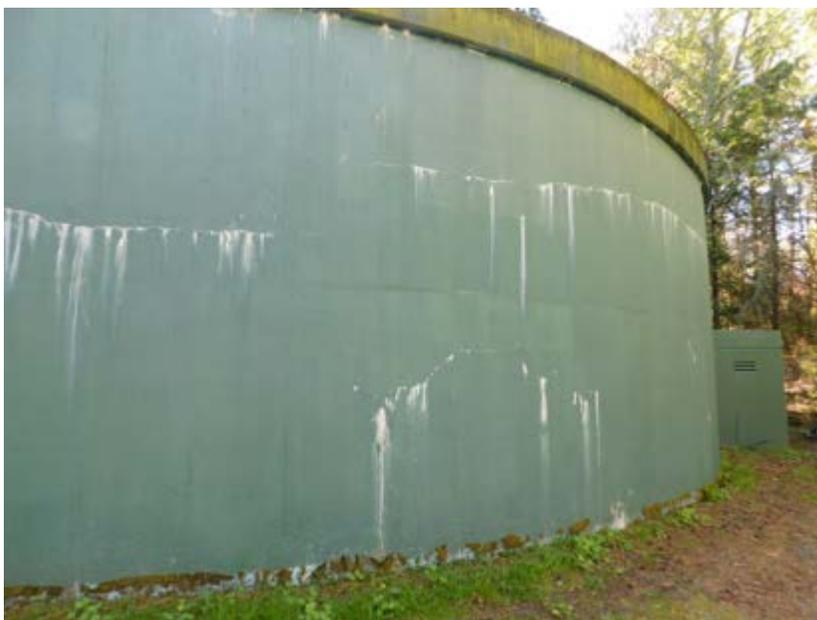
40th Street – typical exterior surface condition around sidewalls. Cracks in the concrete have led to calcium carbonate accumulation on the surface.

In order to help preserve the life of the concrete, the tank exterior sidewalls will need to be cleaned and have all cracks properly sealed. This will extend the life of the existing coating an additional (+/-) 10 years. The roof coating should be cleaned to remove all materials accumulation.

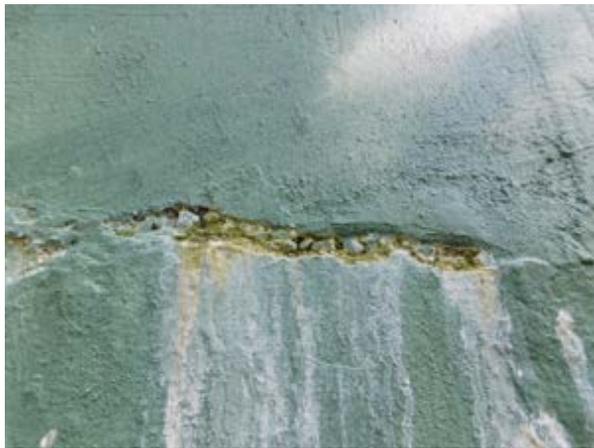
Sidewall concrete damage

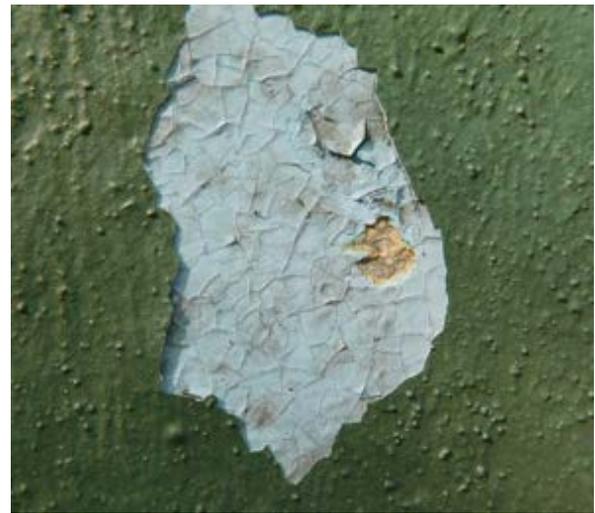
Green overcoat, blue undercoating has cracking over entire surface, unknown if this is typical

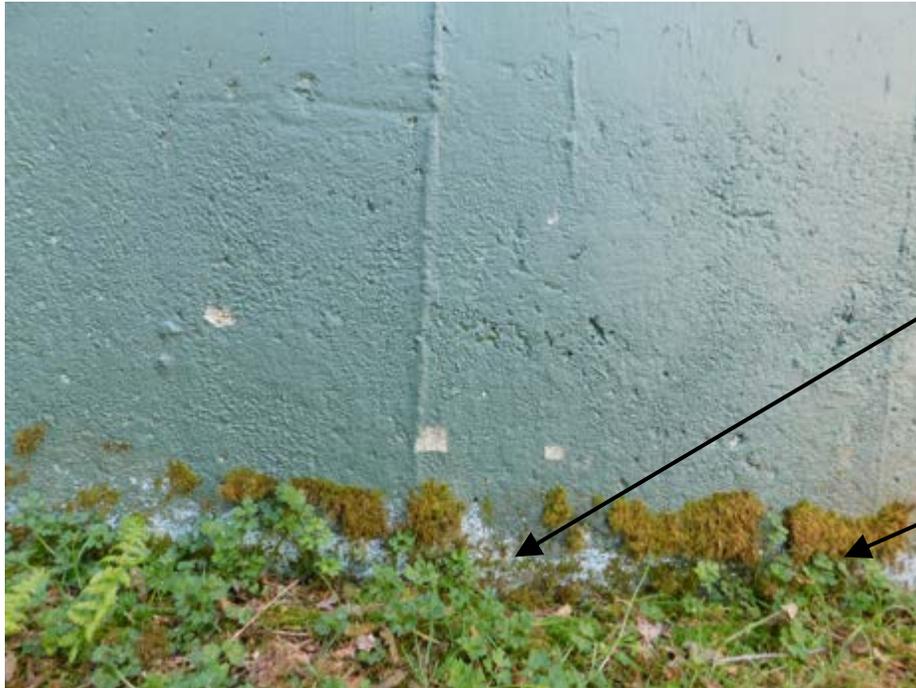
The lower 4-inches of the tank has coating disbondment and is missing coating in many locations with moss and other organic material buildup extending from grade up to the first 6-inches of the exposed concrete. The original coating appears to be a three coat system with a beige primer, green intermediate coat and blue overcoat. At a later date, it appears that the sidewalls were covered with a green coating. The top coating is moderately tight and measures 5 – 8 mils thick. A majority of the bug holes have been coated over as opposed to filled during the coating work.

Missing coating
bottom 4-inches
of tank

Moss accumulation
on bottom 6-inches
of tank

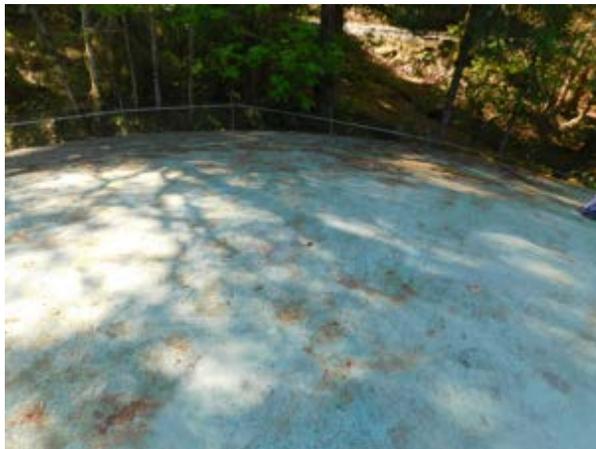
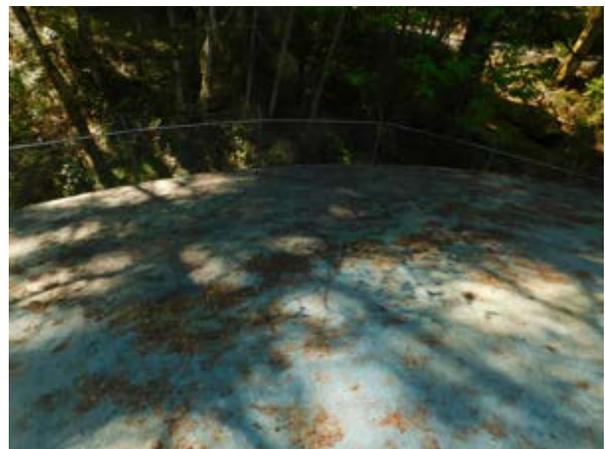
The exterior surfaces, particularly the roof, are very dirty and need to be cleaned in order to discourage continued coating damage.

Tank roof surfaces, should be power washed to remove material buildup

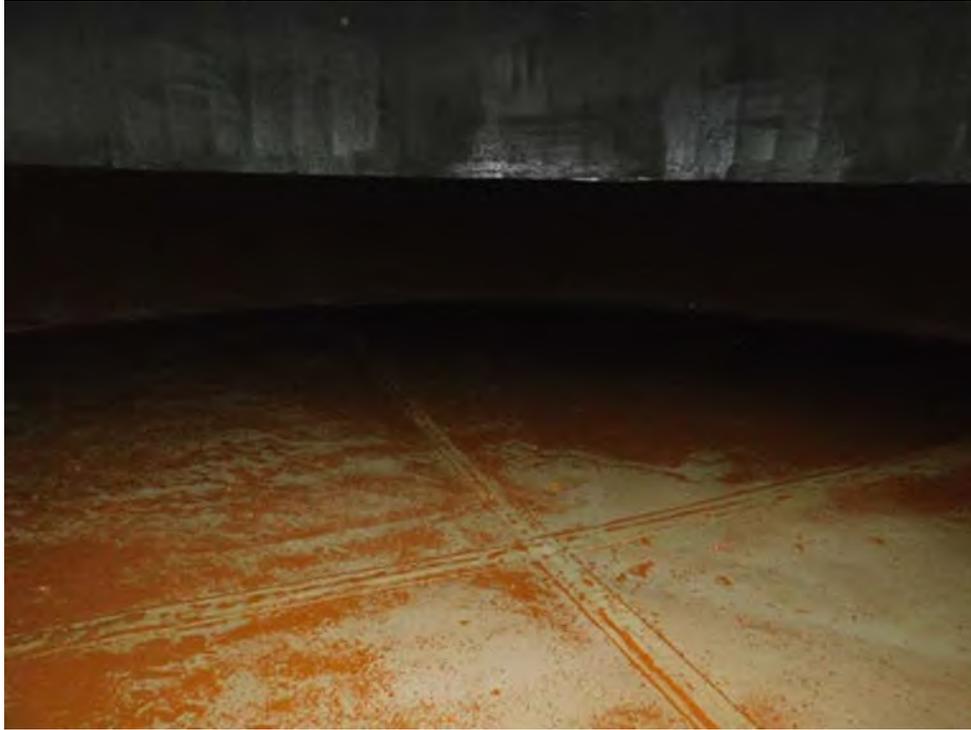
Outlines of the tape seams applied to the floor joints were visible in multiple areas. The tape material is still adhered to the floor surface. There was coating blistering found on the floor and sidewall transition. This may be due to groundwater effects as the tank was properly dry and cooling (to discourage outgassing) when the coating material was applied.

Floor with tape applied over joint seams

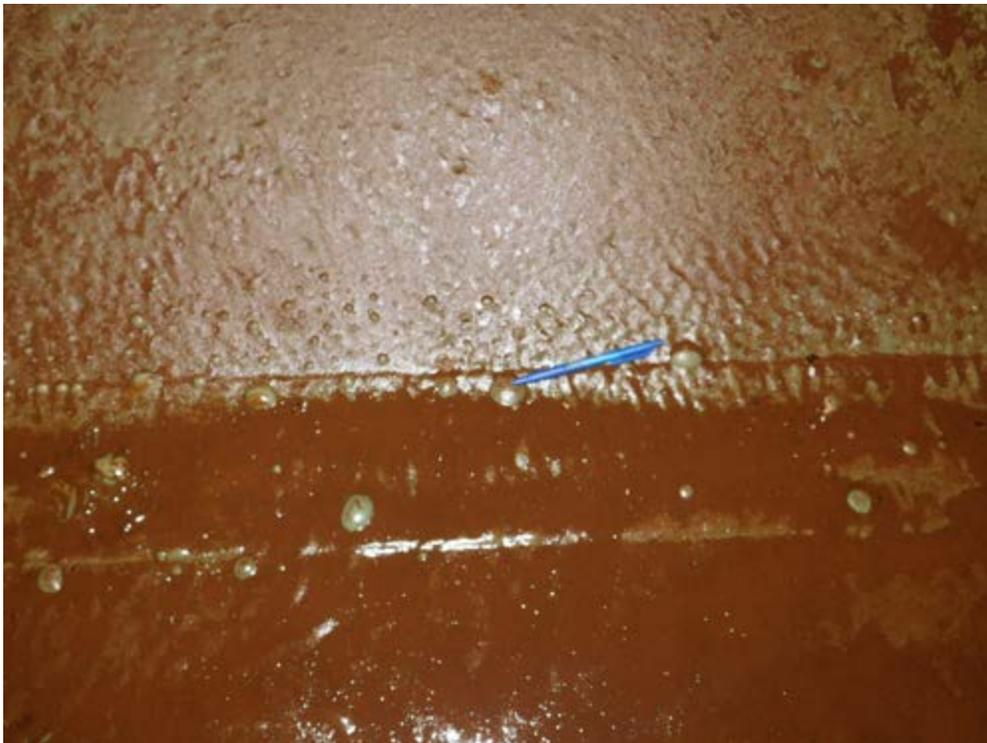
Blistering at floor/side wall transition zone

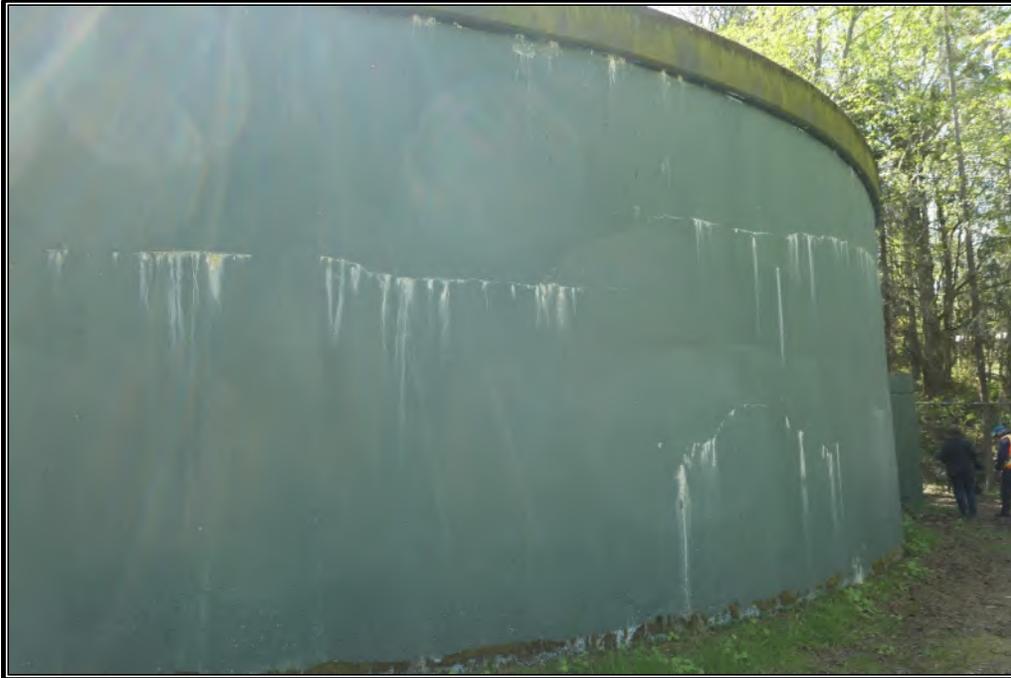
Figure 2-6: 40th St Reservoir – Circumferential Cracking around Reservoir below Roof Line and along Wall

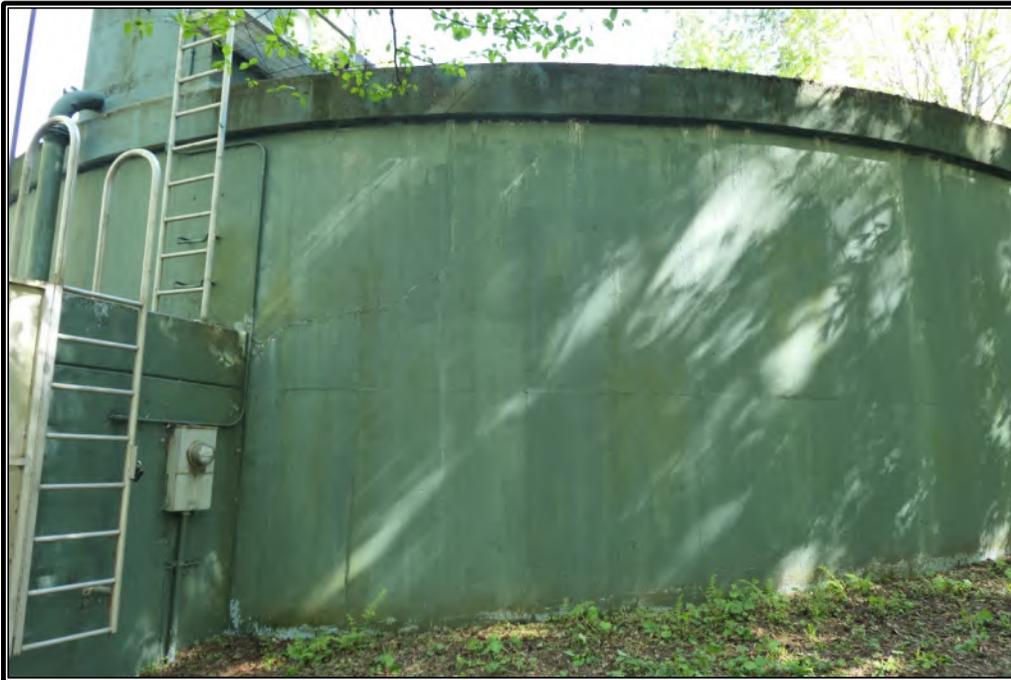
Figure 2-7: 40th St Reservoir – Cracking adjacent to Valve Vault

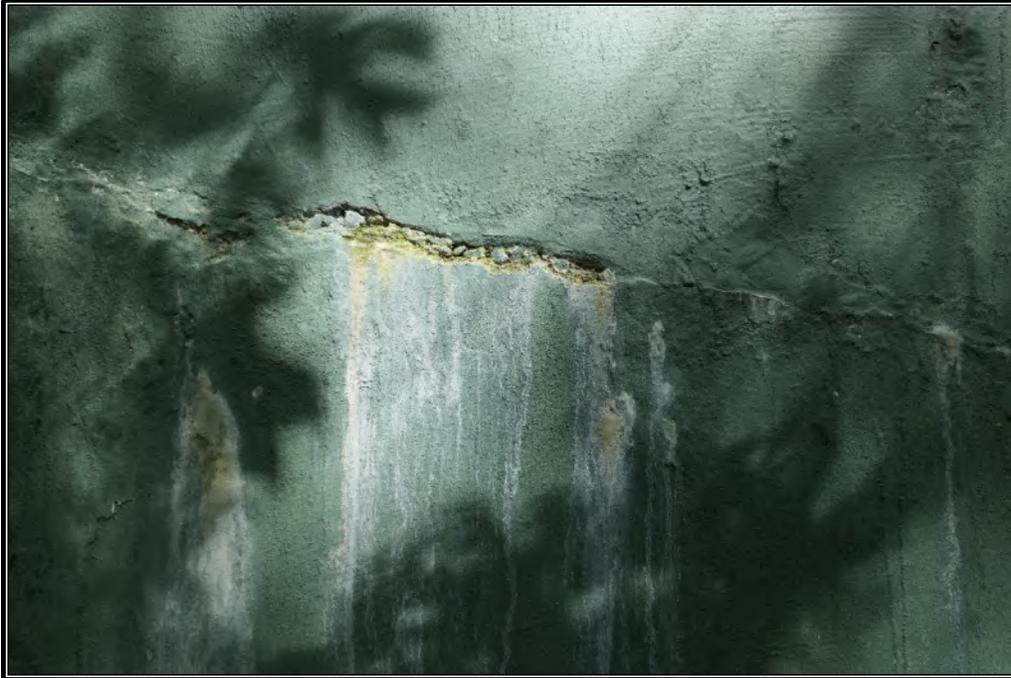
Figure 2-8: 40th St Reservoir – Rock Pocket and Associated Failure and Cracking

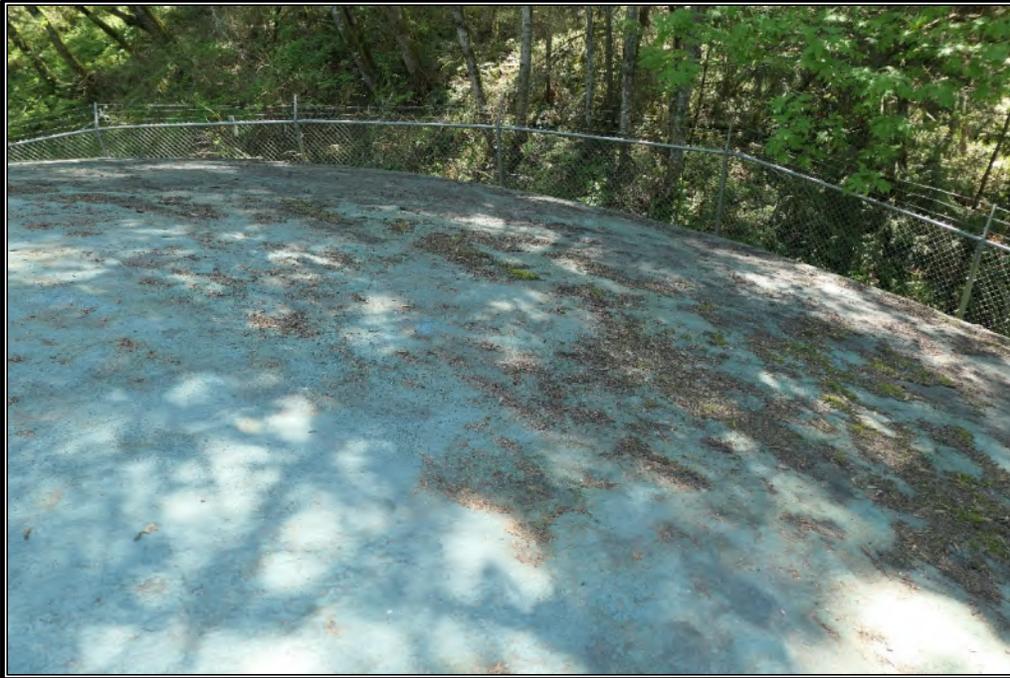
Figure 2-10: 40th St Reservoir – Moss on Roof in southwest side of roof overhung by trees

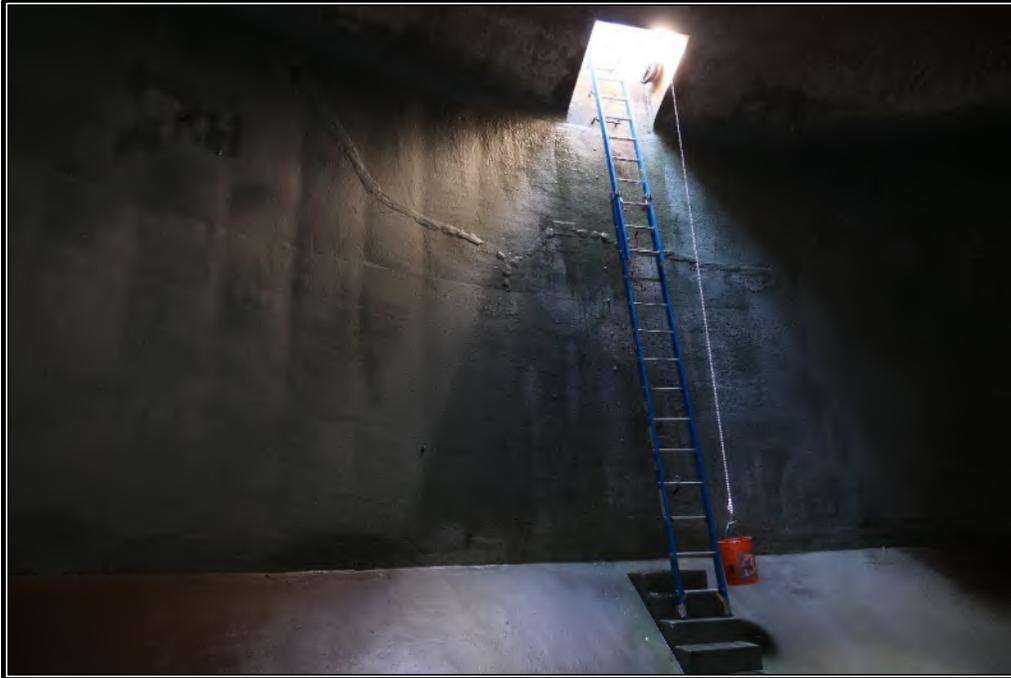
Figure 2-12: 40th St Reservoir – Coating Patchwork Over Interior Crack adjacent to Valve Vault

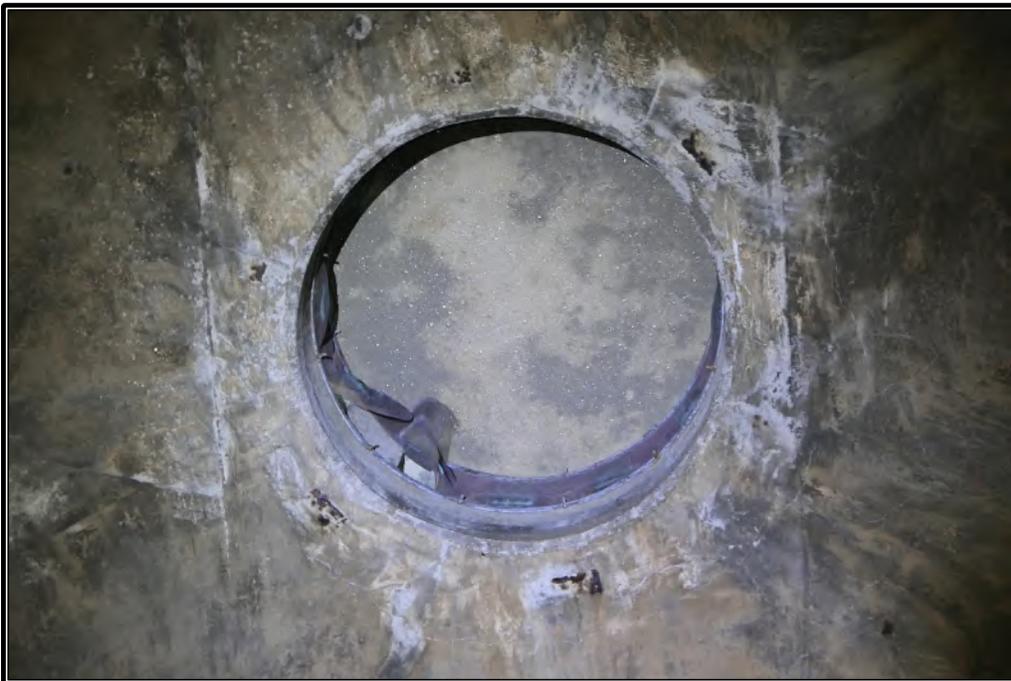
Figure 2-13: 40th St Reservoir – Dome Roof Interior Side of Vent – Concrete Spall noted around perimeter.

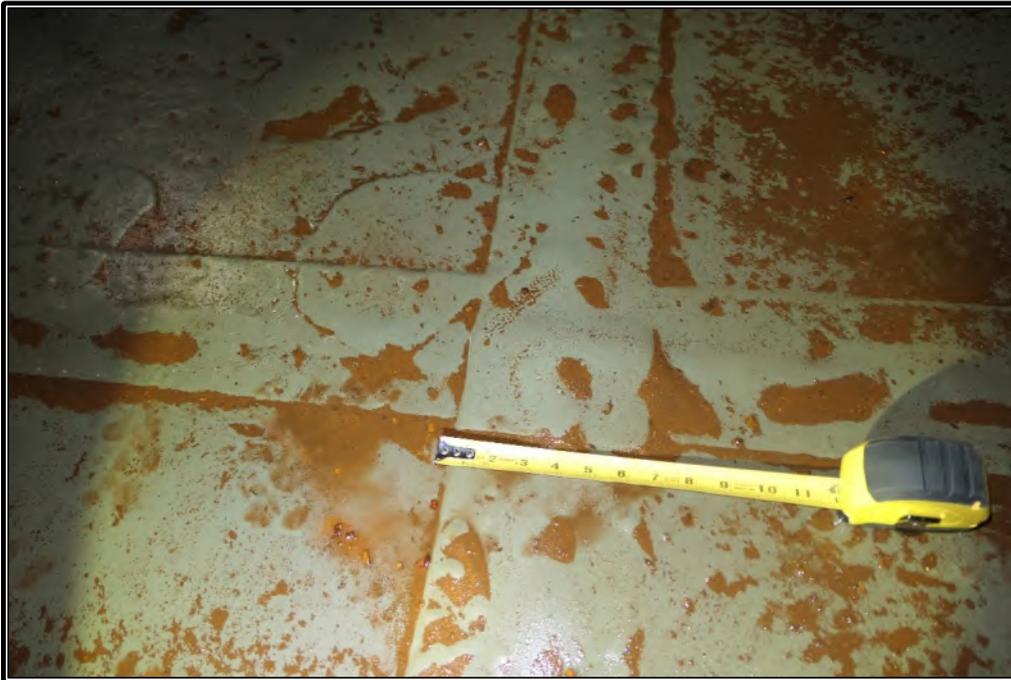
Figure 2-15: 40th St Reservoir – Reservoir Floor Coating Joint

Floor Slab Condition: Coated floor. No cracking visible. Coating is bubbling in some areas
