APPENDIX

Date: January 22, 2020

Subject: City of Bellingham Reservoirs Inspection and Repairs
Marietta Site

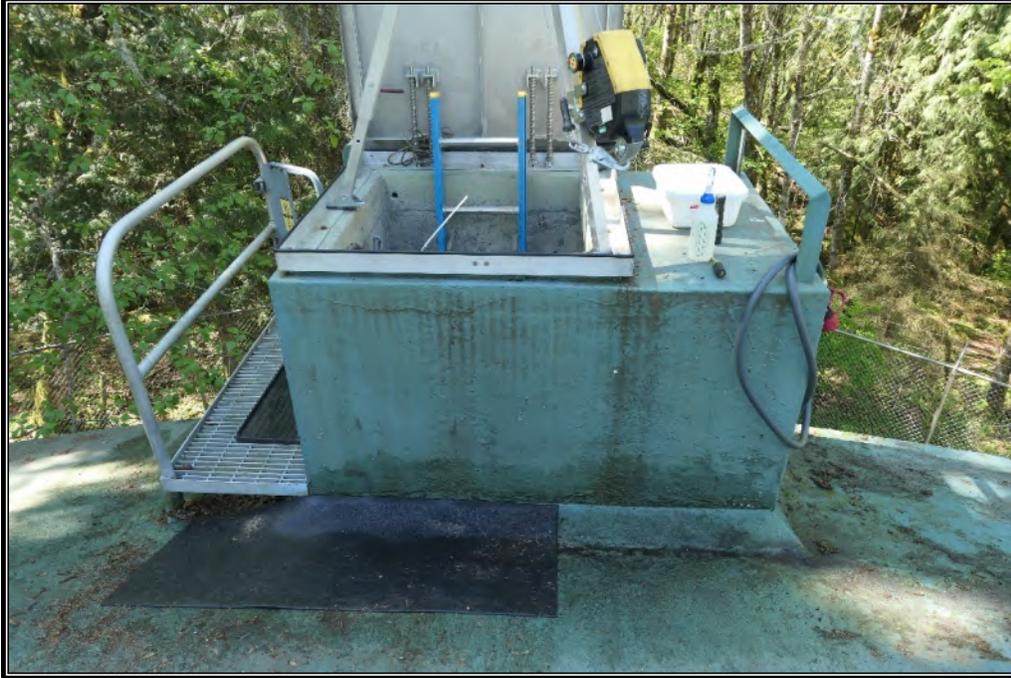
Figure 2-16: 40th St Reservoir – Access Hatch

Entry Hatch:		
Hatch Location:	Roof	
Material:	Aluminum	
Condition:	Good	
Gasketed:	Yes	
Intrusion Alarm:	Yes	
Lock:	Yes	
Frame Drain Location:	Toward center of reservoir	
Measurement Type	Measurement	Unit
Size:	3x3	ft
Curb Height:	4	in
Notes: 3 ft 2in from roof to top of concrete

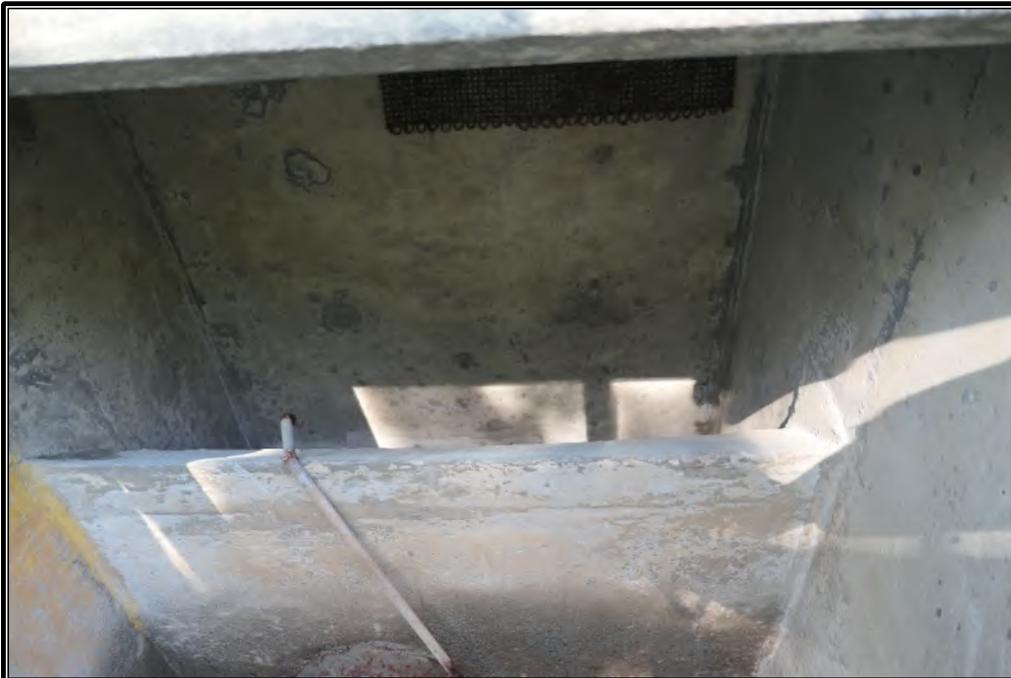
Figure 2-17: 40th St Reservoir – Overflow Weir Gate and Shear Gate Handle - Located in Access Hatch

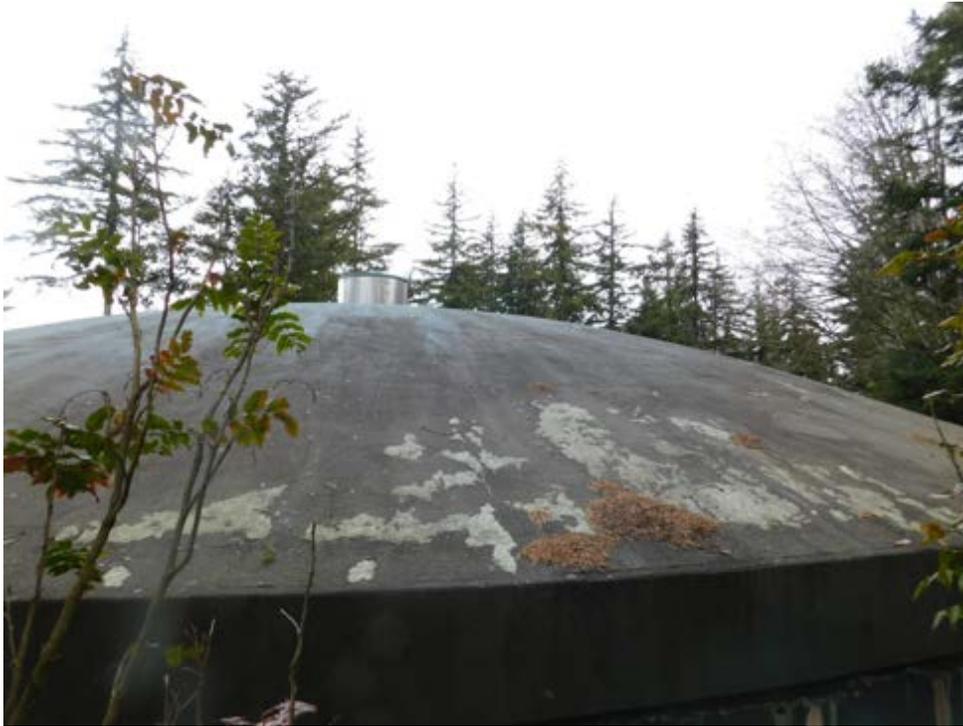
The exterior roof surfaces are covered with organic matter and debris. The top coat material is peeling off in several locations and ~ 15% of the top coating has delaminated exposing the underlying coating. The underlying coating is tightly adhered to the concrete surface, however the top coat can be easily peeled off using a razor knife at the defect areas. Otherwise, the top coat material appears to be well adhered.

Heavy debris accumulation and top coat loss

In order to help preserve the life of the concrete, the tank will need to be cleaned, have all cracks properly sealed, and a repair overcoating applied. This will extend the life of the existing coating an additional (+/-) 10 years. Otherwise, removal of all existing coatings, repair of concrete and sealing of cracks, plus the application of a new exterior protective coating can be applied that will provide a protective service life of more than 20 years with appropriate minor maintenance.

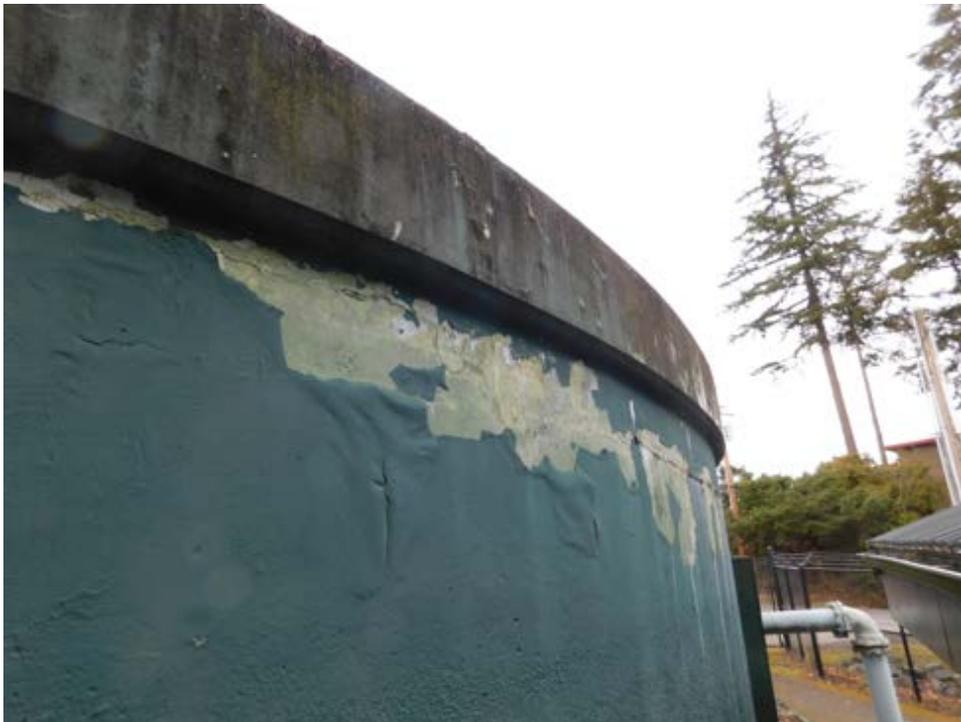
The sidewall surfaces also have significant coating damage, mostly near cracks in the concrete where pressure exerted on the coating has peeled it from the surface. This is readily evident along most of the upper sidewall perimeter. A small area was also noted where the concrete at the soil interface had not been coated and aggregate material is exposed to the atmosphere. There is also a large crack in what appears to be a mortar type lining near the exterior roof access ladder. This may have been a previous concrete repair area that is now failing.

Top coat loss and delamination on sidewalls

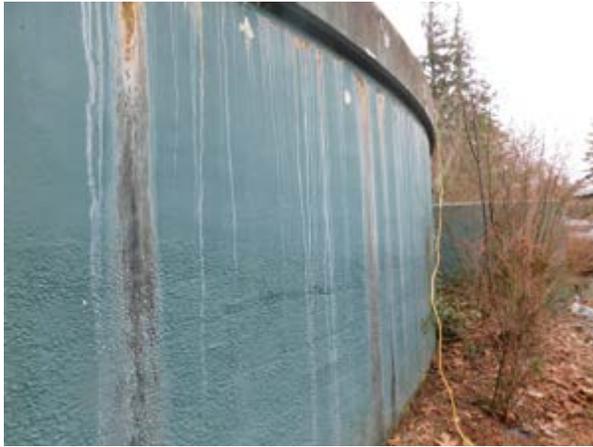
Sidewall staining

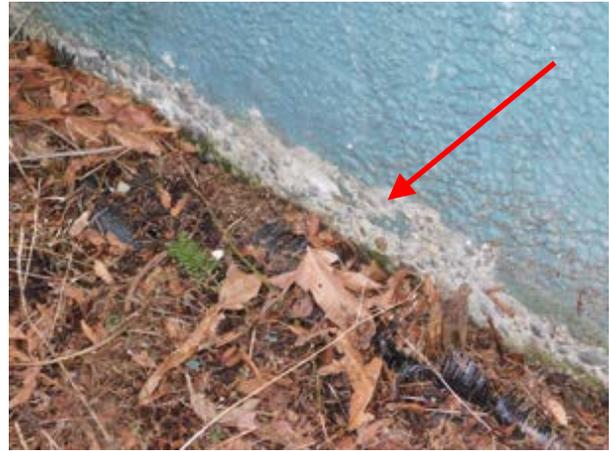
Missing coating at base of tank

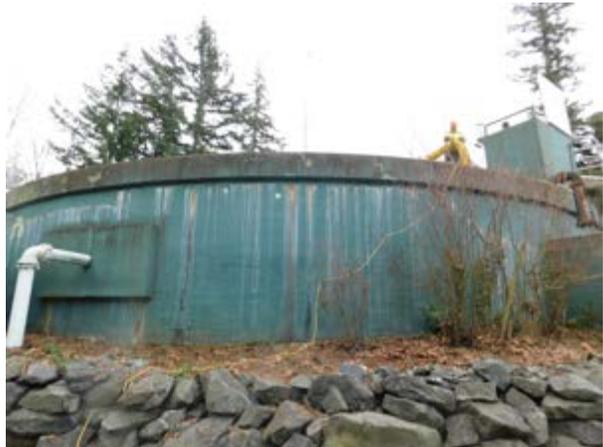
Additional staining on sidewall

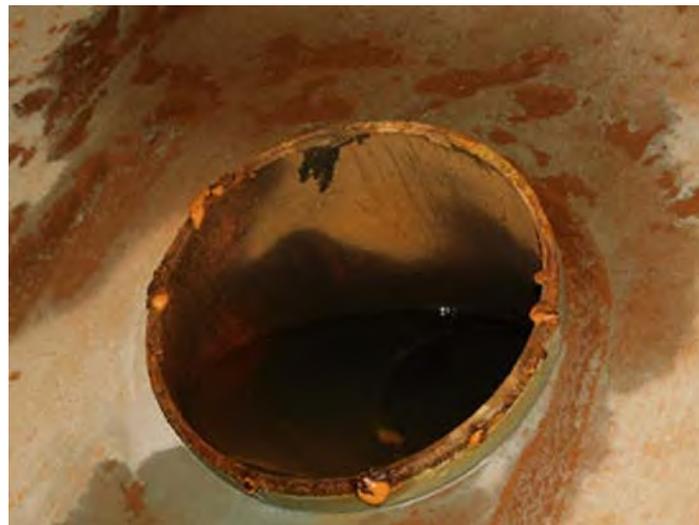
The hydraulic mixing pipe has developed a thick layer of external corrosion and tuberculation. This is the result of a metallic couple whereby the ductile iron surfaces in contact with the water become anodic relative to the ductile iron in contact with (transitioning through) the concrete wall. If the piping transitioning through the wall is in contact with prestressing cable or rebar, the surface area ratio between the anode (pipe in contact with water) and the cathode (embedded pipe and cable) is very large resulting in the noted corrosion. As can be seen in the picture below, the center of the short spool piece exiting the concrete is in relatively good condition because of its external coating. The outlet pipe to the pump station also has a lesser degree of tuberculation development on the exposed metallic edges.

Outlet pipe to pump station

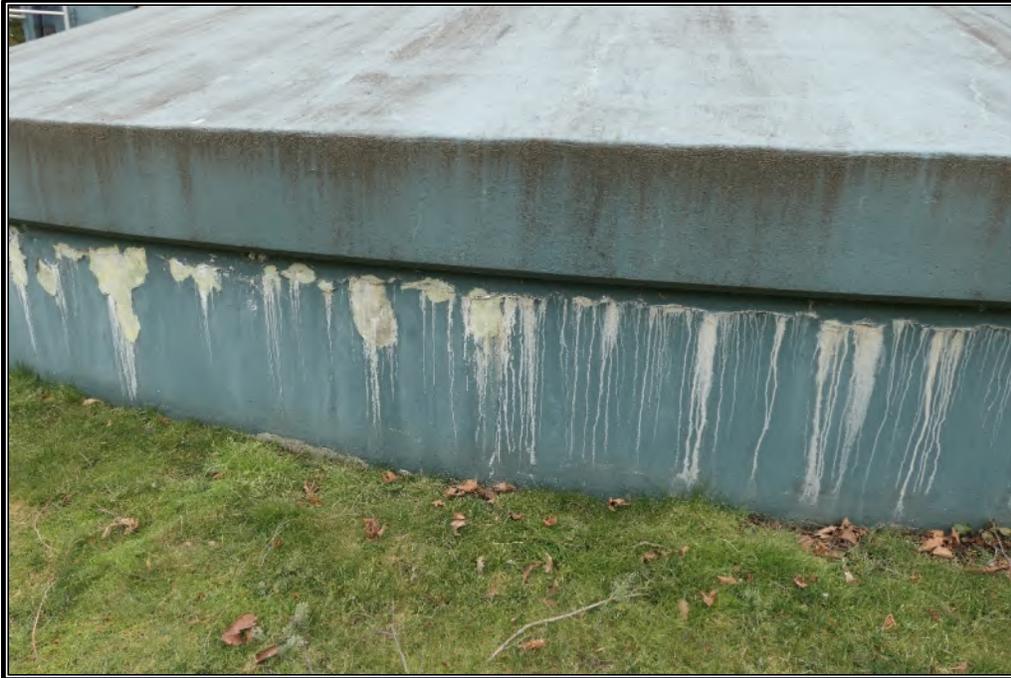
Figure 2-6: College Way Reservoir – Circumferential Cracking around Reservoir below Roof Line

PSE recommends the exterior wall be cleaned to remove all concrete which has been damaged due to the thermal expansion effects. As thermal movement is likely to continue, PSE does not recommend stiffening or reinforcing this area. By constraining the roof, the failure zone could be moved and potentially cause issues within the dome roof itself, if it is constrained against expansion. Rather, the cracking around the exterior should be cleaned and coated to protect any reinforcing against water infiltration and to prevent further damage to the concrete. Coatings and any repair medium should be flexible to prevent cracking during thermal movement. This is not a long-term fix but intended to limit the impact of water and corrosion on this area until a new roof or roof-to-wall retrofit solution is selected. Once the area is cleaned and any damaged concrete removed it is recommended that it be observed by a Structural Engineer to review the extent of damaged concrete and to determine if any additional or alternate repairs are advisable at that time.

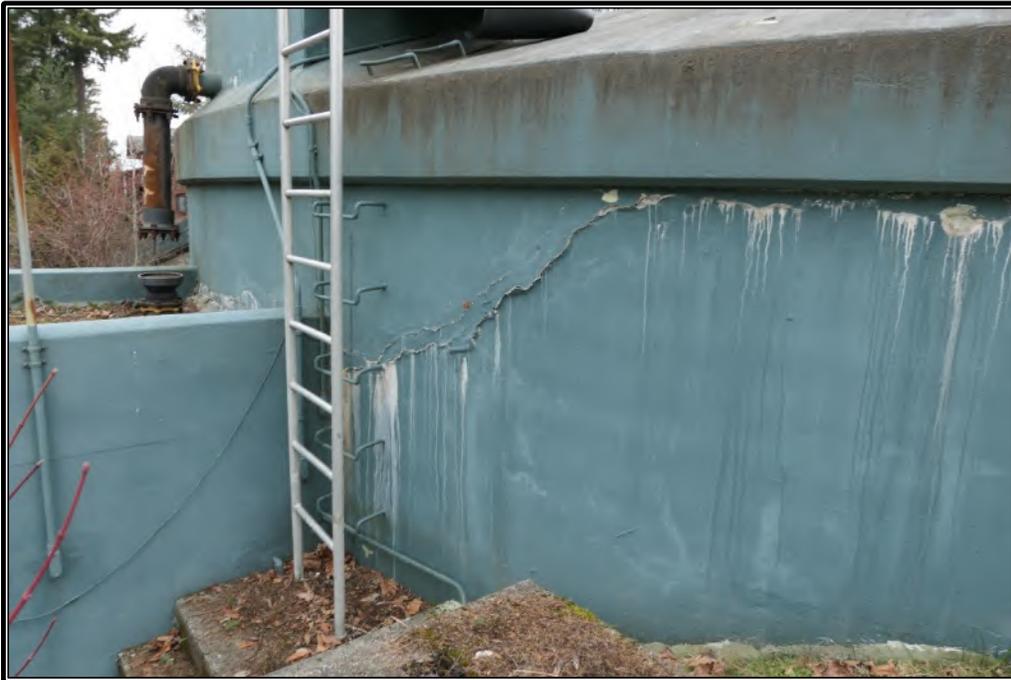
Figure 2-7: College Way Reservoir – Circumferential Cracking at Valve Vault

Finally, the valve vault piping should be retrofitted to ensure the piping has flexible fittings which can allow for differential horizontal and lateral movement between the vault and reservoir in a seismic event. Without appropriate flexible fitting piping could be damaged during a seismic event. As the structure is in close proximity to the reservoir's foundation, which is cast as part of the vault's wall, there is a potential for differential settlement or movement at this interface. As part of general maintenance, the vault should be cleaned and where it is attached to the reservoir, those joints should be sealed so as to prevent leakage. The lower level of the vault should be cleaned, and the leak location identified and sealed. Notches or overflow scuppers should be installed in the parapet to prevent the roof from overflowing if the drain backs-up.

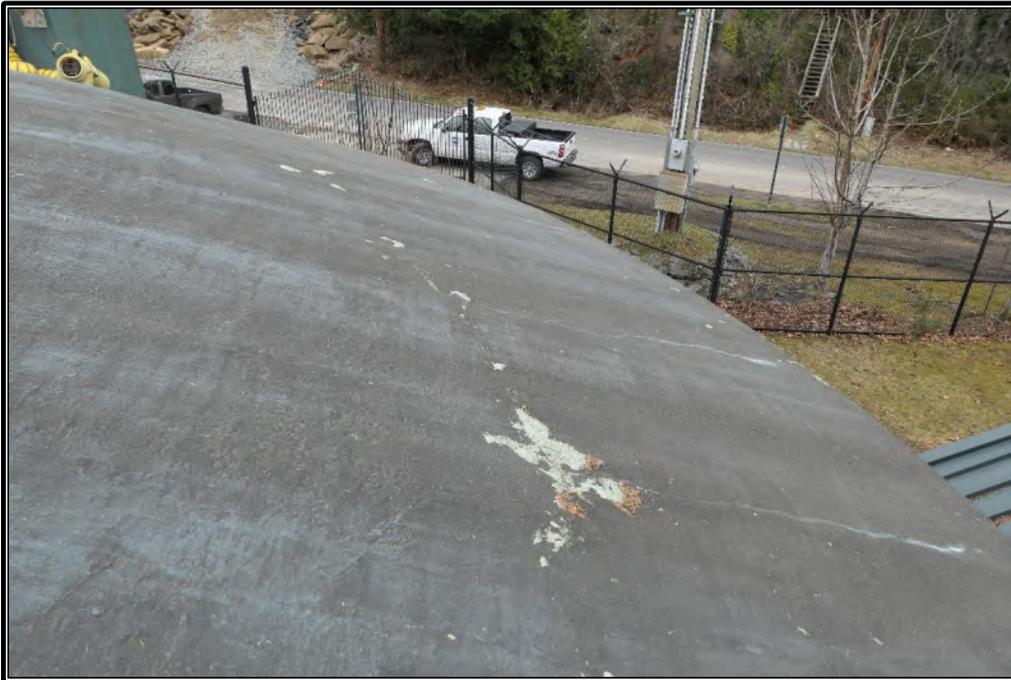
Figure 2-9: College Way Reservoir – Circumferential Cracking around Dome Roof Edge

If the existing dome roof cannot be removed, a retrofit bracket similar to as shown bellow could be installed. This type of bracket is configured to allow for thermal expansion of the roof while restricting lateral movement due to a seismic event. This type of connection would not impart additional operating or thermal loads on the walls. In a seismic event the brackets would "catch" the roof limiting its movement and transferring its lateral load into the walls. This option could be more difficult to implement (versus an aluminum dome roof) as it requires an elastomeric bearing pad to be placed between the roof and the top of the wall. Lifting the roof to install such a pad might not be practical. However, this type of retrofit would allow the current roof to remain without it being demolished. Alternately, retrofit brackets could be installed and the bearing pad omitted with the knowledge that in a seismic event the top of the wall connection could be significantly damaged, but the brackets would retain the dome and help prevent a complete failure of the roof.

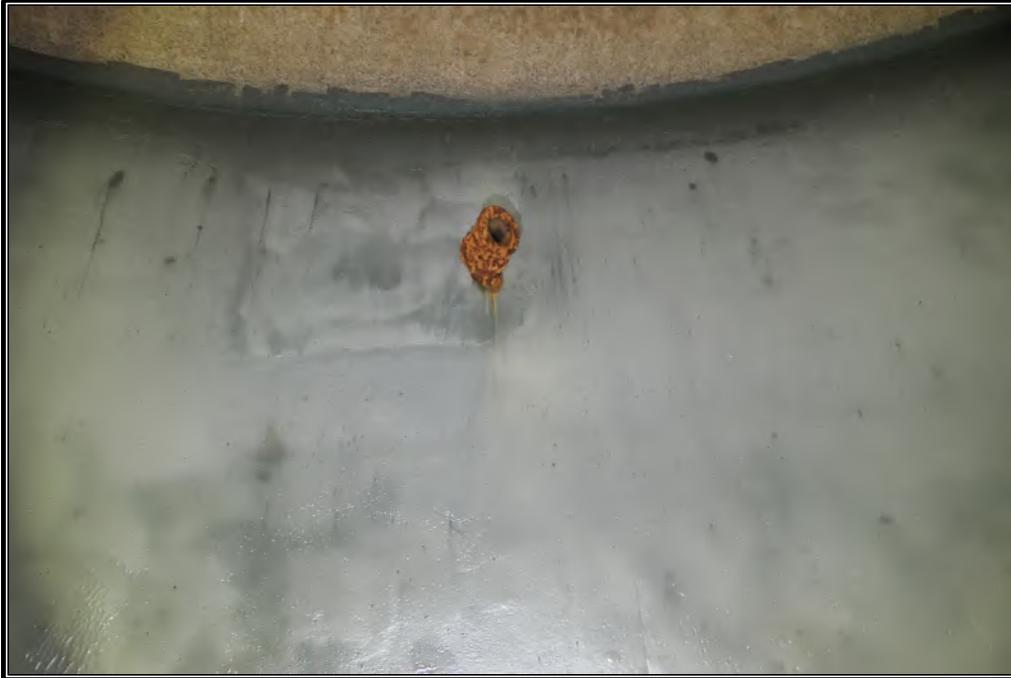
Figure 2-12: College Way Reservoir – Corrosion on Recirculation Pipe

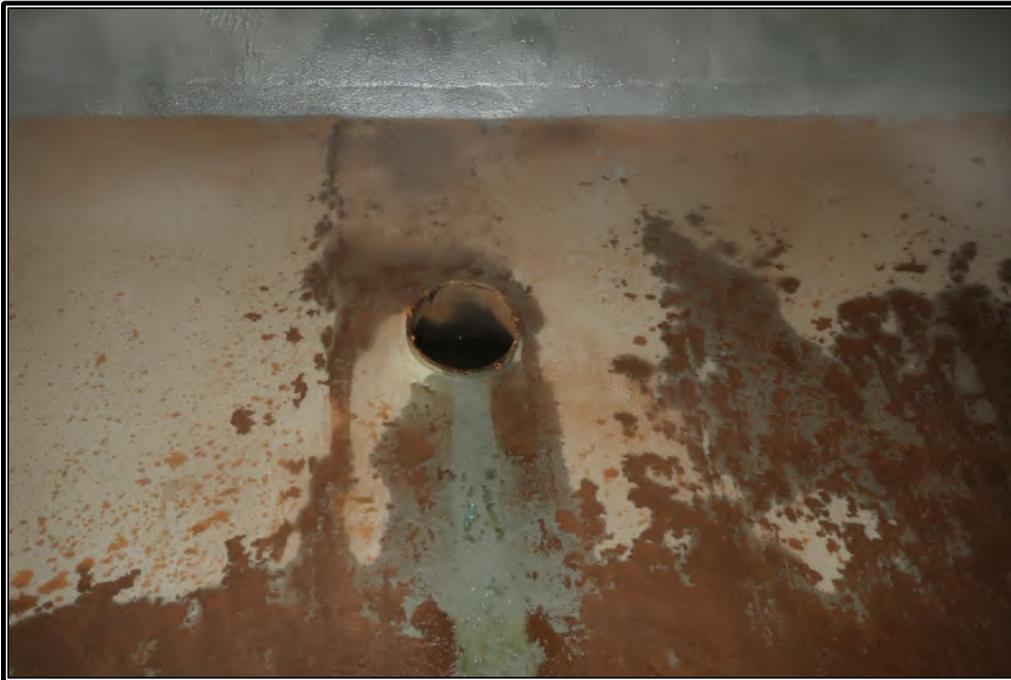
Figure 2-13: College Way Reservoir – Inlet Pipe in Hopper Base

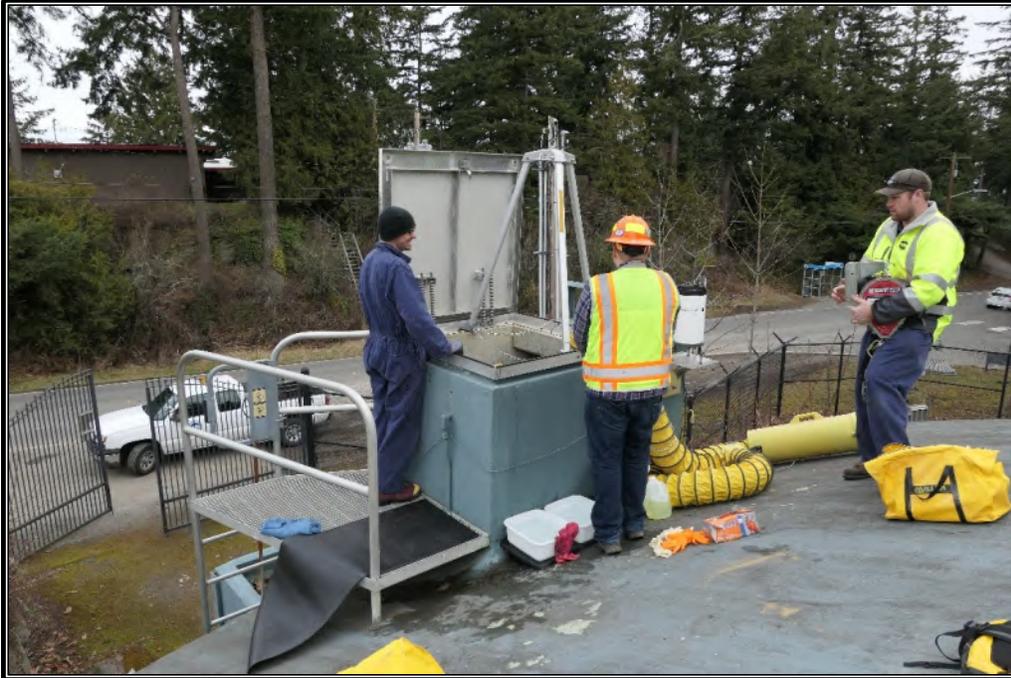
Figure 2-14: College Way Reservoir – Access Hatch

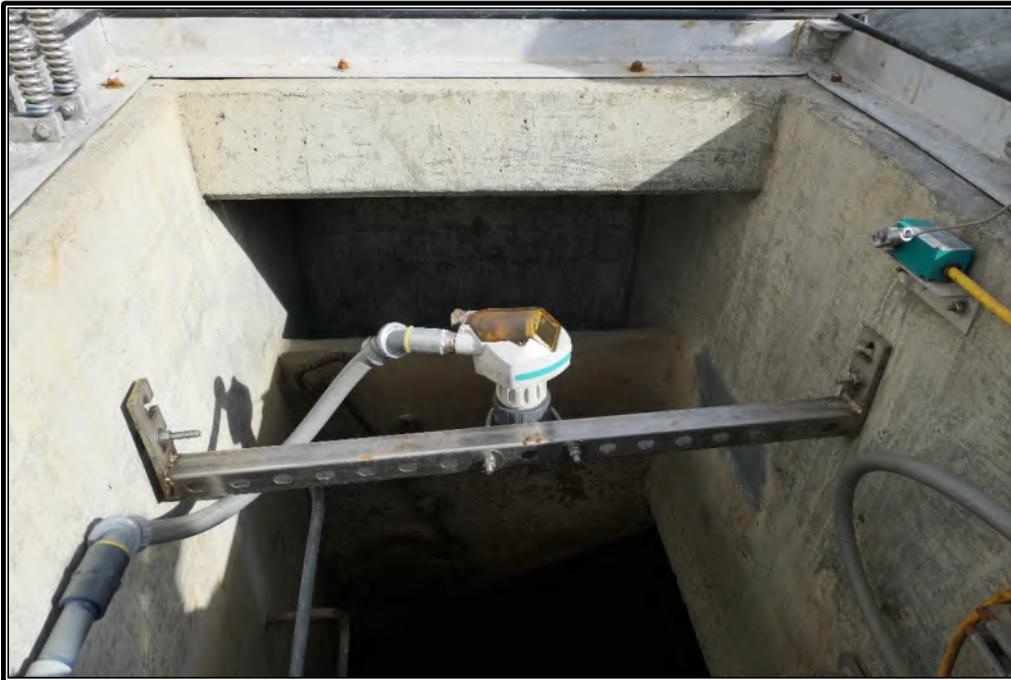
Figure 2-15: College Way Reservoir – Overflow Weir Located in Access Hatch

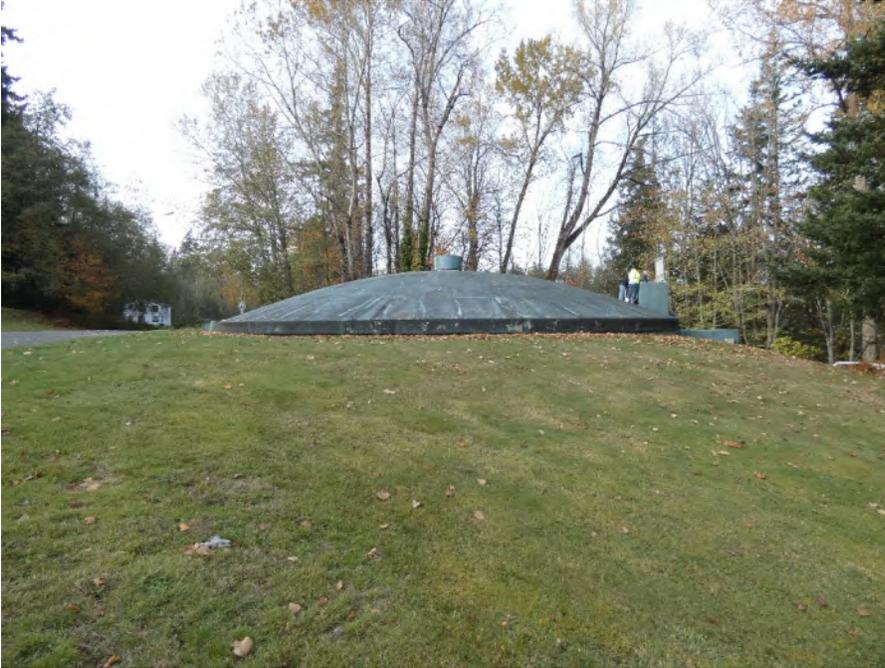
Figure 2-4: Consolidation Reservoir –Elevation

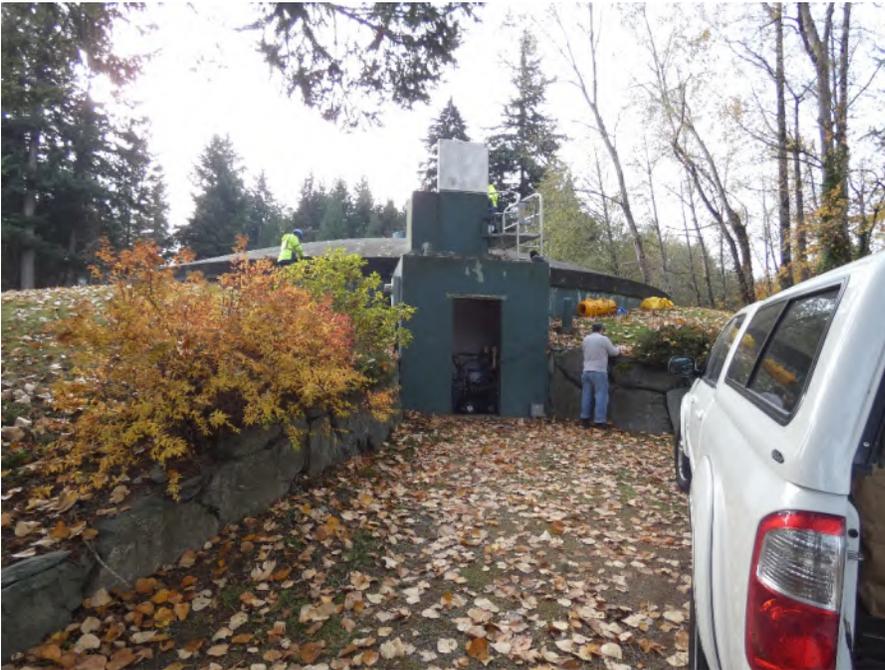
Figure 2-5: Consolidation Reservoir – Entry to Valve Vault

Finally, the valve vault piping should be retrofitted to ensure the piping has flexible fittings which can allow for differential horizontal and lateral movement between the vault and reservoir in a seismic event. As the structure is in close proximity to the reservoir’s foundation which is cast as part of the vault’s wall, there is a potential for settlement or movement at this interface. Notches or overflow scuppers should be installed in the parapet to prevent the roof from overflowing if the drain backs-up.

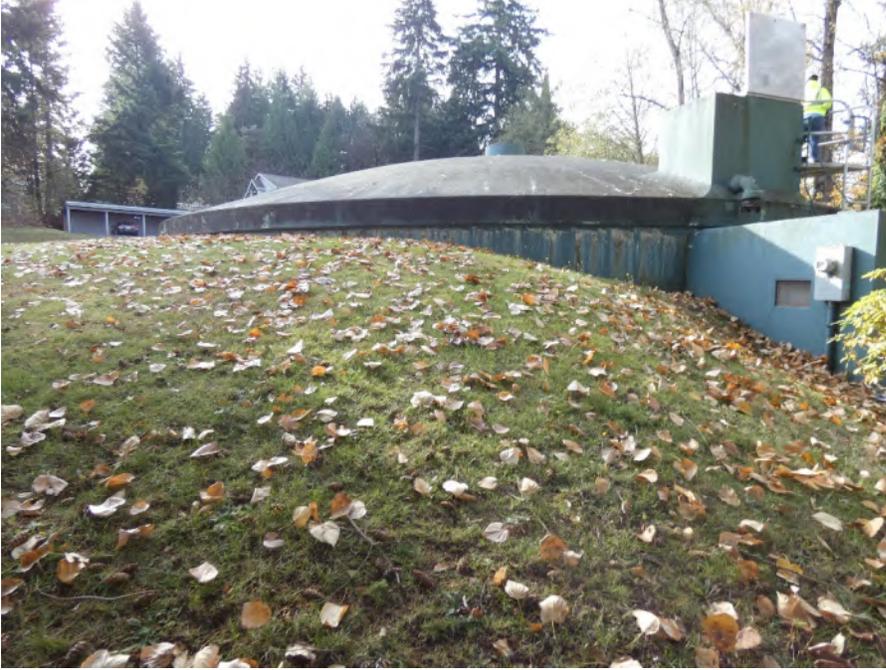
Figure 2-6: Consolidation Reservoir – Circumferential Cracking around Reservoir below Roof Line

PSE recommends the exterior visible portion of the wall be cleaned to remove all concrete which has been damaged due to the thermal expansion effects. As thermal movement is likely to continue, PSE does not recommend stiffening or reinforcing this area as further damage could occur to the dome. By constraining the roof, the failure zone could be moved, potentially causing issues within the dome roof itself if it is constrained against expansion. Rather, the cracking around the exterior should be cleaned and coated to protect any reinforcing against water infiltration and to prevent further damage to the concrete. Coatings and any repair medium should be flexible to prevent cracking during thermal movement. This is not a long-term fix but intended to limit the impact of water and corrosion on this area until a new roof or roof-to-wall retrofit solution is selected. Once the area is cleaned and any damaged concrete removed it is recommended that it be observed by a Structural Engineer to review the extent of damaged concrete and to determine if any additional or alternate repairs are advisable at that time.

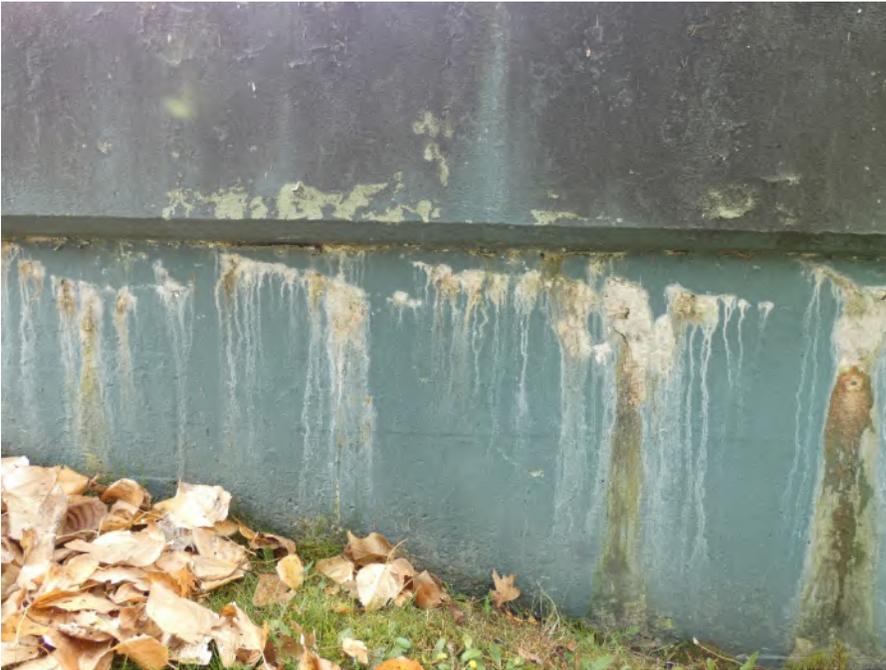
Figure 2-7: Consolidation Reservoir – Circumferential Cracking Close-up

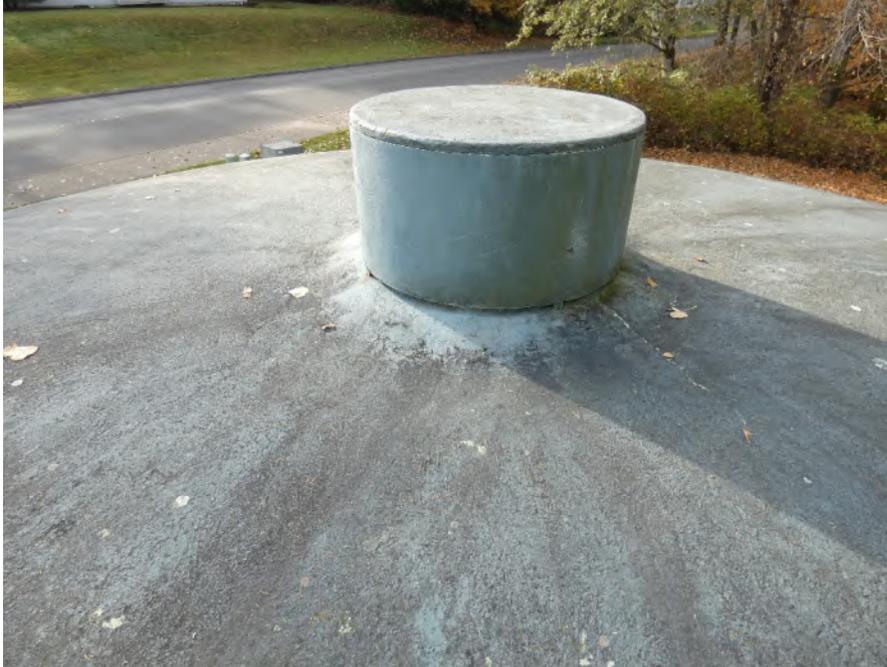
Figure 2-8: Consolidation Reservoir – Dome Roof Vent

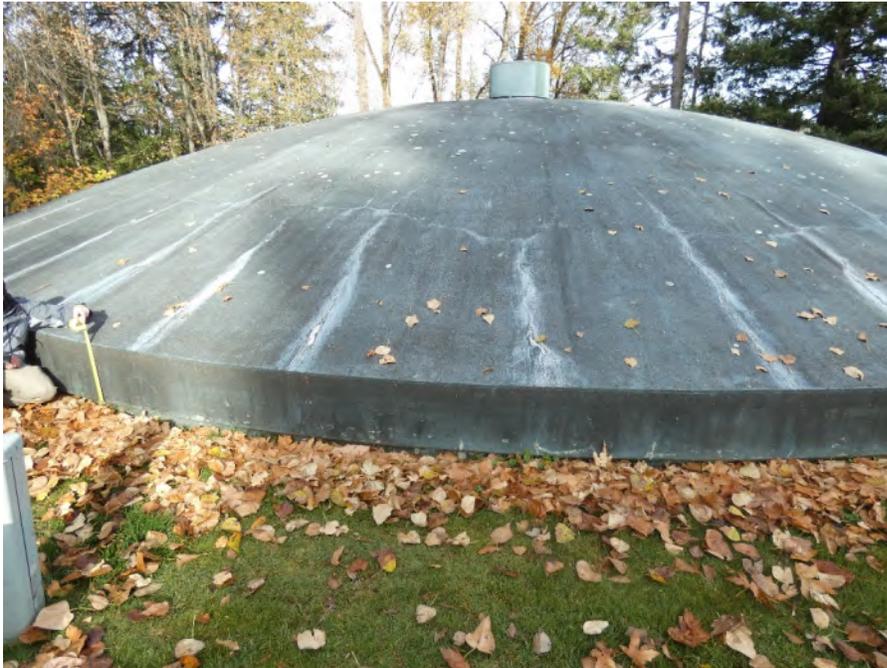
Figure 2-9: Consolidation Reservoir – Radial and Circumferential Cracking around Dome Roof Edge

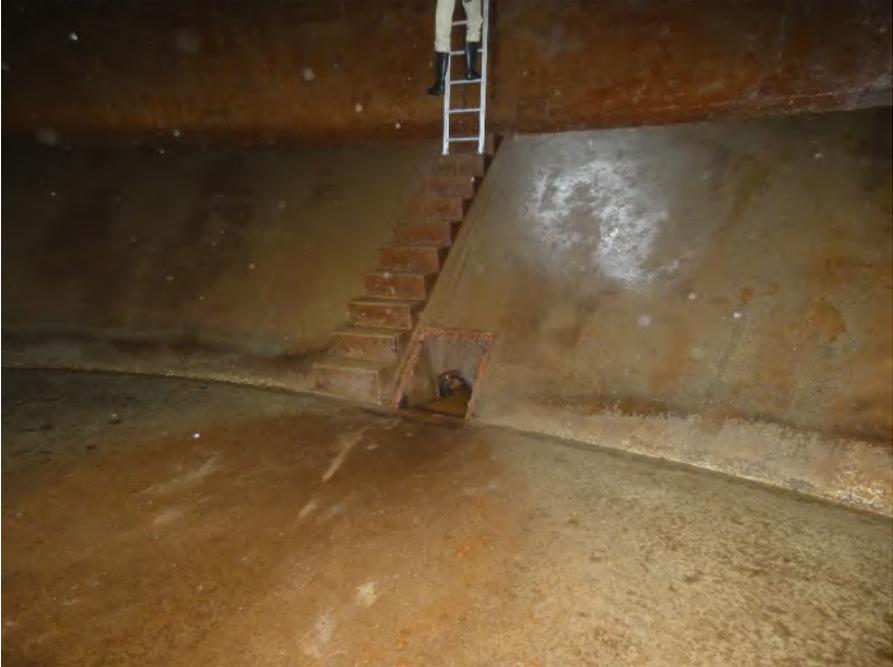
Figure 2-10: Consolidation Reservoir – Steps Cast into Hopper Base and Outlet

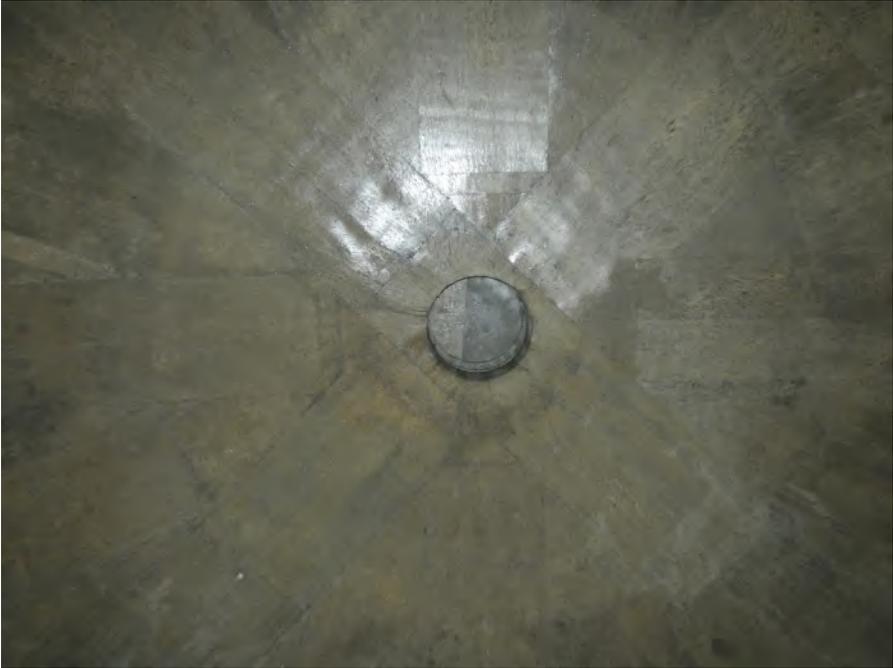
Figure 2-11: Consolidation Reservoir – Dome Roof Interior Side of Vent

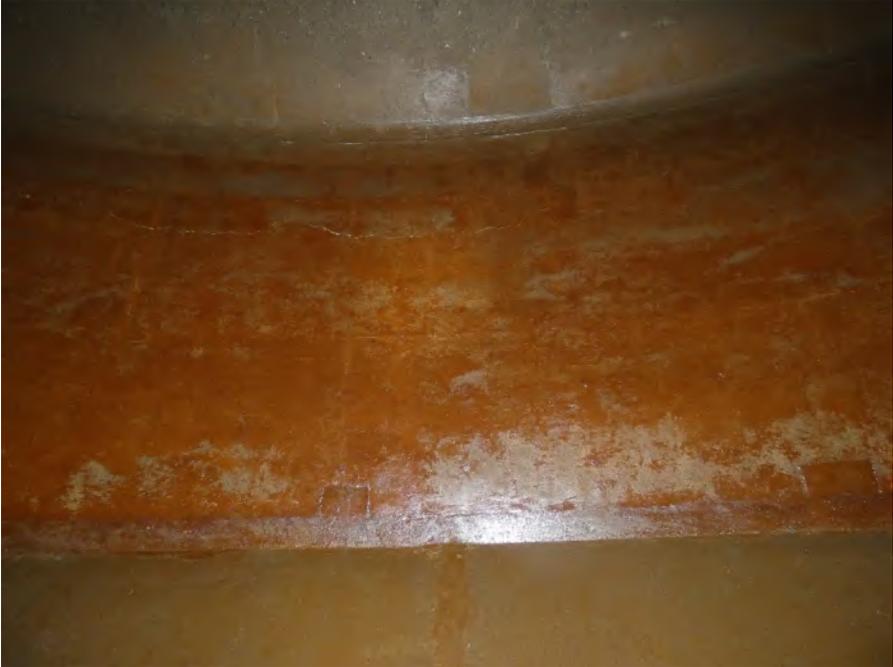
Figure 2-12: Consolidation Reservoir – Rear Wall (opposite entry hatch) with Cracking in Upper Wall Section

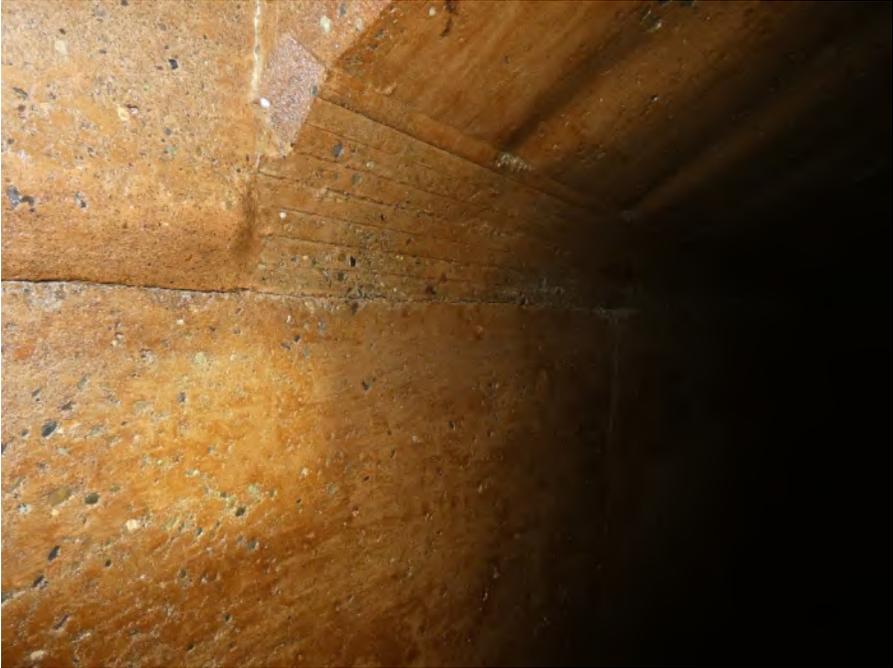
Figure 2-13: Consolidation Reservoir – Interior Roof-to-Wall Joint

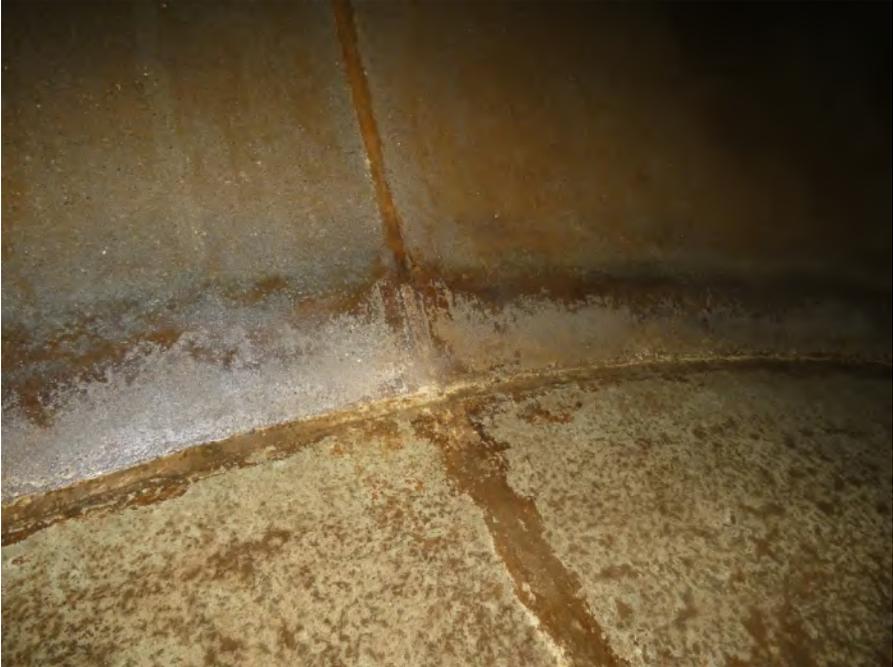
Figure 2-14: Consolidation Reservoir – Interior Hopper-to-Floor Slab Joint

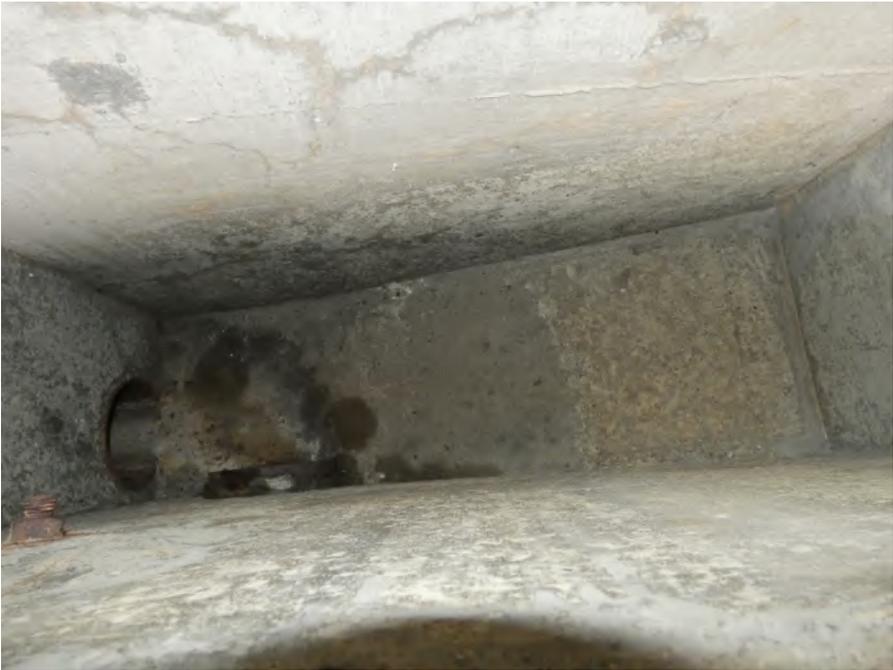
Figure 2-15: Consolidation Reservoir – Interior of Overflow Weir, Located in Access Hatch

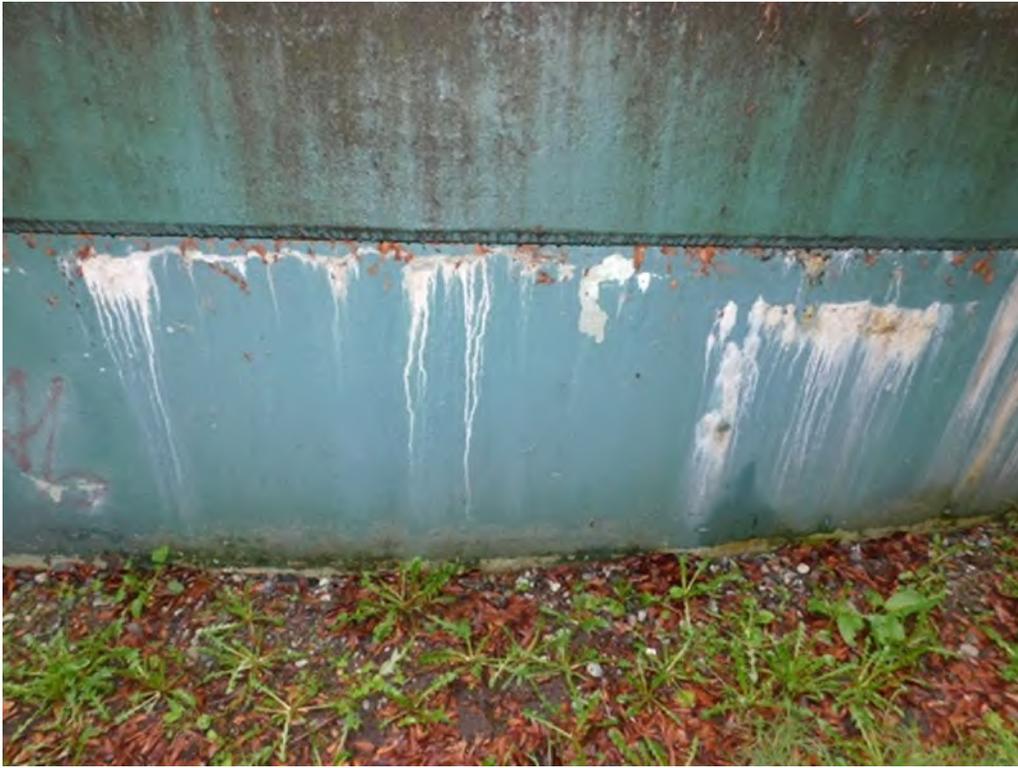
There is a significant amount of calcium carbonate (lime) buildup on the sidewalls. Approximately 5-10% of the top coat is missing on the sidewall surfaces, mostly at the ground interface. From grade to 6-inches above grade, top coat loss is approximately 40%, with 10-15% of the concrete exposed. There are multiple locations (approximately 1-3%) of blistering in the coating, however the prime coat appears to be in good condition underneath the blisters. On the attached shed and roof hatch column, about 40% of the top coat is missing. A razor knife test showed the coating to be tightly adhered at sound locations on the tank sidewalls.

Heavy debris accumulation and calcium carbonate leaching

1. The exterior tank surfaces need to be pressure washed to remove dirt and other debris.
2. Spot repair areas of exterior coating loss. This will require the development of appropriate surface preparation and coating application procedures. This should extend the useful life of the coating an additional 10 years.
3. The interior blistering is not a concern at this time. However, increased inspection intervals to every 3 – 5 years should be performed in order to photograph and evaluate if any additional blistering is occurring or if the top coat is separating and exposing the underlying coating material. This work can be completed by City personnel.
4. The metallic piping extending along the access hatch should be internally and externally coated to prevent additional corrosion loss.

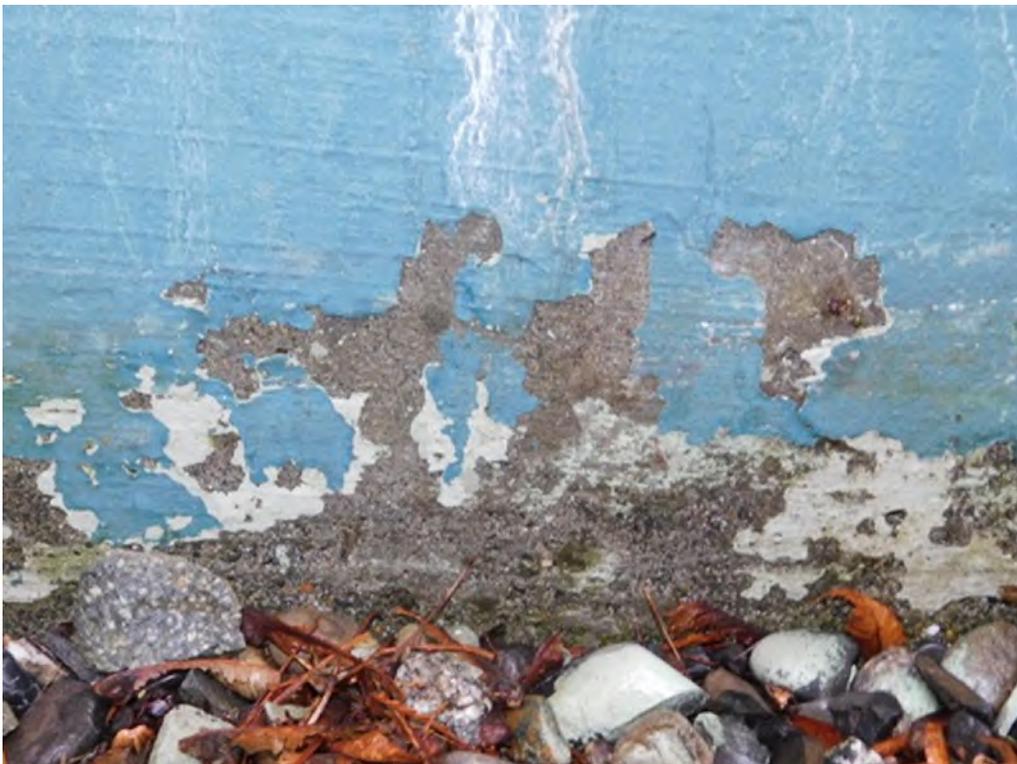
Exposed concrete at grade to 6-inches above grade

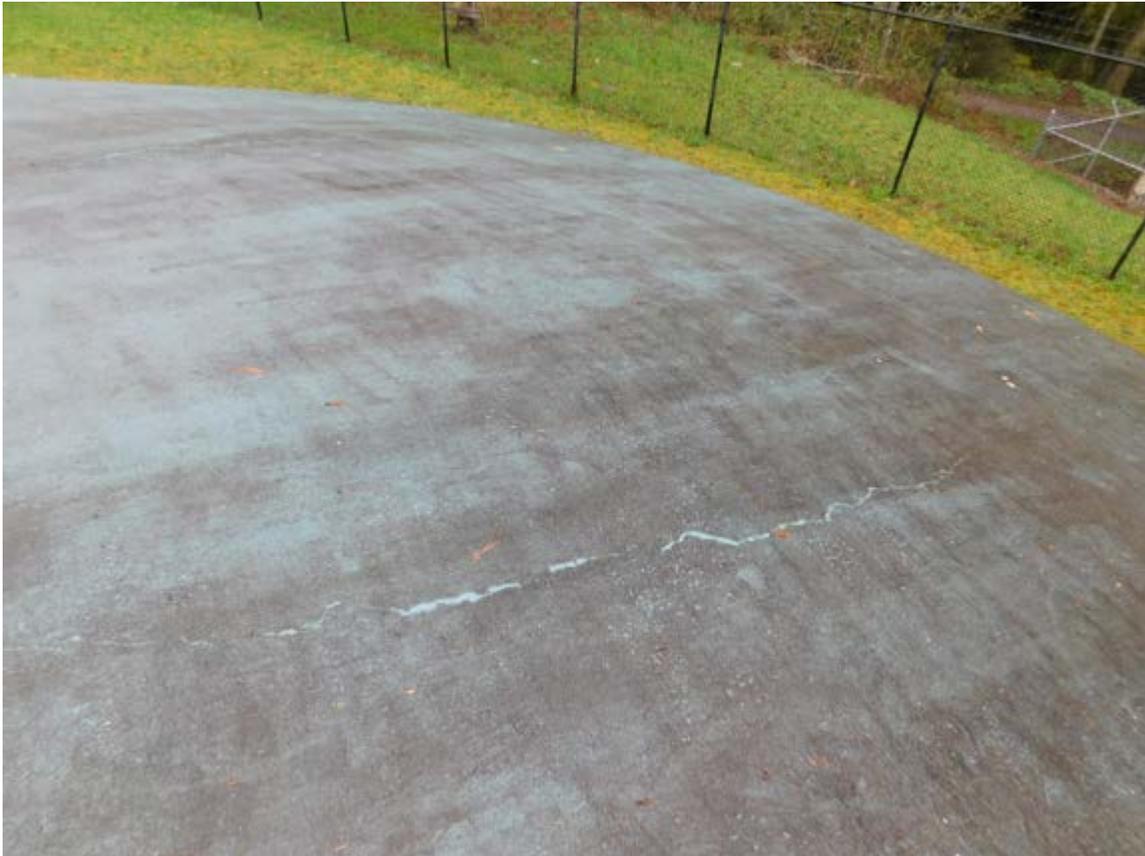
The exterior roof surfaces are covered with organic matter and debris. A razor knife test showed the coating on the roof to be well adhered. There are four locations of exposed concrete around the vent most likely due to mechanical damage from the vent cover legs. There are a few axial and circumferential cracks, but the coating is intact around the cracks.

Heavy debris accumulation on roof

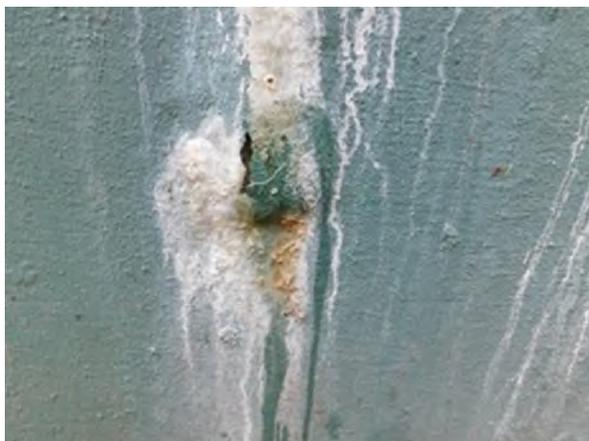
Blister in coating on sidewall
(filled with water)

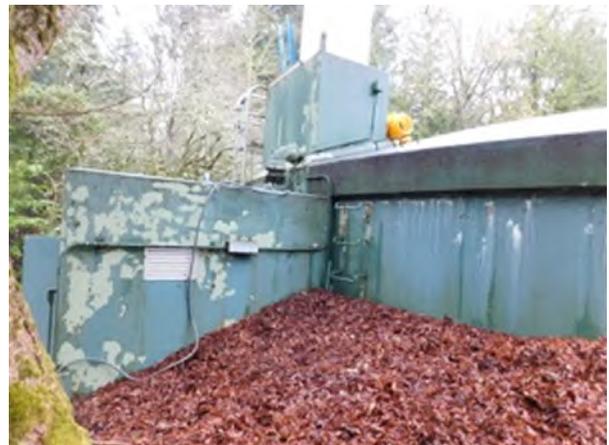
Missing coating on attached shed
and roof hatch column

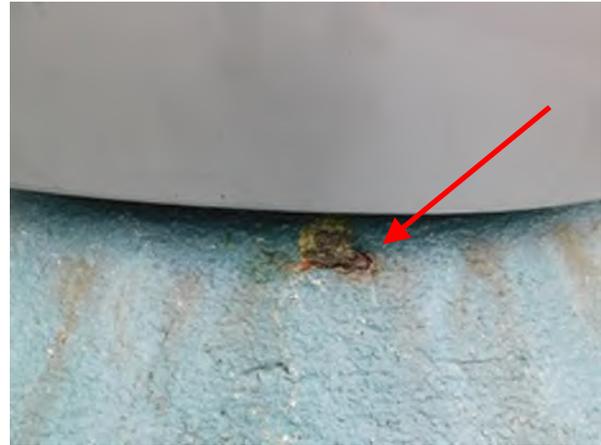
Area of missing coating at base of
roof vent
