APPENDIX

Date: January 22, 2020

Subject: City of Bellingham Reservoirs Inspection and Repairs
Marietta Site

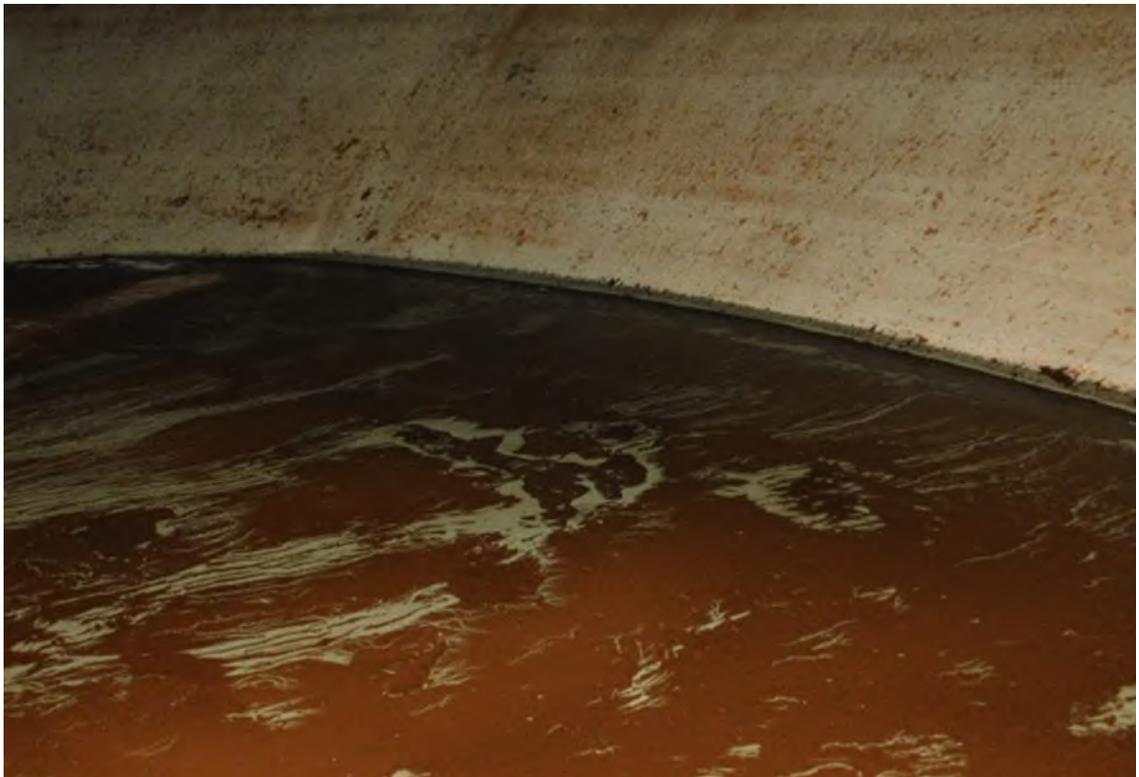
Interior floor covered with dirt

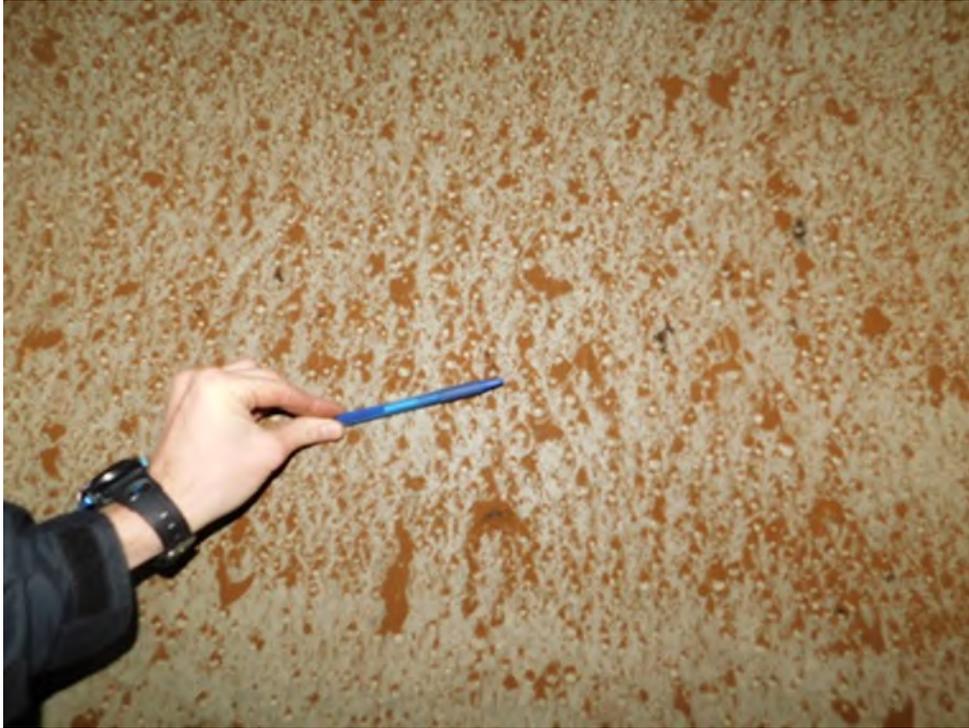
At the 60° transition on the sidewalls, 40% of the coating is blistering. The top coat is easily peeled off, exposing the blue prime coat underneath. The top coat is very elastic and water is present under the blisters. The blue prime undercoating is well adhered.

Blistering on 60° wall transition, noted on over 40% of the area

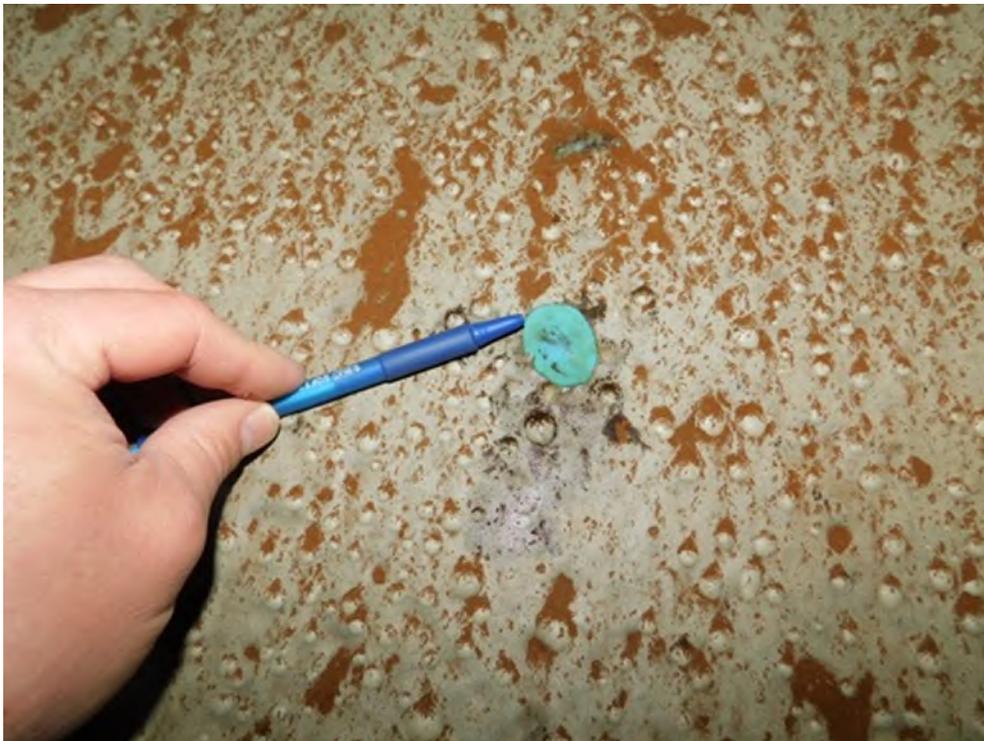
Intact blue prime coat underneath coating blister

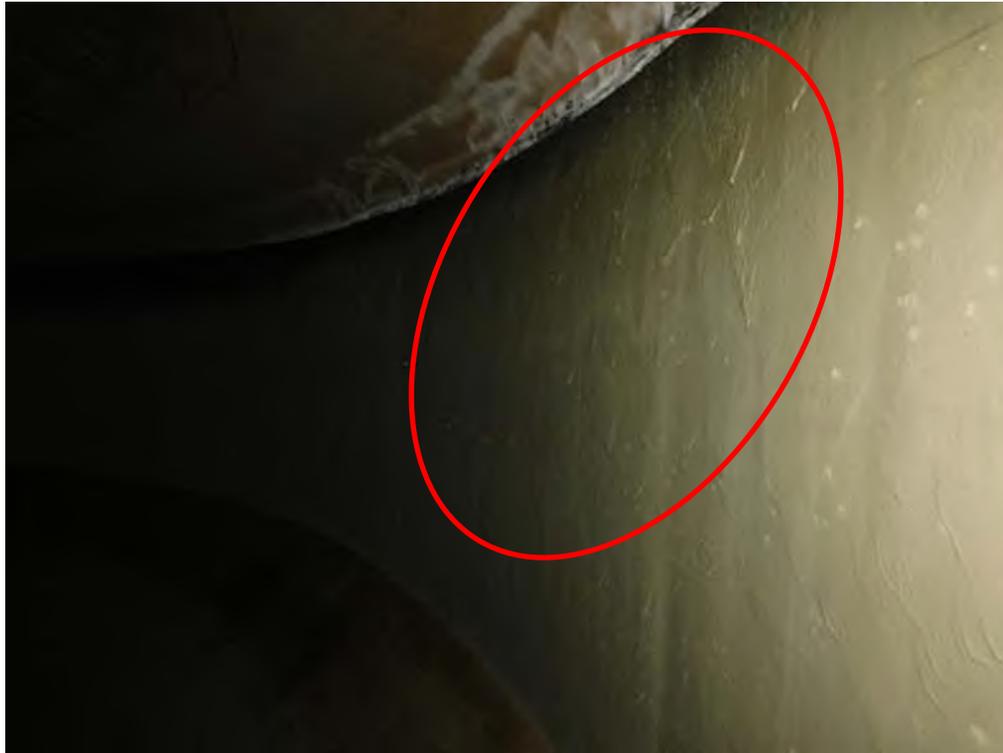
The kerf line (1/4" cut in concrete made between coated and non-coated transition used as an anchor point for the coating) did not show any instances of coating delamination. The vertical sidewalls were 100% visible and there are multiple areas of coating runs and sags, but no failures are evident on these surfaces.

Runs and sags in coating, not affecting coating integrity

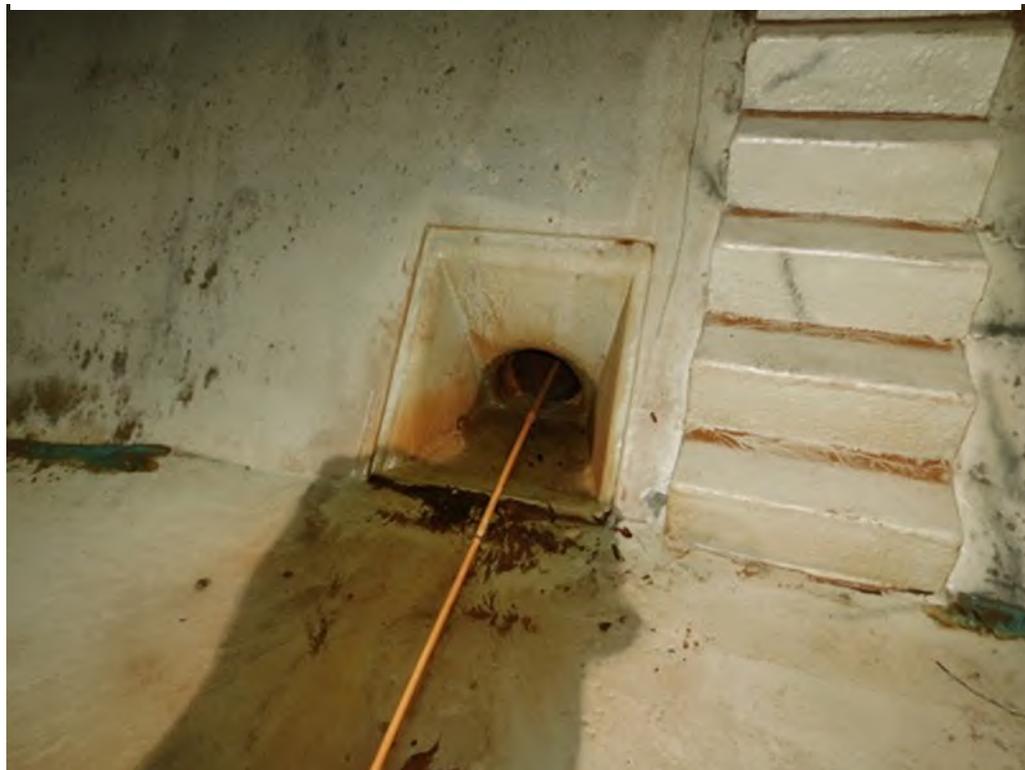
Piping transition is well coated with water staining on the surface

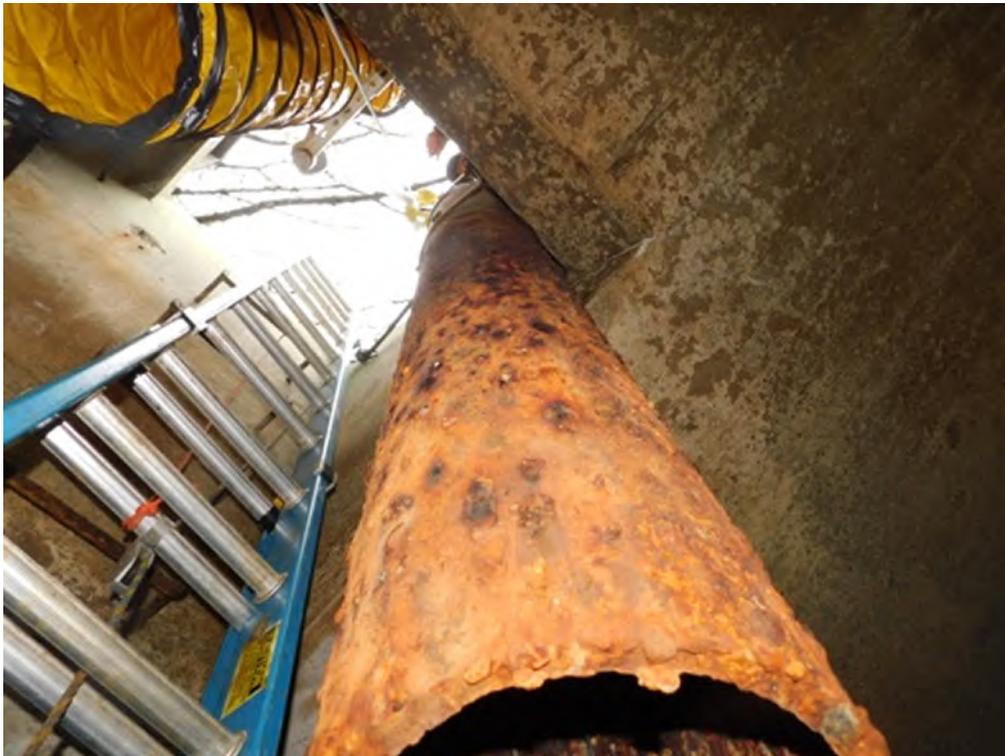
Uncoated metallic piping with surface corrosion and extensive tuberculation

1. The exterior tank surfaces need to be pressure washed to remove dirt and other debris.
2. Spot repair areas of exterior coating loss. This will require the development of appropriate surface preparation and coating application procedures. This should extend the useful life of the coating an additional 10 years.
3. The interior blistering is not a concern at this time. However, increased inspection intervals to every 3 – 5 years should be performed in order to photograph and evaluate if any additional blistering is occurring or if the top coat is separating and exposing the underlying coating material. This work can be completed by City personnel.
4. The metallic piping extending along the access hatch should be internally and externally coated to prevent additional corrosion loss.

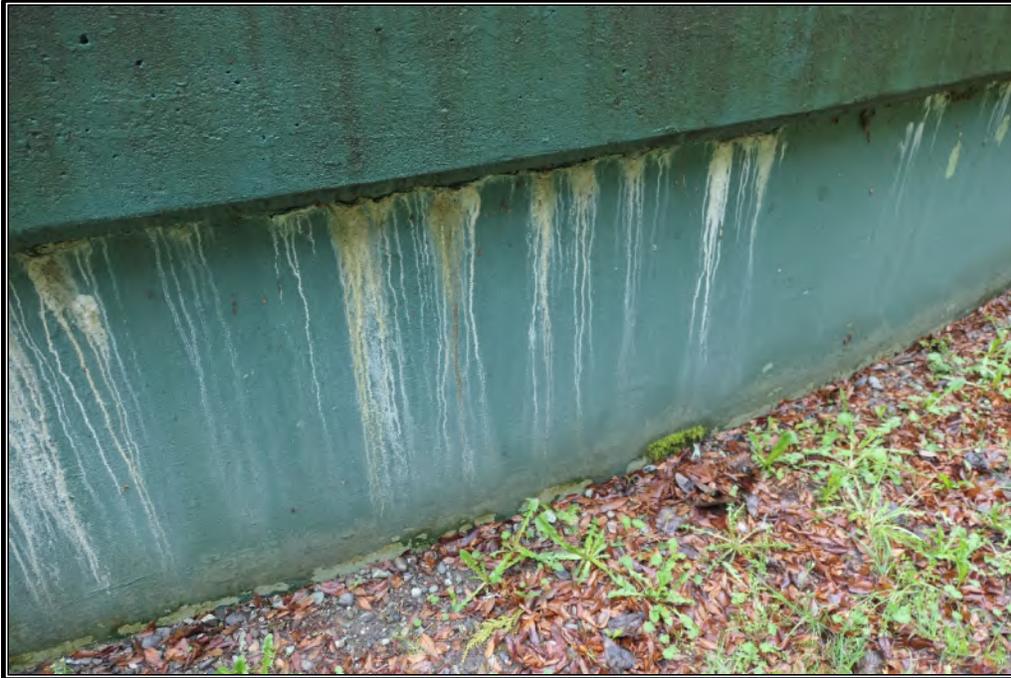
Figure 2-5: Dakin 1 Reservoir – Circumferential Cracking around Reservoir below Roof Line

The effects of thermal movement appear to have damaged the roof-to-wall interface and have likely affected its structural shear capacity and water-tightness. To alleviate this issue, PSE would recommend either the retrofit or replacement of the roof. Note that this may not be economically feasible or practical.

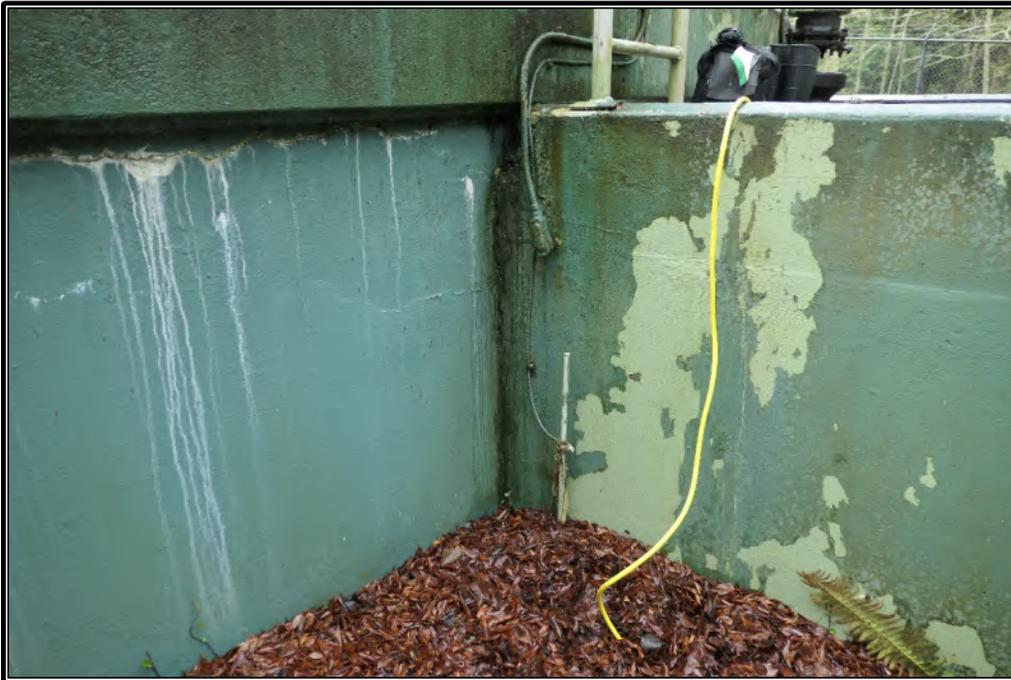
Figure 2-6: Dakin 1 Reservoir – Circumferential Cracking at Valve Vault

Finally, the valve vault piping should be retrofitted so as to ensure the piping has flexible fittings which allow for differential horizontal and lateral movement to occur between the vault and reservoir in a seismic event. As the structure is in close proximity to the reservoir's foundation, which is cast as part of the vault's wall, there is a potential for settlement or movement at this interface. Notches or overflow scuppers should be installed in the parapet to prevent the roof from overflowing if the drain backs-up.

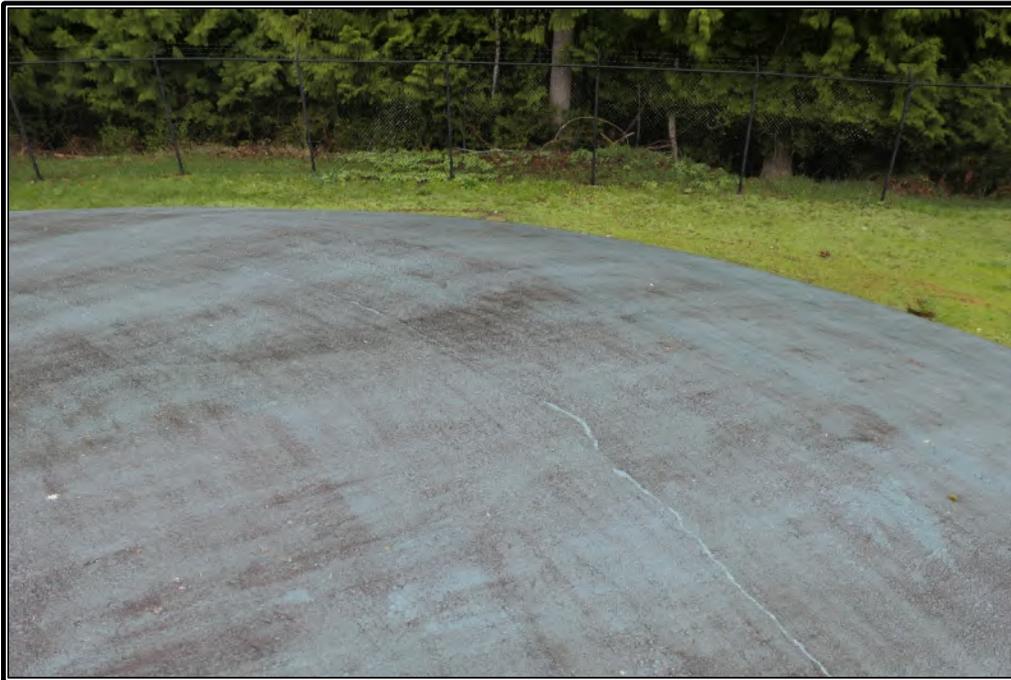
Roof-to-Wall Connection: A concrete reservoir requires a roof-to-wall configuration that will simultaneously allow for differential thermal movement between the reservoir roof and the wall as both components deform differently as a result of temperature variations due to temperature or solar gain. At the same time, the roof must be able to engage the walls in order to transmit seismic loads into the components of the structure able to resist lateral loads. Currently the roof is supported in a manner that does not allow for thermal movement and has resulted in cracking along the top of the wall as noted above. This is a result of its original design that allows water to be stored above the wall line. To adequately account for thermal movement the existing roof attachment would need to be modified or replaced with a roof system able to accommodate thermal movement. This may not be practical or economically feasible.

Figure 2-8: Dakin 1 Reservoir – Circumferential Cracking around Dome Roof Edge

The first option would be to remove the existing roof and replace it with a new roof. As the operating height is now below the wall height, there are a variety of options available. For example, aluminum geodesic dome roofs have been used to either add new roofs or retrofit existing roofs to many types of reservoirs. As an aluminum dome roof is relatively light, strengthening of the existing walls and foundation would be limited if required at all. Alternately, a new concrete dome or flat roof could be designed and installed.

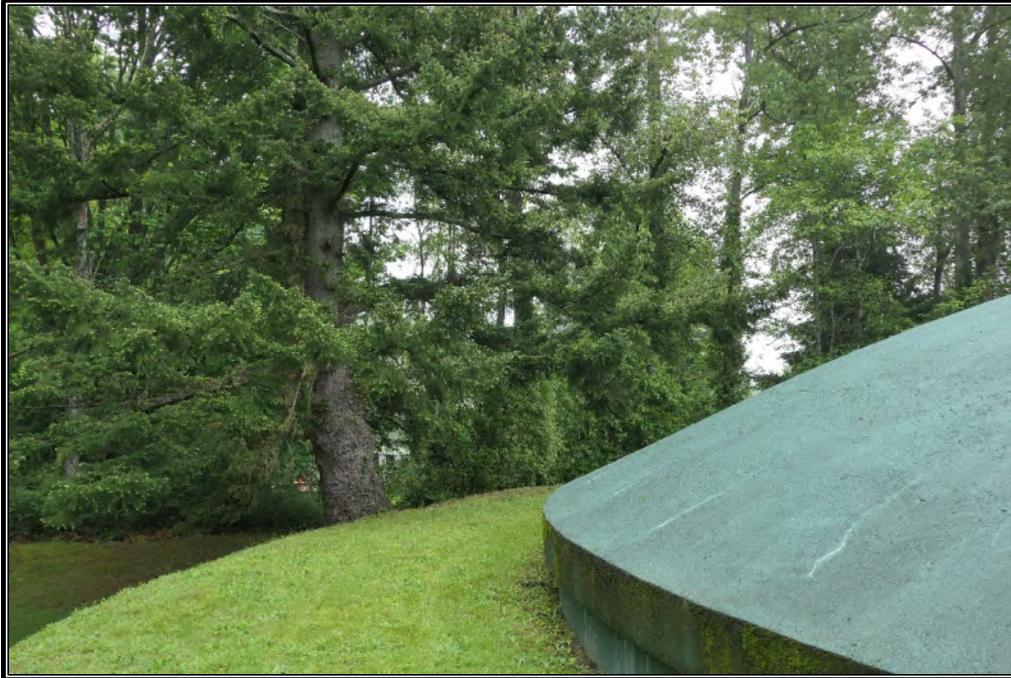
Figure 2-6: Reville Reservoir – Adjacent Tree Growing from Reservoir Berm

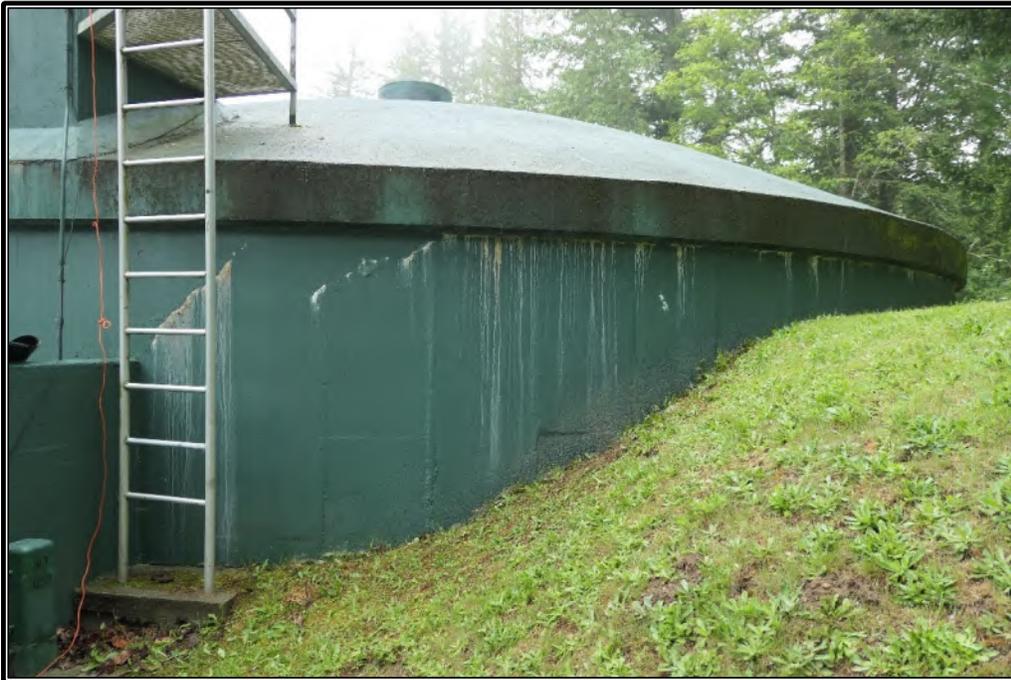
Figure 2-7: Reville Reservoir – Circumferential Cracking Below Roof and Diagonal Cracking near Vault

PSE recommends the exterior wall be cleaned and all efflorescence or loose concrete be removed. For damage due to the thermal expansion effects, these areas can be cleaned but left un-grouted. As thermal movement is likely to continue to occur, PSE does not recommend stiffening or reinforcing this area. By constraining the roof, the failure zone could be moved and potentially cause issues within the dome roof itself if it is constrained against expansion. Rather, the cracking around the base of the dome should be cleaned and coated to protect any reinforcing against water infiltration and to prevent further damage to the concrete. Coatings and any repair medium should be flexible to prevent further cracking during any future thermal movement. This is not a long-term fix but intended to limit the impact of water and corrosion on this area until a new roof or roof-to-wall retrofit solution is selected. Once the area is cleaned and any damaged concrete removed it is recommended that it be observed by a Structural Engineer to review the extent of damaged concrete and to determine if any additional or alternate repairs are advisable at that time.

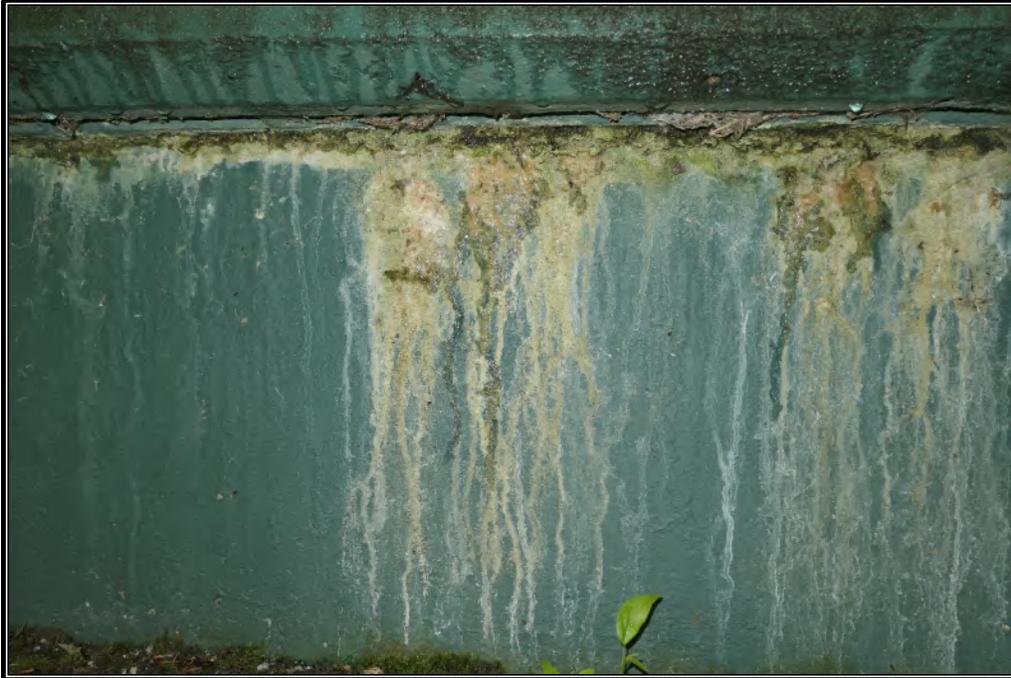
Figure 2-8: Reville Reservoir – Close-up of Cracking and Efflorescence under lip of Roof

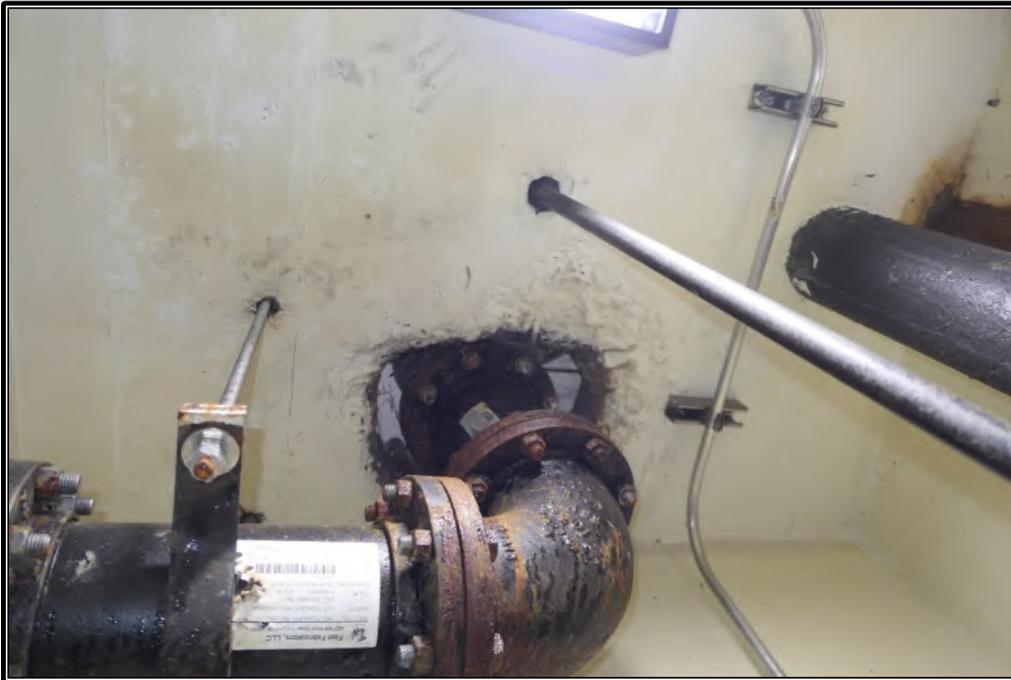
Figure 2-9: Reville Reservoir – Valve Vault Floor Slab Penetration

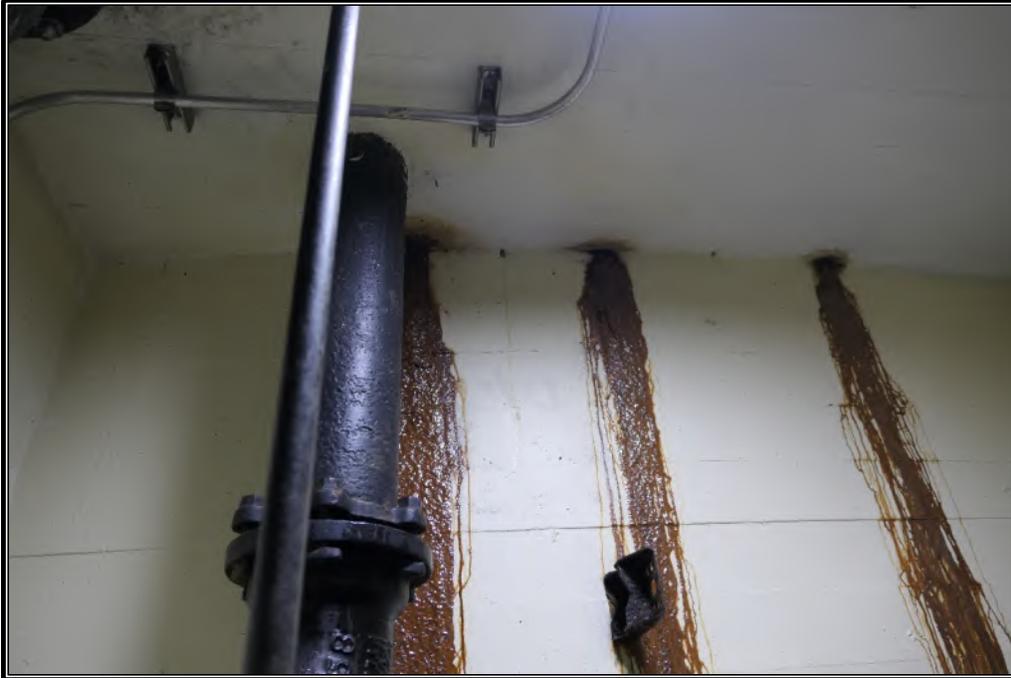
Figure 2-10: Reville Reservoir –Rust-tinged Leaks Entering Lower Level of Valve Vault

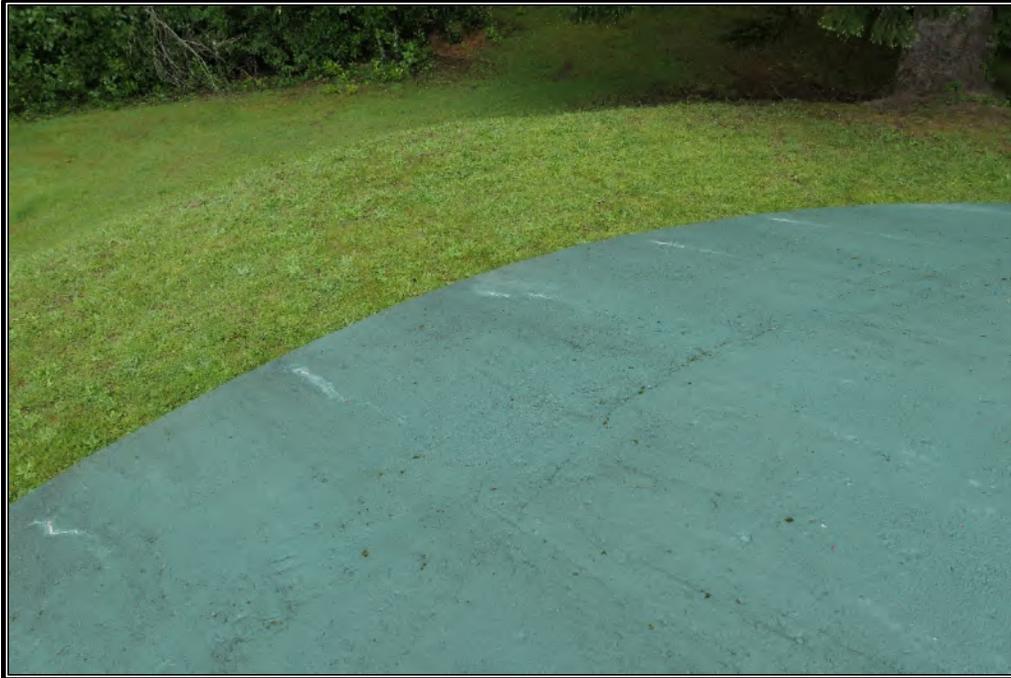
Figure 2-12: Reville Reservoir – Circumferential and Radial Roof Cracking

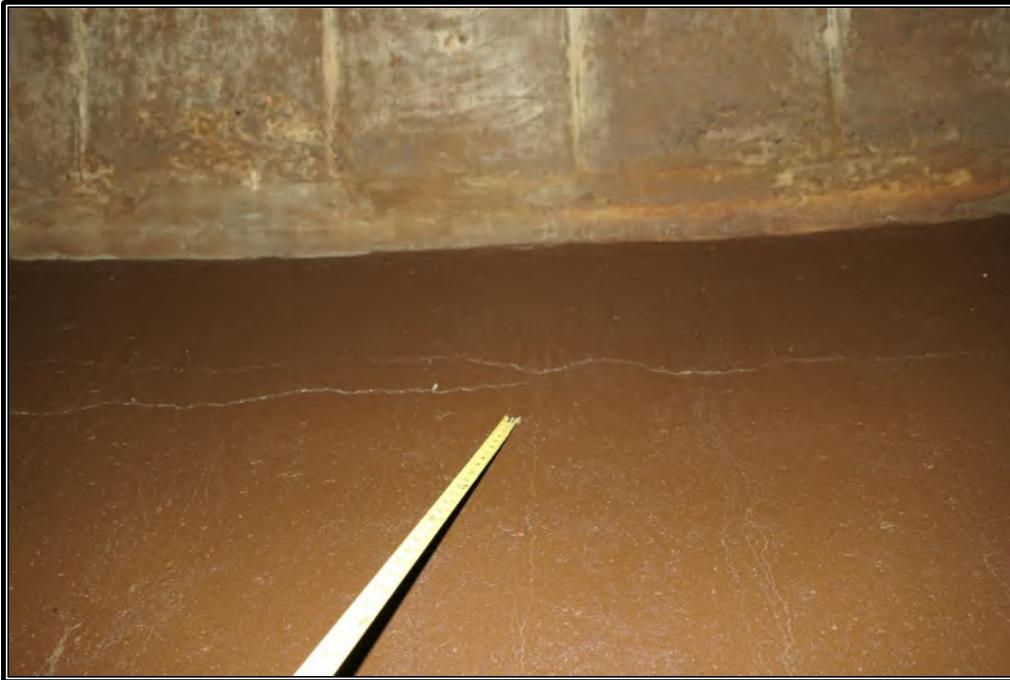
Figure 2-16: Reville Reservoir – Circumferential Cracking in Hopper Base

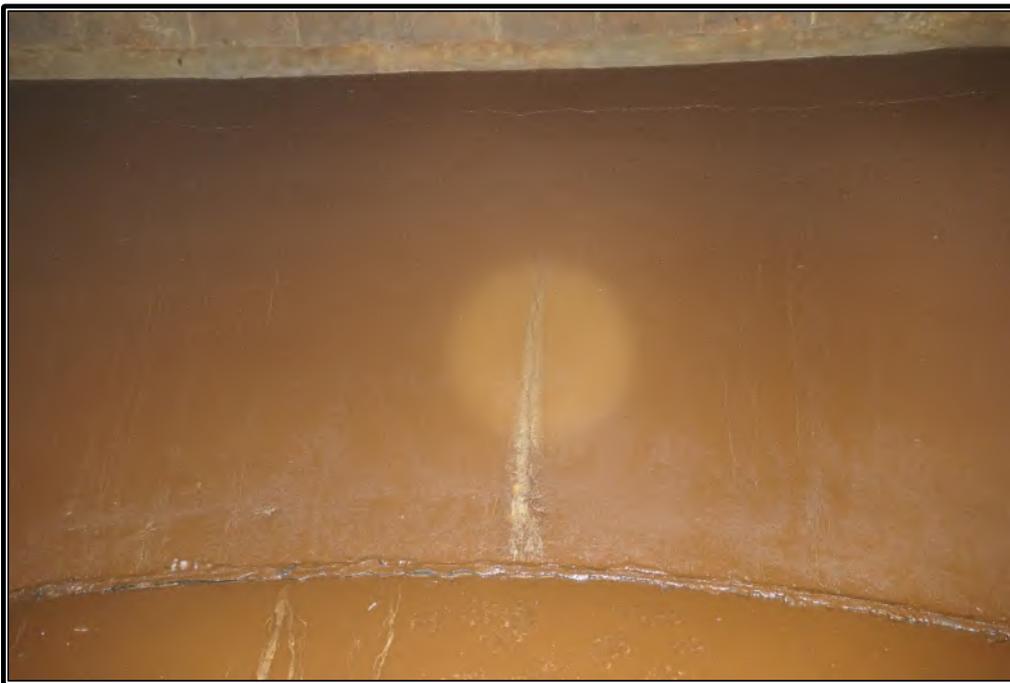
Figure 2-17: Reville Reservoir – Radial Cracking in Hopper Base

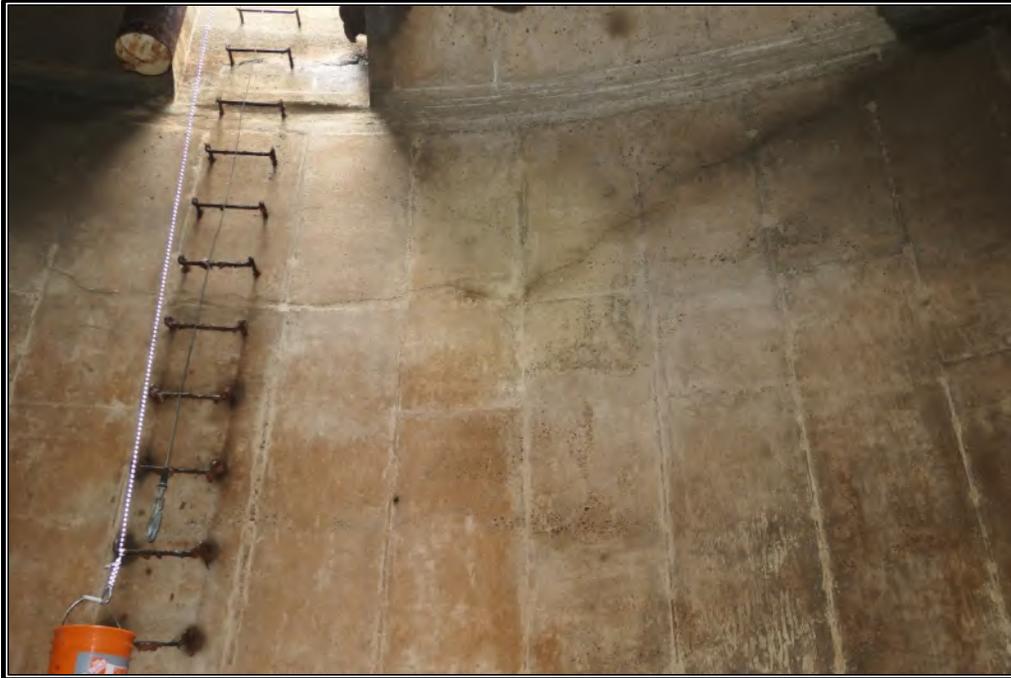
Figure 2-18: Reville Reservoir – Circumferential Cracking in Reservoir Wall (This location adjacent to Valve Vault)

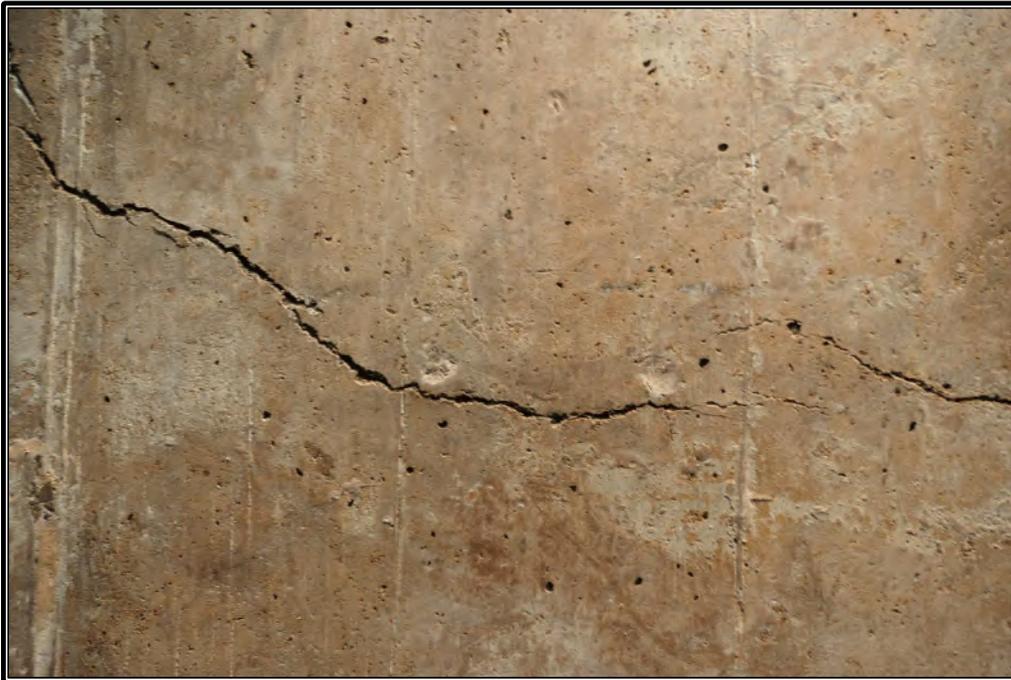
Figure 2-19: Reville Reservoir – Close-up of Wall Cracking from Ladder

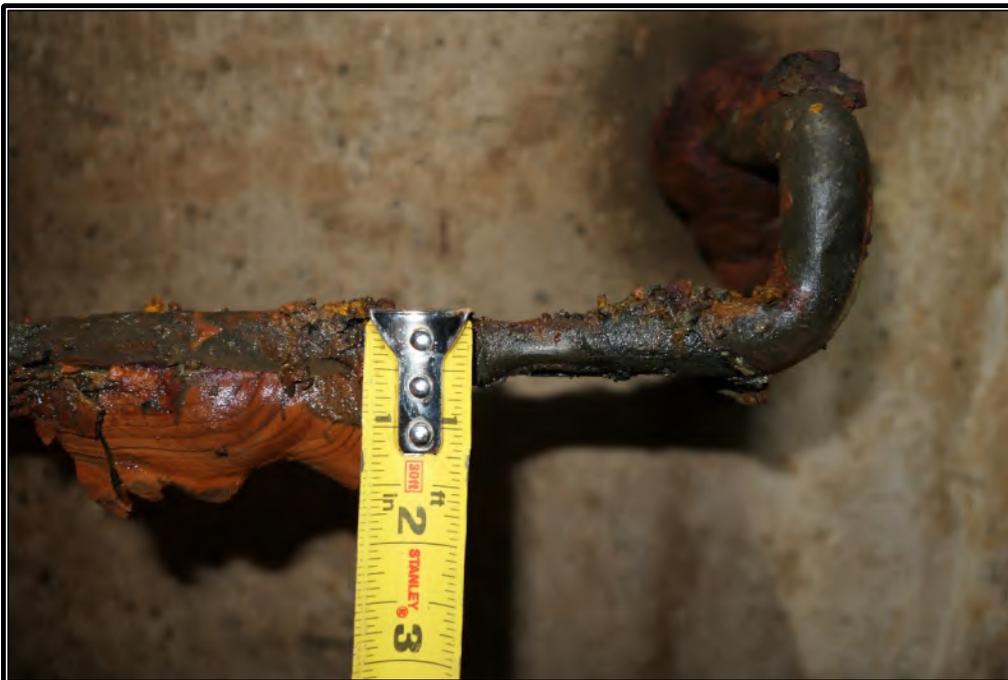
Figure 2-23: Reville Reservoir – Ladder Rung Cross-Section Loss

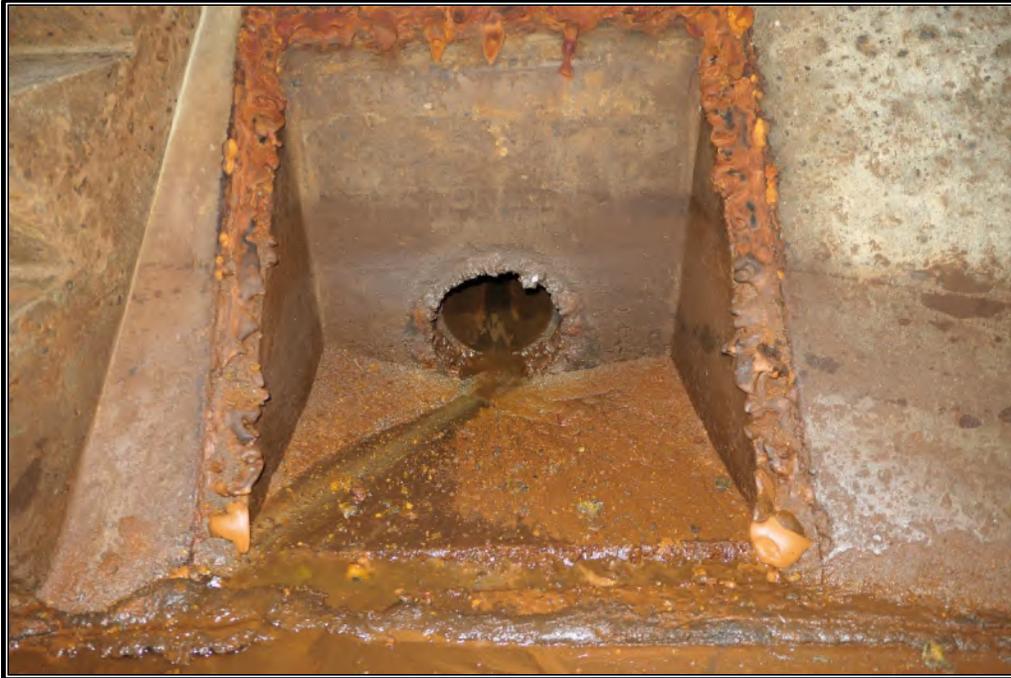
Figure 2-24: Reville Reservoir – Inlet/Outlet Drain and Corrosion Around Frame and Rough Concrete around pipe.

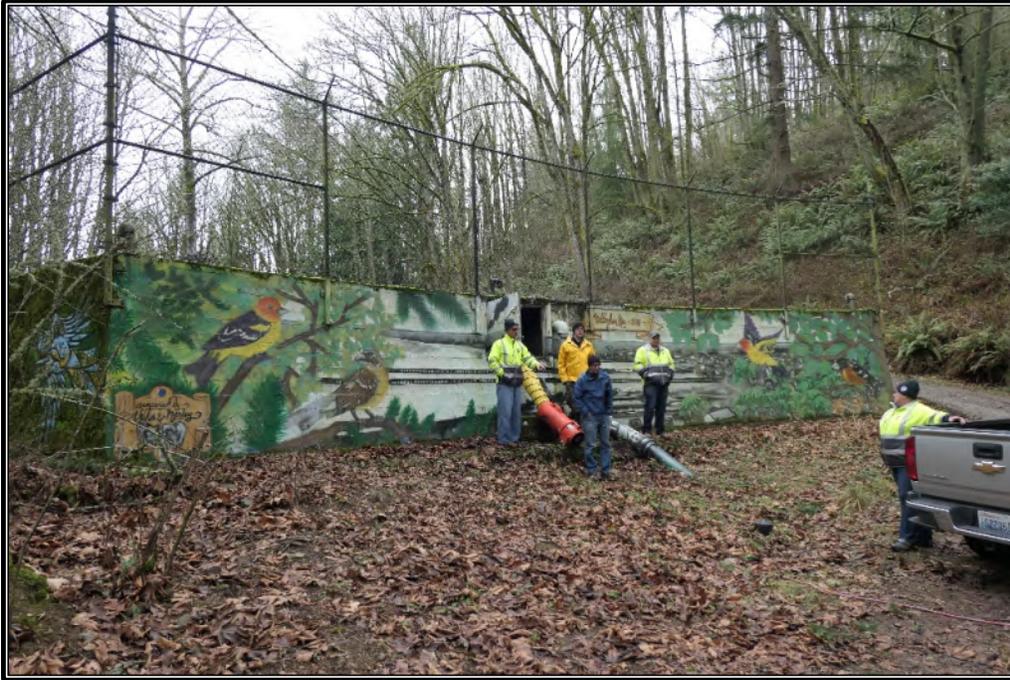
Figure 2-4: Sehome Reservoir - SW Elevation & Exterior Wall Hatch

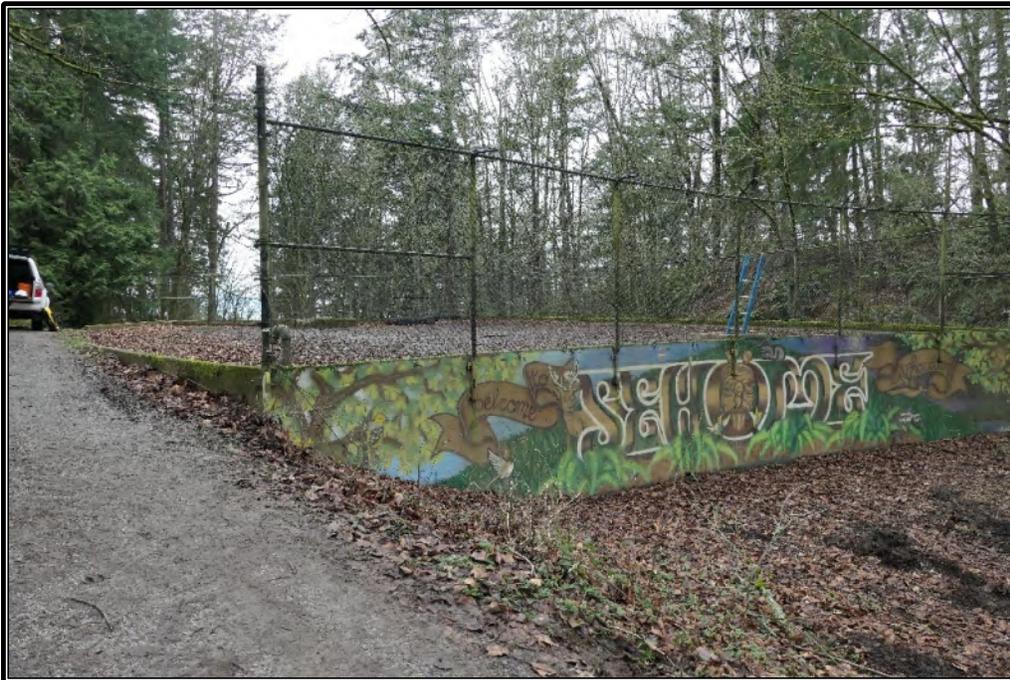
Figure 2-5: Sehome Reservoir - NE Elevation & View of Roof Slab

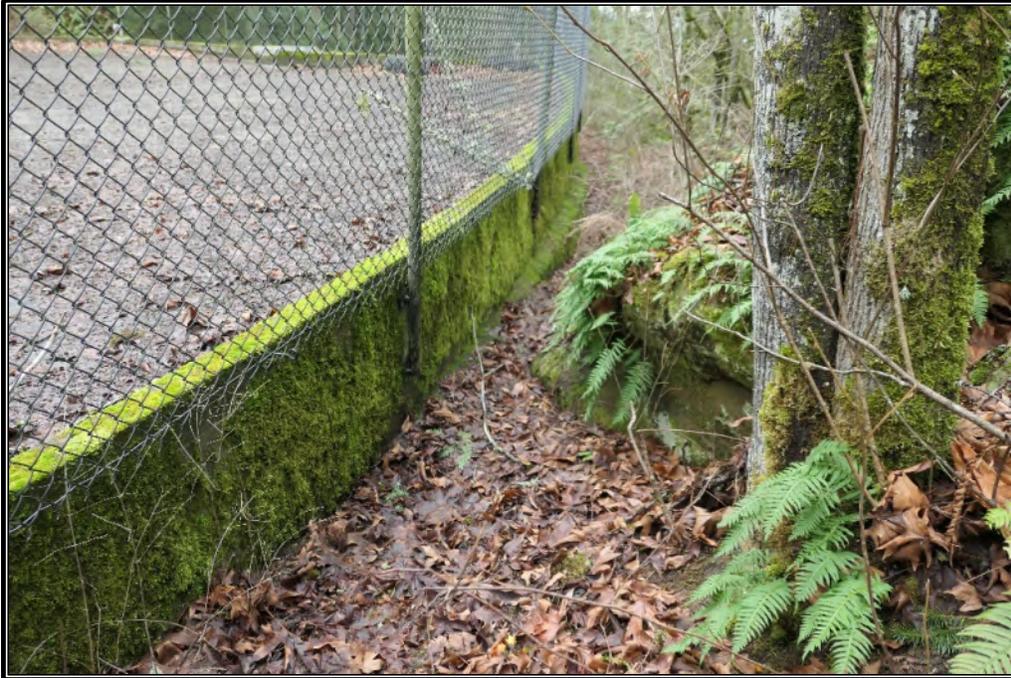
Figure 2-6: Sehome Reservoir - NW Elevation along sandstone outcropping

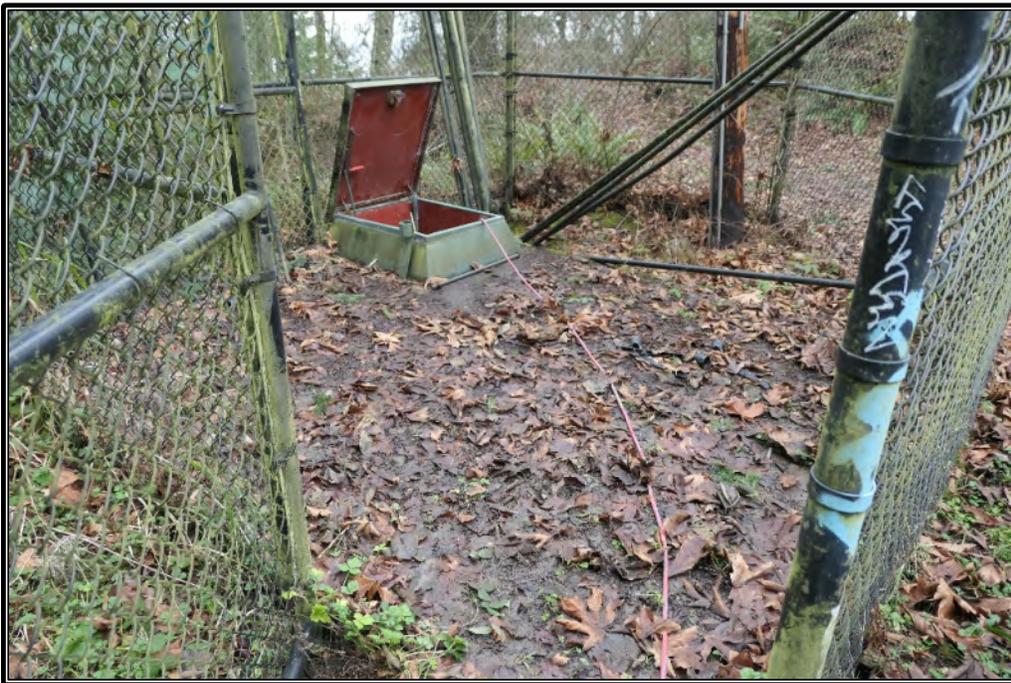
Figure 2-7: Sehome Reservoir - Piping Vault SW of Reservoir

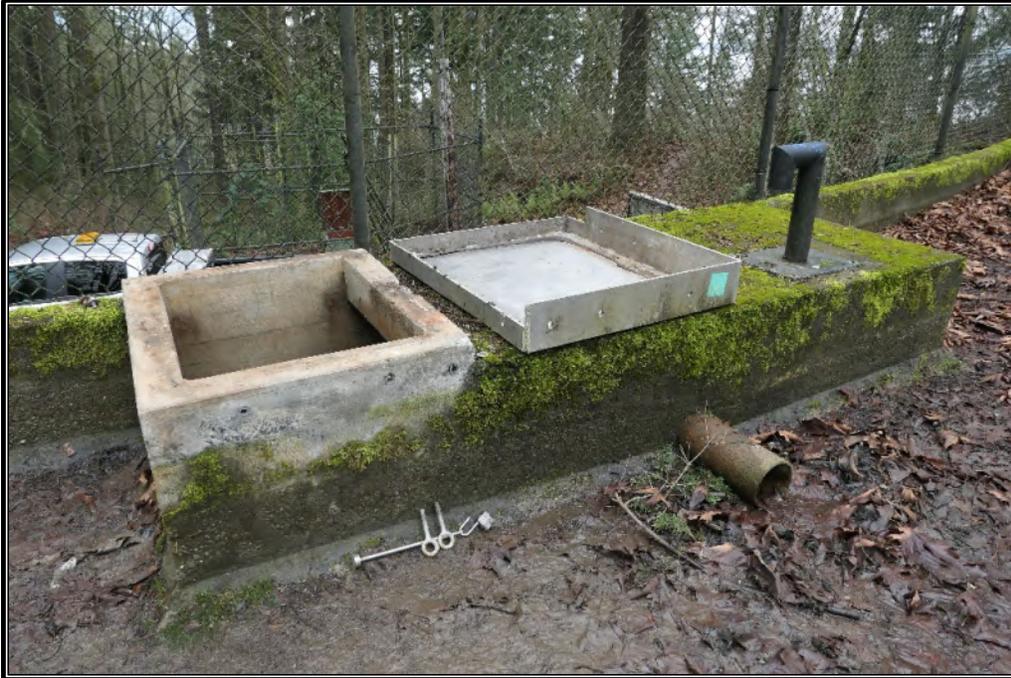
Figure 2-8: Sehome Reservoir - SW Hatch, Vent Pipe, and Roof Drainpipe

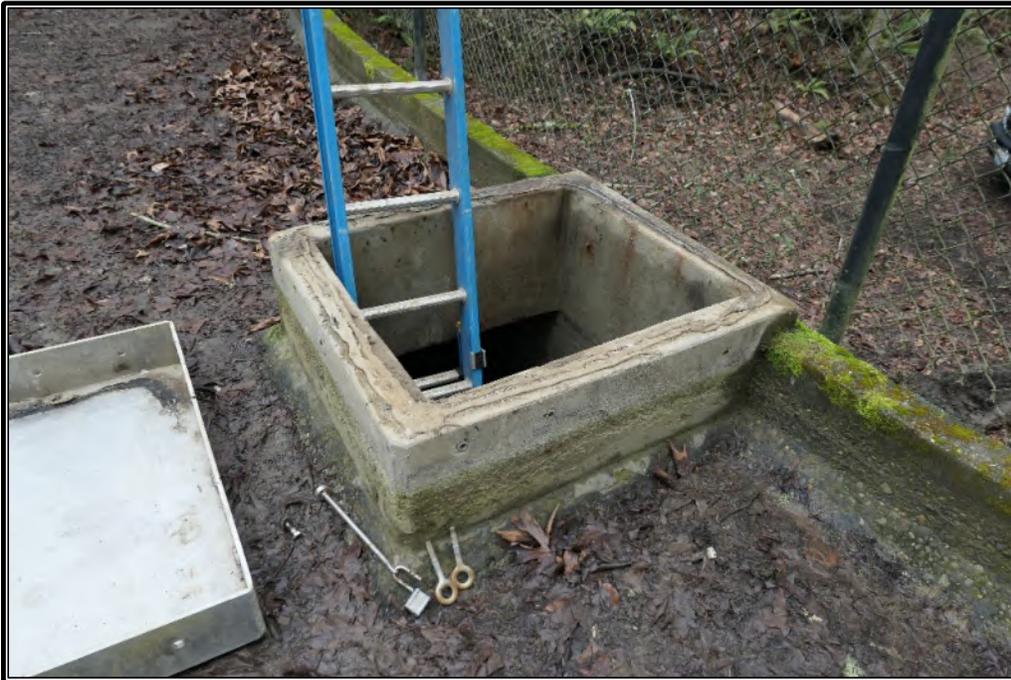
Figure 2-9: Sehome Reservoir - NE Hatch

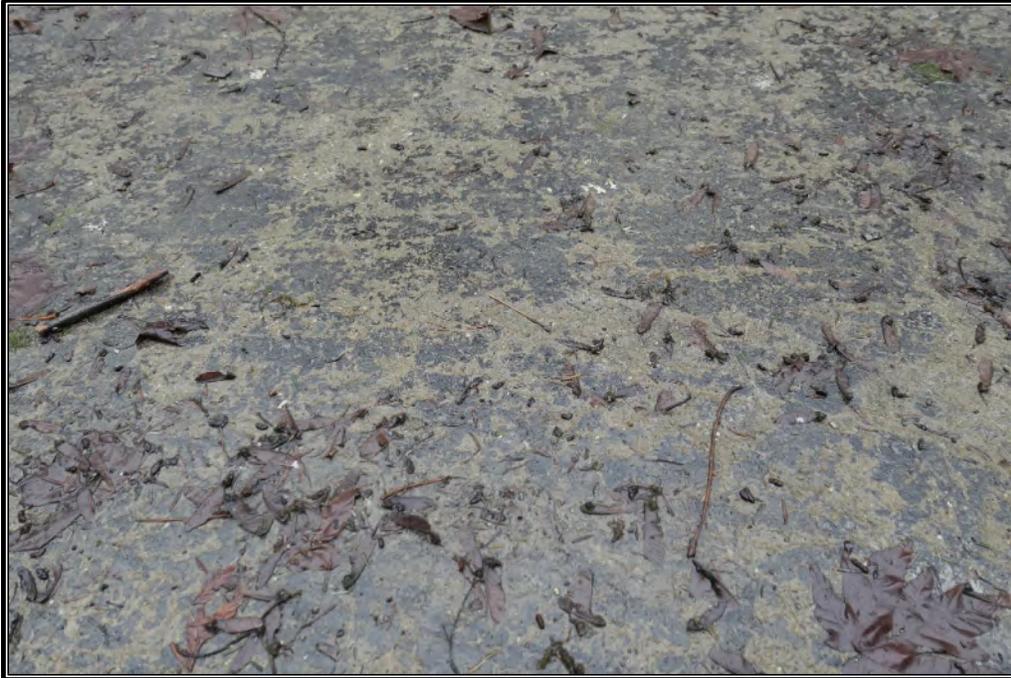
Figure 2-10: Sehome Reservoir - Roof Slab

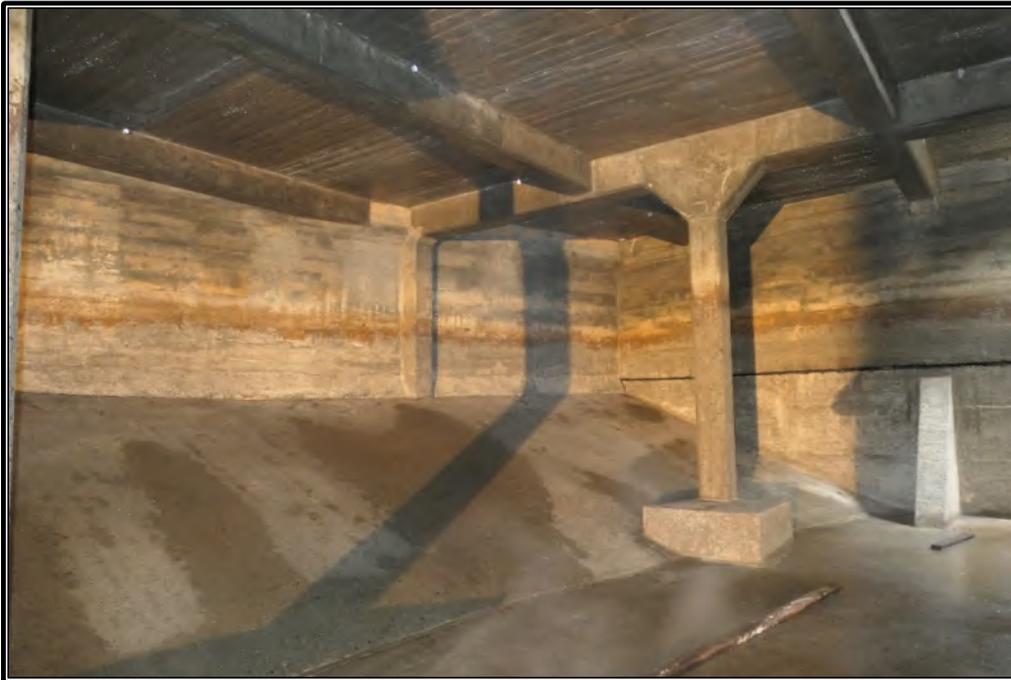
Figure 2-11: Sehome Reservoir - Interior North View, showing sloped floor, roof slab with cast-in beams, and support columns

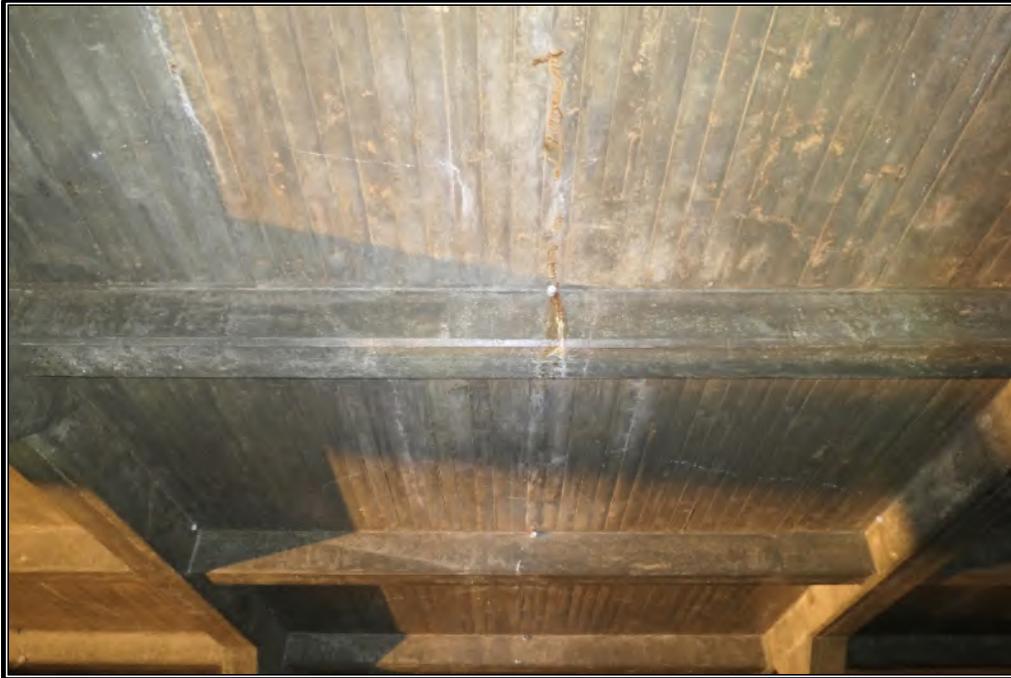
Figure 2-12: Sehome Reservoir - Roof Slab near center, cracking visible at beam centers
